**ATIGUN PASS
REROUTE
REHABILITATION PROJECT
FINAL REPORT
1994**

**Prepared for
Alyeska Pipeline Service Company**

**Prepared by
Stoney J. Wright
Alaska Plant Materials Center**

January 25, 1995

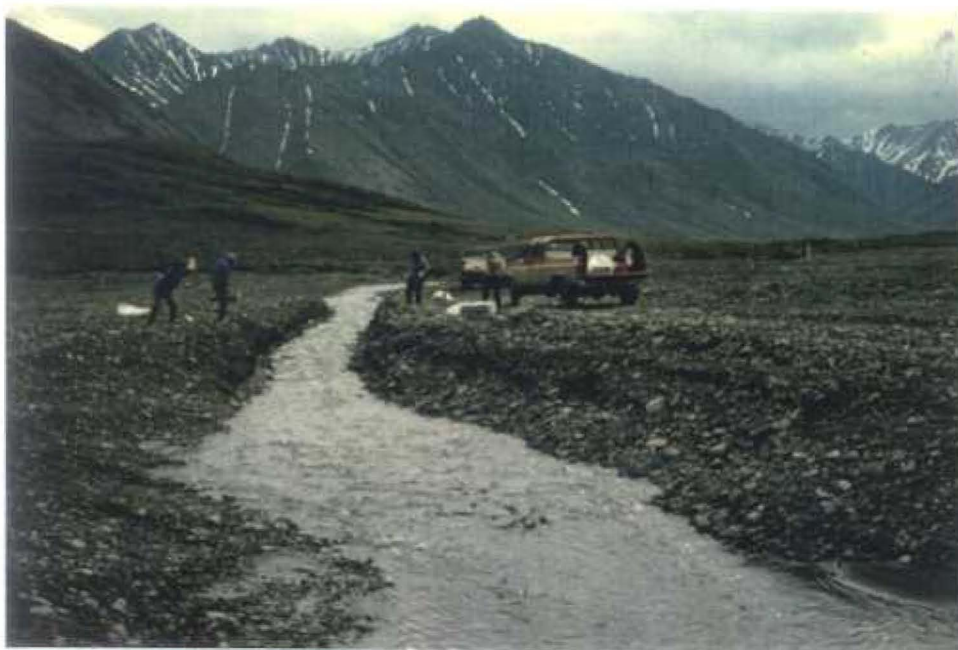
Figure 3. Overflow channel being planted with willow sprigs.

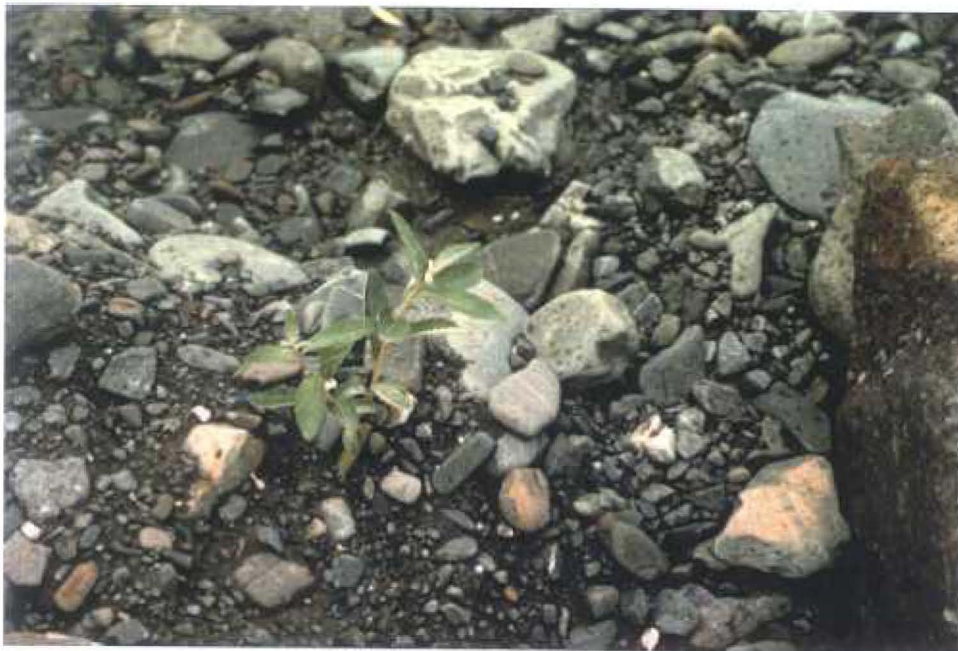
Figure 5. Willow sprig, August 11, 1992, on edge of overflow channel.

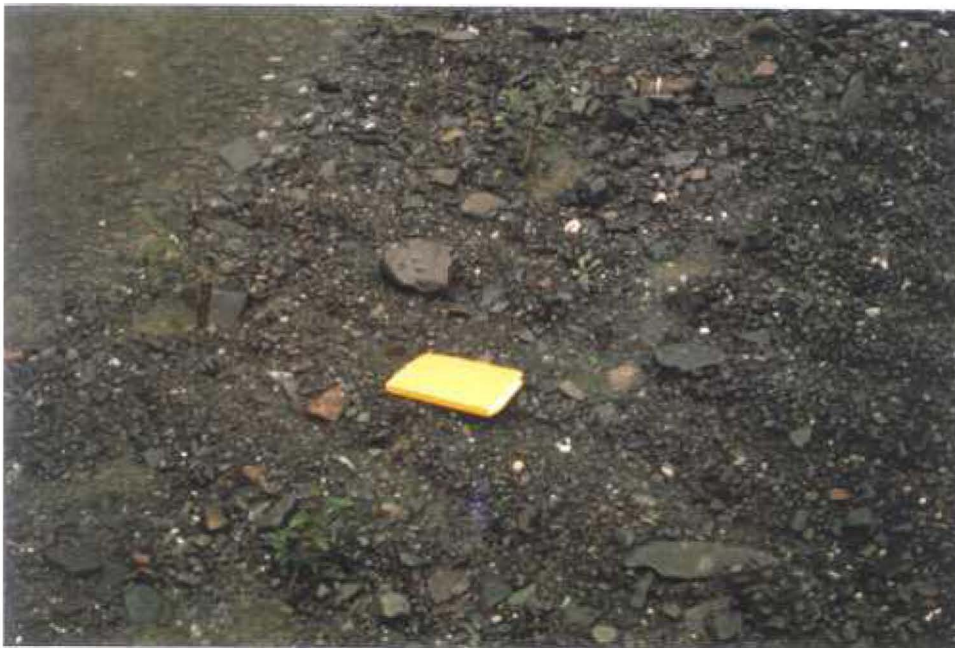
Figure 6. Willow sprig, August 11, 1992, adjacent to Sten Creek Pond.

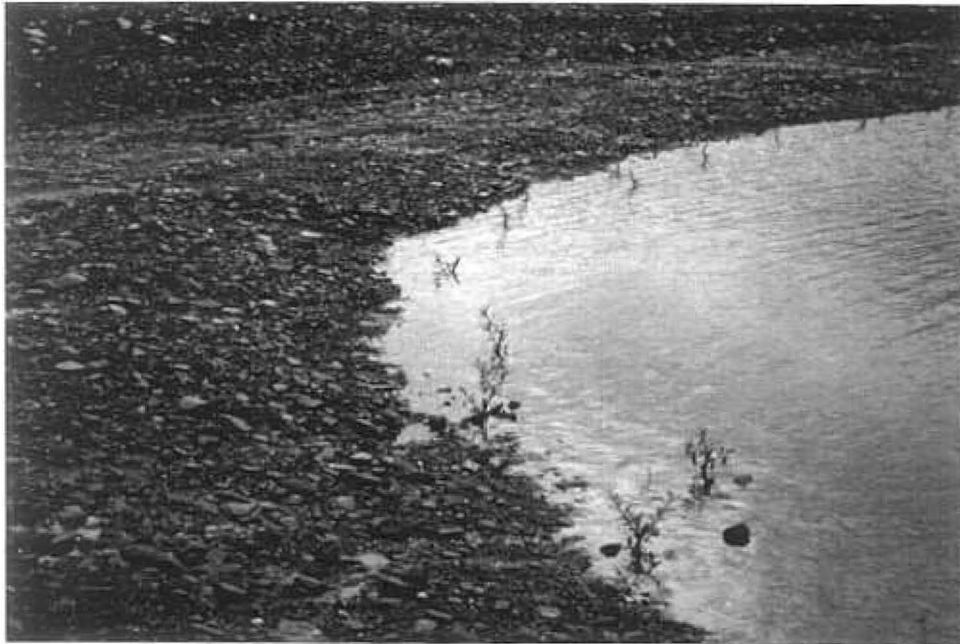
Fluctuating water levels had not been expected in the pond complexes. Approximately 50% of the cuttings were in water at the upper complex on August 12, 1992 (figure 7). The water rose approximately three to four inches after planting. Both Winters Pond and Mosquito Pond also had elevated water levels but fewer cuttings were affected. The higher water levels are not expected to cause problems if they fluctuate seasonally. However, long-term flooding of the root zones may reduce the chances of survival. Documentation of water levels and cutting survival continued through 1994.

Figure 7. Willow sprigs in standing water, August 11, 1992.

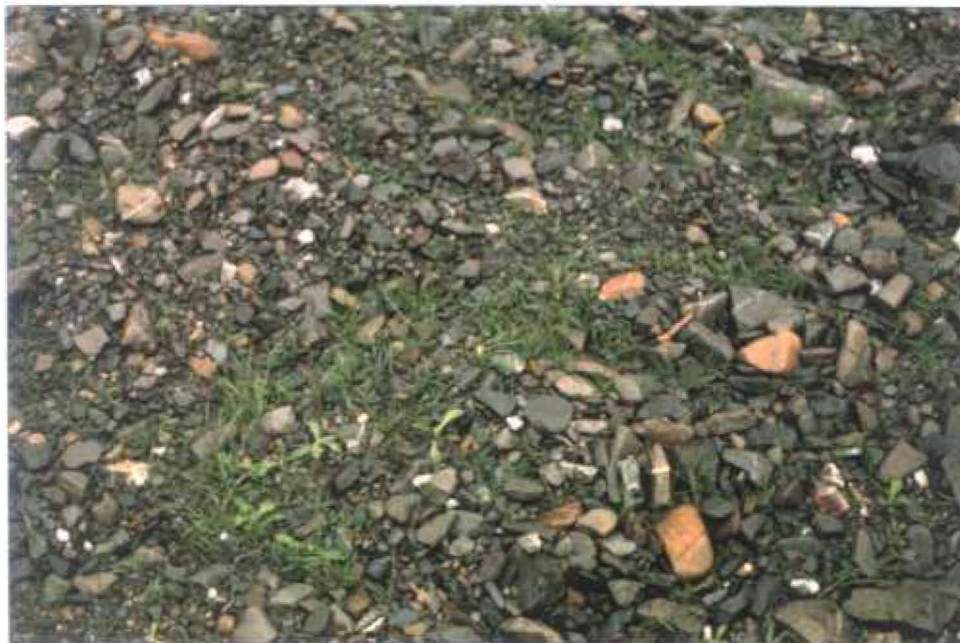
The seeded areas at the Sten Creek Ponds produced very good first-year stands in most areas (figure 8). 'Norcoast' Bering hairgrass, *Deschampsia beringensis*, was the dominant seeded species. Both 'Tundra' glaucous bluegrass, *Poa glauca*, and 'Gruening' alpine bluegrass, *Poa alpina*, were present. 'Caiggluk' tilesy sagebrush, *Artemisia tilesii*, was very prominent throughout the site. The seed mix did not become established on excessively compacted areas.

Figure 8. A dense, first-year stand of seeded grasses. Note *Artemisia*.

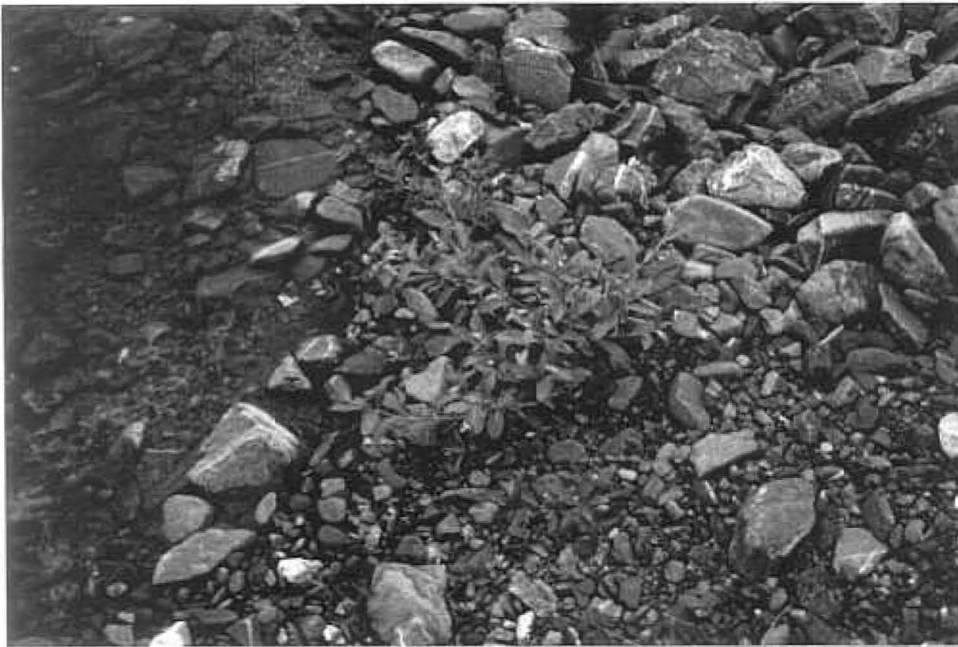
During the summer of 1993, reports were received by the PMC suggesting that the plantings were growing well. During the evaluation on August 3, a decline in the number of surviving willow sprigs was noted. Additionally, the overall vigor of the surviving willow appeared to be in decline. Whether this was a result of temporary seasonal climatic stress or actual site conditions was not determined. It was noted that some new (1993) willow growth was developed on the previous year's growth. Some of the plantings had lost the 1992 shoot growth and new growth was originating from the main stem and other cuttings continued their growth from the 1992 branches (figures 9 and 10).

Figure 9. Willow showing new growth from main stem.

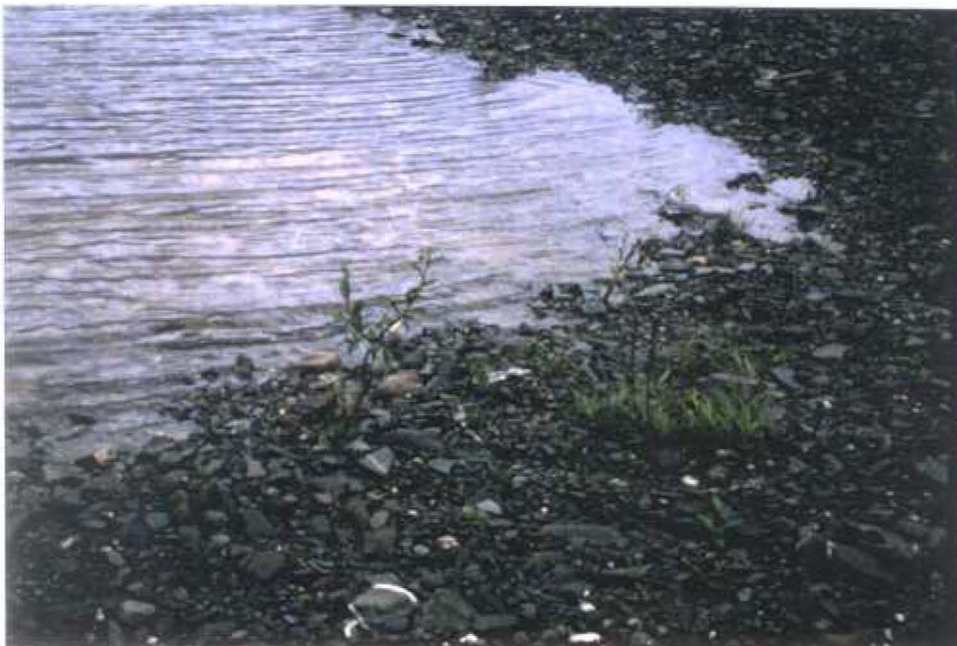
Figure 10. Willow showing new growth from previous year's growth. Note *Artemisia*.

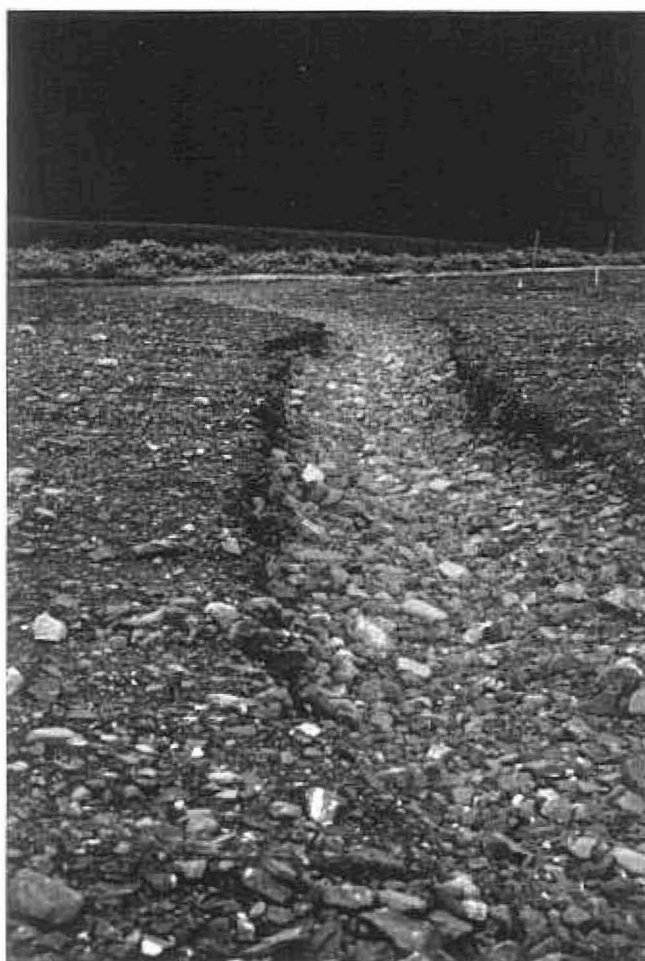
During the design phase of this project, it was suggested that the overflow channels were not suited for willow sprigging. By agency insistence, the channels were sprigged. Initial estimates of survival for the willow sprigs ranged from 15 to 20%. Actual survival as recorded in 1993, ranged from 10 to 20%. The vigor of the surviving willow sprigs was rated as being low. It appeared that the majority of the loss could be attributed to erosion of the banks of the channels (figure 11).

Figure 11. Eroded banks of overflow channel.

1. Willow sprigging on the work pad failed. The initial plan recognized the problems associated with the concept of planting willow adjacent to the overflow channels. The data seems to show that the practice of sprigging or planting willow on the work pad will fail.

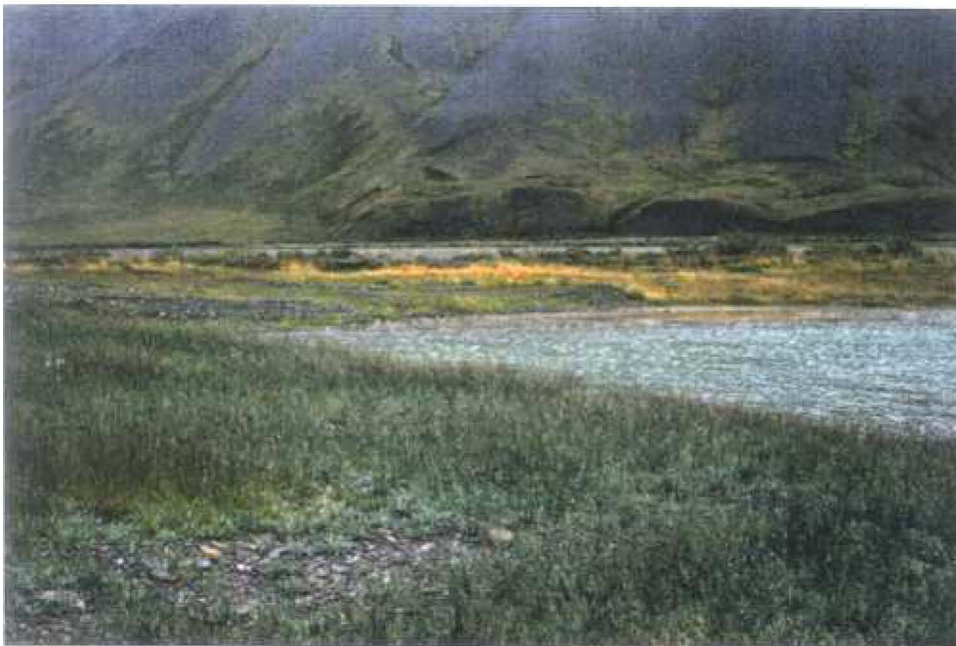
Plant cover for the seeded areas around the Sten Creek ponds, continued to increase. The upper pond complex supported approximately 40% cover in 1993. The vigor of the grass was rated good to excellent. The most vigorous growth occurred on the mound area west of Pond A (figures 12 and 13). The drier, gravelly sites had the poorest vigor and lowest ground cover.

Figure 12. Upper pond complex seeding after two full growing seasons.

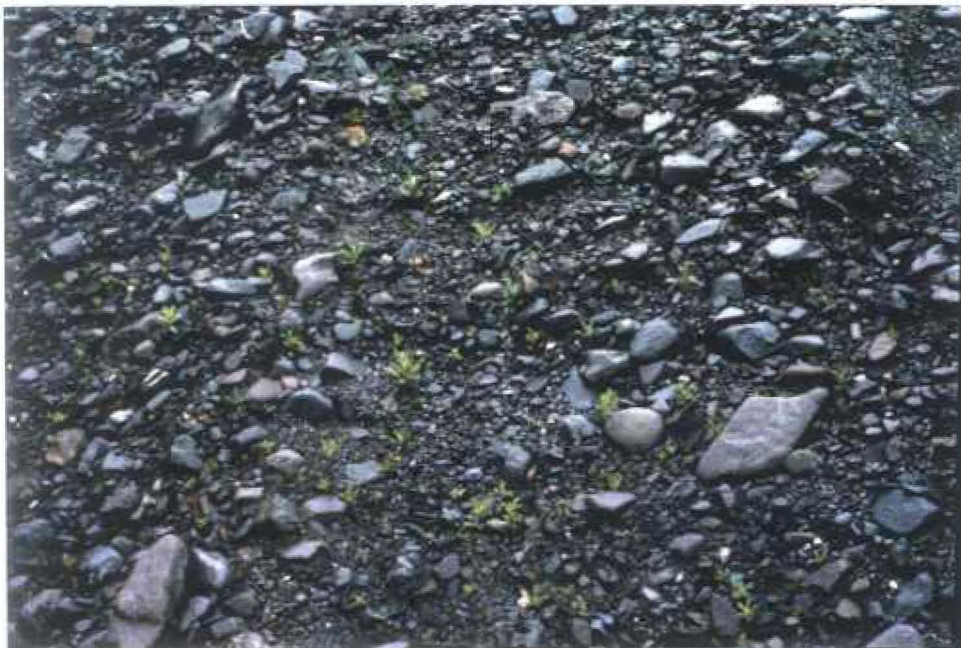
The light seeding used in the area allowed invasion of native species including River Beauty, *Epilobium latifolium*, and willow, *Salix* sp., (figure 14). In some areas, 30% of the vegetation was composed of invading species.

Figure 14. Reinvansion of native species on open areas where seed did not establish.

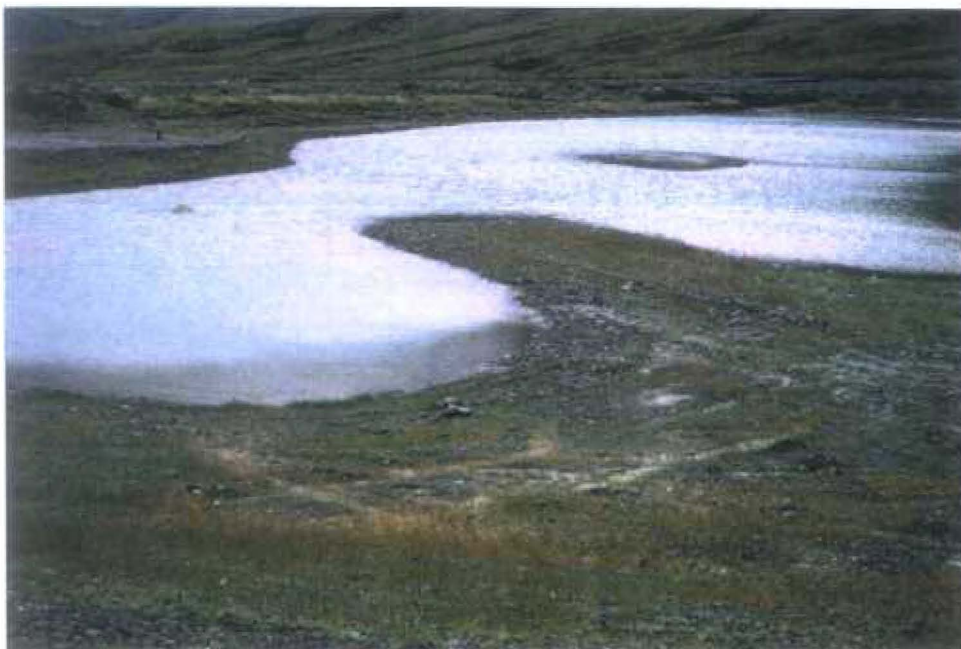
In 1993, the lower pond area continued to show poor performance. This, in part, can be attributed to the highly compacted site. The overall cover for the lower pond was 30%, and vigor was rated poor (figure 15). The previously (1978) seeded areas adjacent to the lower pond responded very well to the fertilizer application. Growth and vigor of the plants increased markedly from the previous year.

Figure 15. Lower pond areas in 1993.

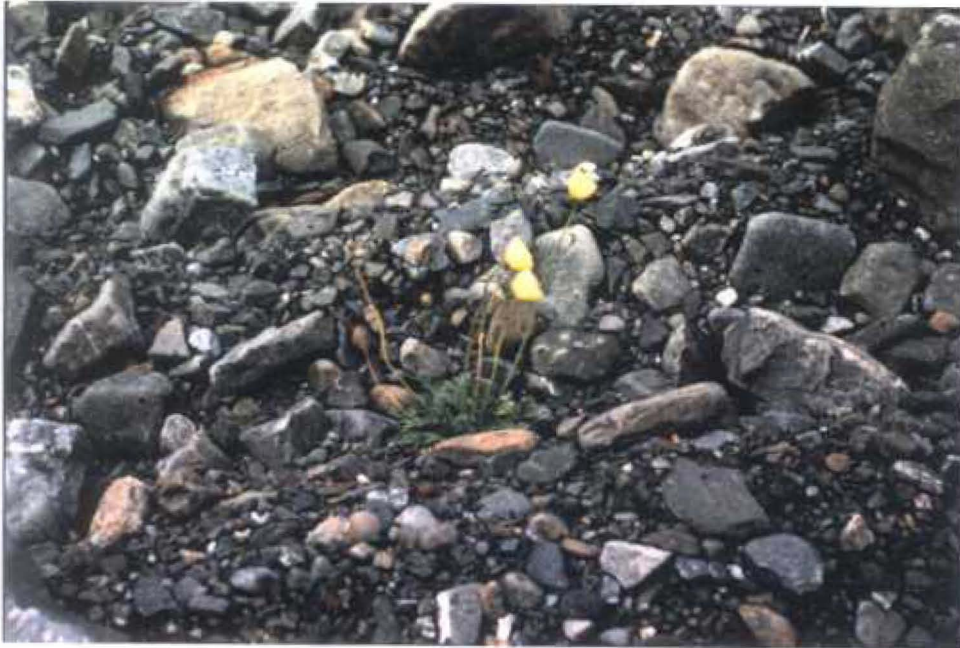
By August 1993, the areas scarified and fertilized in 1992 were starting to show signs of reinvasion. The percent cover was not estimated since it appeared to be less than one percent. The species noted included hairgrass, *Deschampsia* sp., bluejoint, *Calamagrostis* sp., sedges, *Carex* sp., River Beauty, *Epilobium latifolium*, sagebrush, *Artemisia* sp., poppy, *Papaver* sp., and vetch, *Oxytropis* sp. (figures 16 and 17).

Figure 16. Scarified work pad reinvasion, 1993.

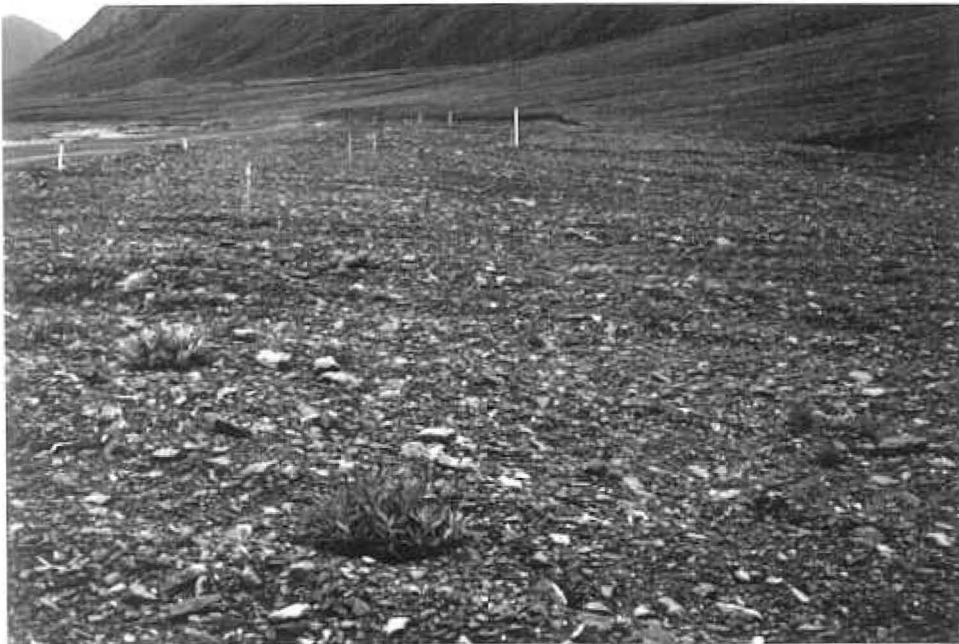
Figure 17. Scarified work pad south of bridge, 1993.

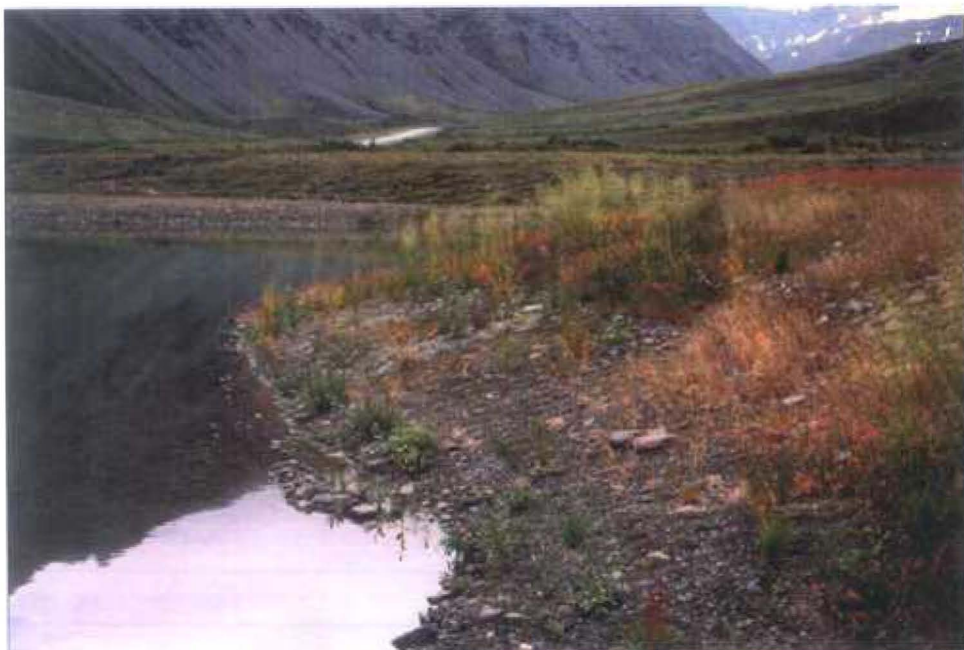
Pond A in the upper complex, continued to support a good stand of willow. Survival ranged from 30 to 80%. Vigor of the surviving cuttings was rated highest at this pond (figure 18).

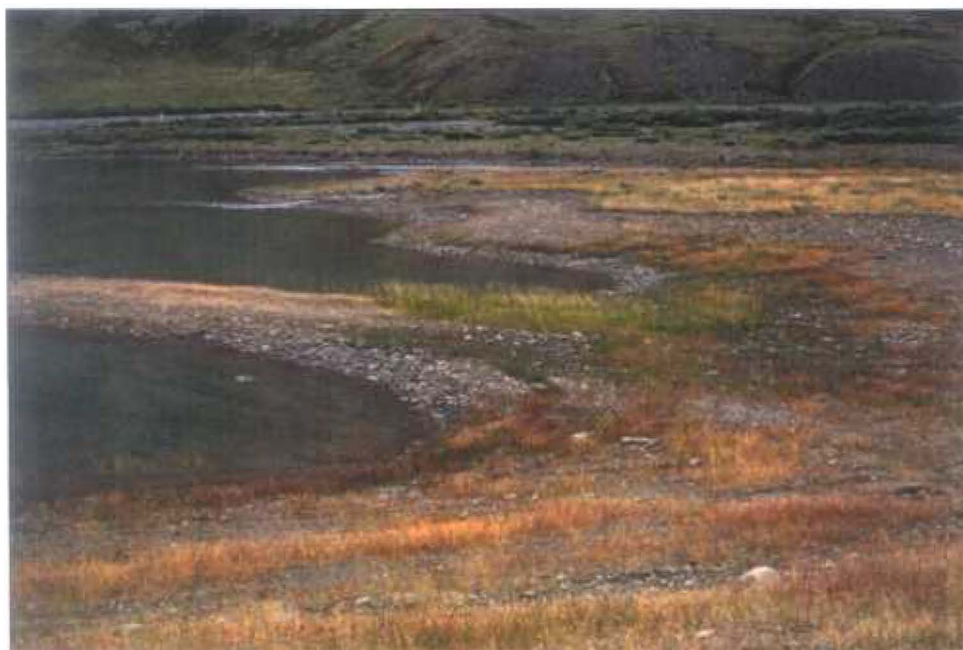
Pond B had a slightly lower survival rate, 20 to 80%. Overall, vigor exhibited by the willow at Pond B was lower than Pond A (figure 19).

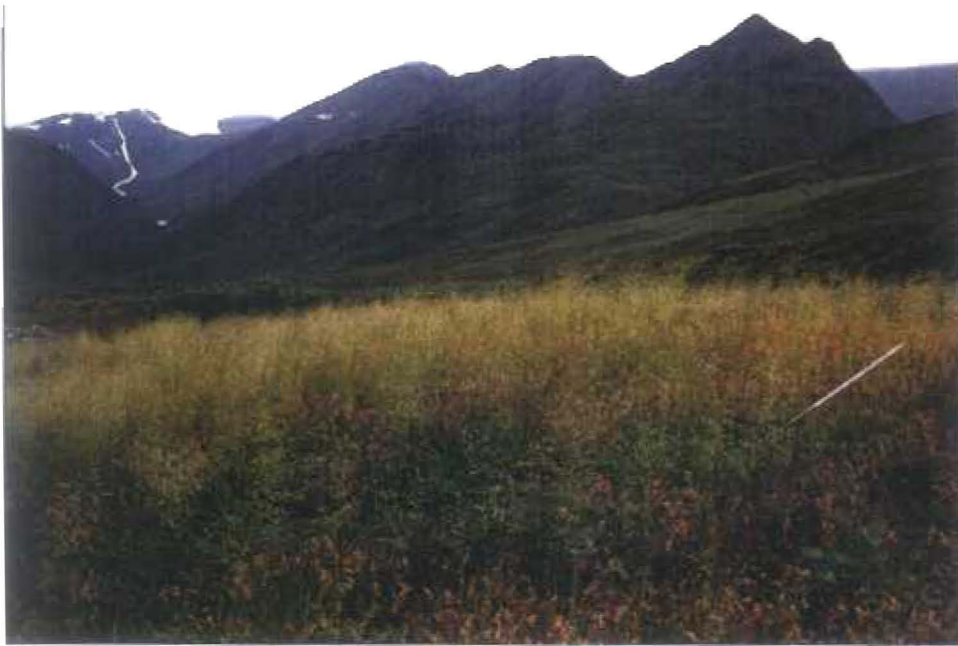
The overall cover at the upper pond area ranged from 30 to 80%. The vigor was rated fair to excellent. The best performance was noted at the mound area west of the Pond A (figure 20), and the poorest overall performance was noted on southern and western aspect of the cut and fill slopes around the ponds.

Figure 20. Mound area west of Pond A in upper complex in 1994
Excellent stand of seed grasses.

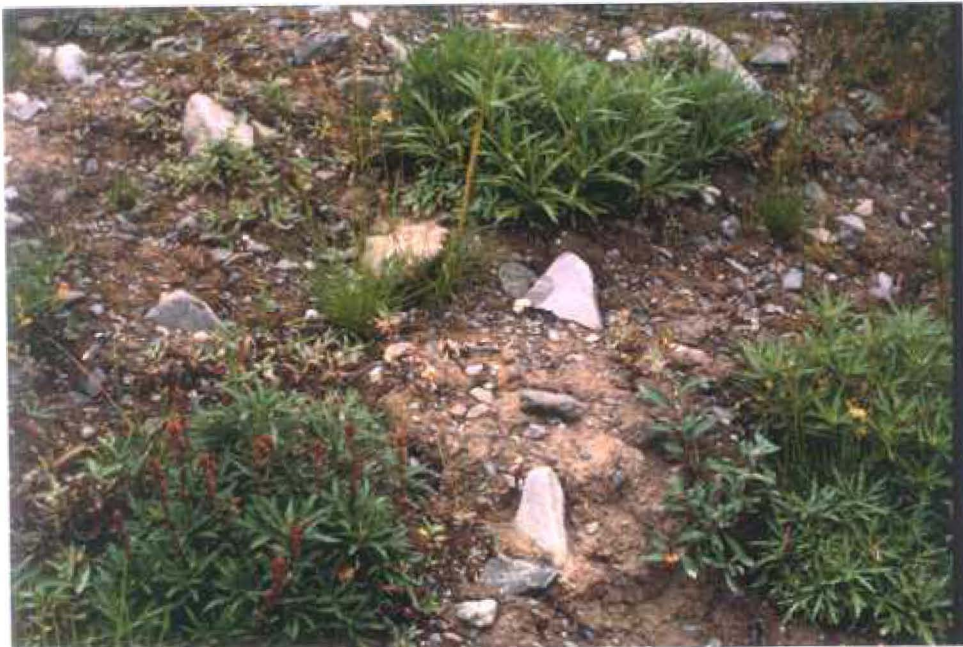
Native species including bluejoint, *Calamagrostis* sp., River Beauty, *Epilobium latifolium*, and willow, *Salix* sp. seedlings were colonizing both the upper and lower areas (figure 21). The upper pond area exhibited greater diversity and some wetland species such as sedge, *Carex* sp., and rushes, *Juncus* sp.

Figure 21. Upper pond complex colonization by native species in 1994.

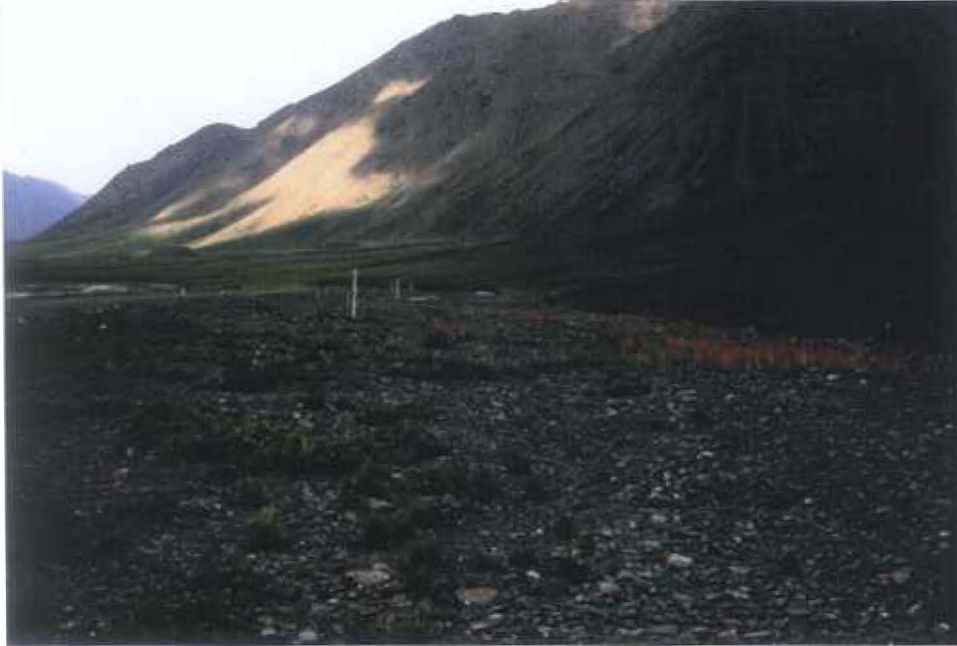
In 1994, the natural recolonization of the workpad Mile Post 161 north to the transition, was excellent. In selected areas, vegetation cover exceeded 10%. In specific sites, estimates of cover approached 40% (figure 22). Based on observations of natural recolonization in other areas along the pipeline or elsewhere in the state, the process of native plant invasion along this section of workpad appeared to have occurred relatively swiftly and supported numerous plant species.

Figure 22. Scarified work pad in 1994 showing extent of colonization.

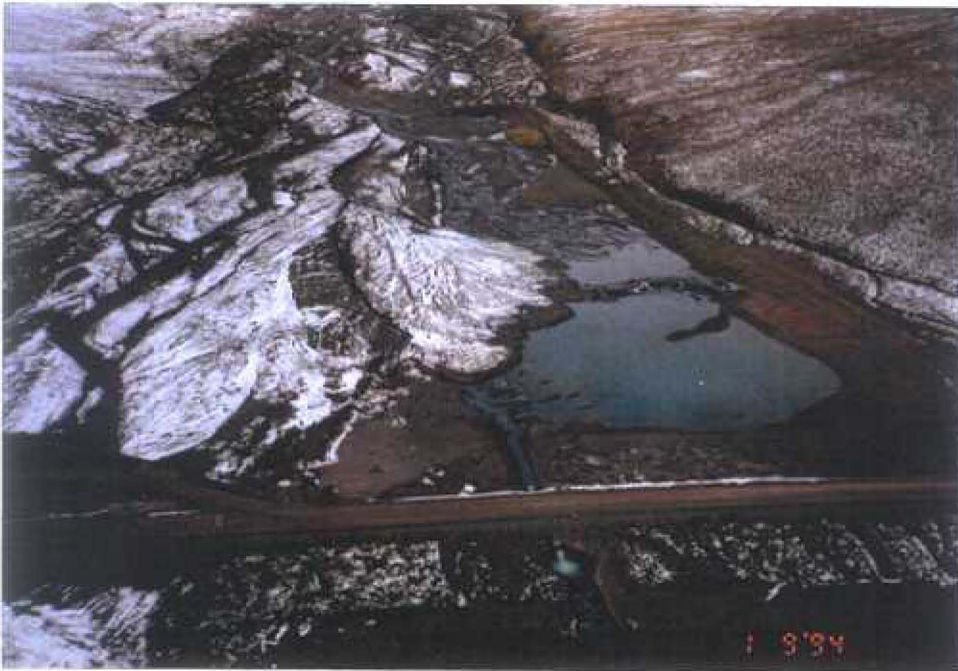
Heavy rains at the end of August 1994 caused Sten Creek to overflow resulting in a massive land slip and breach of the Dalton Highway. Most of the Sten Creek pond area and rehabilitation effort was destroyed by the occurrence (figures 23 and 24).

Figure 23. Upper Sten Creek ponds after flooding. Photo by Mike Thompson.

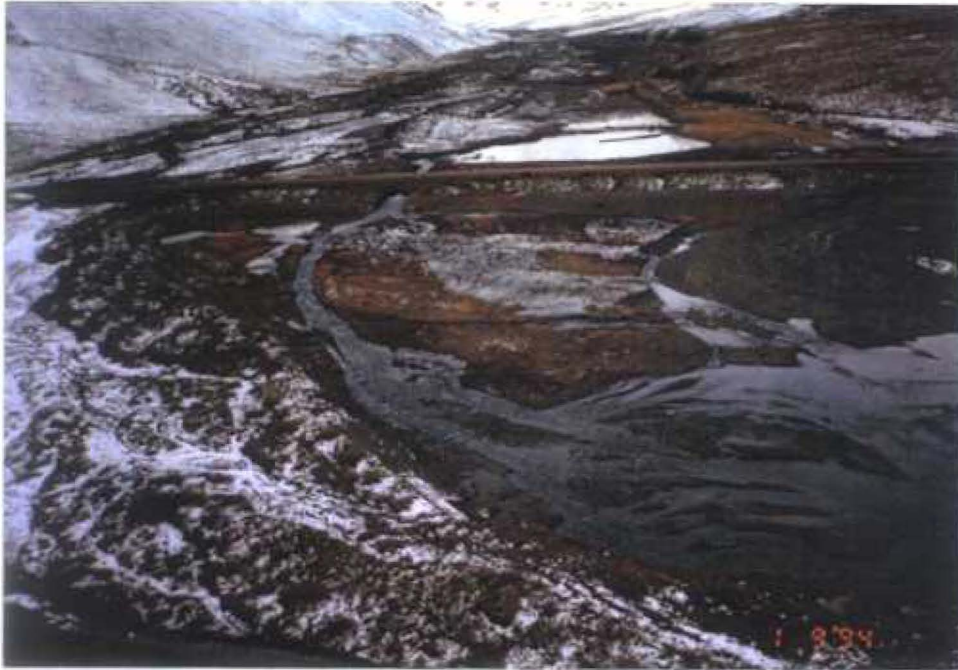
Figure 24. Lower pond area after flooding. Photo by Mike Thompson.
