Landfill Restoration

On Adak Island

December 1999

LANDFILL RESTORATION ON ADAK ISLAND 1997 - 1999

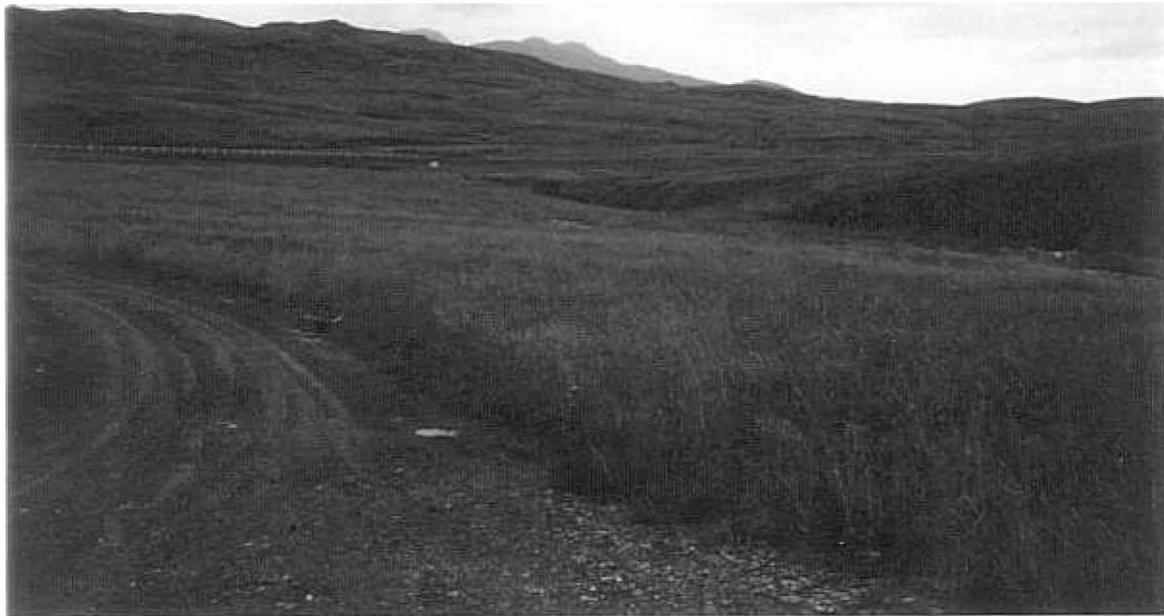
The initial site evaluation in 1996 suggested that the seeding and fertilizer specification was not followed. The site was densely covered with Annual rye; a cover much higher than would be expected with a seeding rate of 5% (Figure 1). A year later in 1997, the perennial cover on the site was near 95% (Figure 2). However, less than 5% of the perennial grass cover was hairgrass, also supporting the possibility that a substitution was made to the seed mix. Native species began recolonizing the site in 1997.

Figure 1. Palisades Landfill, fall 1996, showing heavy stand of Annual ryegrass

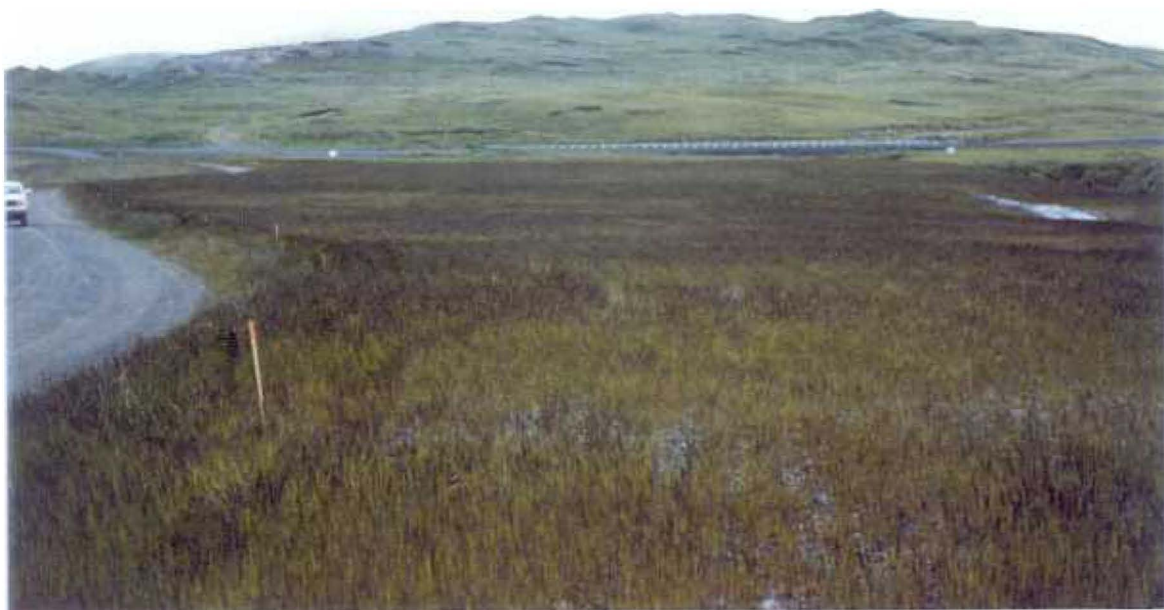
Figure 2. Palisades Landfill, 1997, showing nearly 100% composition of Red fescue.

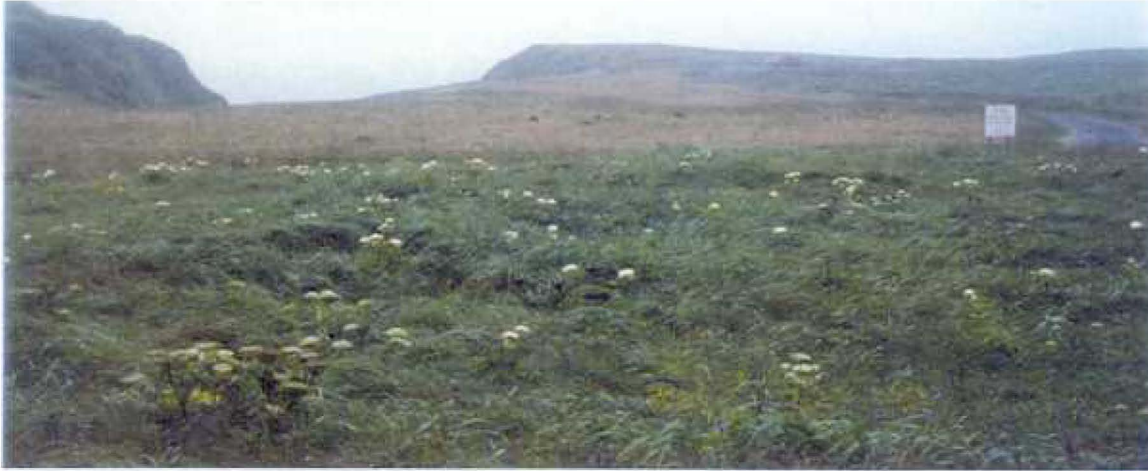
On August 28, 1998, Palisades supported nearly a 100% cover of perennial grasses (Figure 3). The percentage of cover had increased since 1997. The overall vigor of the Palisades vegetation was starting to decline in 1999 (Figure 4). The dense Red fescue stand was showing signs of fertilizer deficiencies. The primary reason hairgrass was included in the seed mix is because it tends to perform well on the low fertility soils of the Aleutians. A maintenance fertilization program has been recommended to the Navy.

Figure 3. View of Palisades Landfill (background) showing good cover but declining vigor of perennial grasses

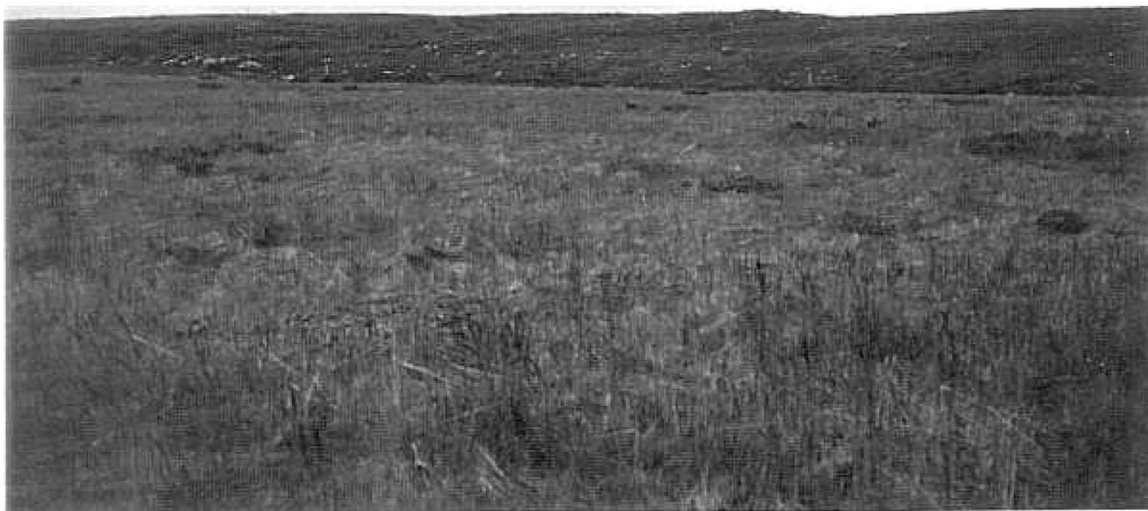
Figure 4. Palisades 999 Note invasion of lupine and low vigor of seeded grasses

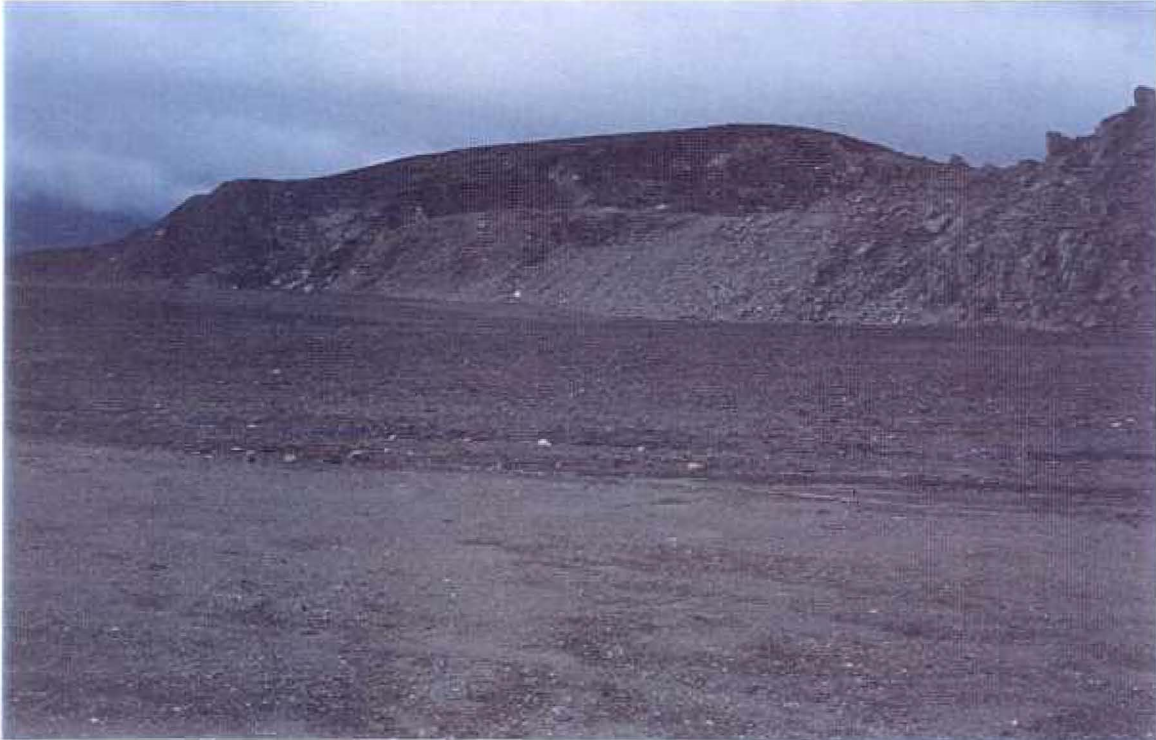
Figure 5. Metals Landfill, 1997, after final grading.

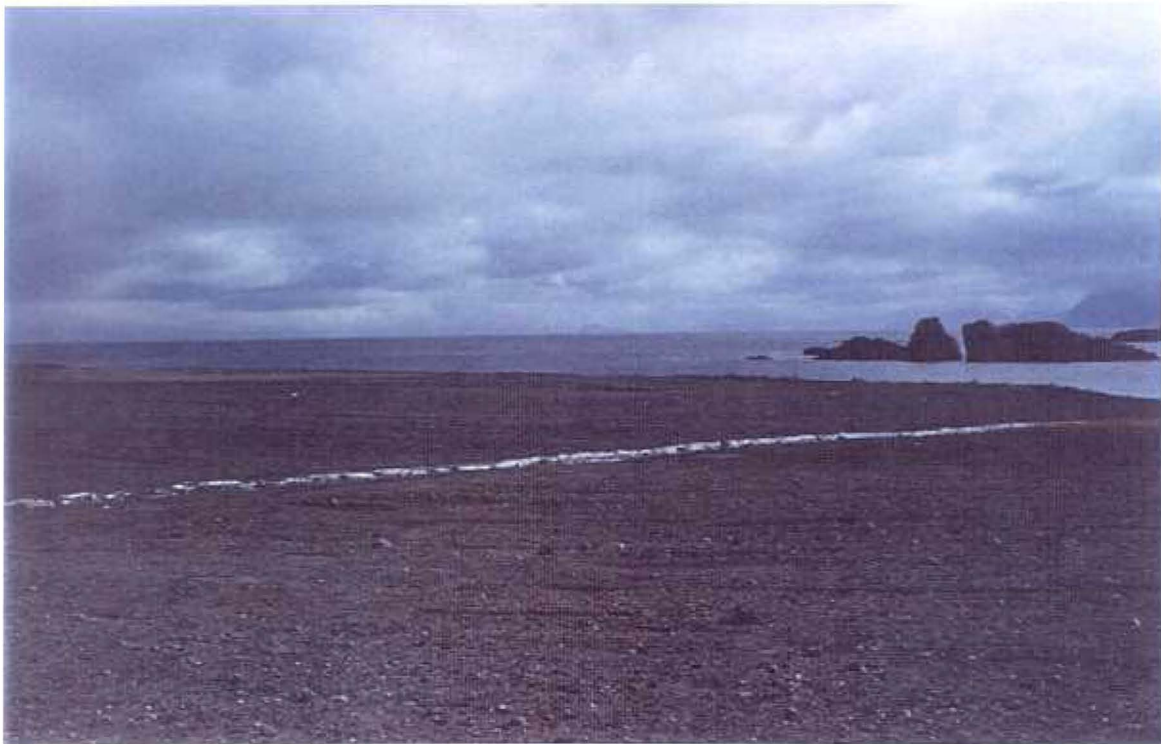
Figure 6. Metals Landfill, 1997, showing finished grades and site preparation for natural revegetation.

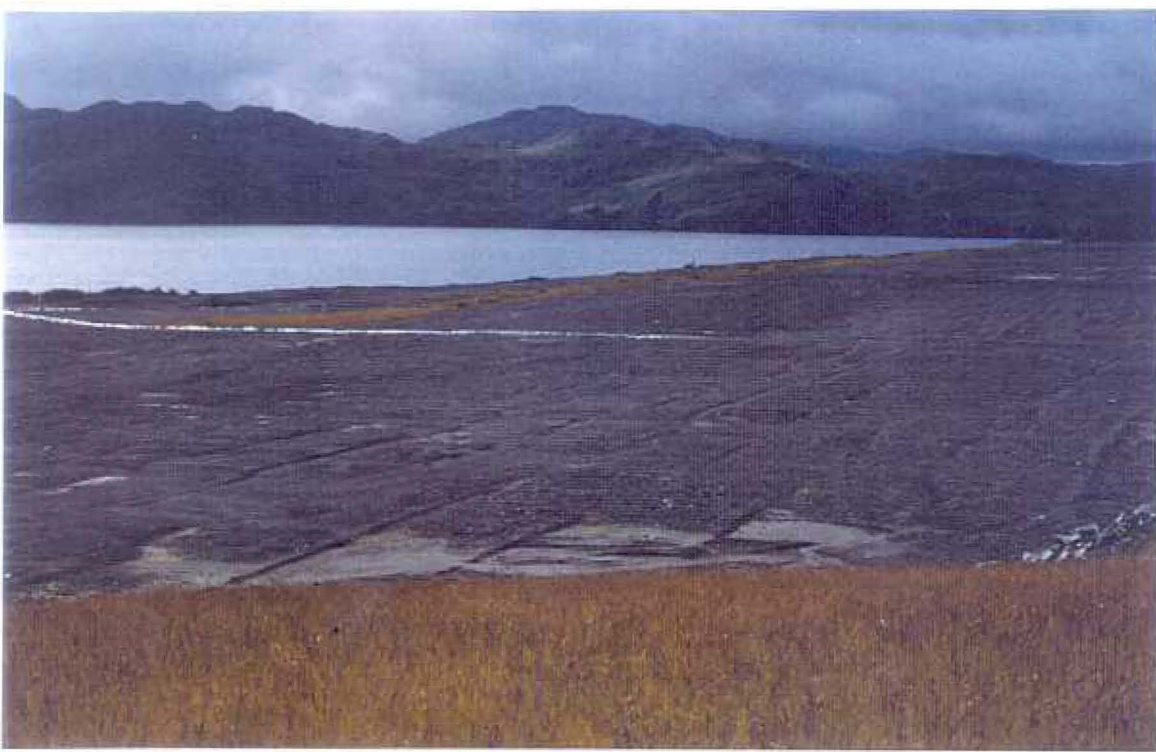
Figure 7. Seeded areas in Metals Landfill, 1998, foreground.

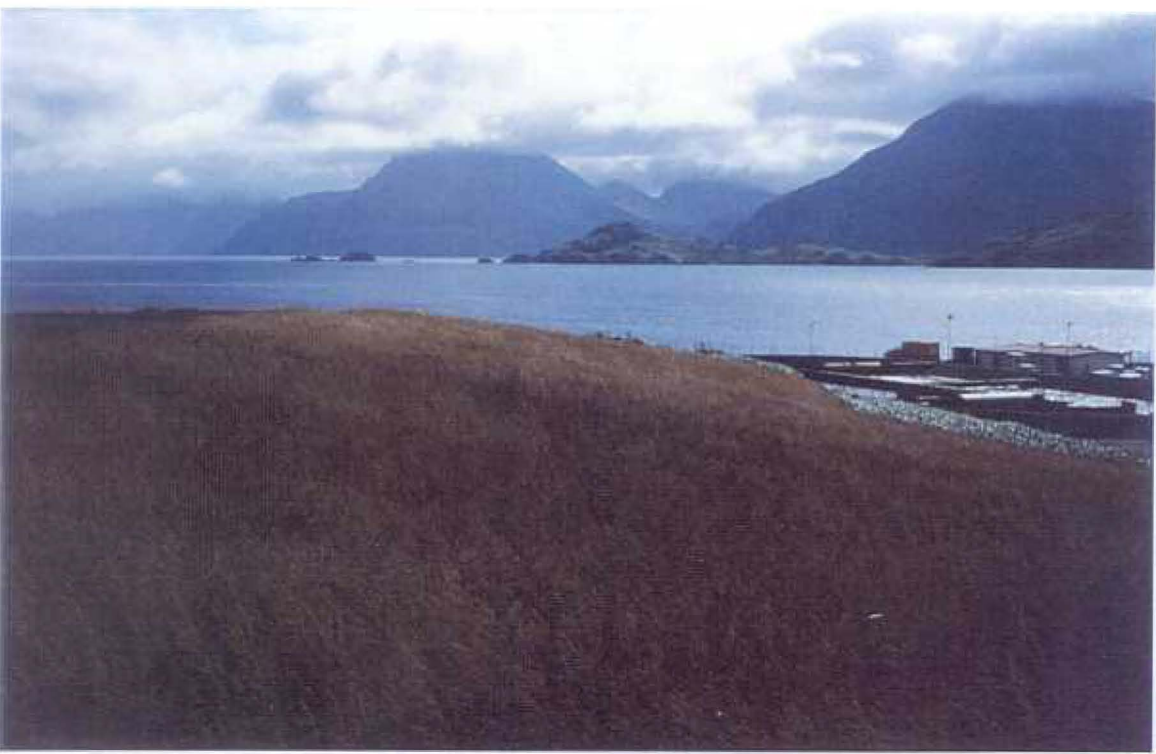
Figure 8. Seeded slope at Metals Landfill, fall of 1998.

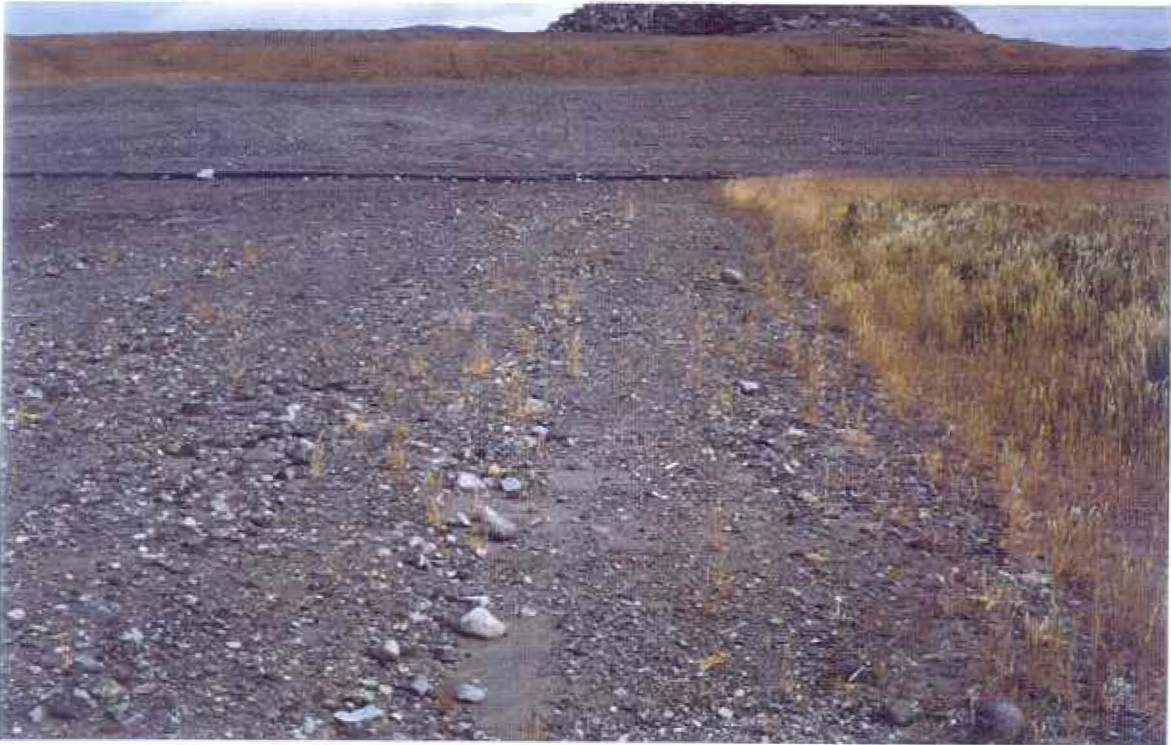
The areas intended for natural revegetation were still languishing and not performing as expected; plant cover was sparse (Figure 9). Light surface scarification and fertilization would assist the natural revegetation process. The most significant problem noted at the Metals Landfill was the erosion on the back slope adjacent to the pit. The effect of the erosion is limited to the interior of the landfill and none of the sediment is escaping the confines of the landfill (Figures 10 and 11). Each year beginning in 1996, these problems were brought to the Navy's attention. Successful corrective measures for the problem area would be very costly.

Figure 9. Metals Landfill at edge of natural vegetation stand (not disturbed during construction) and invading plants on left.

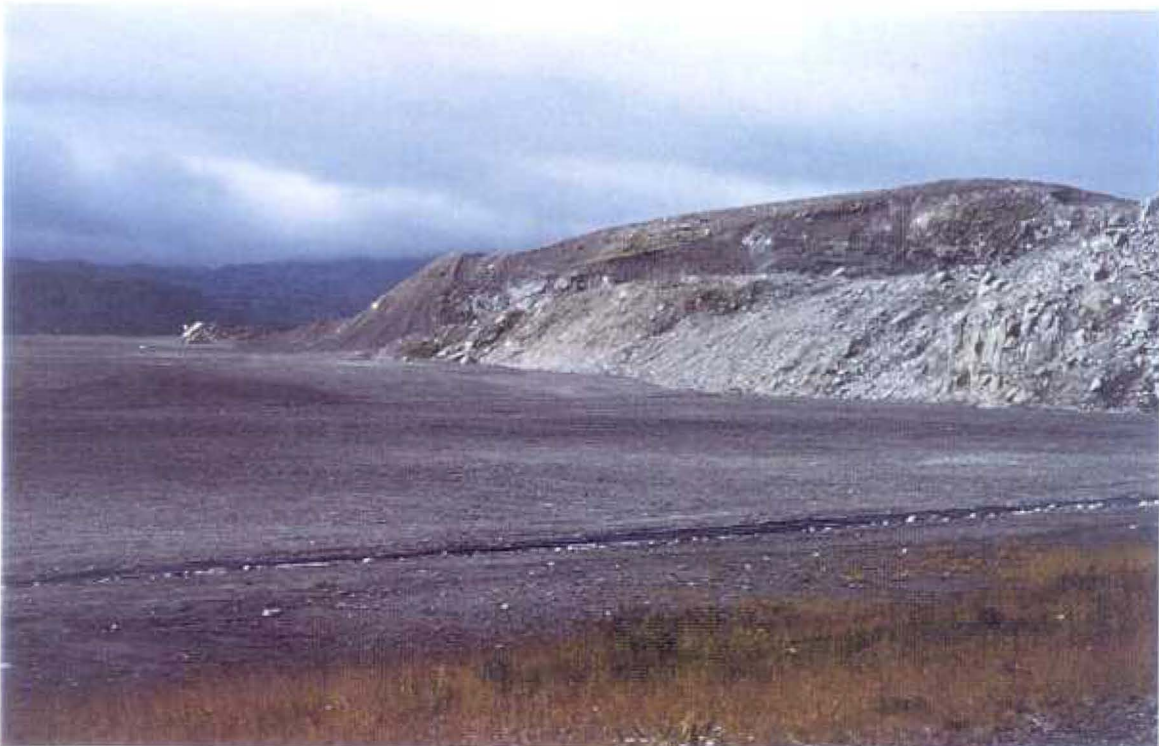
Figure 10. Eroding back slope area at Metals Landfill, 1998.

The back slope areas of Metals Landfill are actively eroding. Some areas showed massive gully formation. The outwash sediments from these sites are covering large areas within the landfill. This is a problem that should be addressed in the near future.

1. Develop a plan to correct the erosion problems in Metals Landfill.
2. Gather plastic netting as it separates from excelsior blankets in White Alice and Robert's Landfills.
3. Eliminate the use of excelsior blankets in revegetation projects on Adak.
4. Weigh the true value of straw mulch. It does not provide much in way of surface protection.
5. Consider extending the duration of this contract to allow for an additional site visit in 1999. This will allow for the evaluation of Robert's Landfill and the corrective measures employed at Metals. The existing obligated monies will cover the contracts extension.

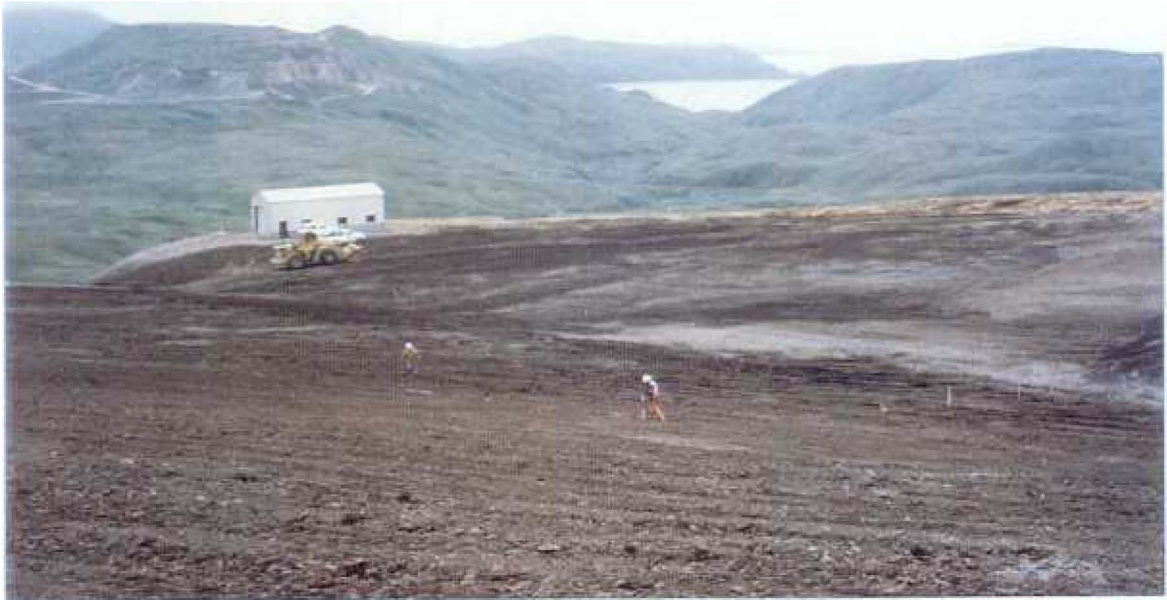
Figure 12. White Alice Landfill after grading, 1997

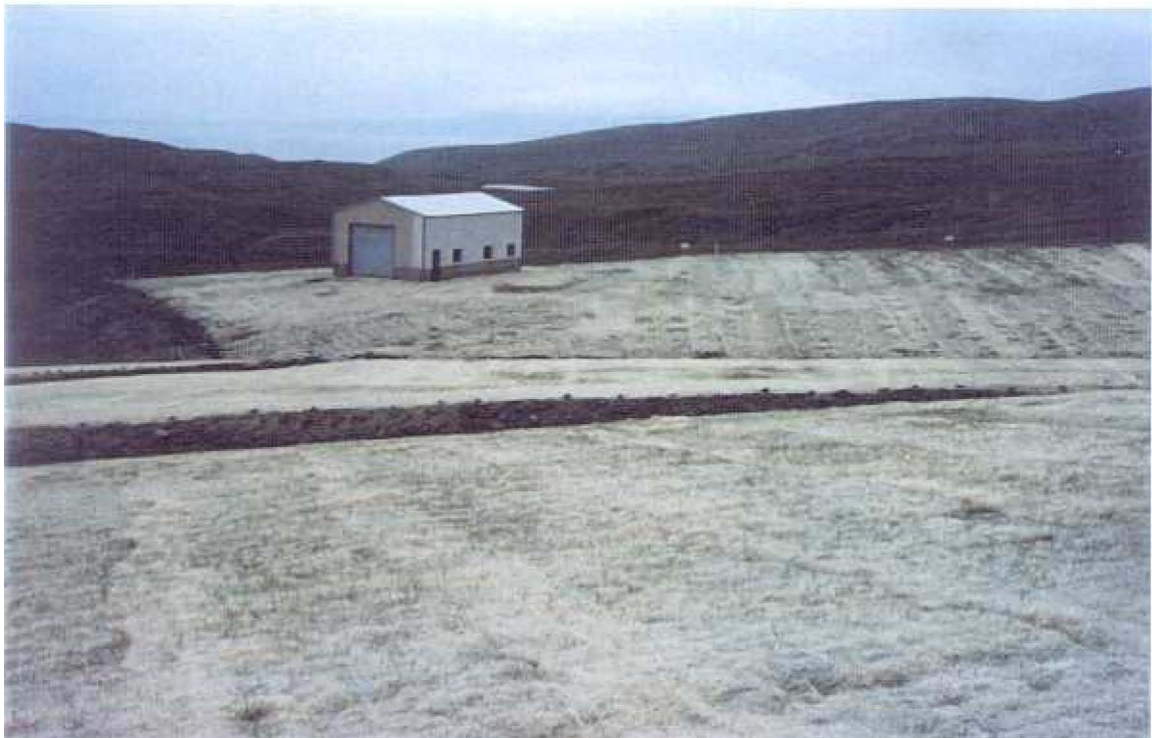
Figure 13. White Alice Landfill, 1997. Note excelsior and emerging Annual ryegrass.

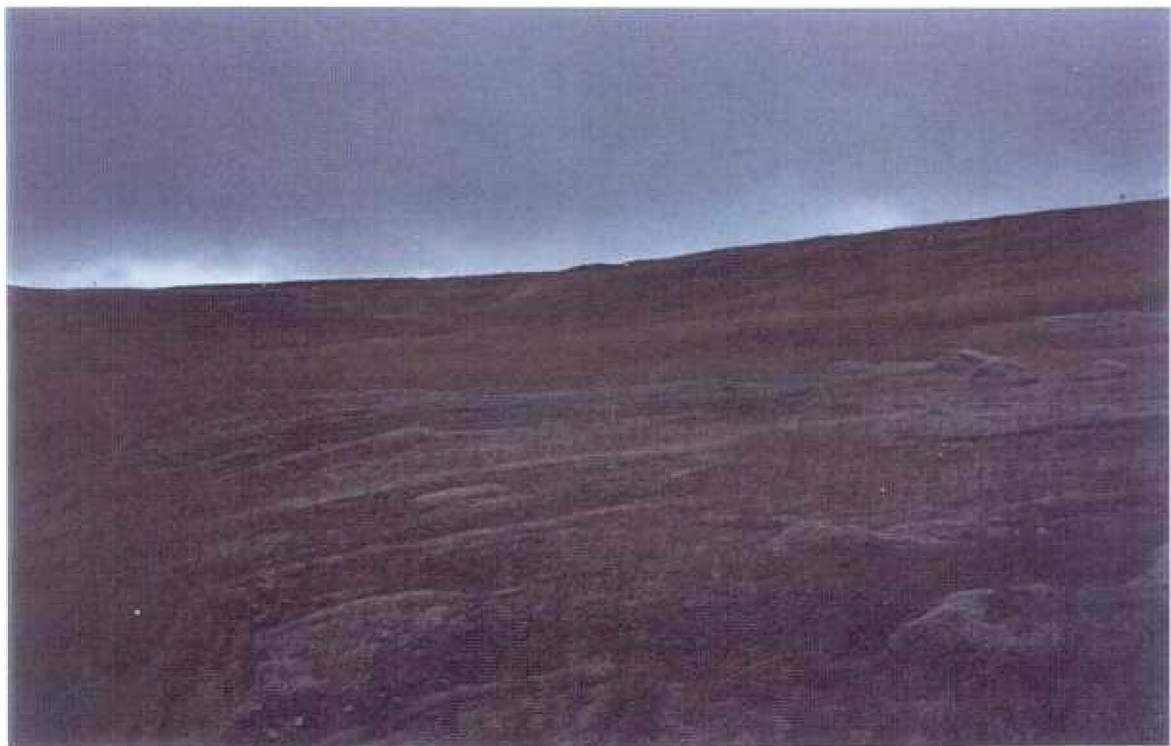
During the final evaluation of White Alice Landfill (Figures 15 and 16), the vegetation was showing signs of nutrient deficiencies. If hairgrass been used this problem would not have occurred.

Figure 15 White Alice landfill 1998 Note very poor growth perennial grasses and poor cover

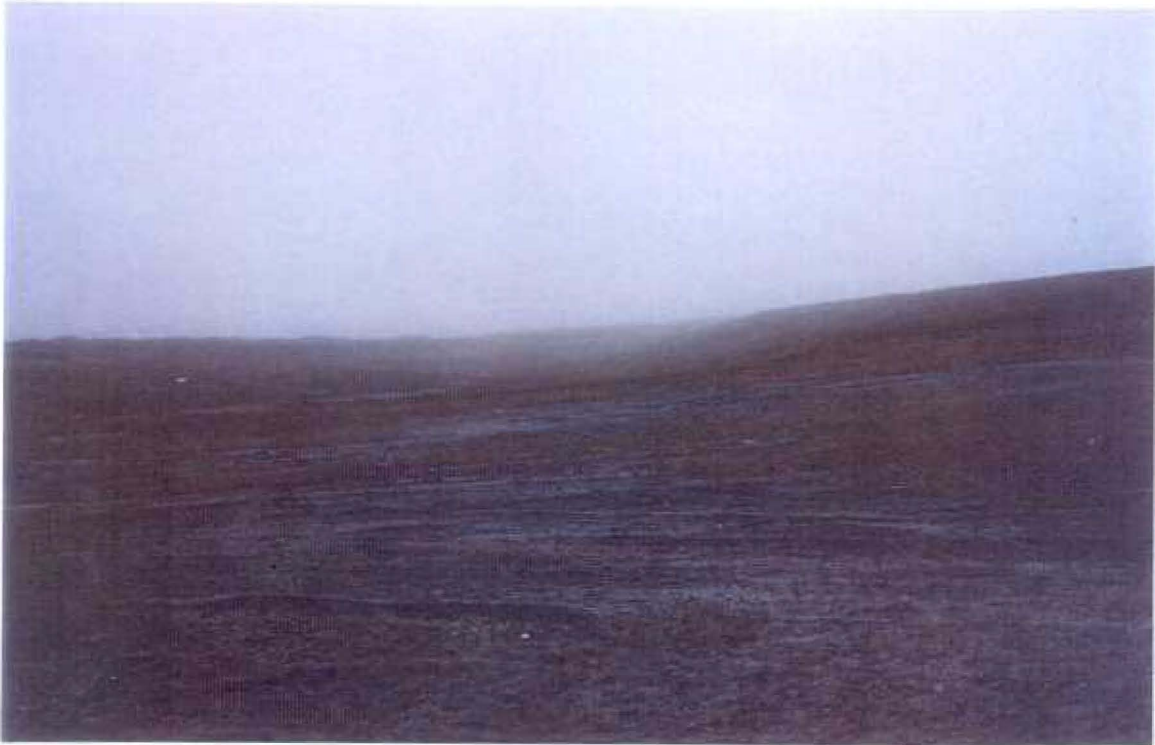
Figure 16. White Alice Landfill, 1999. Note exposed soil and absence of excelsior blankets.

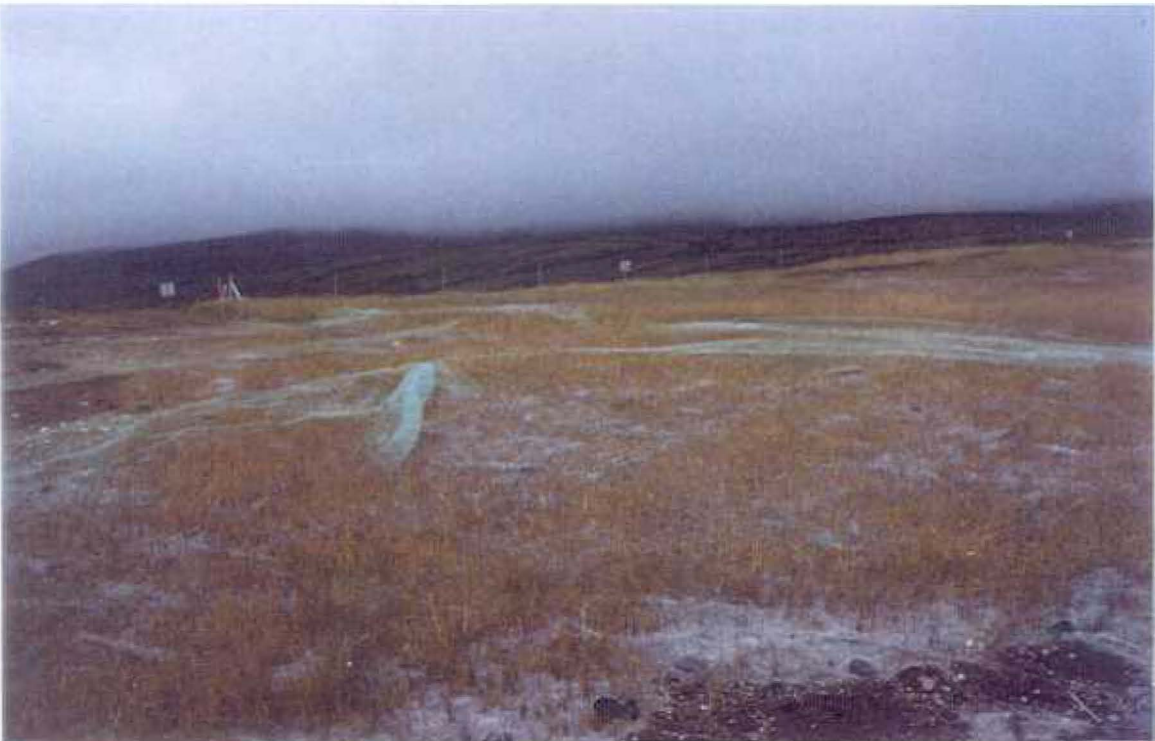
Figure 17. Unraveling excelsior at White Alice Landfill, 1998.

In combination, the result will obviously be more pronounced. Neither have been needed on Adak in the past. Why they were used is not known. Also, the plastic backing on the excelsior blankets is separating from the excelsior. This is leaving pieces of plastic netting throughout the landfill. In other areas of Alaska, excelsior has been avoided because of this trait. It is especially poor near fish streams as the netting can act as gill nets. I recommend the netting be picked up as it breaks loose from the excelsior. Entanglement of small creatures and birds is a real possibility.

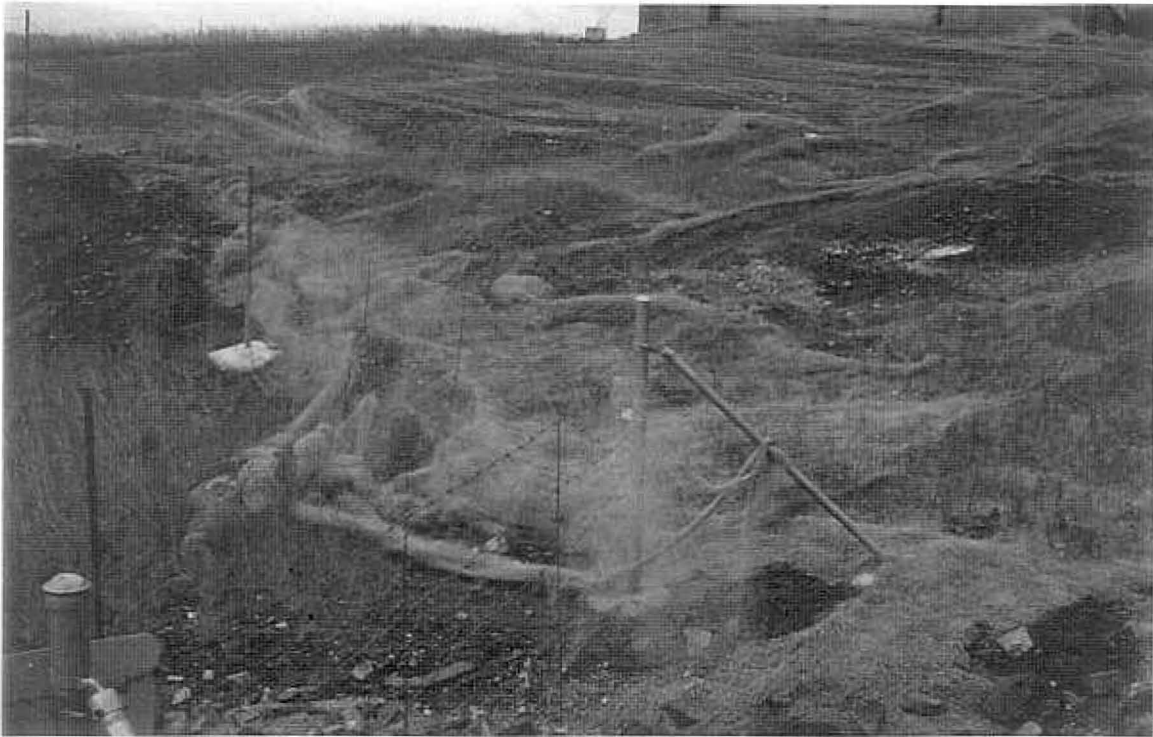
Figure 18 Plastic netting from excelsior piling up fence around White Alice andfill 1998

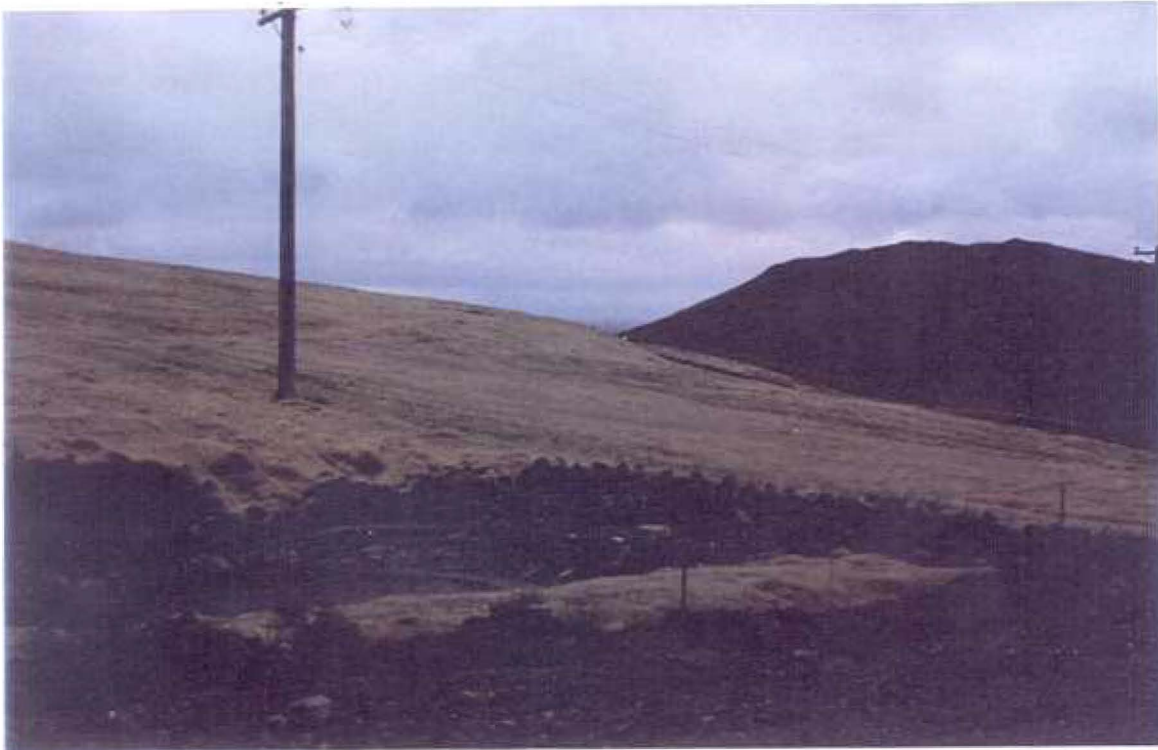
Figure 19. Robert's Landfill, 1998, showing the young grasses emerging from excelsior blankets.

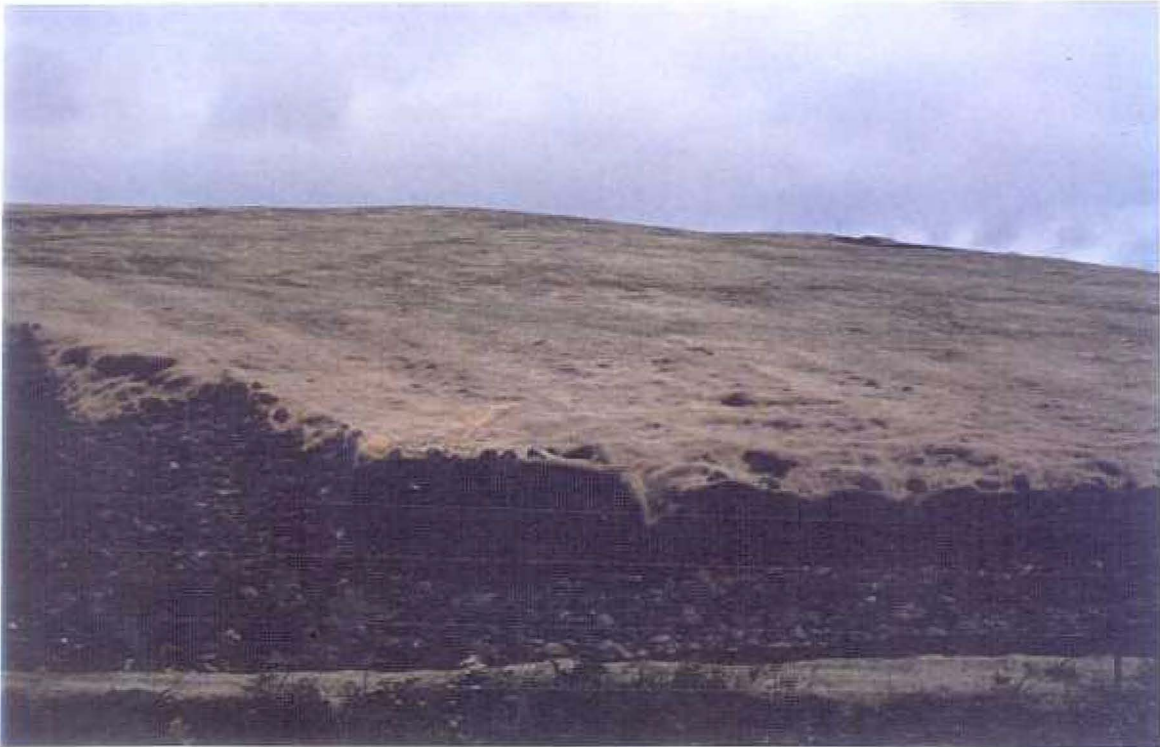
Figure 20. Another area of Robert's Landfill in 1998. Note sparse vegetation.

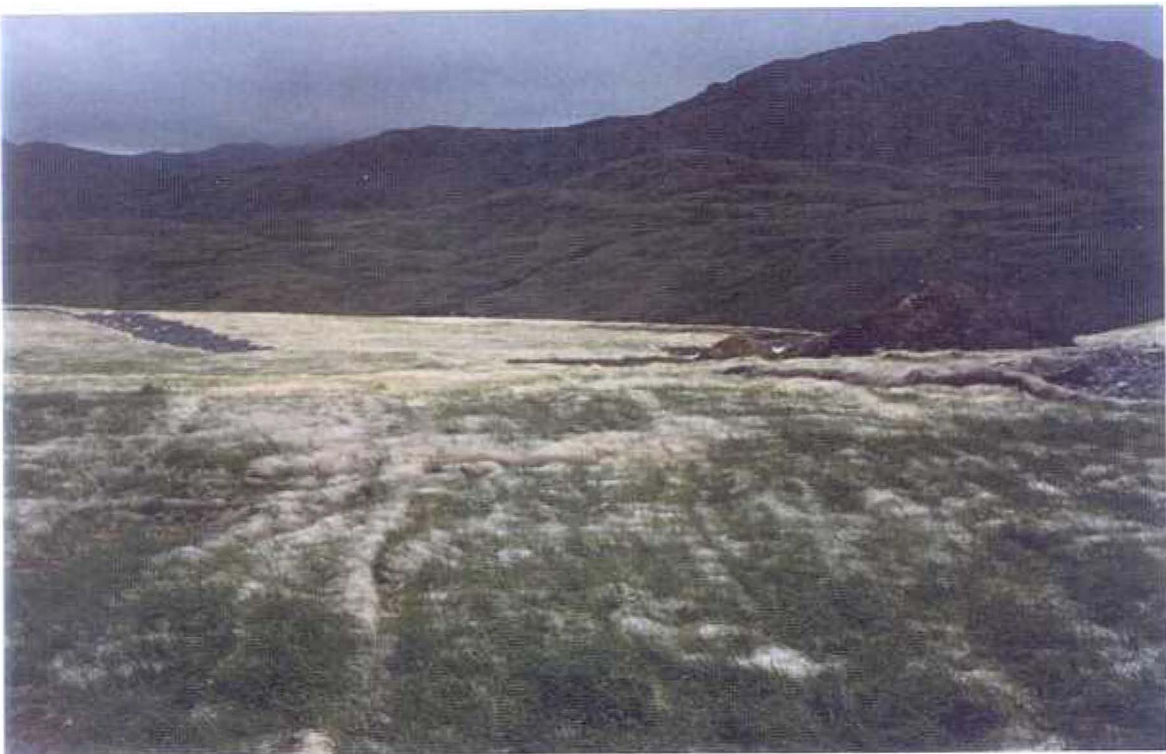
Figure 21. Robert's Landfill, 1998, showing Annual ryegrass emergence.

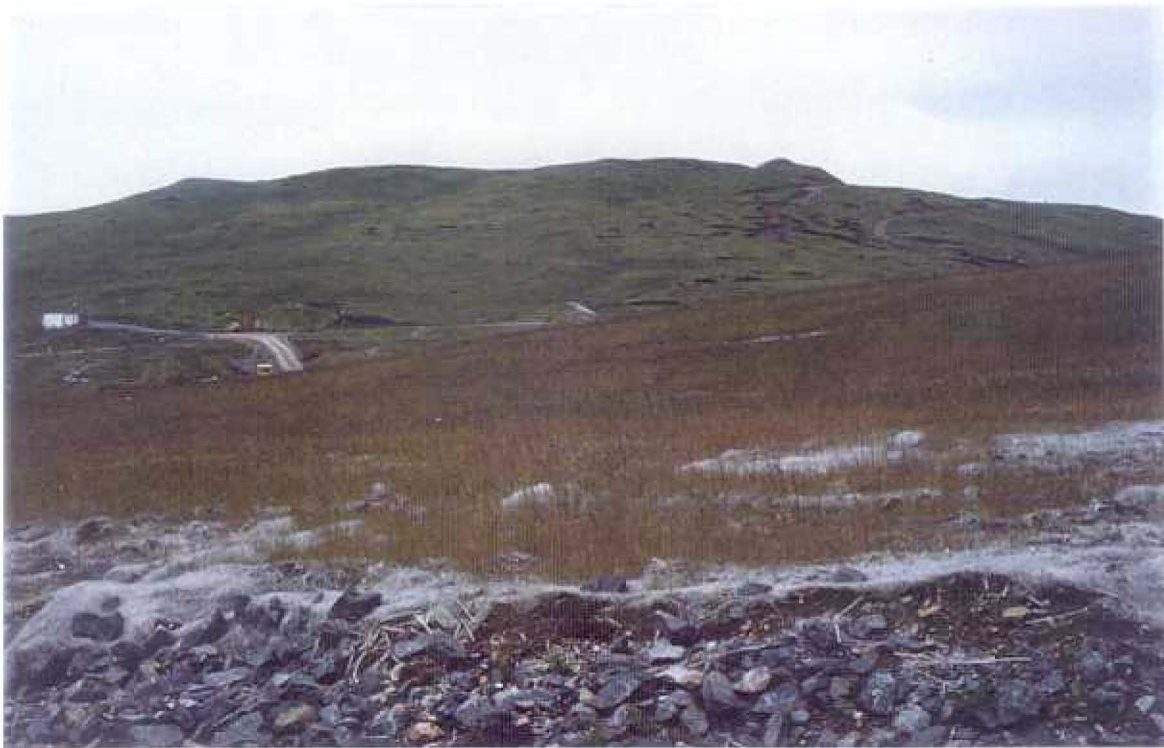
Figure 23. Robert' Landfill 1999 showing decline 1998 seeding.

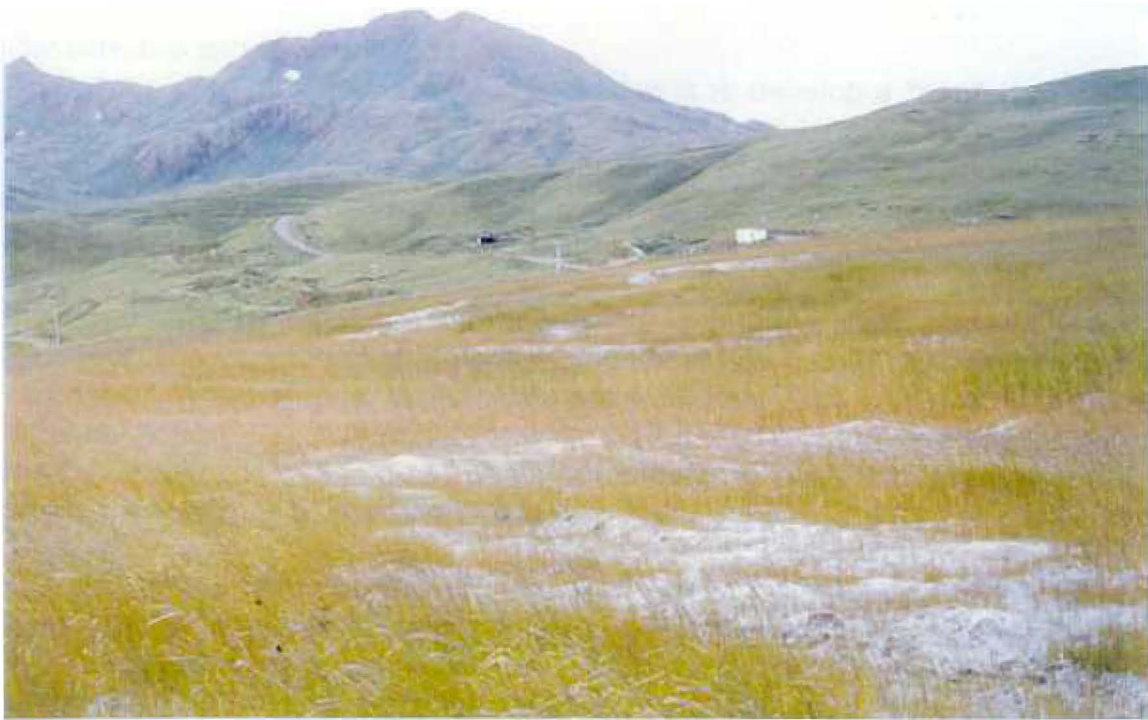
Figure 24 Robert landfill 1999, showing other areas stand decline 1998 seeding.

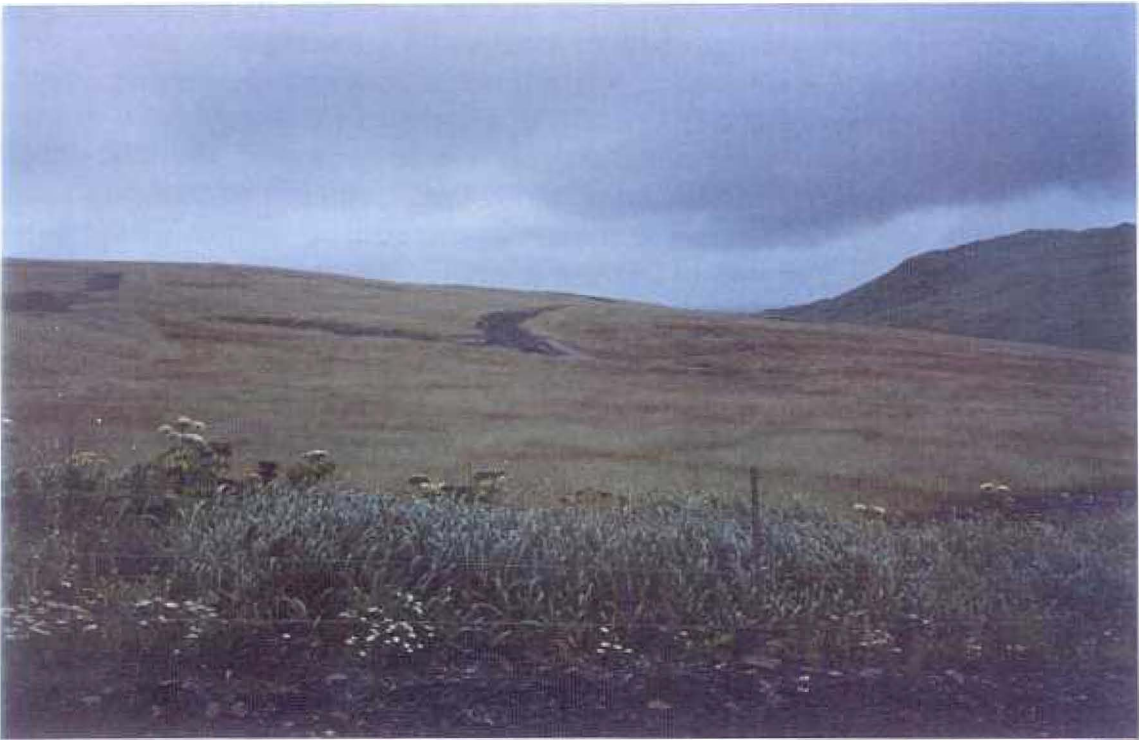
Figure 25 Robert' Landfill showing good stand grass 1999 This seeding planted earlier 1999
