**Revegetation and Monitoring
of the
Closed Section of Access Trail**

**Stewart River Training Area
Nome, Alaska**

**Prepared for:
Alaska Army National Guard**

**Prepared By:
Andrew Nolen
Agronomist
Alaska Plant Materials Center
Division of Agriculture
Department of Natural Resources
February 23, 2006**

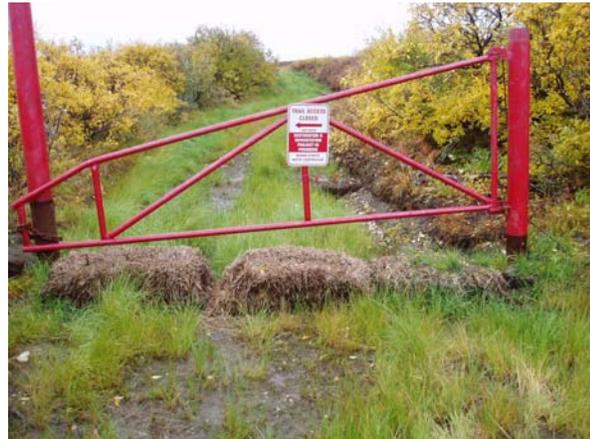
The access to the trail is adequately blocked by a substantial gate (Photo 1). Good establishment of seedling grasses was apparent along the entire length of the eroded trail. Willow cuttings were live staked along much of the project.

Photo 1. Gate and signage

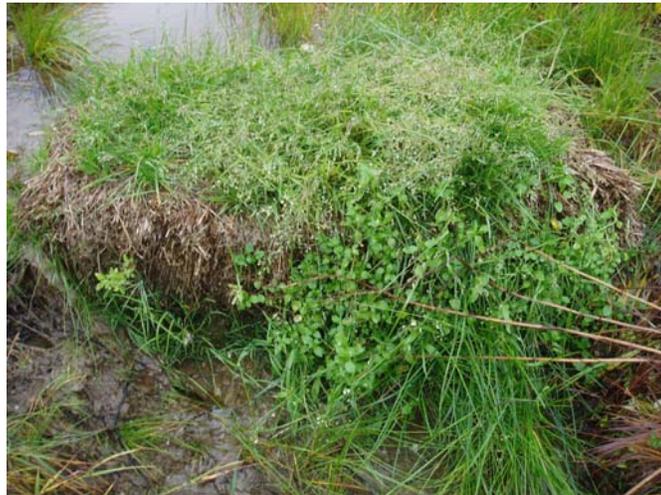
Introduced species were observed during this site visit (Photo 2). Plants of chickweed (*Stellaria media*), annual bluegrass (*Poa annua*), lamb's-quarters (*Chenopodium album*) and corn spurry (*Spergula arvensis*) were growing from many of the straw bales used during the restoration effort. Also, plants of narrowleaf hawksbeard (*Crepis tectorum*) and rough cinquefoil (*Potentilla norvegica*) were observed in the seeded area, likely due to

Photo 2. Straw bale with introduced species

contaminants in the seed mix. The hawksbeard and cinquefoil plants were removed upon observation, however, future monitoring for undesirable plants on the disturbance may be warranted.

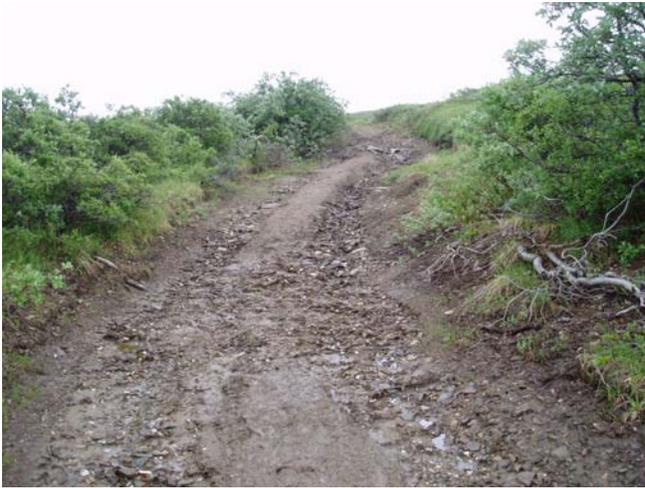
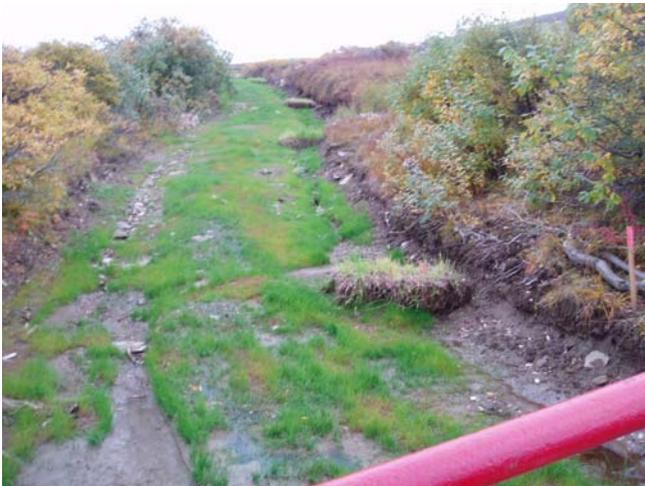
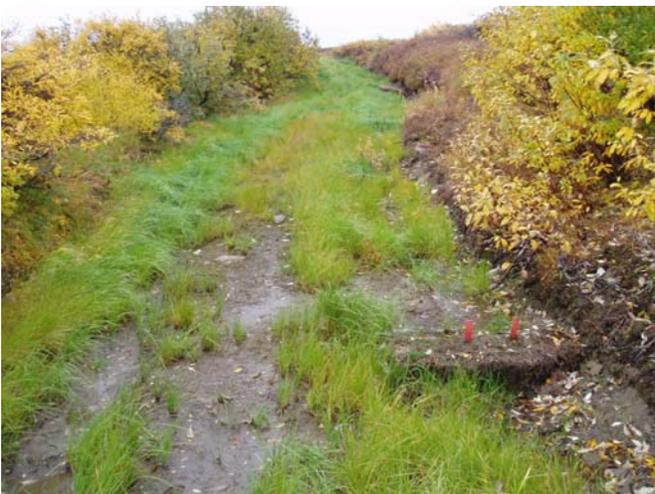
Photo Point 1
N 64° 46' 14.4" W 165° 26' 16.6"
View up the trail from the gate at the southwest end of the project.

Seeded grasses were noted to be well established in most areas with a few locations of exceptional cover (Photo Points 1-4, Pgs 5-8). Plants of hairgrass, polargrass, alpine bluegrass, glaucous bluegrass and red fescue were observed.
