ENVIRONMENTAL MEMORANDUM

Red Chris Development Company Ltd.
200–580 Hornby Street, Vancouver, BC V6C 3B6

Re: Red Chris Monitoring Committee Environmental Report Dec 1, 2015 – Dec 22nd, 2015

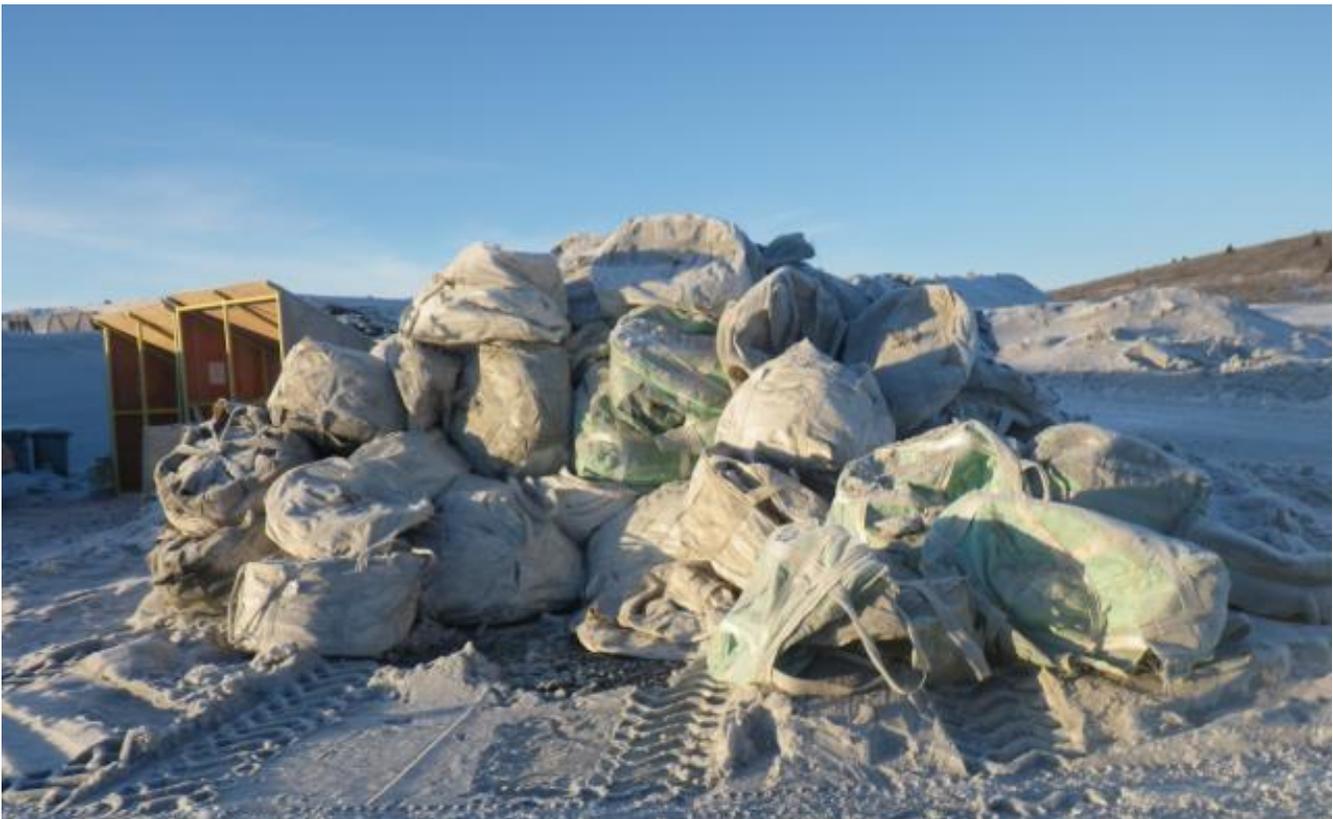
Figure 5: numerous amounts of fly-bags from the mill, which will need to be placed in construction waste bin.

- There continues to be small improvements in organization at the waste area. However, occasional non-compliances with established rules remain.
- PAX bags still remain at General Waste Area. PAX bag need to be moved to the mill for safer storage.

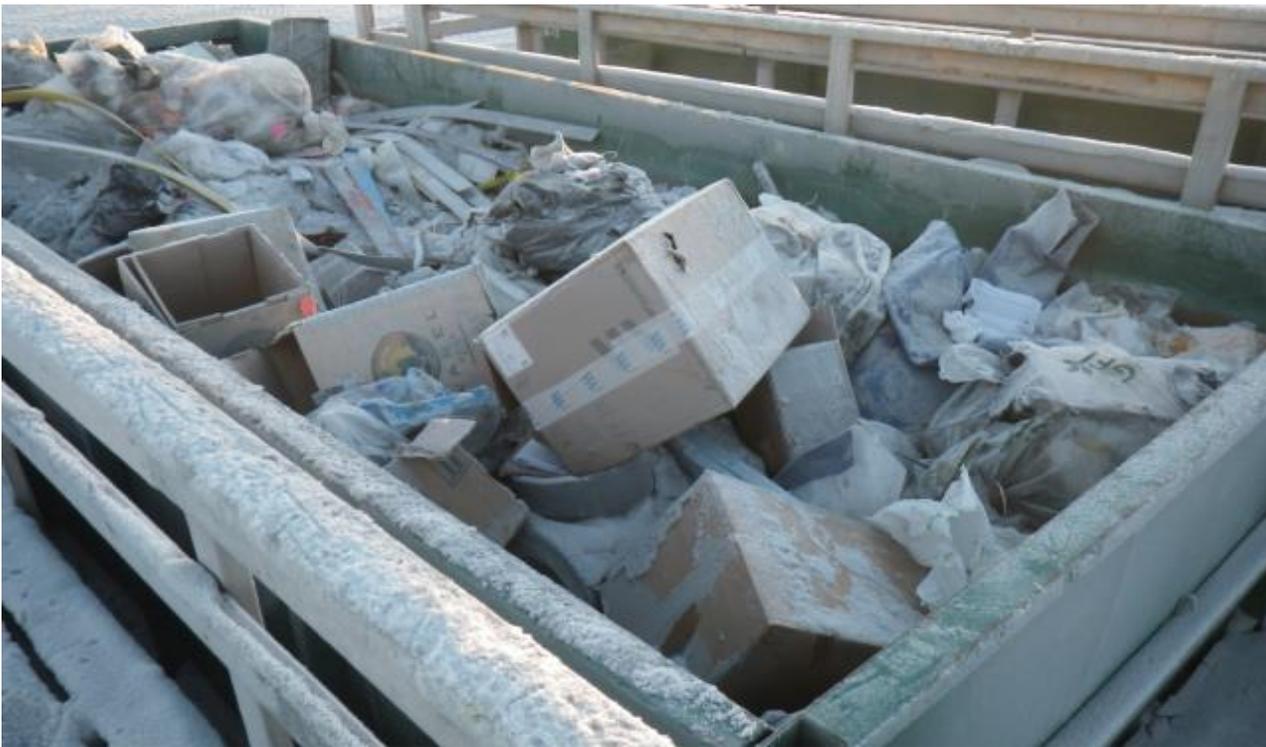
Figure 6: cardboard still a challenge to get employees/contractors to dispose of properly.

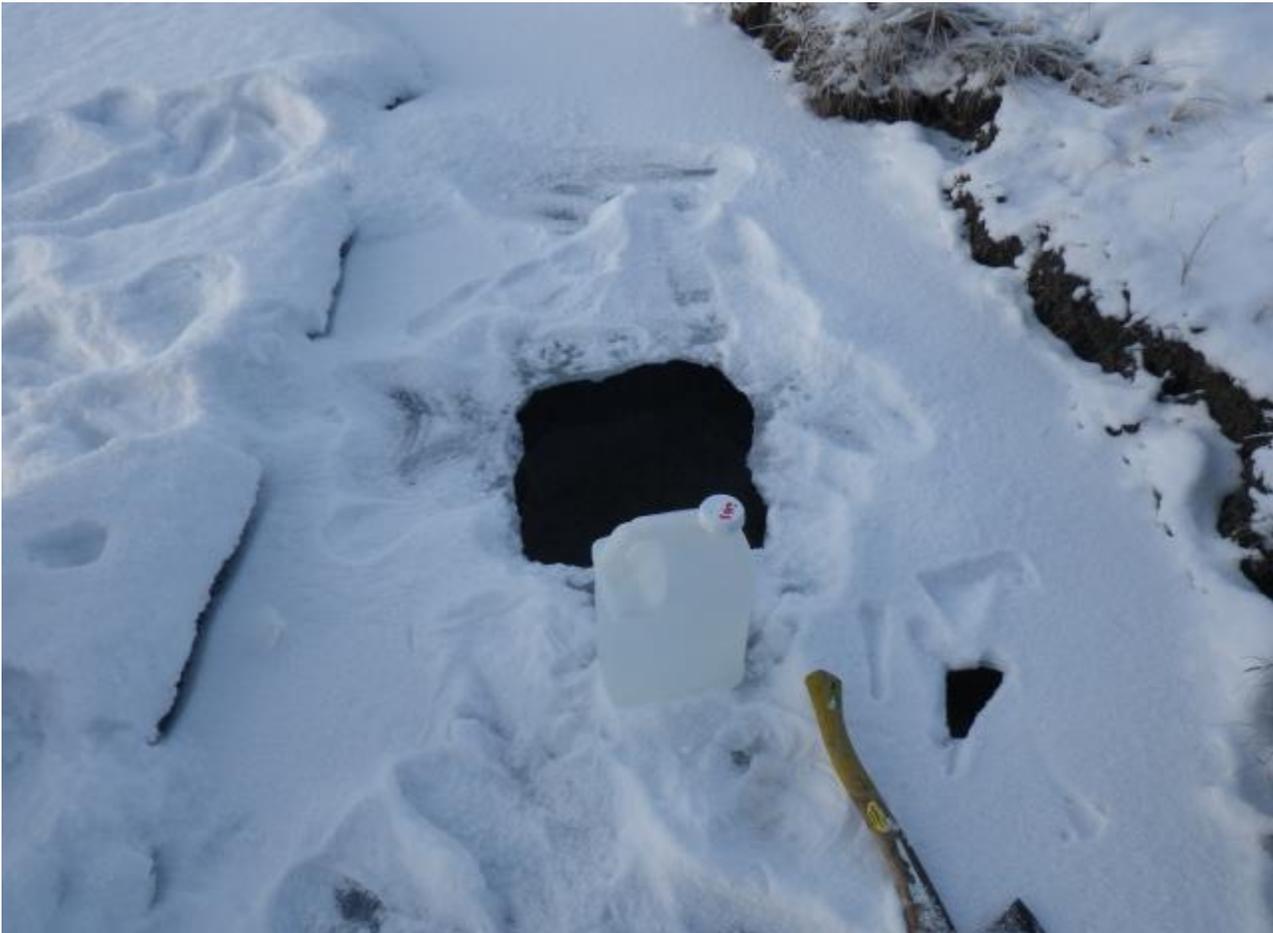
- **December 10, 2015** there was a bypass of the works when the pit sump overflowed. The overflow was low volume (< 1 l/s) but did reach Camp Creek to the south. An incident specific report and monitoring program was developed for the spill. Based on preliminary monitoring and lab results it is not expected to cause and environmental impact.

Figure 7: due to pit sump spill, quality/control samples needed to be taken and analyzed in Trail Creek.

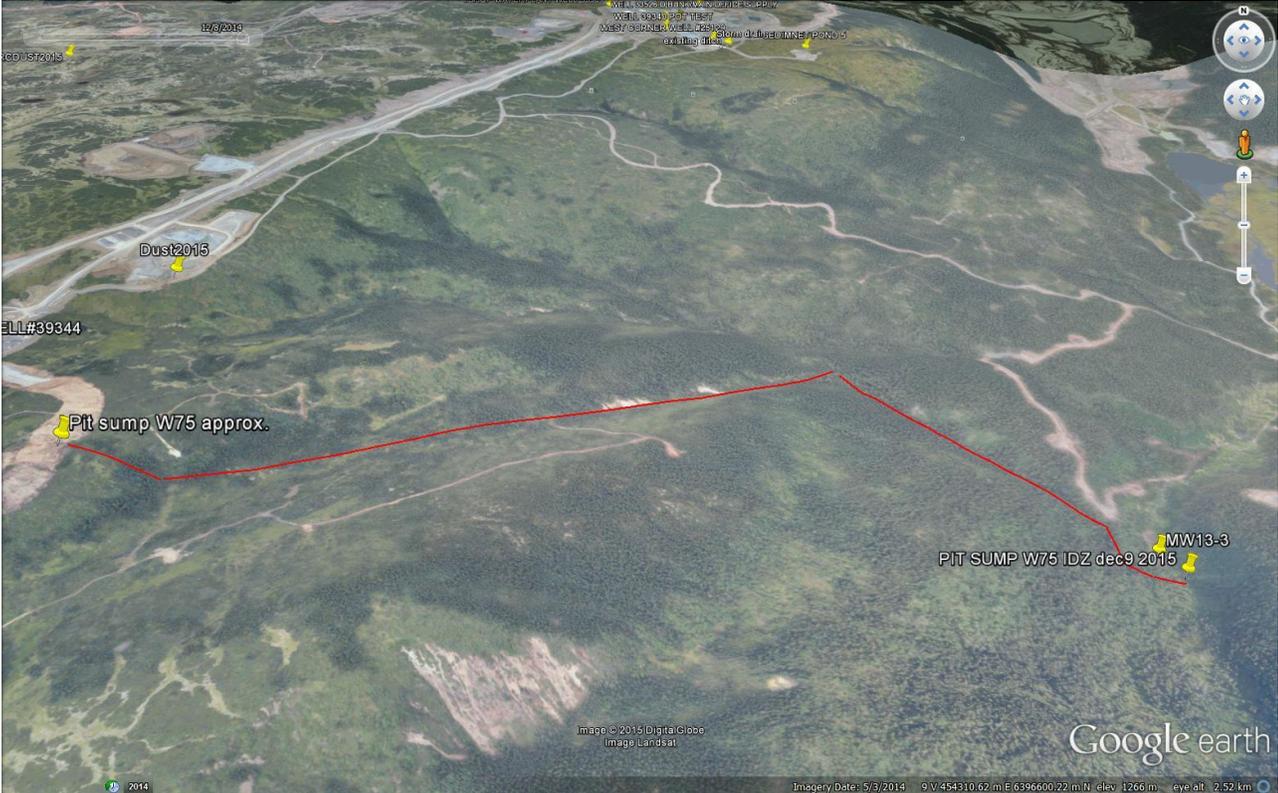
Figure 9: rough draft of Camp Creek and the area affected by pit sump incident.

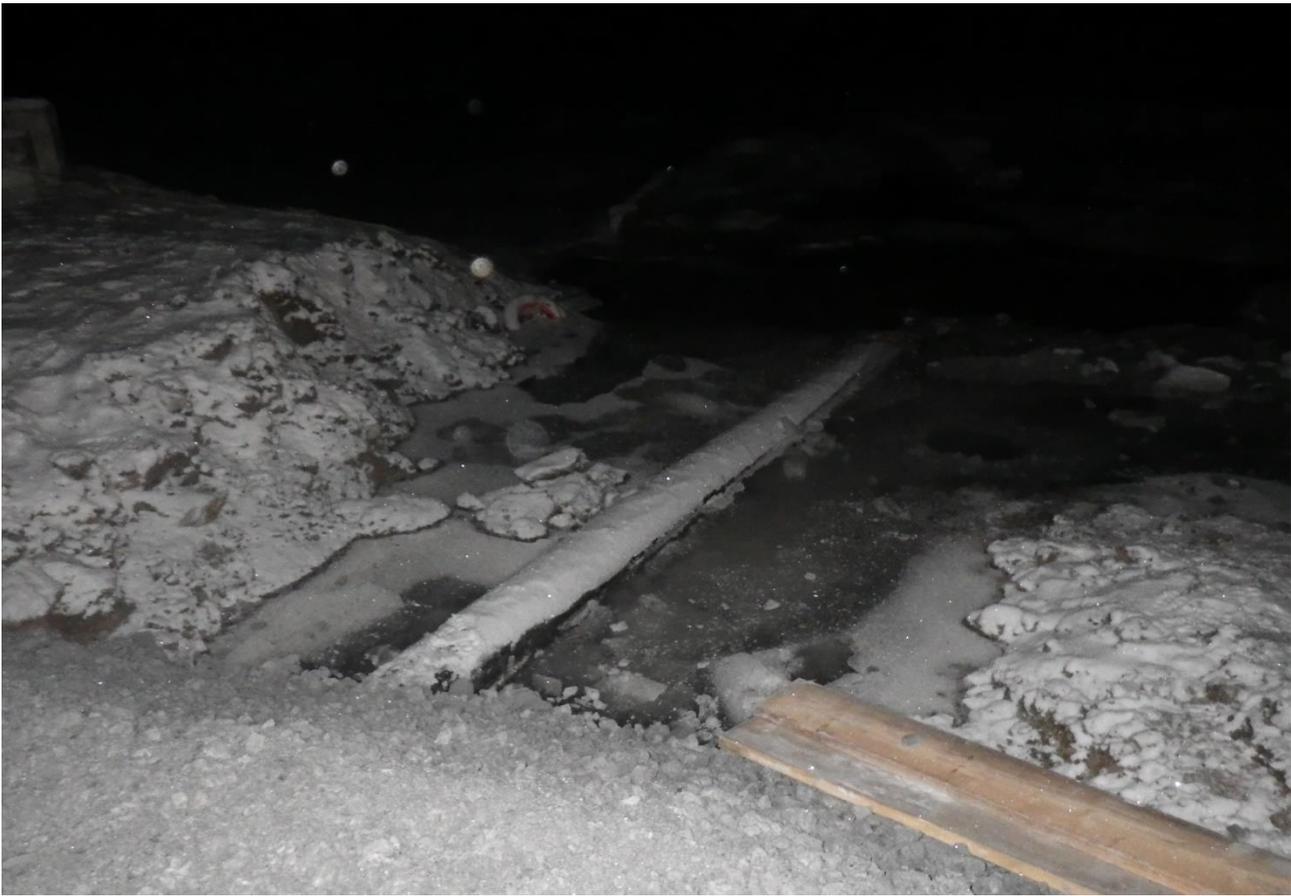
Figure 9: W75 (pit sump). There was a berm put in place after pit sump incident.

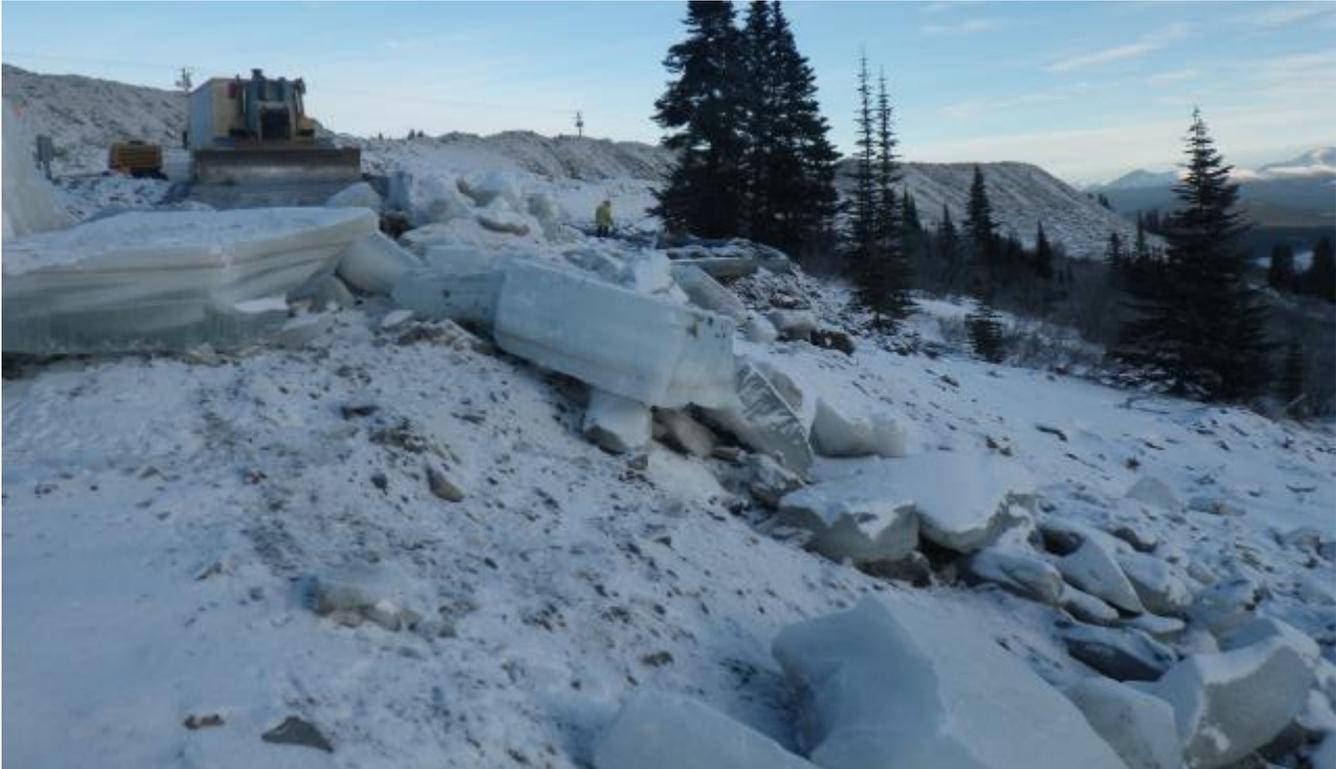
Figure 9: ice chunks at W75 (Pit Sump), cleaned up and disposed of properly from Site Services.

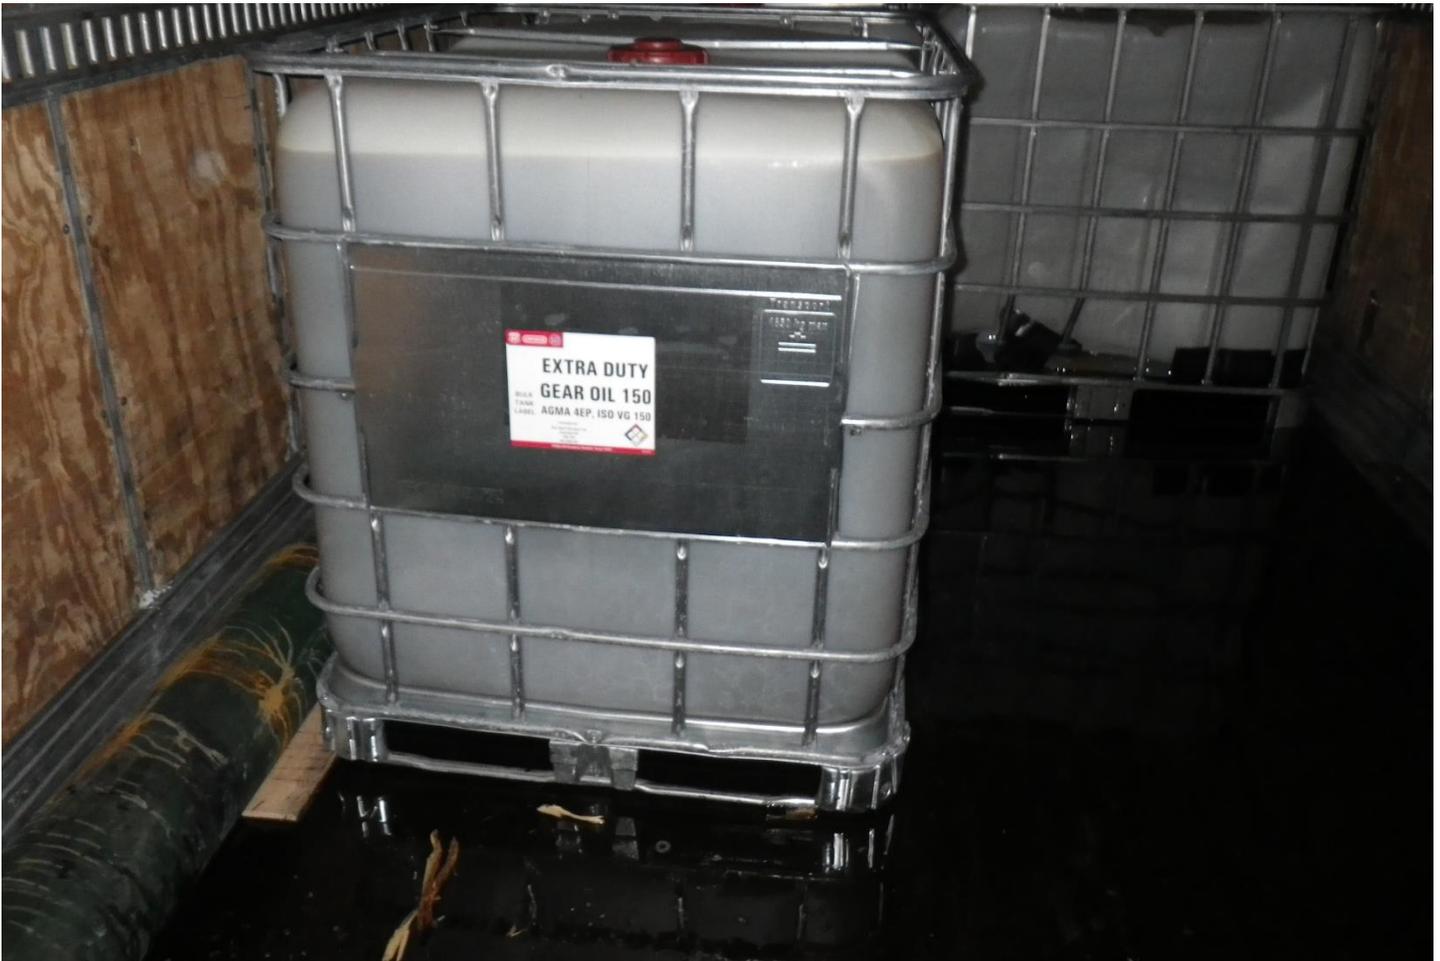
- **December 18, 2015** Gear oil spill: 1,100L tote of gear oil was spilt in the back of a Bandstra trailer oil was contained in trailer and did not cause contamination.

Figure 13: Bandstra trailer gear oil spill, not the clearest picture but you can see the glare of the oil on the floor (1,100L tote of oil spilt onto the trailer floor) spill contained and pumped to waste oil storage.
