**TAILINGS AND PRODUCTION ROCK SITE
2012 ANNUAL REPORT**

Hecla Green Creek Mining Company

April 15, 2013

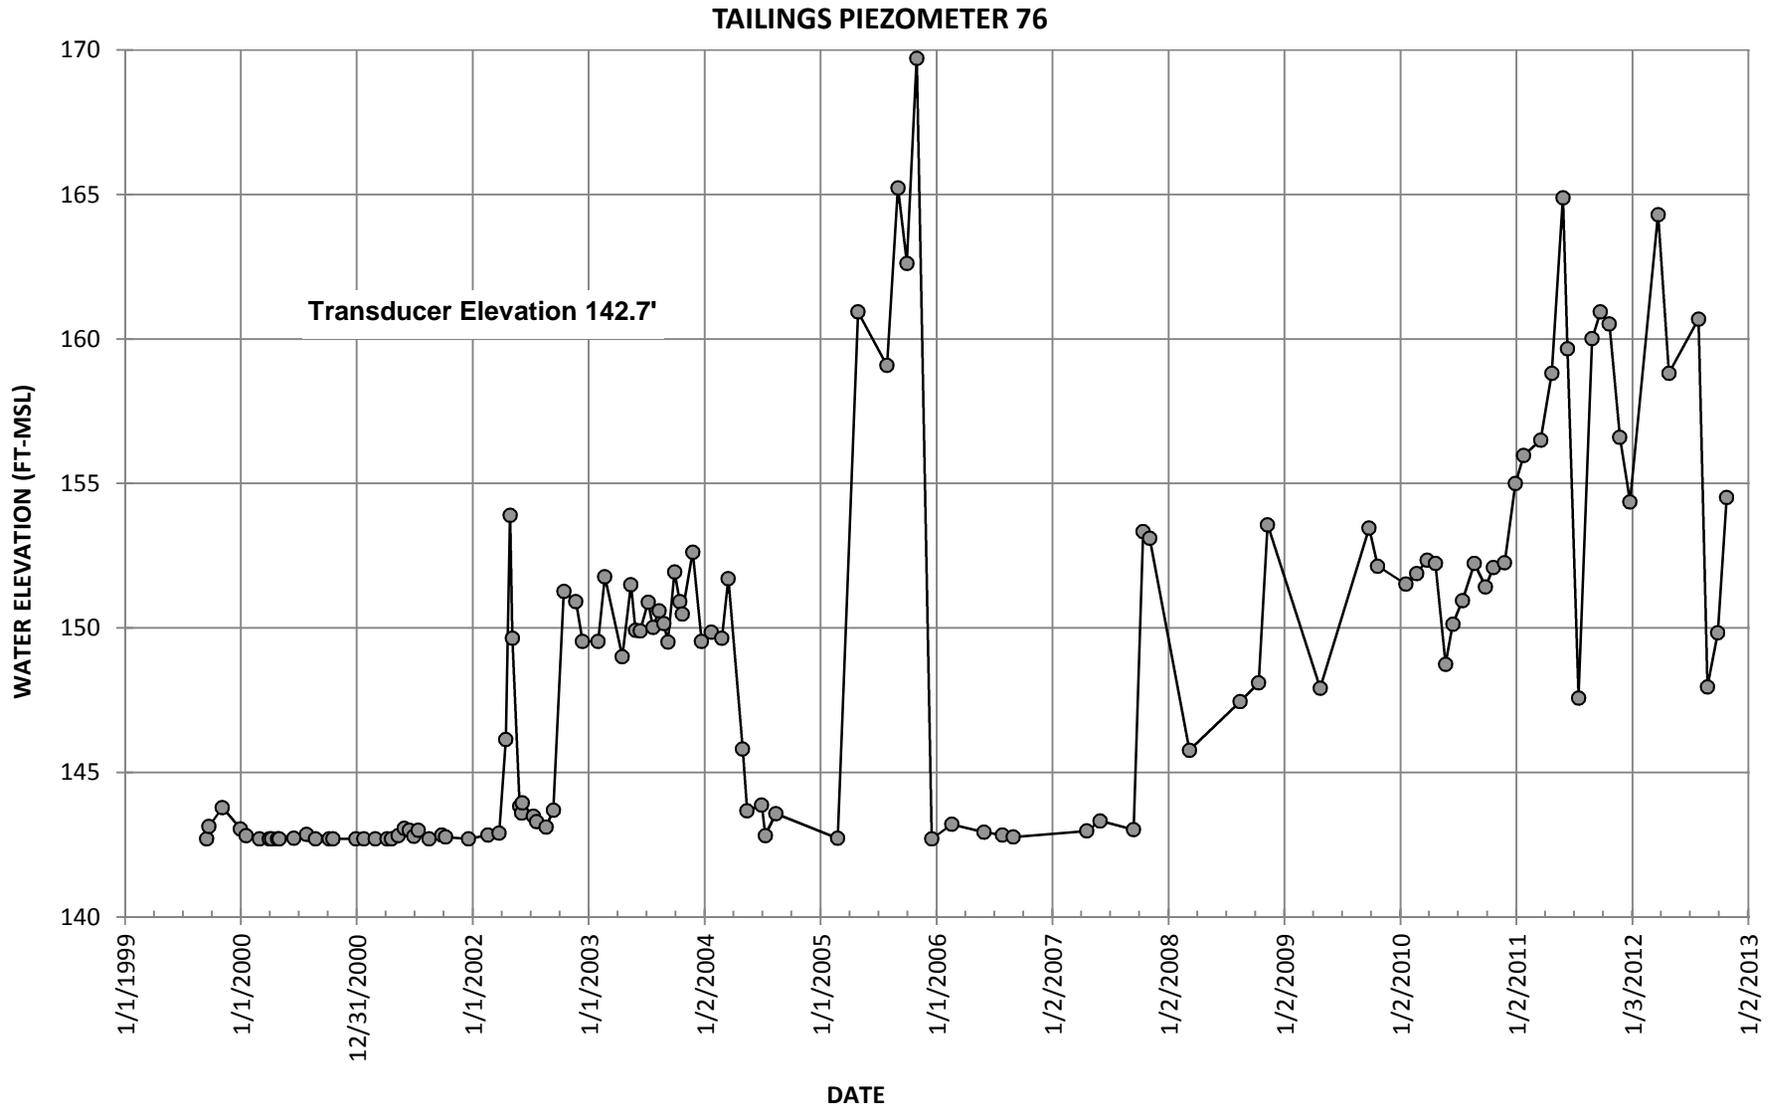
Figure 2.10 Water Level Data for Piezometer 76

The data from standpipe and pneumatic piezometers completed above the blanket drain (Piezometer 76, PZ-T-00-01, PZ-T-00-02, PZ-T-00-03 in Figures 2.10, 2.11, 2.12, 2.13) indicate that saturated conditions can develop above the unsaturated underdrains to a thickness of approximately 12 feet. This is consistent with the low permeability of the tailings and the

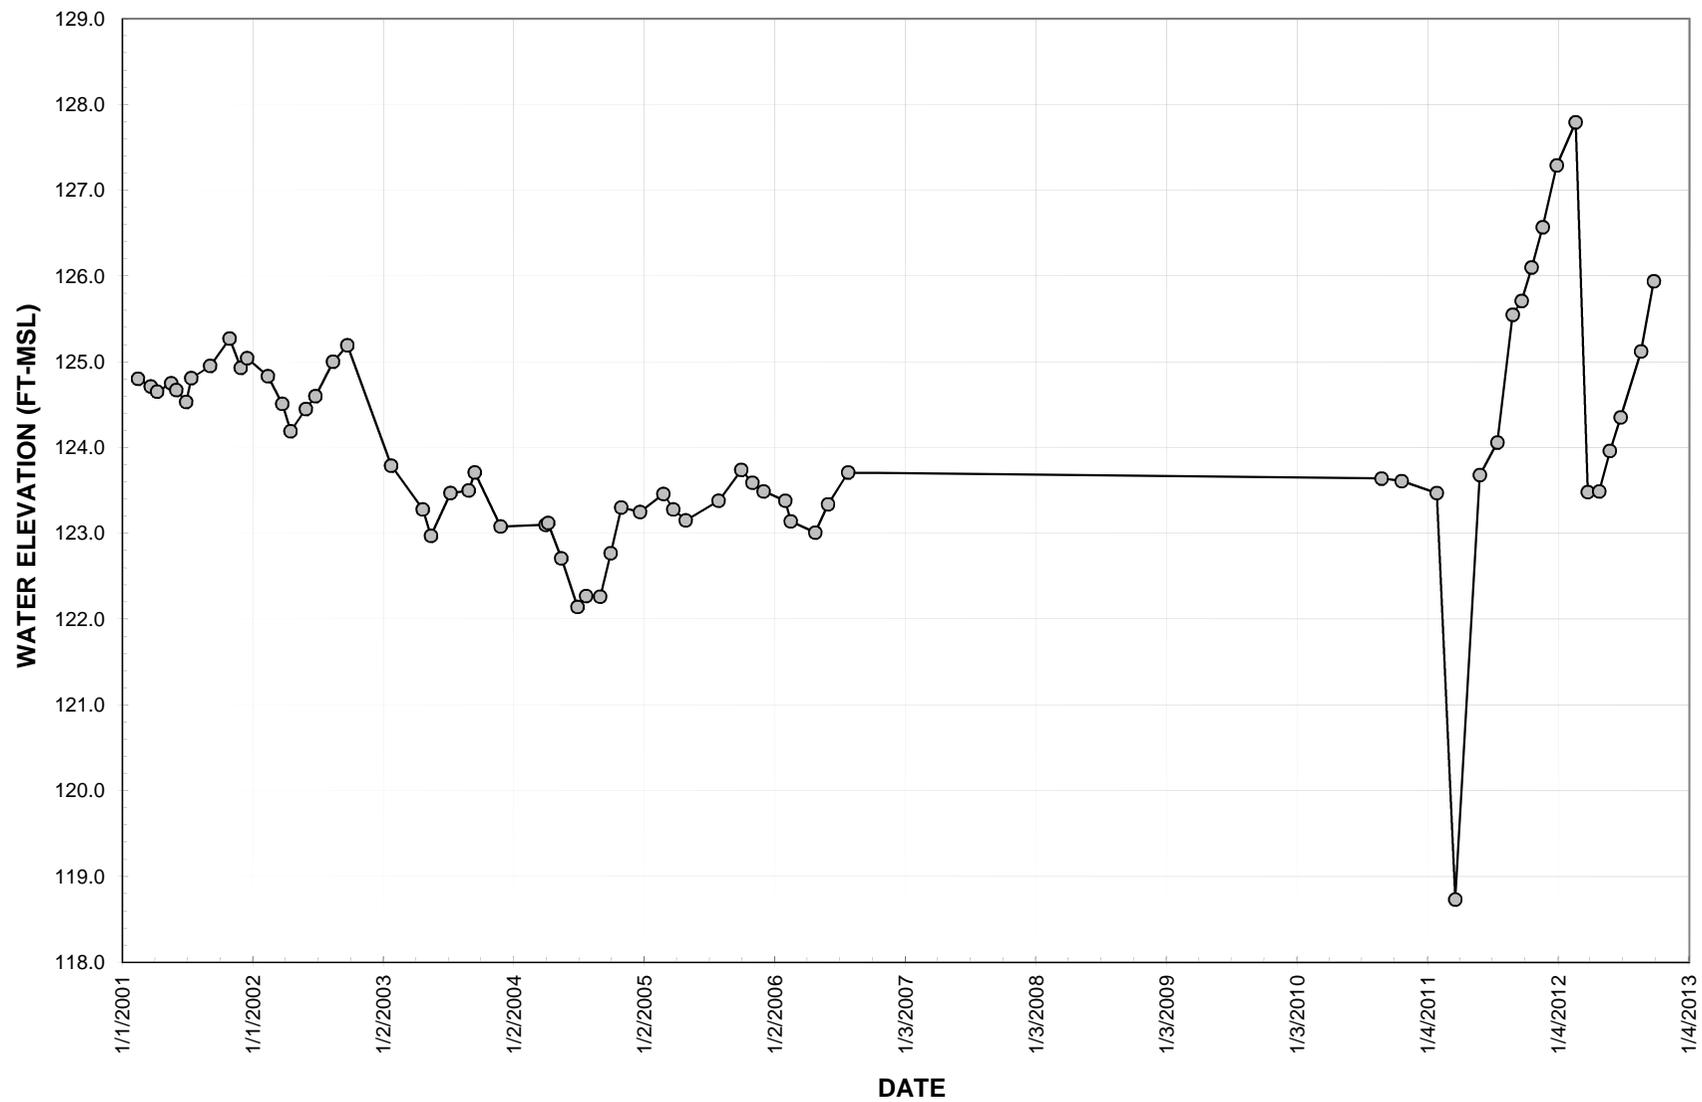
Figure 2.17 Water Level Data for Well MW-T-01-03A

Water levels in four wells completed east and west of the pile are shown for comparison in Figures 2.15 to 2.18. The eastern wells, MW-T-00-03A (Figure 2.15) and MW-T-00-03B (Figure 2.16), are completed in the shallow sands 12 and 17 feet, respectively, below ground surface. The figures for these wells show that the water elevation in shallow completions in native materials can be readily influenced by abnormal weather conditions. Wells MW-T-01-03A and MW-T-01-03B are installed west of the pile. Their water levels are shown in Figures 2.17 and 2.18, respectively. MW-T-01-03A is completed in bedrock to a depth of 20 feet and MW-T-01-03B is completed in clayey silt to a depth of 12 feet. These wells show similar water level fluctuations with weather conditions as the two eastern wells. However, the water level in MW-T-01-03B shows a larger differential than MW-T-01-03A because silts and clays hold more water in tension, so a small increase in water content causes a large change in head. The ground surface elevation is 134 feet in the proximity of these two wells. Both MW-T-01-03A and MW-T-01-03B were damaged by bears in 2006 and attempts to recover them were not successful until 2010. A rapid decrease followed by a gradual increase to levels above recent historical values occurred in MW-T-01-03A in 2011. In 2012, the level decreased to levels seen in the past. The cause for the change is not known at this point, however this type of behavior has been documented in the companion well (MW-T-01-03B).

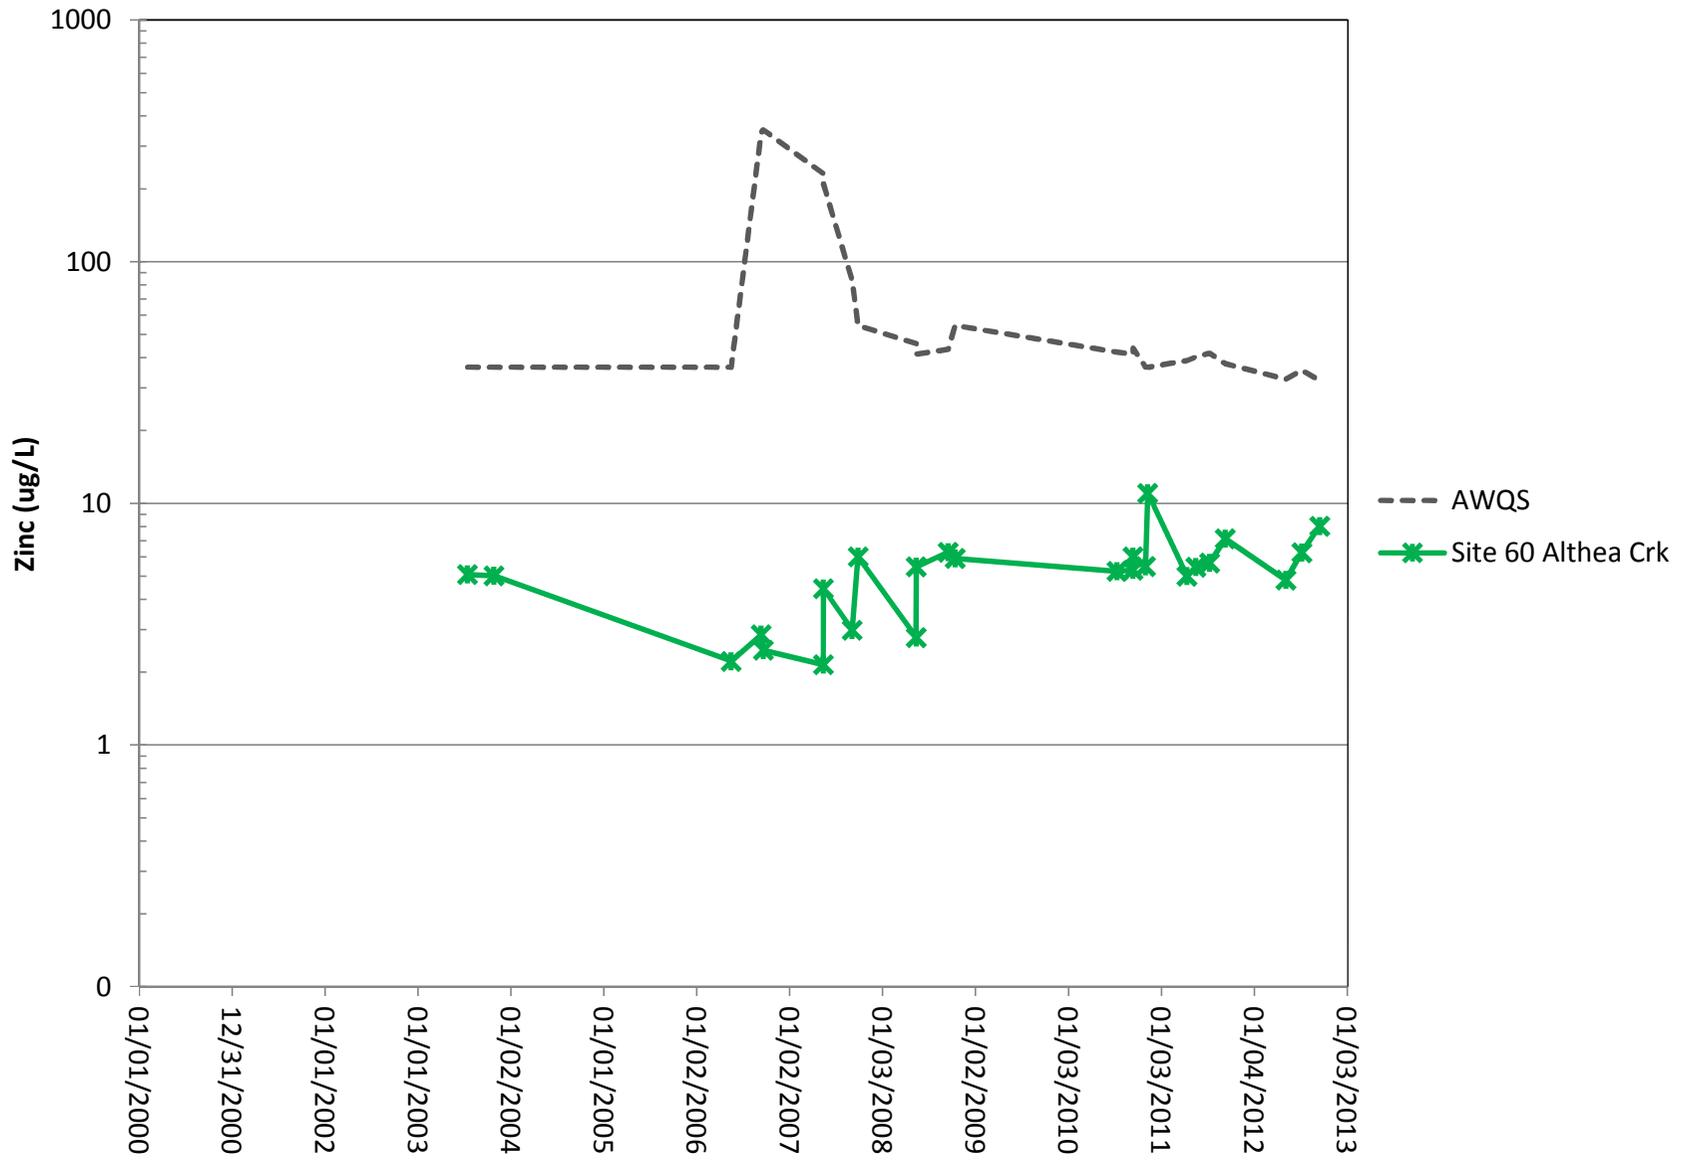
Figure 2.42 Site 60 Zinc Concentration

- Zinc and lead concentrations at Site 60 area shown in Figures 2.42 and 2.43. Zinc concentrations are very low (< 11 ug/L). As the hardness at Site 60 decreases toward background conditions, the AWQS for lead, which is hardness dependent, may approach the lead concentration at Site 60. This was the case in 2012 when a slight increase in lead and a continued decrease in hardness caused an exceedance of the AWQS for lead as Site 60.

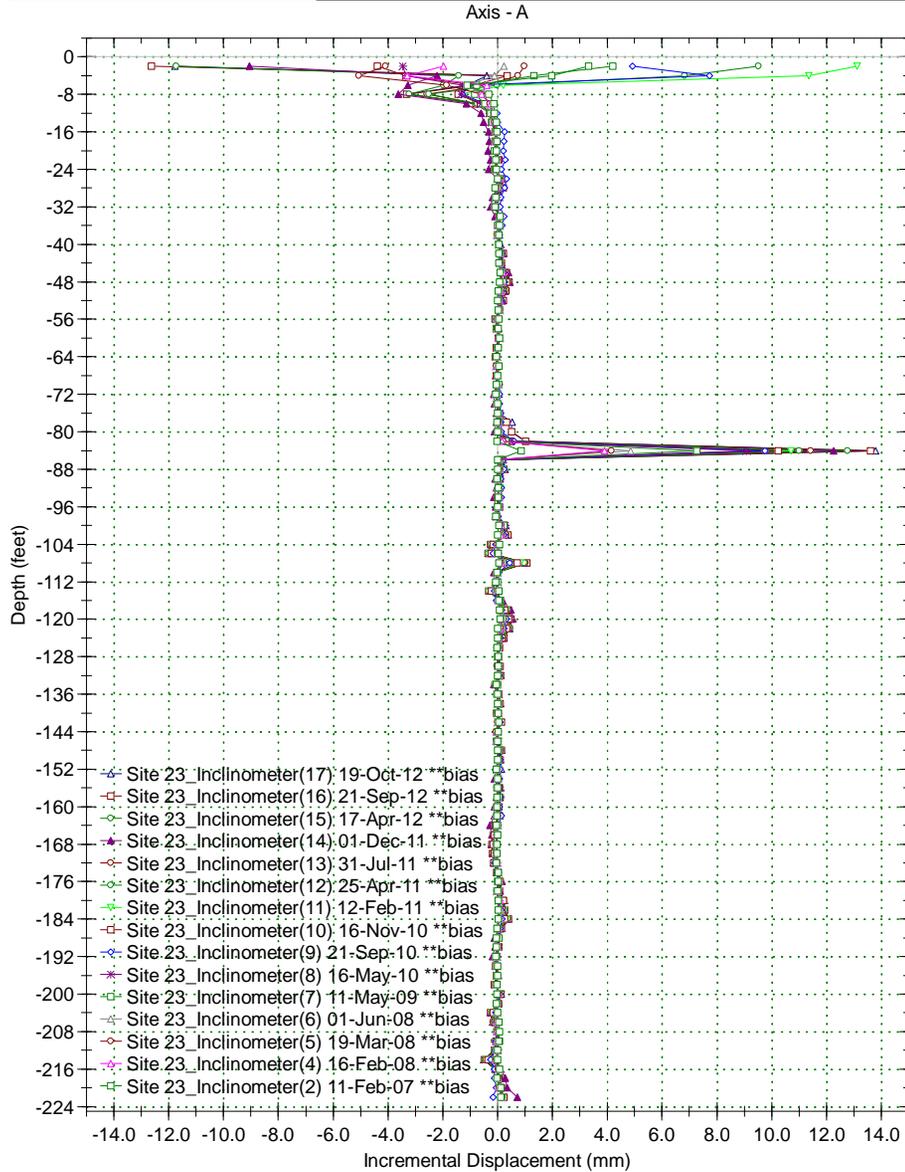
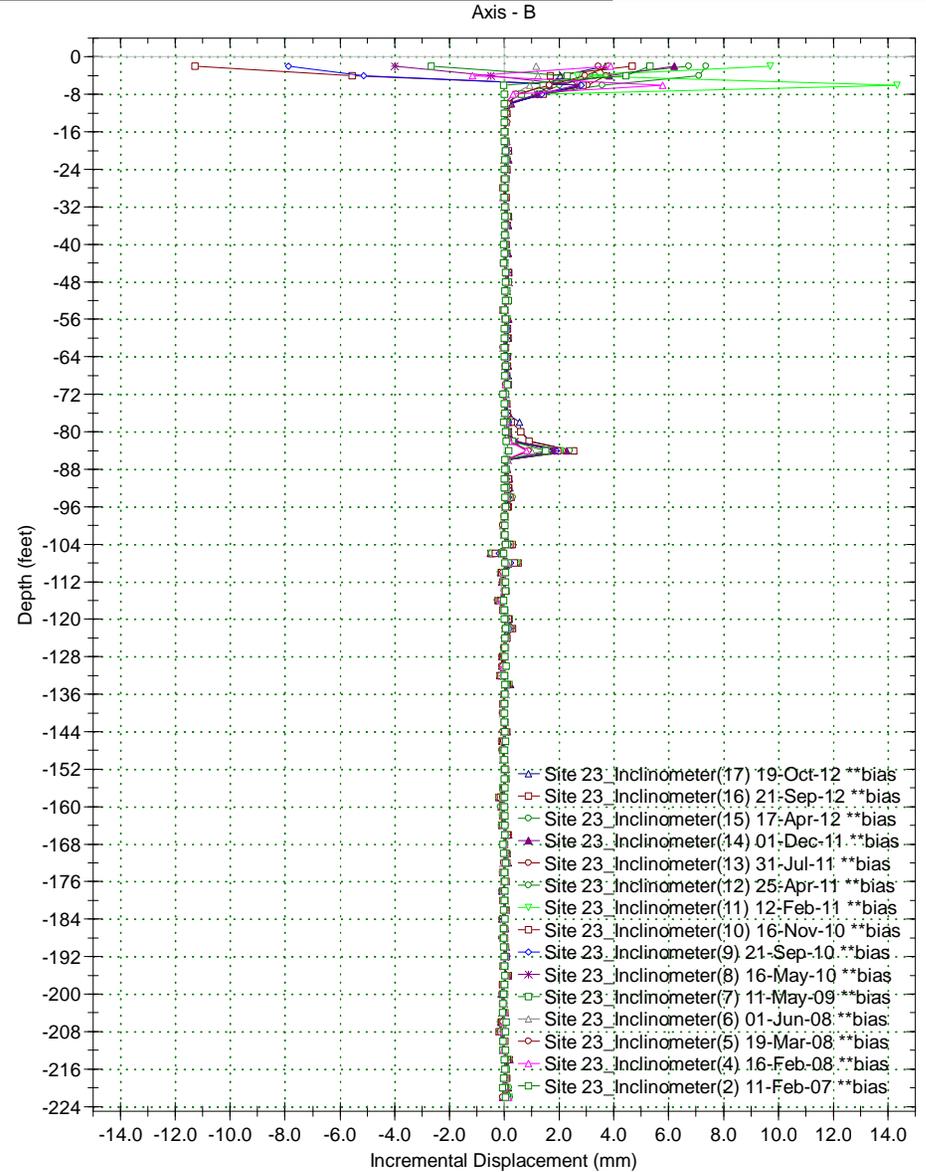
Figure 3.30 Site 23 Inclinometer Incremental Displacement

Notes:
 Zero reference is top of casing, at ~4.7 ft above ground surface.
 Top section of casing/damaged joint replaced in July 2011.
 Bias-shift correction by pinning data sets at 150-ft depth (A_B axis)

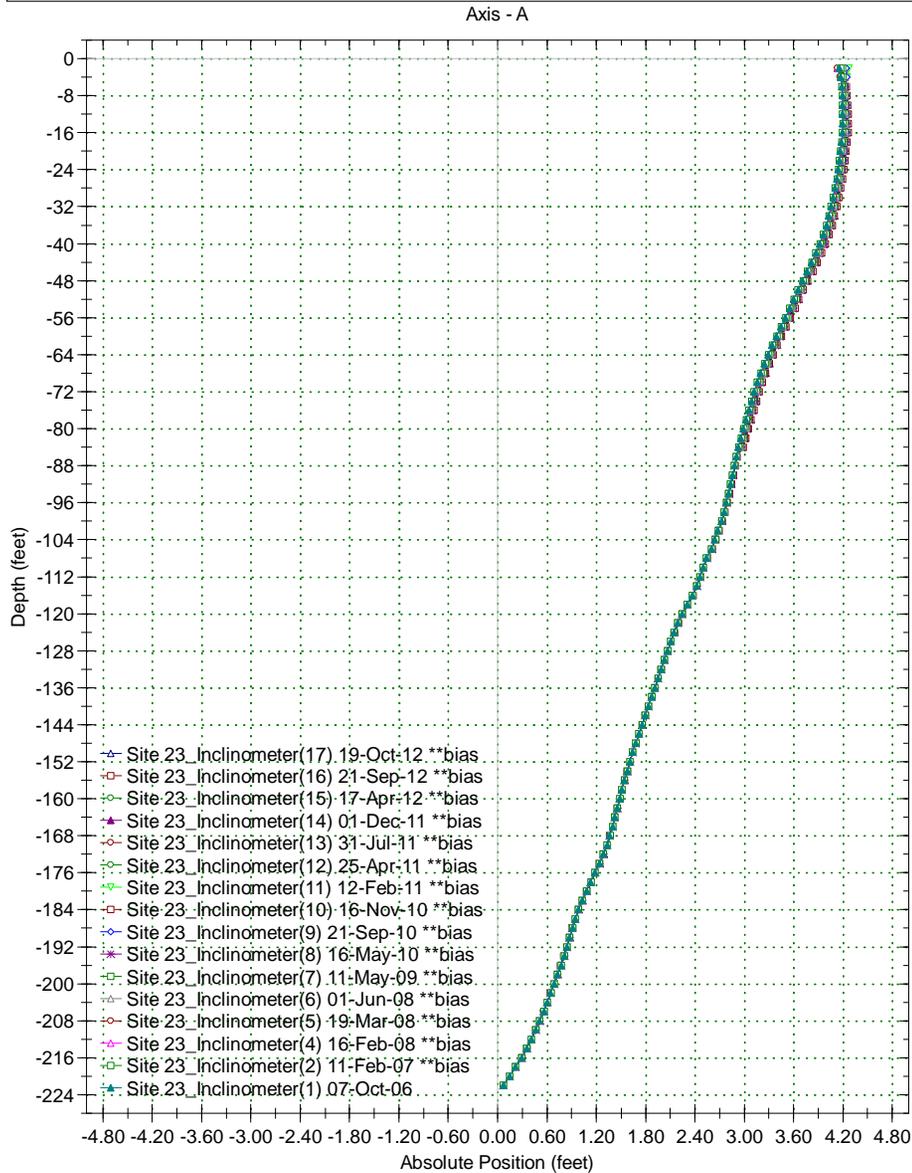
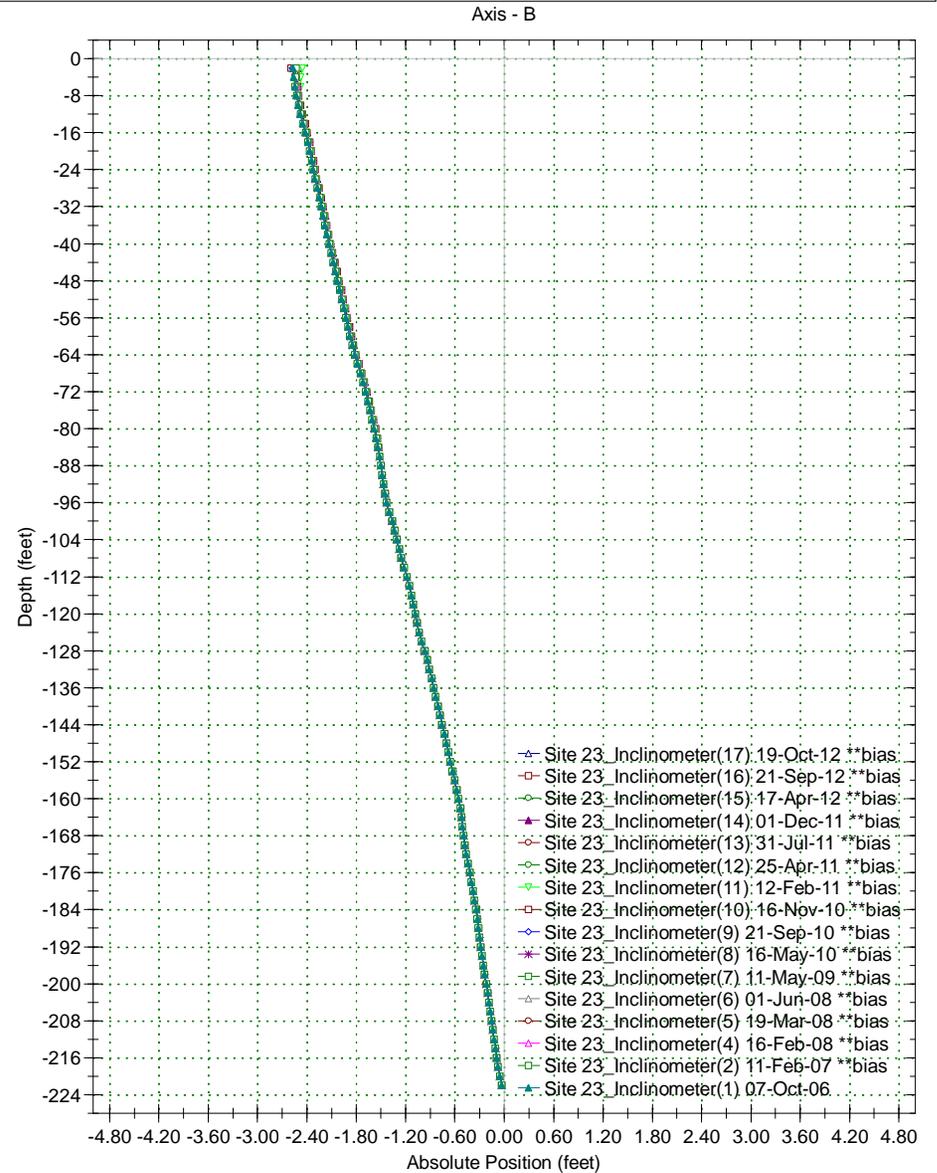
Figure 3.31 Site 23 Inclinator Absolute Displacement

Notes:
 Zero reference is top of casing, at ~4.7 ft above ground surface.
 Top section of casing/damaged joint replaced in July 2011.
 Bias-shift correction by pinning data sets at 150-ft depth (A_B axis)
