**Division Of Environmental Health
Solid Waste Program
410 Willoughby Avenue, Suite 303
Juneau, Alaska 99801-1795
<http://www.state.ak.us/dec/home.htm>**

Subject: January 16, 2002 Site Visit

Kenwyn George and myself representing the Alaska Department of Environmental Conservation (ADEC) visited the Kennecott Greens Creek (KGC) waste disposal facilities on January 16, 2002. This was the first formal inspection of the facility since it was permitted in January 2001. The goals of this inspection were to understand compliance with the permit and the solid waste management regulations. Additionally, we were interested in current and future issues related to disposal and permitting. Due to time constraints an inspection for compliance with all aspects of the permit was not possible. However, we were able to review all issues we felt were of high priority as well as many additional items. We believe that ongoing contact and future inspections will adequately cover those items missed on this inspection.

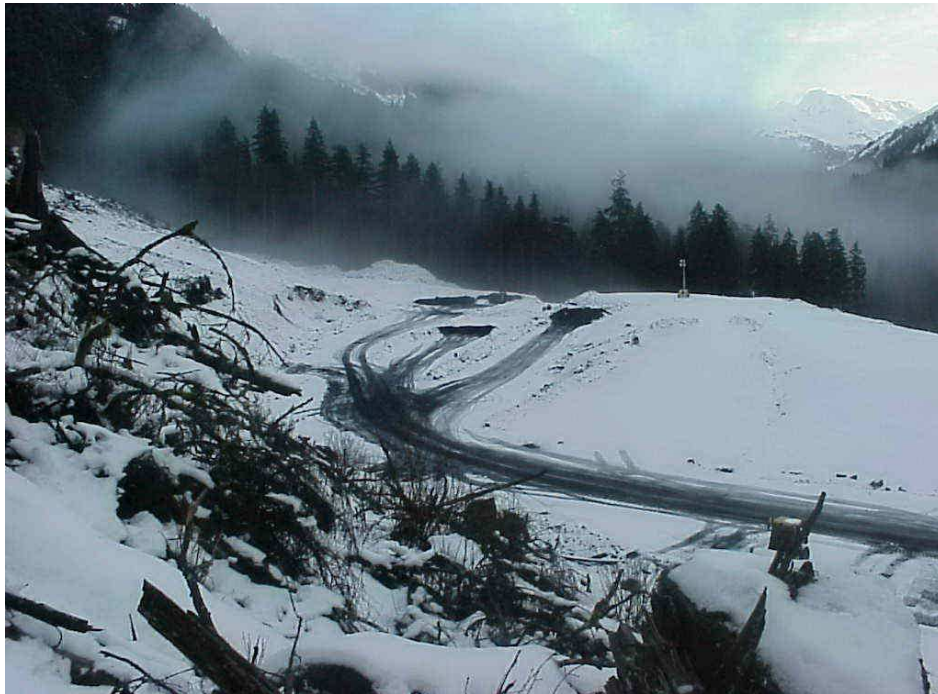
Production Rock Site 23

This past year, approximately 53,000 tons of production rock was disposed at Site 23 and 157,000 tons were placed underground.

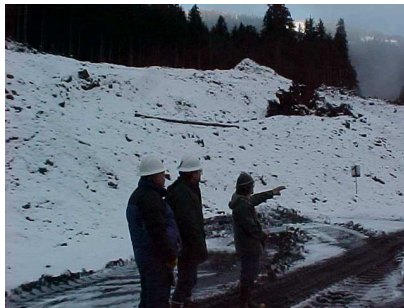
Waste was placed according to classification type. Class I rock was disposed peripherally at the site according to plan. Class II and Class III rock was disposed centrally in specific zones within the fill. Class III rock was placed more centrally within the pile than Class II rock. It was reported that waste is compacted with dedicated compaction equipment and the resultant hydraulic conductivity is approximately 1×10^{-5} cm/sec. Outside slopes were estimated to be constructed at a gradient of 3(H):1(V) for stability.

Disposal of Class I Waste Rock

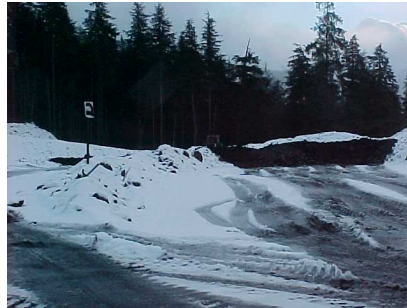
Class II Waste Rock

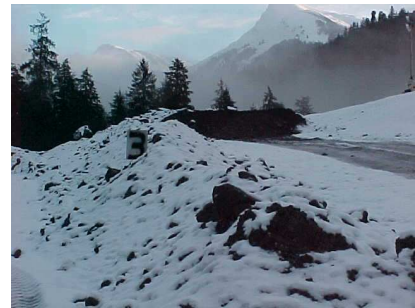
Class III Waste Rock

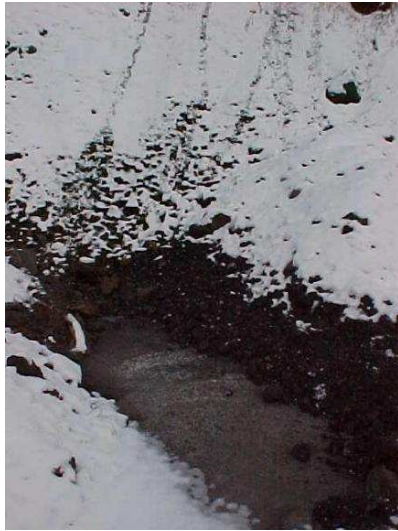
Finger drains were placed in run-on zones and staked for ease of extension as the fill expanded vertically. There was very little observed run-on to the facility, and KGC staff report little run-on during the spring thaw. Where run-on was observed, finger drains were in place. Because of time constraints we were not able to observe all internal and compliance monitoring devices in detail and correlate their placement on the map that was provided to the Department on May 31, 2001. However, these were pointed out and it appeared the placement was correct. KGC has field verified all site monitoring device locations. Monitoring devices should be fitted with locking caps and be locked when not in use to prevent unauthorized access. A map providing geographic coordinates based on the local coordinate system should be included with the annual report for all monitoring devices, along with relevant data from the stations. This information will be very helpful to the department for a variety of reasons, including historic records, changes that occur during the life of the mine, and tracking post-closure monitoring.

Run-on at Finger Drain

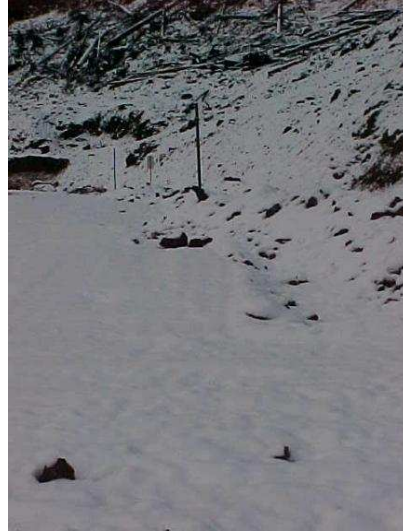
**Staked Finger Drains
Production Rock Site 23 - Detail**

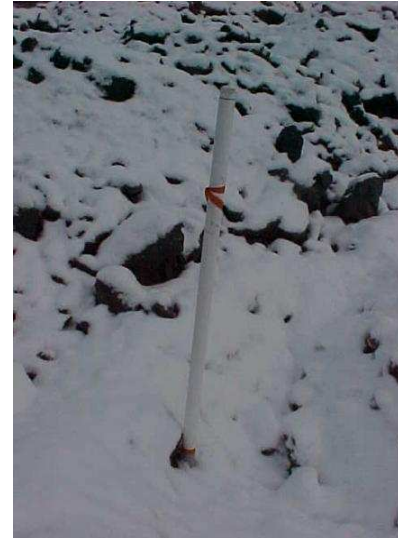
Monitoring Device Without Lock

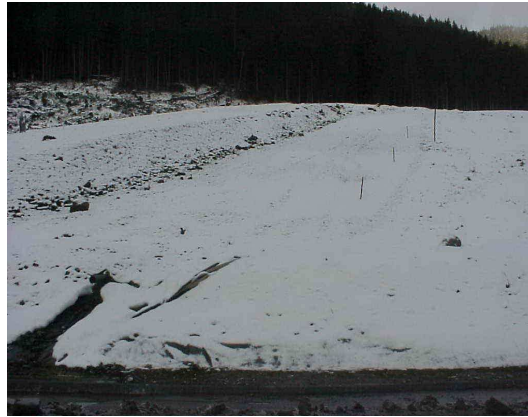
The test plot is relatively small and accessible to air on all sides of the test plot. Therefore, according to site operations staff, the implementation of direct oxygen monitoring would likely result in inaccurate results because of the lateral diffusion of air below the installed barrier layer.

Production Rock Site 23 - Final Cover Test Plot Showing Exposure At Sides To Air

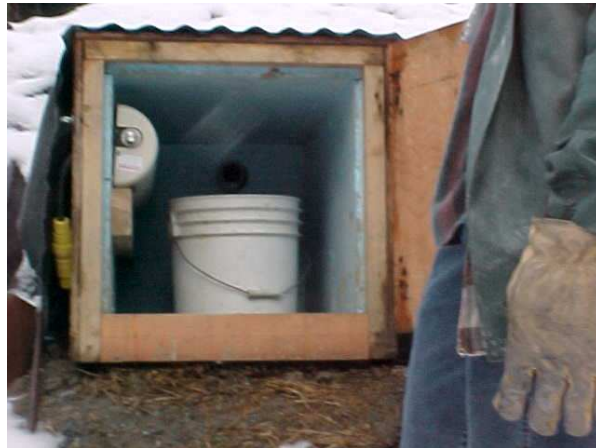
Water was observed in the lysimeter collection system that indicated the passage of water through the cover system. Site personnel reported this result is expected as the cover system design is expected to pass water at the rate of approximately 10% of the annual rainfall, or between 7-9 inches a year.

Production Rock Site 23 - Lysimeter Drain at Final Cover System Test Plot

Demonstrating the effectiveness of this soil cover system would be advantageous with the complete closure of Waste Site "E" or some other site with acid producing potential. Completely closing a site on all sides would allow for the effective establishment of the soil cover as well as installing monitoring devices or access tubes for direct oxygen readings could enhance the demonstration of the final cover system performance.

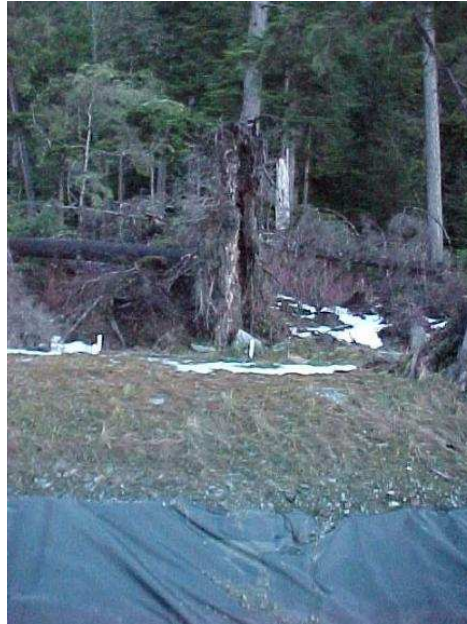
The long-term success/failure of the engineered final soil cover system is directly related to maintaining the integrity of a 2-foot thick barrier layer such that water infiltration is minimized, water saturation is maintained, and the passage of oxygen (air) through the cap is minimized. According to the plan, the final cover system will be provided a 2-foot thick growth layer installed above the barrier layer. One of the functions of the growth layer is to protect the barrier layer. An important feature related to the long-term success of the overall cover system is related to maintaining the growth layer such that soil is not taken away and blow-down of trees does not expose the barrier layer. The thinner the growth layer, the higher the chance of damage by root growth and freeze/thaw.

At this inspection several large trees had been blown down immediately above the tailings disposal site. It was clearly visible that for stability, roots spread horizontally, rather than penetrated deep into the soil. The root system of the blown down tree did not appear to bring the underlying soil up with the roots, except for that which was caught within the roots themselves. The roots appeared to be penetrate up to 18" from the surface, however it could not be determined whether that would have been a full 18" into the soil itself, some of the root mass may have been growing on the surface of the soil. Whether this is considered to be substantial enough over time given further development of the organic mat is unclear. It is also unclear by this examination whether or not soil in the growth layer of the final cover system would be taken away over time as there is likely to be an increase in growth layer thickness over time due to the accumulation of organic material.

Uprooted Tree Above Tailings Site

Qualified personnel should explore long-term issues related to tree blow-down and relate this information to the final cover system for the facilities at Greens Creek in a more quantitative manner. Issues to be explored should take into account at a minimum the age of trees and soil conditions of the growth layer at blow-down. If it is found the growth layer deteriorates over time, then a plan should be developed that minimizes or prevents tree growth or “blow-down” of trees.

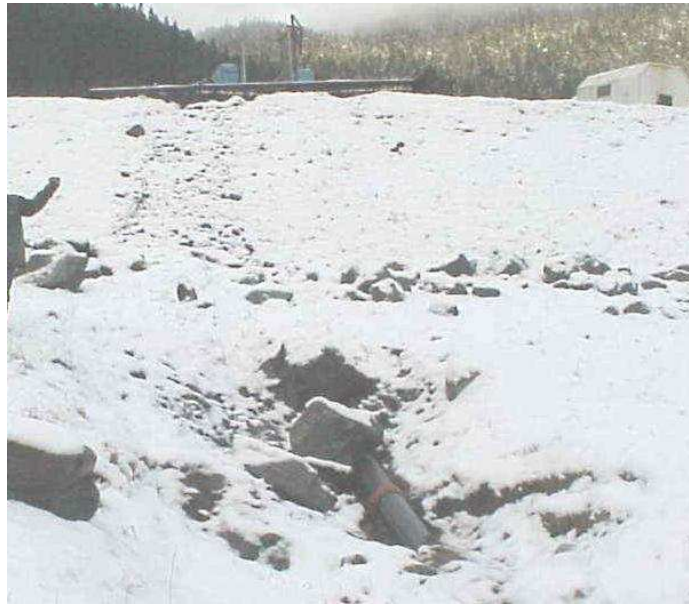
During the inspection we took a look at the exposed pipe from the Site 23 curtain drain. Sampling the water in this pipe would enable us to understand the chemical composition of the water that enters this drain from Site 23. This exposed portion of the drain pipe should be added to the internal monitoring program and sampled according to the internal monitoring program for the facility as prescribed in the General Plan of Operations.

Drainage Pipe From Curtain Drain At Site D

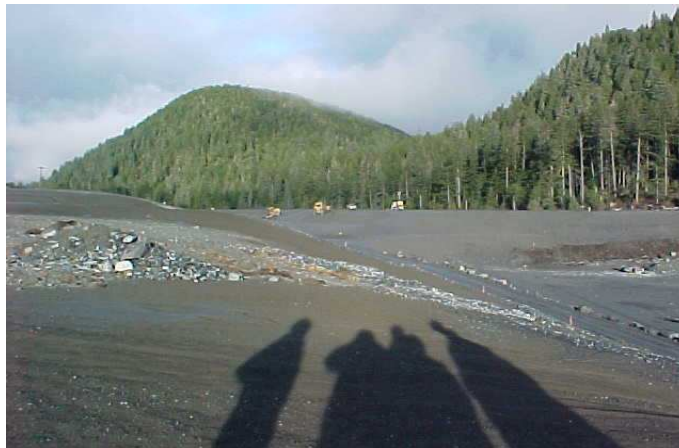
Landfill capacity is an issue as the site has achieved maximum vertical height in the south section of the landfill. Soon the eastern expansion will achieve maximum height as much disposal has occurred in this section over the past year. In January 2002 the Department and the USDA Forest Service approved a liner design for the Wide Corner (southeastern aspect). Tailings placement in the Wide Corner area will likely be available in the spring of 2002 after the liner is installed. Development in the Wide Corner and West Buttress areas during the next year should provide sufficient disposal space during the time the EIS for Stage II of the tailings project is completed (3rd quarter 2002).

Central Portion (left) and Eastern Portion (right) of Tailings Disposal Facility

Depending upon the outcome of the EIS for Stage II of the tailings project, the areas of the site that achieve maximum vertical design elevation will require interim or final reclamation once maximum vertical expansion is achieved. Should the EIS recommend expansion of the existing tailings, then the facility will expand both horizontally and vertically thereby postponing final

reclamation. Should the EIS not recommend expansion, these areas of the landfill are to be reclaimed within 3.5 years after last tailings is placed (final design elevation). Please keep us informed on disposal capacity issues. This is an item that should be addressed in the April 15th annual report.

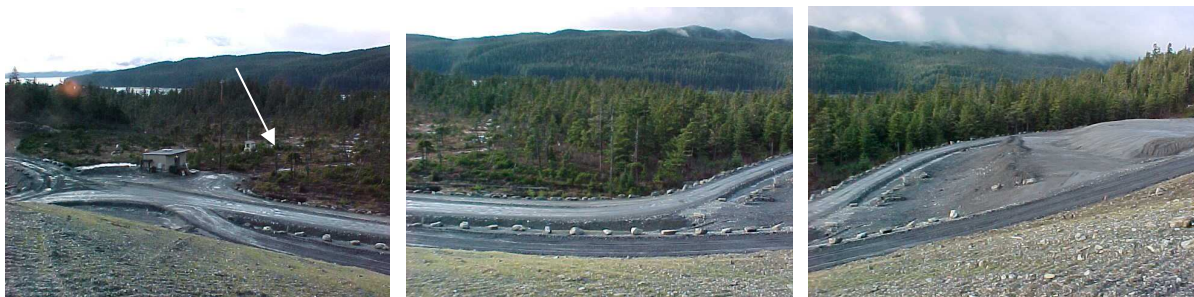
Pyritic rock that contains carbonate mineralization appears to have been used as bedding for a segment of the NPDES pipeline just west of Pond 6. Similar rock appears to have also been used to construct an access road that lies to the west (outside) of the Saddle Embankment slurry wall. Water flowing along the preferential pathway caused by this rock fill has neutral pH (due to carbonate buffering) but has modest sulfate concentrations. The water that follows this preferential pathway emanates from the drain of the NPDES pipeline flow meter housing, named “Duck Blind” (because of its appearance). Information gathered to date does not indicate that failure of the seepage control structure or that seepage of tailings contact water is the cause of the seeps. Extensive sampling of contact water from the tailings facility show it to be alkaline not acidic like the Further Seep water.

Duck Blind Drain Area Further Seep Drainage Area Northwest Tailings Area (West Buttress)
Downgradient Western Area Of The Tailings Disposal Facility

This investigation will continue as discussed in the updated action plan in the January 2002 report. We ask KGCMC to continue to monitor and take actions as outlined in the action plan to confirm the source of acid drainage and increased sulfates/metals. In addition, the KGCMC plan outlines mitigation of these sources. Information concerning sampling and the actions taken should be addressed in future progress reports and the annual report.

13. Confirm and potentially remove or treat pyritic material in the access road below the Saddle Embankment (north of Wet Well 1) and the material in the Duck Blind drainage to the west of the facility. Alternatively, if the EIS (due 3rd quarter 2002) recommends expansion over this area, then provide information that may enable the material to be left in place provided it is contained within a containment structure.
