FIELD INSPECTION REPORT HECLA GREENS CREEK MINING COMPANY

Inspection Date: May 5, 2008
Report Date: May 21, 2008
Weather: Cool and breezy with temperatures around 45-50F, no rainfall. Snow prevented access to Sites 960 and 1350, otherwise no snow was encountered at the site.
Inspection Objectives: To accompany the audit team from SRK Consulting Engineers and Scientists. The audit is a requirement of the Waste Management Permit and must be conducted every 5 years prior to renewal of the permit.
Operator Contact: HGCMC: Bill Oelklaus, Jennifer Saran, Pete Condon
State Personnel: Ed Emswiler, ADEC; Kenwyn George, ADEC
Steve McGroarty, ADNR
Other Personnel: SRK: Stephen Day, Don Hovdebo, Daryl Hockley, Kathleen Willman
USFS: Jeff DeFreest, Sarah Shoemaker
Documentation: Photos were taken and are available for inspection at ADEC in Juneau

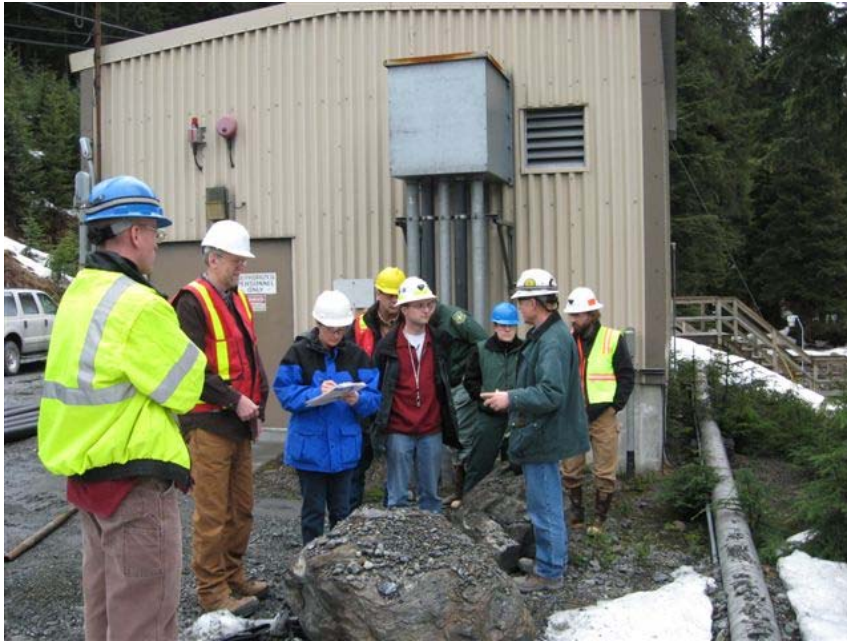
**SRK team, agency staff
and HGCMC personnel
at the water treatment
plant / Greens Creek
near the mine portal.**

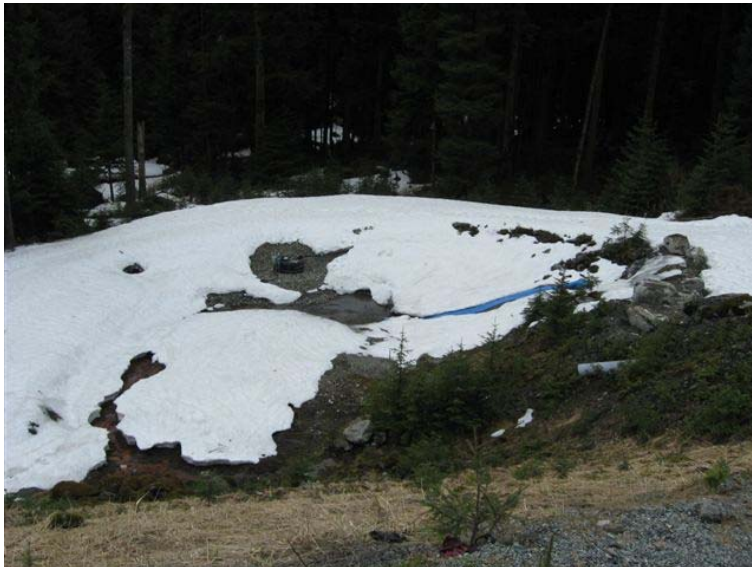
Pete Condon explained how water was collected from roads and ditches and transmitted to Pond C. Seepage through the down-gradient berm of the pond was potentially the cause of an elevated lead level in Site 6 (the nearest down gradient freshwater monitoring plan monitoring site) in November 2003. He explained the recent (2007) installation of a sump collection system and

proposed application of glacial till to the outside of the berm as measures to prevent this re-occurrence. ADEC recommended that a plan be submitted for application of the glacial till to the outer bank. This is an action item to this report. Mr. Condon mentioned that Site C would be excavated and placed either underground or at a disposal site at closure of the mine as it contains pyritic material that can cause ARD and metals leaching. This is programmed into the most recent closure cost estimates.

1. water collection and diversion at the road from the mill and how this could be improved to prevent contamination from entering Pond C.
2. ADEC recommended that the SRK team further analyze the whole water management situation related to Pond C as well as the measures being taken to reduce the likelihood of seepages, and provide recommendations.

**Pond C. Note sump and
berm**

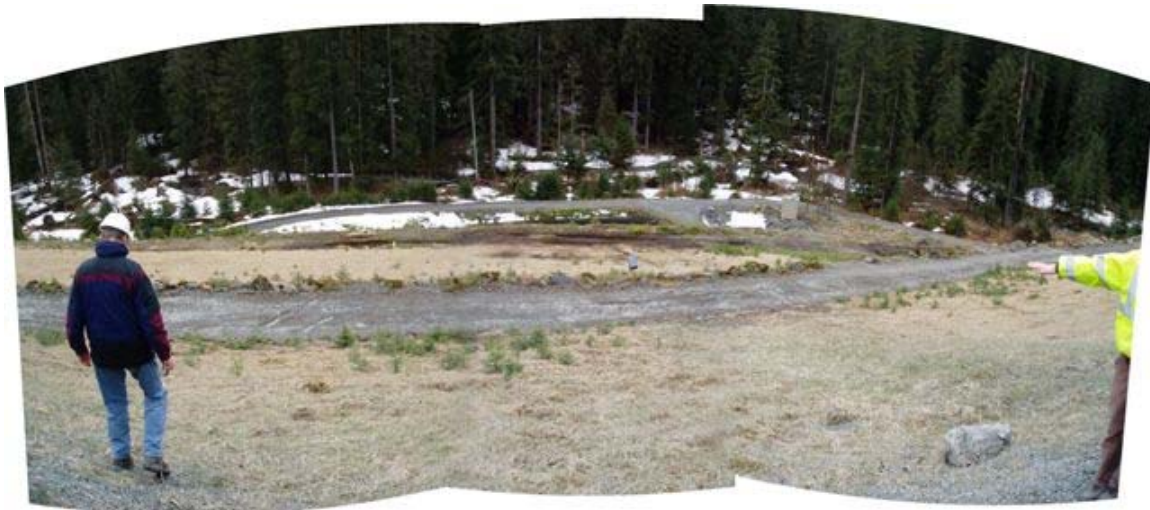
Site D and Pond D

characterization of the waste rock was used to develop these facilities during the initial development of the mine. This was prior to regulation by the Agencies which commenced in 1990. All of the materials at these sites will be excavated prior to closure and placed into the tailings disposal site or inside the mine. It was noted by the SRK team that excavation of portions of the glacial till material below the waste rock may be needed as contamination from the waste rock may have influenced the condition of this material. The site was constructed with a pond (Pond D) to collect stormwater and run-off from a curtain drain at Site 23. Pond D contains approximately 12% contact water and approximately 80% of the D Pond flow is from the curtain drain. During a storm event in November of 2005 the flow over-topped the embankment to Pond D and spilled into Greens Creek.

2. The Site D berm has pyritic material and seeps water. We are interested in the best way to deal with the Site D berm such that contamination and leakages are eliminated, as well as having it withstand a 24-hour, 25-year storm to prevent discharge to Greens Creek. The Site D berm should be re-built using material that does not cause ARD or metals leaching; and, should be made not to create seepages. HGCMC should submit a plan and schedule for this.

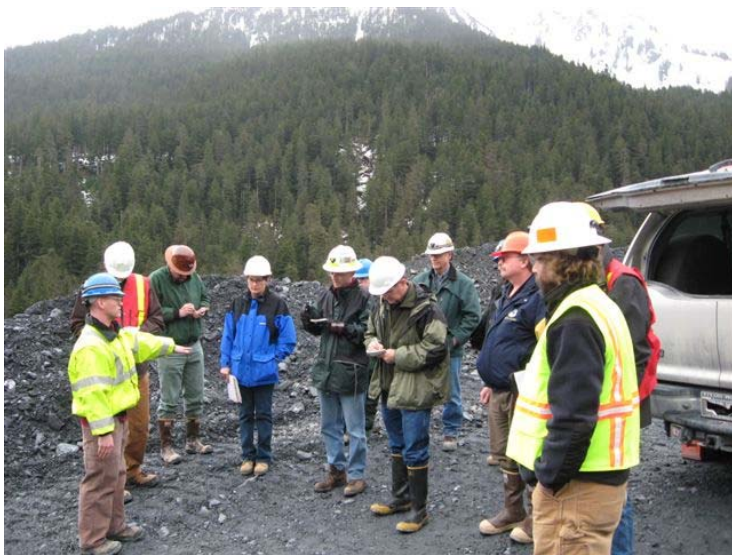
**SRK team, agency staff
and HGCMC personnel
at Site 23.**

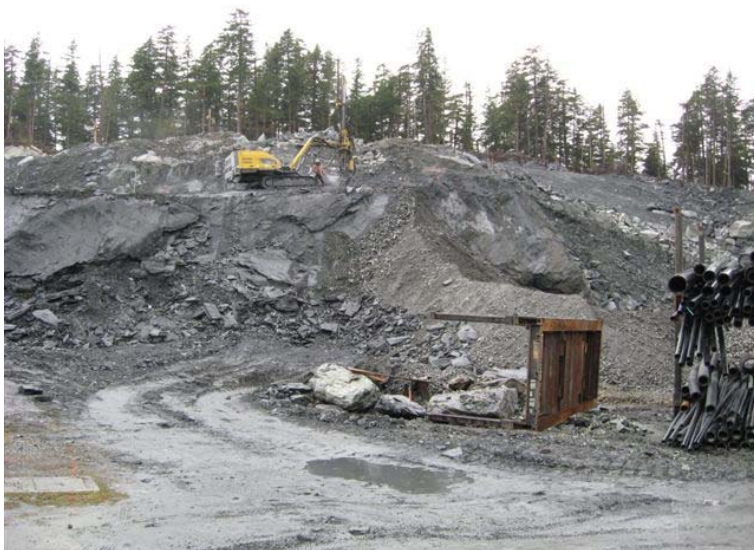
**Pit 5 excavation in
progress.**

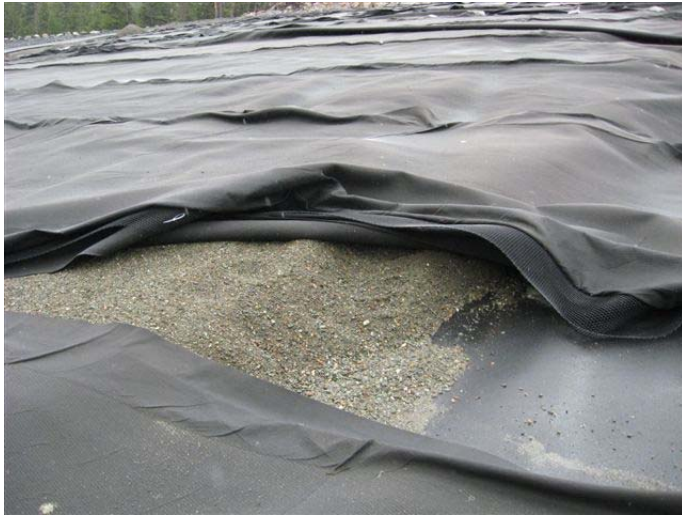
Geomembrane, geotextile and lower protective granular layer at the tailings NW expansion site.

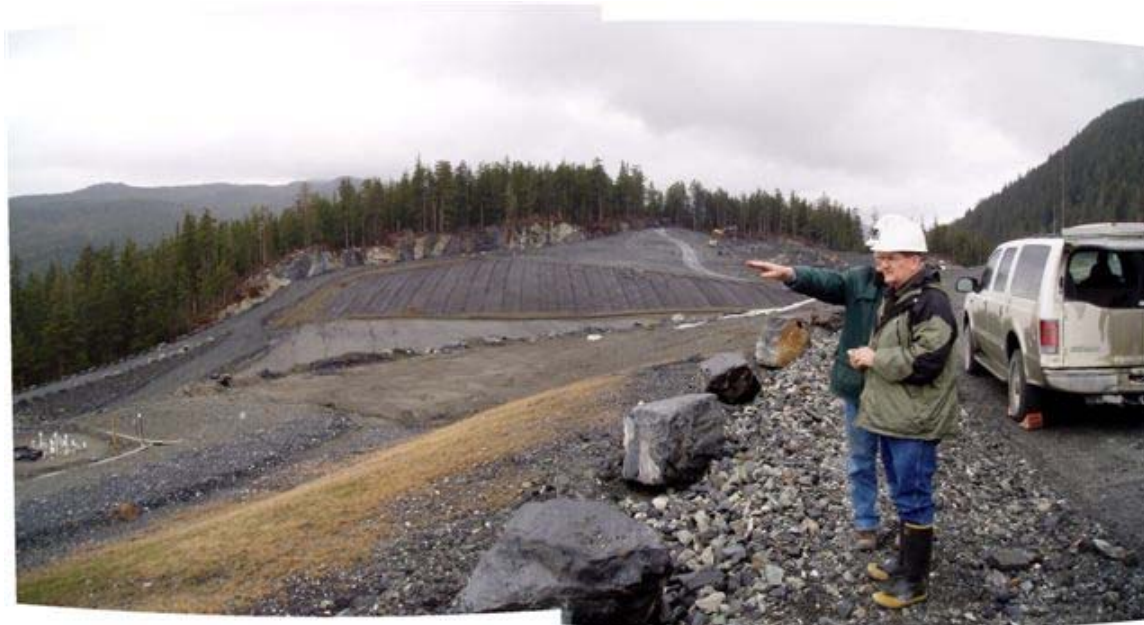
Tailings pile, SRMP cells to the left, Northwest expansion area in the center, Pit 5 to the right.
