MEMORANDUM

State of Alaska

SUBJECT: Kennecott Greens Creek Site
Visit, May 11, 2006

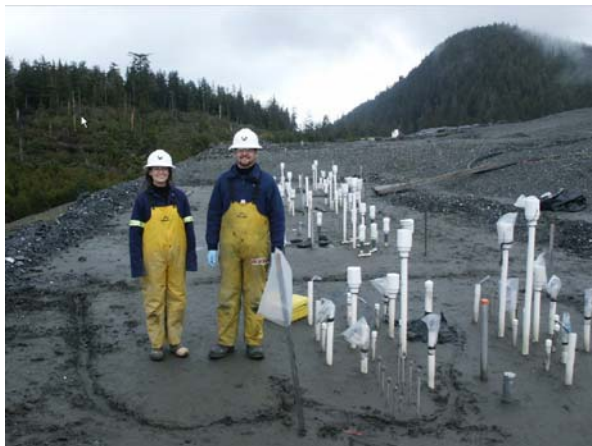
The SRMP units were being worked on (data collected) by the University technicians. The far cell had a depression, most probably from a cavity between the cell fabric and the native tailings, and the tails in the cell settled. This cavity will be filled in so that it does not form a sump for surface runoff.

University of Waterloo technicians

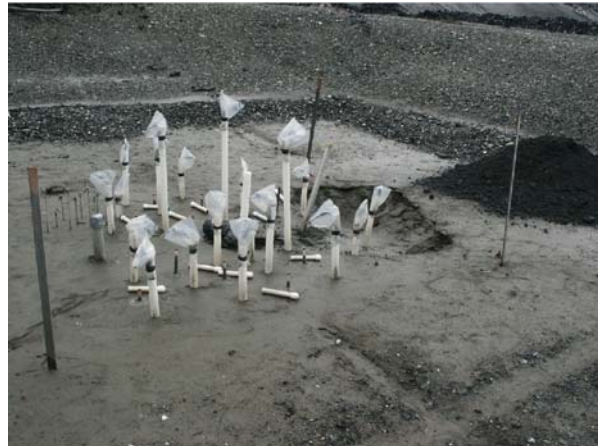
Sinkhole in southernmost cell

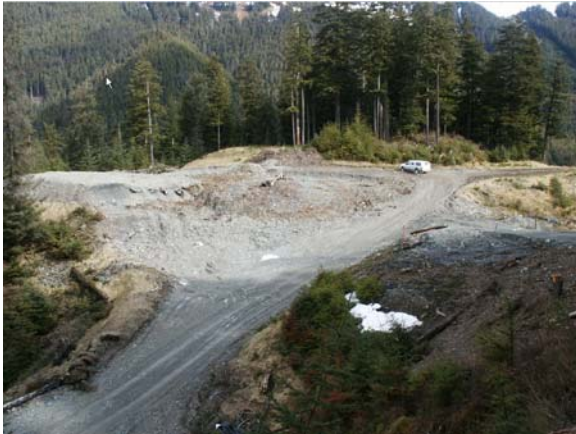
Material from this site had been taken underground. This will continue when feasible during the summer months. A new road had been constructed to a proposed pad that will be used to bore a hole for a ventilation shaft.

Area at Site 1350 where material removed.

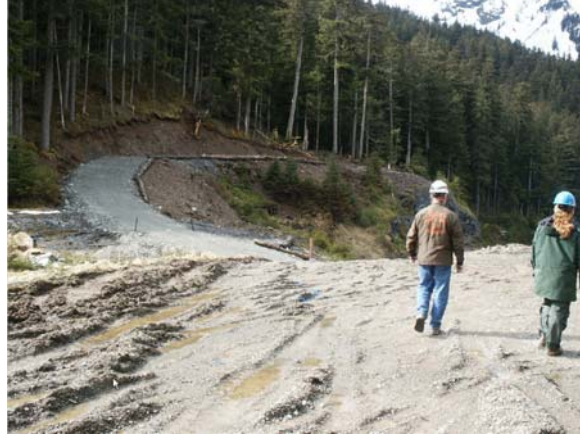
Road to ventilation shaft drill site.

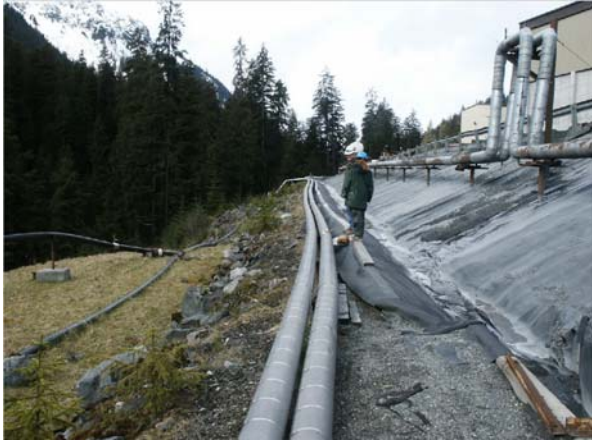
We hiked down the slope from the break to Greens Creek. Sediment was visible in the pipe. The majority of the sediment had been removed from the ground; however there was a small patch of gray solids near the river that Greens Creek will be removing. The sampling technique and protocol for sediments in the river was discussed. Sediment testing is required under the NOV for the spill. Because of the gravel and coarse sediments in the river, it was agreed that the sampling technique specified in the NOV should be modified in order to capture fine sediments. An updated sampling protocol was subsequently sent to KGCMC after the site visit.

The dewatering pipeline that broke.

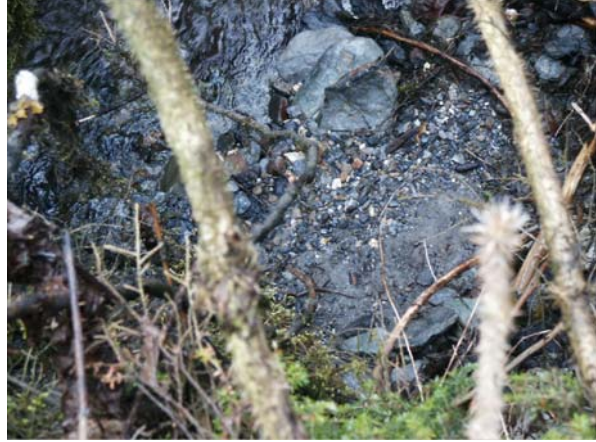
Sediment (which looked like natural sediment) and rocks in the creek.

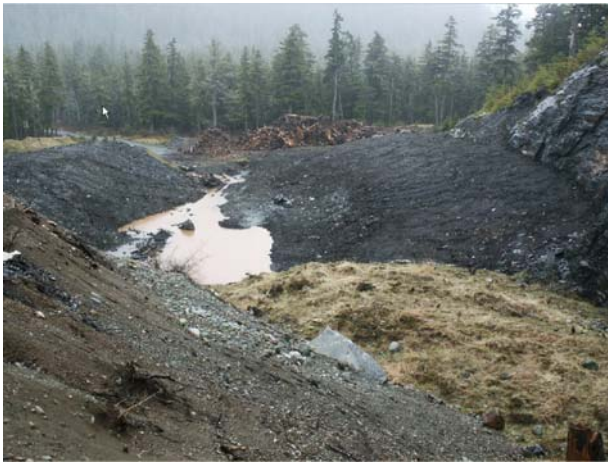
This pit is on the “A” road. Organics such as muskeg have been placed in the pit for storage purposes. It could be seen that a lot of iron and manganese were being released from the organics.

Pit 7 – organics & runoff.

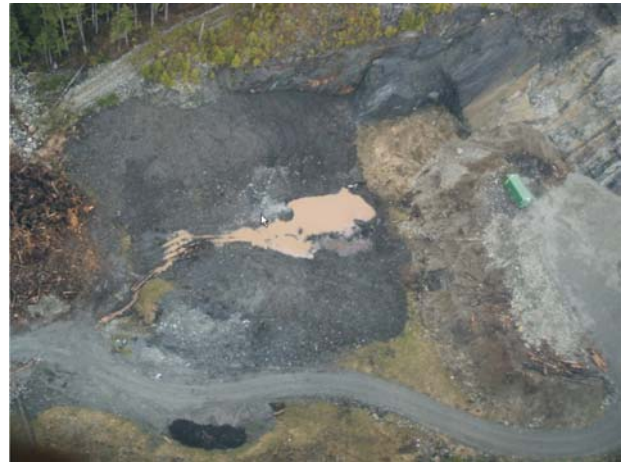
Aerial view of Pit 7.
