INSPECTION REPORT: GREENS CREEK MINE

Tongass National Forest Minerals Group
8510 Mendenhall Loop Rd
Juneau, AK 99801
(907) 789-6276 – office
(907) 586-8808 – fax

Date of Inspection: Wednesday, October 26, 2022
Date of Report: December 5, 2022
USDA Forest Service Inspector: Pat Dryer

The site inspection included: The A and B access roads, 1350 area, 920 area, Site 23, Pond C, Pond D, 7.4 mile B-Road Bridge (Killer Creek Bridge), 5.6 mile B-Road landslide area, Site E, 3.4 mile B-Road bridge (Falls Creek Bridge), 3.0 mile B-Road bridge (Zinc Creek Bridge), and the Tailings Disposal Facility (TDF).

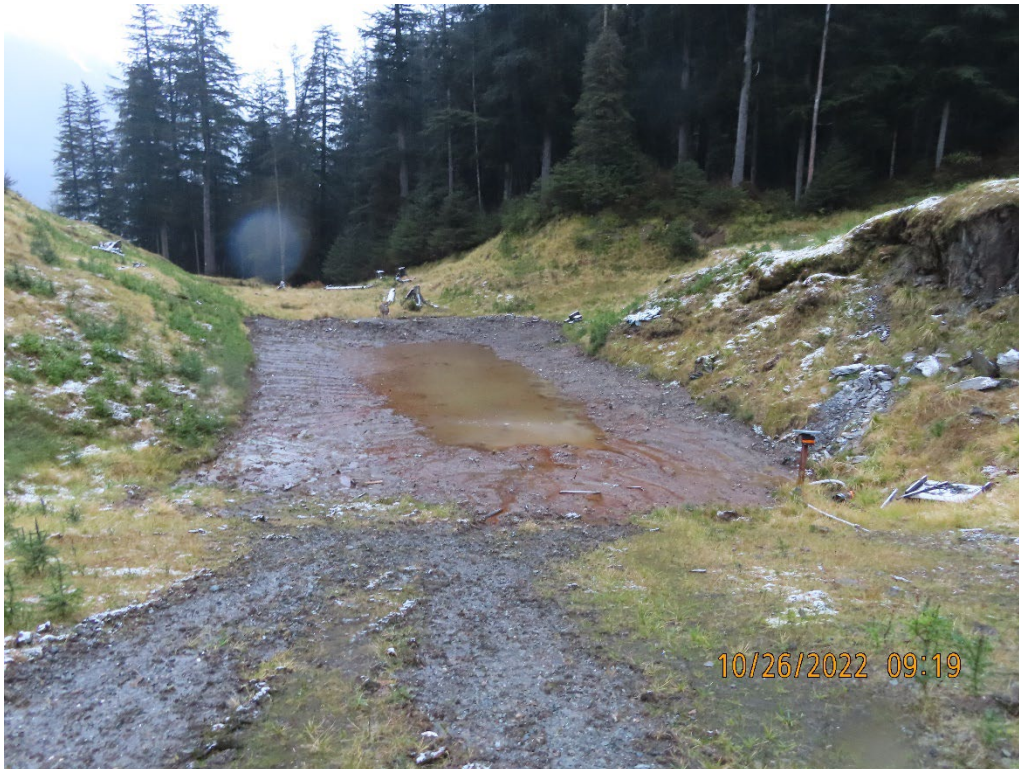
The drill pad that was documented in inspection report 422 was removed in late summer. The drill collars were recently cut off below ground level and perforated pipe was installed to promote drainage of surface water collected in the sump (Photo 1). Water from this sump is now collected underground and treated prior to discharge.

Photo 1. The 1350 area and new water collection sump.

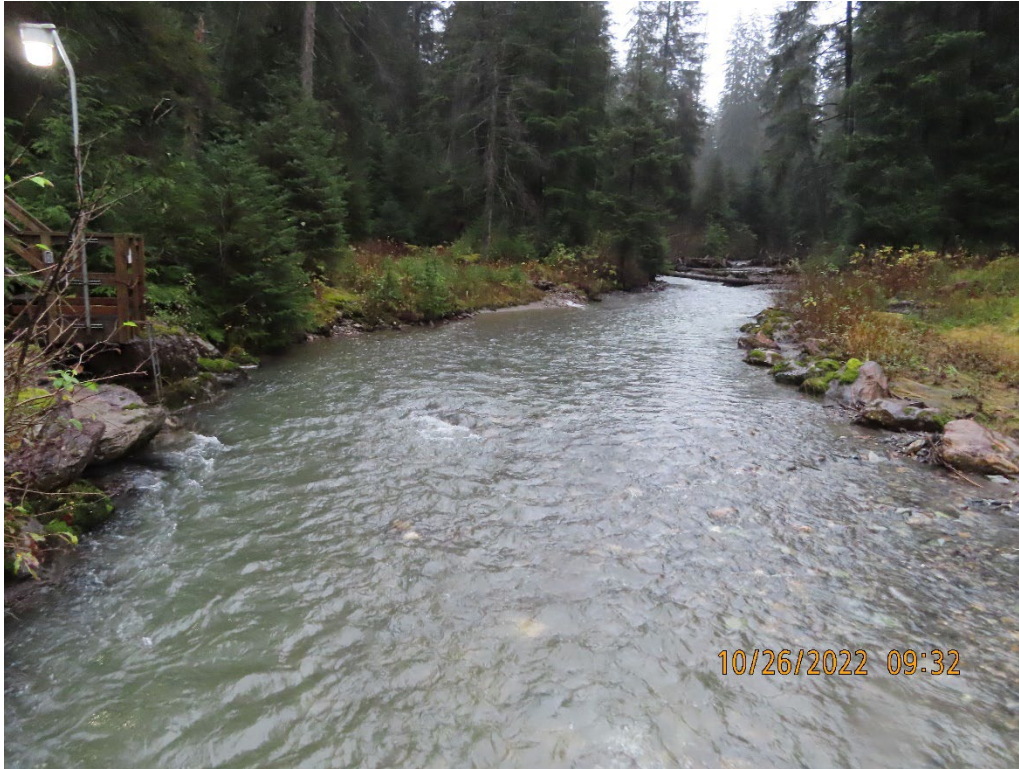
The Greens Creek discharge was 61 cfs (Photos 2-3) and 1.3 cfs was being withdrawn for operational use.

Photo 2. Greens Creek looking upstream from the 920 weir.

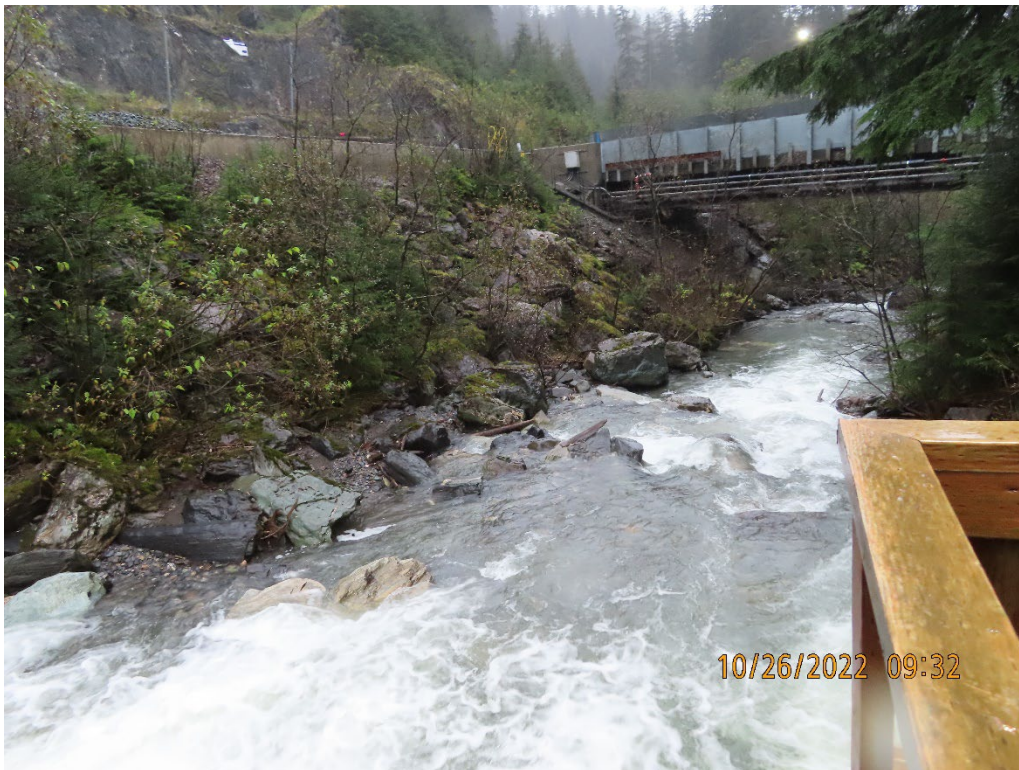
Photo 3. Greens Creek looking downstream from the 920 weir.

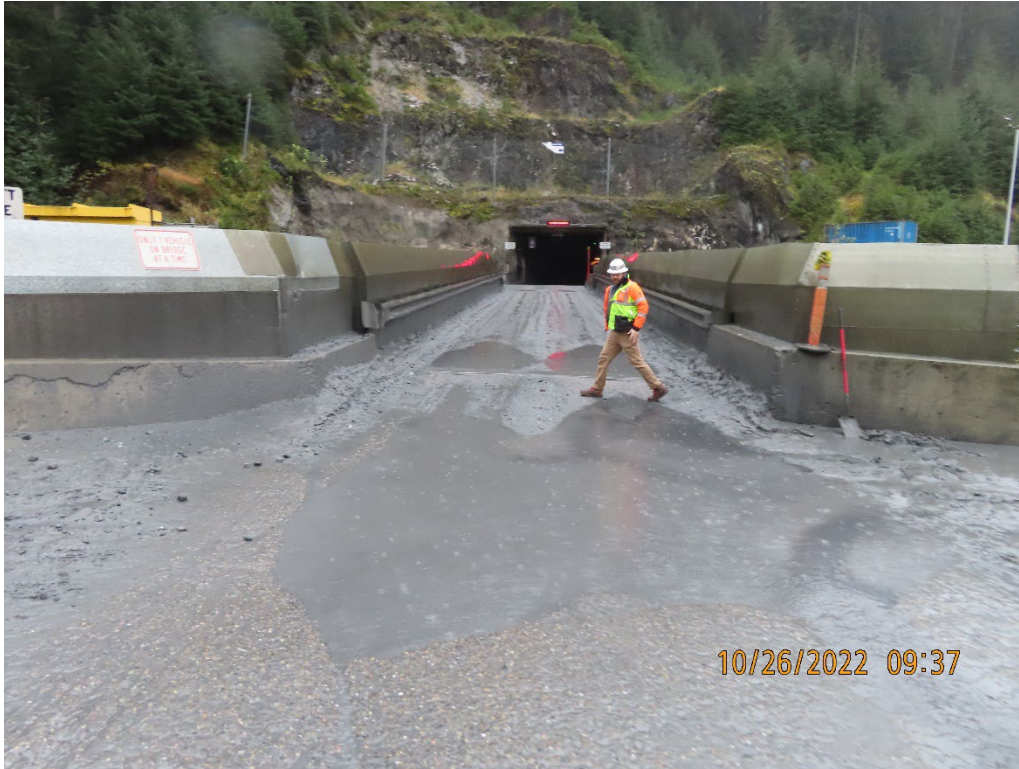
Minor ponding of water was observed on the approach to the Greens Creek bridge (Photo 4). Excess sediment near the degrit basin was blocking the drainage and was removed during the inspection.

Photo 4. Greens Creek bridge with minor ponding of water.

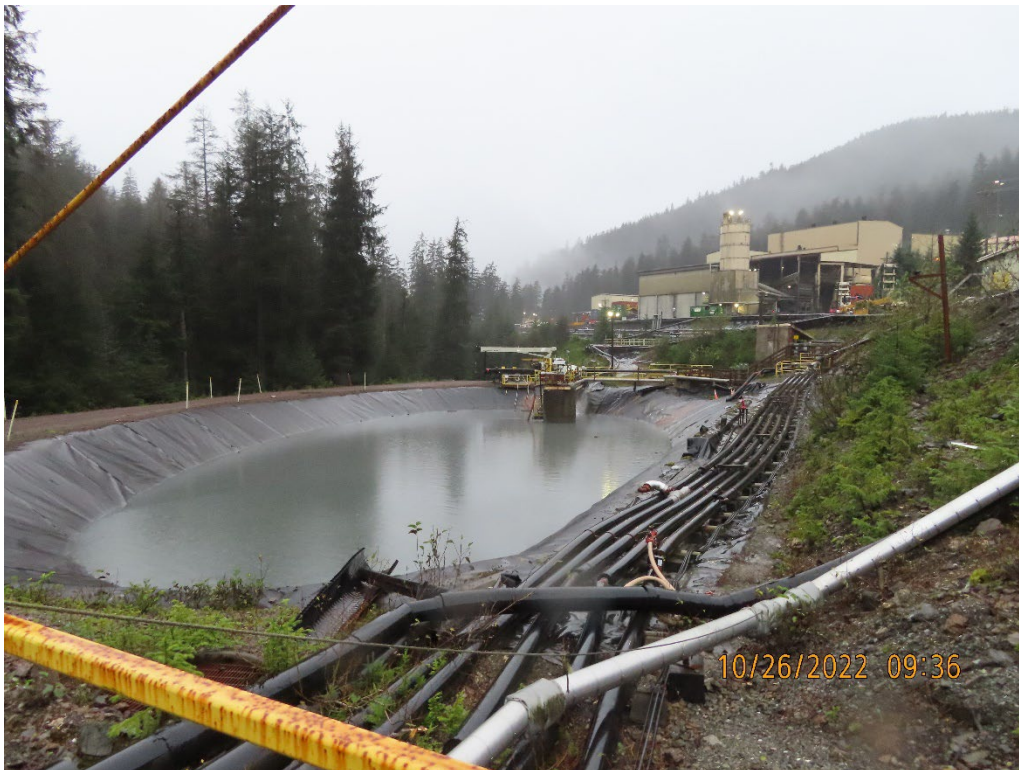
Pond A was in good condition with substantial surge capacity (Photo 5).

Photo 5. Pond A, below the 920 area.

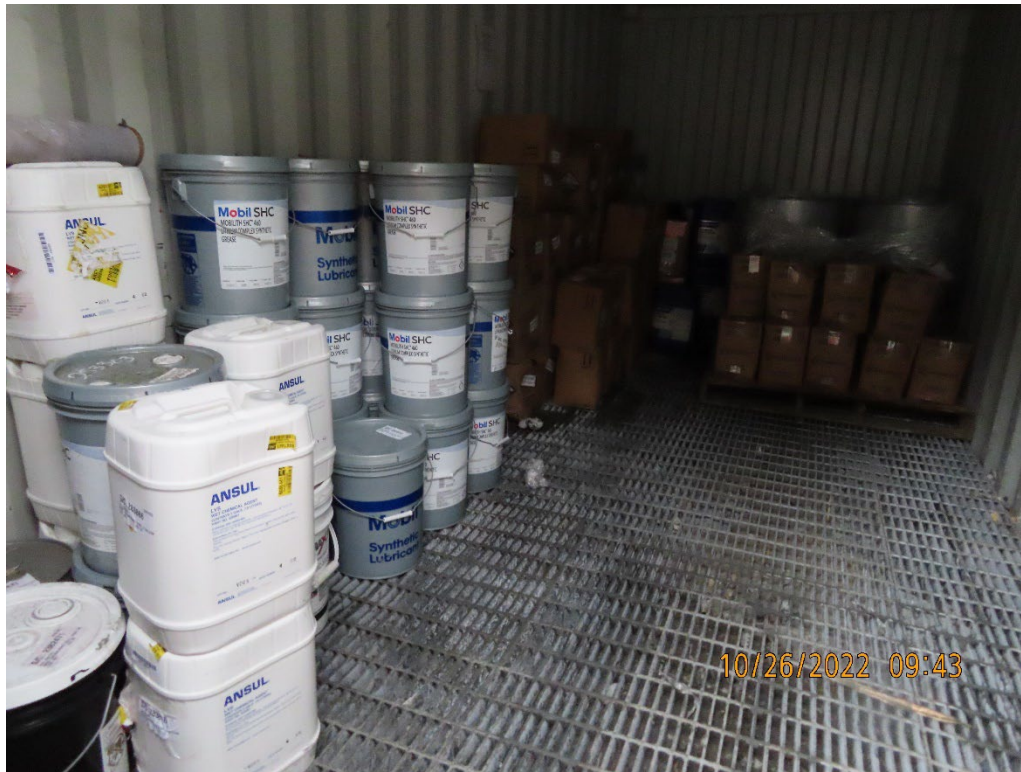
Good housekeeping practices were observed at the 920 warehouse (GPO, Appendix 5 BMP Plan, page 39). All petroleum/chemicals observed were properly stored within secondary containment (Photo 6).

Photo 6. Chemicals stored in appropriate secondary containment at the 920 warehouse area.

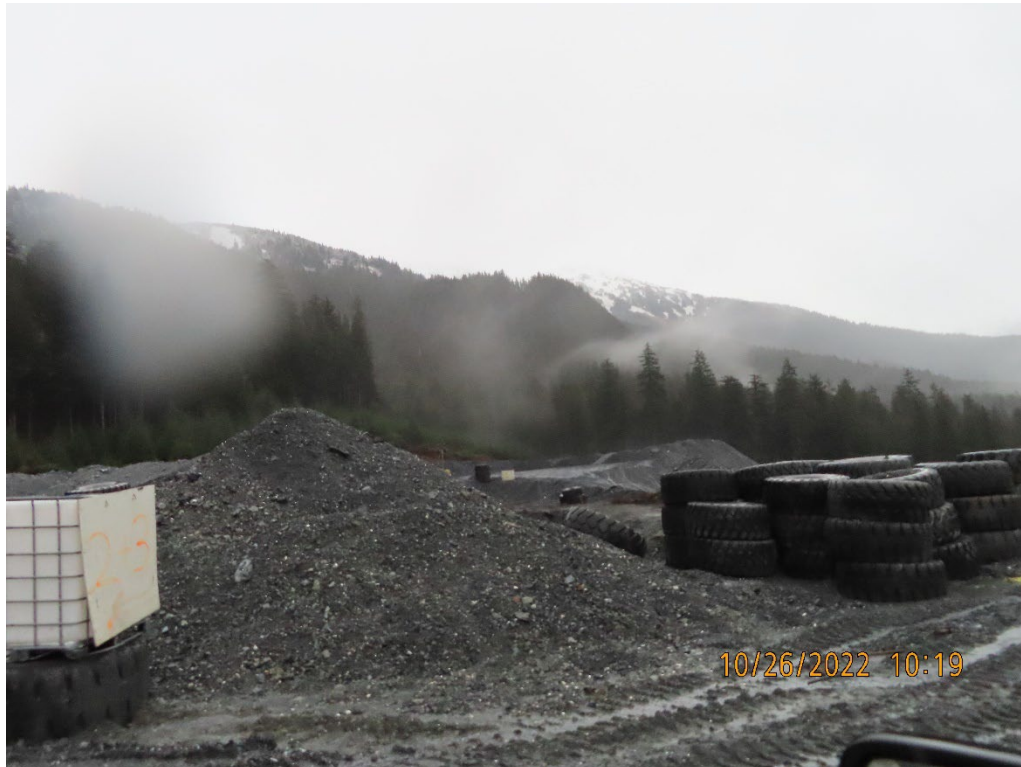
Class 1/2/3 waste rock continue to be placed at this location (Photo 7).

Photo 7. Upper Site 23 waste rock storage area.

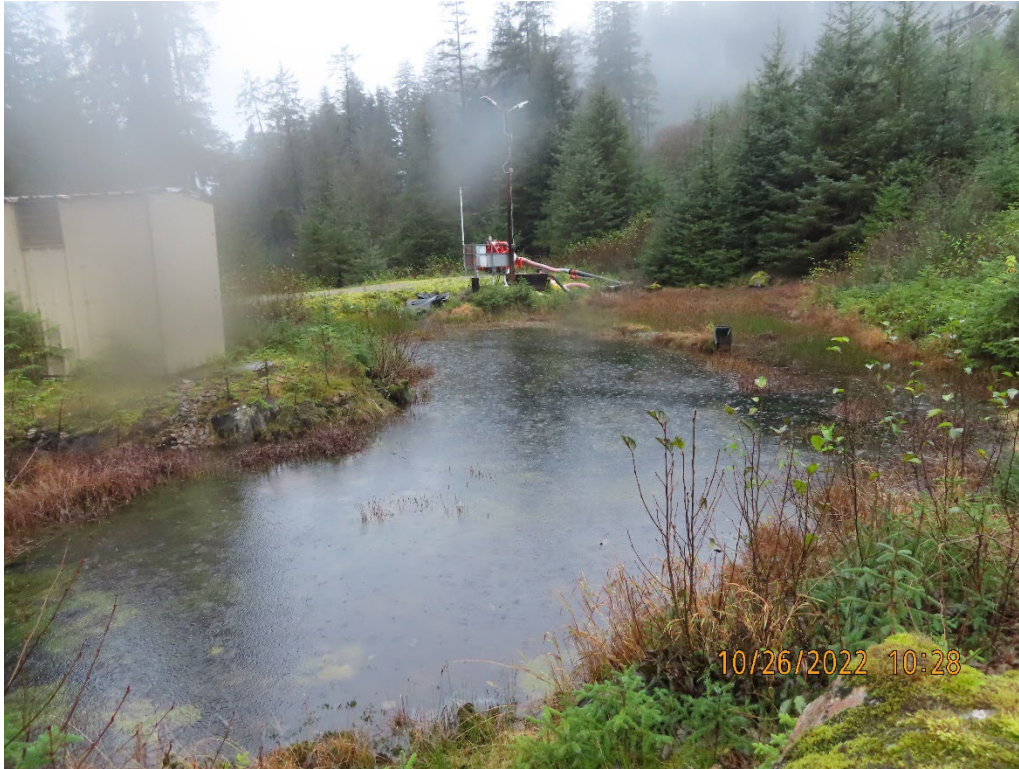
Pond D was in good condition with adequate surge capacity (Photo 8).

Photo 8. "D" pond near the Site 23 pump area.

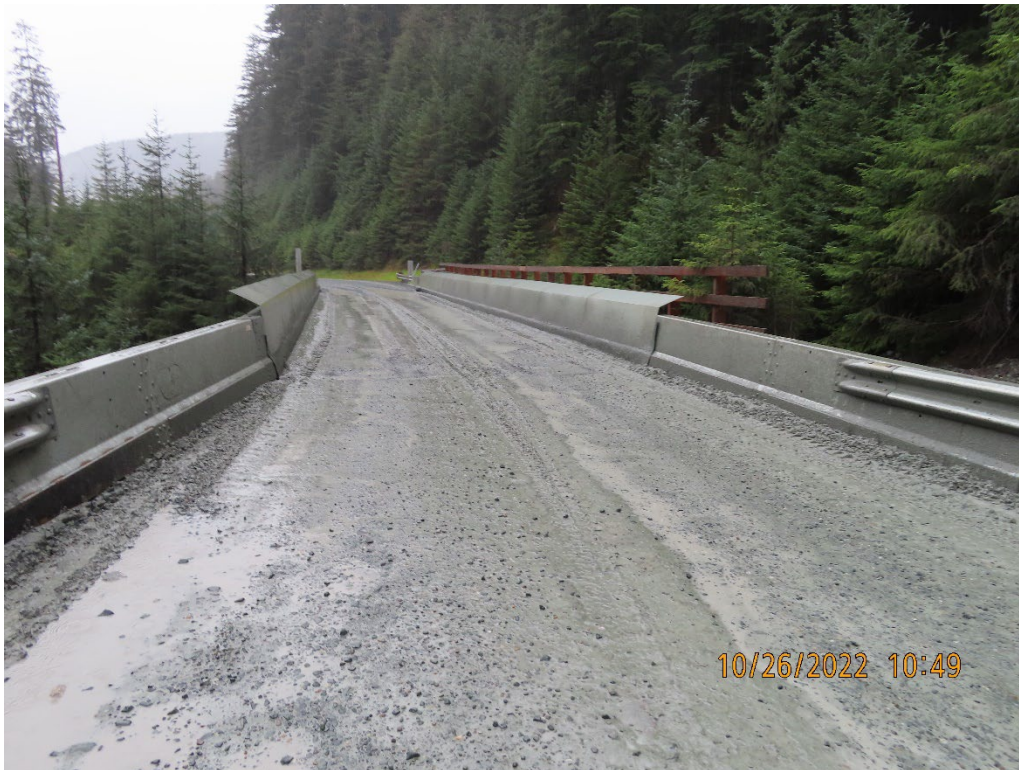
The Killer Creek Bridge appeared in good condition (Photo 9), with sediment deflection concrete barriers preventing sediment from reaching bridge abutments (Photo 10).

Photo 9. Killer Creek Bridge surface.

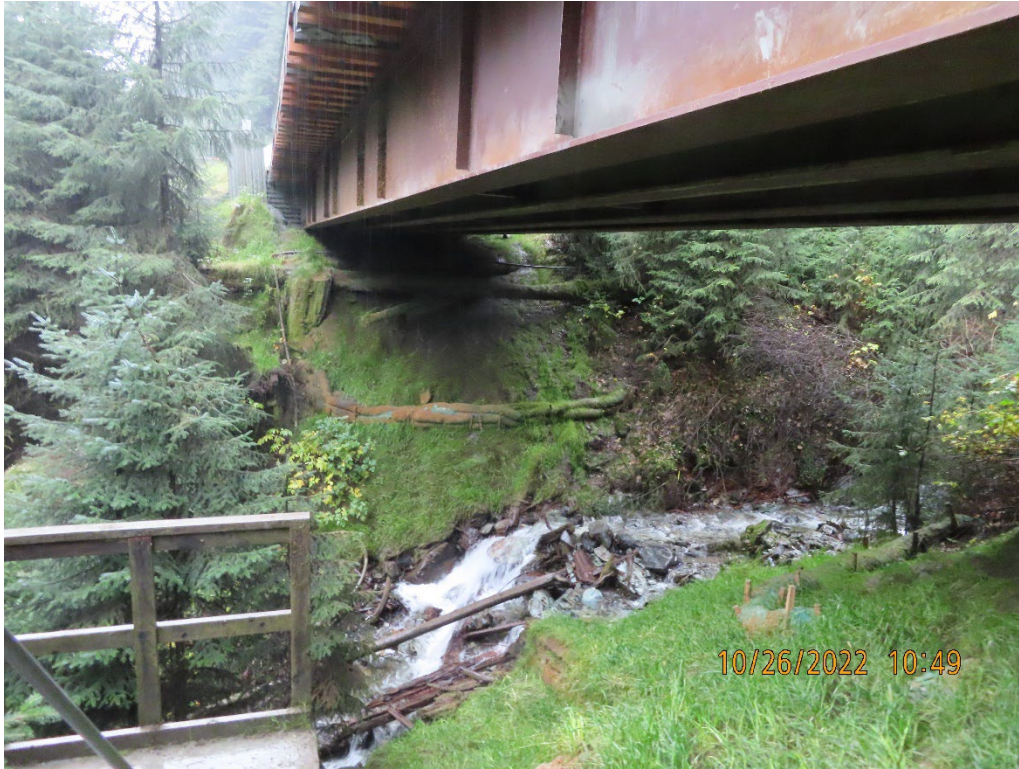
Photo 10. Killer Creek Bridge abutment BMP's.

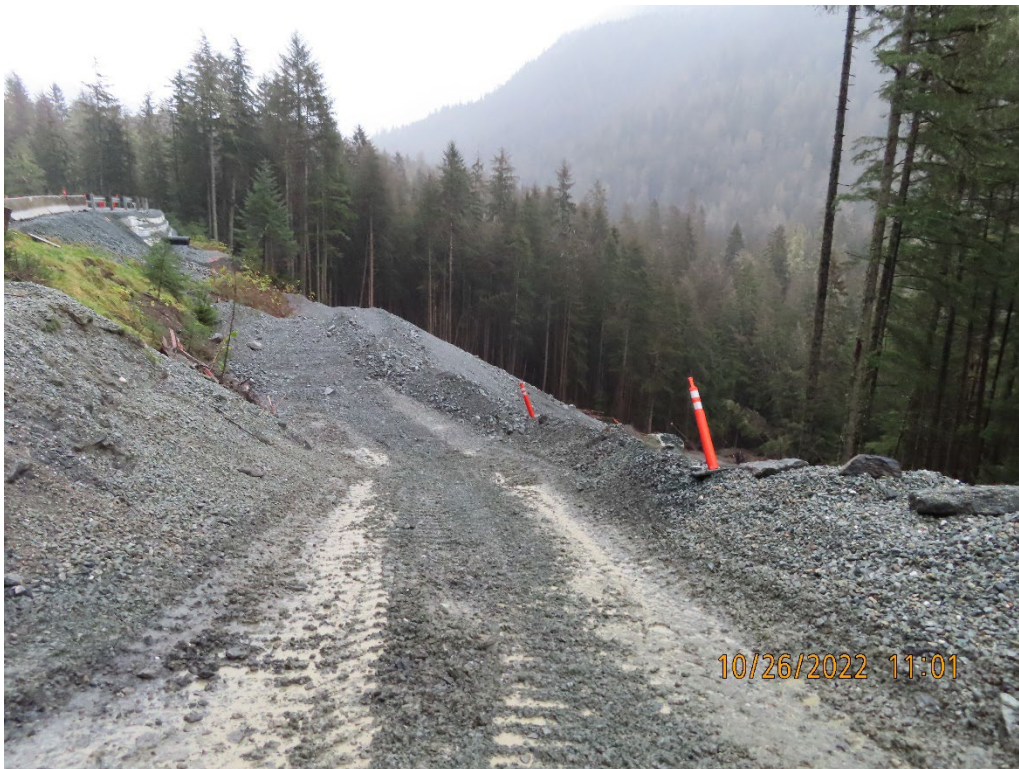
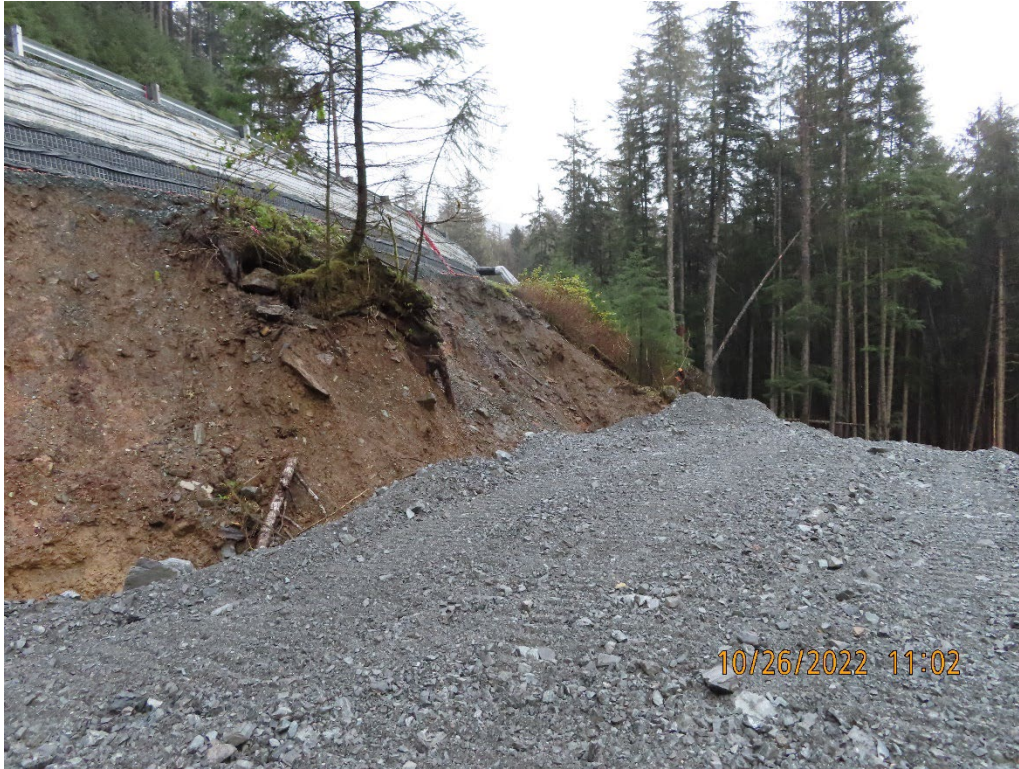
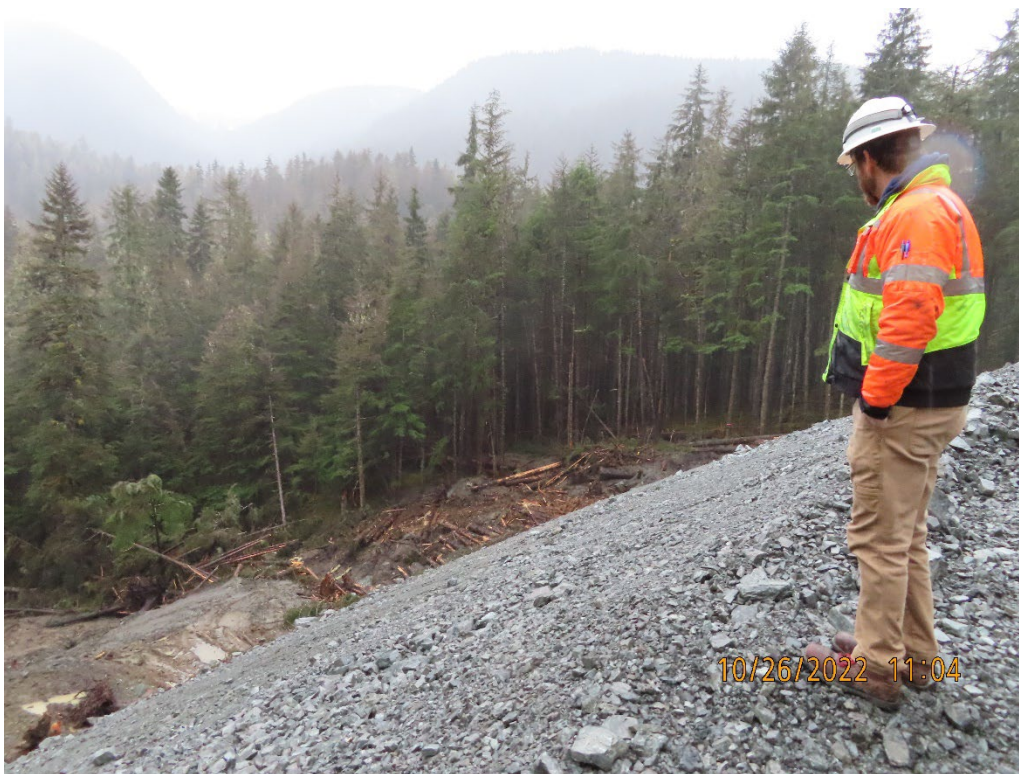
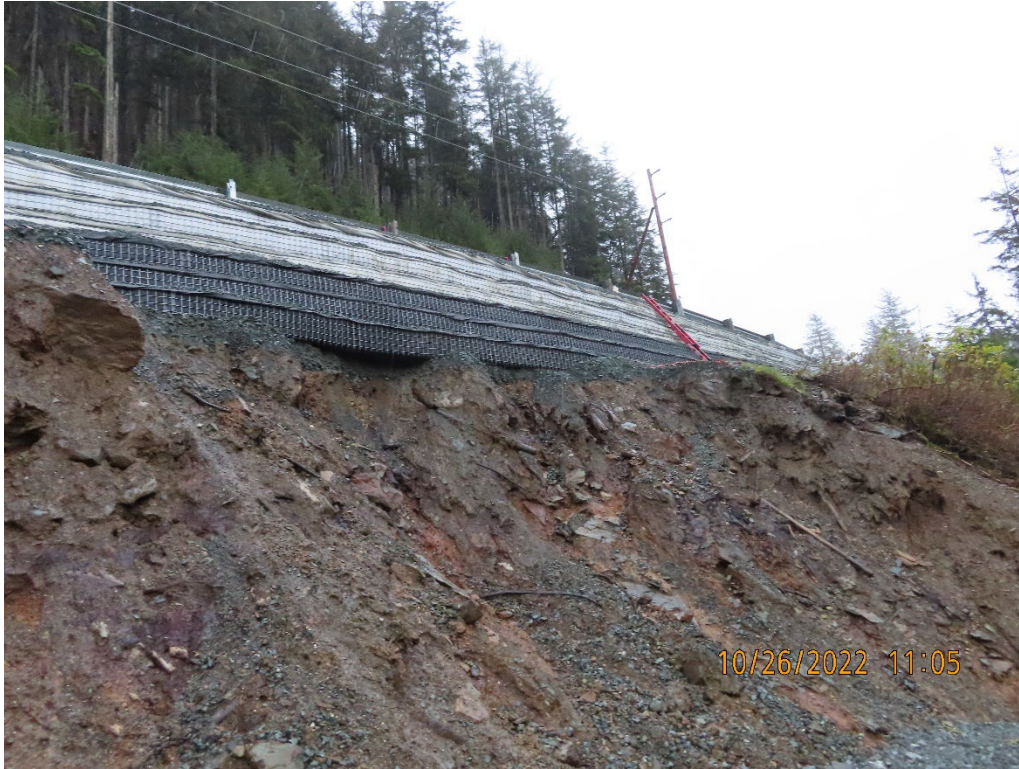
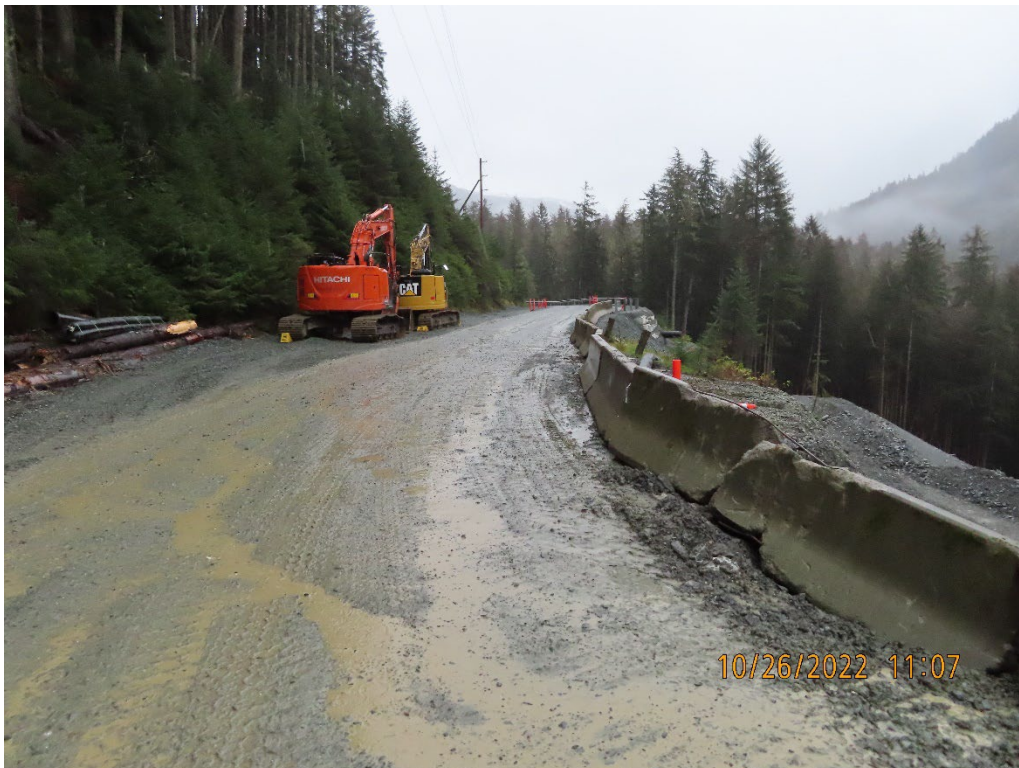
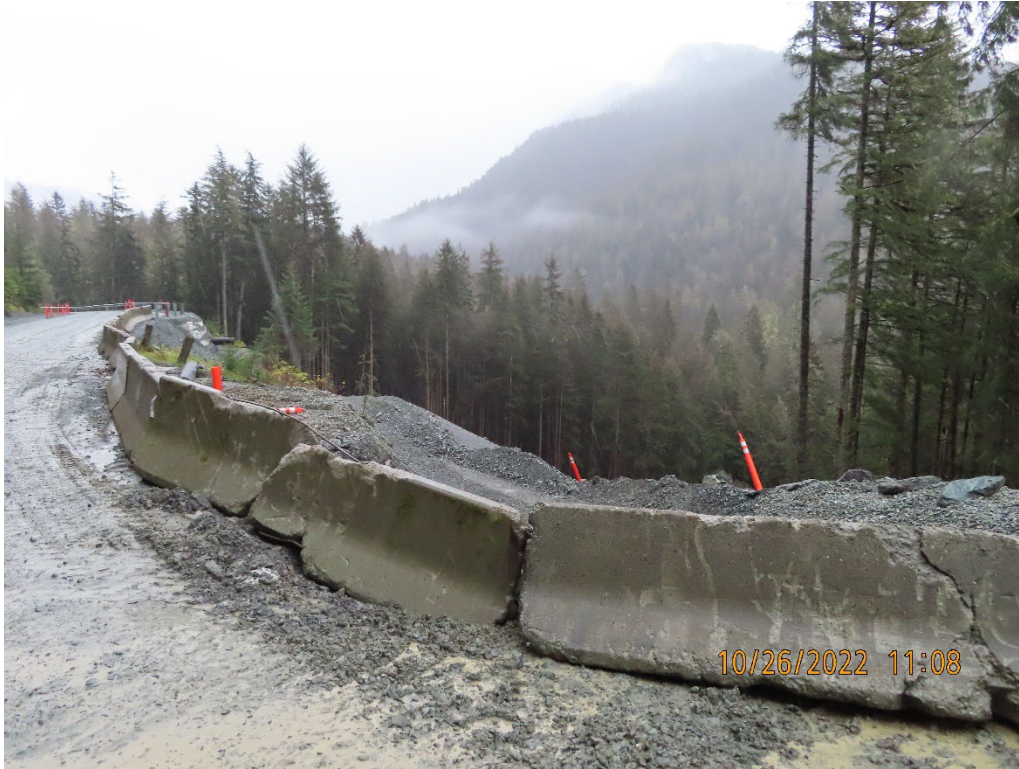
A landslide occurred on Tuesday 27 September at the 5.6 mile of the B-road (Inspection report 423). Substantial work has been completed to stabilize the slope (Photos 11-16). During our inspection a temporary pause in the repair operations was occurring for the contractor to take a necessary break. Work will resume on the project after the required break. Repairs were nearly complete during this visit. Rock was sourced from the 8 Fathom rock pit in Port Frederick, Haines, and Stablers quarry for this project.

Photo 11. 5.6 mile B-road landslide repairs.

Photo 12. 5.6 mile B-road landslide repairs.

Photo 13. 5.6 mile B-road landslide repairs.

Photo 14. 5.6 mile B-road landslide repairs.

Photo 15. 5.6 mile B-road landslide repairs.

Photo 16. 5.6 mile B-road landslide repairs.

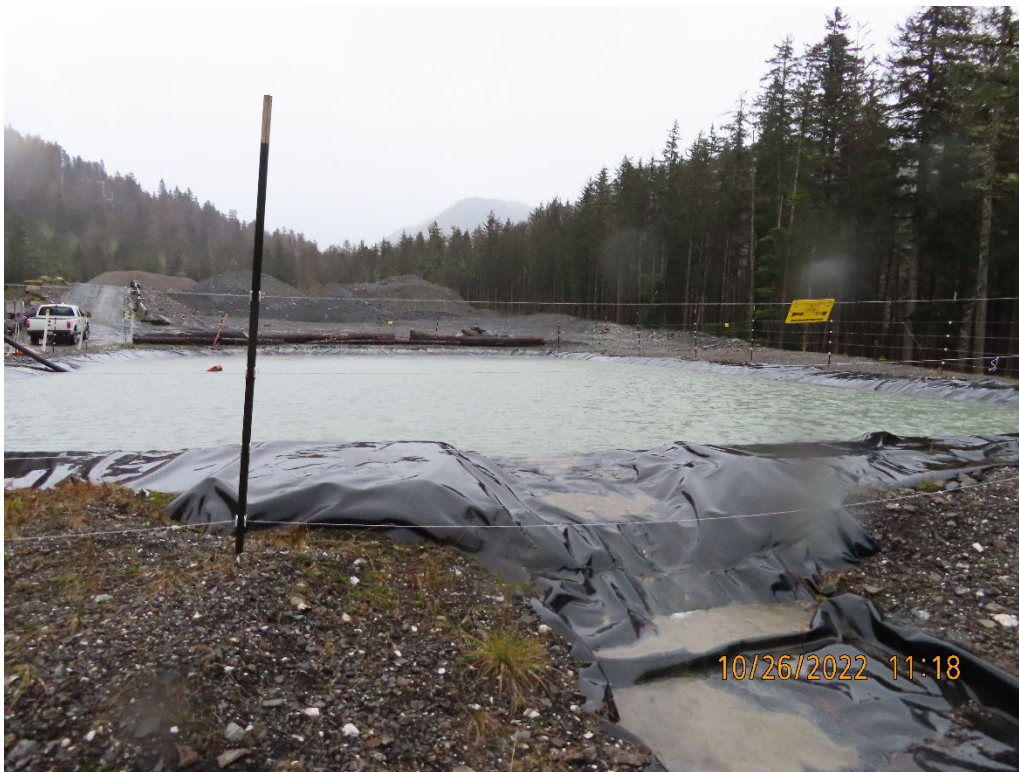
Site E continues to be used as a laydown area for storing road surface rock, equipment, explosives, and materials excavated and/or used for projects including bridge replacement and repair, and the 5.6 B-Road slope stabilization project. The stormwater pond was full, limiting the available surge capacity, and observed discharging to the environment (Photos 17-18). Discharge from this location is permitted via an APDES stormwater outfall, however HGCMC typically collects and treats this water during summer and shoulder season months. The USFS will work with HGCMC and appropriate State agencies to evaluate whether water quality monitoring near this location is suitable for monitoring potential environmental impacts.

Photo 17. Stormwater pond at capacity at Site E.

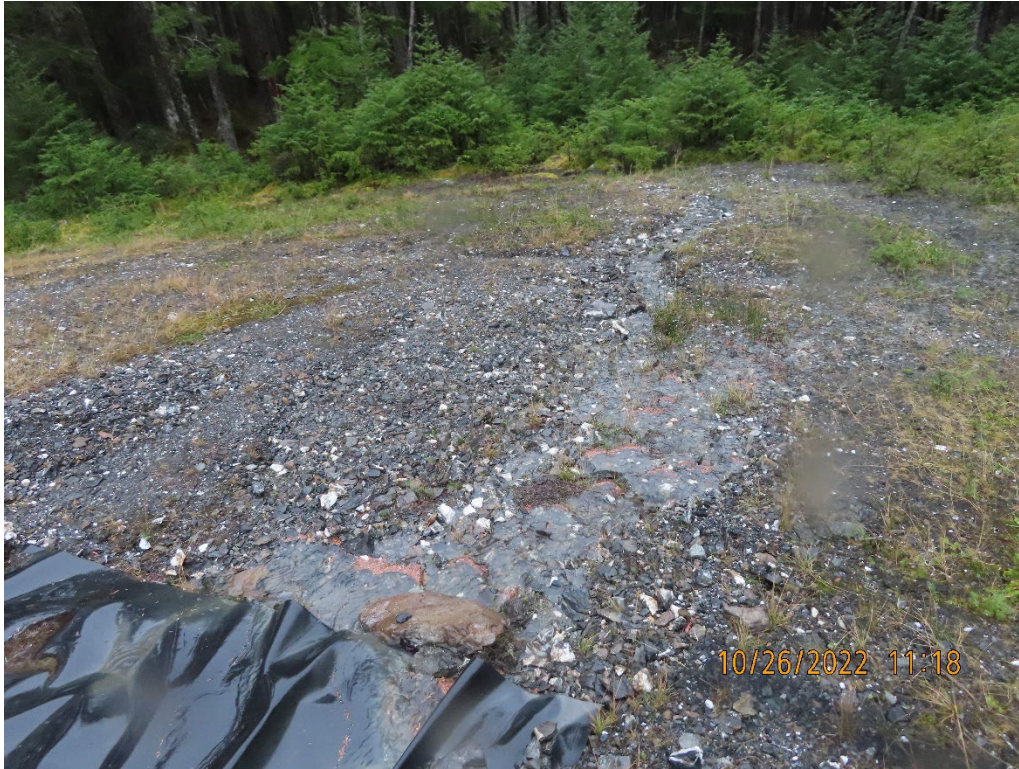
Photo 18. Stormwater pond discharge at Site E.

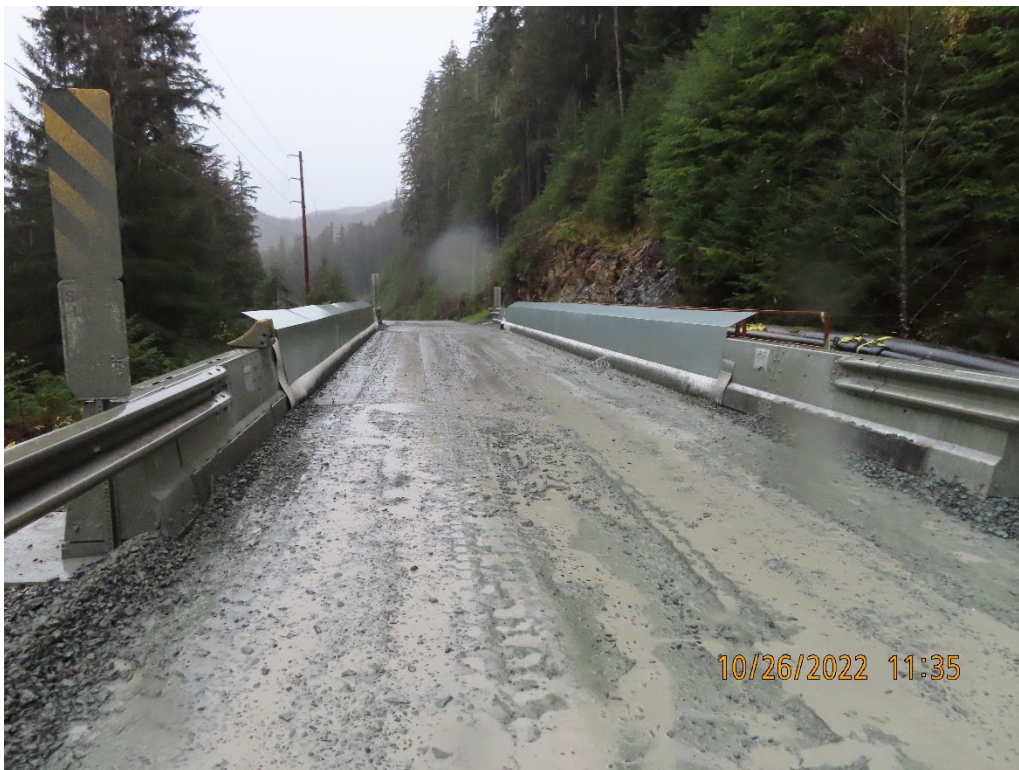
This bridge was replaced earlier this year. The new bridge wear surface was installed higher than the adjacent roadbeds which is intended to prevent excessive ponding of water on the bridge surface (Photo 19).

Photo 19. Falls Creek Bridge surface.

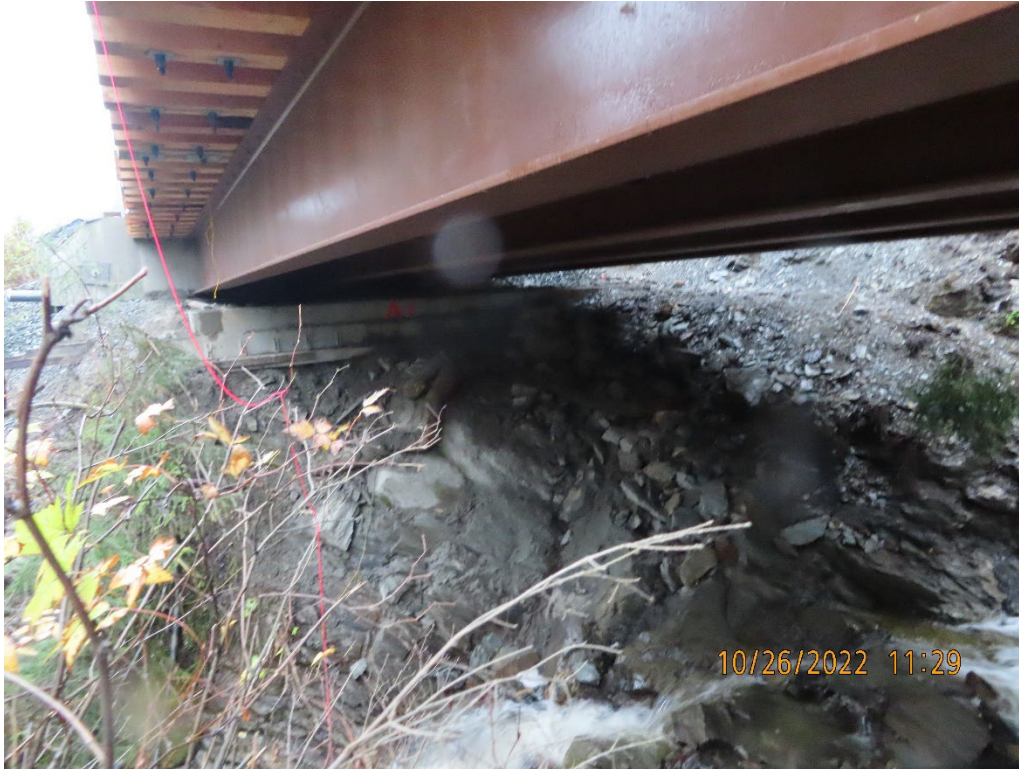
424-2: 8/31/2022	Stormwater sediment BMPs on the downhill side of the Falls Creek Bridge abutment are in disrepair (Photo 19). BMPs require improvement to effectively contain sediment or prevent sediment from accumulating on the abutment.	PENDING.
424-3: 8/31/2022	Sumps that precede the "Gnome Pond" along the B-Road are filled with sediment that should be removed to improve BMP efficiency (Photo 27).	PENDING. Recent heavy rains have filled sumps along the B-road.

PENDING ACTION ITEM 424-2: Stormwater sediment BMPs on the downhill side bridge abutment are in disrepair (Photo 20). These BMPs require improvement to effectively contain sediment or prevent sediment from accumulating on the abutment.

Photo 20. Falls Creek Bridge downhill side abutment BMPs in disrepair.

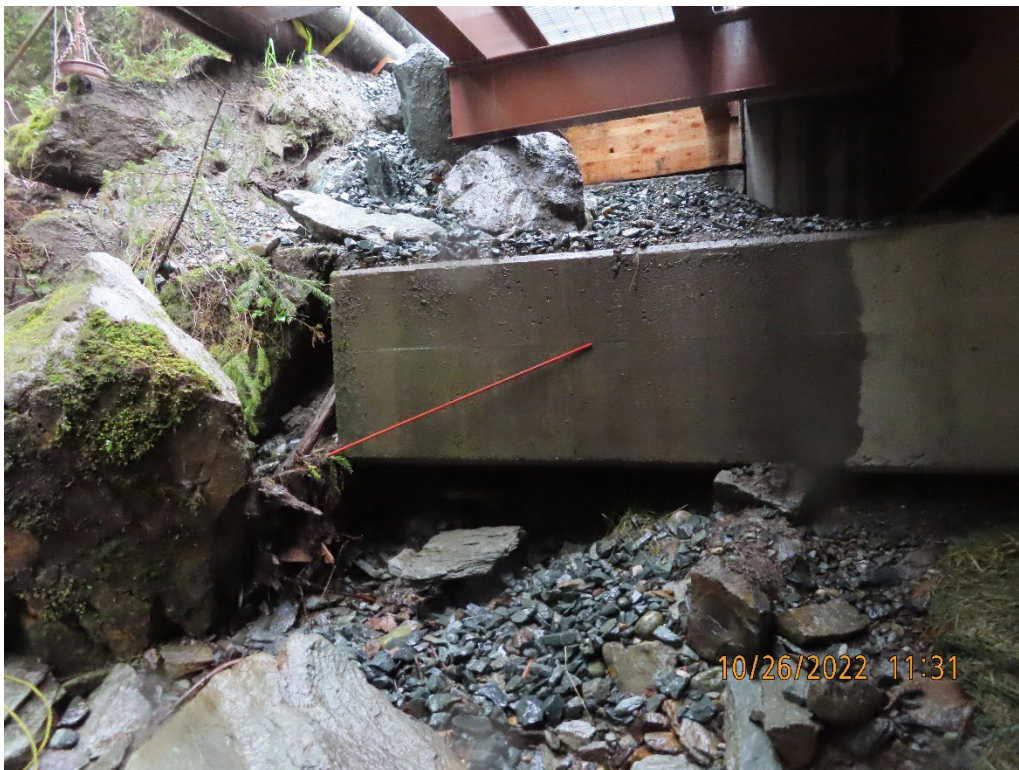
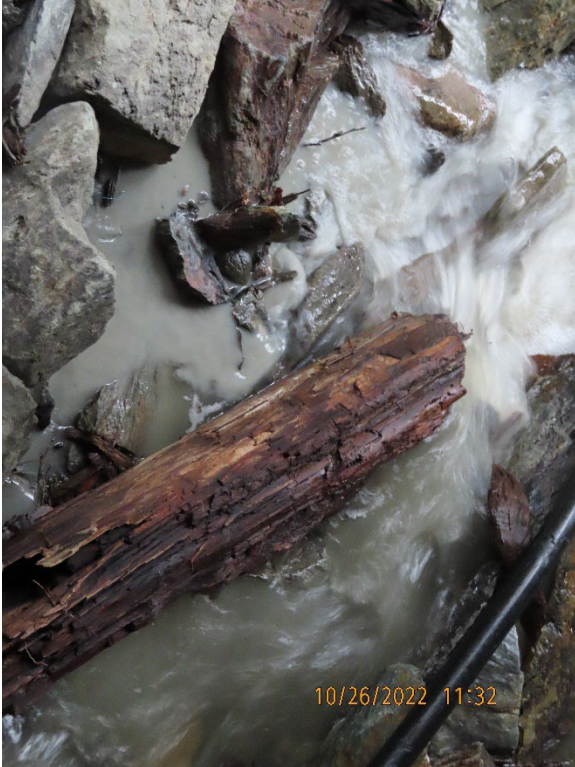
NEW ACTION ITEM 426-1: Stormwater sediment BMPs on the uphill side of the Falls Creek Bridge abutment are not functioning as designed and turbid water is reaching Falls Creek (Photos 21-22). BMPs require improvement to reduce turbidity of runoff prior to discharge into Falls Creek.

Photo 21. Falls Creek Bridge uphill side abutment BMPs in disrepair and likely source of turbid water.

Photo 22. Turbid waters entering Falls Creek from bridge abutment.

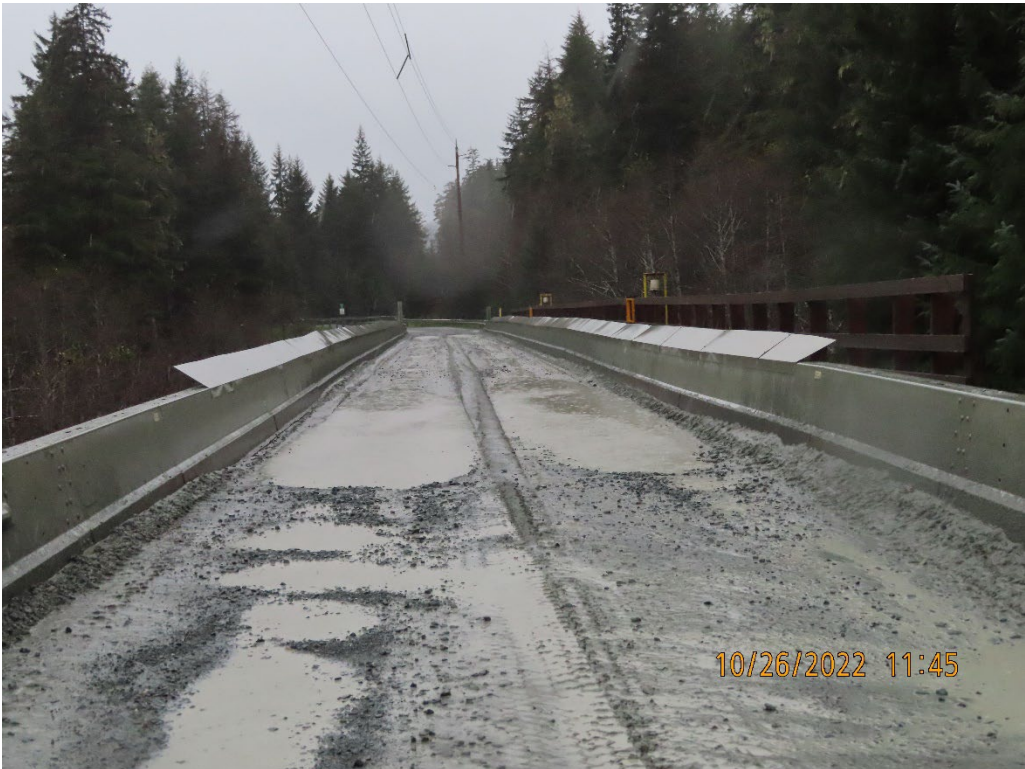
Ponded water was observed on the approach to the Zinc Creek Bridge (Photo 23).

Photo 23. Zinc Creek Bridge with minor ponding of water.

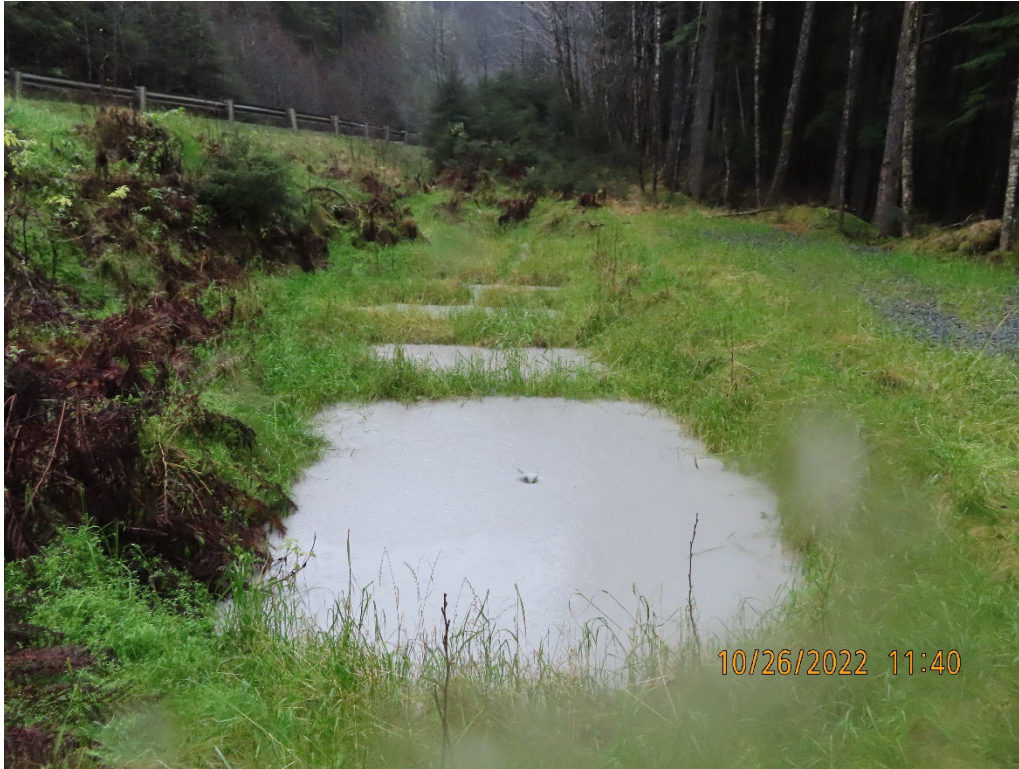
The “Gnome Pond” was observed at capacity with turbid water from surface water runoff (Photo 24).

Photo 24. "Gnome Pond" BMPs at capacity.

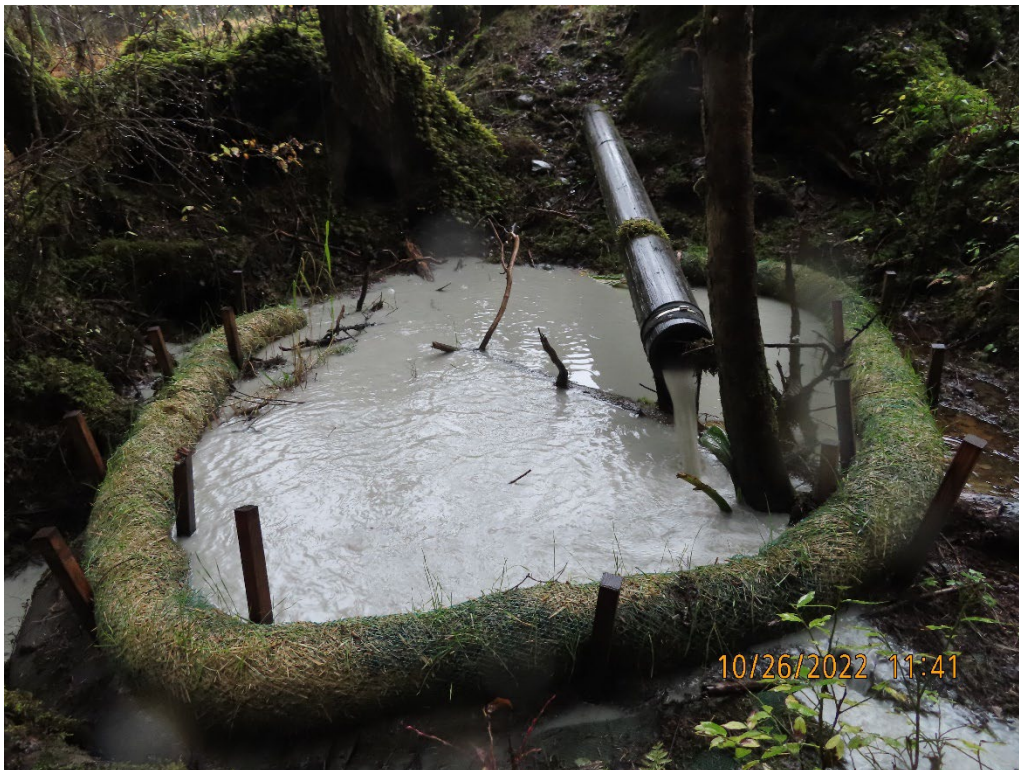
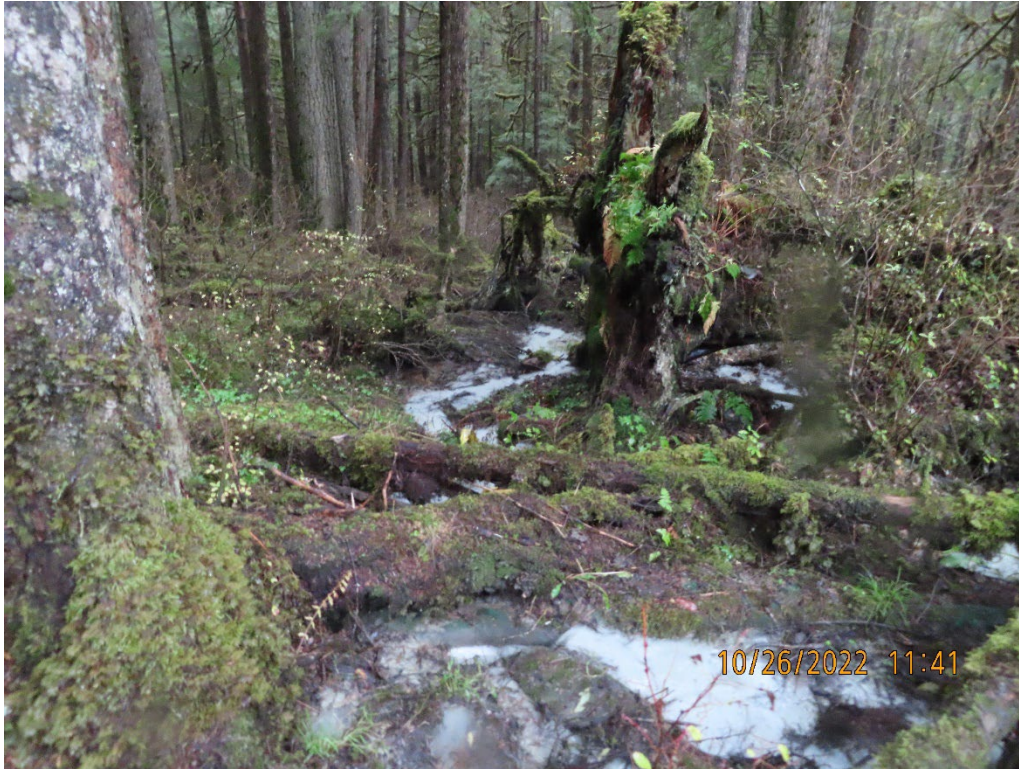
Date/Item No.	Item Description	Status
423-1; 7/28/2022	Increased turbidity of surface water runoff was observed at the 3.0 mile B-Road Zinc Creek Bridge uphill side stormwater BMPs.	PENDING. Hecla requested to use anionic polymers or “floc logs” to reduce turbidity in stormwater BMP’s on 9/26/2022. In a subsequent meeting with ADEC, ADF&G, ADNR, and the USFS Hecla was approved to test the polymers for use in BMP’s.

PENDING ACTION ITEM 423-1: Turbid water was observed being discharged from the stormwater BMP colloquially known as the “Gnome Pond” (Photo 25). Turbid waters were also observed downstream of the discharge pipe along the forest floor flowing towards a tributary of Zinc Creek (Photo 26).

Photo 25. Outlet pipe of the "Gnome Pond" BMPs located adjacent to the Zinc Creek Bridge.

Photo 26. Downstream of the “Gnome Pond” outlet looking towards Zinc Creek.

HGCMC staff has submitted a request to test anionic polymers or “floc logs” to reduce turbidity in roadside BMP’s. Due to limited available space to increase the size of settling ponds the anionic polymers will be tested to determine if appropriate for use in the BMP’s. Hecla will conduct laboratory and field testing this fall to determine the effectiveness of the polymers and provide a report to the Forest Service on effectiveness and how the polymers could be used on the mine site.

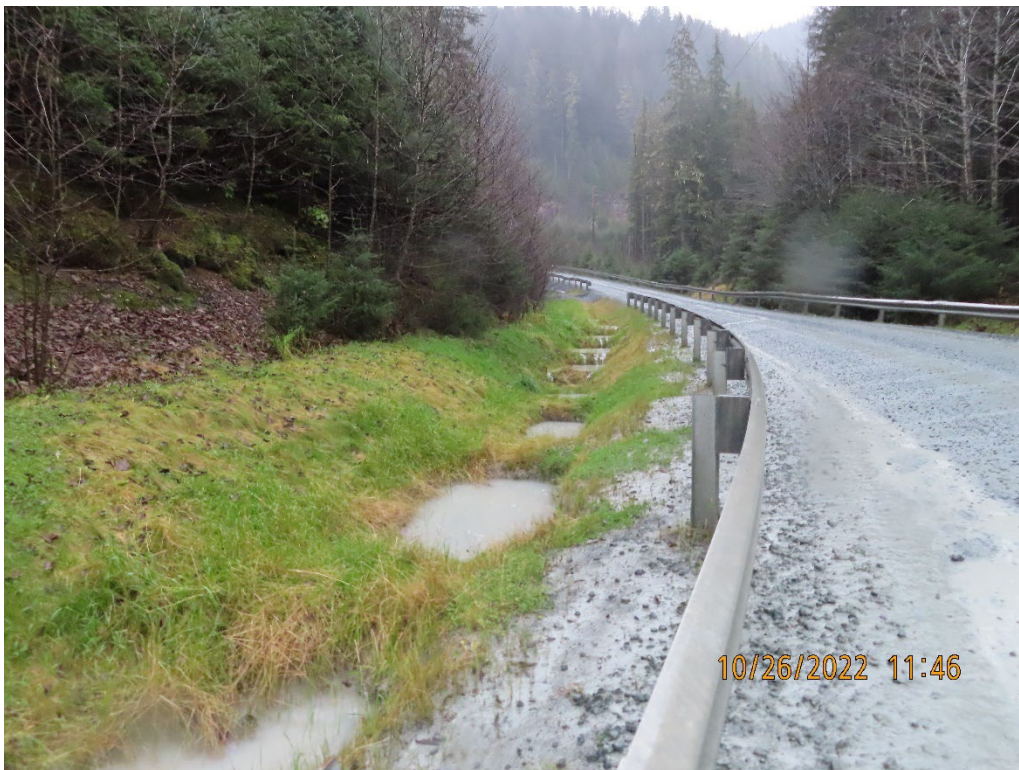
PENDING ACTION ITEM 424-3: Sumps that precede the “Gnome Pond” along the B-Road were filled with sediment that requires removal (Photo 27). Recent heavy rainfall has caused additional sedimentation.

Photo 27. Small sumps above the Gnome Ponds that require sediment removal.
