INSPECTION REPORT: GREENS CREEK MINE

Tongass National Forest Minerals Group
8510 Mendenhall Loop Rd
Juneau, AK 99801
(907) 789-6276 – office
(907) 586-8808 – fax

Date of Inspection: Wednesday, October 26, 2022
Date of Report: December 5, 2022
USDA Forest Service Inspector: Pat Dryer

The site inspection included: The A and B access roads, 1350 area, 920 area, Site 23, Pond C, Pond D, 7.4 mile B-Road Bridge (Killer Creek Bridge), 5.6 mile B-Road landslide area, Site E, 3.4 mile B-Road bridge (Falls Creek Bridge), 3.0 mile B-Road bridge (Zinc Creek Bridge), and the Tailings Disposal Facility (TDF).

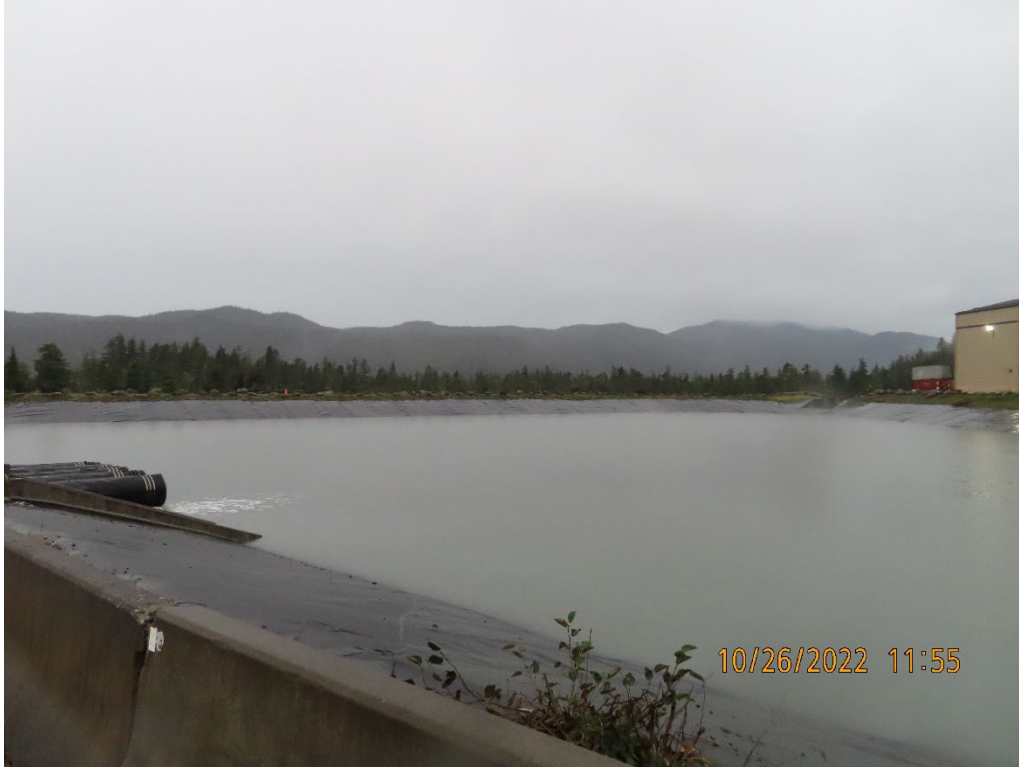
Photo 28. Pond 7.

At the time of the inspection, Pond 7 (Photo 28) was collecting contact and process water, and Pond 10 (Photo 29) was not receiving water.
