INSPECTION REPORT: GREENS CREEK MINE

Tongass National Forest Minerals Group
8510 Mendenhall Loop Rd
Juneau, AK 99801
(907) 789-6276 – office
(907) 586-8808 – fax

Date of Inspection: Wednesday, December 7, 2022
Date of Report: January 5, 2023
USDA Forest Service Inspector: Pat Dryer

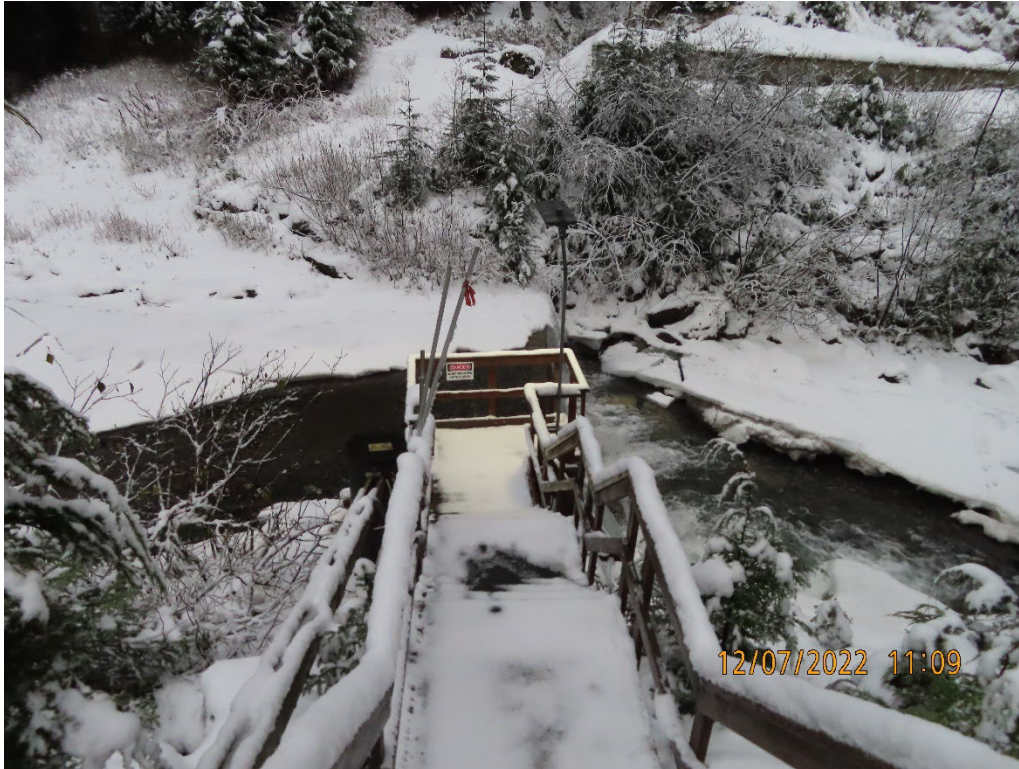
The Greens Creek discharge was 18 cfs (Photos 1-2) and 1.3 cfs was being withdrawn for operational use.

Photo 1. Greens Creek looking down towards the 920 weir.

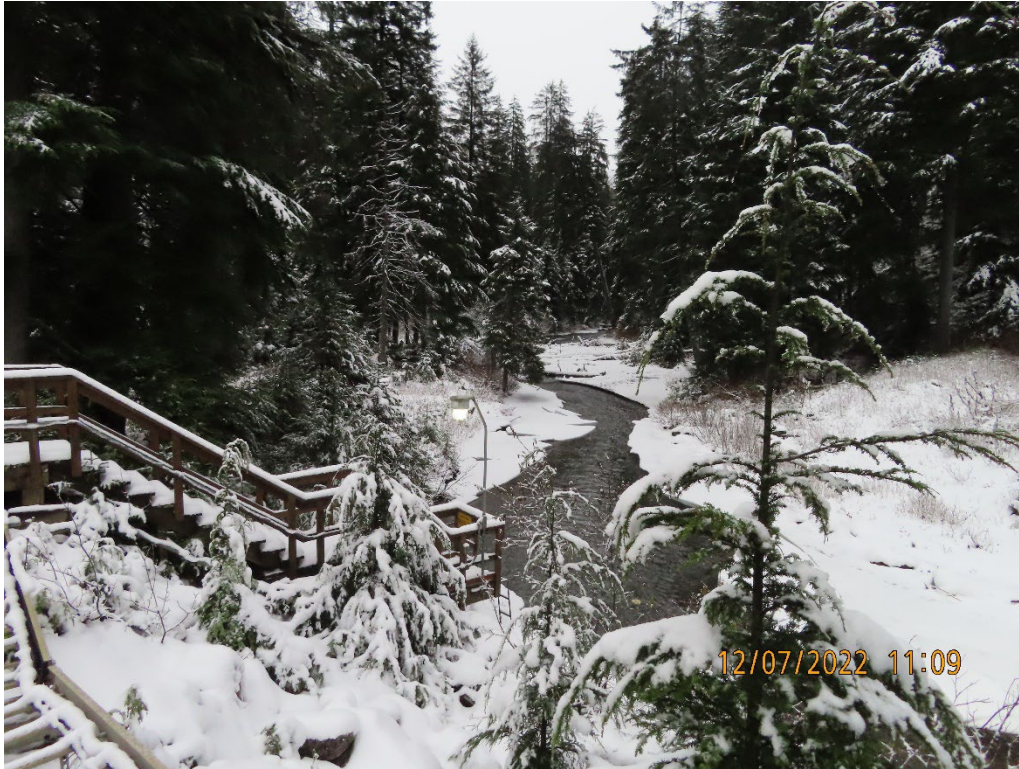
Photo 2. Greens Creek looking upstream of the 920 weir.

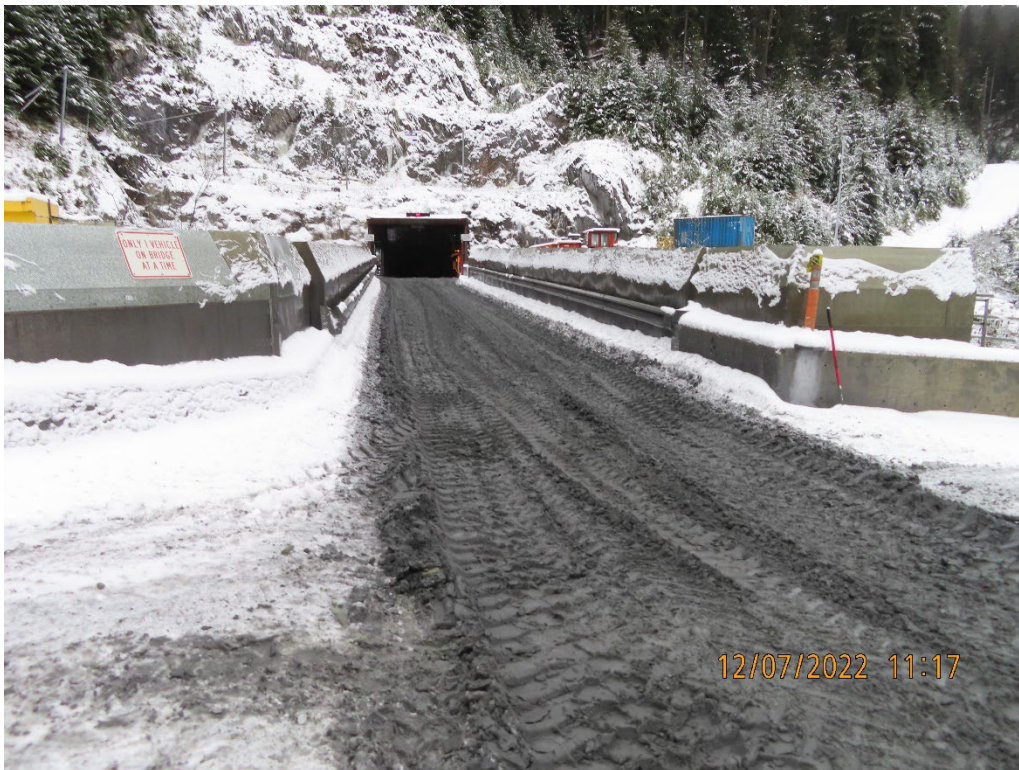
The Greens Creek bridge appeared in good condition, with sediment deflection concrete barriers preventing sediment from reaching bridge abutments (Photo 3).

Photo 3. Greens Creek bridge and 920 portal.

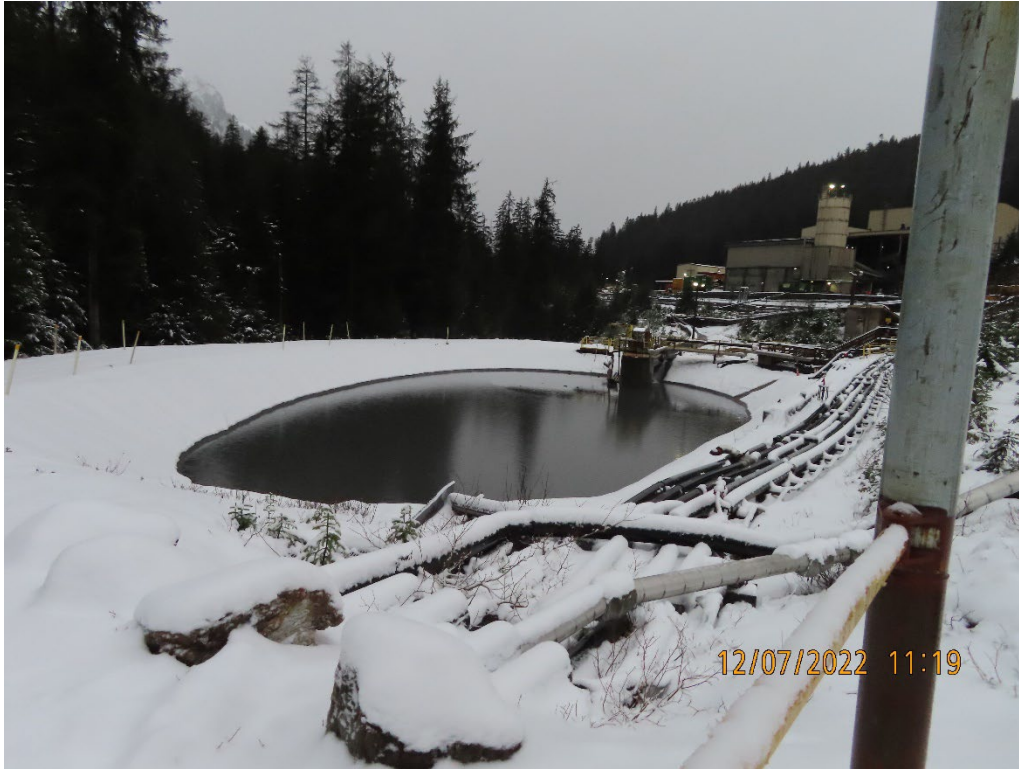
Pond A was in good condition with substantial surge capacity (Photo 4).

Photo 4. Pond A, below the 920 area.

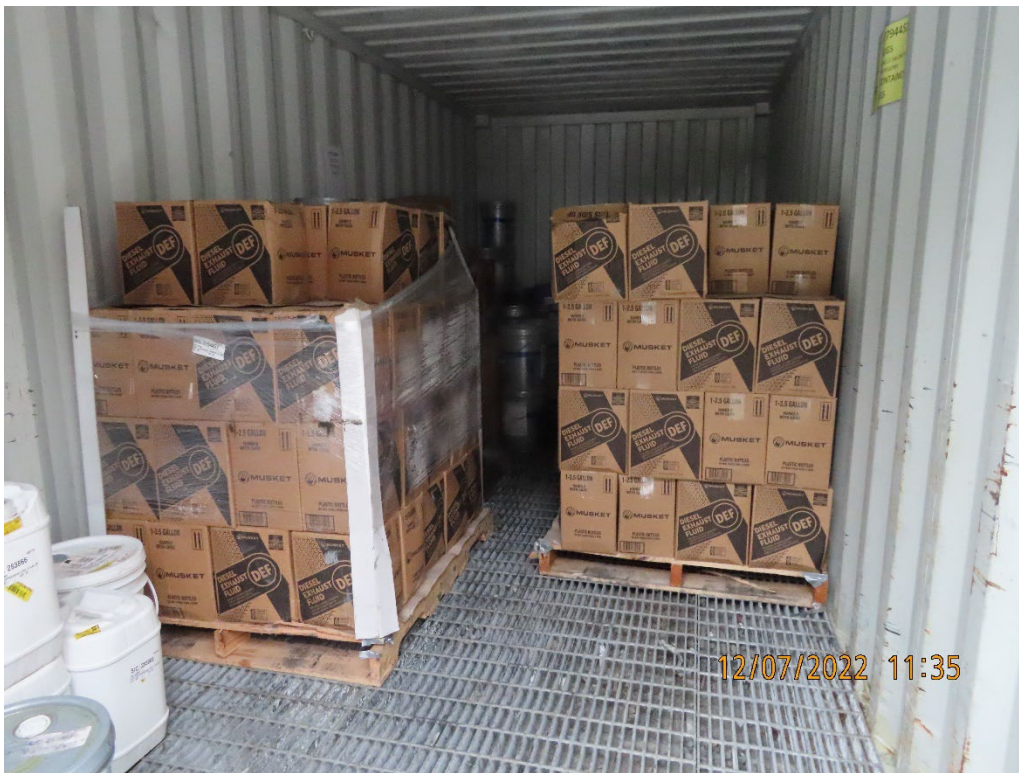
Good housekeeping practices were observed at the 920 warehouse (GPO, Appendix 5 BMP Plan, page 39). All petroleum/chemicals observed were properly stored within secondary containment (Photo 5).

Photo 5. Chemicals stored in appropriate secondary containment at the 920 warehouse area.

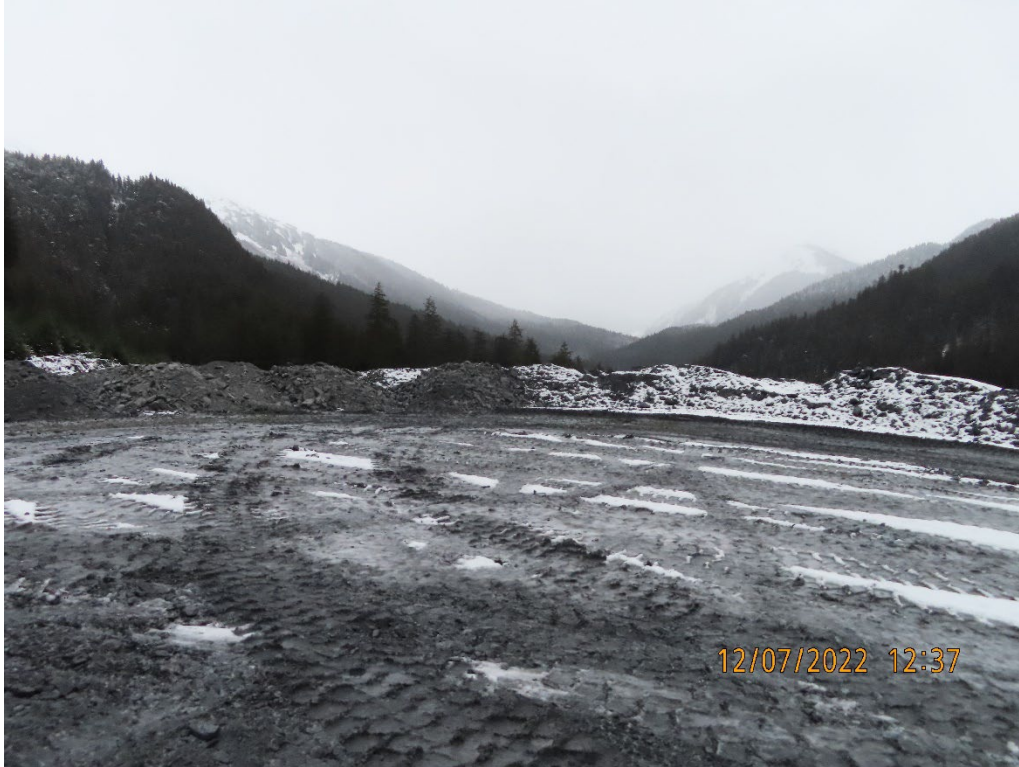
Class 1/2/3 waste rock continues to be placed at this location (Photo 6).

Photo 6. Upper Site 23 waste rock storage area.

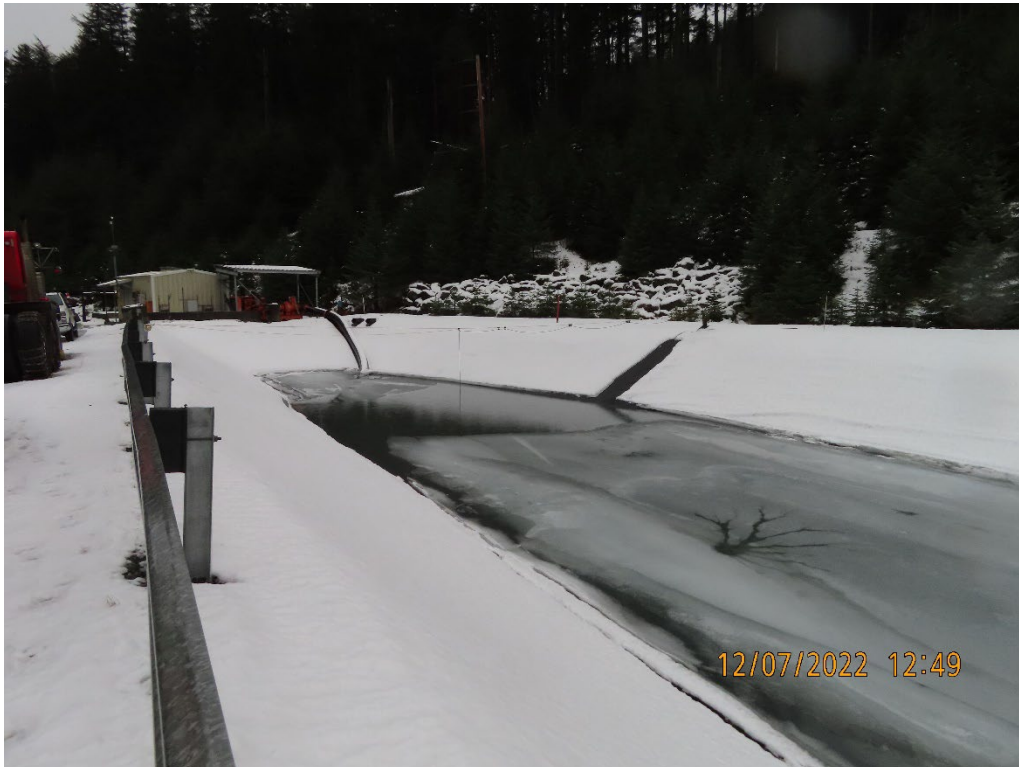
Site 23 pond was in good condition with substantial surge capacity (Photo 7).

Photo 7. 23 Pond with substantial surge capacity.

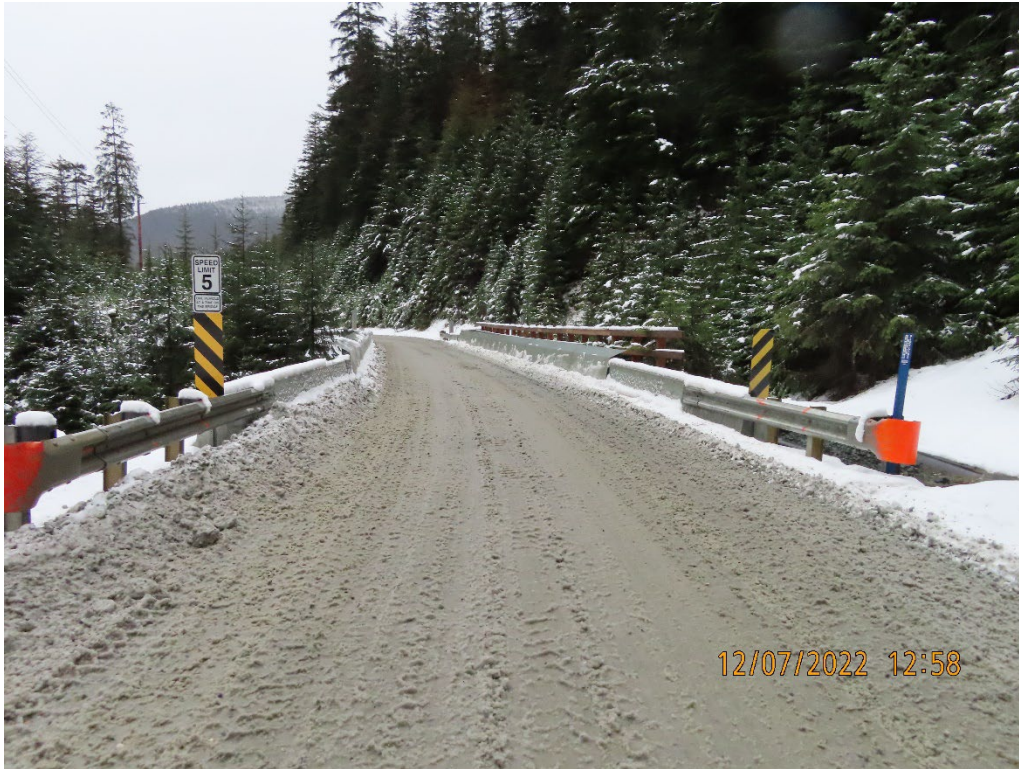
The Killer Creek Bridge appeared in good condition, with sediment deflection concrete barriers preventing sediment from reaching bridge abutments (Photo 8-9).

Photo 8. Killer Creek Bridge surface.

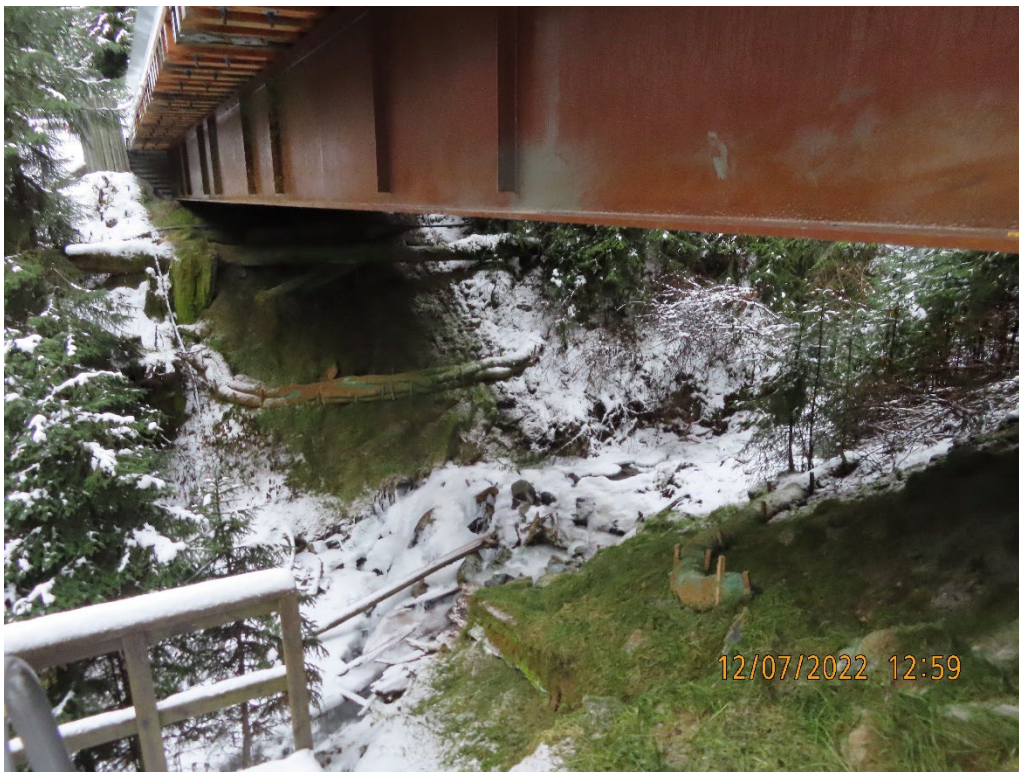
Photo 9. Killer Creek Bridge abutment BMP's.

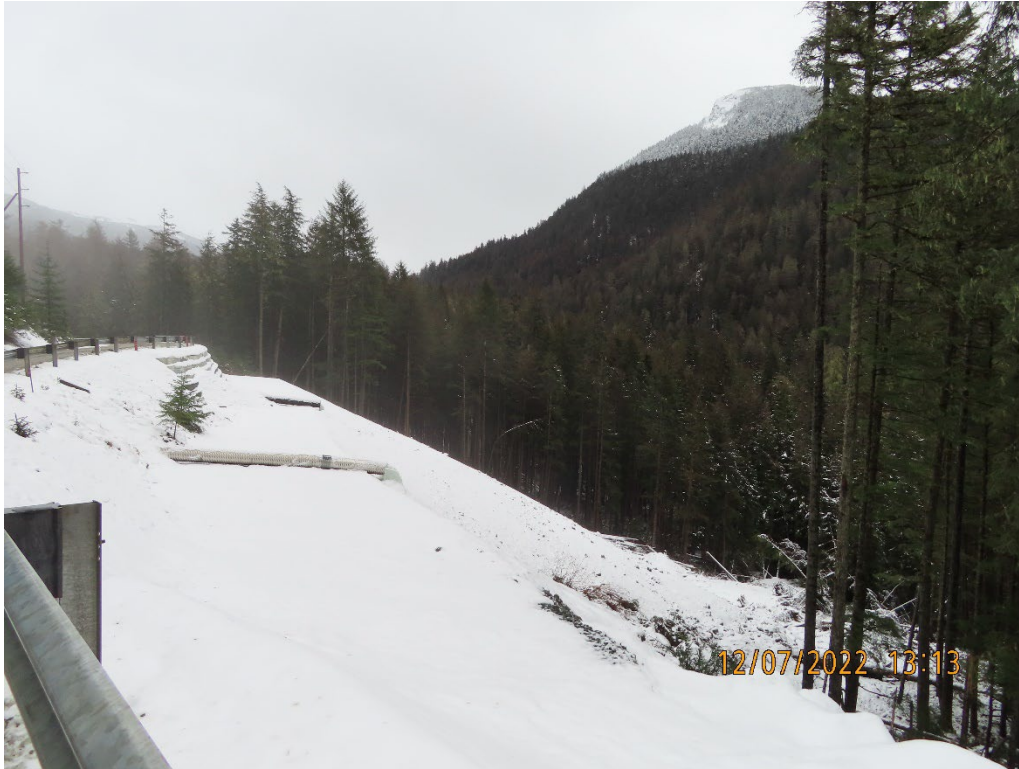
The rock buttress fill that was placed adjacent to the roadway at the 5.6 mile of the B-road has been completed (Photo 10). Snow had covered the slope during this inspection and future inspections will document the completed repairs.

Photo 10. 5.6 mile B-road landslide repairs.

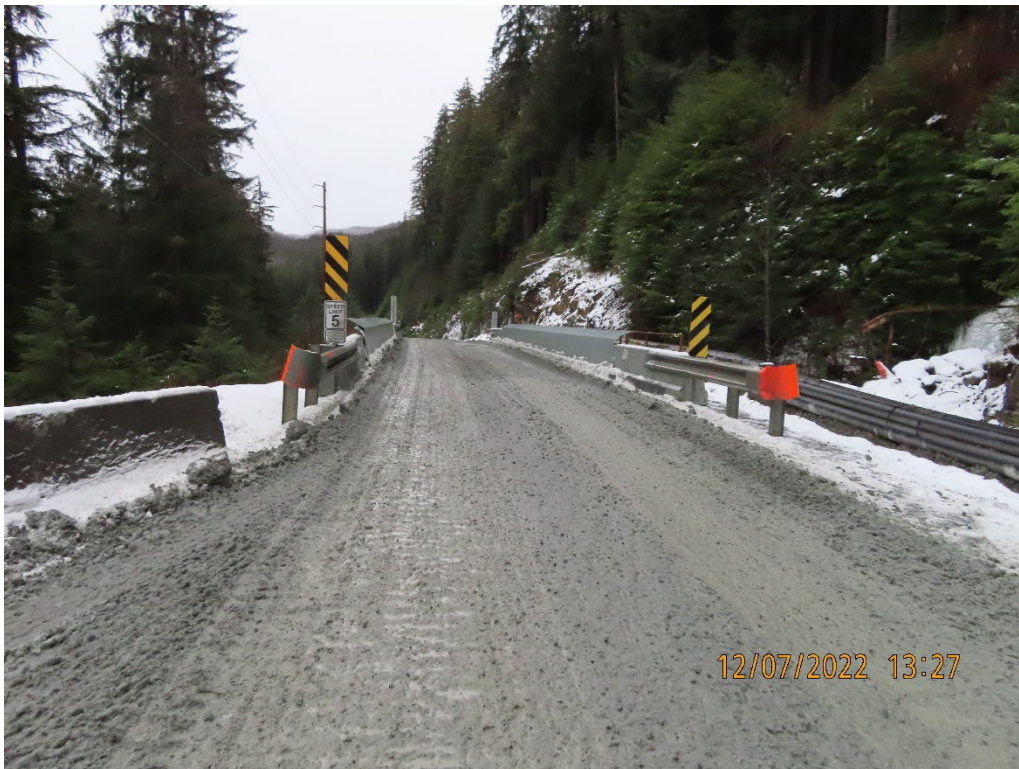
This bridge was replaced earlier this year. The new bridge wear surface was installed higher than the adjacent roadbed which is intended to prevent excessive ponding of water on the bridge surface (Photo 11).

Photo 11. Falls Creek Bridge surface.

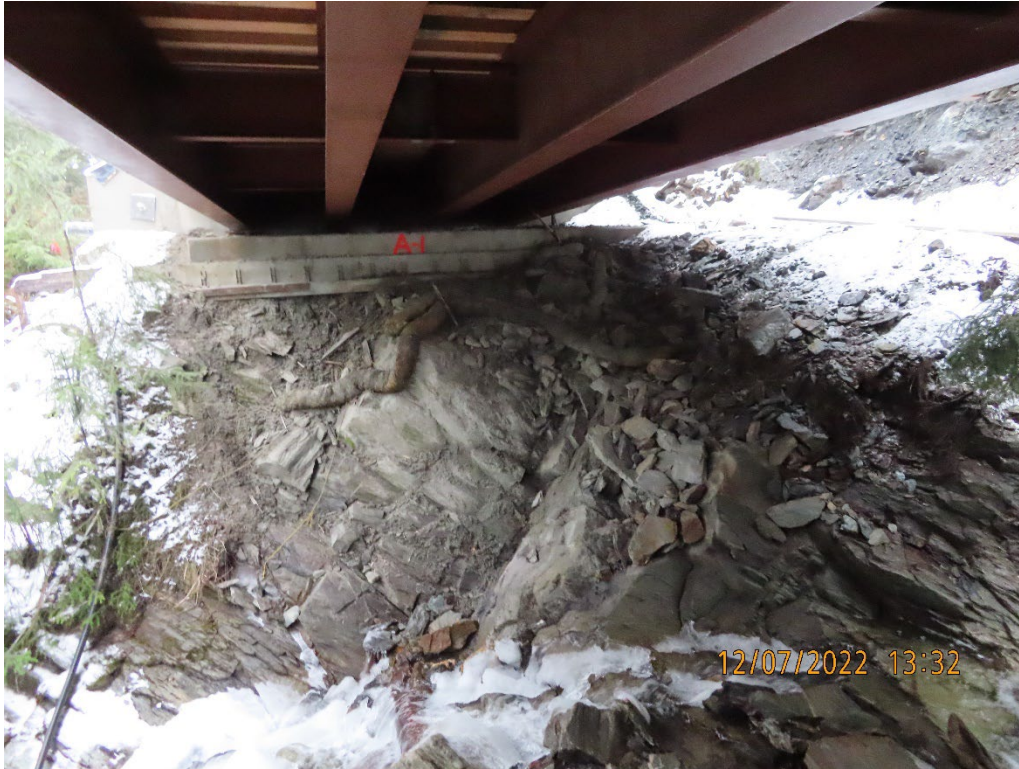
PENDING ACTION ITEM 424-2: Stormwater sediment BMPs on the downhill side bridge abutment are in disrepair (Photo 12). These BMPs require improvement to effectively contain sediment or prevent sediment from accumulating on the abutment.

Photo 12. Falls Creek Bridge downhill side abutment BMPs in disrepair.

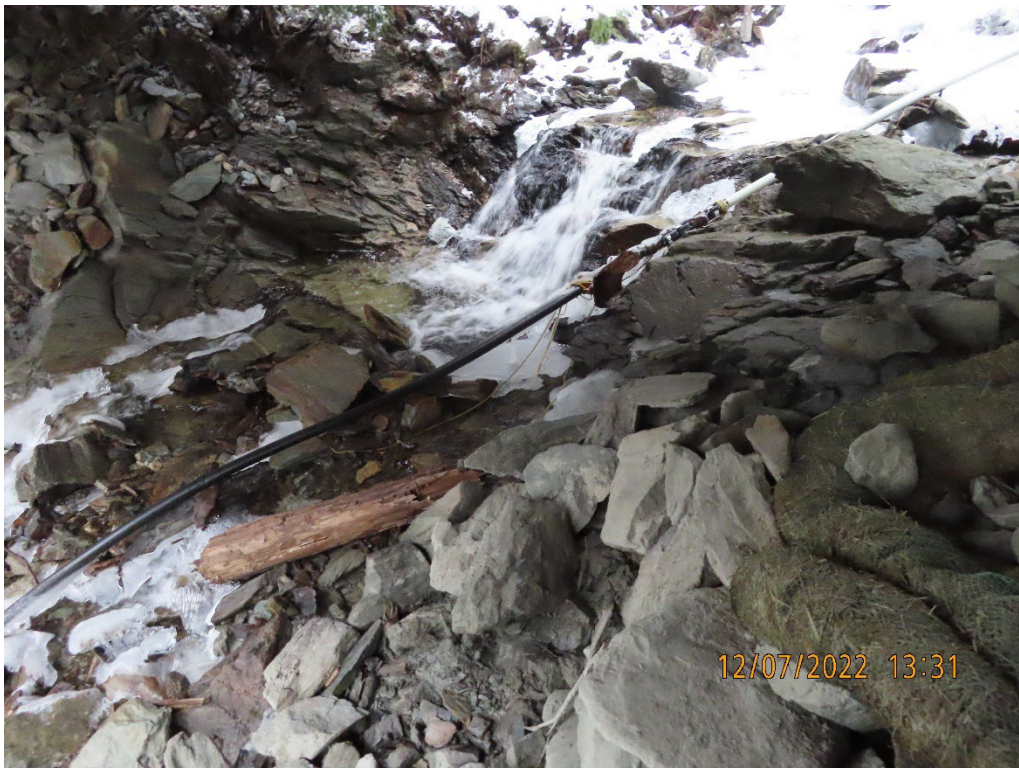
PENDING ACTION ITEM 426-1: Stormwater sediment BMPs on the uphill side of the Falls Creek Bridge abutment are not functioning as designed and turbid water is reaching Falls Creek. BMPs require improvement to reduce turbidity of runoff prior to discharge into Falls Creek. No turbid discharge was observed during this inspection, but freezing temperatures have reduced surface water runoff (Photo 13).

Photo 13. Area where turbid waters were observed entering Falls Creek from bridge abutment during previous inspection. Turbid water was not observed during this inspection.

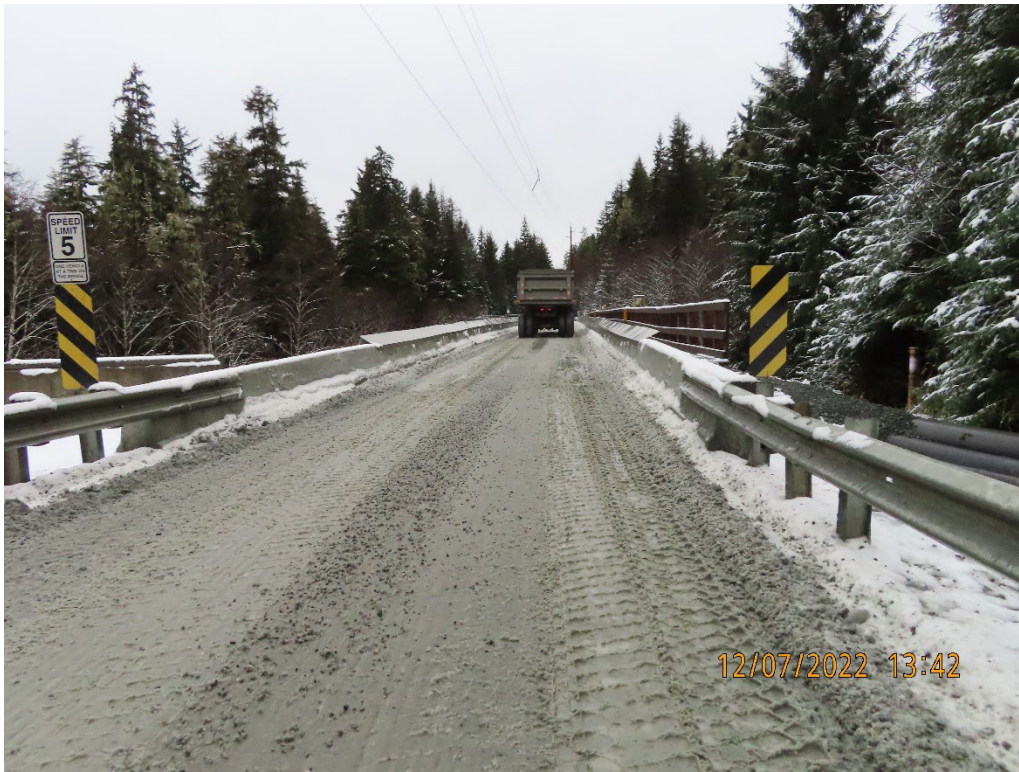
The Zinc Creek bridge appeared in good condition, with sediment deflection concrete barriers preventing sediment from reaching bridge abutments (Photo 14).

Photo 14. Zinc Creek Bridge.

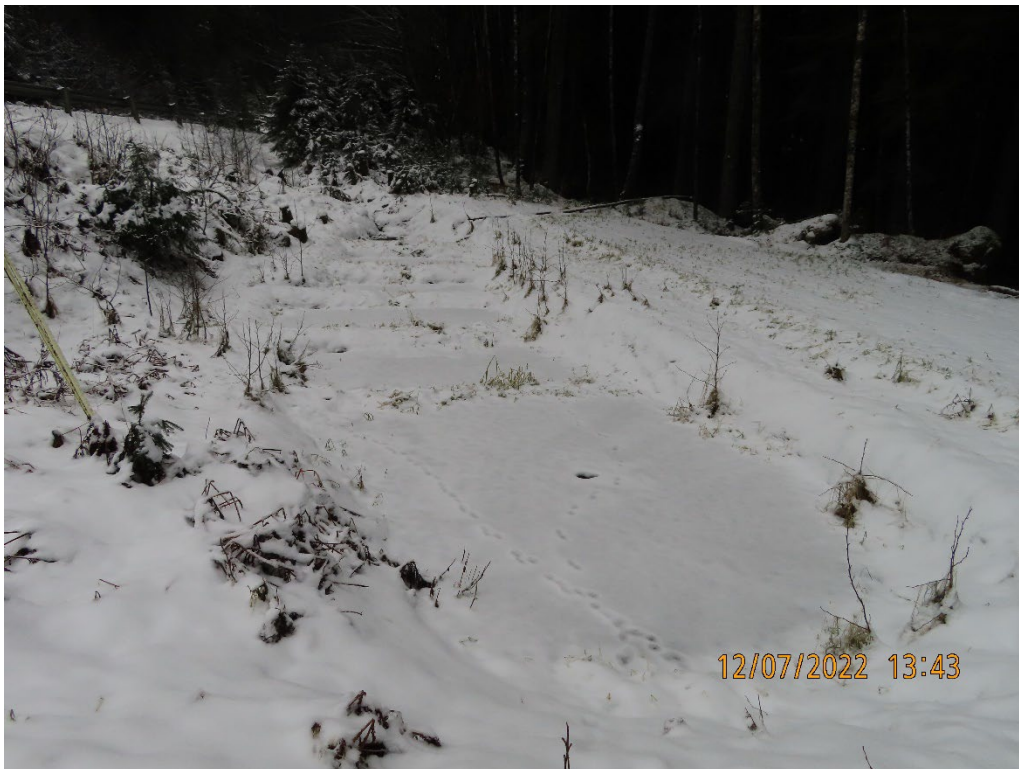
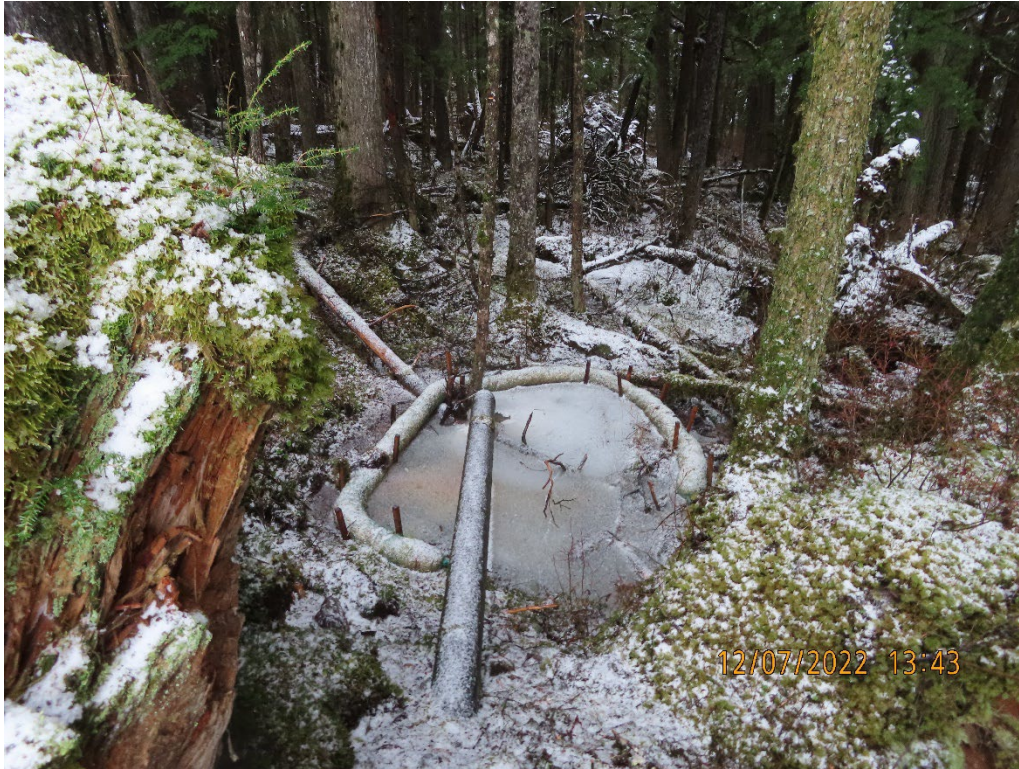
PENDING ACTION ITEM 423-1: Turbid water was observed being discharged from the stormwater BMP colloquially known as the “Gnome Pond” (Report 423). The “Gnome Pond” was observed covered in snow and ice with reduced inflow from runoff (Photo 15-16).

Photo 15. "Gnome Pond" BMPs frozen and snow covered.

Photo 16. Outlet pipe of the "Gnome Pond" BMPs located adjacent to the Zinc Creek Bridge.

HGCMC staff has submitted a request to test anionic polymers or “floc logs” to reduce turbidity in roadside BMP’s. Due to limited available space to increase the size of settling ponds the anionic polymers will be tested to determine if appropriate for use in the BMP’s. Hecla will conduct laboratory and field testing this fall to determine the effectiveness of the polymers and provide a report to the Forest Service on effectiveness and how the polymers could be used on the mine site.

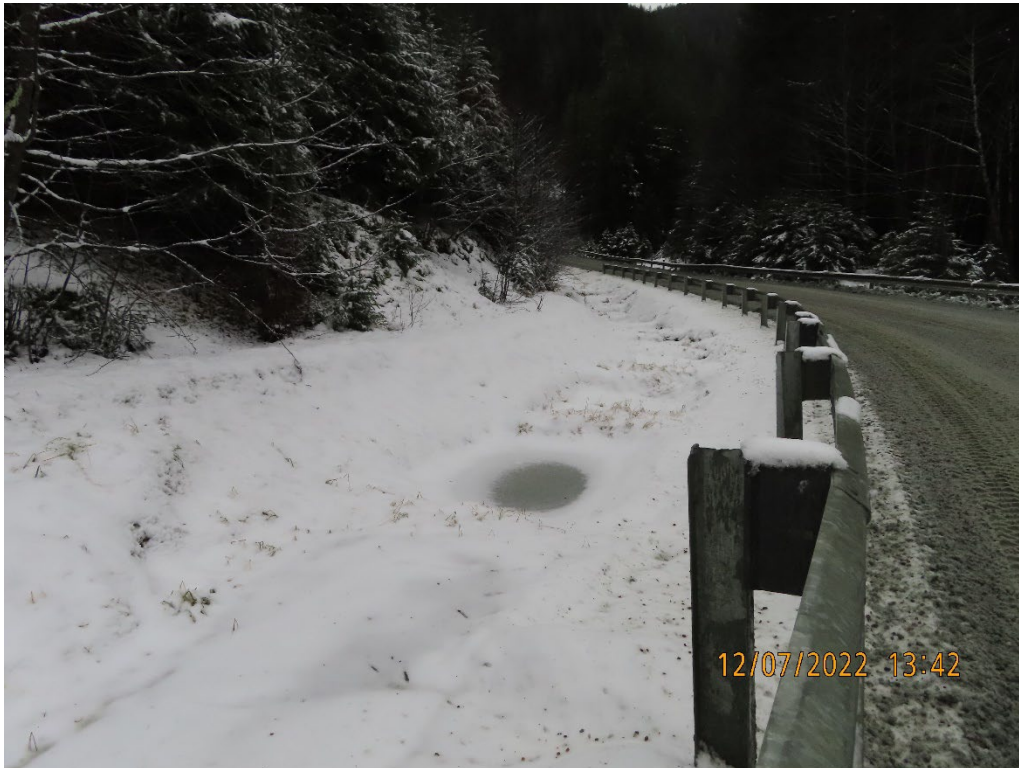
PENDING ACTION ITEM 424-3: Sumps that precede the “Gnome Pond” along the B-Road were filled with sediment that requires removal (Photo 17). Winter conditions have reduced surface water runoff to the sumps and subsequent roadside BMP’s.

Photo 17. Small sumps above the Gnome Ponds covered in snow and ice.

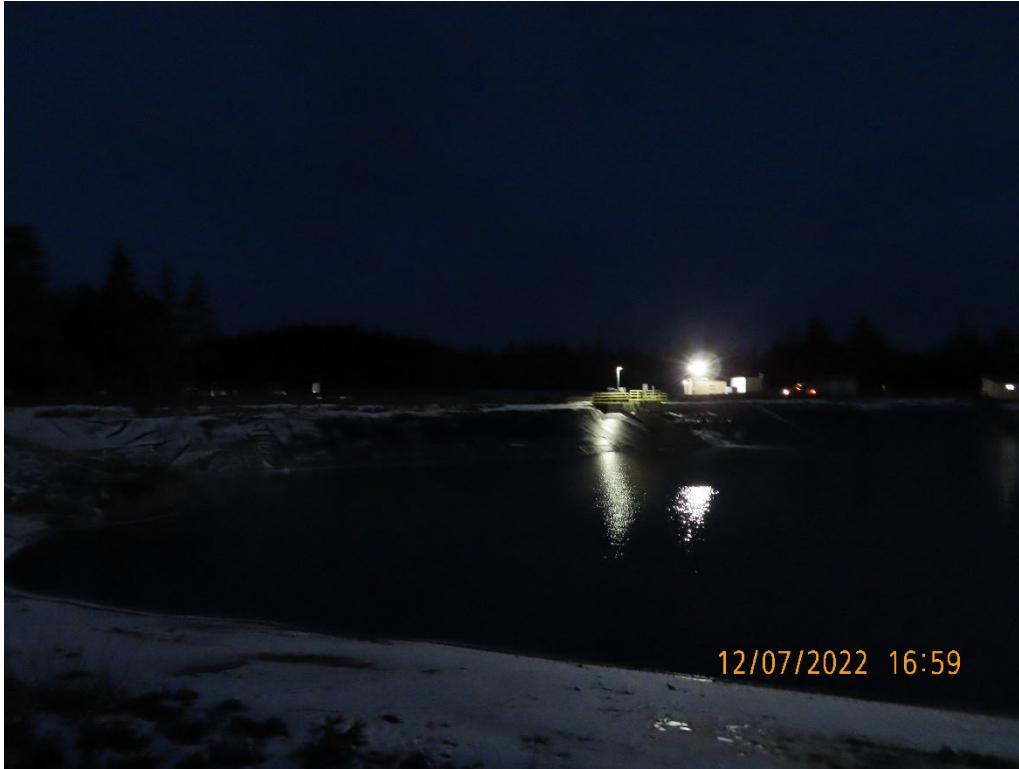
Photo 18. Pond 7.

At the time of the inspection, Pond 7 (Photo 18) was collecting contact and process water, and Pond 10 (Photo 19) was not receiving water.

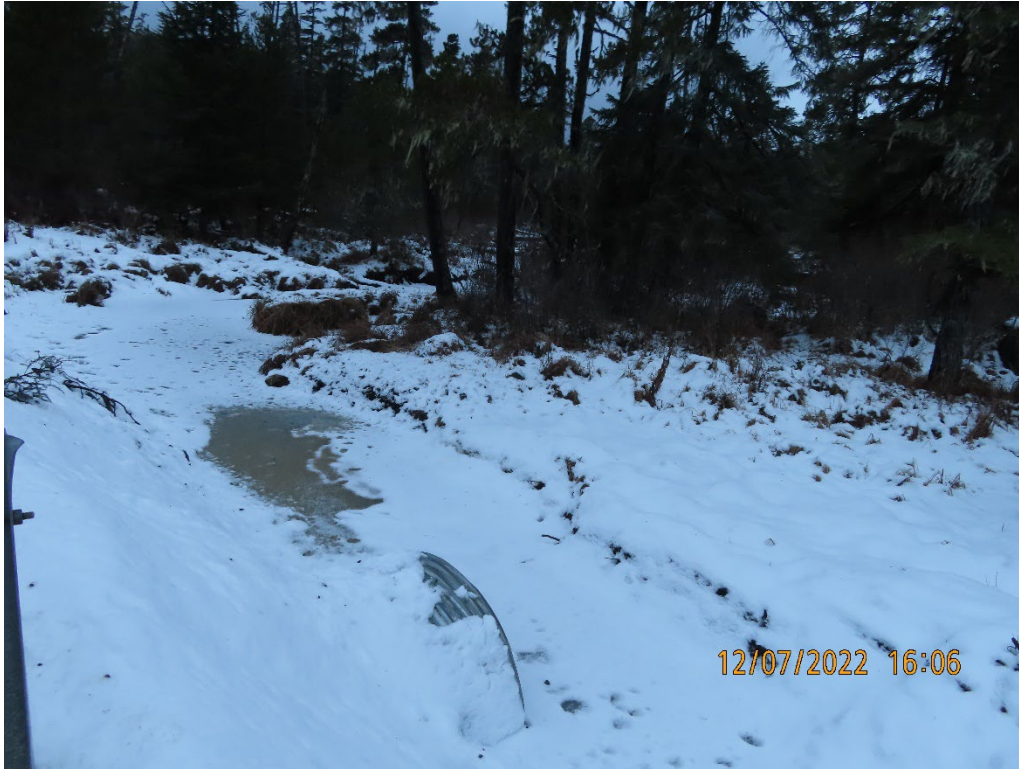
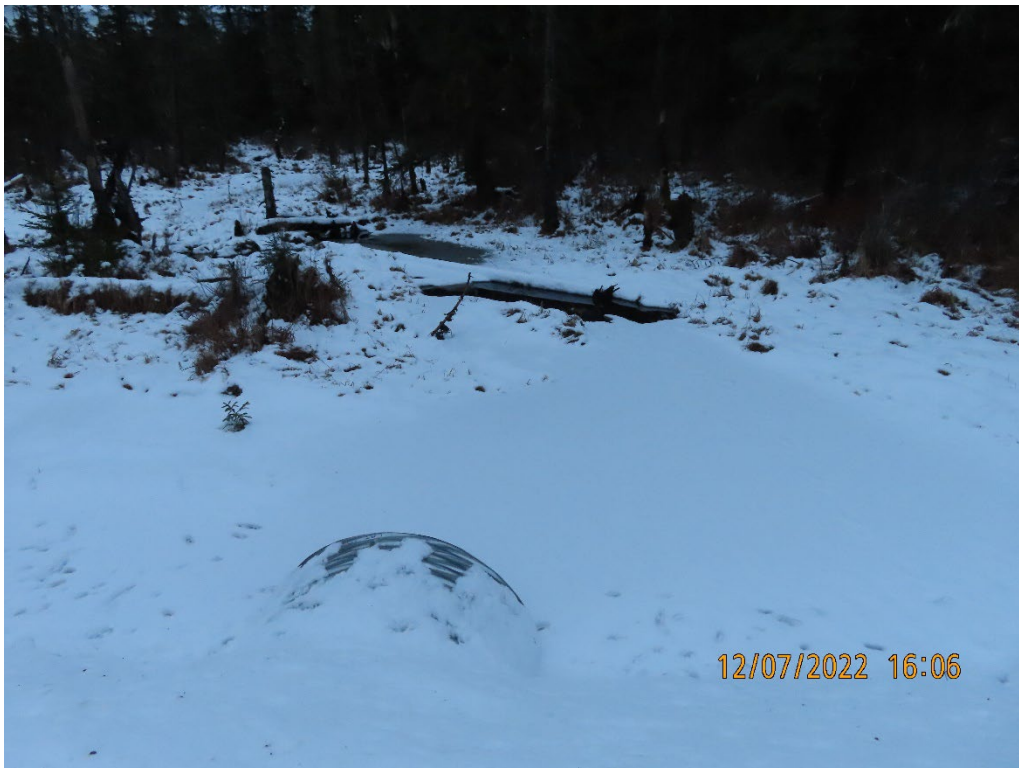
Photo 20. View upstream from new 2.5 mile A-road culvert.

Photo 21. View downstream from new 2.5 mile A-road culvert.

Several culverts were inspected during this visit to discuss options for future replacement. HGCMC has completed the replacement of the culvert at the 2.5 mile of the A-road in November 2022 as approved by the USFS (Photos 20-21).
