INSPECTION REPORT: GREENS CREEK MINE

Tongass National Forest Minerals Group
8510 Mendenhall Loop Rd
Juneau, AK 99801
(907) 789-6275 – office
(907) 586-8808 – fax

Date of Inspection: Tuesday, April 26, 2023
Date of Report: Thursday, June 8, 2023
USDA Forest Service Inspector: Richard Dudek

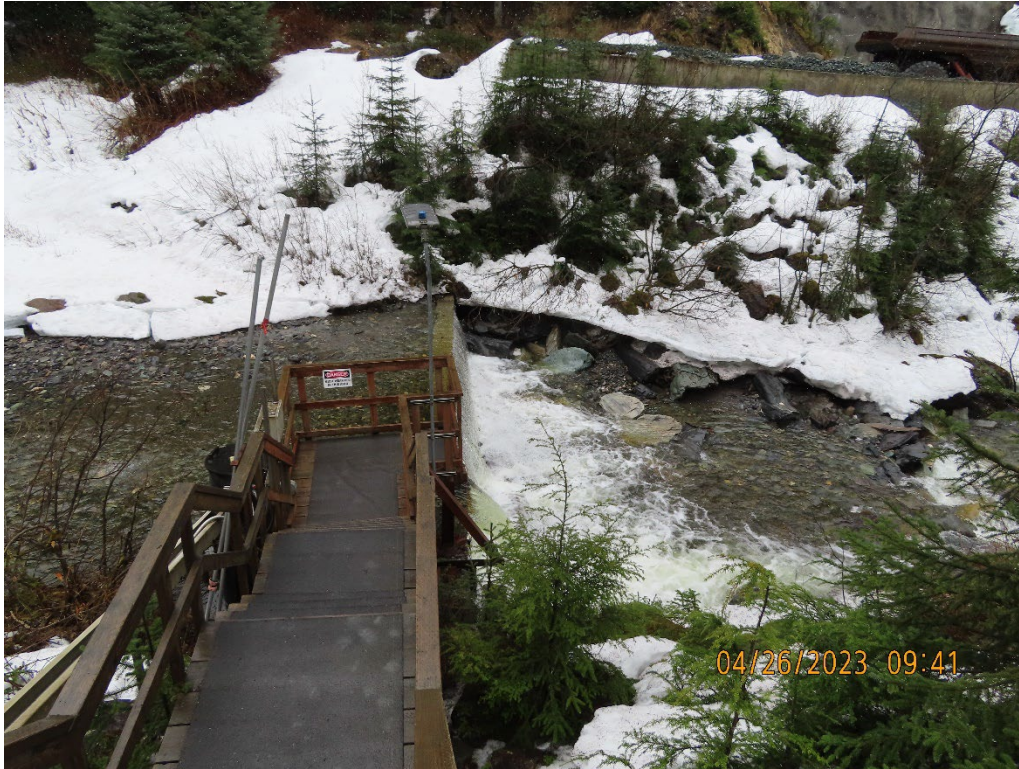
Photo 1). The 920 Greens Creek Weir.

The Greens Creek weir discharge was 28.65 cfs (Photo 1), and 1.34 cfs was being withdrawn for the 920 facilities.

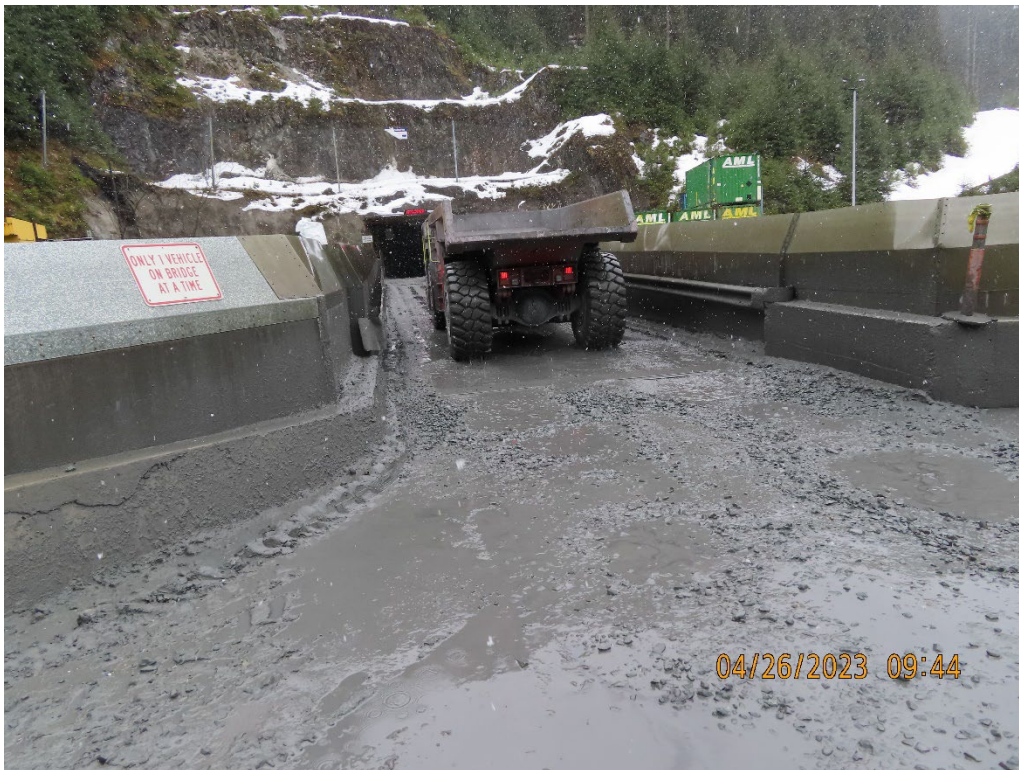
Photo 2). The 920 Bridge.

The 920 bridge was in good condition. The bridge ends, and the sediment barrier requires sediment removal. During the annual spring cleaning and maintenance, HGCMC will use a vacuum truck and hand tools to remove sediments on and around this bridge and the other B-road bridges. The metal splash guards are working as intended by preventing sediment splash-over from mine vehicle traffic (Photo 2).

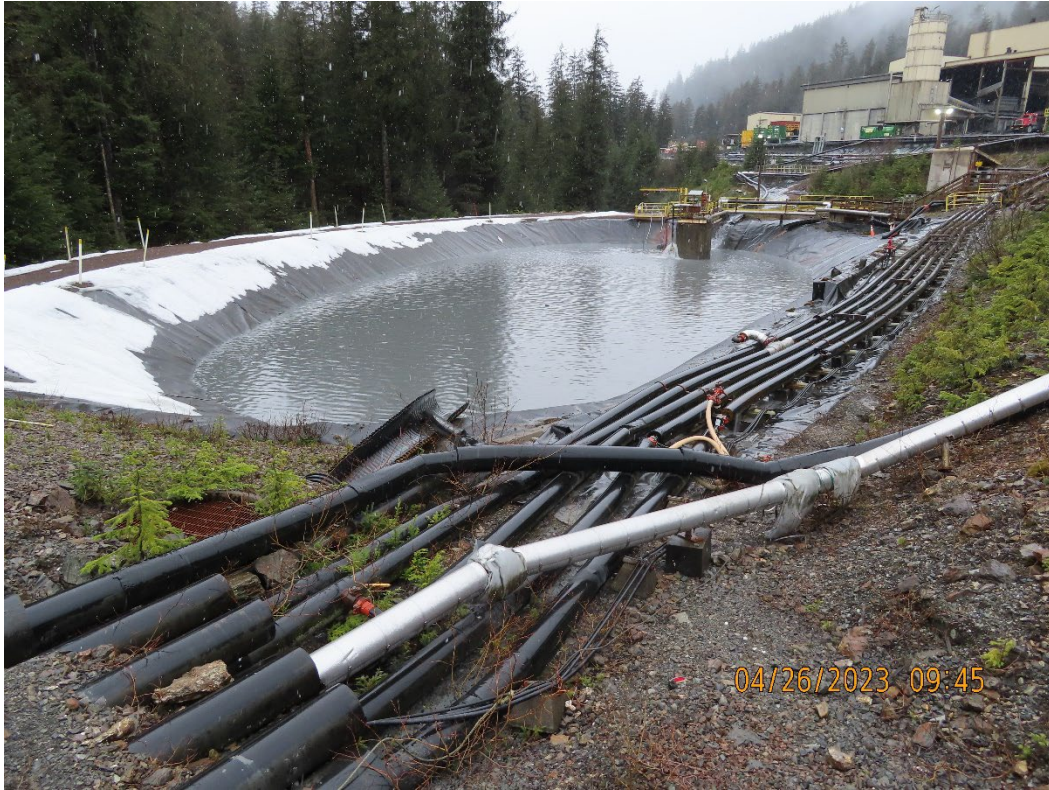
Photo 3). Pond A.

Pond A was in good condition and was receiving mine site contact water (Photo 3).

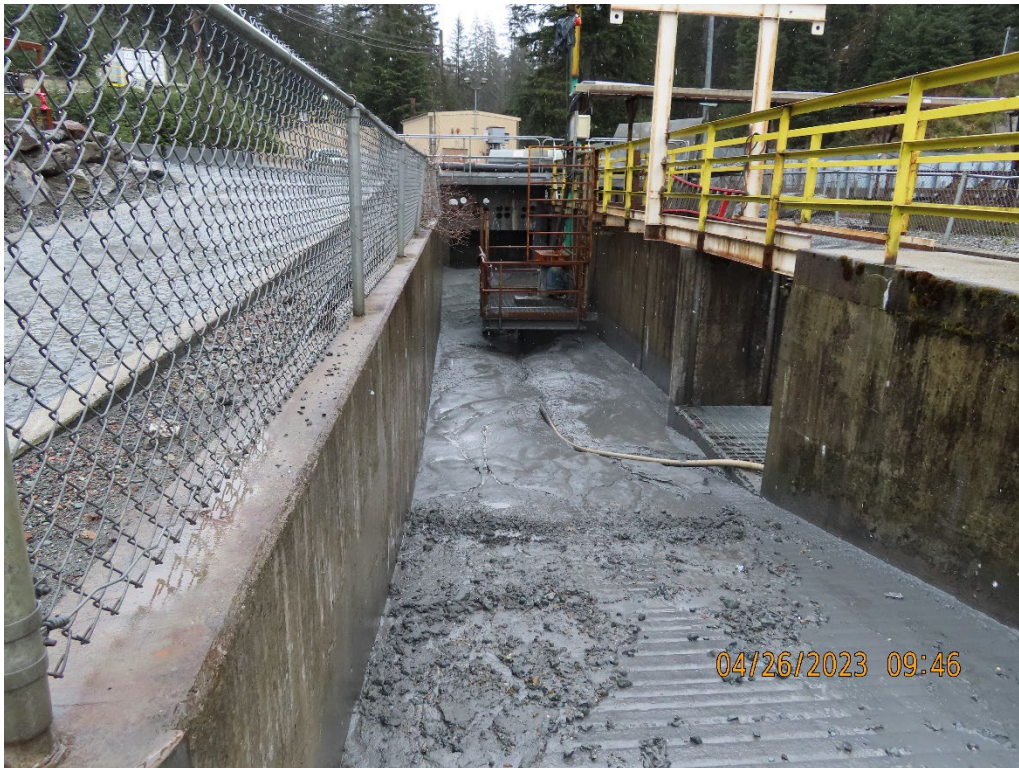
Photo 4). DB-01.

DB-01 will be mucked out during the site's spring-cleaning project (Photo 4). These sediments will be disposed of underground.

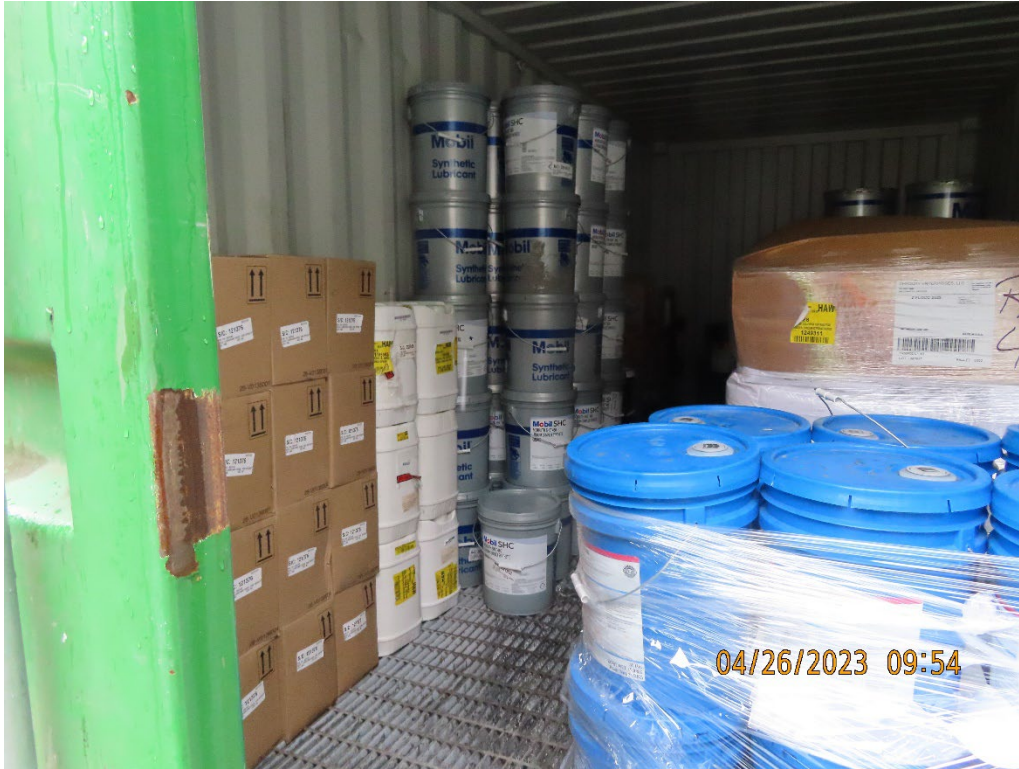
Good housekeeping practices were observed at the 920 warehouse (Appendix 5 BMP Plan, page 39). All petroleum/chemicals were stored adequately within secondary containment (Photos 5).

Photo 5). A storage container at the 920-warehouse facility.

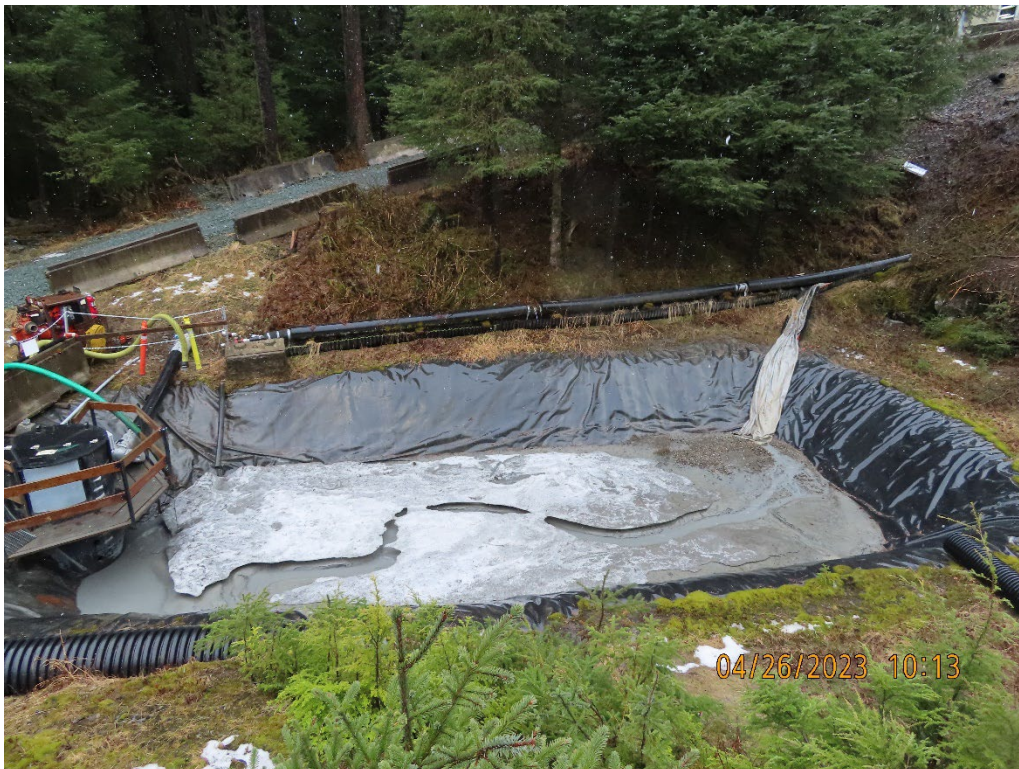
Photo 6. Upper C Pond.

Both upper and lower C ponds had snow and ice with still enough volume capacity to contain stormwater from a heavy spring rain event (Photos 6-7).

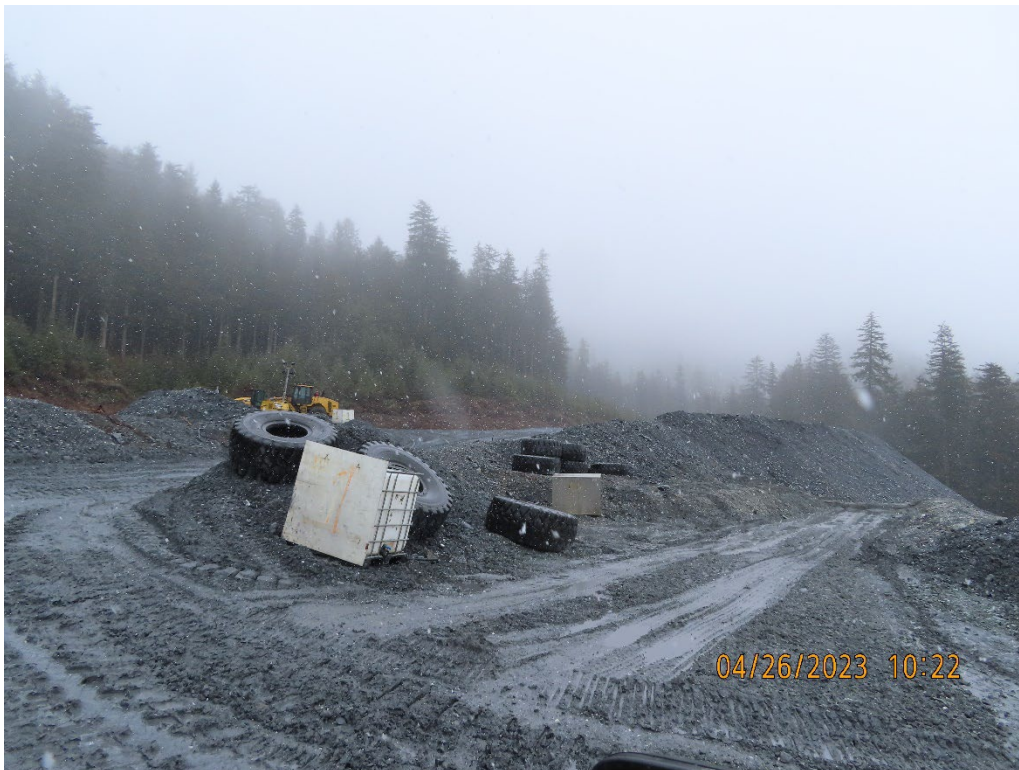
HGCMC continues to stage Class 1, 2, and 3 waste rock at this location (Photos 8-9). Class 4 waste rock is kept underground and disposed of underground (Appendix 11 Waste Rock Management Plan, page 11).

Photo 8. Site 23. Class 1 waste rock is separately stored from Class 2/3 waste rock.

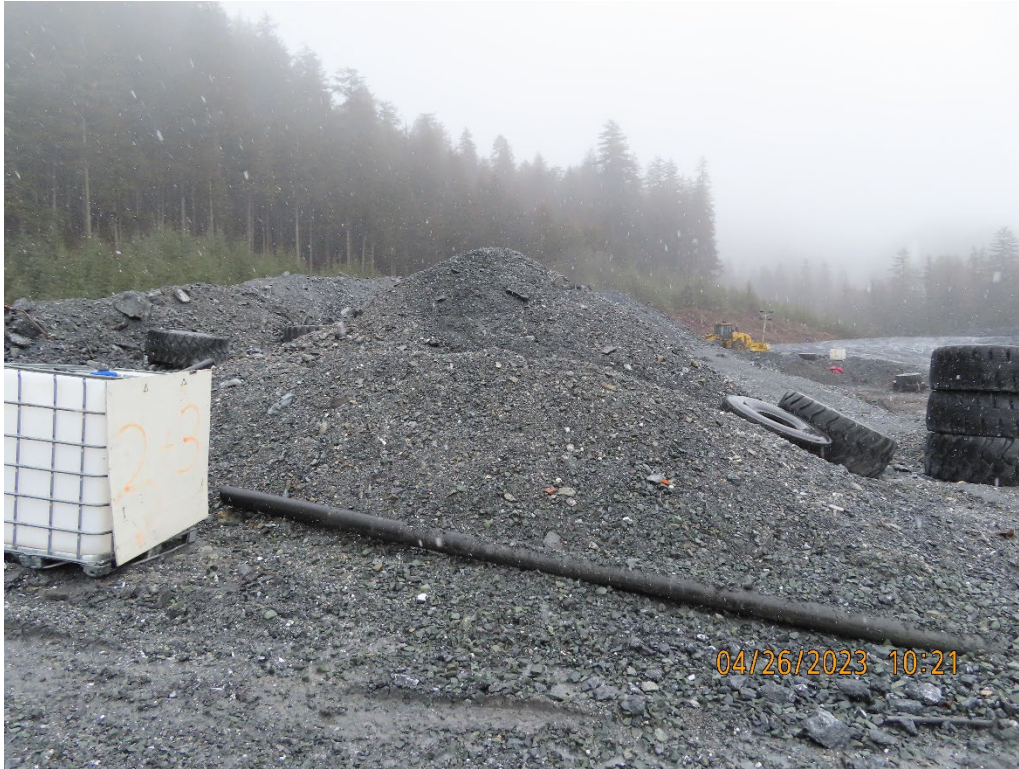
Photo 9. Class 2/3 waste rock.

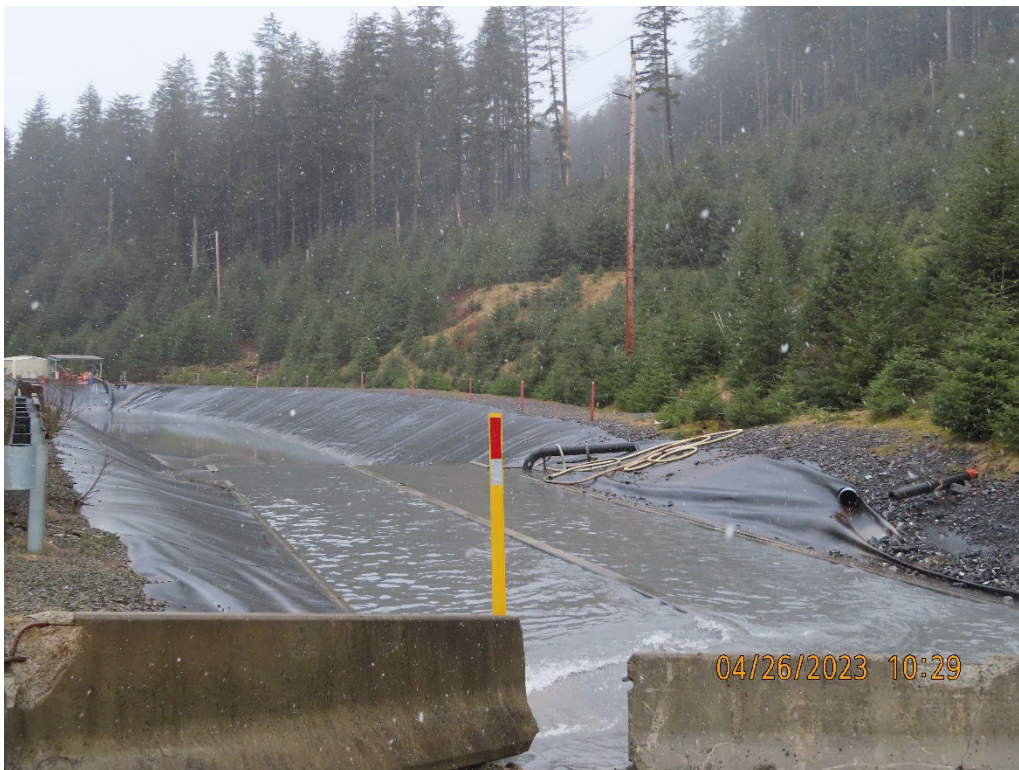
Photo 10. Pond 23.

Site 23 Pond was receiving mine site/contact water (Photo 10). This water will be routed to the TDF water treatment plant for treatment and discharge.

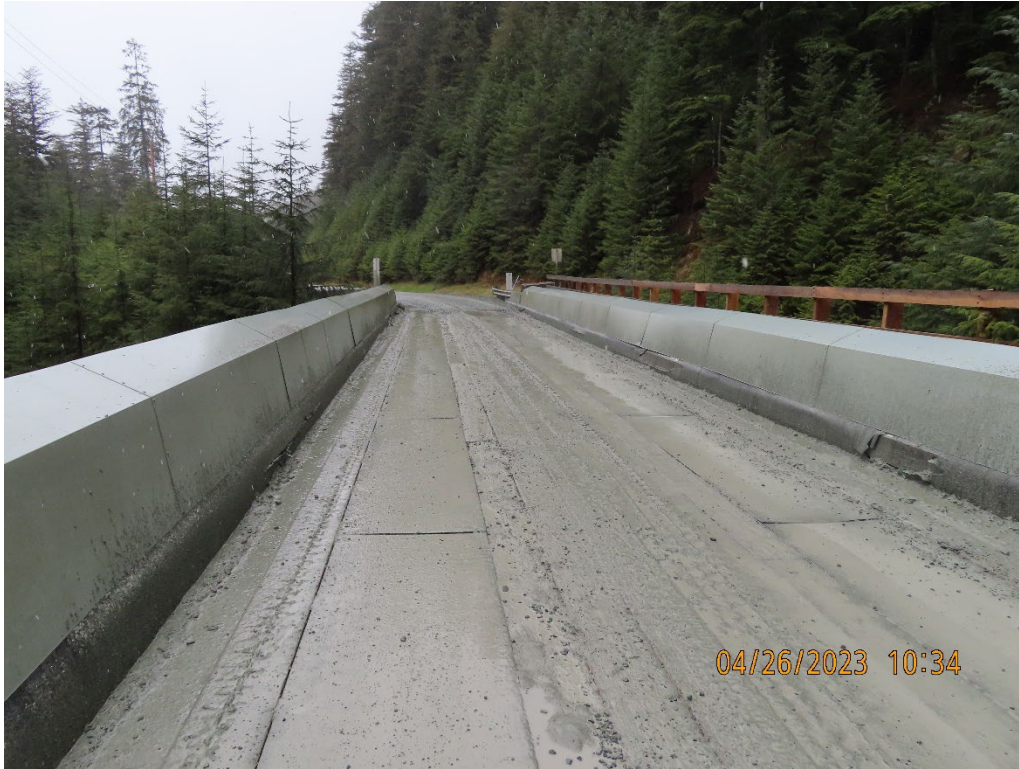
Photo 11. 7.4-mile B Road Bridge (Killer Creek Bridge).

The Killer Creek Bridge had some ponding water (Photo 11-12), and sediment accumulation has reached the maximum capacity for the BMPs at this site. Sediments will be removed before BMP effectiveness has been compromised.

- **403-1: B-Road Bridge requires sediment removal from the deck and the associated BMPs.**
- **430-2: 3.0-mile B-Road Bridge abutment Gnome Pond's outlet. Turbid water was observed discharging and breaching the BMPs. Mitigations at this site are required to prevent the potential of turbid water from reaching surface waters.**

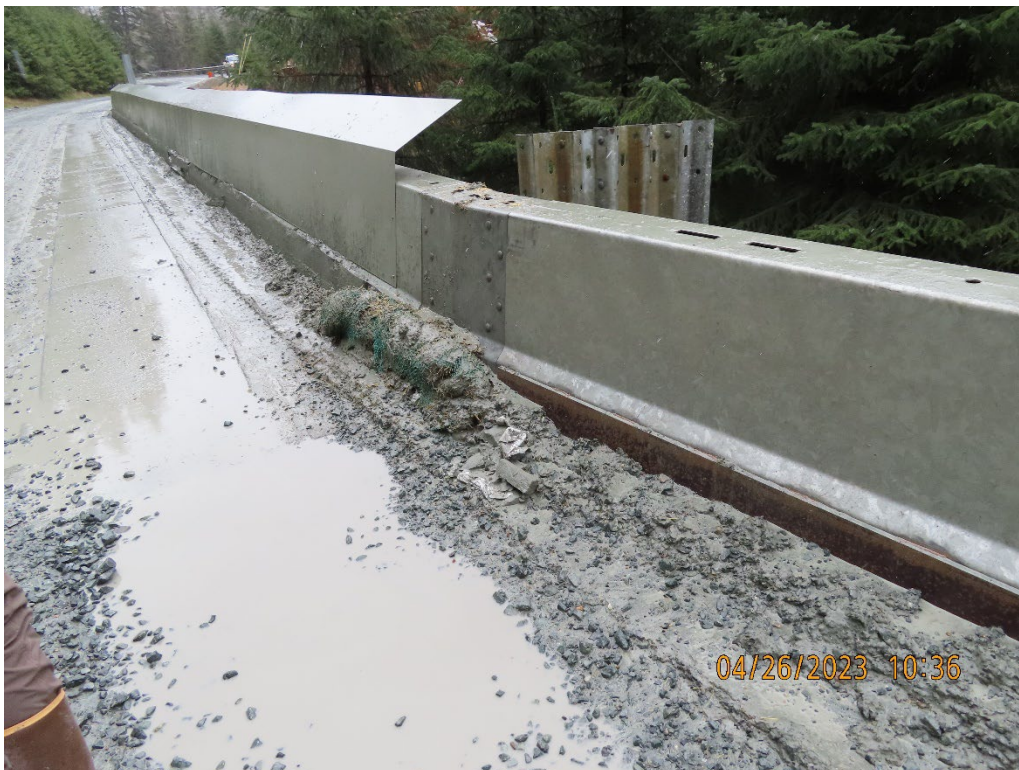
Photo 12. The downhill side of the 7.4 Bridge end requires sediment removal.

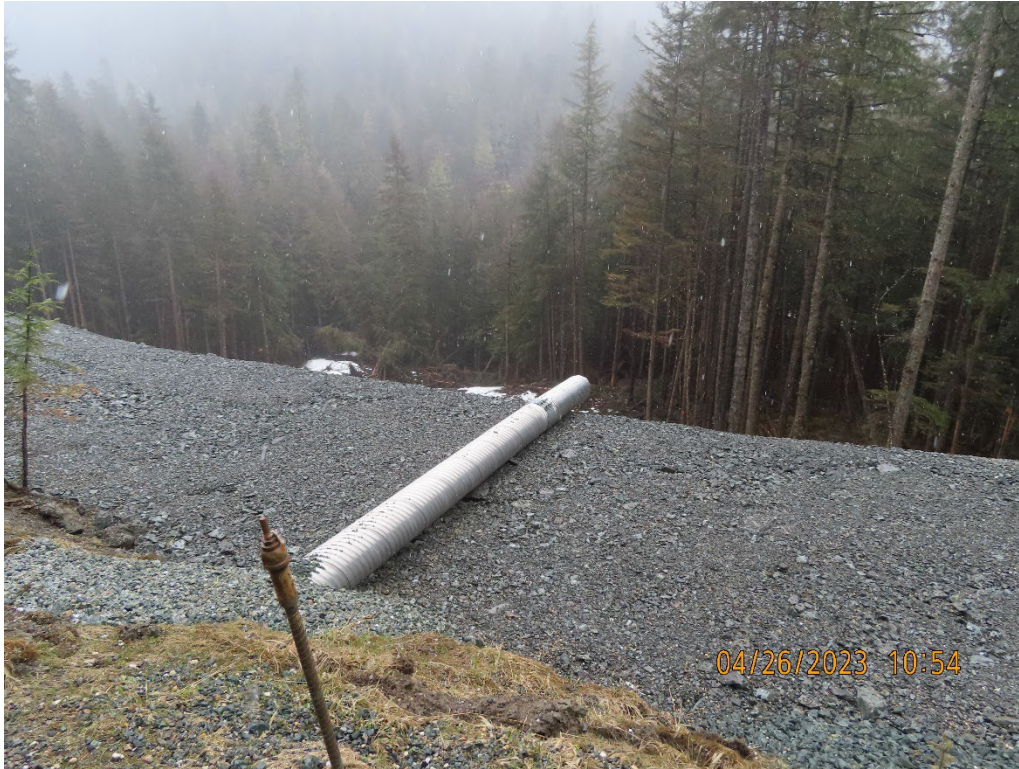
The BMPs, and drainpipes installed during the access road shoulder reconstruction are working as designed to help minimize any erosion to the access road (Photo 13).

Photo 13. Larger drainpipes were installed during the reconstruction to improve drainage.

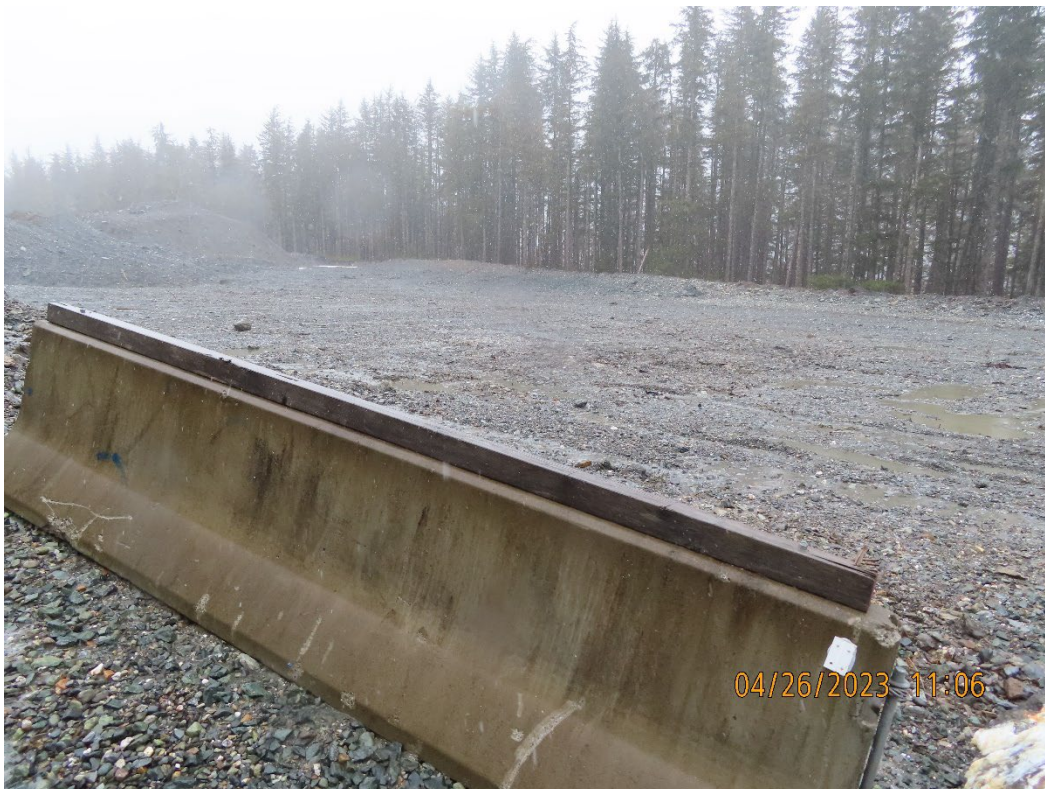
Photo 14. Site E-waste rock storage.

HGCMC has plans this summer to remove more waste from this site and dispose of it in the TDF (Photo 14).

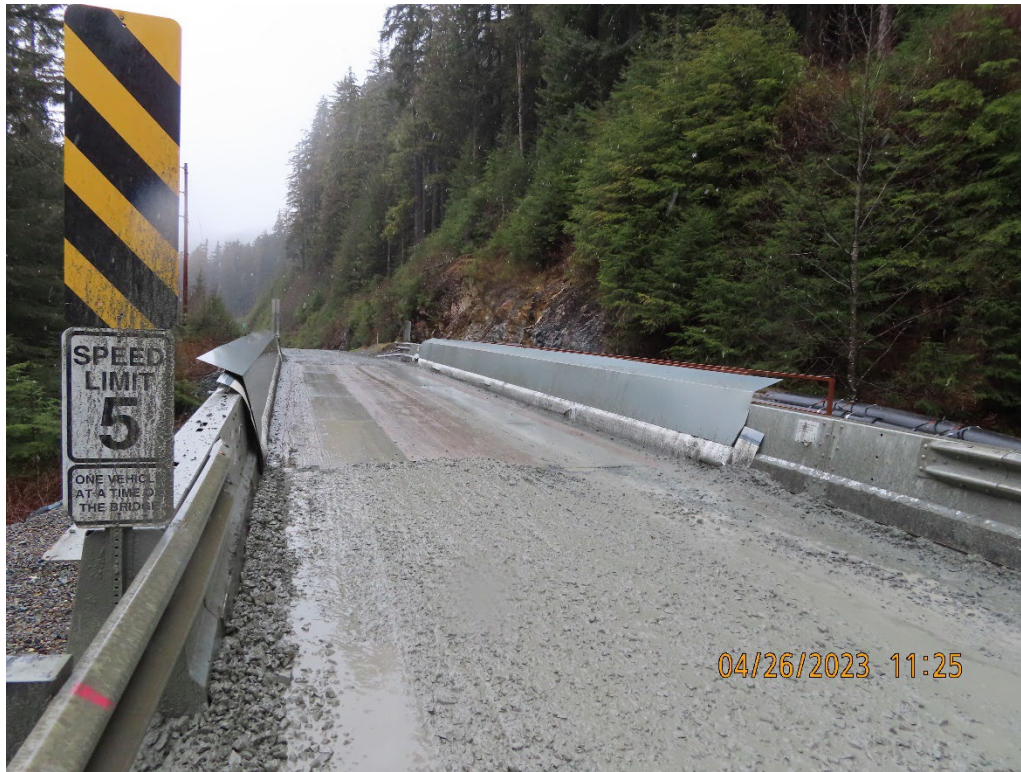
Photo 15. 3.4 B Road Bridge (Falls Creek Bridge).

The bridge surface or wear layer was in good condition, and the sediment-deflection barriers functioned as intended (Photos 15-16). The bridge's deck, abutments, and the BMPs will be cleaned during the site spring-cleaning project.

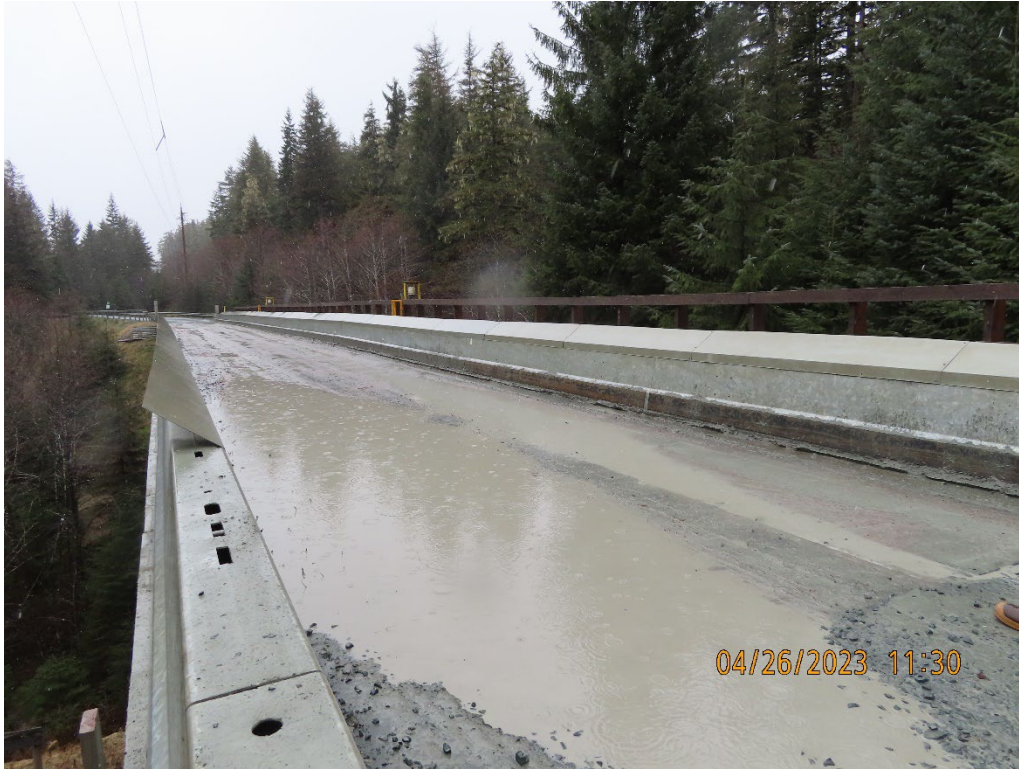
Photo 17. 3.0-mile B Road Bridge (Zinc Creek Bridge).

The Zinc Creek bridge had water ponding, and the sediment-deflection barriers prevented sediments from reaching bridge abutments (Photos 17-18). Some sediments have accumulated at both bridge ends from snow melt which requires cleaning and removal.

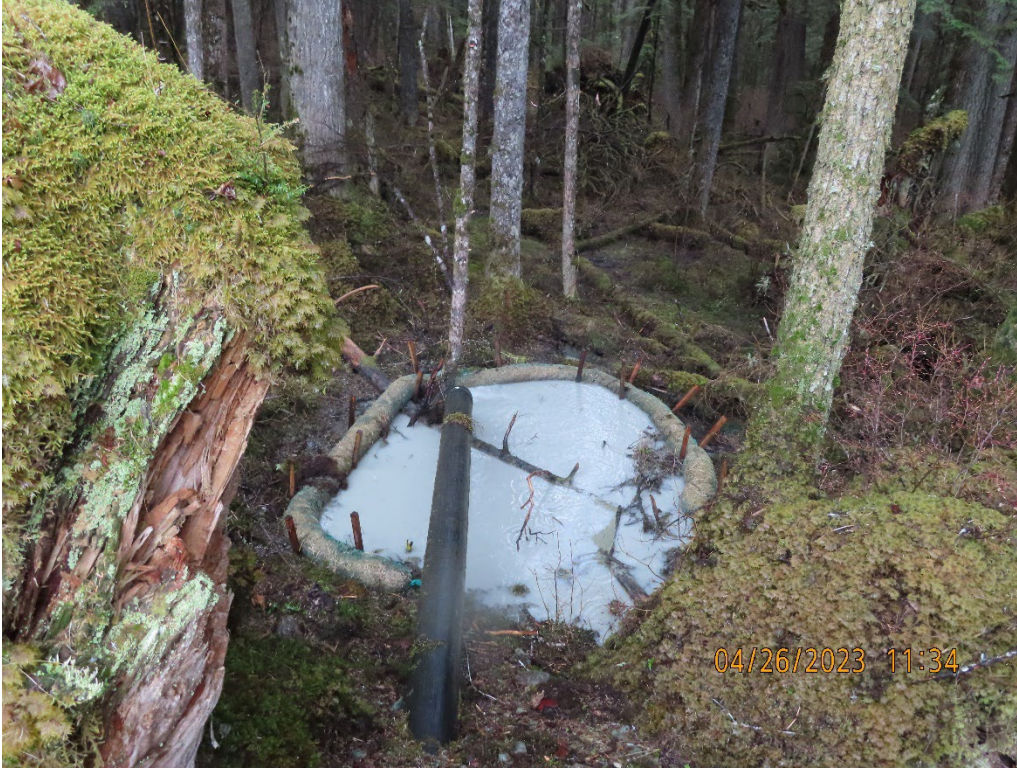
Turbid water was discharging from the stormwater BMP Gnome Pond's outlet and pooling in low spots on the forest floor (Photos 19-20). The outlet requires cleaning and potentially installing additional BMPs or modifying the current BMPs to prevent turbid water from entering surface waters.

Photo 19. Turbid water was observed breaching the BMP straw wattle.

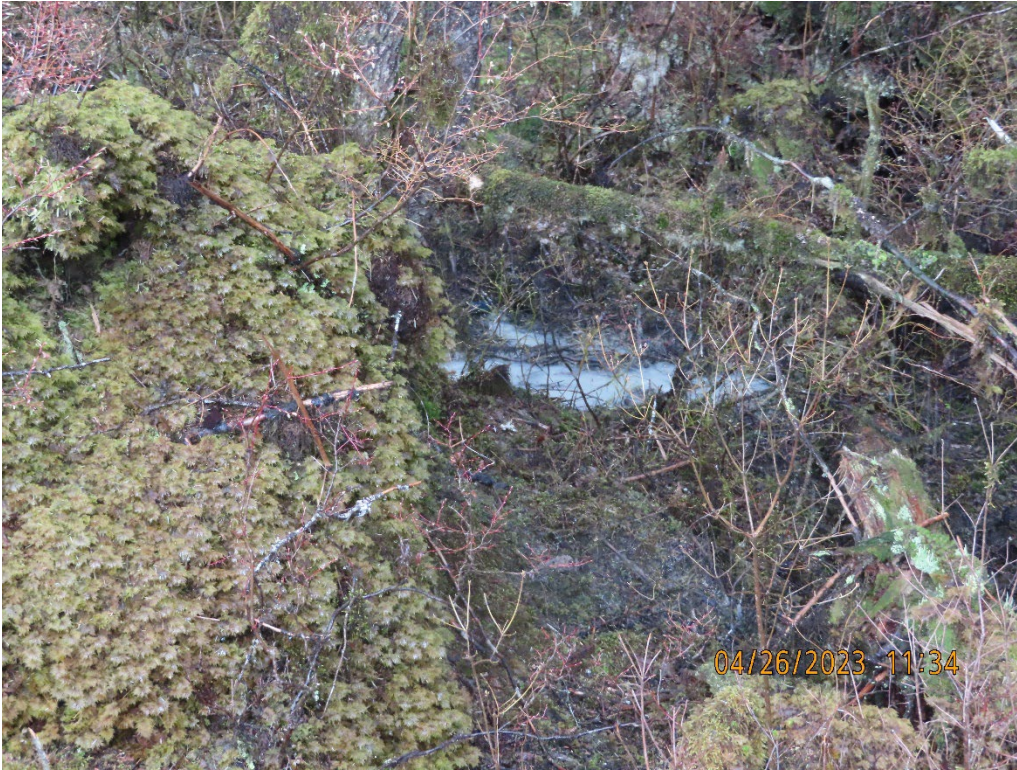
Photo 20. Turbid water can be seen on the forest floor.

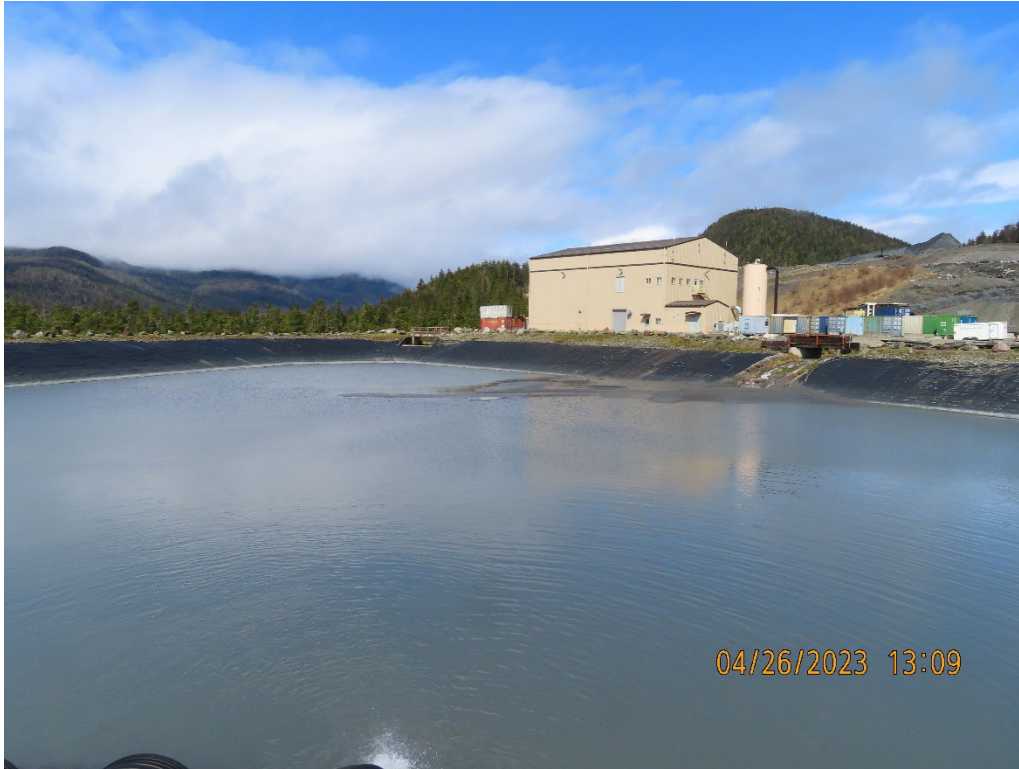
Photo 21. Pond 7

During the site inspection of Pond 7, contact water was entering the pond (Photo 21). The treatment plant also was recirculating processed/treated water back into the pond. Pond 10 was not receiving mine site water (Photo 22).
