**INACTIVE PRODUCTION ROCK SITES AND QUARRIES
2011 ANNUAL REPORT**

Hecla Greens Creek Mining Company

April 15, 2012

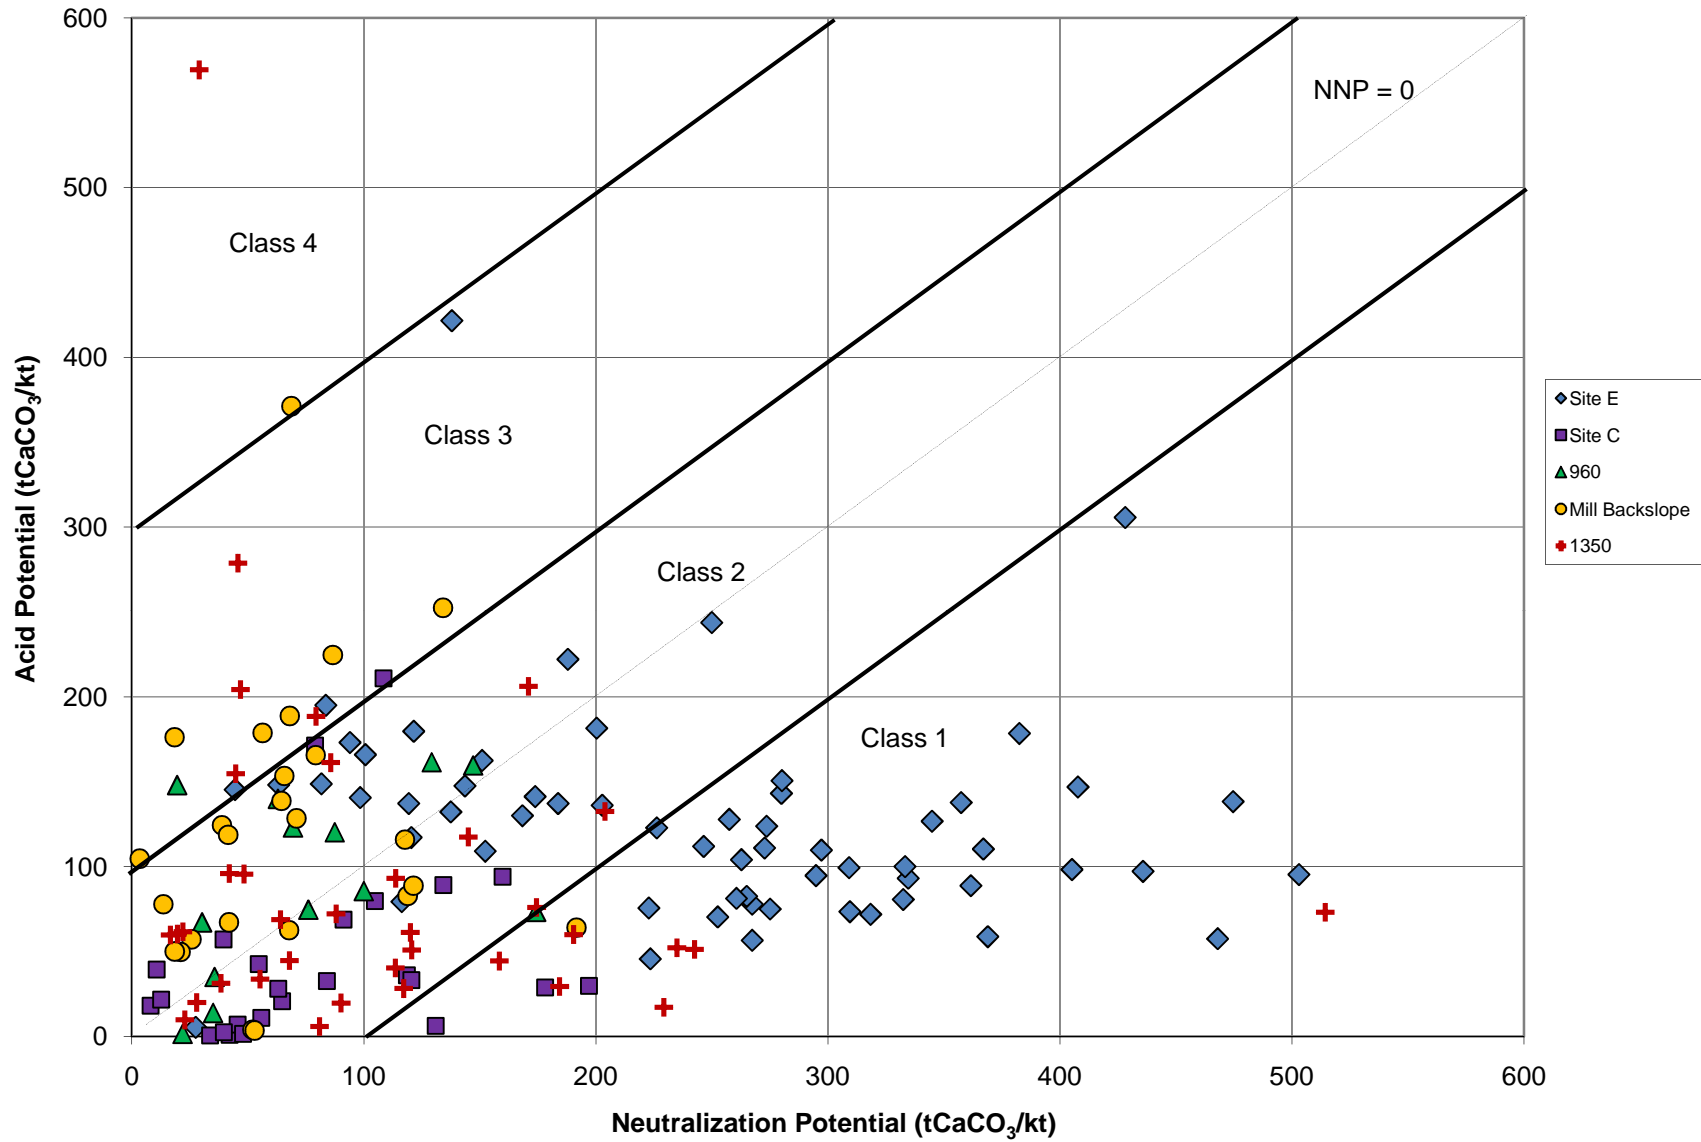
FIGURE 2.3a 2002-2008 INACTIVE SITE ABA DATA

Figure 2.3a compares acid potential (AP) with neutralization potential (NP) for surface grid samples for the inactive sites. The inactive sites were constructed prior to development of the classification protocol that HGCMC currently uses. At the time the inactive piles were constructed HGCMC did not classify or segregate its production rock. Symbols in Figure 2.3a represent actual laboratory data points. Lines indicating the currently utilized production rock

classes are shown on Figure 2.3a for reference only. Figure 2.3a shows the distribution of potentially acid generating (upper left half of figure) and potentially acid neutralizing (lower right half of figure) samples. Many samples from Site E have more neutralization potential than those from other sites, reflecting a greater proportion of argillite. Samples from the mill backslope and the 1350 site generally have a higher acid generation potential than those from the other sites. Reclamation activities at the 960, 1350 and Site E have removed significant quantities of potentially acid generating material from these sites.

Grid sampling of the Mill Backslope rock cover and access road (Figures 2.3a and 2.3b) indicate that this rock is acid generating, and shows the higher sulfide content and low carbonate content in the rock. The low carbonate content is likely a combination of deficient initial composition and depletion of carbonate from the fines fraction through weathering.

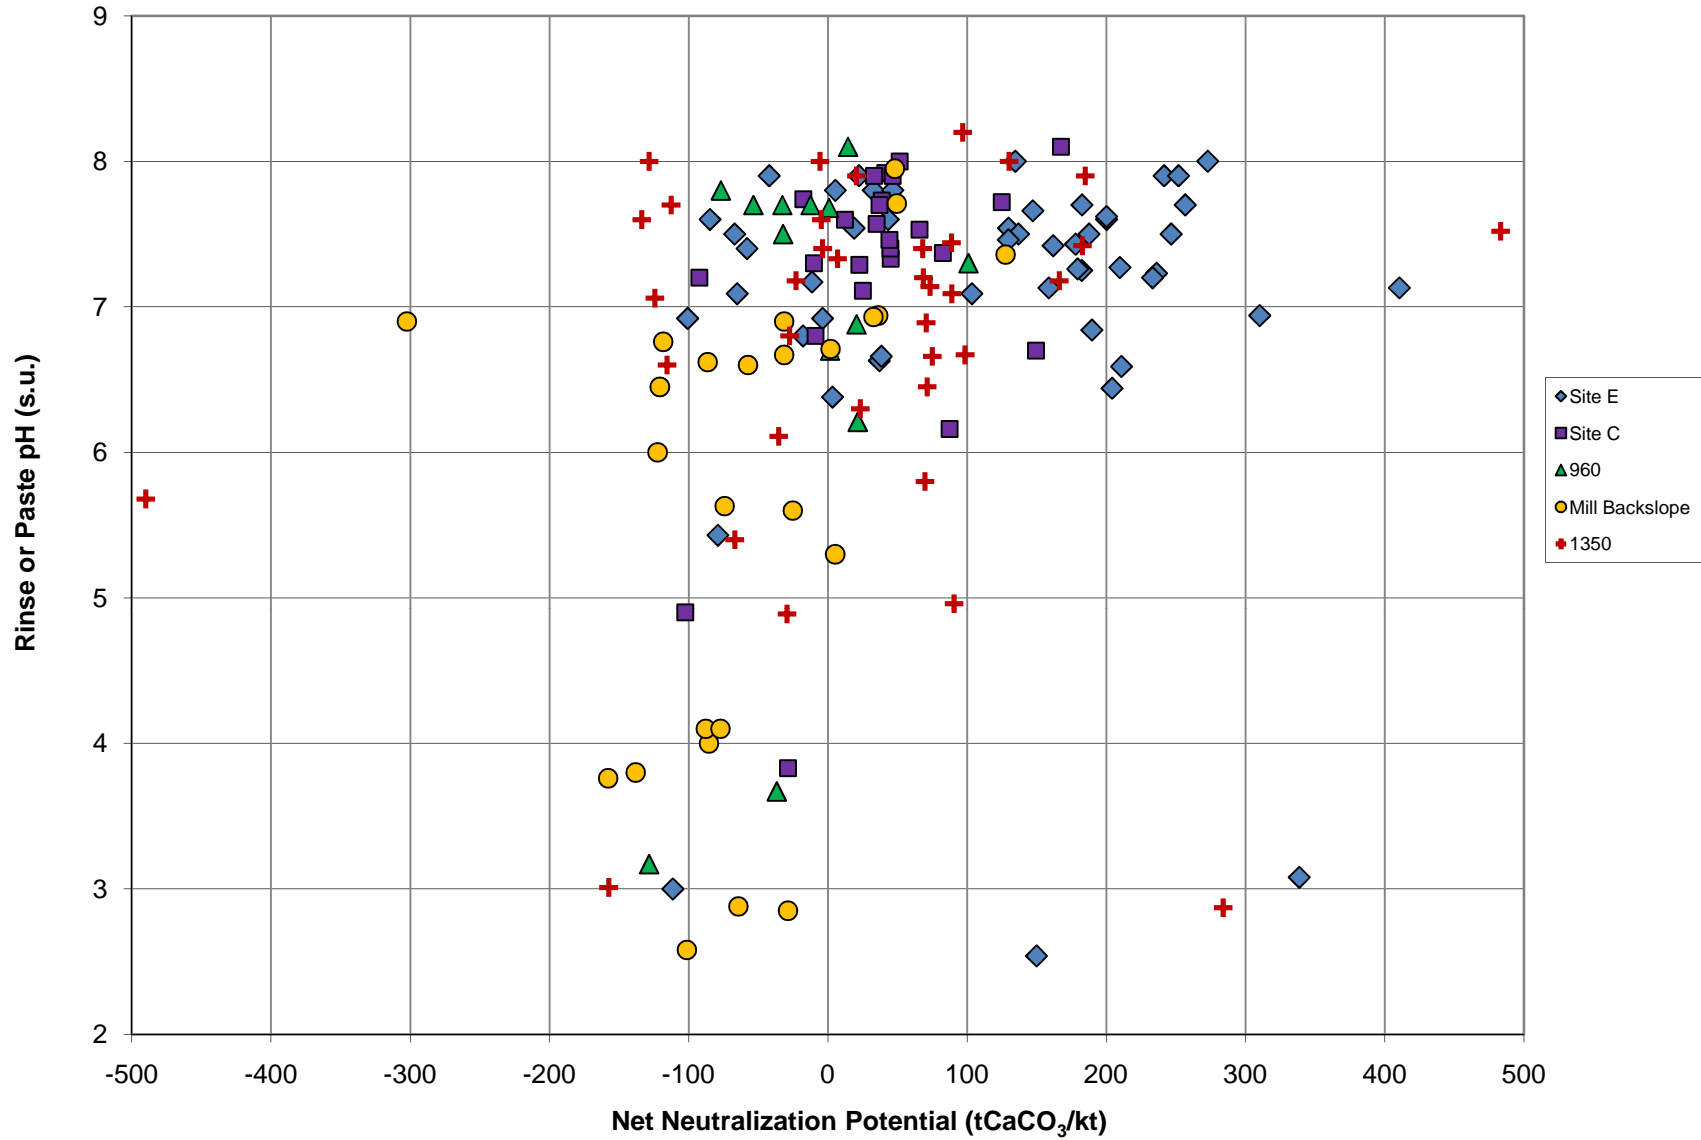
FIGURE 2.3b 2002-2008 INACTIVE SITE ABA DATA (NNP vs pH)

Figure 2.3b shows the results of rinse pH relative to net neutralization potential (NNP) for the five inactive sites. Most samples produced a rinse pH greater than 6.0; however, each site has produced at least two samples with rinse pH values less than 5.0. This is consistent with the distribution of NNP values and the duration of waste rock exposure. Grid sampling occurs at the surface of the piles where oxidation rates are greatest. Drainage from the inactive sites remains near neutral because the bulk of the material in the piles contains sufficient carbonate to neutralize the acidity formed by pyrite oxidation near the pile surface. There are a few cases where samples produced a low rinse pH and high NNP. This is likely a result of accumulated acidic oxidation products in the fines fraction of the sample and remaining carbonate minerals in the coarse fraction.

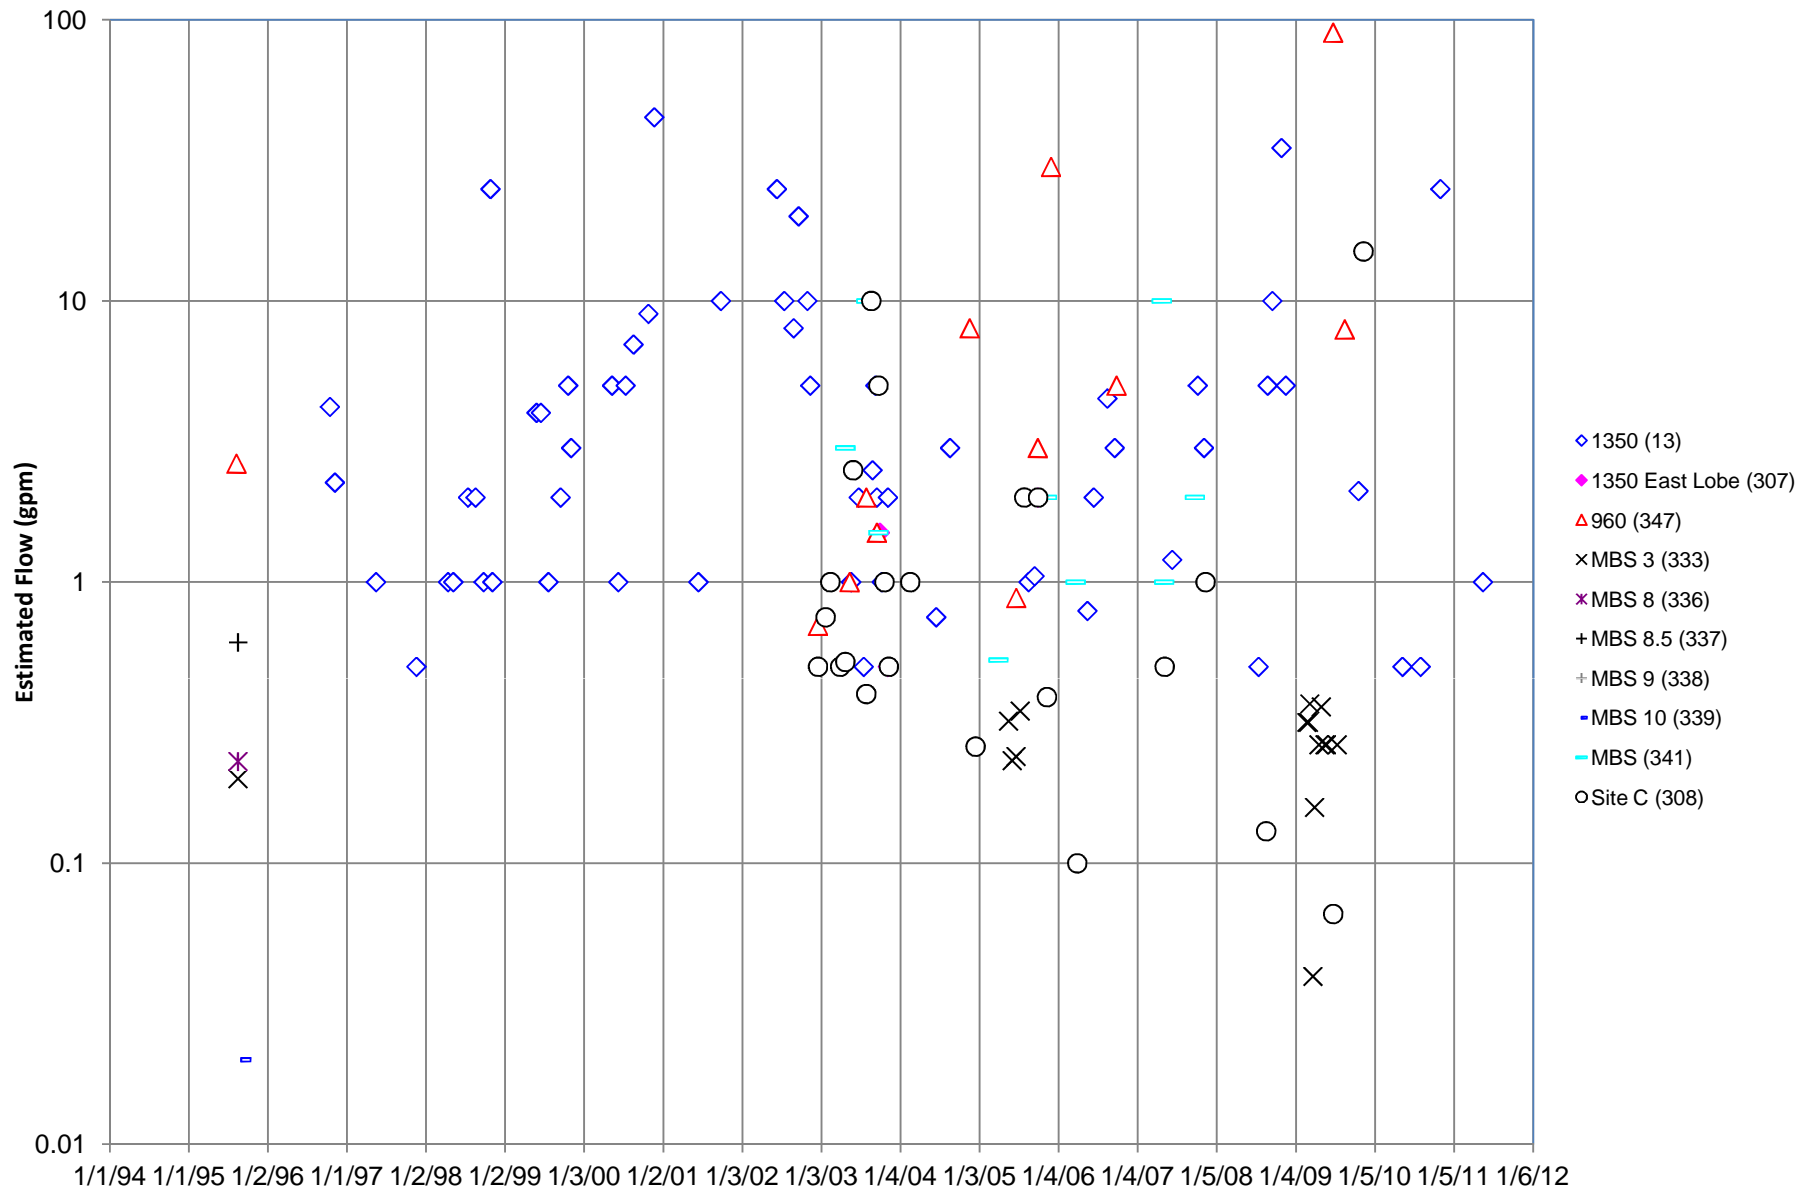
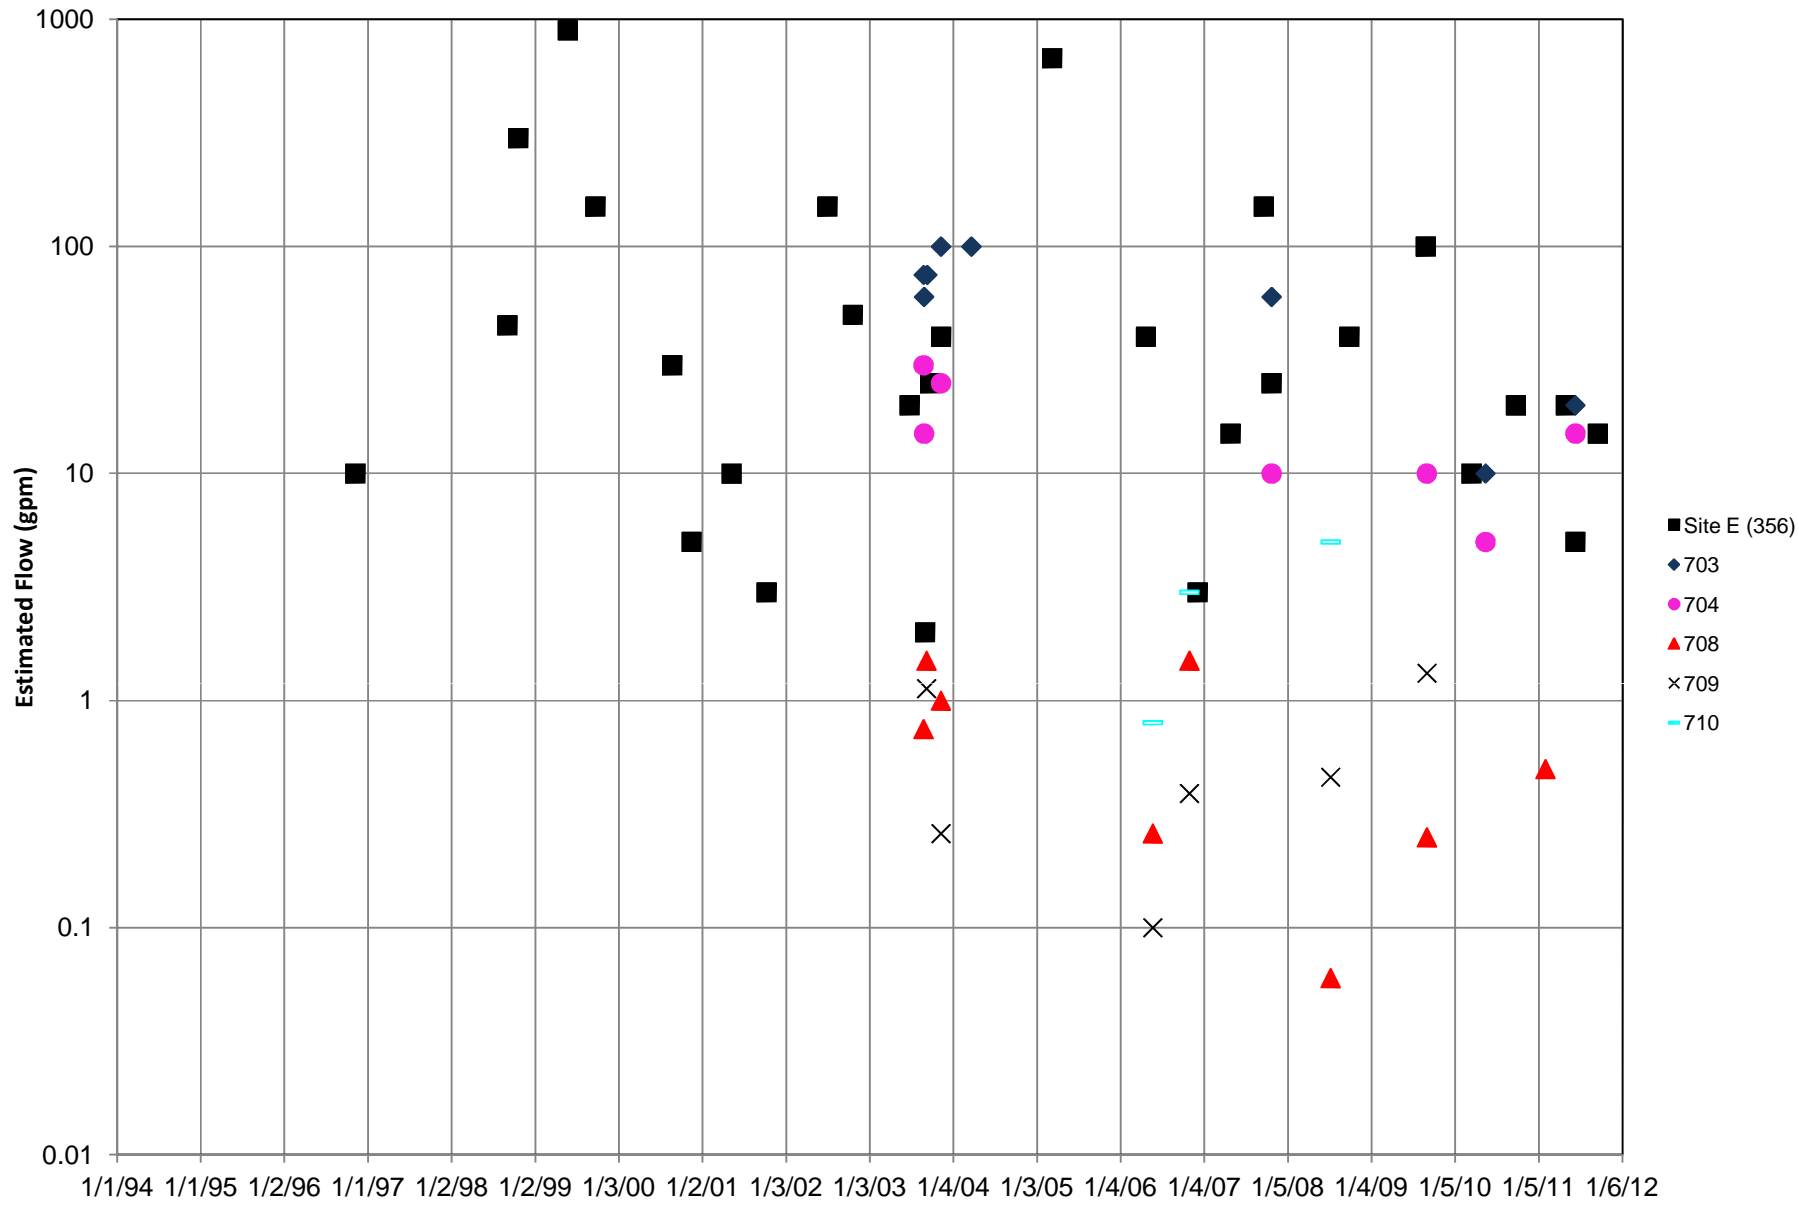
Flow data presented in Figures 2.5 and 2.20 demonstrate that flows at most of the sample locations are generally low (less than 10 gpm) with the exception of Site E. Some of the flow data were collected as part of the APDES stormwater monitoring program. Collected during or following storm events, flow data from these locations (e.g. Site E 356, 960 347) represent short-term maximum flow values in response to relatively large precipitation events. Lack of significant flow from inactive sites is a positive characteristic because it reflects minimization of potential off-site impacts.

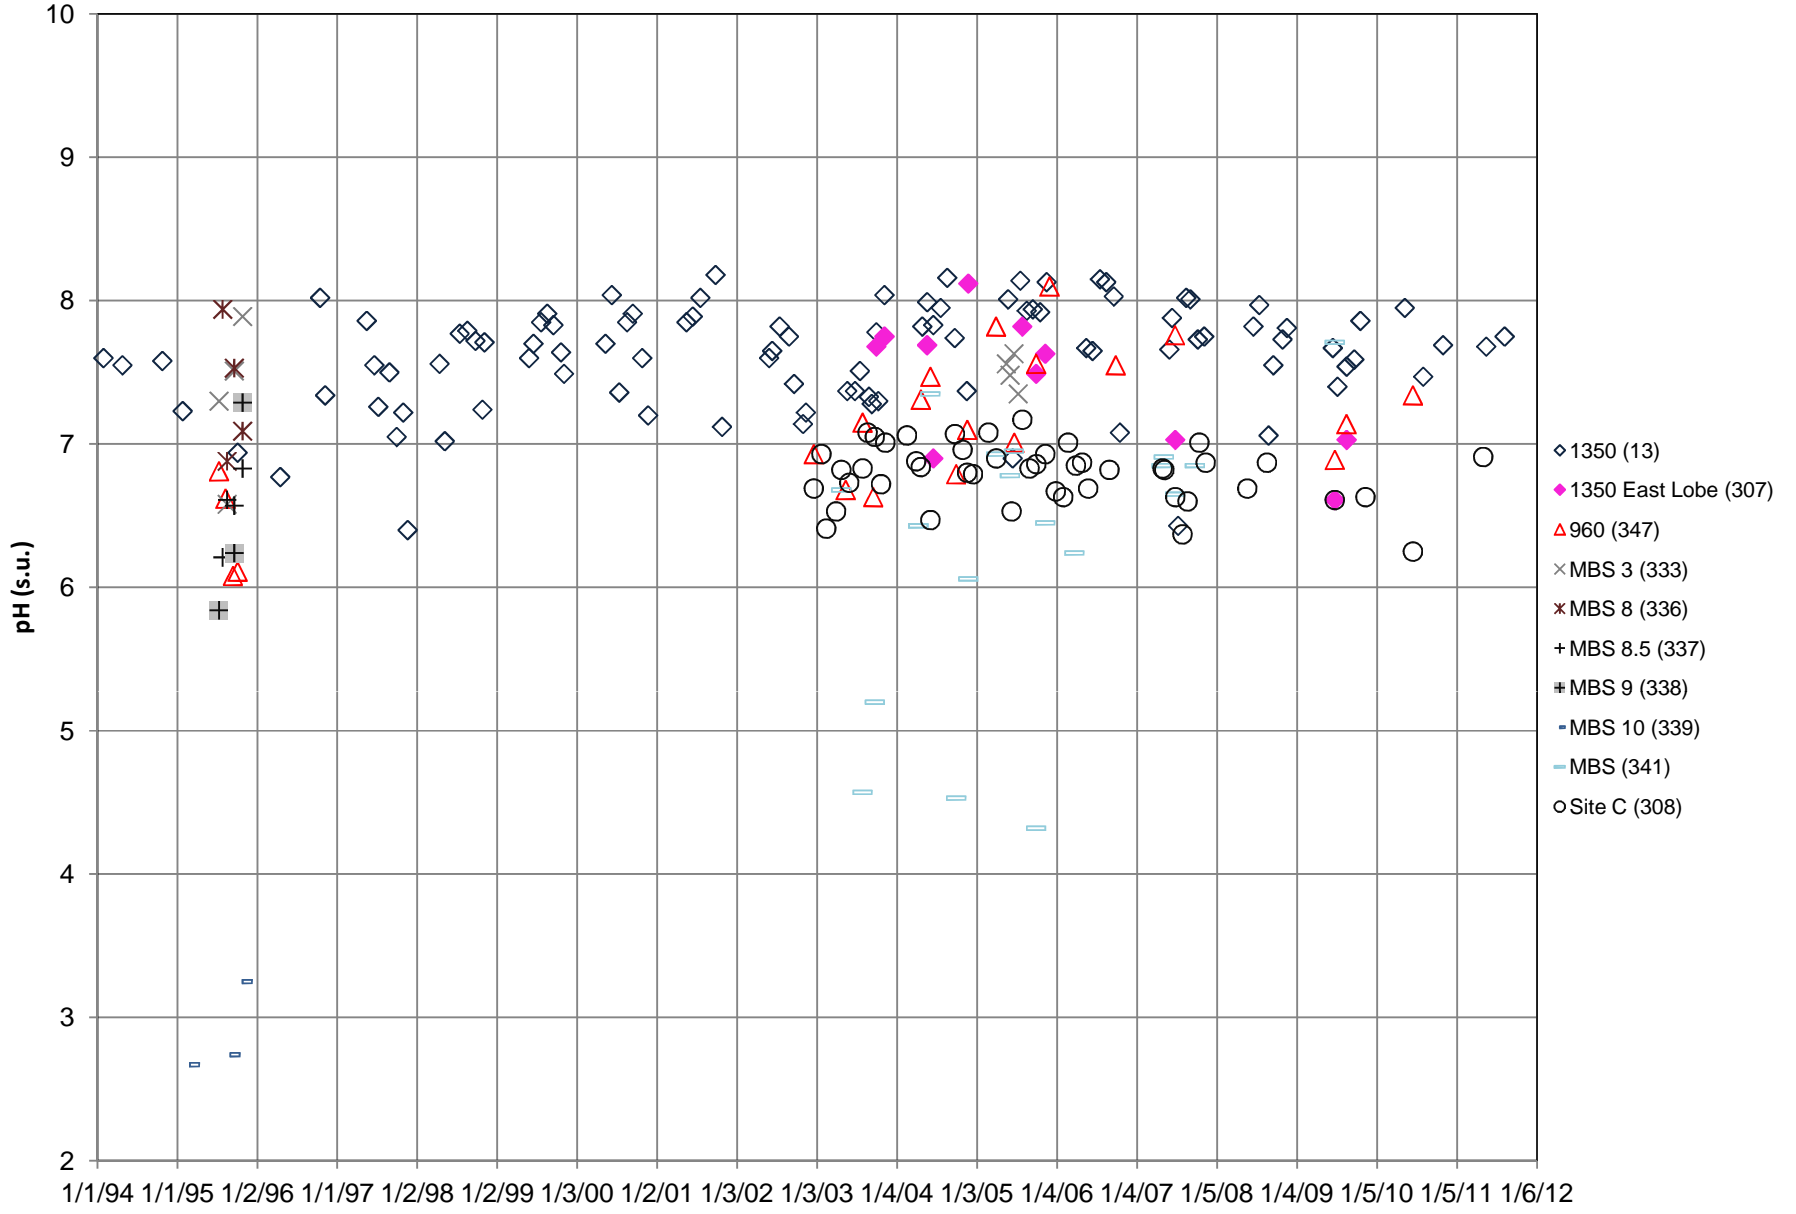
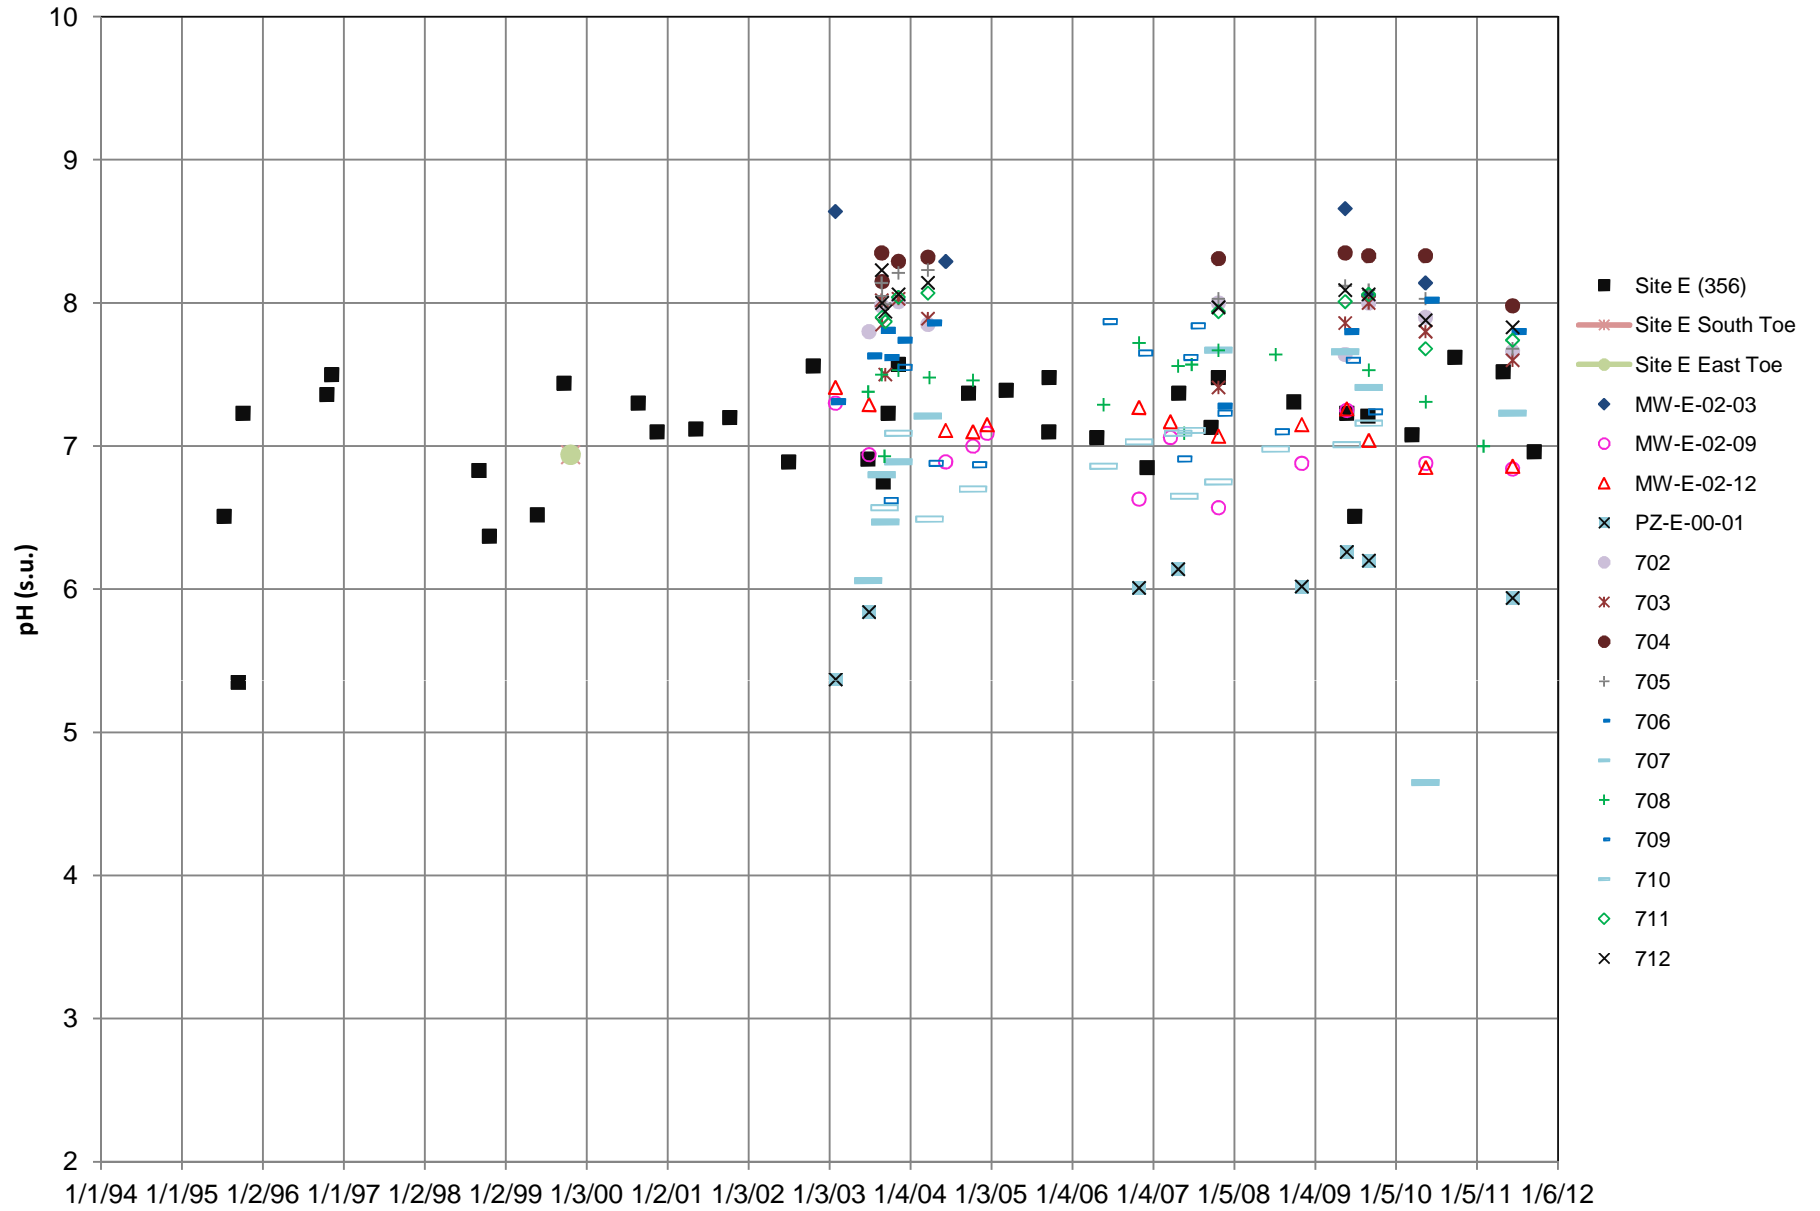
Figures 2.6 and 2.21 show pH data from inactive site sampling locations. Lower pH values can represent influences from pyrite oxidation and/or organic acids from muskeg and forest soils. The data show that the vast majority of the site drainage remains above pH 6.0. The sample from the Mill Backslope in 1995 was runoff collected from a bench containing zones of heavily pyritized rock. For a brief period in 1998 and 1999, acidic conditions began developing at the 960 (site 347). HGCMC applied lime and removed 1000 cubic yards of oxidized pyritic rock from the site in 2000. The pH of the drainage quickly rebounded and has remained near-neutral since 2000. Removal of additional Site 960 material in 2003, 2004 and 2005 is discussed below in Section 2.3. The material removal activities may also be responsible for the pH of 8.0 measured at the 960 site in 2005. This is the highest recorded for this site. The reason for the elevated pH is likely due to the removal of pyritic rock that had consumed much of its readily available buffering capacity. Fresh carbonate mineral surfaces exposed during the excavation and the placement of the toe buttress may have contributed to the higher pH values observed. Alkalinity data presented in Figures 2.7 and 2.22 are consistent with the pH results in Figures 2.6 and 2.21. Sample locations continued to maintain measurable alkalinity provided by dissolution of carbonate minerals.

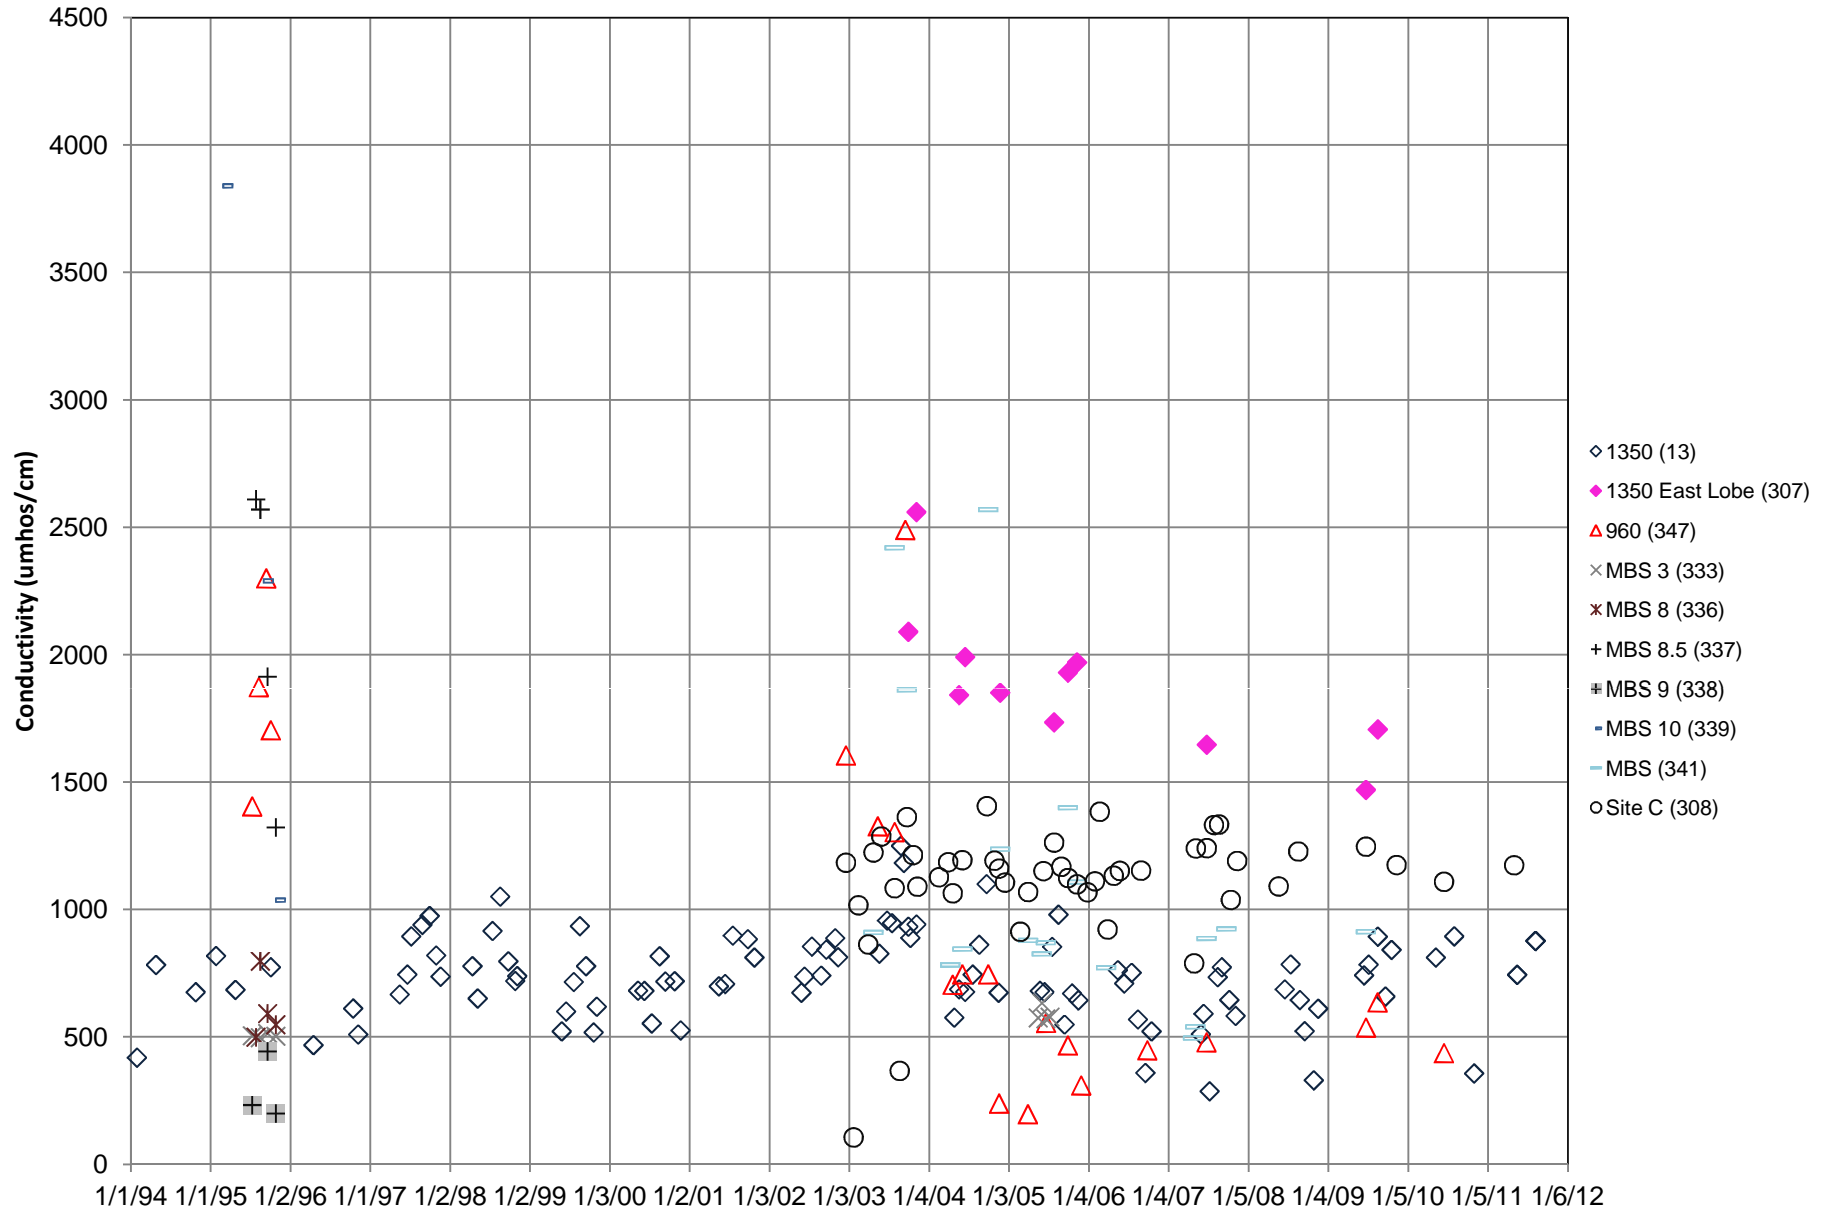
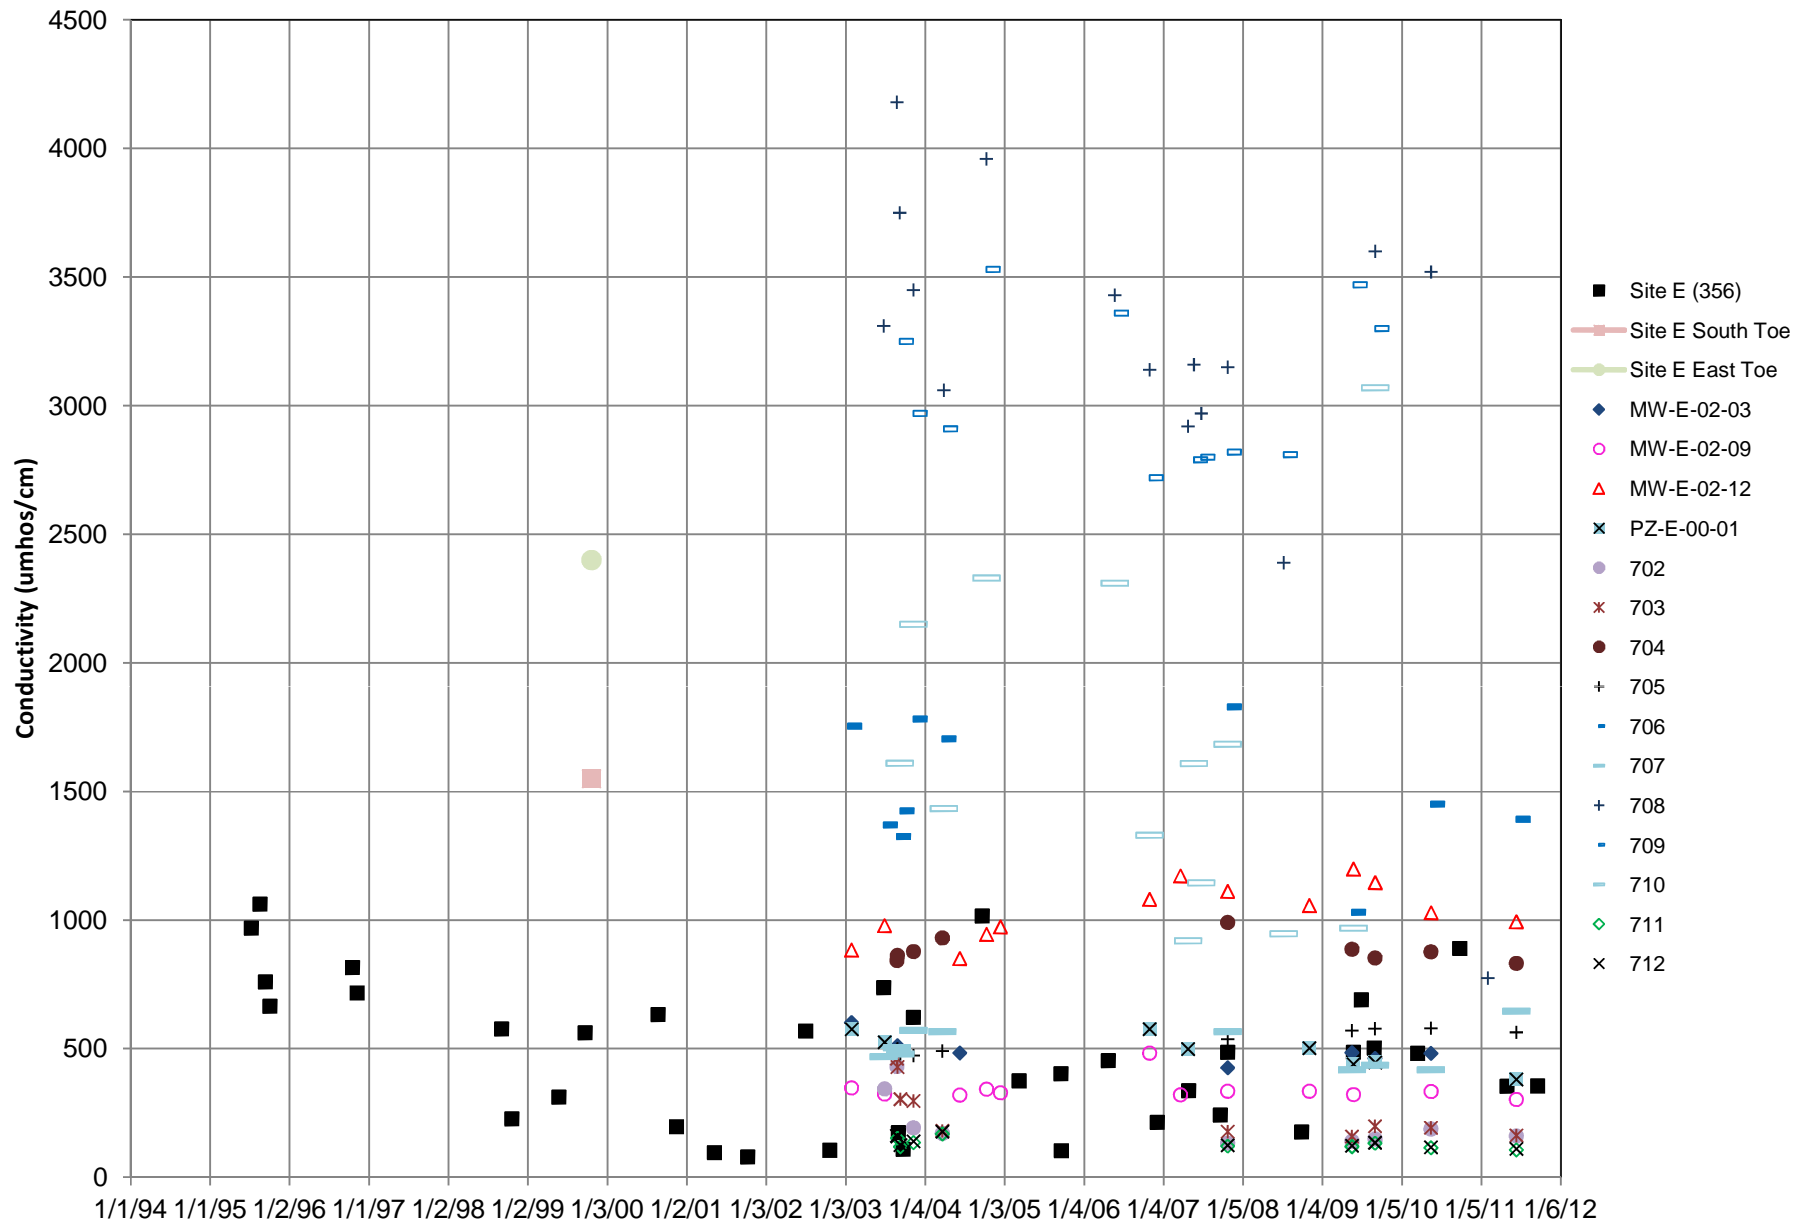
Conductivity data are shown in Figures 2.8 and 2.23. Conductivity indicates the amount of dissolved constituents in the water. HGCMC samples having higher conductivity values usually have higher sulfate, calcium and magnesium (hardness) concentrations, reflecting influences from sulfide oxidation and carbonate mineral dissolution. Water that has contacted production rock is expected to have higher conductivity values than background waters. The 960 (Site 347) shows an overall decreasing trend in conductivity, while the Site 1350 data remains unchanged. The combined drainage from the Mill Backslope area (Site 341) continued to have a lower dissolved load relative to 2003 and 2004 values. The decreasing trends apparent in Figures 2.8 and 2.23 are

the result of decreasing reactive surface area available for oxidation and dissolution. The reactive surface area decreases as reactants are consumed and mineral surfaces become coated with oxidation products. The results for sulfate, magnesium and hardness, shown in Figures 2.9 and 2.24, 2.10 and 2.25, and 2.11 and 2.26, respectively, correlate with conductivity results and are consistent with the concept of generally decreasing or static reactive surface area.
