**INACTIVE PRODUCTION ROCK SITES AND QUARRIES
2011 ANNUAL REPORT**

Hecla Greens Creek Mining Company

April 15, 2012

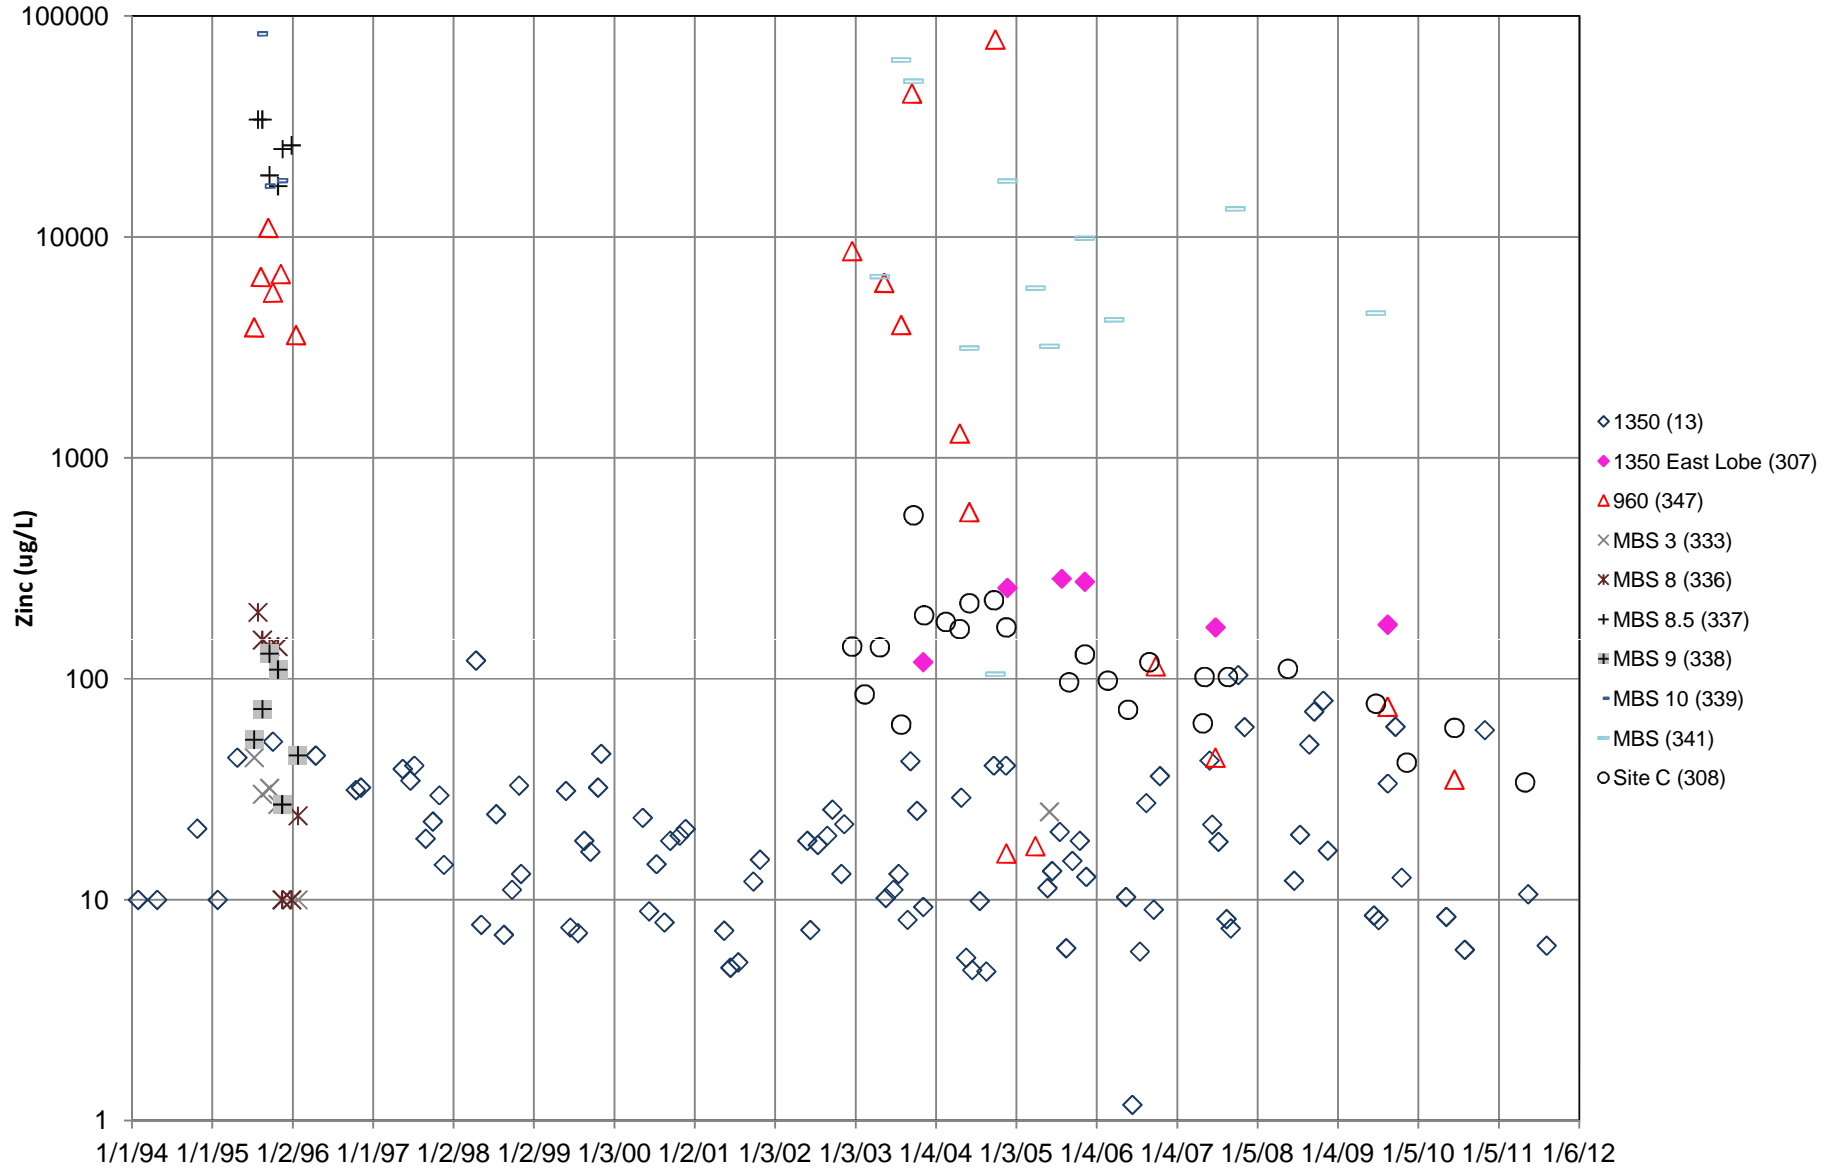
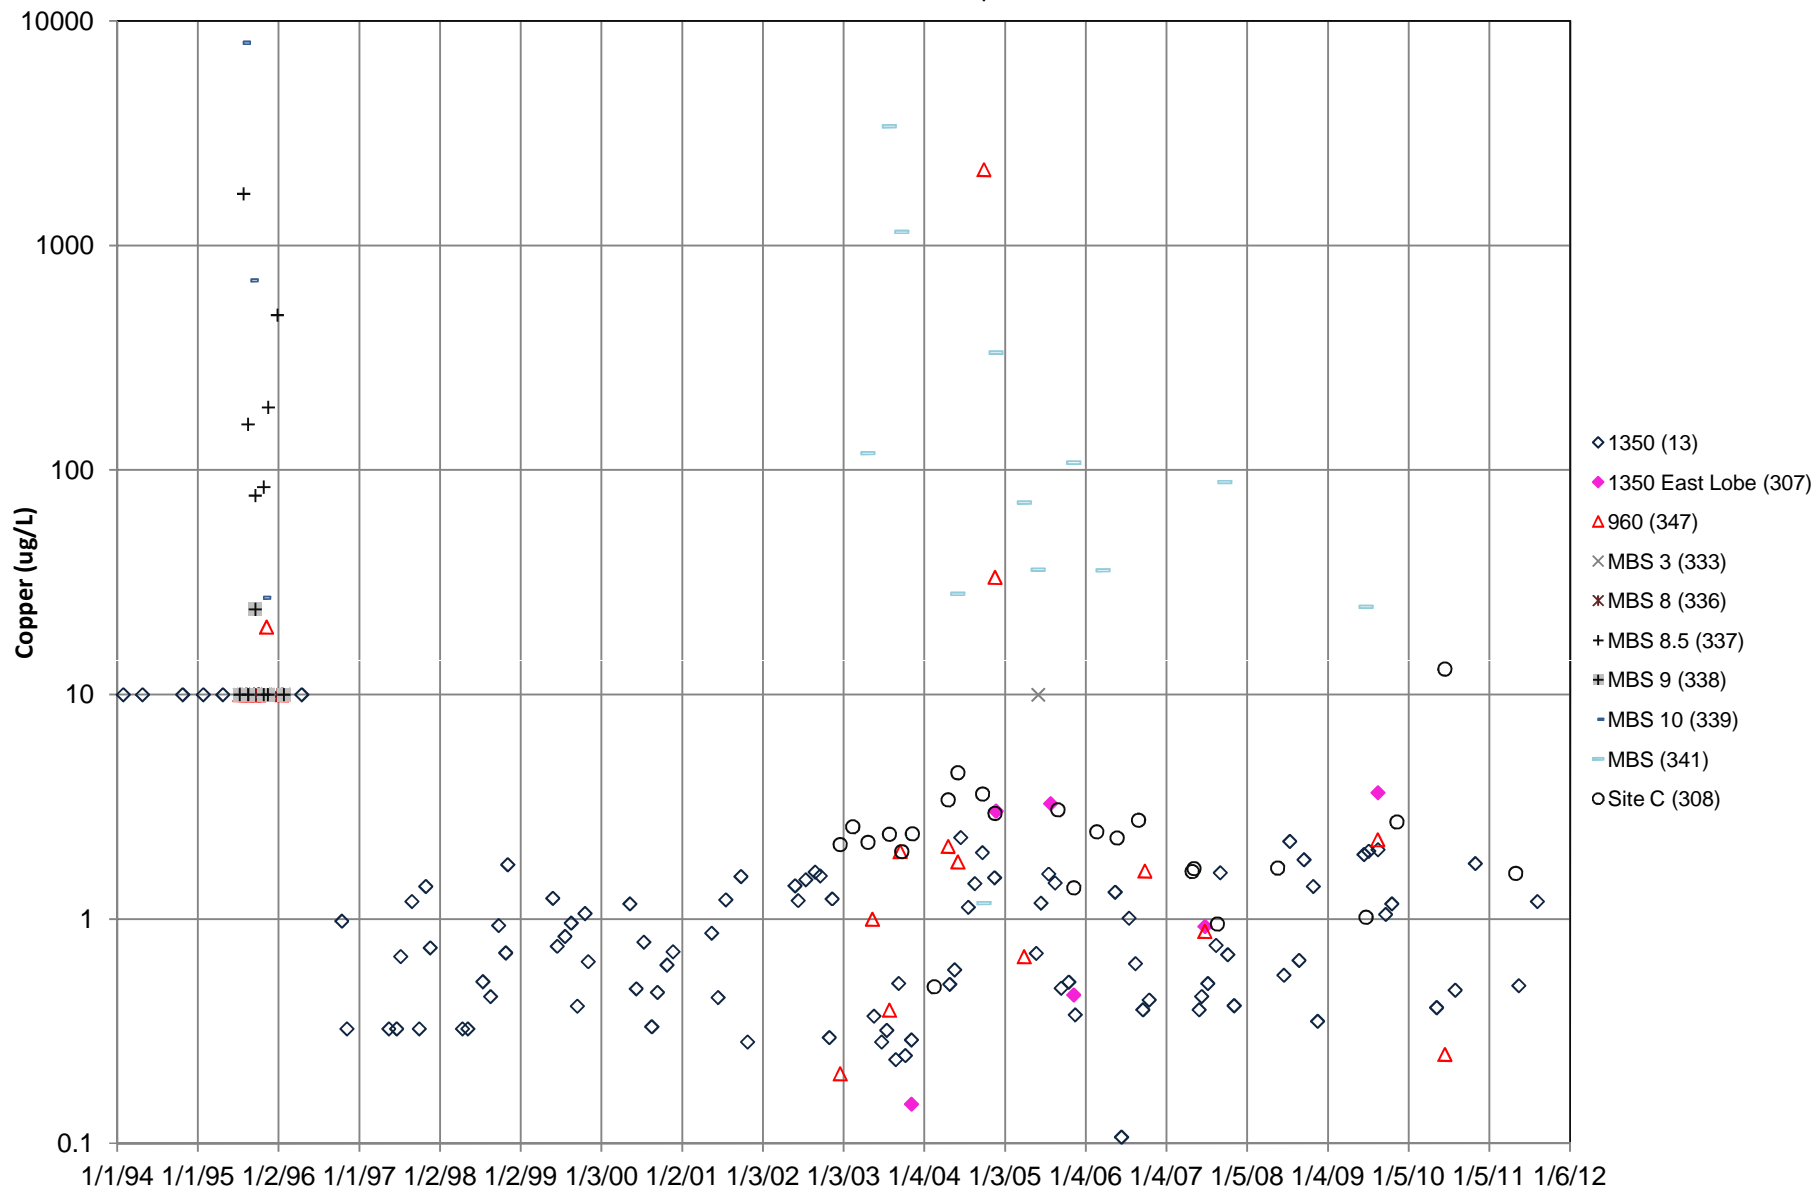
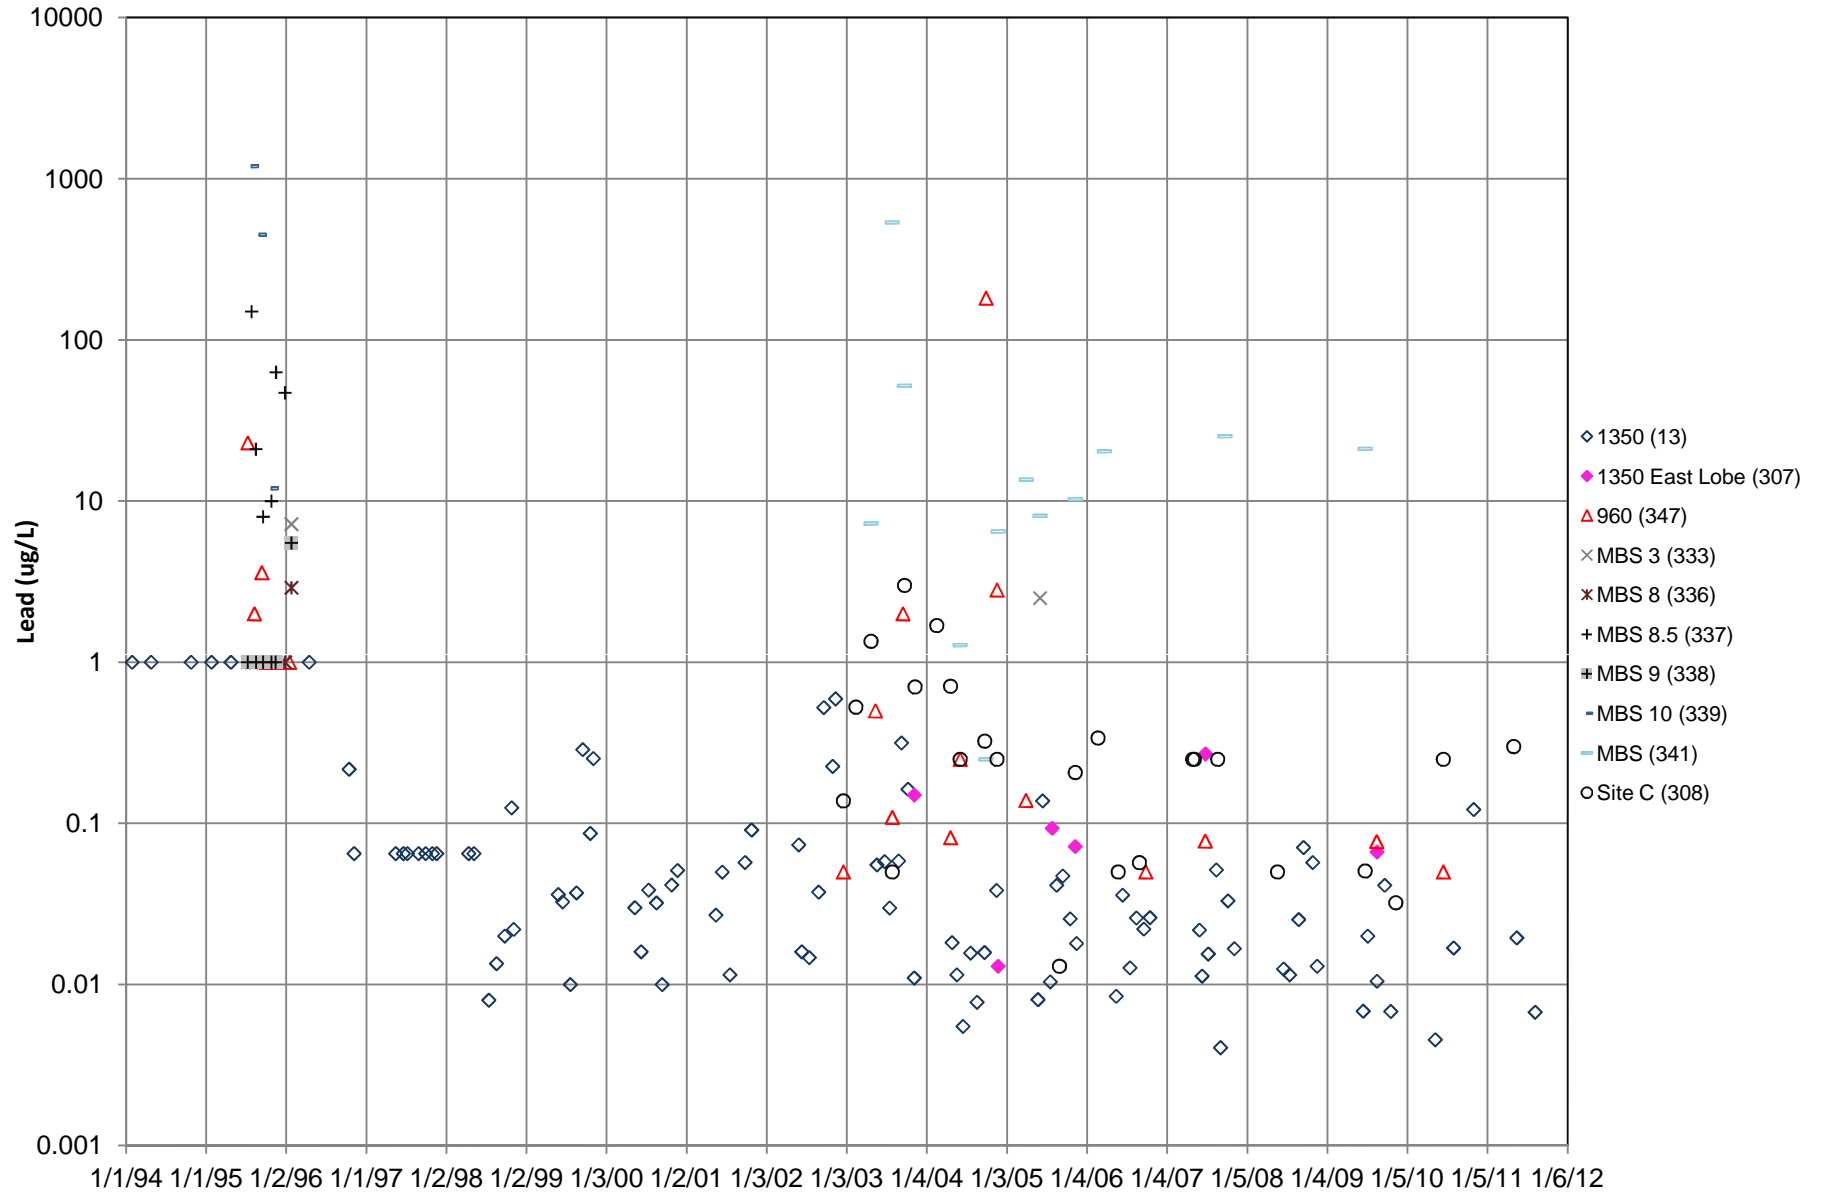
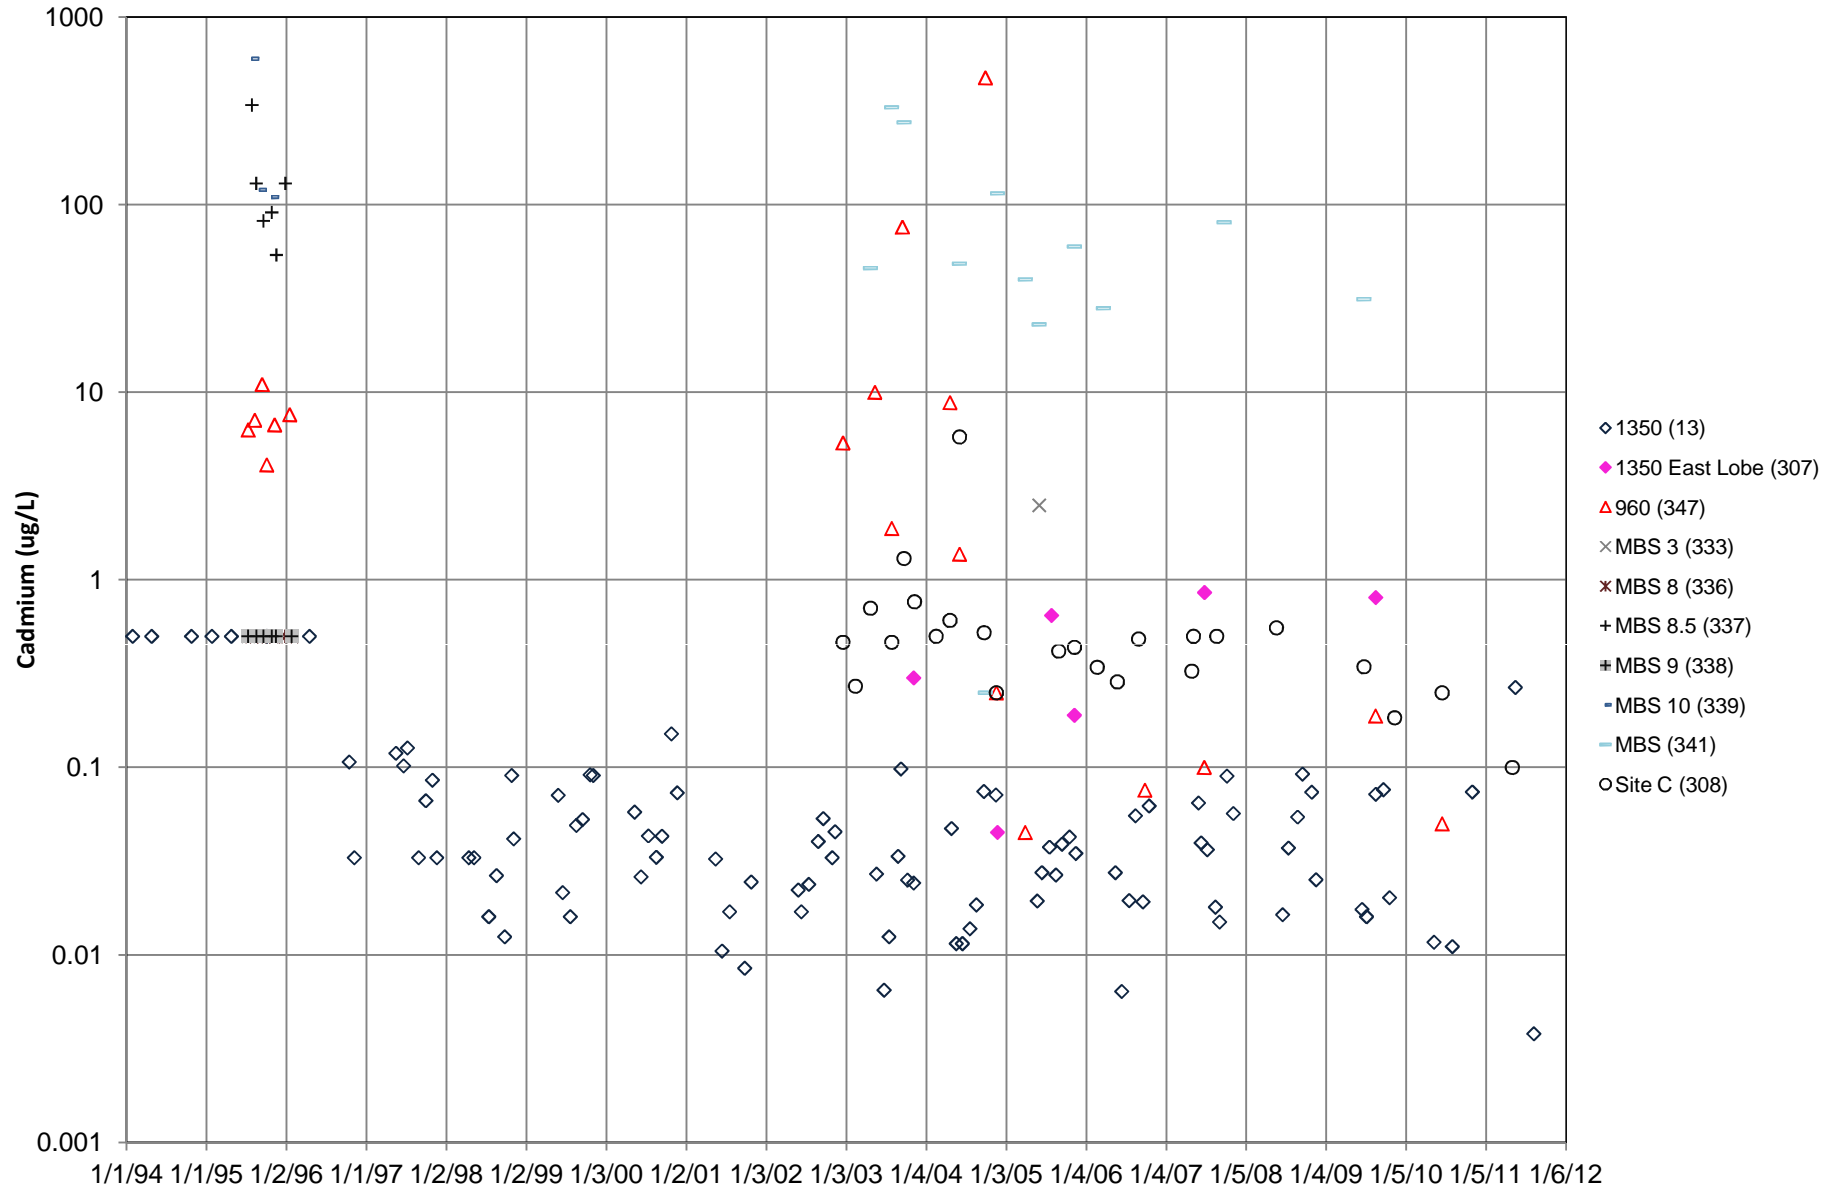
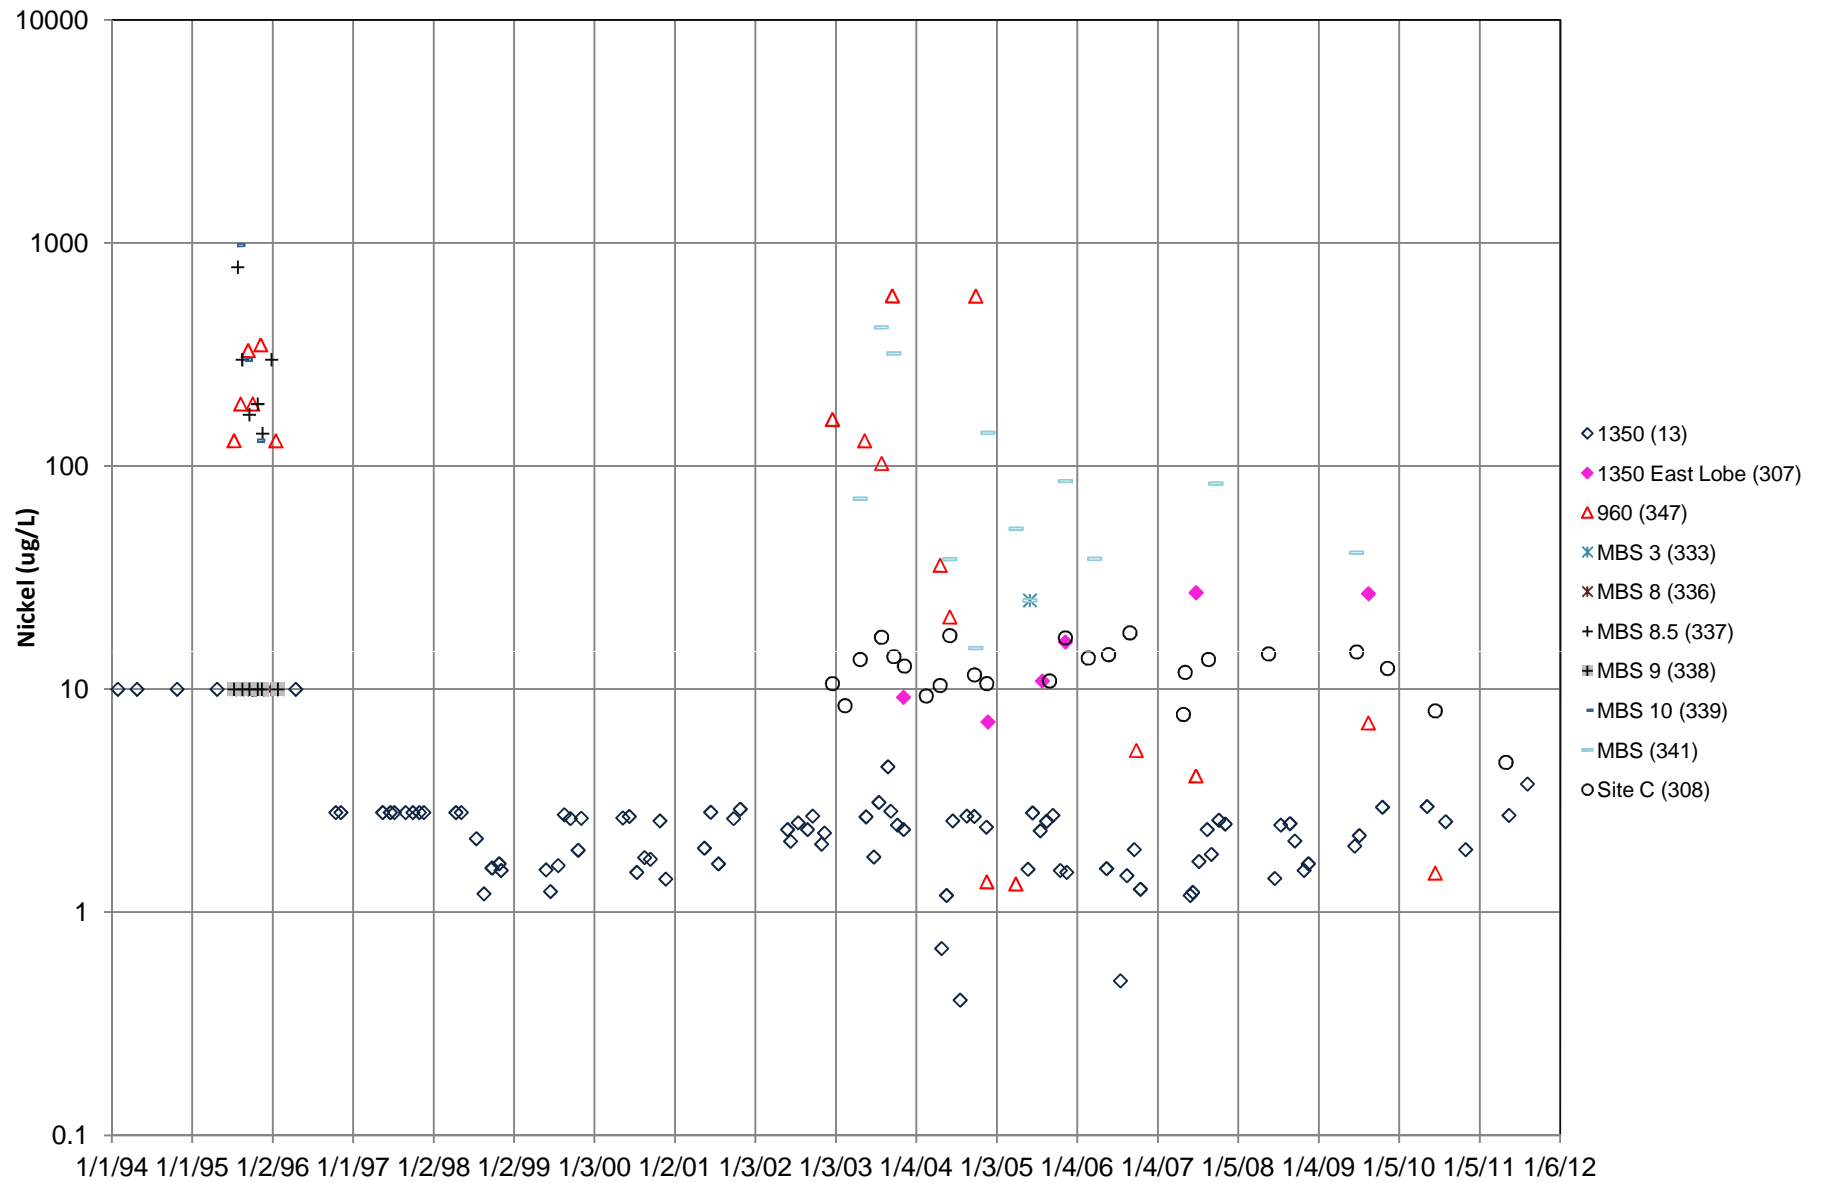
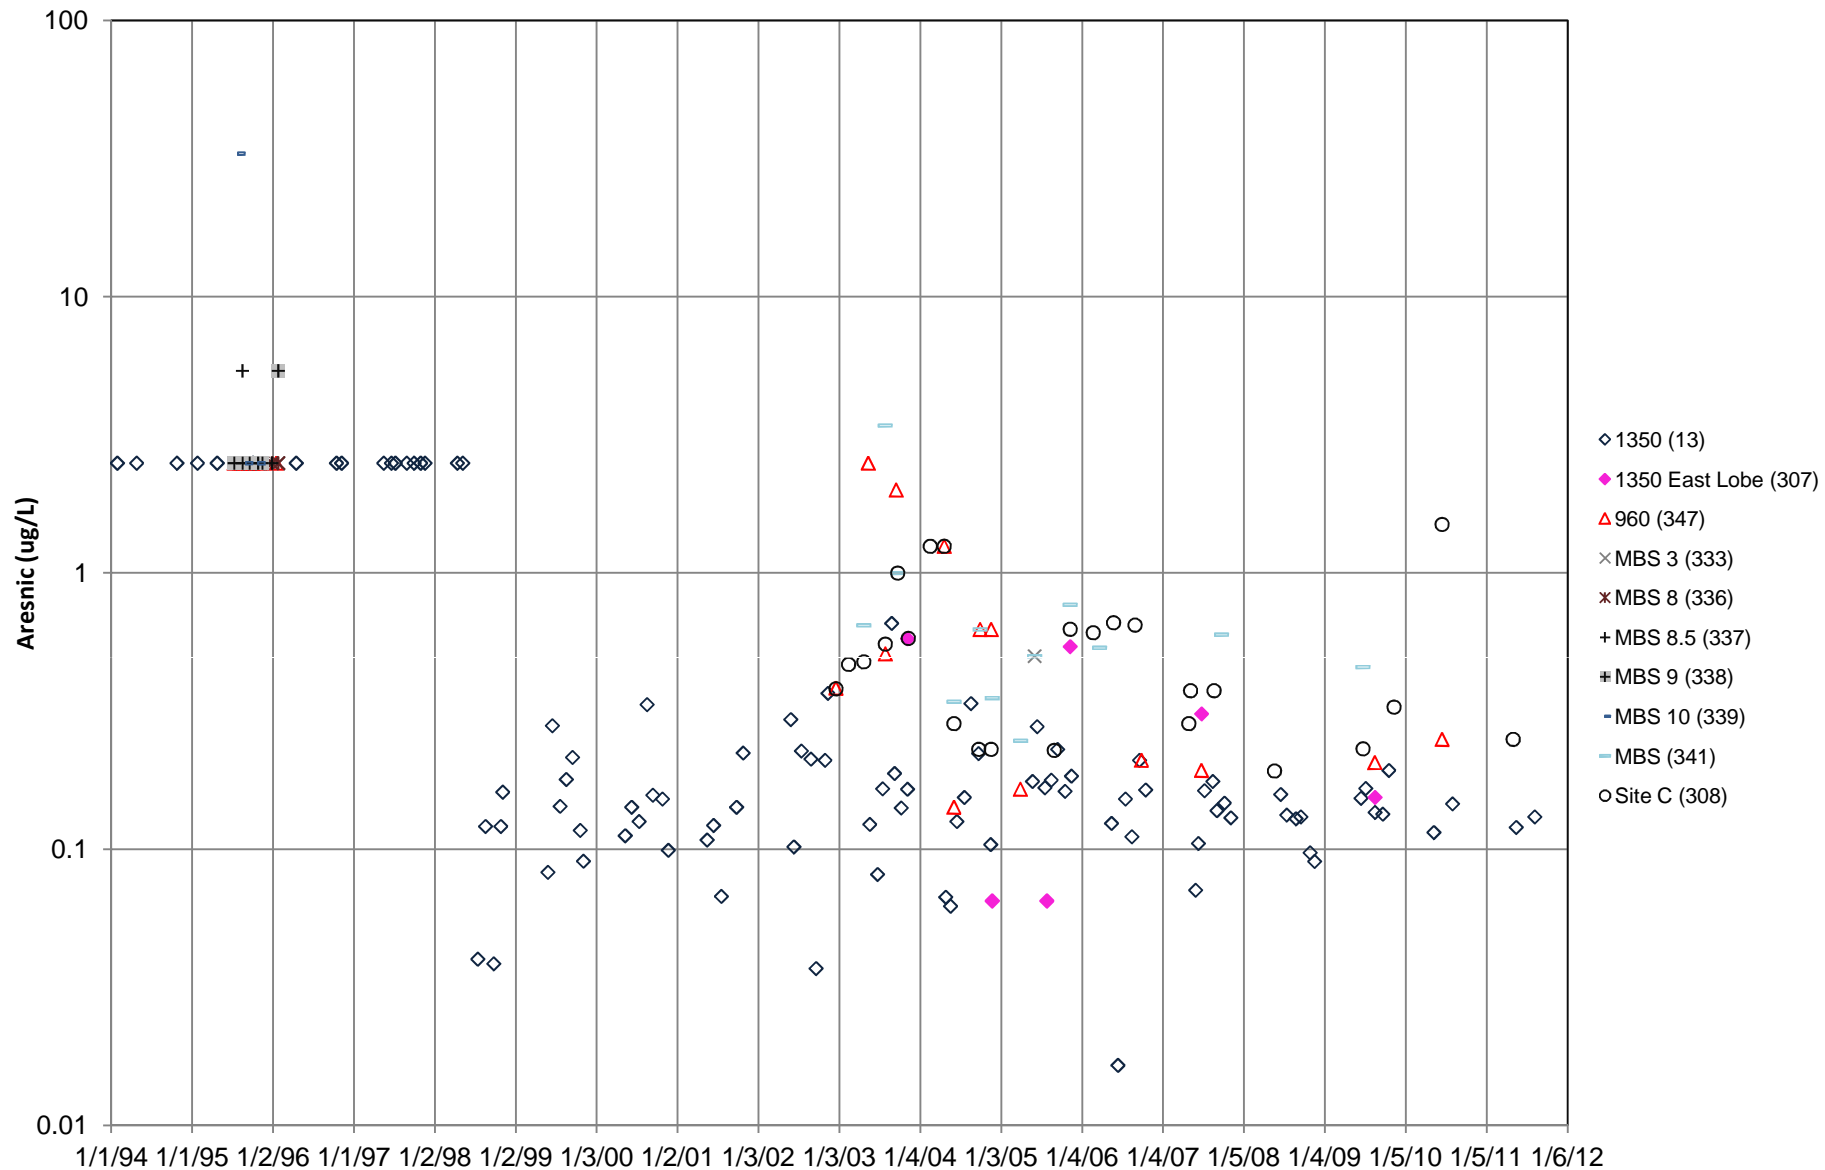
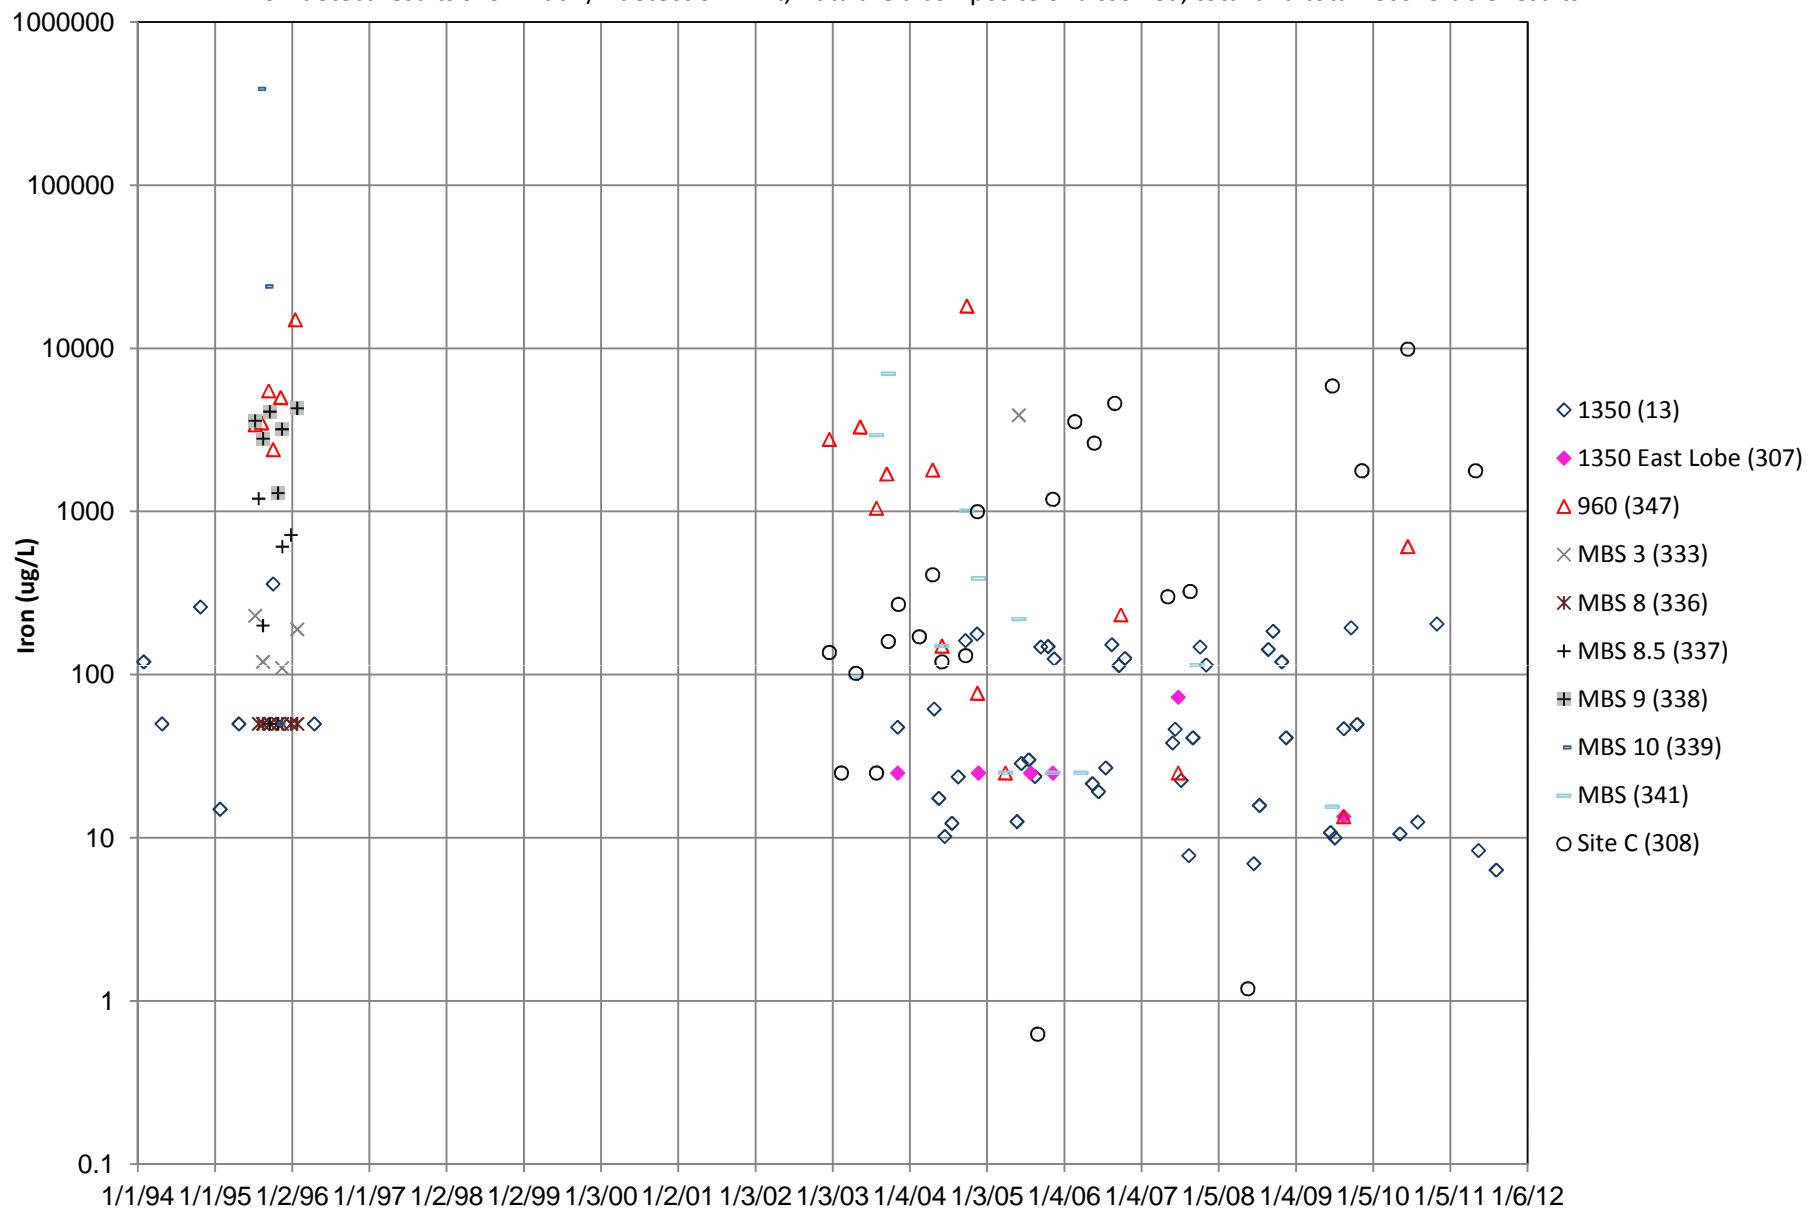
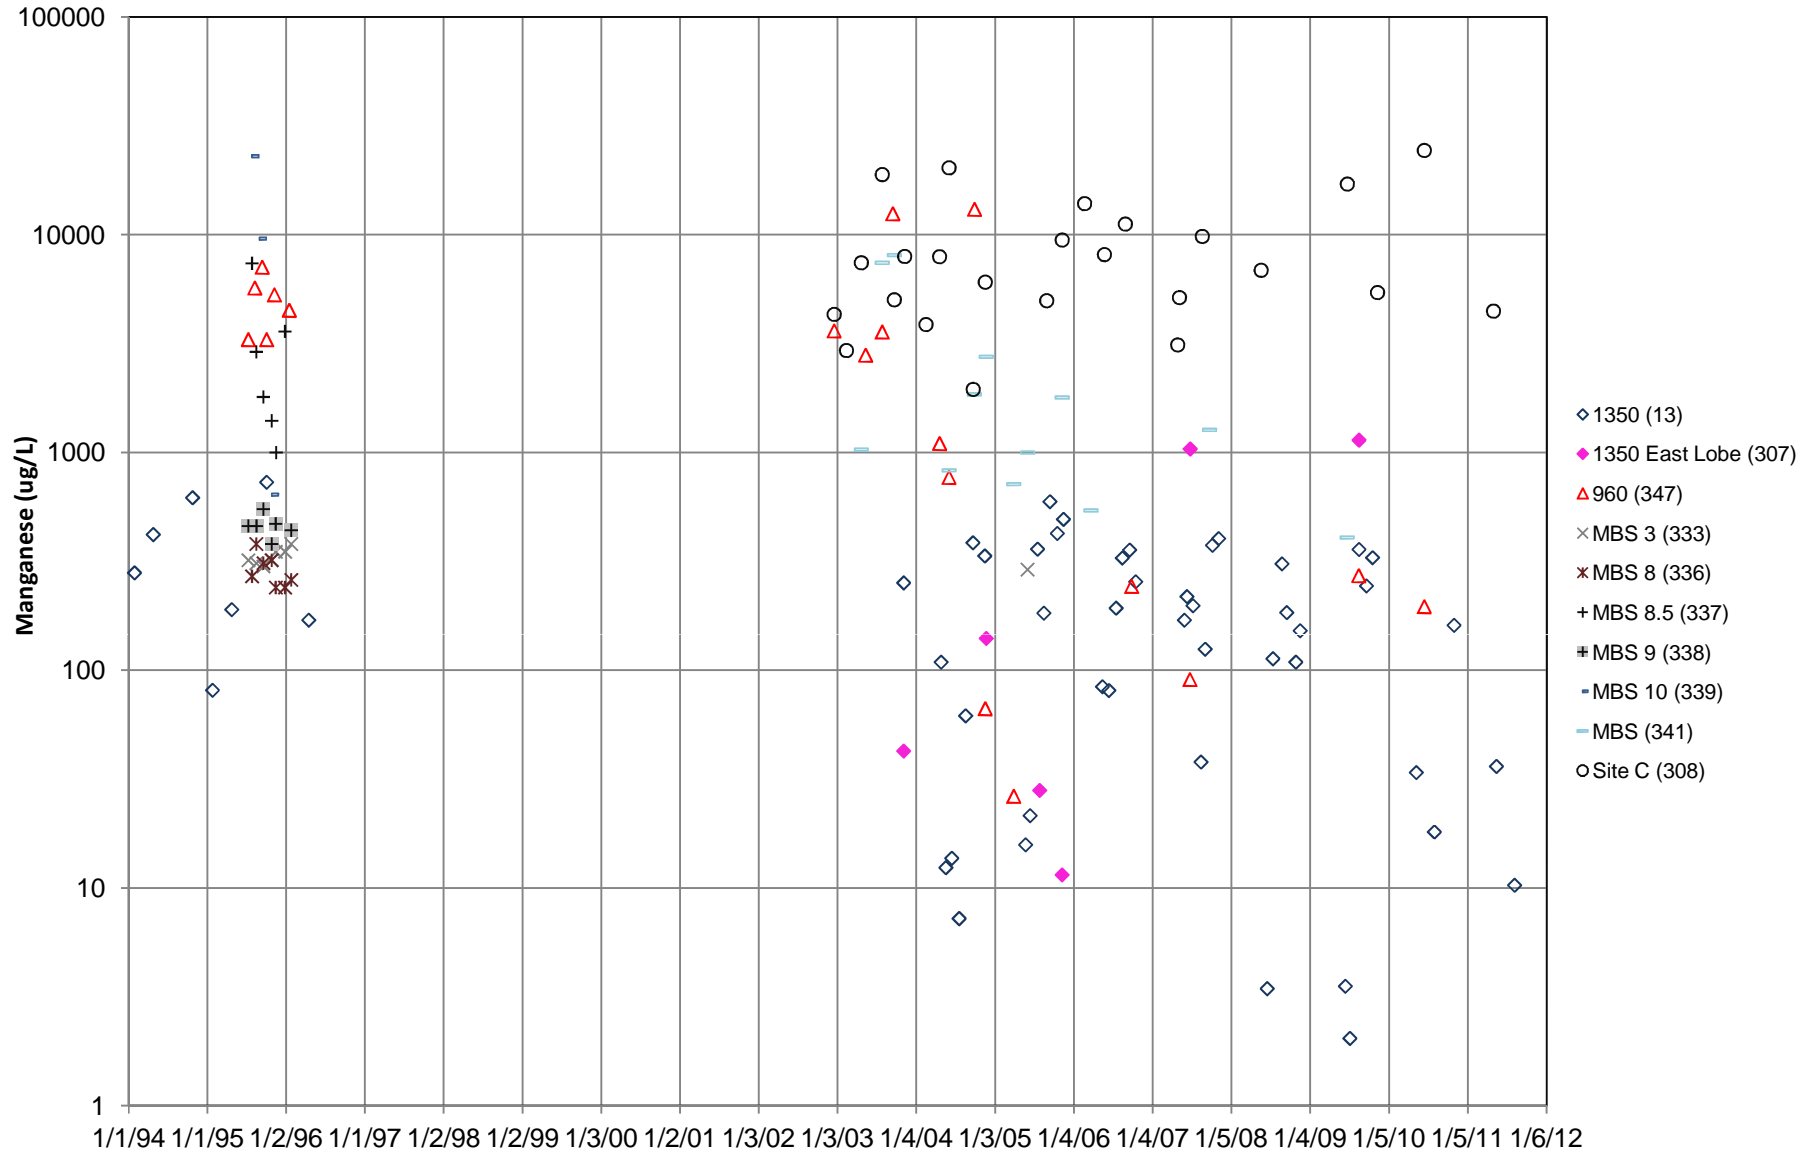
The data for zinc, copper, lead, cadmium, nickel, arsenic, iron and manganese are presented in Figures 2.12 to 2.19 and Figures 2.27 to 2.34. Sample results that were less than the detection limit are plotted at one half the detection limit value. While this allows the results to be plotted on a logarithmic scale, it causes non-detect results with high detection levels to appear more concentrated than they actually are. Detection limits have varied with time and are often evident on the graphs as horizontal groupings of symbols. The results for metals generally correlate with conductivity values. Zinc concentrations reflect the higher solubility of this element relative to the other metals at these near-neutral pH conditions. Manganese concentrations are elevated at most of the inactive sites, indicating the generation of secondary products from localized redox and buffering reactions as well as this metal's higher solubility in the prevailing pH conditions. Metal loads from inactive sites have either remained relatively constant or decreased with time. The decrease in metal loading is attributed to the reduction of reactive surface area discussed above. Site 960 showed some elevated copper, zinc and cadmium concentrations in 2004. This was likely due to the removal of production rock from the area, which exposed additional production rock materials in the base of the road, and rerouted additional water sources into the sampling area, confounding comparative water sampling with pre-removal data. Post removal Site 960 data in 2005-2011 have shown a decrease in most metal concentrations, with close to an order of magnitude decrease in cadmium, nickel, manganese and zinc.
