**INACTIVE PRODUCTION ROCK SITES AND QUARRIES
2011 ANNUAL REPORT**

Hecla Greens Creek Mining Company

April 15, 2012

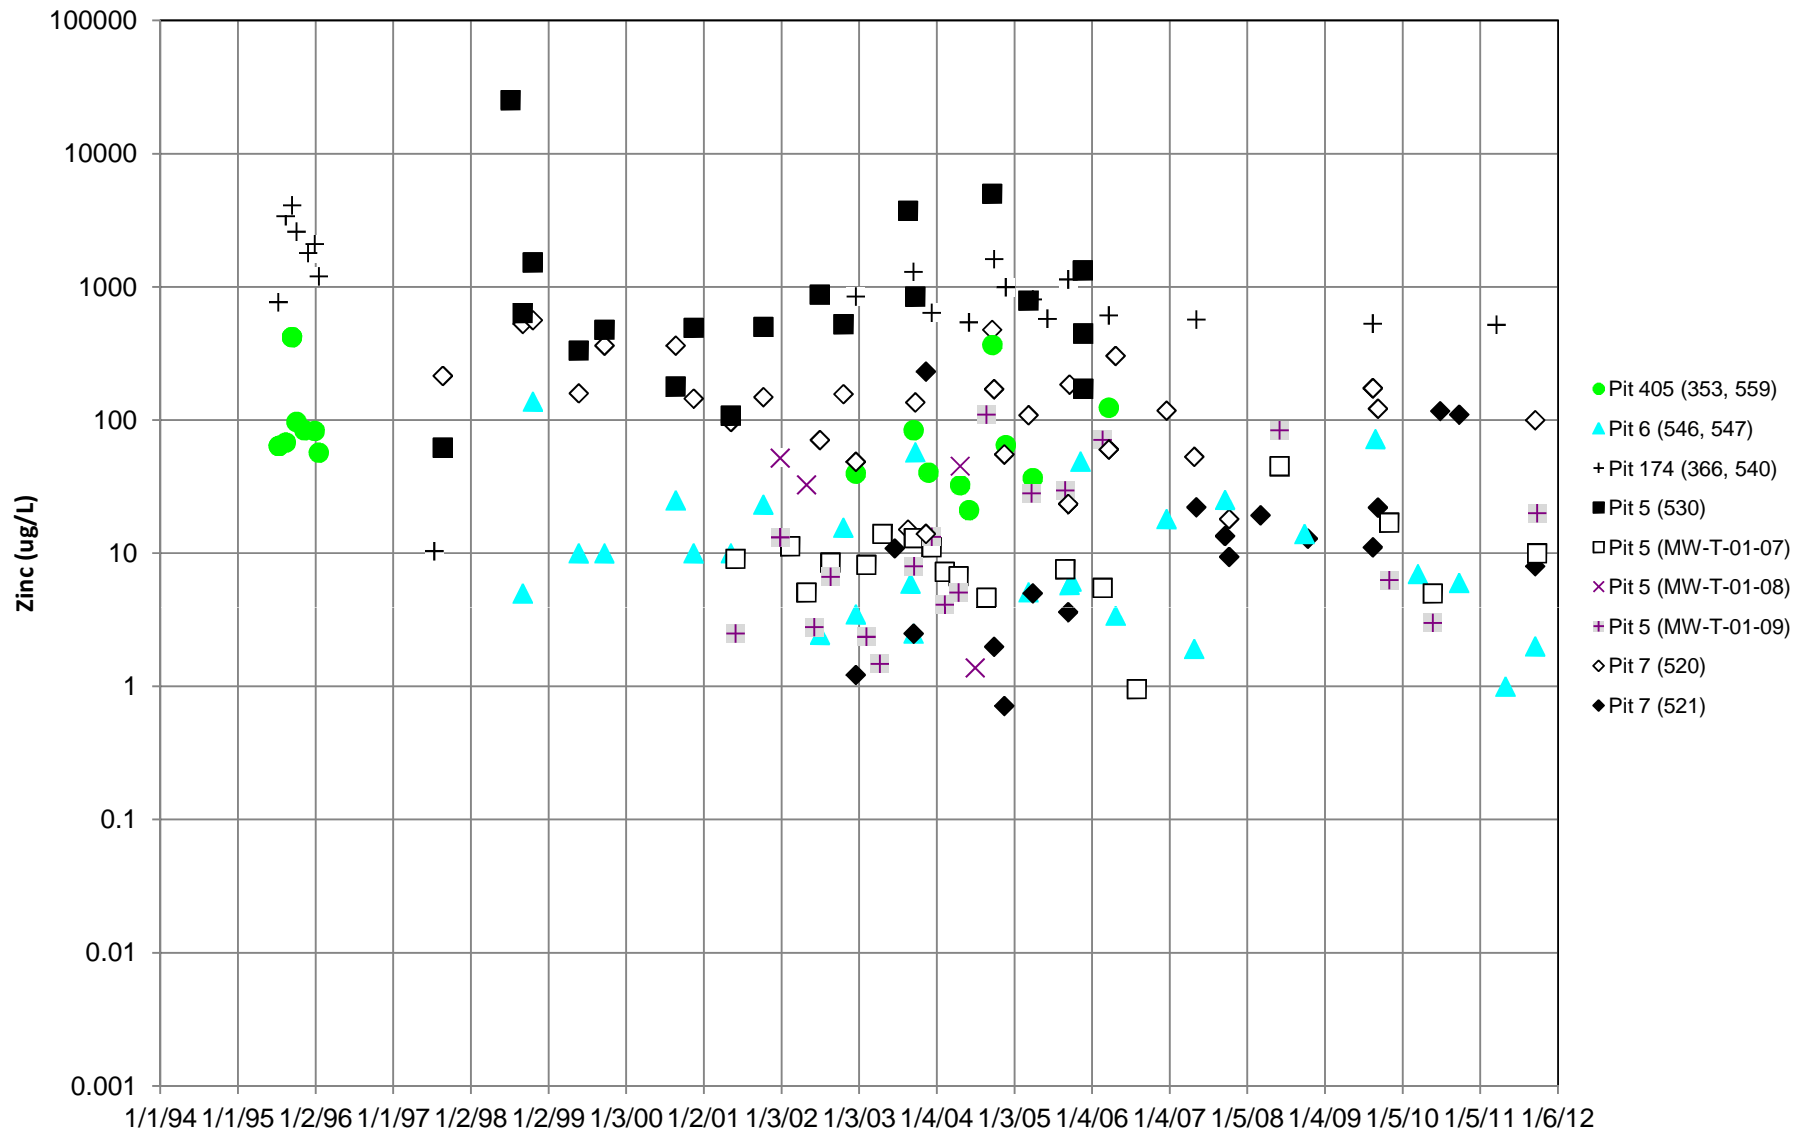
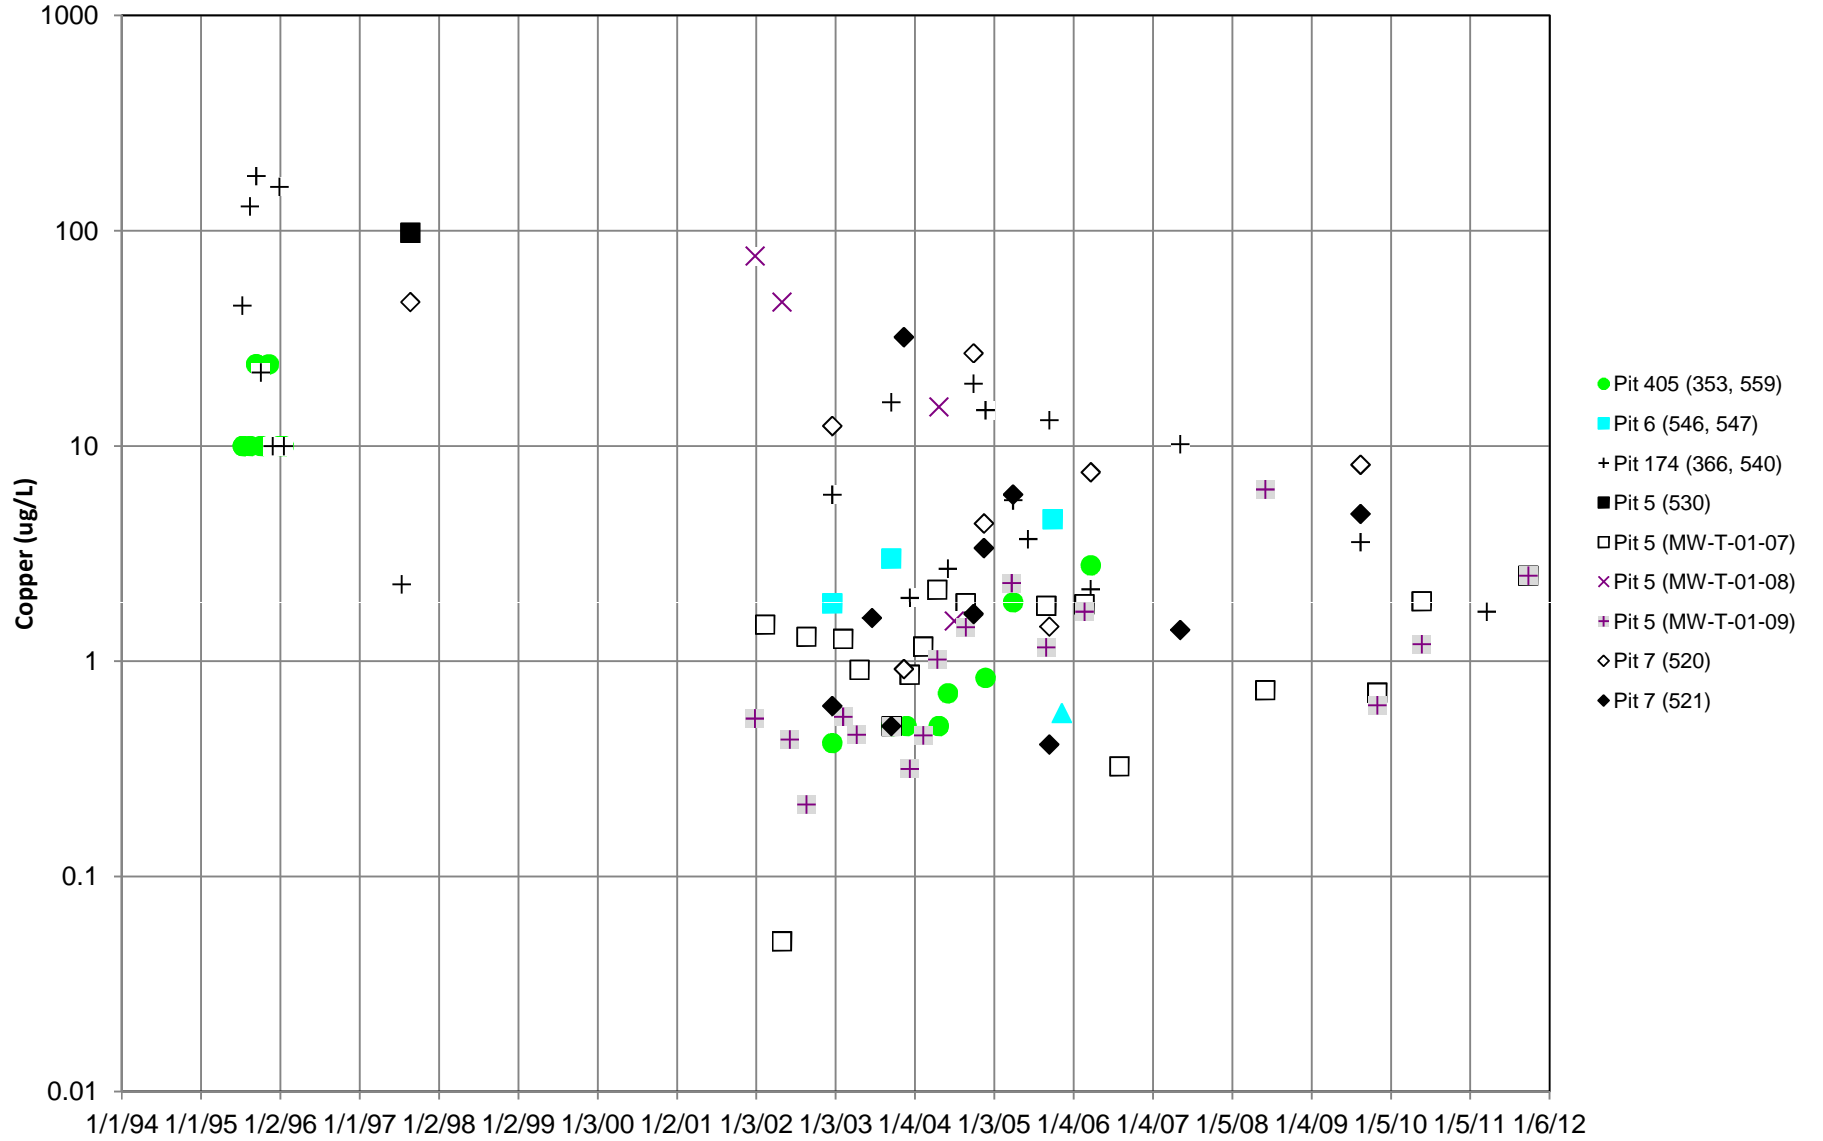
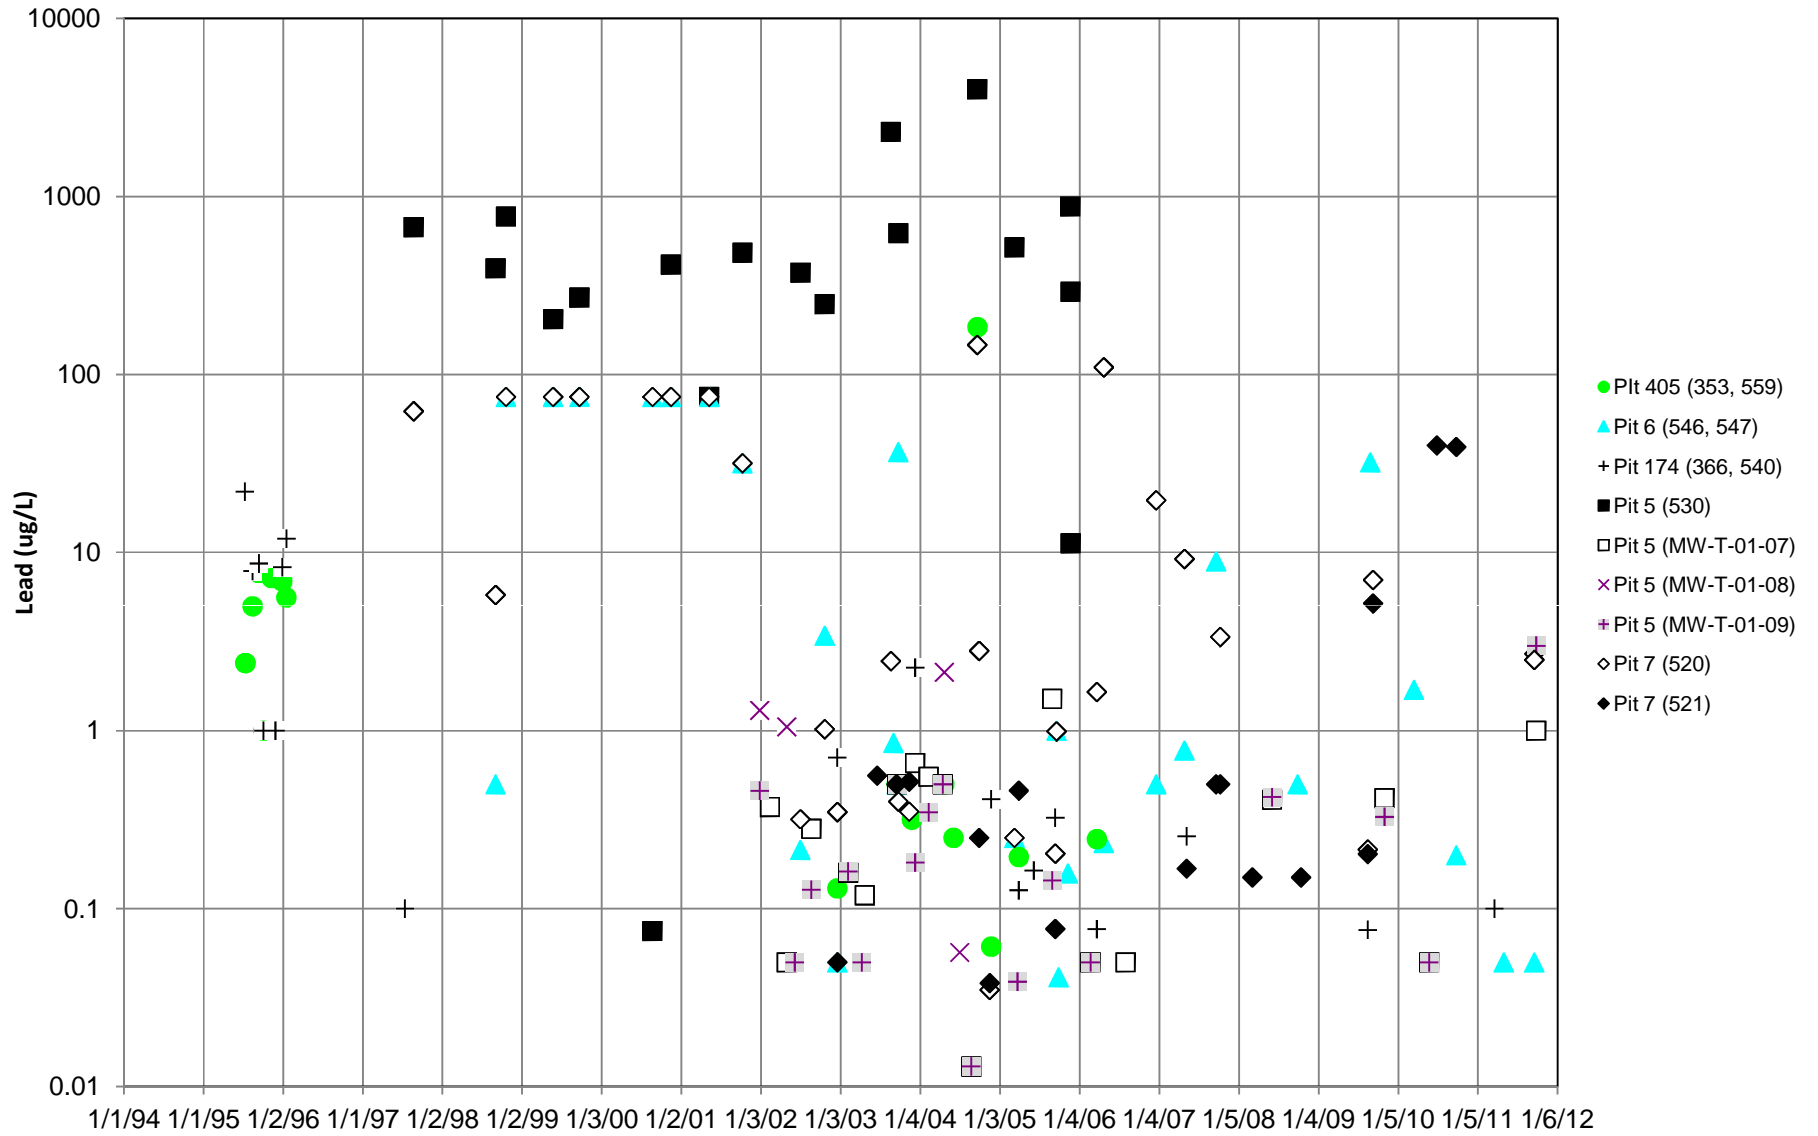
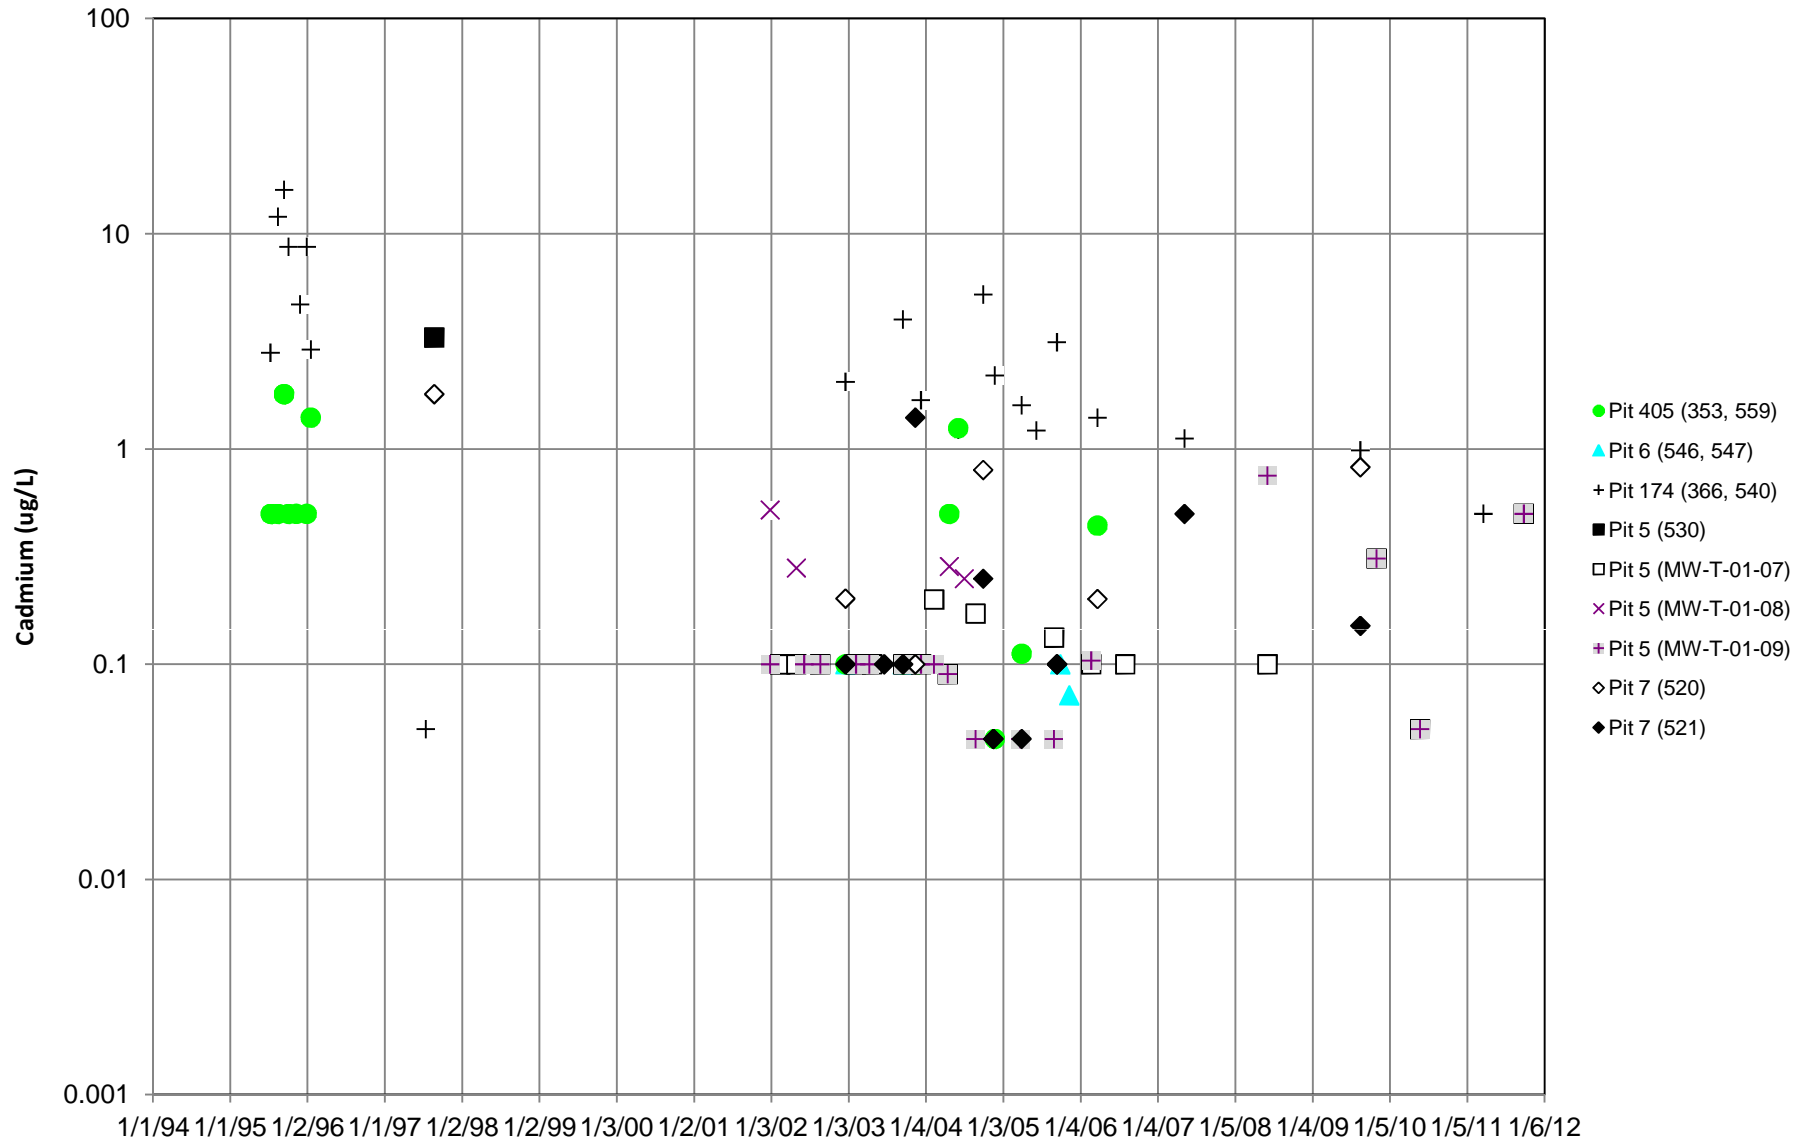
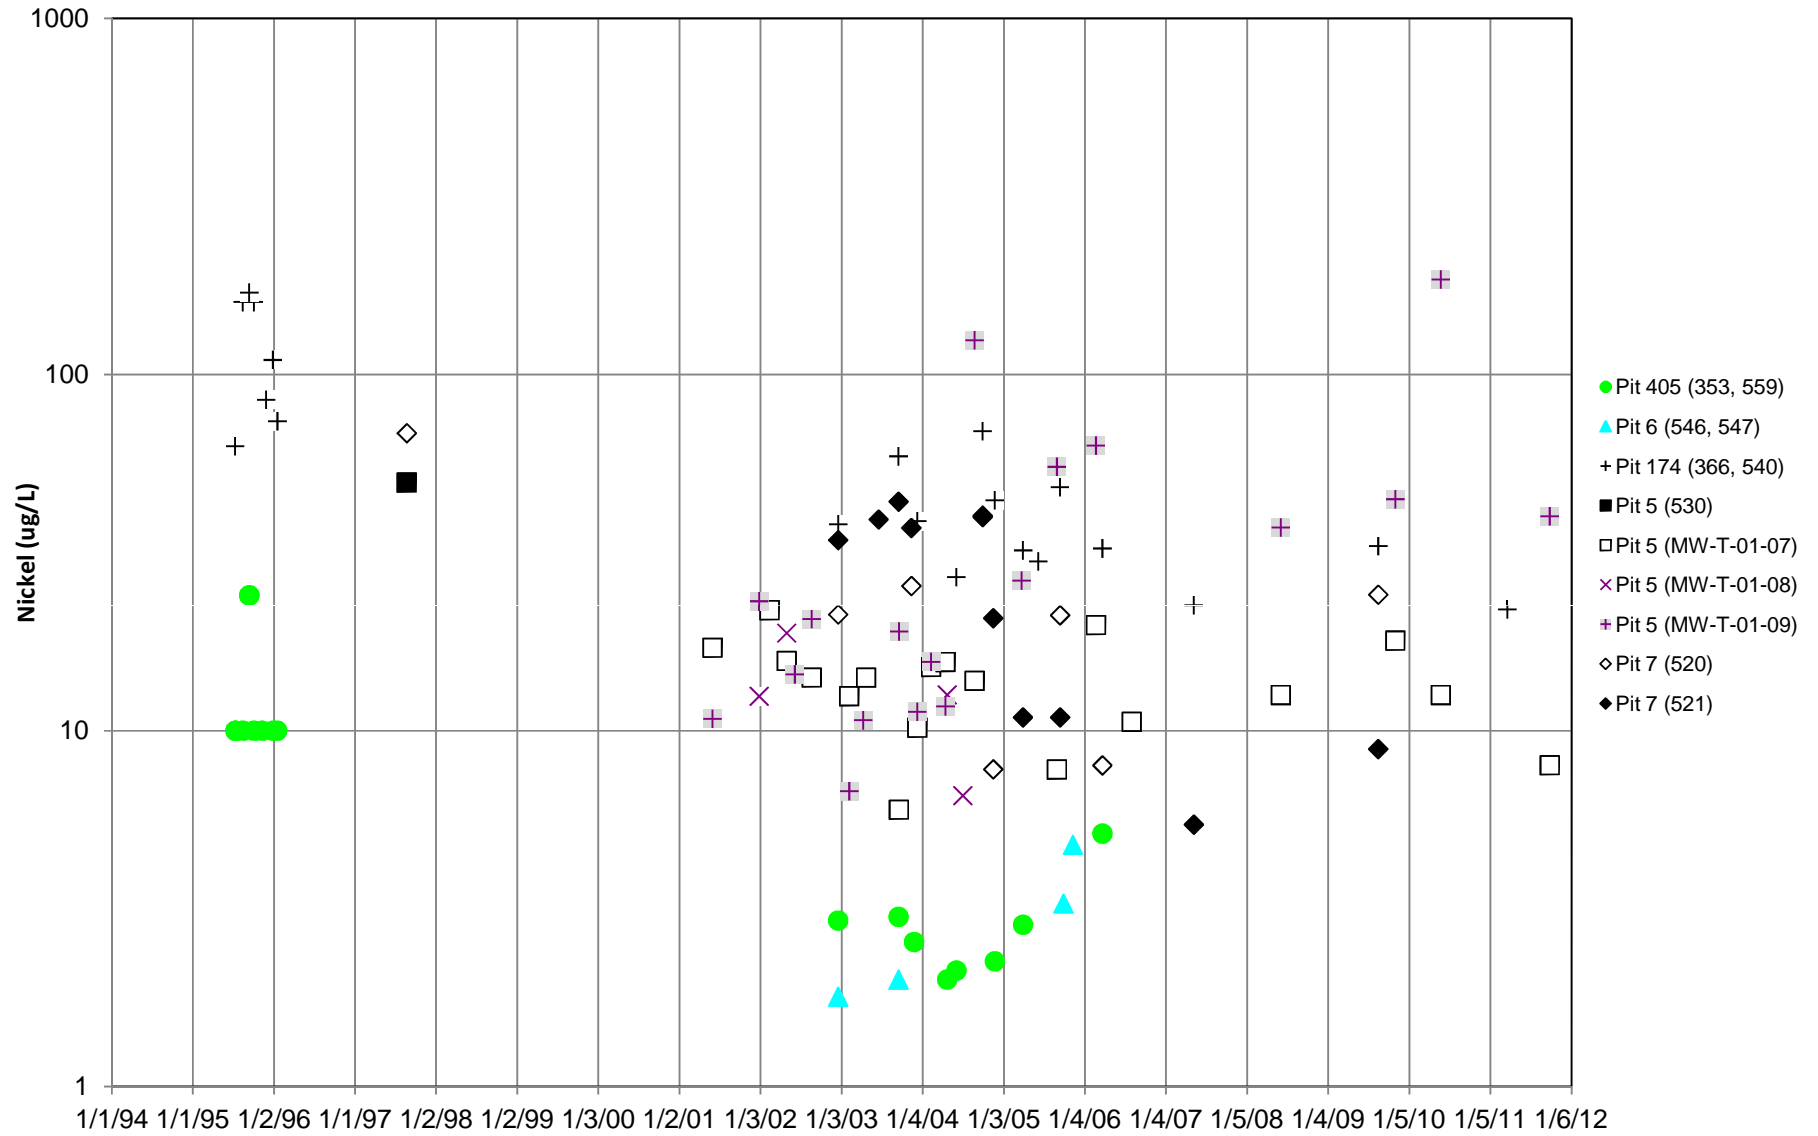
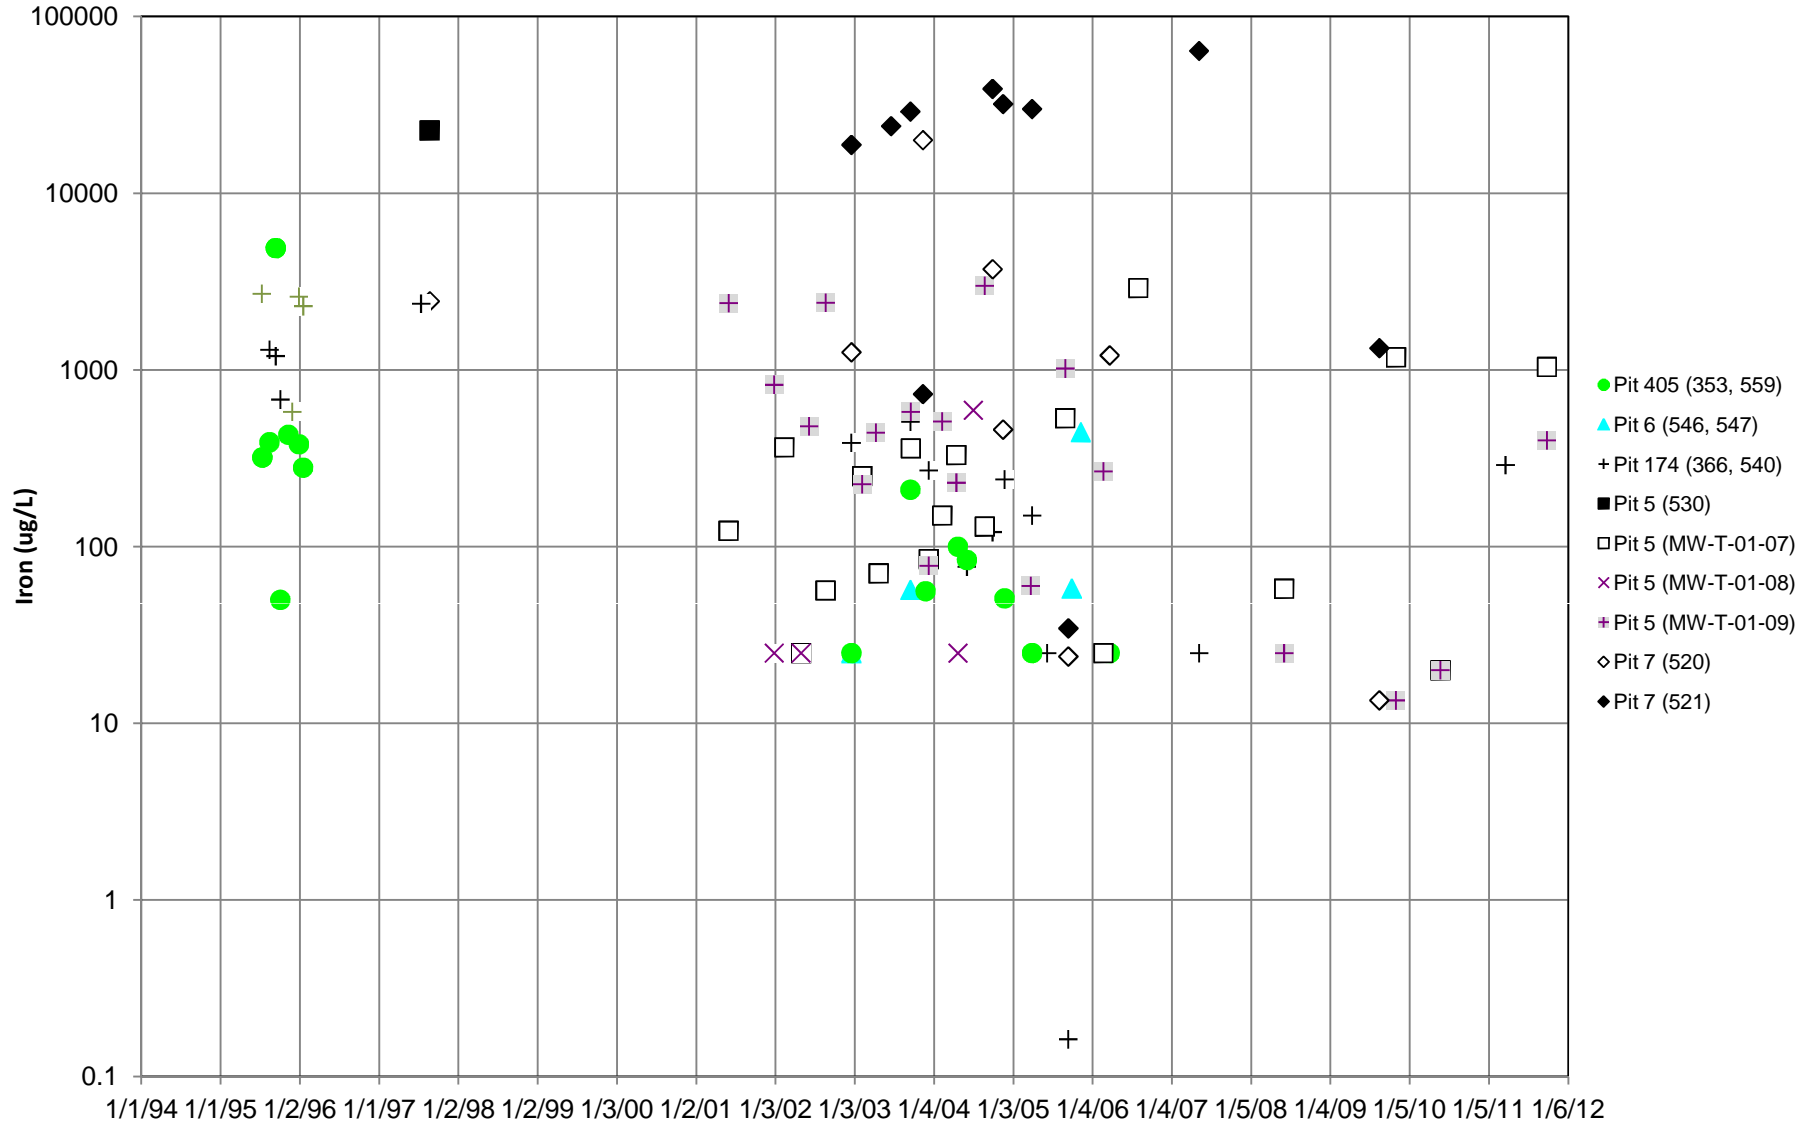
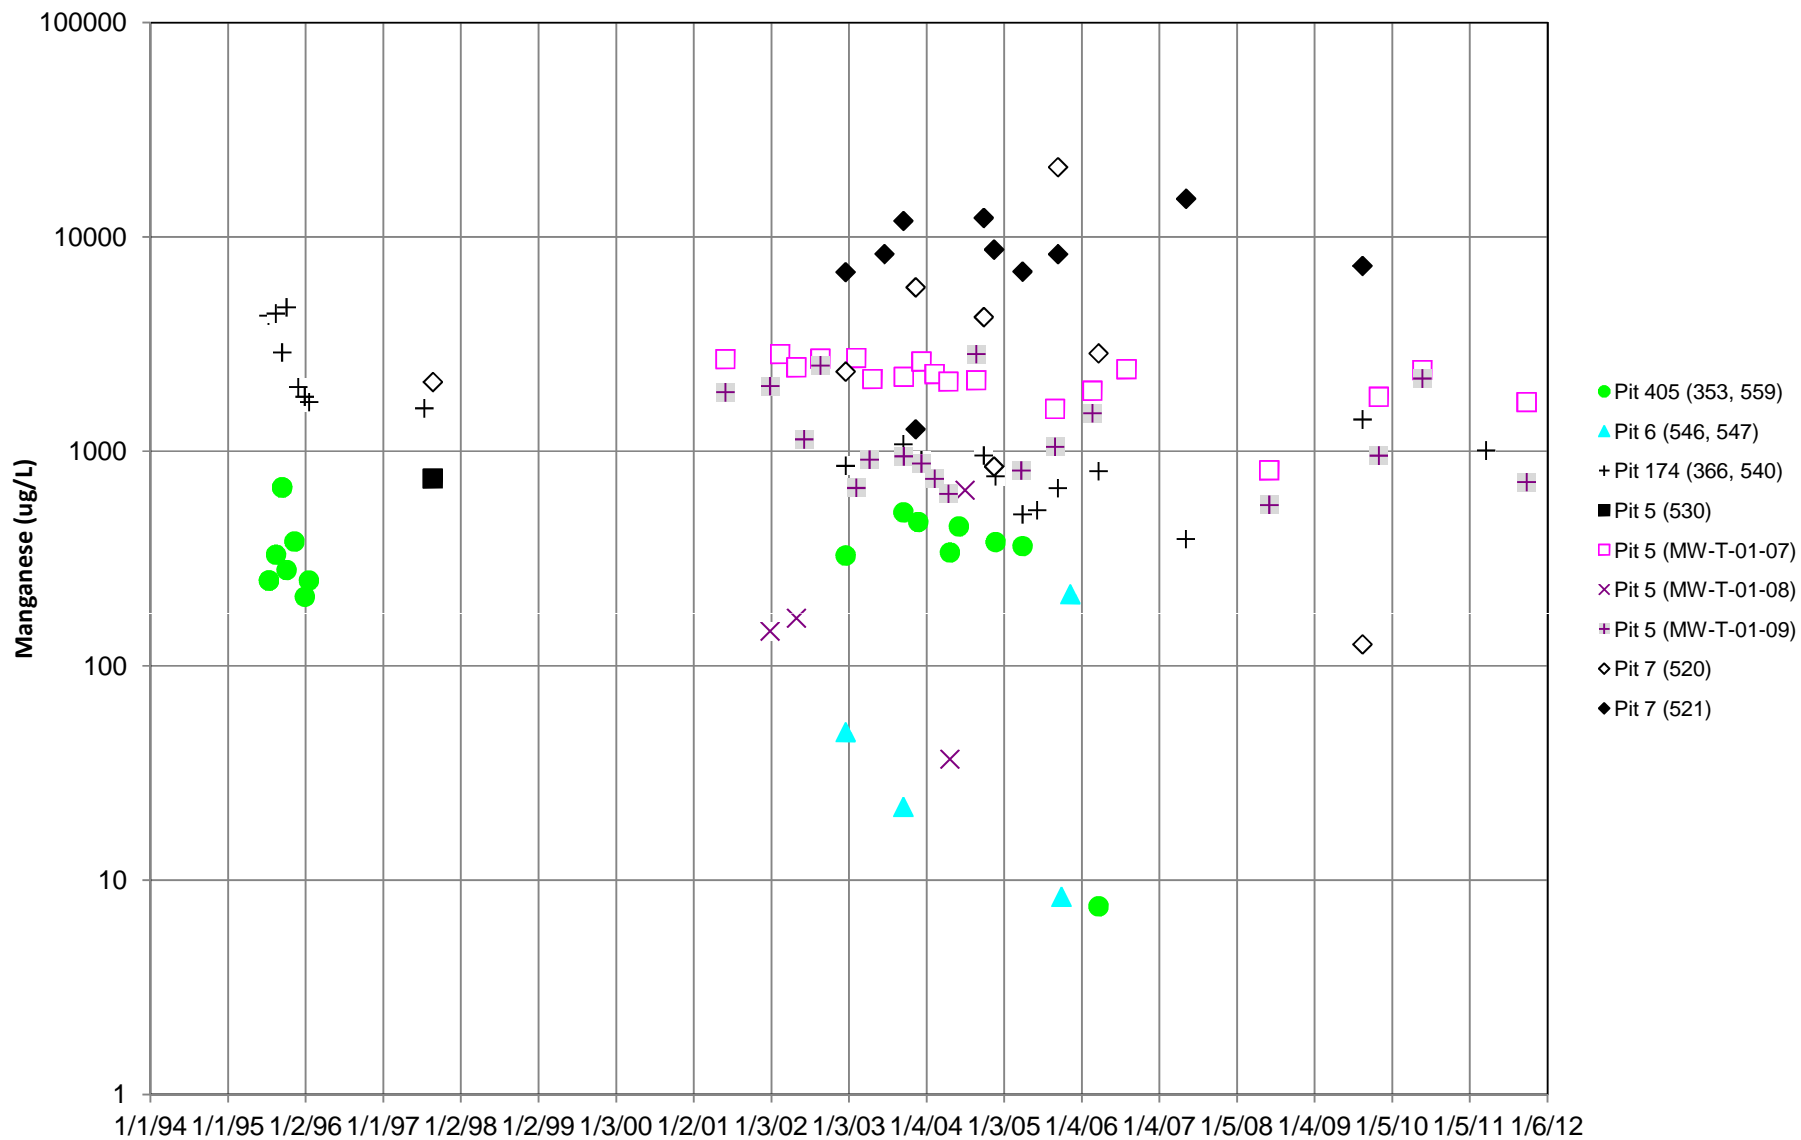
The data for zinc, copper, lead, cadmium, nickel, arsenic, iron and manganese are presented in Figures 3.8 to 3.15. Sample results that were less than the detection limit are plotted at one half the detection limit value. While this allows the results to be plotted on a logarithmic scale, it causes non-detect results with high detection levels to appear more concentrated than they actually are. Detection limits have varied with time and are often evident on the graphs as horizontal groupings of symbols. The results for metals generally correlate with conductivity values. Zinc and manganese concentrations reflect the higher solubility of these elements relative to the others at the near-neutral pH conditions. Dissolved metal loads from quarry sites have been consistently low and either remained fairly constant or decreased with time. The decrease in dissolved metal loading is attributed to a reduction of reactive surfaces as reactants are consumed and coatings form on mineral surfaces. Elevated total metal concentrations occur periodically in response to increased suspended solids during storm events. The storm water monitoring data are presented to provide a general indication of the effects of sediment loading, typically from road surfaces, and do not reflect dissolved loading from the quarry walls.

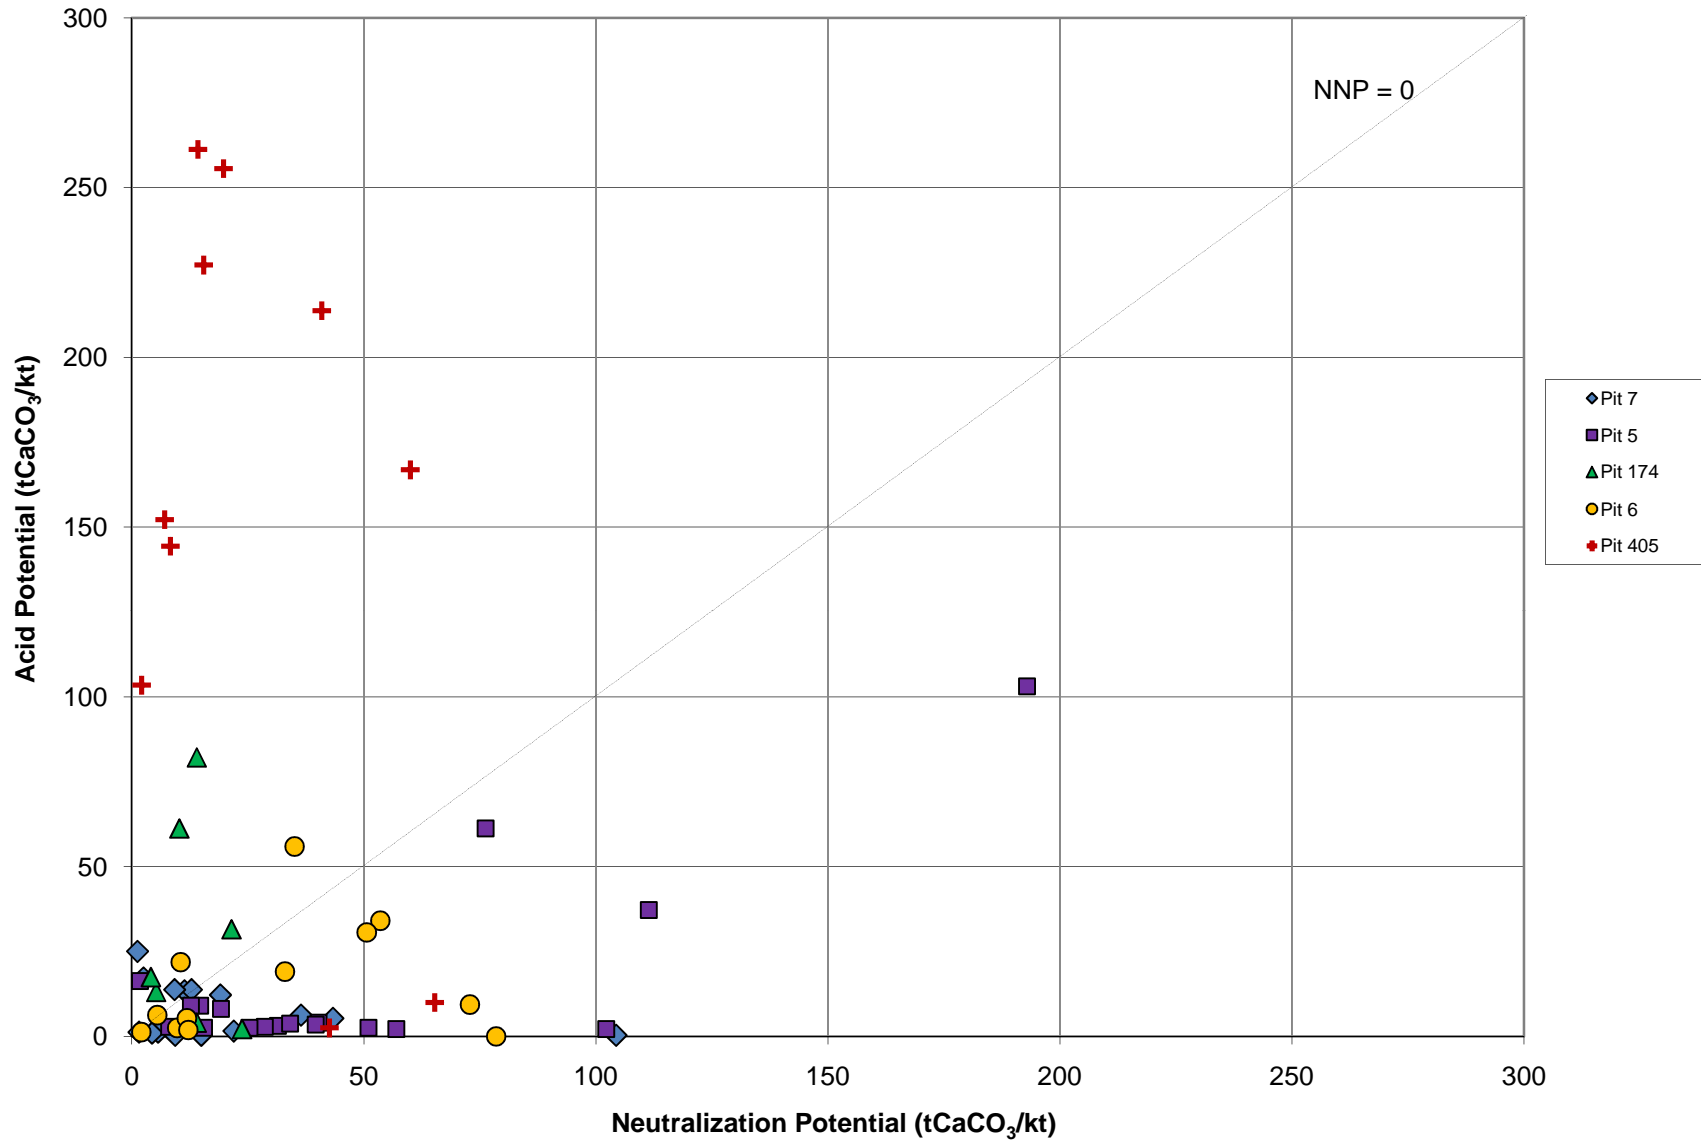
FIGURE 3.16a 2002-2008 QUARRY SITE ABA DATA

Acid Base Accounting data collected from 2002 to 2008 are summarized in Figures 3.16a and 3.16b. Pit 405 and Pit 174 have significant exposures of potentially acid generating rock and produced several samples with acidic rinse pH. Pit 6 and Pit 7 produced samples showing a broad distribution of NNP and rinse pH, and Pit 5 generally produced acid neutralizing samples with alkaline rinse pH. Buildup of oxidation products (salts) on overhanging quarry walls was noted at each of the five quarry sites and may have contributed to the lower rinse pH readings for several samples.
