Inspection Report: Hecla Greens Creek Mine

Date of Inspection: Tuesday, November 12, 2013
Date of Report: Monday, November 25, 2013
USDA Forest Service Inspector: David Schmerge

Ranger District: Admiralty National Monument, Juneau Ranger District
Weather Conditions: Cloudy, temperature in the 30s.

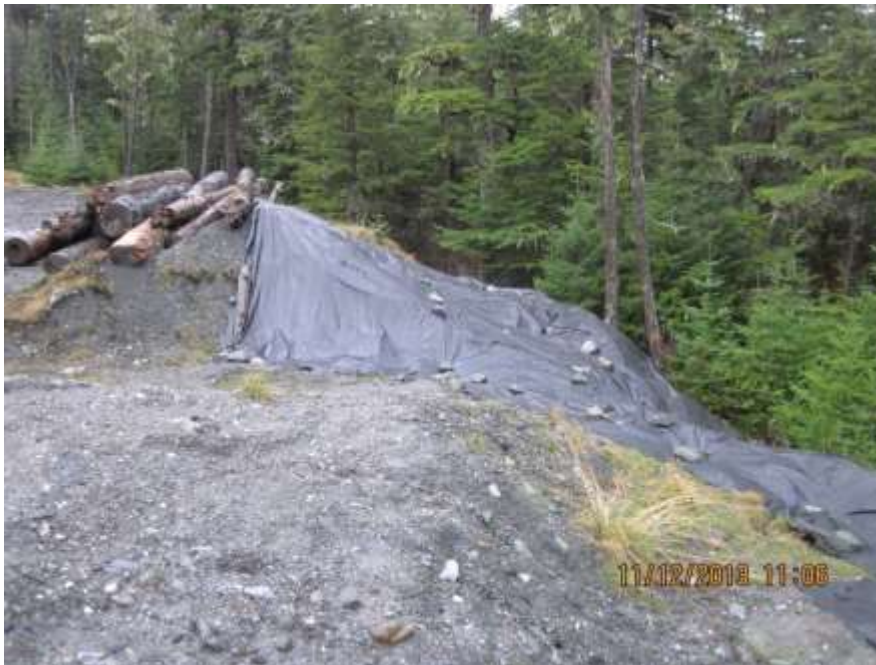
Canada thistle is an invasive plant that was found at Pit 7 last year. Hecla has been attempting to eradicate it by pulling the plants by hand. Recently, the area was covered with tarps in an effort to prevent further growth (photo 01). Invasive plants are not discussed in the Plan of Operations, but the 2013 Greens Creek Mine Tailings Disposal Facility Expansion Final Environmental Impact Statement (section 3.10.3.1) requires the removal of existing invasive plant populations.

Photo 01. The disturbed area at pit 7 where Canada Thistle has been recently found is being covered to prevent growth of the plants.

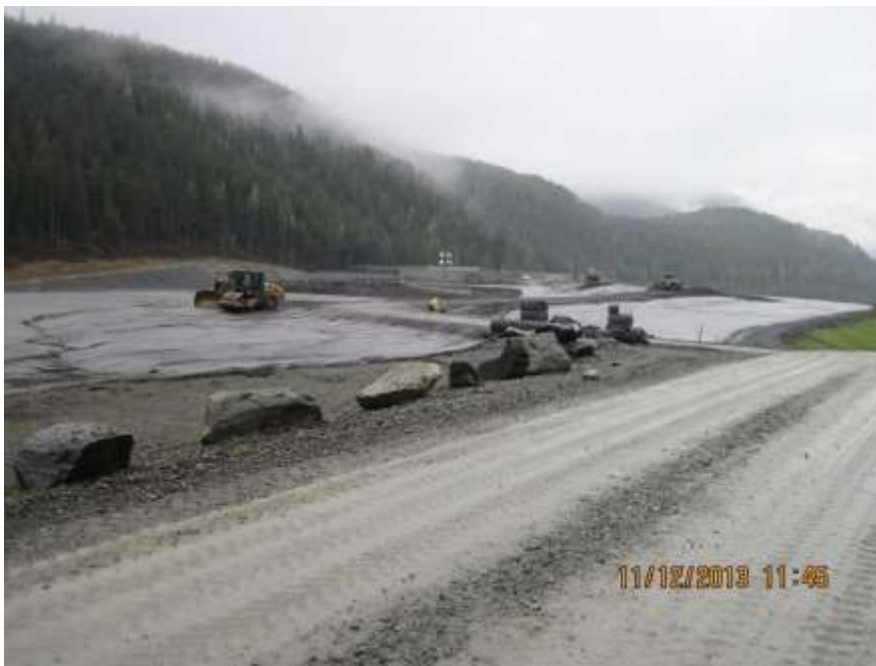
Photo 02. Tailings were being placed in the northwest expansion area on the day of our visit.

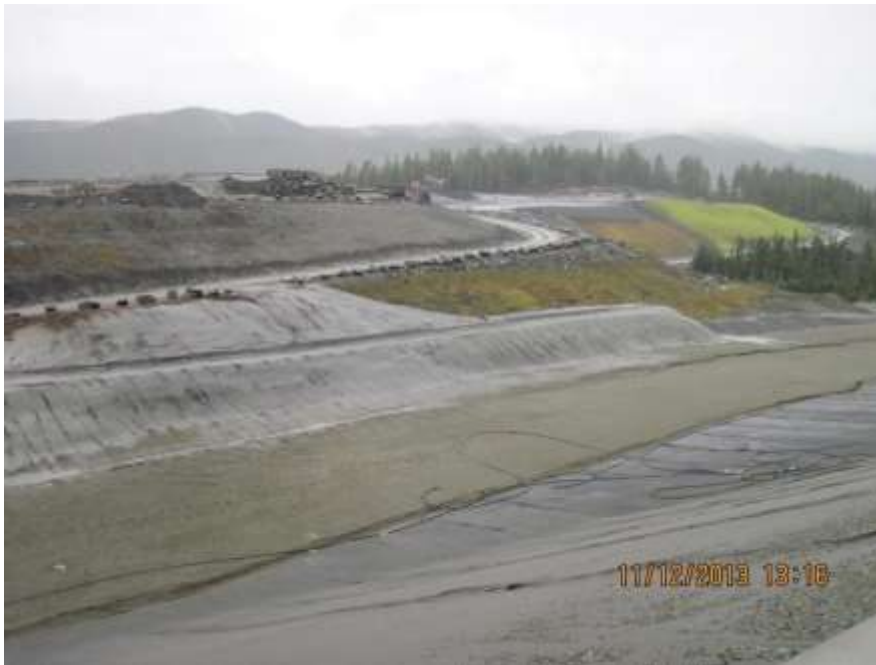
Photo 03. Tailings recently began being placed in the east ridge expansion area for the first time.

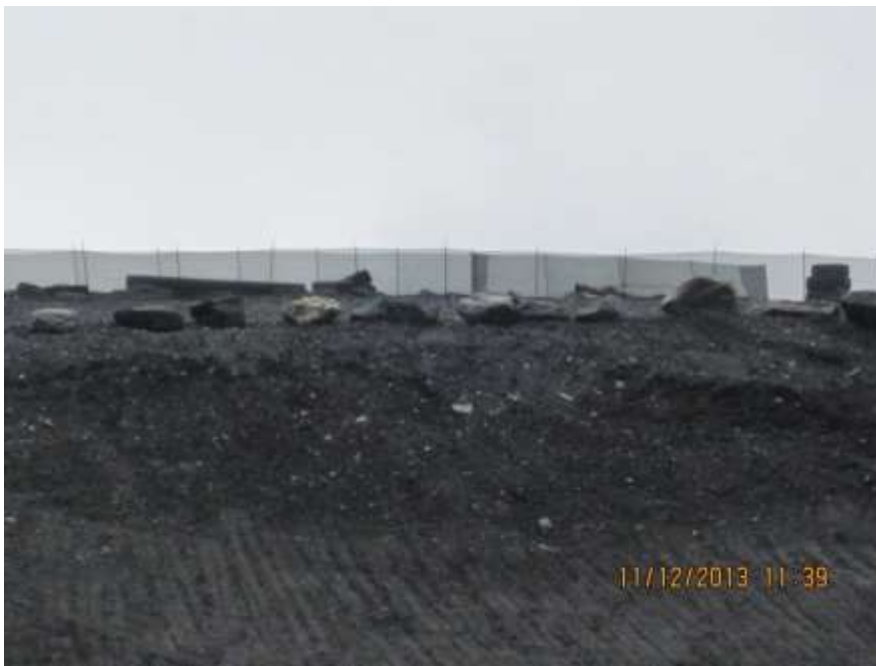
Photo 04. This snow fence is installed on the crest of the tailings pile during the winter months to reduce dust loss.

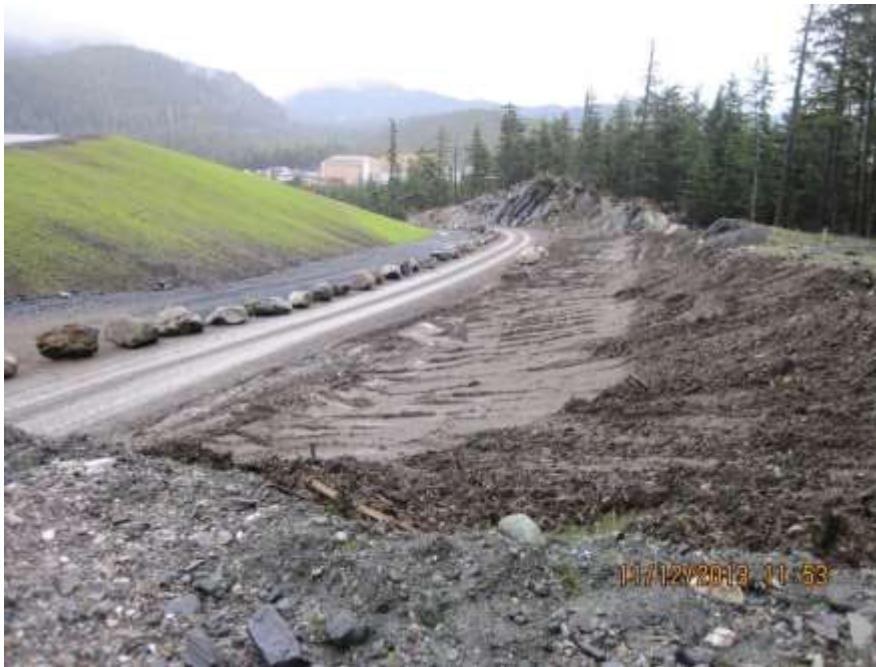
Photo 05. In October, till was placed to seal the west buttress quarry site at the tailings facility.

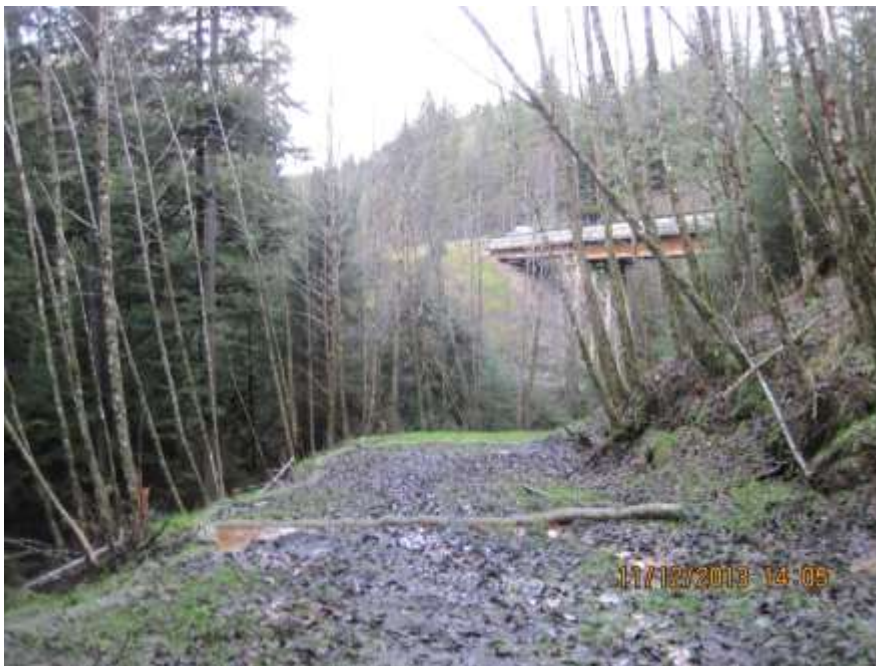
Stormwater runoff on the south side of the bridge was much reduced since the last inspection in September (photo 06).

Photo 06. Stormwater runoff on the south side of Zinc Creek Bridge has been greatly reduced since our last visit in September.

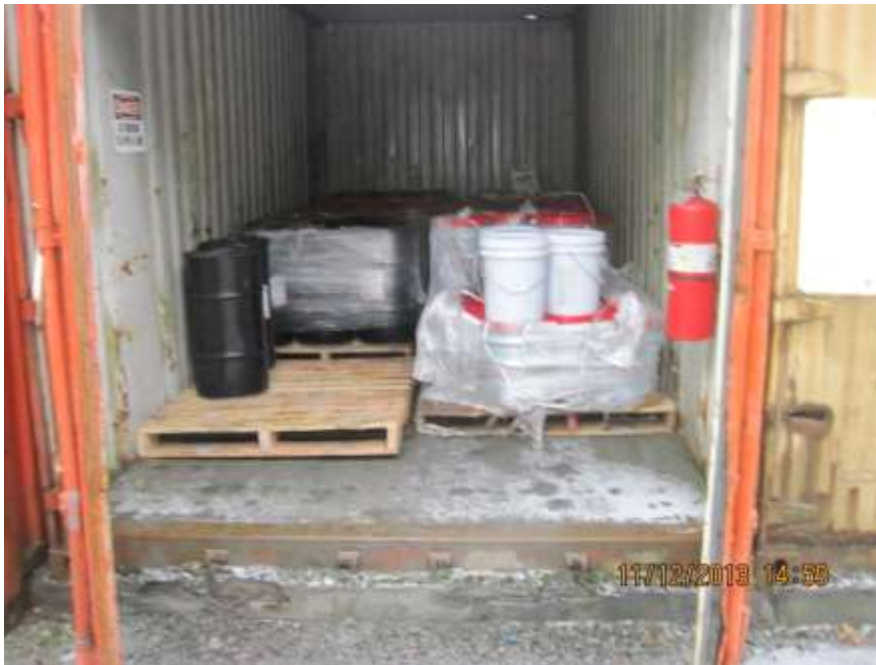
At the warehouse storage area at the mill, petroleum products are stored in several sea vans. A sea van without secondary containment is storing vehicle grease (photo 07). Another sea van with secondary containment is storing antifreeze, transmission fluid, diesel exhaust fluid, and drive train oil (photo 08). These sea vans are not on a concrete surface.

Photo 07. This sea van at the warehouse storage area at the mill is storing petroleum products (grease) without secondary containment. Also, the sea van is not on a concrete surface that drains to Pond A.

All chemicals and oil stored at the 920 Area must be in areas that drain across concrete surfaces to the lined containment ditch which flows to Pond A as required by the BMP Plan (Appendix 5 of the Plan of Operations) and the Spill Prevention Control and Countermeasure (SPCC) Plan (Appendix 6 of the Plan of Operations). Section 4.3.1 of the BMP Plan states that areas where chemicals are stored drain across concrete surfaces to the lined containment ditch which flows to Pond A, and section 4.1 (Hazardous Substance and Toxic Materials Inventory) of the BMP Plan states that oil is also subject to the requirements of the BMP program. Oil includes "oil of any kind or in any form, including but not limited to, petroleum, fuel oil, sludge, oil refuse, and oil mixed with wastes other than dredged spoil." The SPCC Plan indicates in table 1 that the oil storage locations at the 920 area are contained by the site runoff collection system (concrete surfaces that drain to Pond A). I spoke with Chris Wallace (Hecla, Environmental Manager) and he said that within a week he would submit an update to the BMP plan for the storage of reagents and hydrocarbons at the 920 area. The updated plan will have to be approved by the Forest Service.

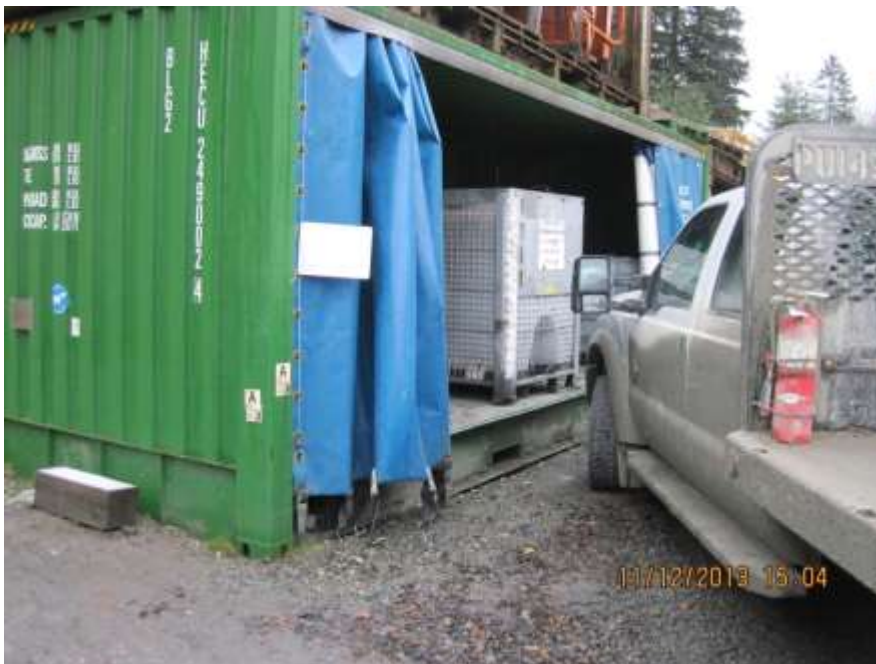
Photo 08. This sea van at the warehouse storage area at the mill has built in secondary containment. It stores vehicle fluids including antifreeze, transmission fluid, diesel exhaust fluid, and drivetrain oil.

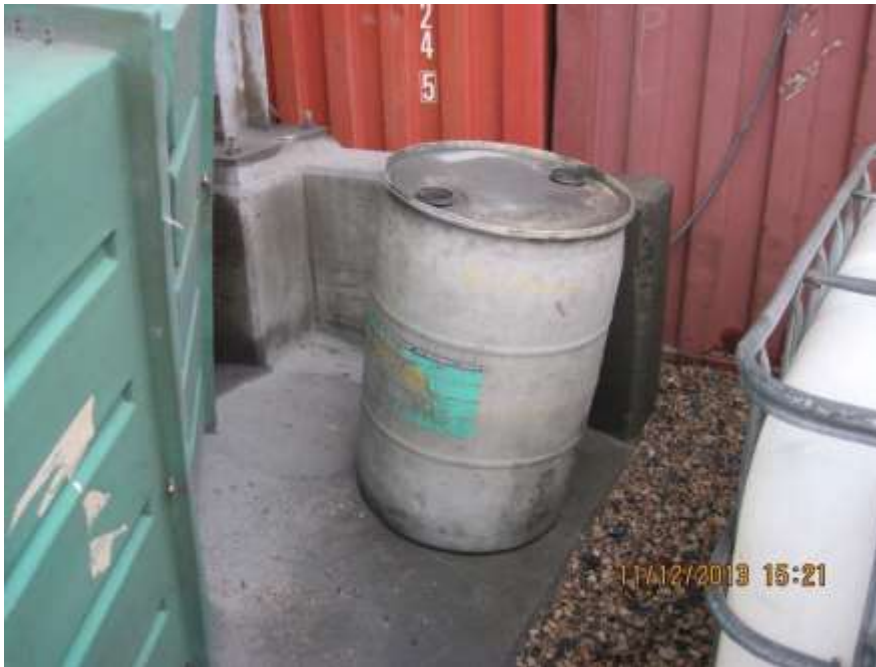
At the powerhouse, we found two 55 gallon drums stored outside of secondary containment (photos 09 and 10); one was antifreeze and the other was fuel/water. The drum of antifreeze did not have a lid. Both drums were immediately moved and placed in secondary containment.

Photo 09. This drum of antifreeze at the powerhouse did not have a lid, and was stored outside of secondary containment.

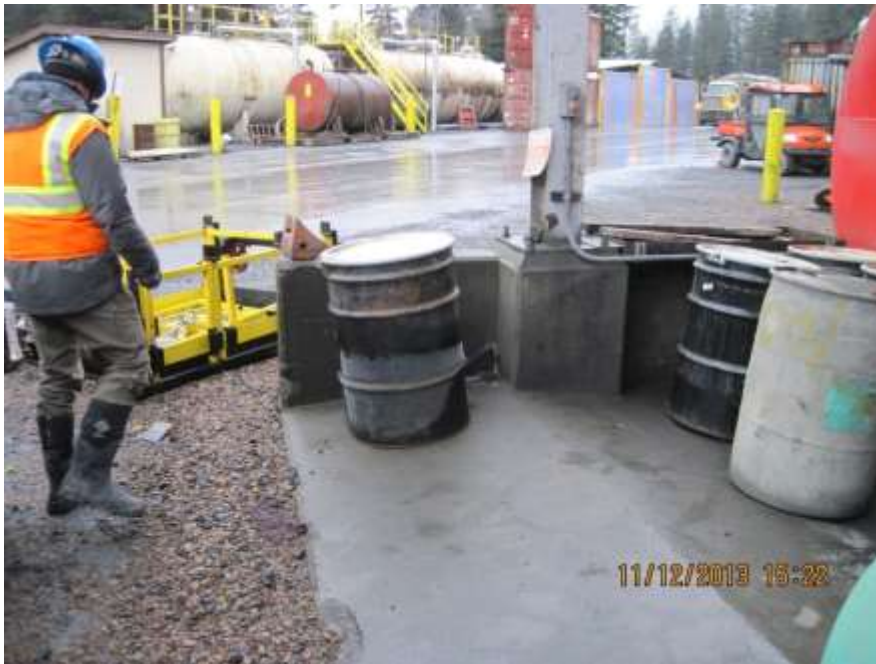
Photo 10. This drum of fuel waste was stored at the powerhouse without secondary containment.

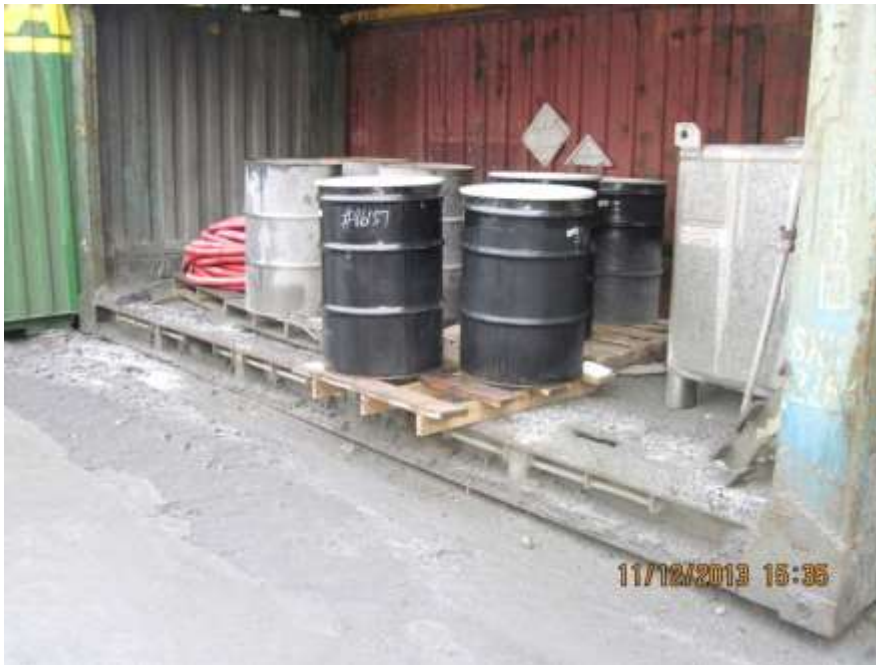
At the Used Petrol Conex, we found several drums and a tote of used coolant and rock drill oil (photo 11). Several of the drums did not have lids, and the conex is not on a concrete surface. All of the containers were moved immediately (photo 12) to a sea van that is on a concrete surface that drains to Pond A (photo 13).

Photo 11. Several drums and a tote of used petroleum products were stored at the Used Petrol Conex. There is no secondary containment and the conex is not on concrete that drains to Pond A.

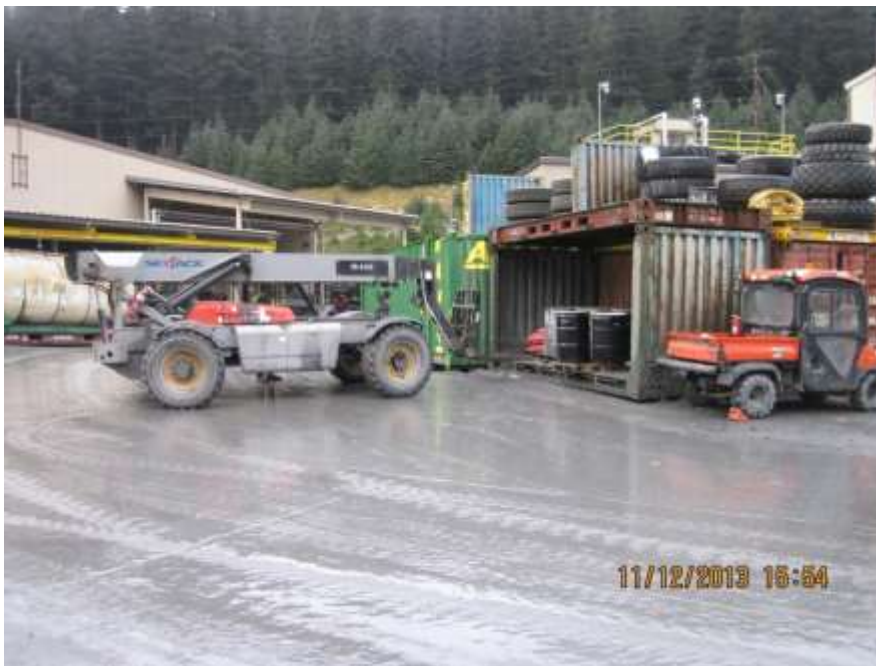
Photo 12. The drums and tote of used oil products were immediately moved.

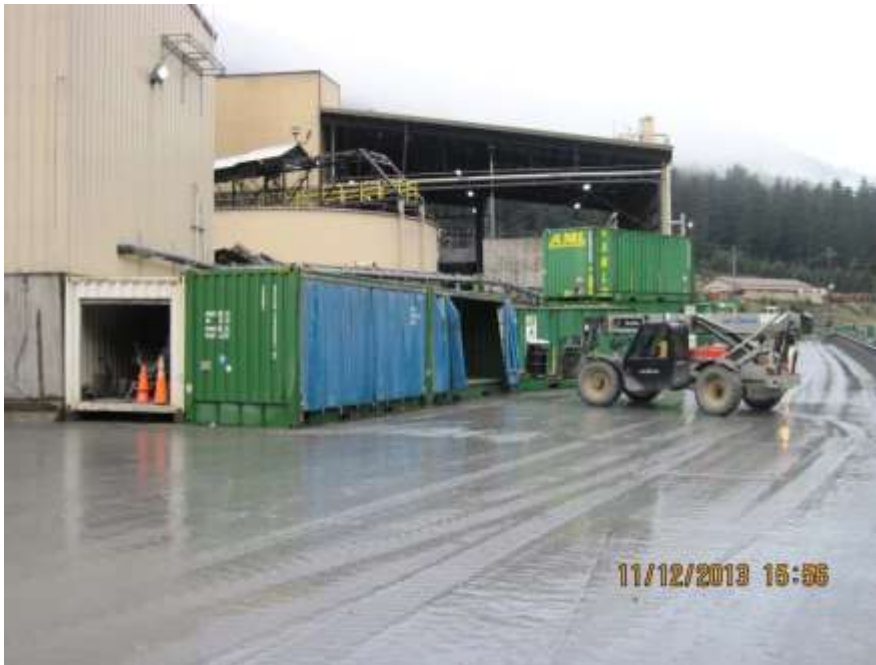
Photo 13. The drums and tote of used oil products were temporarily placed in this sea van. The sea van is on a concrete surface that drains to Pond A.
