RE: APDES Permit Number AK-004320-6  
2014 Annual BMP and Storm Water Monitoring Report

Attached please find the Hecla Greens Creek Mining Company (HGCMC) Annual Best Management Practices and Storm Water Monitoring Report for year 2014 activities.

This 2014 Best Management Practices (BMP) and Storm Water Report is submitted by Hecla Greens Creek Mining Company (HGCMC) pursuant to Sections II.F.1 and II.F.2 of APDES Permit AK-004320-6, effective 1 July 2005. Authority over the federal permitting, compliance and enforcement NPDES program transferred to the Alaska Department of Environmental Conservation (ADEC) in November of 2010 for the mining industry. This report summarizes the scope and dates of the comprehensive site compliance inspections/evaluations, major observations related to implementation of the BMP plan, corrective actions taken as a result of the inspections/evaluations, identification of potential incidents of noncompliance as they pertain to the BMP plan, description of the quantity and quality of the storm water discharged, and BMP plan modifications made during the year. The final section of this report contains the required annual certification under Section II.

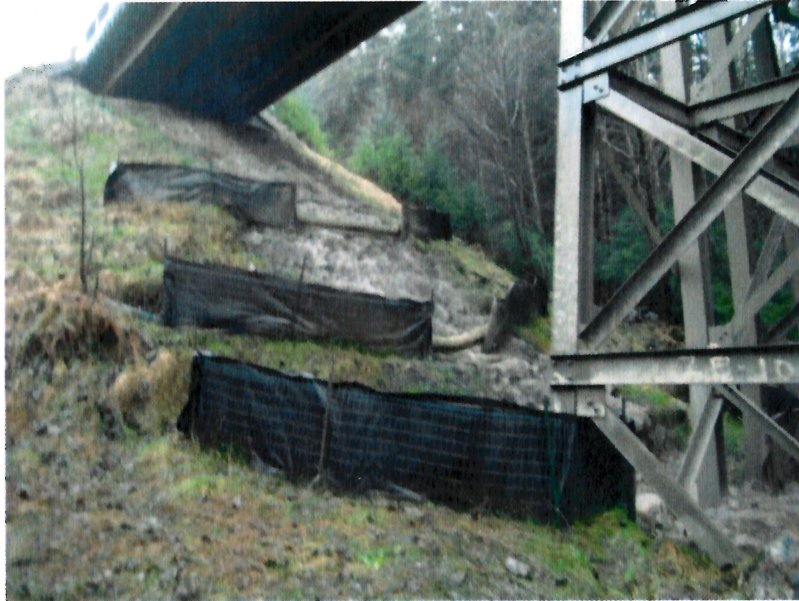
- Major sediment was observed under the Zinc Creek Bridge.
- Silt fences were installed (in a staggered position) but were not effective in controlling the sediment. The staggering of the silt fences was discussed with onsite representatives. It was said that the staggering was an experiment due to bears are constantly destroying the BMPs HGCMC staff put in place.
- Straw wattles were in place near the creek but were filled beyond their effective capacity with sediment.

PHOTO 1. Northern bridge abutment BMPs (24 November 2014). The fencing seen in this photograph was designed to funnel sediment to a sump at the base of the slope and is operating as intended. A portion of the sump can be seen behind the base of the tower.

Within two weeks of receiving the Notice of Violation HGCMC as requested, submitted photographic evidence, that the stormwater Best Management Practices under the Zinc Creek bridge had the necessary maintenance performed. Maintenance of the BMPs began on 18 November 2014 and was completed within a week. In a follow up email from the ADEC it was stated that ‘ADEC considers this matter closed.’

In 2014 accumulated sediment was cleared from underneath the bridge, existing BMPs were maintained, and additional silt fences and straw wattles were installed. These BMPs are routinely damaged by bears, HGCMC is investigating other practices for controlling sediment in the area that are bear 'resistant'.

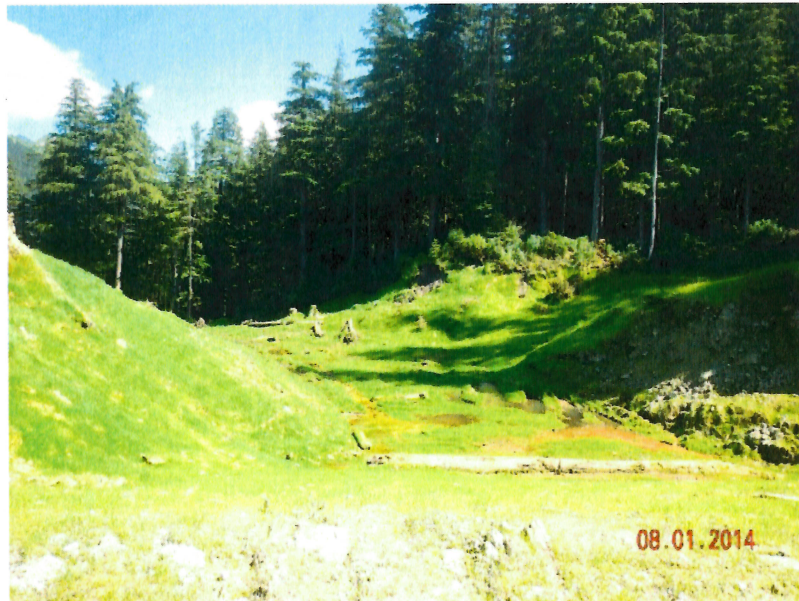
Approximately 11,231 cubic yards of material was removed from the 1350 site in 2014. This material was hauled to the temporary, lined, reclamation storage pad (RSP) at Site 23. Excavation and haul activities, from the 1350, were performed in June 2014 by the HGCMC surface operations group, using a Hitachi 160LC or CAT 330 and two to three 35-ton Volvo off-road haul trucks. HGCMC also operated an excavator at the Site 23 RSP to allow blending of stockpiled materials with lime. The disturbed areas at the 1350 were hydro seeded after removal of material in 2014 (Photo 2). With the completion of these activities, HGCMC had anticipated not needing to remove additional material from the area until final reclamation (material still in the road base to the 1350 portal and ventilation ports). However, in the fall after reviewing water chemistry HGCMC decided that some additional material should be removed from the access road to the ventilation ports. Along with future removal activities, there will be continued grading efforts to ensure that contact water from this area is routed to collection at the 1350 portal.

Generally, the results for this year are in the historical range for each of the sites, the notable exception is outfall 009. This outfall is located near the original mine adit at the 1350. HGCMC has been reclaiming the site for several years, by removing the waste rock and disposing of it in the underground mine. The reclamation work in 2014 was directly in the drainage that is monitored at outfall 009. The 9 June 2014 storm water sample was being collected as work was just being started immediately up gradient in an old sediment settling basin. Reclamation activities were stopped, additional sediment controls were added, and surface runoff was captured and pumped to containment.

Water chemistry during the June storm event showed increases in total lead, total suspended solids, and total zinc. By the October samplings TSS was within an expected range, however total lead and total zinc, though lower than in June, remained elevated. HGCMC expects the water chemistry to continue to improve as the site stabilizes from the reclamation disturbance.

PHOTO 2. 1350 area view towards east and former sediment pond location (1 August 2014).
