RE: APDES Permit Number AK-004320-6
2015 Annual BMP and Storm Water Monitoring Report

I. Introduction

This 2015 Best Management Practices (BMP) and Storm Water Report is submitted by Hecla Greens Creek Mining Company (HGCMC) pursuant to Sections II.F.1 and II.F.2 of APDES Permit AK-004320-6, effective 1 July 2005. Authority over the federal permitting, compliance and enforcement NPDES program transferred to the Alaska Department of Environmental Conservation (ADEC) in November of 2010 for the mining industry. The ADEC reissued APDES Permit AK-0043206 on 20 August 2015, with an effective date of 1 October 2015. Storm water monitoring performed in 2015 was completed prior to the effective date of the reissued permit; and, therefore was performed in accordance with the requirements of the previous permit. The reissued permit contains additional requirements for monitoring receiving water quality associated with the storm water outfalls, which HGCMC will implement with the 2016 storm water monitoring program.

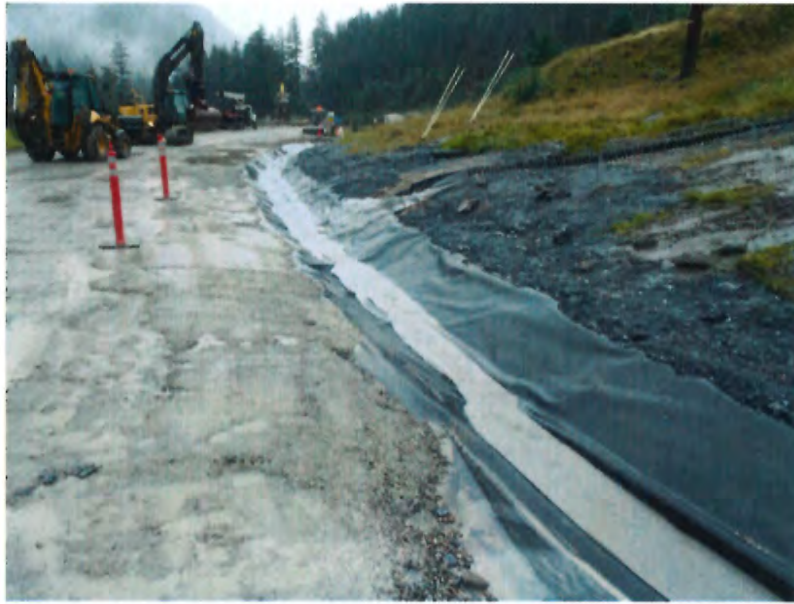
- A storm water conveyance channel was constructed on the lower face of Site 23 using a pre-fabricated flexible HDPE ditch lining system (SmartDitch®) to route runoff from the upper portions of Site 23 to the lined Site 23 ditch along the B-Road. SmartDitch is a leak-free channel lining system with a corrugated design to help regulate the flow in the steep gradient channel. This stabilized channel will prevent erosion and reduce sediment accumulation in Pond 23.

- The Site 23 ditch along the B-Road at the toe of Site 23 was reconstructed in 2015. The existing liner and accumulated sediments were removed and it was excavated to remove unsuitable subgrade material. Clean fill material was hauled in, placed and compacted to establish the proper dimension and profile to convey the design peak flow rate of 7,000 gpm. The ditch was then lined with geotextile and 45-mil reinforced polypropylene liner. The reconstructed Site 23 ditch ensures adequate containment of mine drainage runoff from Site 23 and storm water runoff from the B-Road.

PHOTO 1. Lower section of reconstructed Site 23 Ditch and lower section of SmartDitch that conveys storm water off upper portions of Site 23 (September 2015).

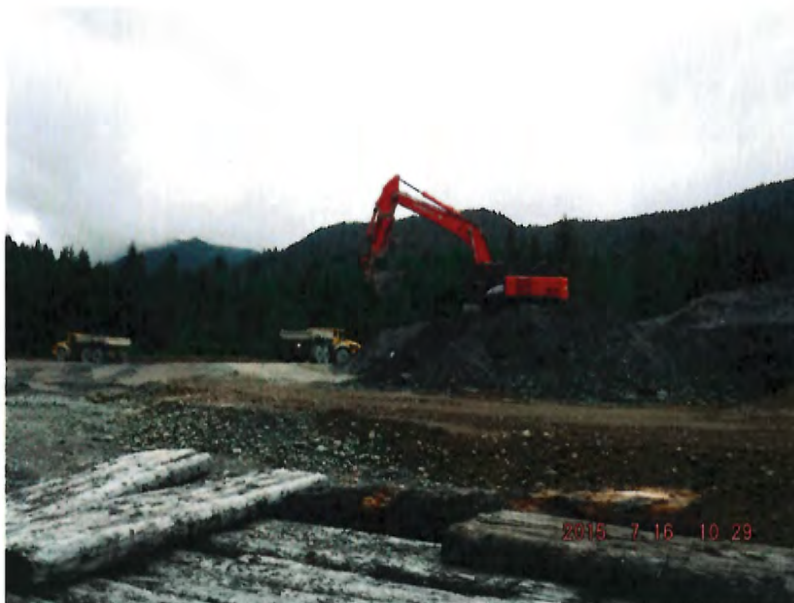
A surveyed quantity of 20,498 cubic yards of waste rock was hauled from Site E to the tailings facility in July 2015 as part of the tailings expansion project. Prior to commencing the haulage, the grading of Site E was verified to ensure surface runoff would be directed to the storm water pond at the northern end. Road rock was also hauled in and placed to establish a clean road for haul trucks and minimize the potential for tracking of contaminants onto the B-Road. Water captured in the storm water pond was pumped to Pond 7 at the tailings facility throughout the summer.

- At Outfall 005.3, total recoverable lead and total suspended solids were elevated during the August sampling event. The concentrations of each were below the maximums measured at this outfall, but were the highest concentrations measured since 2009. This sampling event occurred shortly after completing waste rock removal activities at Site E. The elevated solids likely resulted from the loaded Volvo haul trucks on the B-Road causing degradation of the aggregate road base, which contributed excess sediment to the BMPs during the storm event. The elevated lead may have resulted from tracking by the haul trucks from Site E, despite HGCMC's best efforts to maintain a clean haul road over the waste rock.

PHOTO 2. Waste rock removal from Site E (16 July 2015). Note the clean material placed for the haul road.
