INSPECTION REPORT: GREENS CREEK MINE

Date of Inspection: Thursday June 16, 2016
Date of Report: Monday July 11, 2016
USDA Forest Service Inspector: Richard Dudek

This inspection included A/B access roads, Pit7, Sand Pit, 1350 area, 920 area, Falls Creek Bridge, Zinc Creek Bridge, Site 23, Tailings Disposal Facility (TDF), and the 0.9 mile marker B-road.

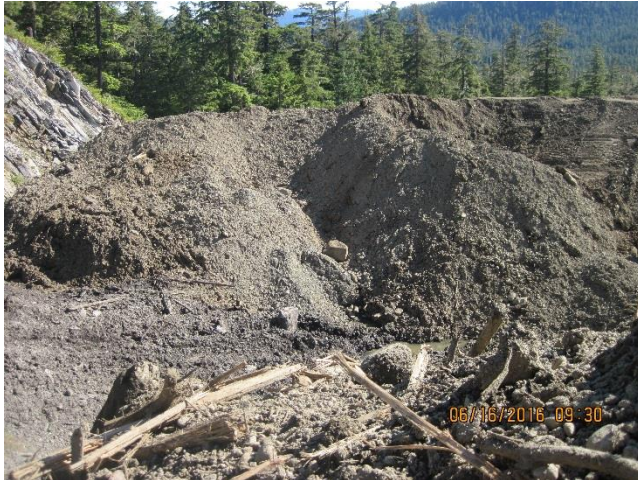
Pit 7 is located at 1.9 mile on A-Road. Some material that is being excavated from the Sand Pit is being stockpiled at Pit 7. The amount of sand pit material that has been stockpiled at Pit 7 is 74,400 cubic yards with a total of approximately 120,000 cubic yards of material being stored there. (Photo 1-2). This site was tidy and in order.

Photo 1. Pit 7 additional material stockpiled from the Sand Pit.

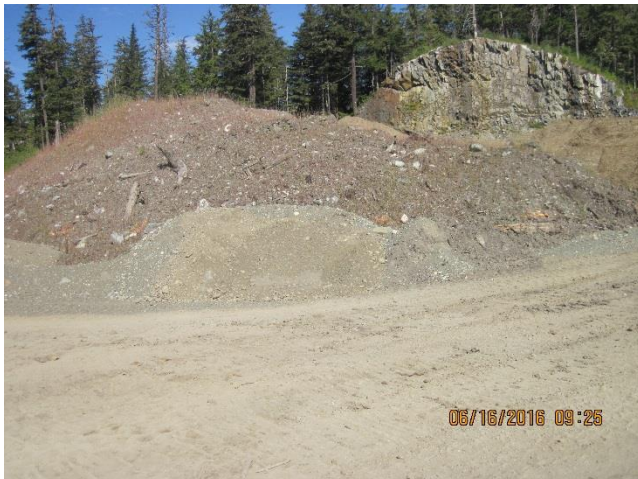
Photo 2. Pit 7 stockpiled excavated material from the Sand Pit.

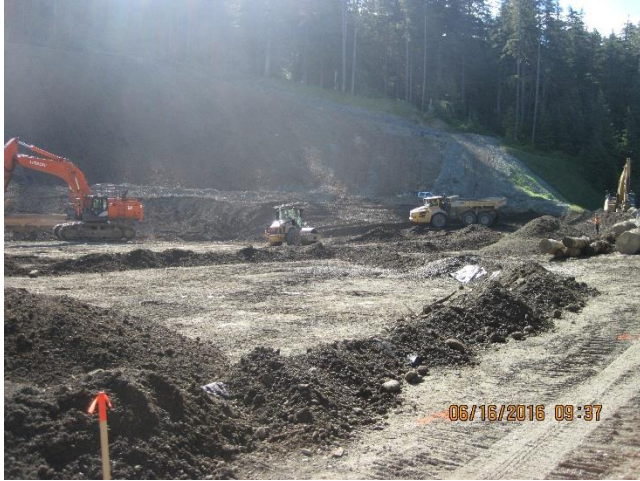
A portion of the excavated material from the Sand Pit (Photos 3-4) will be used for the TDF expansion. The site was active with contractors excavating material needed for the TDF. The material that will be excavated for the construction of Pond-10 and will be transported to the Sand Pit for storage, and potentially used as reclamation material.

Photo 3. Sand Pit excavation material used for the TDF expansion.

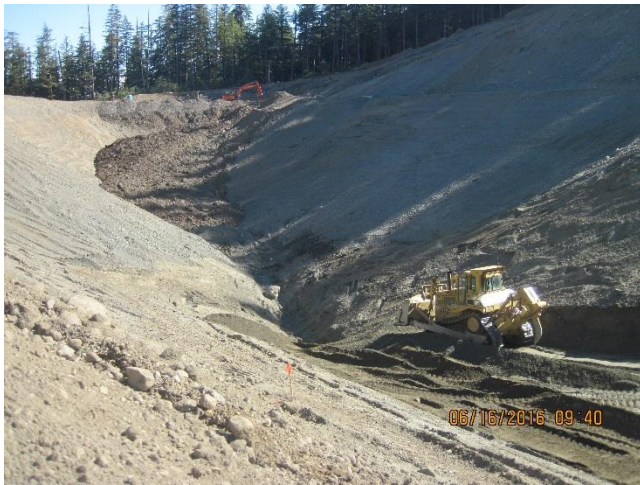
Photo 4. Sand Pit excavation material used for the TDF expansion.

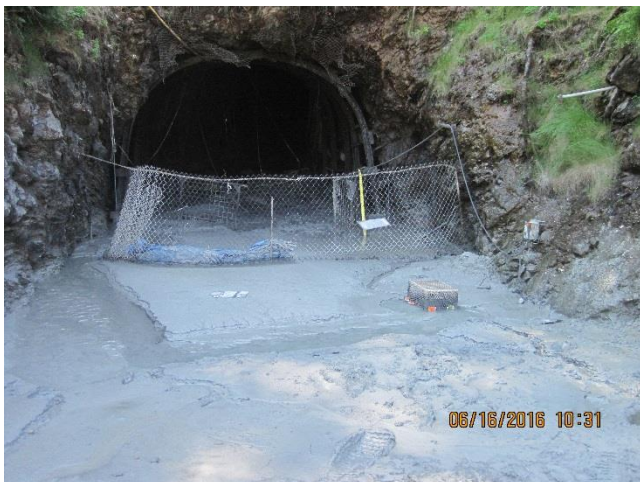
The 1350 adit is inactive and currently serves as a ventilation system and secondary escape way for the underground mine. During the site inspection on 5/19/16, it was reported that the 1350 area was in need of slight improvements. After that report was submitted, HGCMC surface maintenance crews hydroseeded the exposed rock, and the sump (Photo 5) near the adit has been mucked.

Photo 5. 1350 adit sump is mucked when necessary.

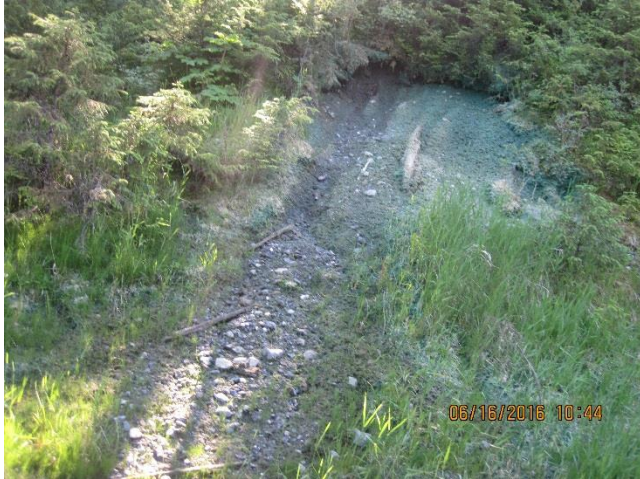
Along the 1350 access road, six water bars have been re-constructed and are in good working order. There was a minor erosional feature near the 960 area (Photo 6) observed on a hill slope along the access road. Surface Operations are aware of this and will hydroseed the exposed the area.

Photo 6. 1350 access road erosion along the hill slope.

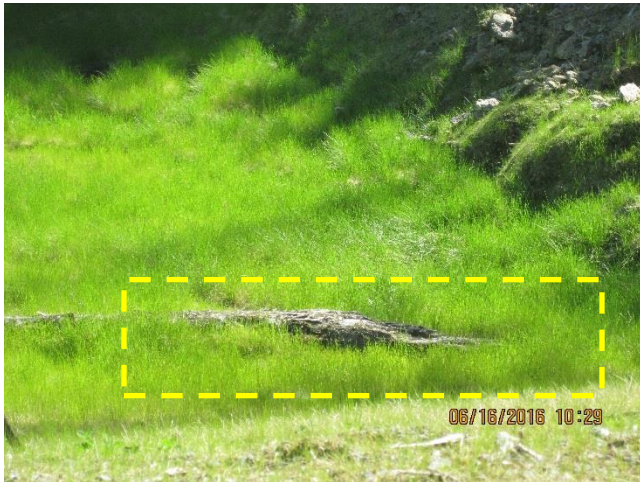
HGCMC's Environmental Manager, Chris Wallace stated high levels of zinc have been reported at the FWMP Site 13, which is located near the 1350 east drainage. These zinc concentrations at Site 13 are in exceedance of the Alaskan Water Quality Standard (AWQS). The high levels of zinc may be a result from previous reclamation activities at the 1350 area. Since the reclamation activities have concluded, zinc concentrations has at times, been in exceedance. To gain a better understanding, HGCMC is going to collect water samples at the toe of the fill material east of the 1350 adit. HGCMC will also continue to monitor Site 13 for any changes in zinc concentrations over time. If zinc levels continue to remain high in the 1350 area, HGCMC has plans to install a sump system to capture surface water runoff from the nearby hill slope (Photo 7) and divert the water to the 1350 adit.

Photo 7. Possible location for a sump to divert water to the 1350 adit sump.

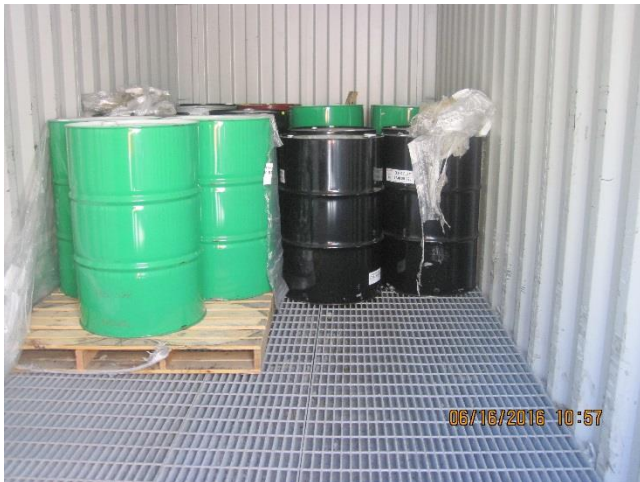
The 920 warehouse area was tidy and is properly maintained by HGCMC personnel (Photo 8). During the site visit, shipments of supplies were being staged for placement into the appropriate storage containers (Photo 9). The empty hydraulic container and totes (Photo 10) will be shipped off site. The rock check dam and sump across from DB-01 appear to be in good working order (Photo 11). The 920 Bridge

Photo 8. Storage containers are tidy and with secondary containment.

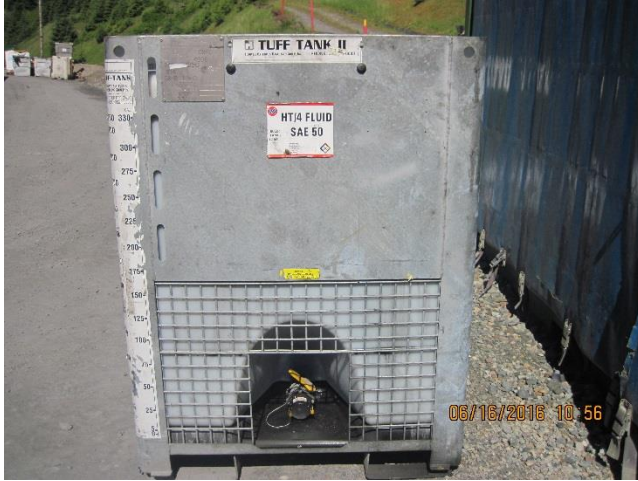
Photo 9. Shipment of hydraulic fluid tote staged for storage next to the containment curtain.

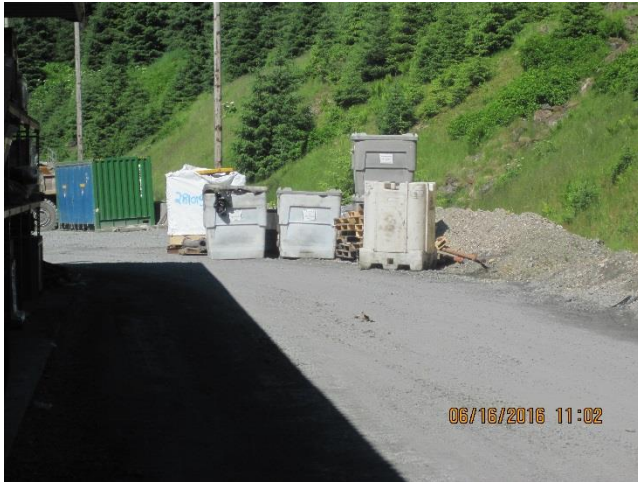
Photo 10. Empty containers will be shipped off site.

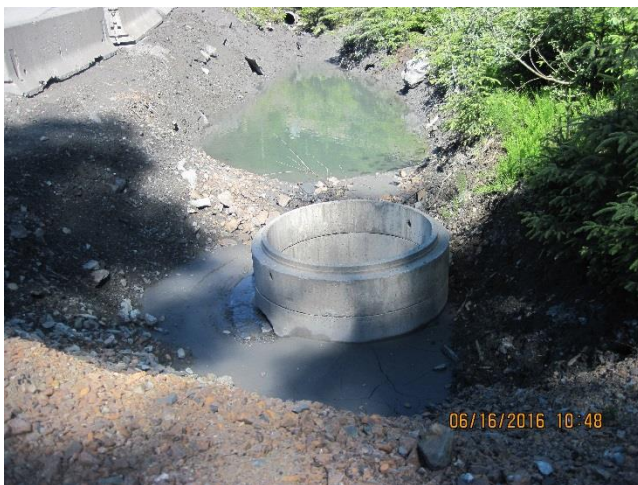
Photo 11. Rock check dam and sump across from BD-01.

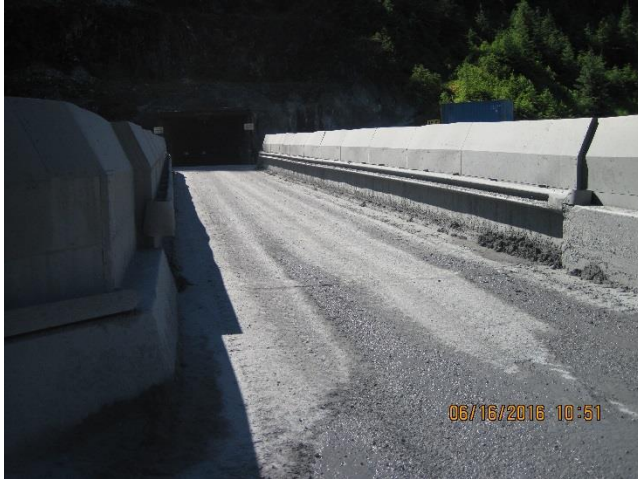
Photo 12. 920 Bridge.

splashguards are effectively working to prevent sediments from entering into Greens Creek (Photo 12). Chris Wallace stated the repairs for the 920 broken concrete overlay (Photo 13) would begin in late June. HGCMC personnel will need to remove boulders and other debris (Photo 14) across from the broken concrete in order to re-route mine traffic during the repairs for the concrete overlay.

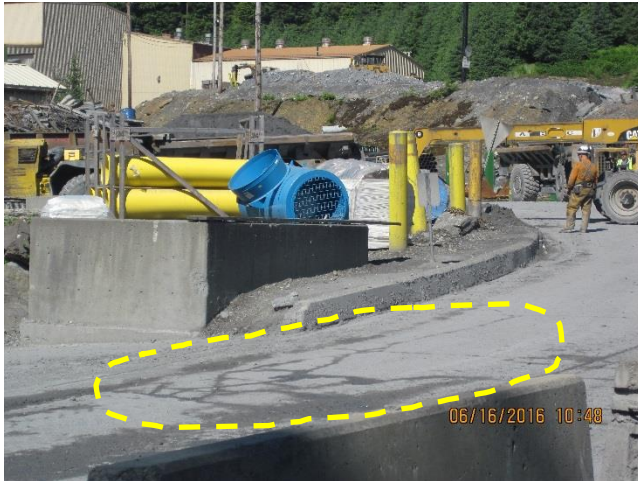
Photo 13. Dash line is the location of the broken 920 concrete overlay.

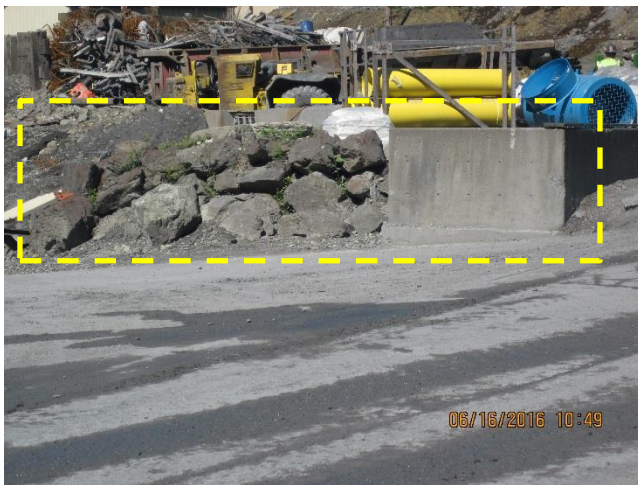
Photo 14. The rectangle is the location (920 area) that will be excavated in order reroute mine traffic.

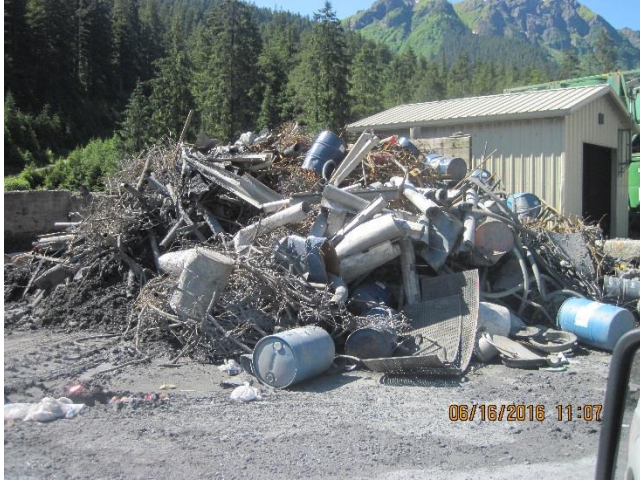
HGCMC is in the initial phase of beginning metal recycling at the mine site (Photo 15).

Photo 15. HGCMC's proposed recycling area (re-muck area).

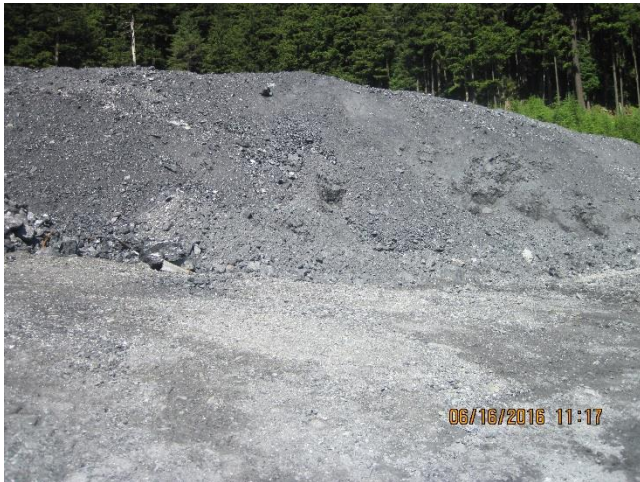
Photo 16. Site 23 Class 1 (Argillite) waste rock.

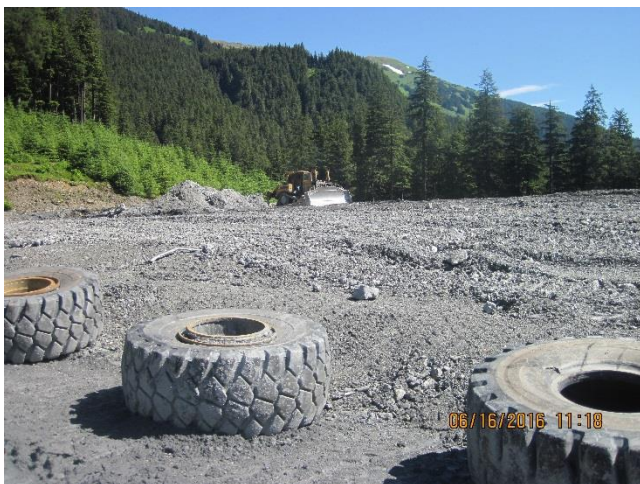
Site 23 is the location for Class 1, 2, and 3 waste rock stockpiles. Class 1 rock is stockpiled separately from Class 2 and 3 rock. The Class 1 rock (Argillite) is designated as acid neutralizing and is placed on the outer slopes of the tailings pile at the TDF (Photo 15). The Class 2 waste rock is designated as potentially being acid neutralizing or acid generating. Class 3 waste rock is designated as having acid generation potential. Both Class 2 and 3 waste rock will be co-disposed of with tailings at the TDF during mine closure. During the site inspection, HGCMC personnel were leveling an area for additional waste rock storage (Photo 16). This site was active and in order.

Photo 16. Bull dozer leveling an area for Class 1, 2, and 3 stockpiles.

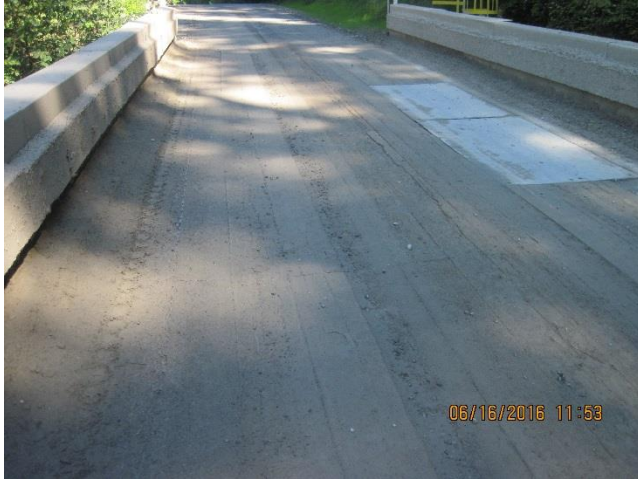
Photo 17. Falls Creek Bridge.

Falls Creek Bridge is located at 3.4 mile B-road. In the 5/19/16 inspection report, sediments were identified accumulating around the bridge abutments (Photos 17-18) and permeating through the wood decking for the bridge. HGCMC Environmental and Surface Operations are developing a plan for the safest way for removing the sediments from under the bridge.

- **Falls Creek Bridge: Mitigations for sediment capture along and under Falls Creek Bridge.**
- **Falls Creek Bridge: Removal of sediments under the bridge.**
- **3.2 mile B-Road: BMP removable sediment bag needs cleaning.**

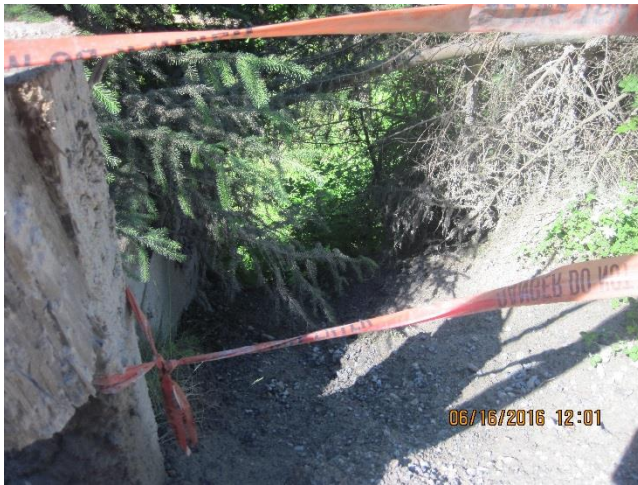
Photo 18. Sediments depositing below the edge of the bridge abutments.

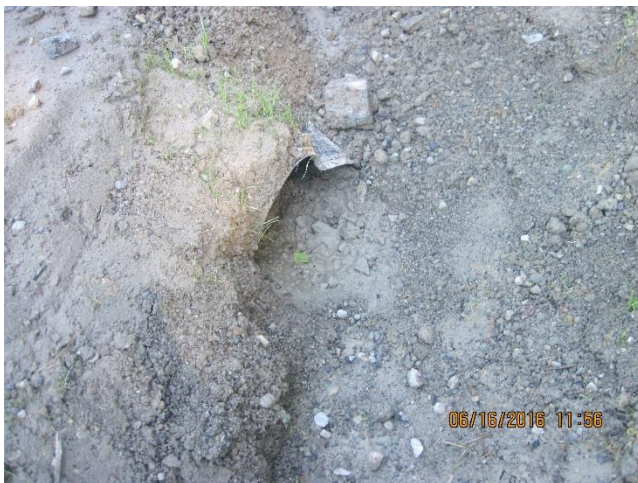
A nearby culvert that was covered in sediments, and listed as an action item from the 5/19/16 inspection report, has been mucked by HGCMC Surface personnel (Photo 19).

Photo 19. Nearby culvert has been mucked.

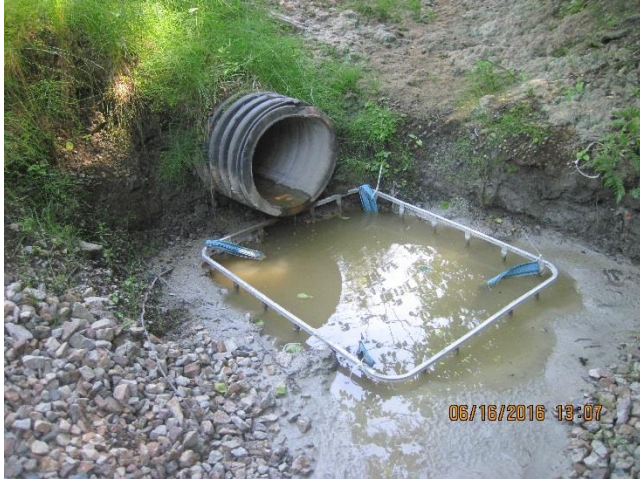
The additional mitigation systems previously constructed in early 2016 are effectively working by eliminating turbid water from entering into the forest. The 3.2 mile B-road removable sediment screen appears to be full of sediments, and needs to be cleaned out (Photo 20). The rock check dams and sumps (Photos 21-22) are in good working order and the standpipe drain was discharging clean water into the forest (Photos 23-24). The hydroseeding has helped with establishing dense grasses needed for filtering sediments from surface water runoff.

Photo 20. 3.2 mile B-road removable sediment bag.

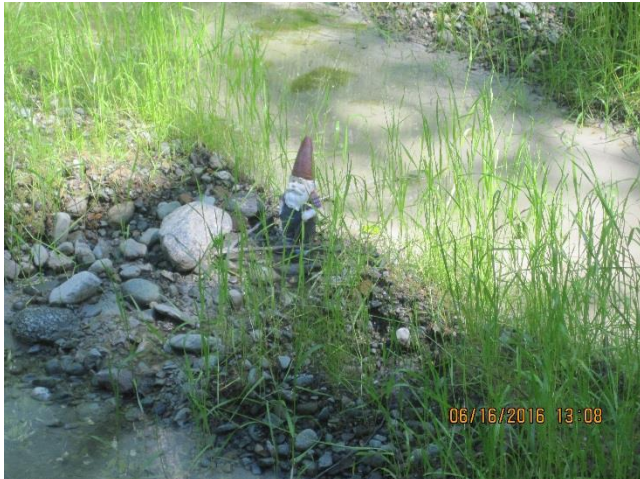
Photo 21. Zinc Creek Bridge rock check dam.

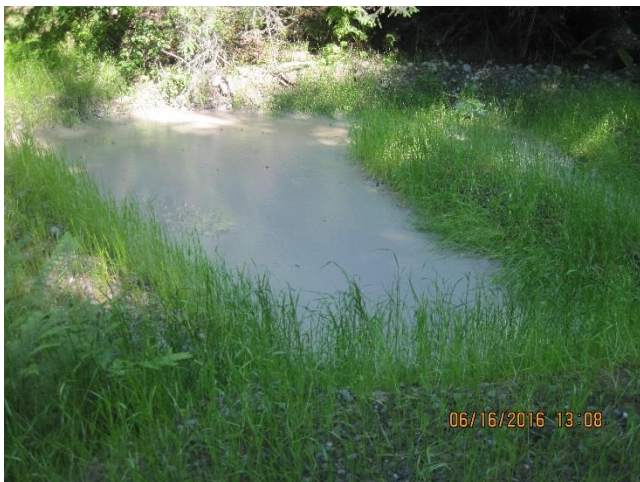
Photo 22. Zinc Creek Bridge sump.

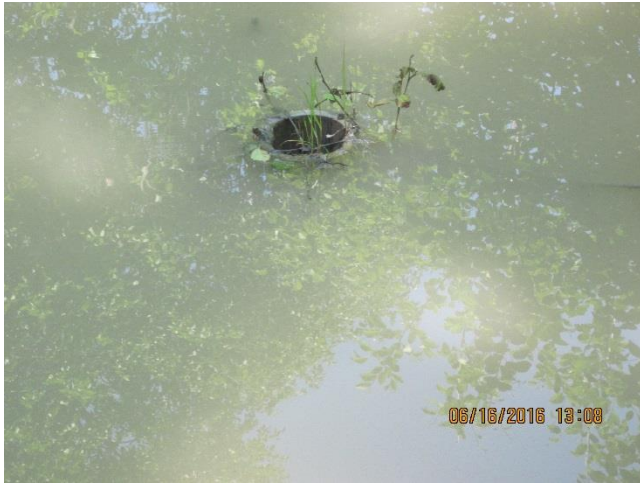
Photo 23. Zinc Creek Bridge standpipe.

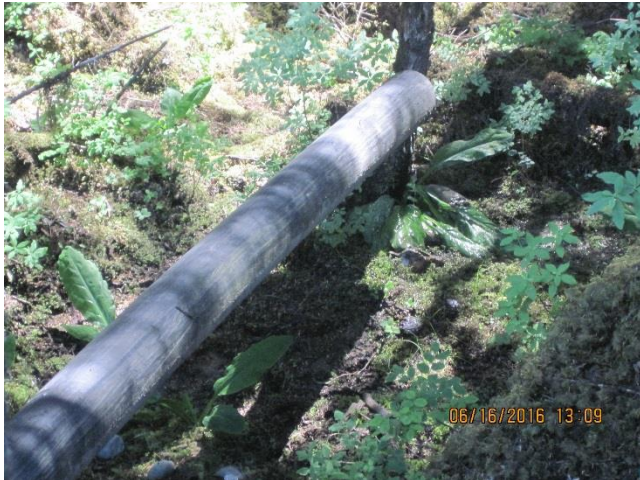
Photo 24. Zinc Creek Bridge standpipe drain.

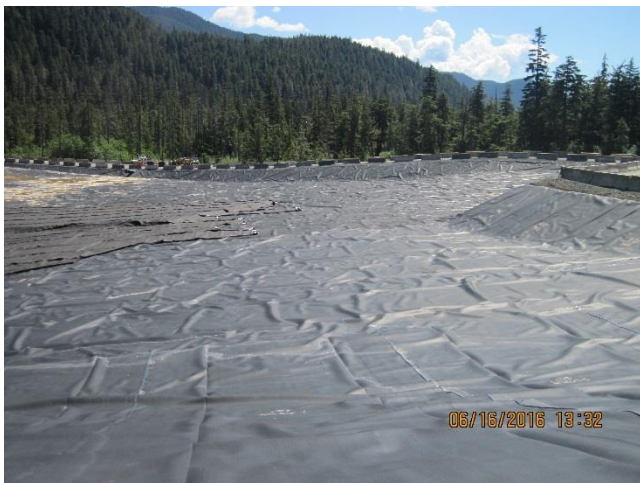
The TDF expansion is progressing. Contractors have installed the liner for the TDF expansion, and were in the process of installing the service sand layer (Photos 25-26). The HGCMC's APDES Outfall 002 (Photos 28-29) pH for water discharge was 8.2. The permitted pH range for an APDES permit for effluent water is 6.5-9.0. The TDF water treatment plant was neat and orderly (Photo 30).

Photo 25. New liner installed for the TDF expansion.

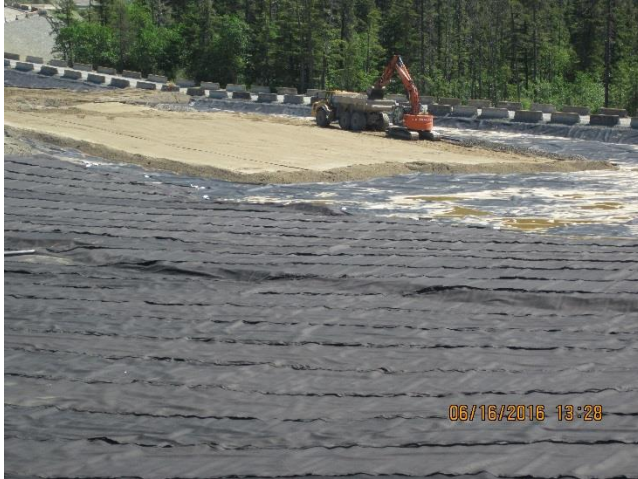
Photo 26. Service sand layer being placed over the geotextile.

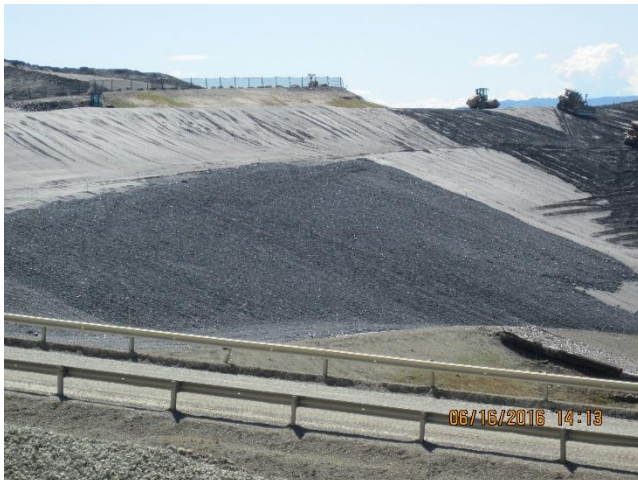
Photo 27. Class 1 rock is placed on the outer slopes at the TDF.

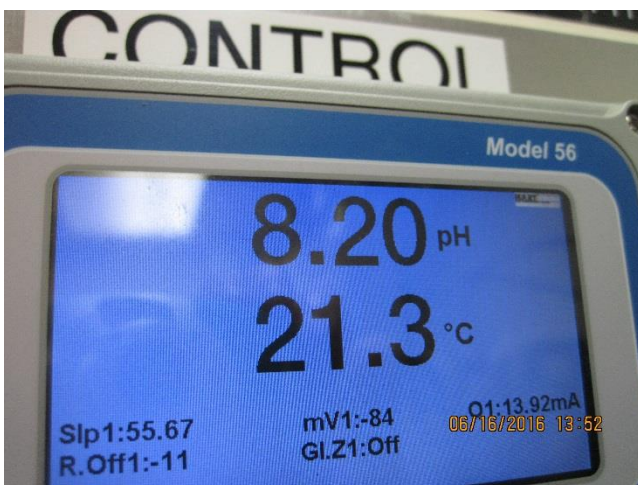
Photo 28. APDES Outfall 002 Control pH.

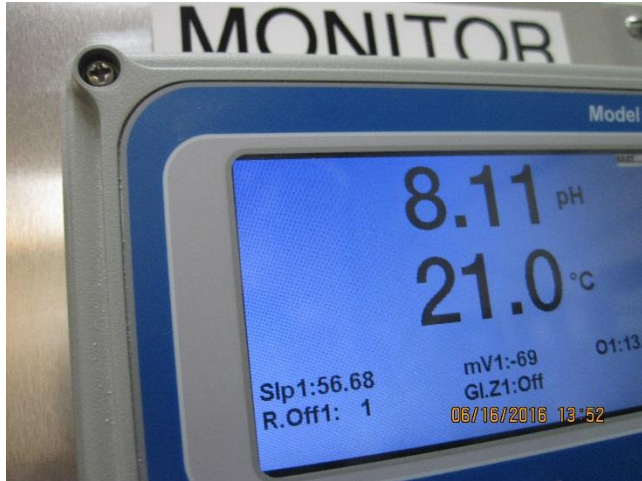
Photo 29. APDES Outfall 002 Monitor pH.

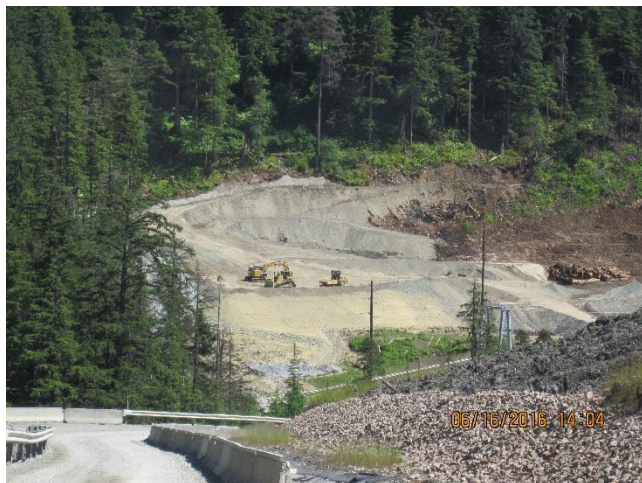
Photo 31. 0.9 mile B-road.

Approximately 28,000 cubic yards of material from the Sand Pit is stockpiled at this location (Photos 31-32). Due to additional capacity at Pit 7, less space was needed in this location than anticipated by HGCMC. A proposal is being developed to use this location as a lay down area to replace current laydowns within the tailings expansion area. This site is active and in order.

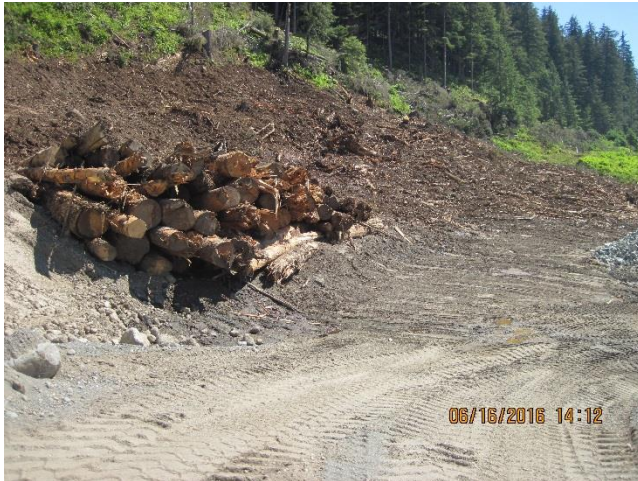
Photo 32. 0.9 mile B-road. The material stockpiled here is base material for the new lay down.
