INSPECTION REPORT: GREENS CREEK MINE

Date of Inspection: Wednesday July 20, 2016
Date of Report: Tuesday August 2, 2016
USDA Forest Service Inspector: Richard Dudek

This inspection included A/B access roads, 1350 area, 920 area, Falls Creek Bridge, Zinc Creek Bridge, TDF area, and the Sand Pit.

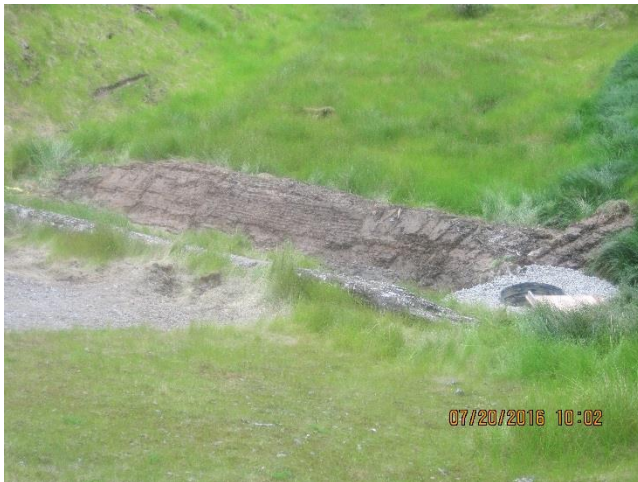
HGCMC has recently installed a 1-foot deep trench and caisson (Photo 1) to capture stormwater runoff from a waste rock stockpile (Photo 2) at the 1350 area. The installation of this trench was due to zinc exceedances detected down gradient at the Fresh Water Monitoring Program (FWMP) Site 13 (Photo 3). The stormwater runoff from the waste rock stockpile flows into the trench, and then drains into a caisson where it will be pumped into the 1350 adit. From there the water will combine with other mine drainage and will route to treatment prior to discharge under the APDES permit.

Photo 1. A trench installed at the 1350 area.

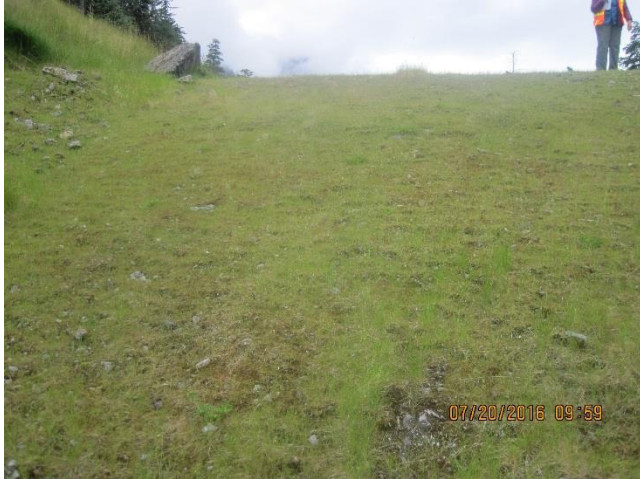
Photo 2. A small waste rock stockpile at the 1350 area.

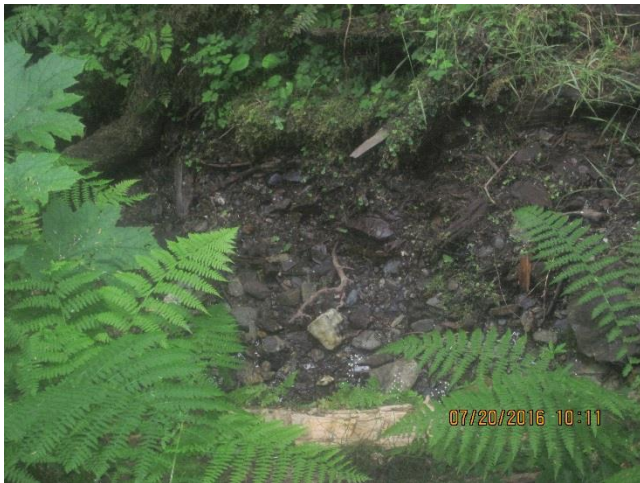
Photo 3. Surface water is not always present at the Fresh Water Monitoring Program (FWMP) Site 13.

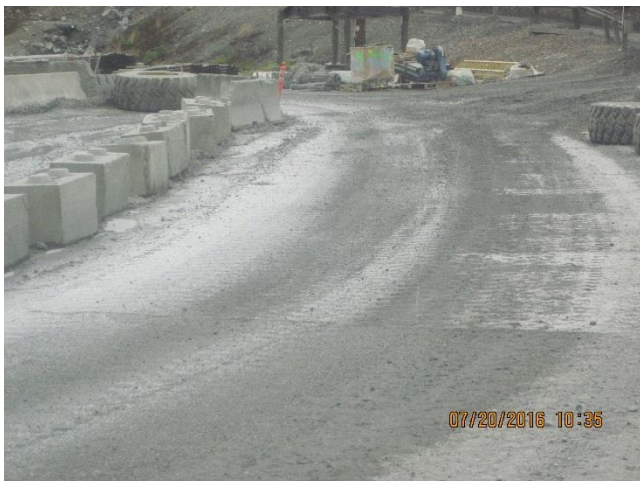
HGCMC Surface Operations have repaired the broken concrete overlay (Photo 4). Prior to the concrete overlay repairs, HGCMC Surface Operations removed some boulders in order to re-route mine traffic to the 920 ore pad (Photo 5). Surface Operations are properly maintaining the 920 bridge (Photo 6) and the bridge's splashguards are effectively working to prevent sediments from entering Greens Creek.

Photo 4. 920 concrete overlay has been repaired.

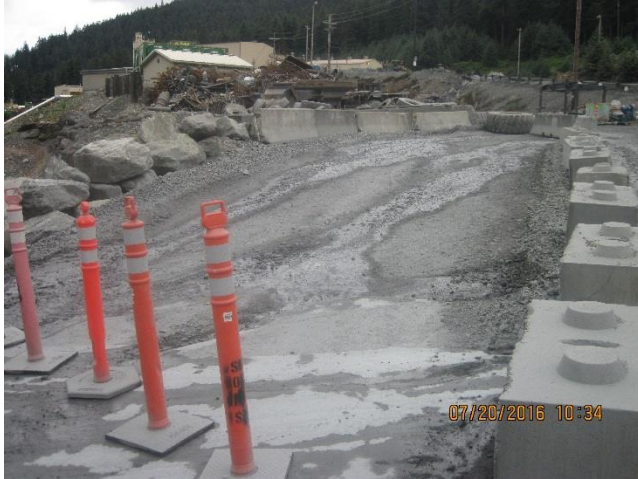
Photo 5. Image shows the area used for rerouting mine traffic.

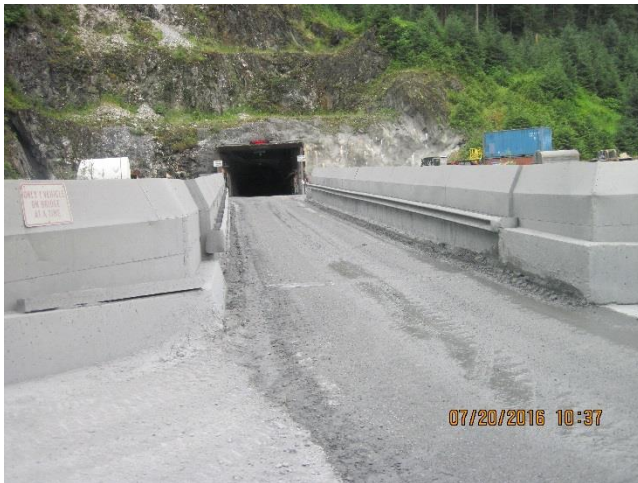
Photo 6. 920 bridge.

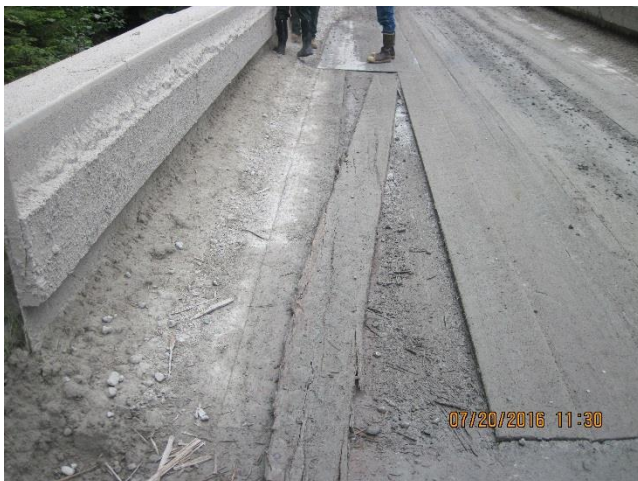
Some of the wood planks for the wear layer of the bridge decking are damaged (Photo 7). HGCMC Surface Operations replaced the damaged planks the same day as this inspection. In 2017, HGCMC has plans to re-deck the wear layer of the bridge. Surface and Environmental Operations are working on a plan for crews to safely remove the sediments that have accumulated underneath the bridge (Photos 8-9). There is significant amount of sediment on rails of both splashguards (Photo 10). There is also sediment accumulation on the pipes that run parallel with the bridge (Photo 11). The splashguards for the bridge are not effectively working to prevent sediments from entering Falls Creek.

Photo 7. Falls Creek Bridge with two damaged wood planks.

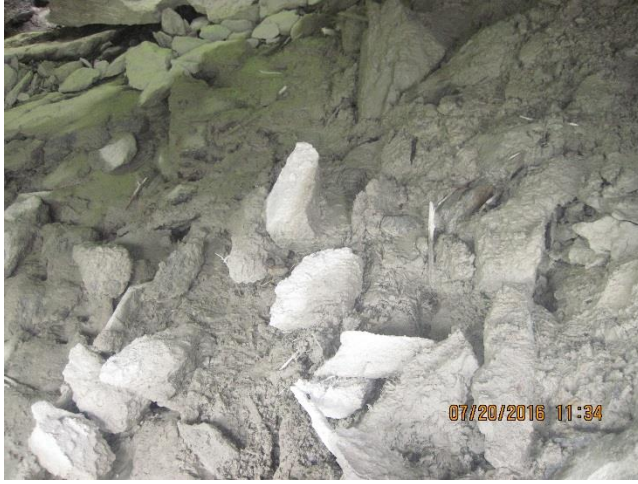
Photo 8. Sediments have accumulated underneath Falls Creek Bridge.

- Falls Creek Bridge: Sediments have accumulated underneath the bridge and on the splashguard rails.
- Falls Creek Bridge: Splashguards need to be taller to prevent sediments from entering Falls Creek.
- Zinc Creek Bridge: A sediment sump is near capacity and needs to be mucked.

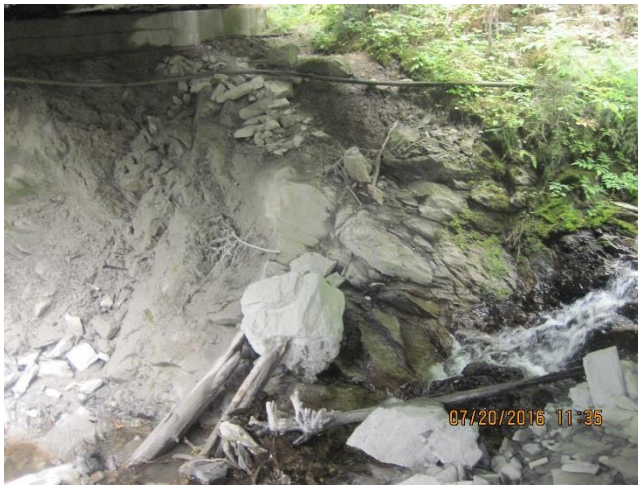
Photo 9. Sediments have accumulated on both sides of Falls Creek.

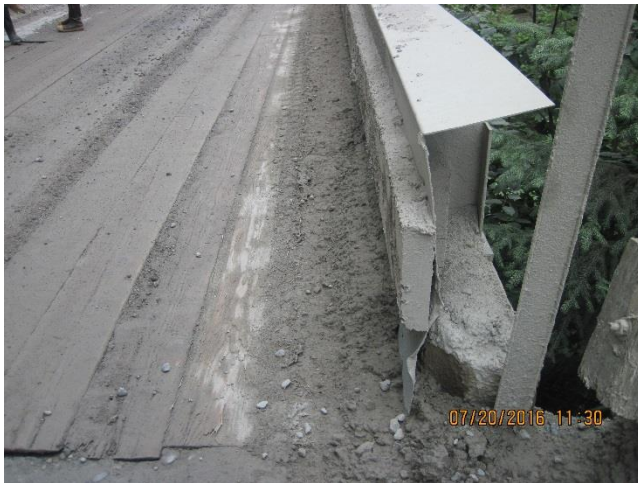
Photo 10. Sediment accumulating on the rails of the splashguards.

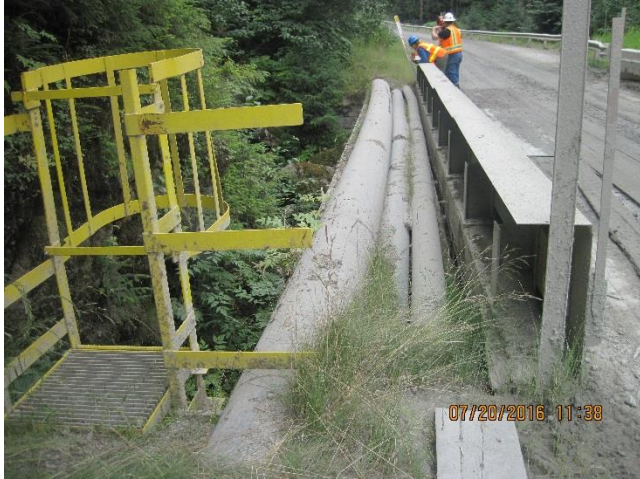
Photo 11. Sediment accumulating on pipes parallel to bridge.

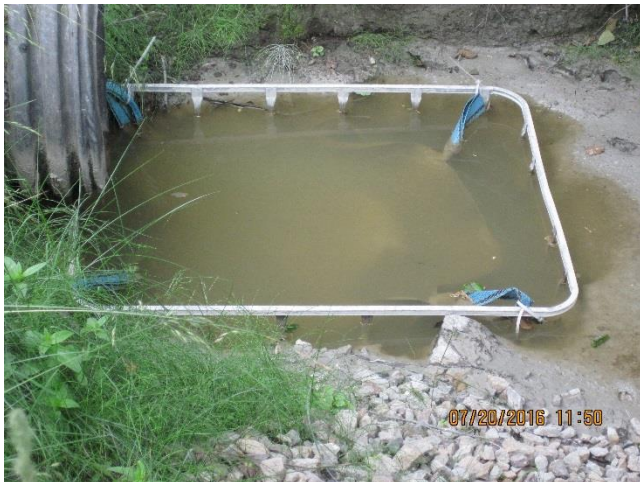
The inspection report from 06/16/16 documented that a removable sediment screen at the 3.1 mile of B-road exceeded its capacity. HGCMC Surface Operations have removed the sediments from the removable screen (Photo 12). HGCMC Surface Operations have removed the silt fences, and recently installed four sets of triple stacked straw wattles (Photo 13) near the bridge's southern abutments to capture sediments from stormwater runoff. A sump installed in early 2016 is near capacity and needs to be mucked (Photo 14). These sumps (Photo 15) and rock check dams need to be continually monitored and maintained to prevent overflow into the forest.

Photo 12. 3.1 mile B-road removable sediment screen.

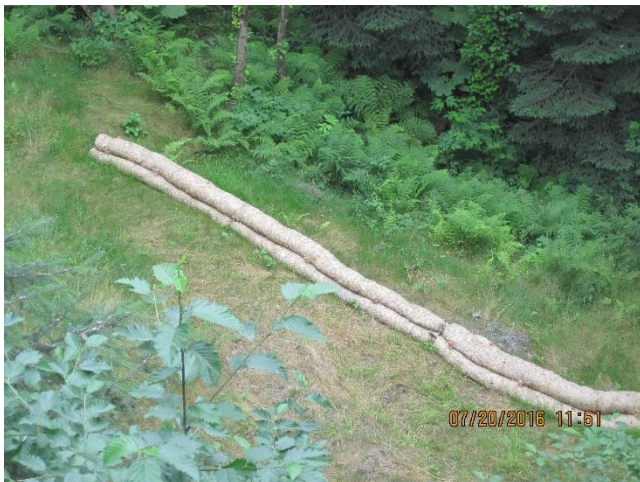
Photo 13. Straw wattles placed to capture sediments from stormwater runoff.

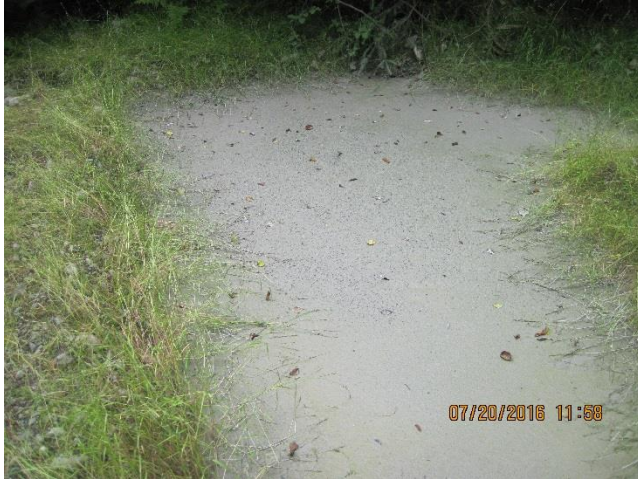
Photo 14. Sediment sump is almost at full capacity.

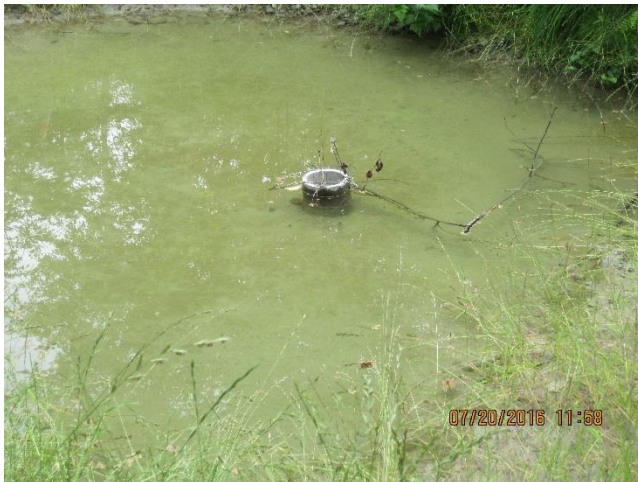
Photo 15. The BMP's stand pipe, sumps and rock check dams installed need to be frequently monitored and maintained.

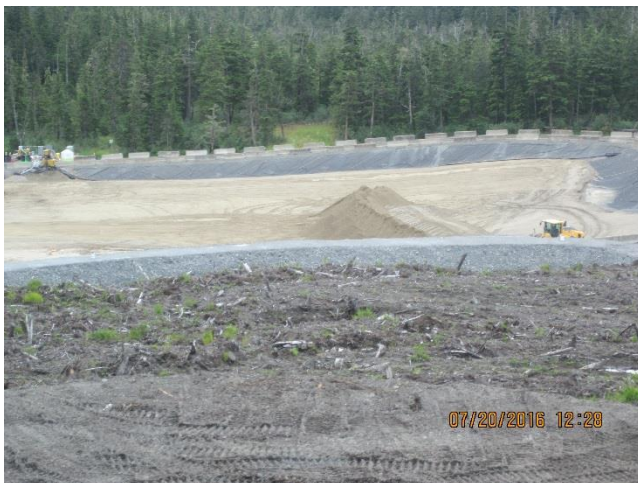
The liner for TDF expansion is installed and contractors are currently placing the service sand layer (Photo 16). The Class-1 waste rock (Argillite) (Photos 17) that is placed on the outer slopes of the TDF is to help minimize the oxidation of tailings, and stabilize the TDF slopes to minimize wind and stormwater erosion. Eventually the Class-1 waste rock will be covered with organic material. HGCMC has also in place portable windscreens on the crest of the TDF (Photo 18) to reduce fugitive dust. The excavation for Pond 10 (Photo 19) is underway. The excavated organic material is stockpiled at the A-road Sand Pit.

Photo 16. The liner for TDF expansion is installed and the service sand is being placed.

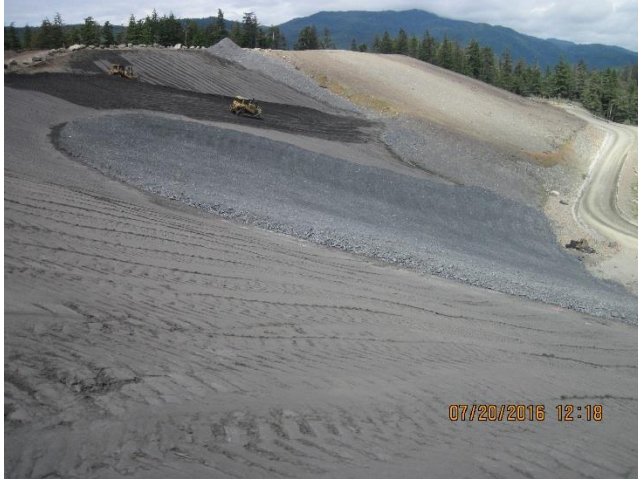
Photo 17. Class-1 waste rock (Argillite) used as armoring layer for the outer slopes of the TDF.

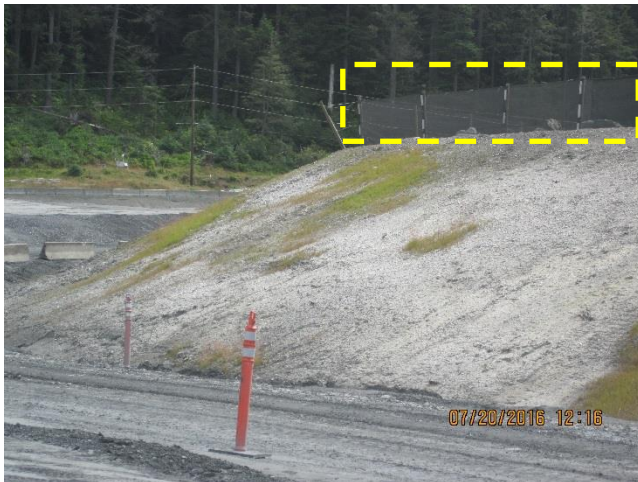
Photo 18. A portable windscreen highlighted in image is used for reducing tailings dust dispersal.

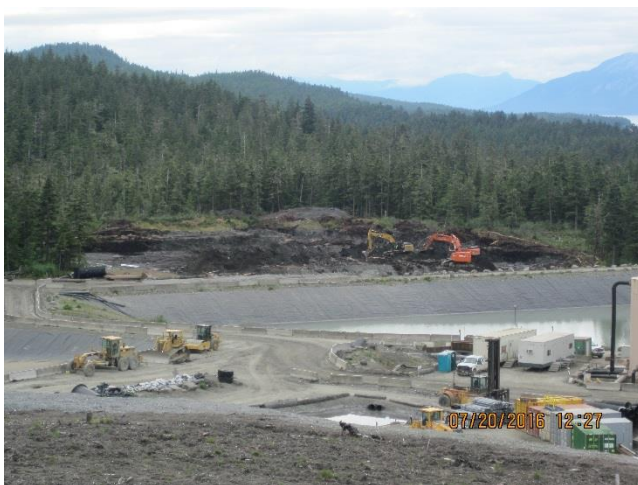
Photo 19. Excavators are removing organic material for the Pond-10 construction.

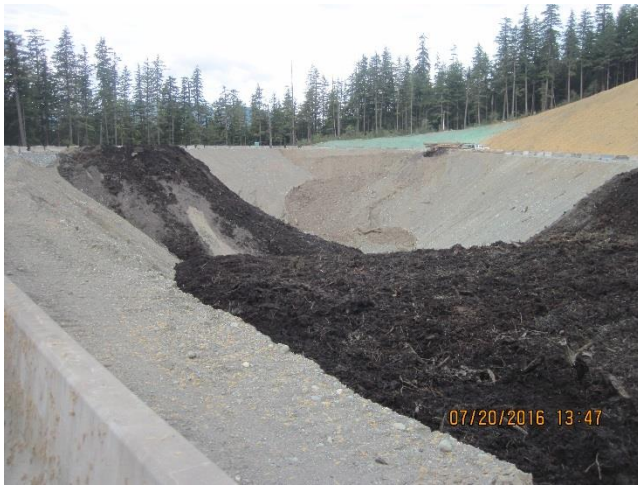
The excavated peat from the Pond-10 construction is being deposited within the Sand Pit (Photos 20-21). The berms constructed for the Sand Pit is material from within the pit and the roadway is constructed from imported material. The disturbed outer slopes and berms have been hydroseeded (Photo 22-23) to establish vegetation for reducing erosion from stormwater (HGCMC's BMP plan page 13).

Photo 20. Excavated organic material from the Pond-10 construction.

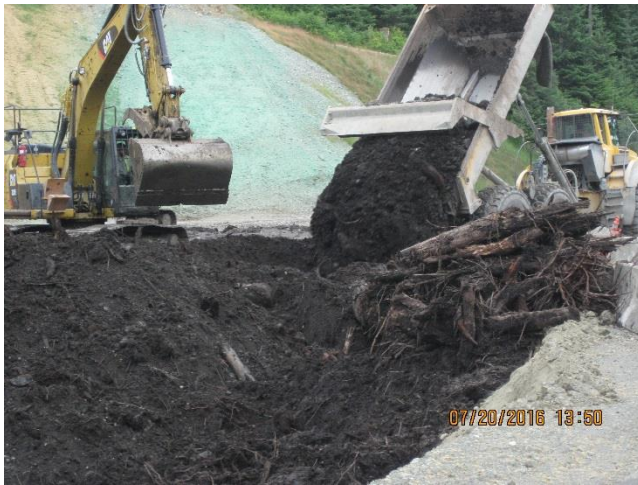
Photo 21. Organic material deposited at the Sand Pit.

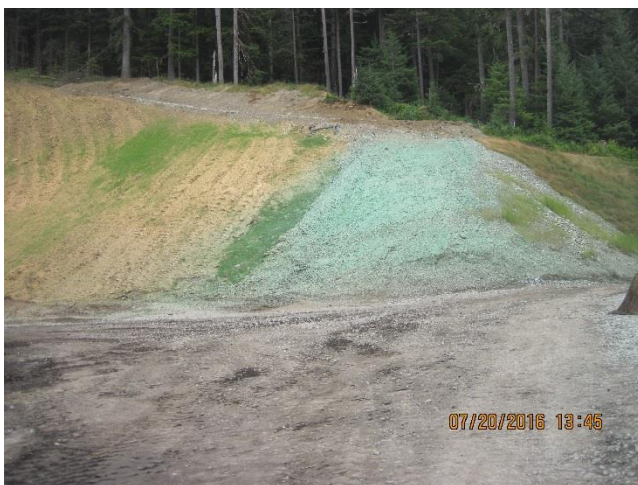
Photo 22. Hydroseeded area at the Sand Pit to prevent erosion.

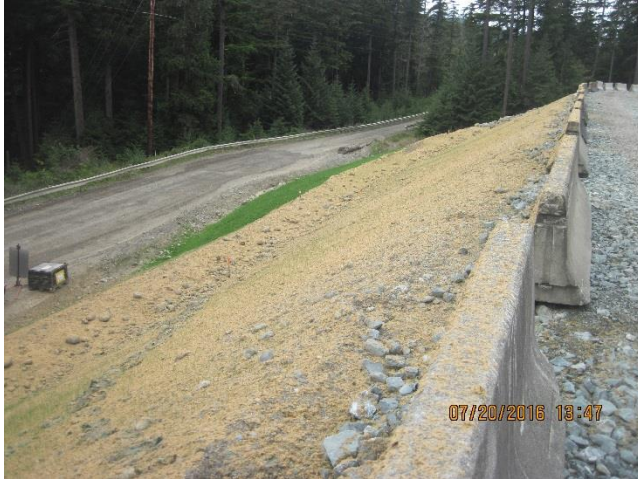
Photo 23. Berm for the Sand Pit has been hydroseeded.

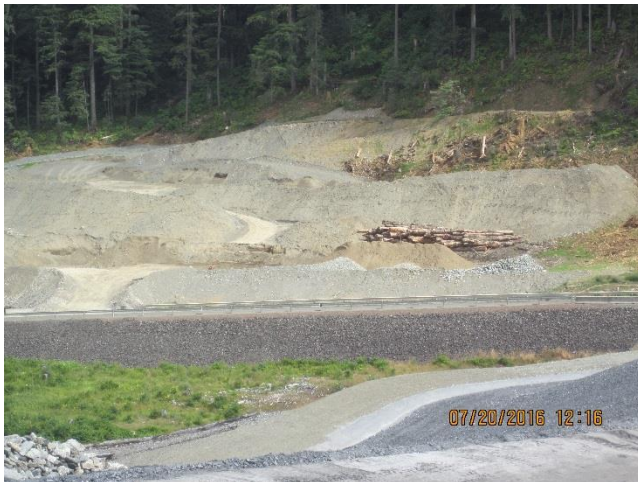
This location is being developed to stockpile material from the 1.4 Mile A-Road Sand Pit excavation. The stockpiled material is for the TDF expansion project and reclamation material (Photo 24). The Forest Service approved the felling of trees for this expansion.

Photo 24. The stockpiled material at 0.9 Mile B-road area is for the TDF expansion project and for reclamation material.
