## INSPECTION REPORT: GREENS CREEK MINE

Date of Inspection: Friday September 2, 2016  
Date of Report: Wednesday September 21, 2016  
USDA Forest Service Inspector: Richard Dudek

Ranger District: Admiralty National Monument  
Weather Conditions: Sunny. Temperature: Mid 60's °F.

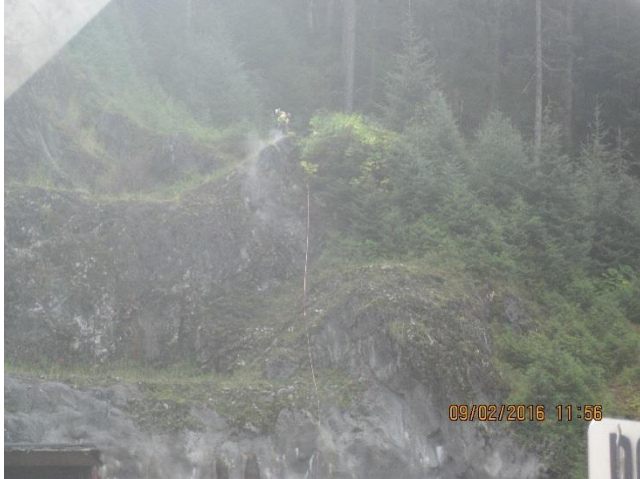
Contractors are currently performing rock cut stabilization at the 920 portal and along sections of the B-road. Image (Photo 1) shows contractors installing anchors for fencing above the 920 portal.

**Photo 1. Rock bolting above the 920 portal.**

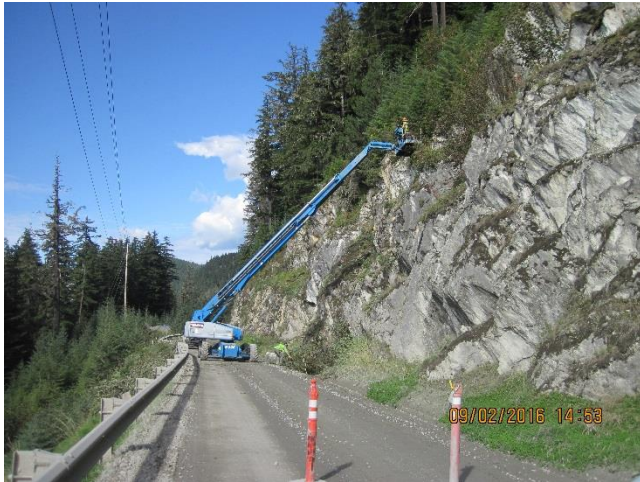
Contractors were brush-cutting vegetation along the rock wall at the 1.9-mile B-road prior to rock scaling (Photo 2). HGCMC has shipped off site thirteen twenty-foot containers for steel recycling.

**Photo 2. Contractors are brush cutting along the rock wall at the 1.9 mile B-road.**

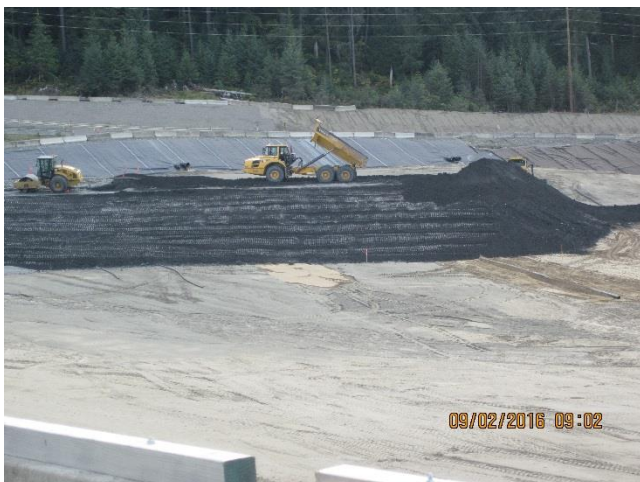
HGCMC continues depositing tailings within the TDF expansion area (Photo 3). HGCMC has deposited additional Class-1 waste rock and organics on the outer slopes (Photo 4) of the TDF. The blasting of bedrock for Pond-10 construction (Photo 5) is still ongoing to meet the planned capacity. HGCMC is currently testing the blasted rock to determine if the material is suitable for construction. The blasted bedrock is being stockpiled at the staging area of 0.9-mile B-road (Photo 6).

**Photo 3. HGCMC continues to deposit tailings at the TDF expansion area.**

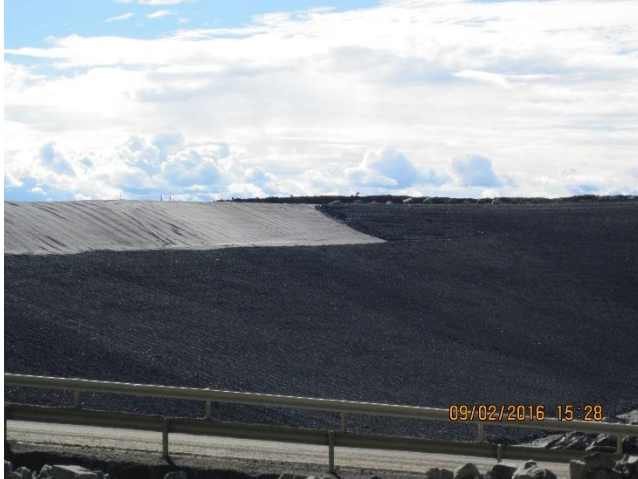
**Figure 4. Class-1 waste rock and organic placed over tailing at the outer slopes.**

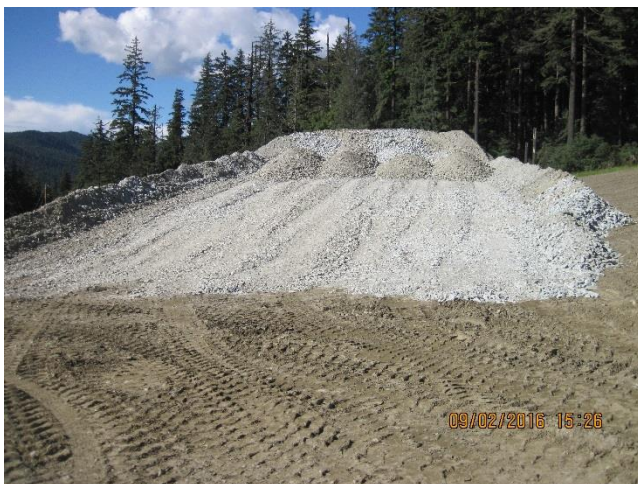
**Figure 6. Crushed bedrock from the Pond-10 construction stockpiled at the 0.9 mile B-road.**

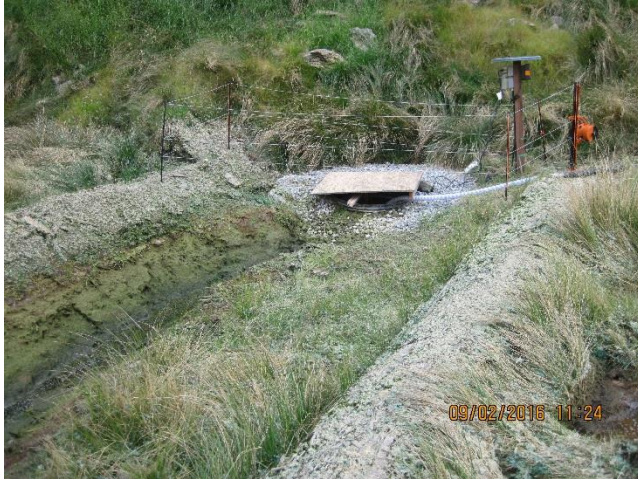
Stormwater runoff, from a remnant waste rock pile is now being pumped from the caisson (Photos 7-8) to the 1350 adit. The water is then routed to the water treatment plant, and discharged under the APDES permit. HGCMC has hydroseeded the disturbed areas from the construction of the trench and caisson. Due to the 1350 adit being designated as a secondary escape-way, a newly installed emergency personnel shelter is now at this location (Photo 9).

**Photo 7. 1350 sump and caisson. The caisson and pump are protected by an electric fence.**

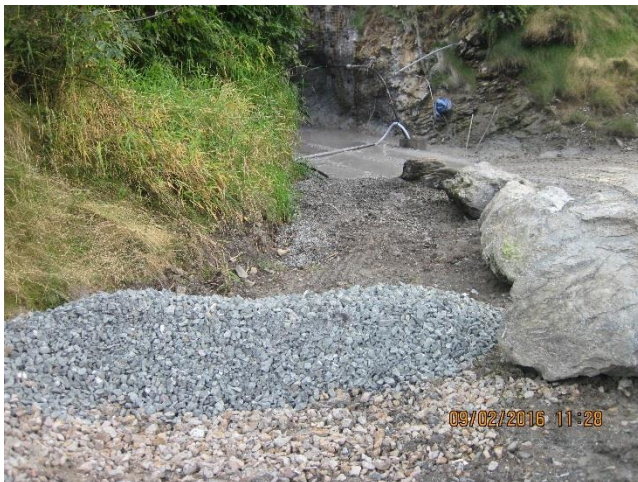
**Photo 8. Imported rock covering the pipeline from the caisson to the 1350 adit.**

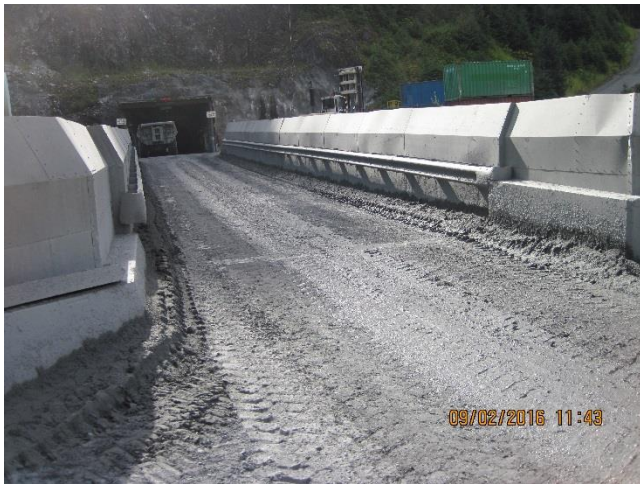
**Photo 11. 920 Bridge.**

Greens Creek (Photo 10) flow rate for the day was 21.3 cubic feet per second (cfs). The 920 Bridge's splashguards are preventing sediments from entering into Greens Creek (Photo 11). Surface operations are maintaining the sump and rock dam (Photo 12) across from DB-01. The ore pad (Photo 13) was active with haul trucks depositing mined rock material. The warehouse area was tidy and in order with all liquid chemicals and petroleum products properly stored with secondary containment (Photo 14).

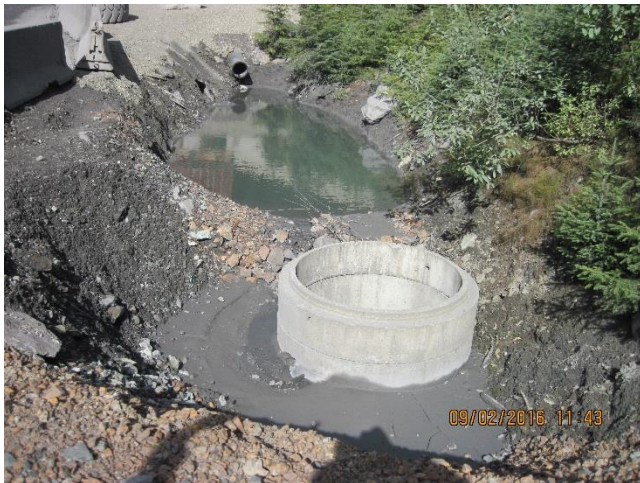
**Photo 12. Rock check dam and sump across from DB-01.**

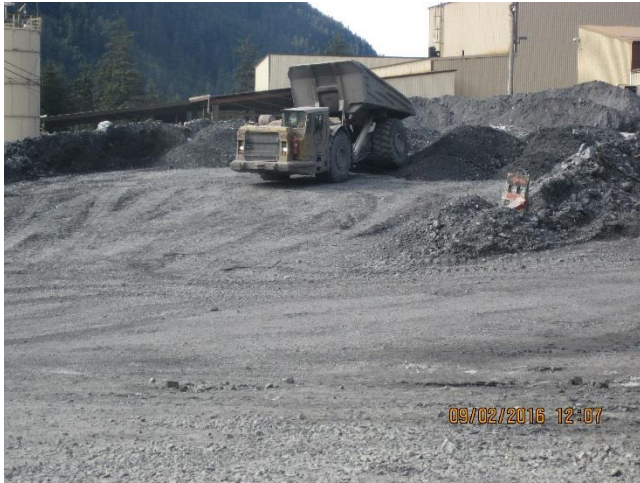
Photo 13. A haul truck depositing mined ore at 920 ore pad.

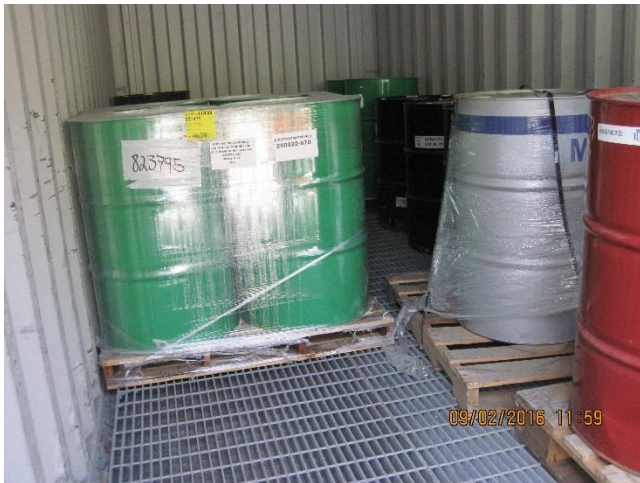
Photo 14. 920 warehouse storage containers.

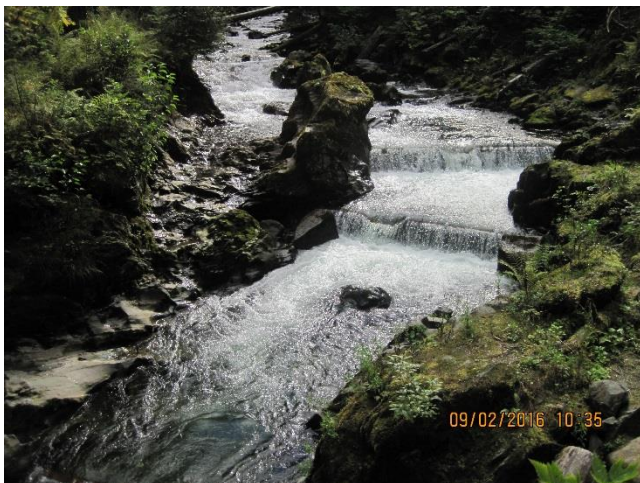
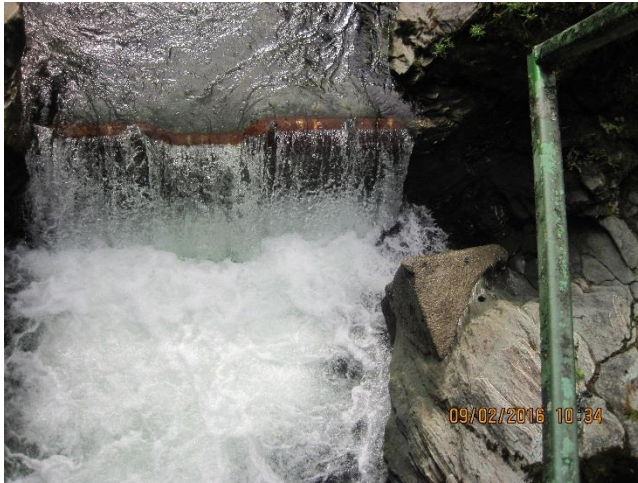
The Greens Creek fish pass was reconstructed as part of the approved Record of Decision for the 2013 Environmental Impact Statement (EIS) for the Tailings Disposal Facility (TDF) Expansion. The construction of the fish pass included installing three concrete steel-capped weirs (Photo 15-16). HGCMC was also issued a fish habitat permit (FH11-1-0123) by the Alaska Department of Fish and Game (ADF&G). This permit authorizes HGCMC to maintain the fish pass in perpetuity. During Bio-monitoring in 2015 and 2016, juvenile Coho were observed at Site 54, which is approximately 3 miles upstream of the fish pass. This is evidence that the previous fish pass structure was not significantly damaged to the point of preventing fish passage. During the site visit, Kate Kanouse of the ADF&G stated that all though not observed at the present time, Pink salmon (*Oncorhynchus gorbuscha*) might be present elsewhere in the stream (Photo 17). Therefore, yearly bio-monitoring should be sufficient to determine fish passage beyond this natural barrier.

Photo 15. Upstream image of the Greens Creek fish pass.

**Photo 16. Upstream image shows 1 of 3 concrete steel capped weirs.**

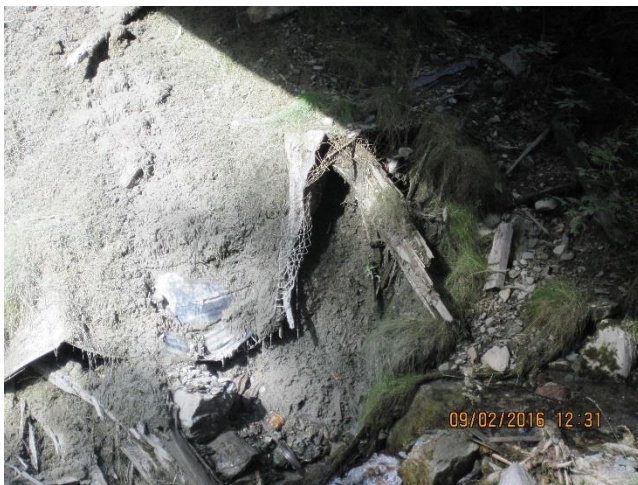
**Photo 18. Downhill side of Killer Creek Bridge.**

An old silt fence (Photo 18) underneath the downhill side of the bridge needs to be improved. Currently the silt fence is not effectively working to prevent sediments from flowing into Killer Creek. The liner on the uphill side (Photo 19) of the bridge is collecting sediments from the abutment however, some sediment from was observed on the ground (Photo 20). This requires frequent monitoring, and maintenance to reduce sedimentation. Removal of sediments is required when accumulation exceeds one-half of the structures design depth (2015 BMP plan Appendix 5 page BMP 24-25).

- 7.4-mile B-road Bridge: Downhill side abutment liner needs improvements.
- 7.4-mile B-road Bridge: Sediment accumulation at both ends of the bridge.
- 3.1 mile B-road sediment screen: The screen is near capacity and needs to be cleaned out.
- Zinc Creek Bridge: The uphill/downstream settling pond needs to be cleaned out.

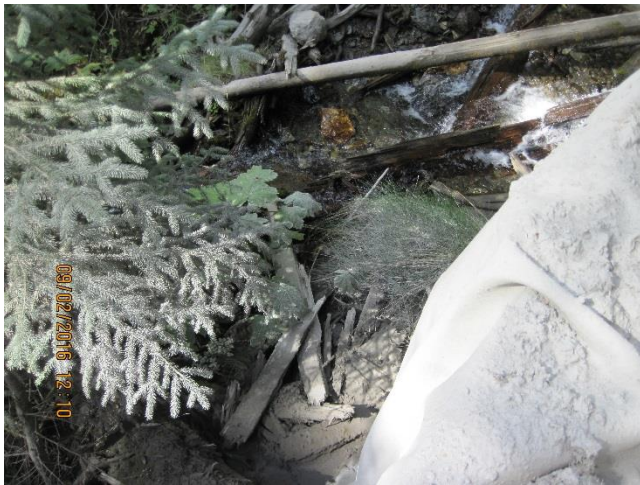
**Photo 20. Sediment on the tree branches and ground below Killer Creek Bridge.**

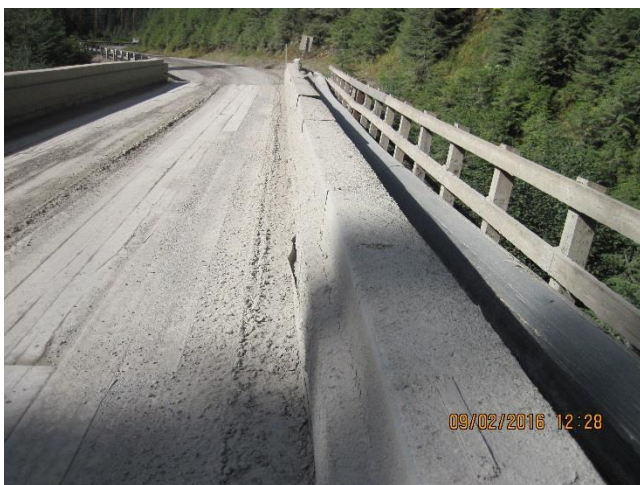
Sediment has accumulated on the bridge's splashguard rails (Photo 21). HGCMC Surface operations should frequently monitor and remove the sediments from the splashguard rails when necessary.

**Photo 21. Sediment accumulation on the rails of Killer Creek Bridge.**

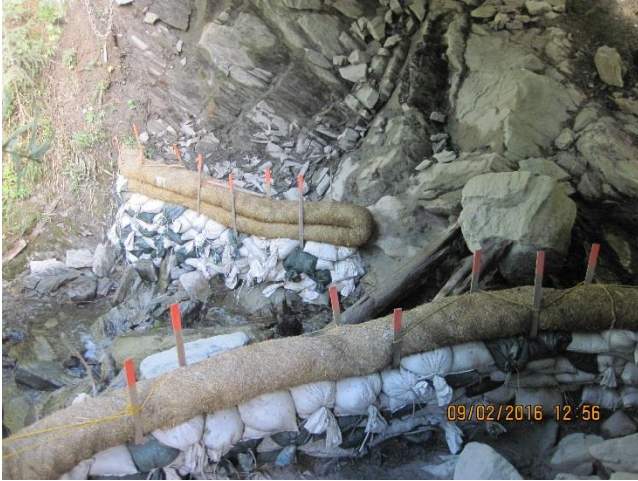
HGCMC Surface operations have placed sand bags (Photo 22), underneath the bridge, to capture sediments from entering Falls Creek. Bridge barriers (downstream side) need to be extended along both ends of the bridge to prevent sedimentation from stormwater runoff. The temporary barrier (Photo 23) on the downhill/downstream side of the bridge has a significant amount of sediment buildup. HGCMC should monitor and maintain the temporary barrier, and remove the sediments to prevent spill over, consistent with the BMPs for silt fencing (2015 BMP plan page BMP 12-13). While this temporary barrier has been shown effective, a longer-term solution for this location is desirable.

**Photo 22. Sandbags and straw wattles placed below Falls Creek Bridge.**

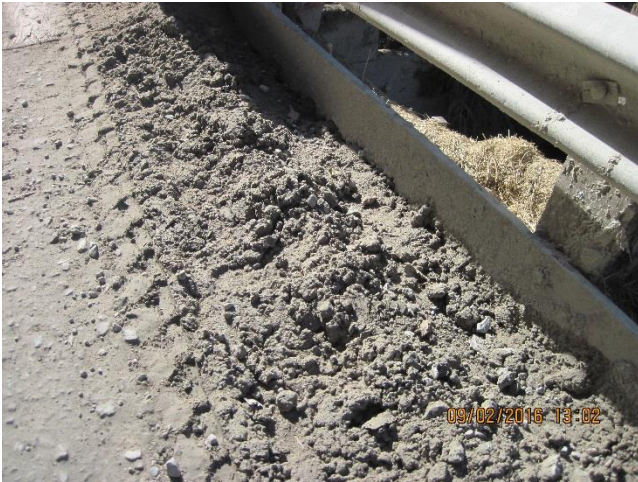
**Photo 23. Temporary barrier at the downhill/streamside of Falls Creek Bridge.**

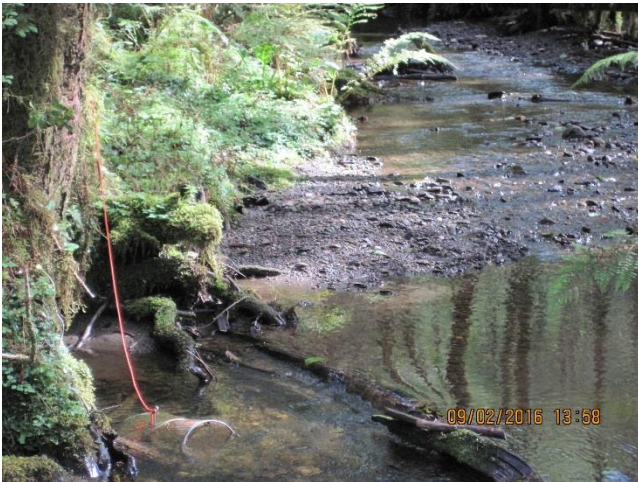
Below the confluence of Falls Creek and another side channel of Zinc Creek, Kate Kanouse from the AF&G, placed four fish traps for several hours to monitor smolt and other juvenile fish populations (Photo 24). The total fish species count for all four traps were 21 Coho salmon, 16 Dolly Varden, 9 Cutthroat/Rainbow trout, 1 Sculpin, and 1 adult female Sockeye salmon observed in a side channel for Zinc Creek.

**Photo 24. 1 of 4 fish traps placed along above the Confluence of Falls Creek and an unnamed tributary.**

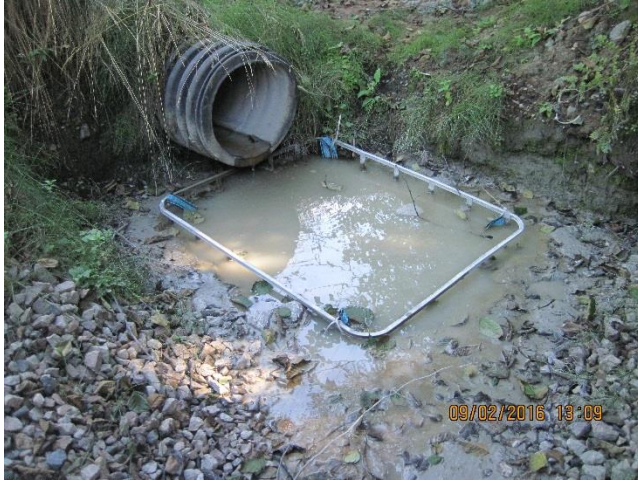
The 3.1-mile B-road sediment bag (Photo 25) is near capacity and requires maintenance. A sediment sump (Photo 26) located on the uphill/downstream side is also near capacity and should be mucked to remove excess sediment. The BMP's installed (Photo 27) at the uphill/downstream side need to be frequently monitored and maintained. The buildup level for a sediment trap should not exceed one-half of the structures design depth as stated in the 2015 BMP plan Appendix 5 page BMP 24-25.

**Photo 25. 3.1 mile B-road removable sediment screen.**

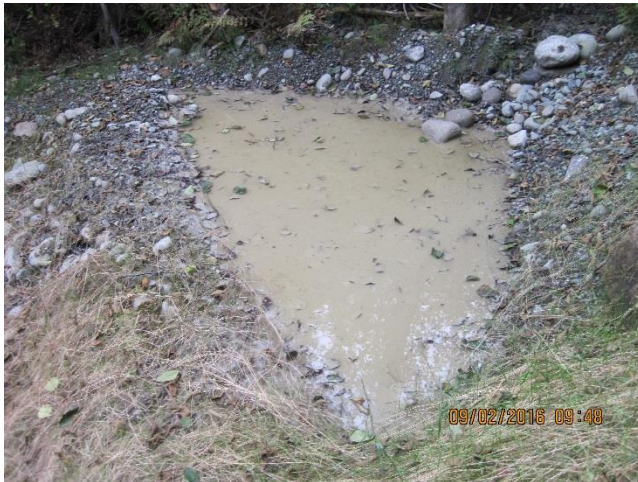
**Photo 26. Zinc Creek Bridge uphill/downstream side sediment sump needs to be mucked.**

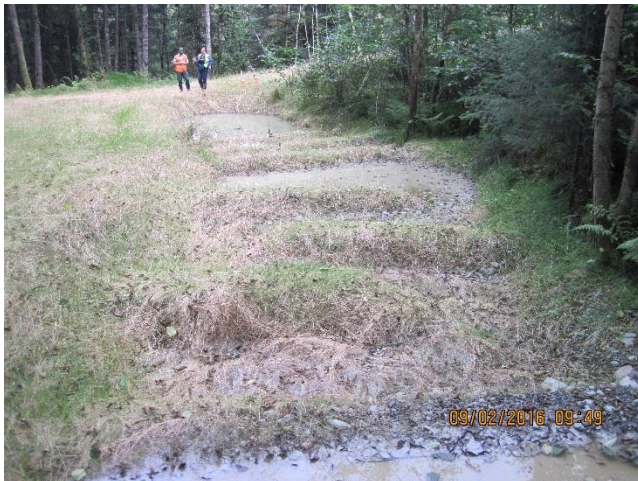
**Photo 27. Zinc Creek Bridge uphill/downstream sumps and rock check dams.**

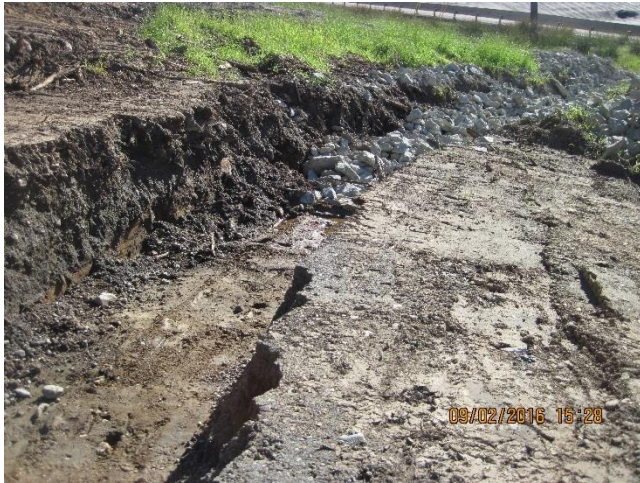
During the last inspection (08/12/2016) it was documented that stormwater flow paths had formed toward the stockpile pad. Contractors have installed an up slope non-contact water trench (Photo 28) to capture and divert stormwater runoff from the stockpile. Additional BMP's were constructed at multiple locations with imported rock to capture stormwater runoff (Photo 29).

**Photo 28. An up slope non-contact water diversion trench at the 0.9 mile B-road.**

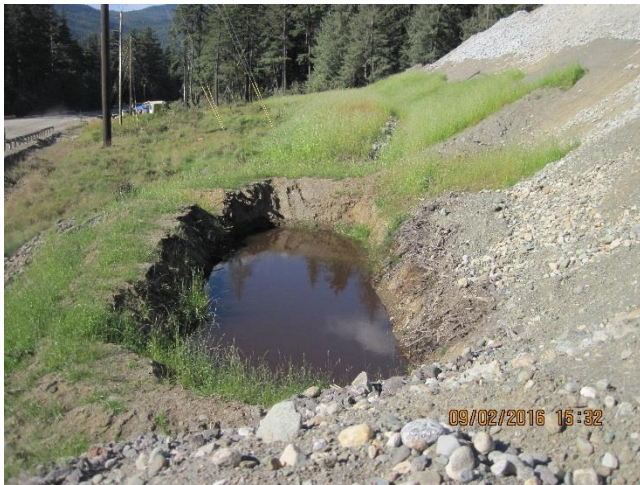
**Photo 29. A sump for collecting stormwater runoff from the gravel stockpile at the 0.9 mile B-road.**

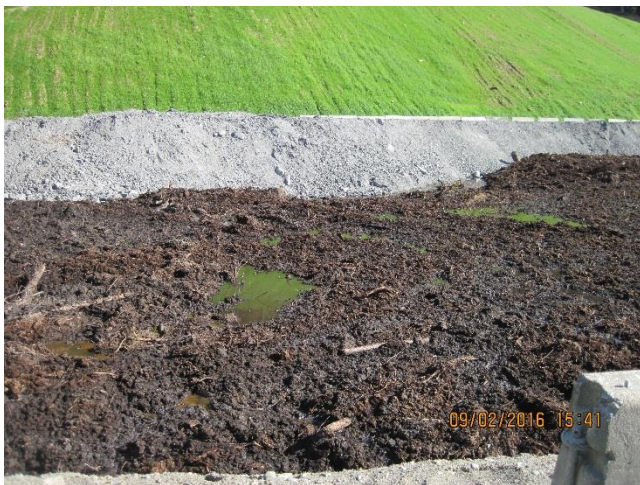
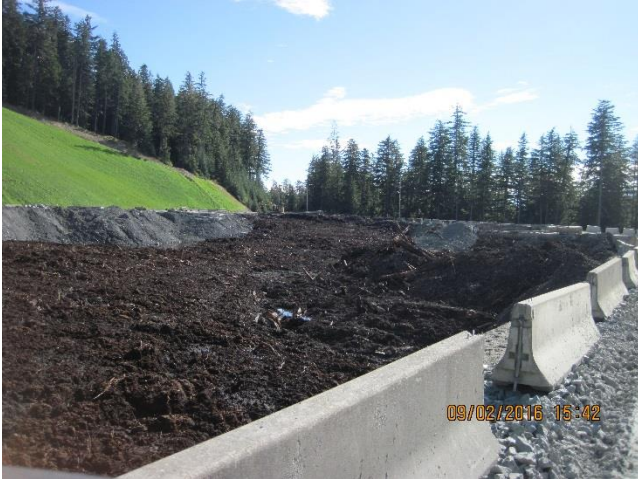
Gray/blue clay material has been stockpiled along the perimeter of the pit (Photos 30-31). The organic material at this location is from the excavation of Pond-10 as approved in the July 2015 Change Analysis. Approximately 148,000 cubic yards has been stockpiled at this location.

**Photo 31. 1.4 mile A-road sand pit approximately two-thirds of the pit is full.**

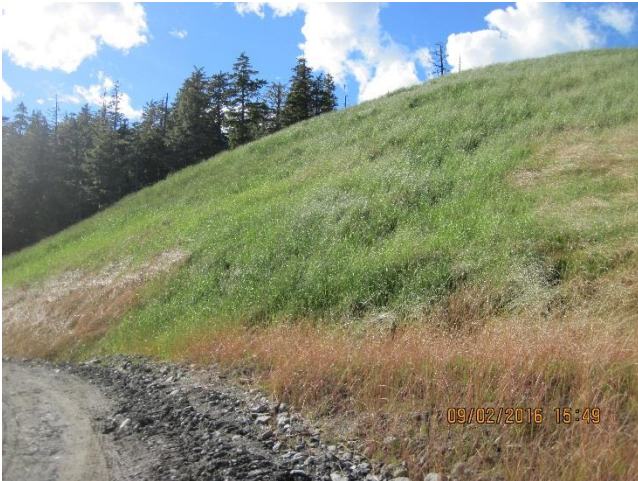
The hydroseeded slopes show grass is growing well (Photo 32). The site was tidy and in order.

**Photo 32. Pit 7 slope. Grass is growing well along the slope.**
