**Division Of Environmental Health
Solid Waste Program
410 Willoughby Avenue, Suite 303
Juneau, Alaska 99801-1795
<http://www.state.ak.us/dec/home.htm>**

Subject: January 16, 2002 Site Visit

Site 23/D

Tailings Site

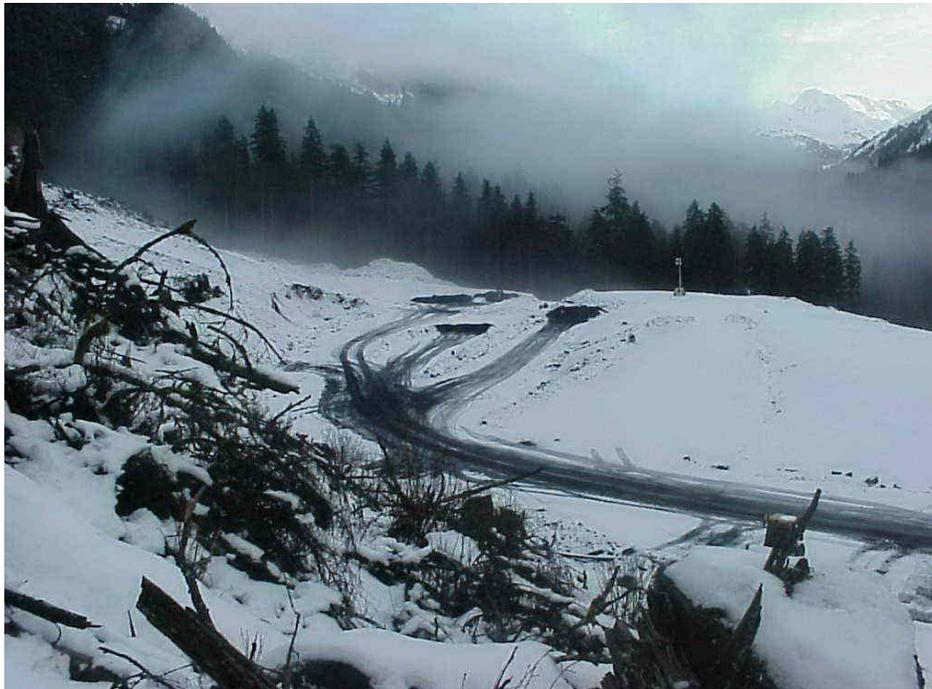
Production Rock Site 23

This past year, approximately 53,000 tons of production rock was disposed at Site 23 and 157,000 tons were placed underground.

Sites 23 & D were snow covered at the time of this inspection. Although snow cover prevented a thorough physical examination of the site, most of the major aspects such as disposal of classified rock, monitoring devices, drainage features and final cover system test plot were observed. It was useful to observe the facility during winter conditions as cold temperatures present unique challenges to landfill operation. The site was found to be operating within the prescribed permit conditions. The site is designed to have capacity to accommodate production rock throughout the current mine plan .

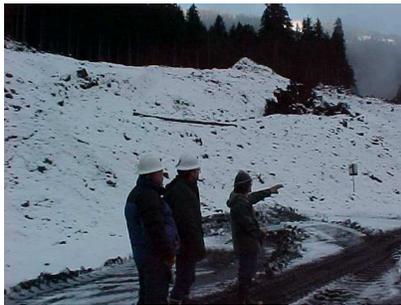
Waste was placed according to classification type. Class I rock was disposed peripherally at the site according to plan. Class II and Class III rock was disposed centrally in specific zones within the fill. Class III rock was placed more centrally within the pile than Class II rock. It was reported that waste is compacted with dedicated compaction equipment and the resultant hydraulic conductivity is approximately 1×10^{-5} cm/sec. Outside slopes were estimated to be constructed at a gradient of 3(H):1(V) for stability.

Disposal of Class I Waste Rock

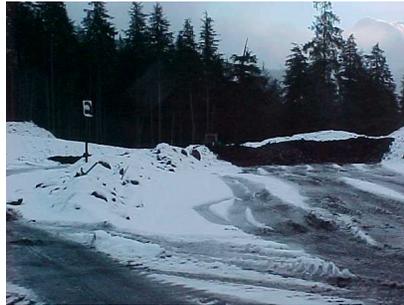
Class II Waste Rock

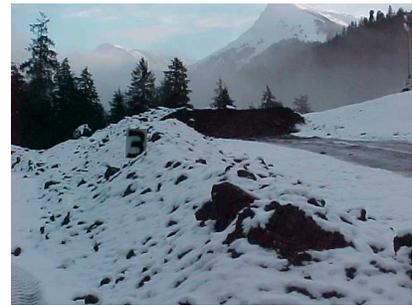
Class III Waste Rock

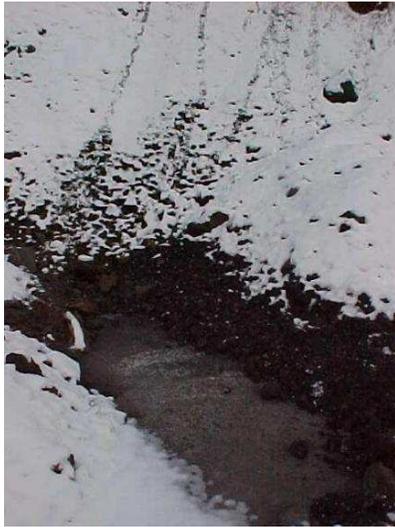
Finger drains were placed in run-on zones and staked for ease of extension as the fill expanded vertically. There was very little observed run-on to the facility, and KGC staff report little run-on during the spring thaw. Where run-on was observed, finger drains were in place. Because of time constraints we were not able to observe all internal and compliance monitoring devices in detail and correlate their placement on the map that was provided to the Department on May 31, 2001. However, these were pointed out and it appeared the placement was correct. KGC has field verified all site monitoring device locations. Monitoring devices should be fitted with locking caps and be locked when not in use to prevent unauthorized access. A map providing geographic coordinates based on the local coordinate system should be included with the annual report for all monitoring devices, along with relevant data from the stations. This information will be very helpful to the department for a variety of reasons, including historic records, changes that occur during the life of the mine, and tracking post-closure monitoring.

Run-on at Finger Drain

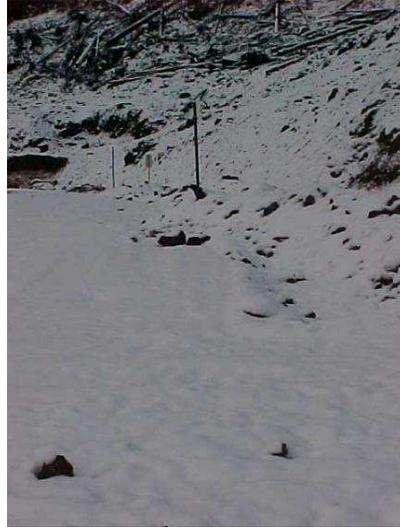
**Staked Finger Drains
Production Rock Site 23 - Detail**

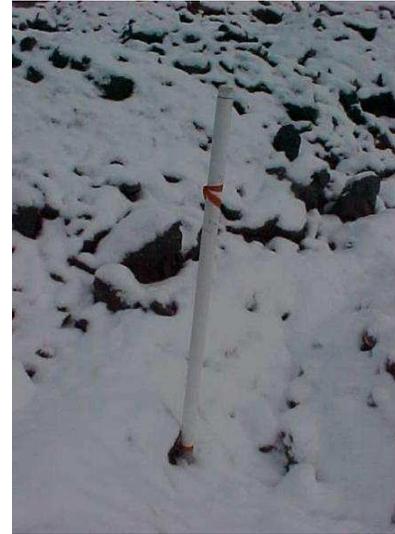
Monitoring Device Without Lock

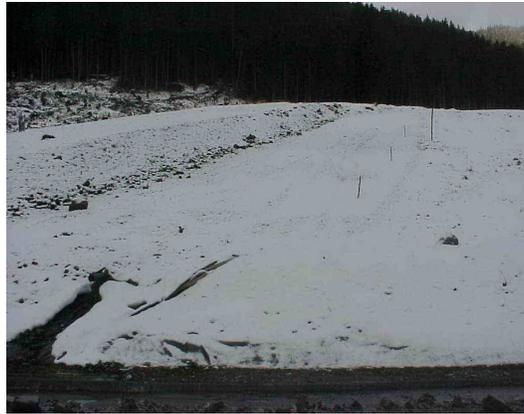
The test plot is relatively small and accessible to air on all sides of the test plot. Therefore, according to site operations staff, the implementation of direct oxygen monitoring would likely result in inaccurate results because of the lateral diffusion of air below the installed barrier layer.

Production Rock Site 23 - Final Cover Test Plot Showing Exposure At Sides To Air

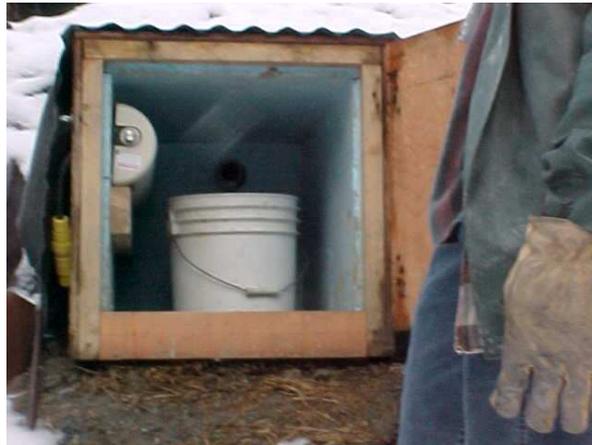
Water was observed in the lysimeter collection system that indicated the passage of water through the cover system. Site personnel reported this result is expected as the cover system design is expected to pass water at the rate of approximately 10% of the annual rainfall, or between 7-9 inches a year.

Production Rock Site 23 - Lysimeter Drain at Final Cover System Test Plot

Demonstrating the effectiveness of this soil cover system would be advantageous with the complete closure of Waste Site "E" or some other site with acid producing potential. Completely closing a site on all sides would allow for the effective establishment of the soil cover as well as installing monitoring devices or access tubes for direct oxygen readings could enhance the demonstration of the final cover system performance.

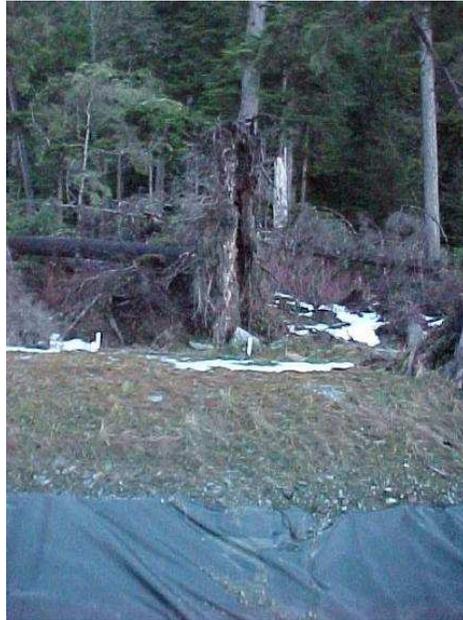
At this inspection several large trees had been blown down immediately above the tailings disposal site. It was clearly visible that for stability, roots spread horizontally, rather than penetrated deep into the soil. The root system of the blown down tree did not appear to bring the underlying soil up with the roots, except for that which was caught within the roots themselves. The roots appeared to be penetrate up to 18" from the surface, however it could not be determined whether that would have been a full 18" into the soil itself, some of the root mass may have been growing on the surface of the soil. Whether this is considered to be substantial enough over time given further development of the organic mat is unclear. It is also unclear by this examination whether or not soil in the growth layer of the final cover system would be taken away over time as there is likely to be an increase in growth layer thickness over time due to the accumulation of organic material.

Uprooted Tree Above Tailings Site

Qualified personnel should explore long-term issues related to tree blow-down and relate this information to the final cover system for the facilities at Greens Creek in a more quantitative manner. Issues to be explored should take into account at a minimum the age of trees and soil conditions of the growth layer at blow-down. If it is found the growth layer deteriorates over time, then a plan should be developed that minimizes or prevents tree growth or “blow-down” of trees.

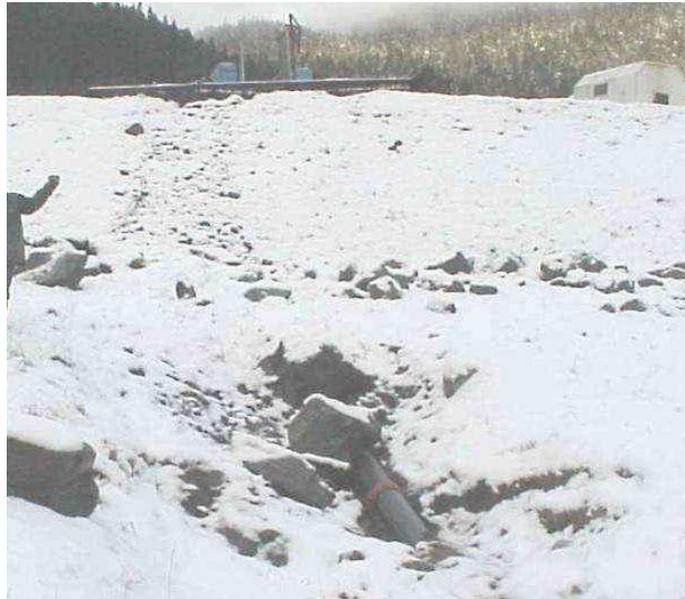
During the inspection we took a look at the exposed pipe from the Site 23 curtain drain. Sampling the water in this pipe would enable us to understand the chemical composition of the water that enters this drain from Site 23. This exposed portion of the drain pipe should be added to the internal monitoring program and sampled according to the internal monitoring program for the facility as prescribed in the General Plan of Operations.

Drainage Pipe From Curtain Drain At Site D

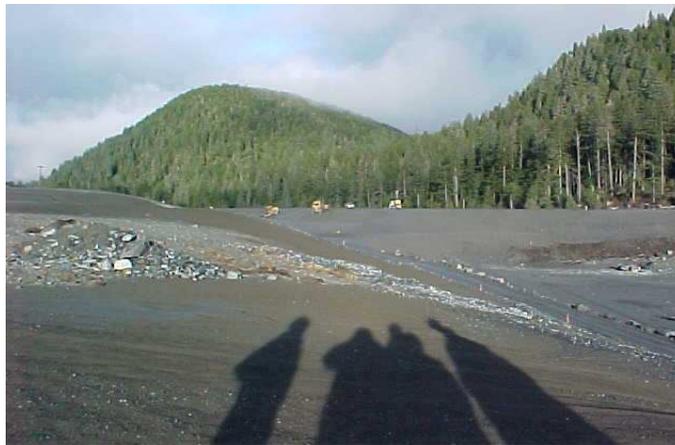
Landfill capacity is an issue as the site has achieved maximum vertical height in the south section of the landfill. Soon the eastern expansion will achieve maximum height as much disposal has occurred in this section over the past year. In January 2002 the Department and the USDA Forest Service approved a liner design for the Wide Corner (southeastern aspect). Tailings placement in the Wide Corner area will likely be available in the spring of 2002 after the liner is installed. Development in the Wide Corner and West Buttress areas during the next year should provide sufficient disposal space during the time the EIS for Stage II of the tailings project is completed (3rd quarter 2002).

Central Portion (left) and Eastern Portion (right) of Tailings Disposal Facility

Depending upon the outcome of the EIS for Stage II of the tailings project, the areas of the site that achieve maximum vertical design elevation will require interim or final reclamation once maximum vertical expansion is achieved. Should the EIS recommend expansion of the existing tailings, then the facility will expand both horizontally and vertically thereby postponing final

reclamation. Should the EIS not recommend expansion, these areas of the landfill are to be reclaimed within 3.5 years after last tailings is placed (final design elevation). Please keep us informed on disposal capacity issues. This is an item that should be addressed in the April 15th annual report.

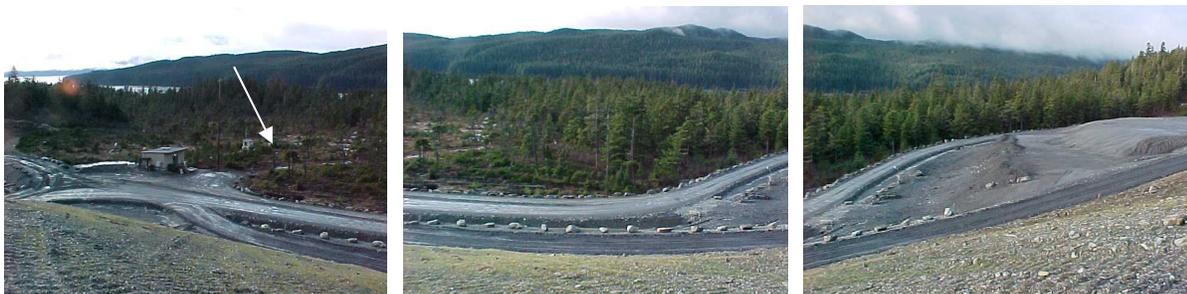
Pyritic rock that contains carbonate mineralization appears to have been used as bedding for a segment of the NPDES pipeline just west of Pond 6. Similar rock appears to have also been used to construct an access road that lies to the west (outside) of the Saddle Embankment slurry wall. Water flowing along the preferential pathway caused by this rock fill has neutral pH (due to carbonate buffering) but has modest sulfate concentrations. The water that follows this preferential pathway emanates from the drain of the NPDES pipeline flow meter housing, named "Duck Blind" (because of its appearance). Information gathered to date does not indicate that failure of the seepage control structure or that seepage of tailings contact water is the cause of the seeps. Extensive sampling of contact water from the tailings facility show it to be alkaline not acidic like the Further Seep water.

Duck Blind Drain Area Further Seep Drainage Area Northwest Tailings Area (West Buttress)
Downgradient Western Area Of The Tailings Disposal Facility

13. Confirm and potentially remove or treat pyritic material in the access road below the Saddle Embankment (north of Wet Well 1) and the material in the Duck Blind drainage to the west of the facility. Alternatively, if the EIS (due 3rd quarter 2002) recommends expansion over this area, then provide information that may enable the material to be left in place provided it is contained within a containment structure.
