MEMORANDUM

State of Alaska

SUBJECT: Kennecott Greens Creek Site
Visit
August 21, 2003

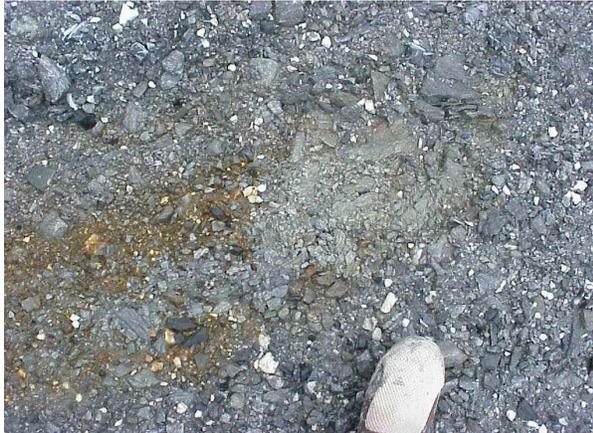
*Site 23 1-year old waste rock at site 23
Note iron staining (approximately 1/4" deep)*

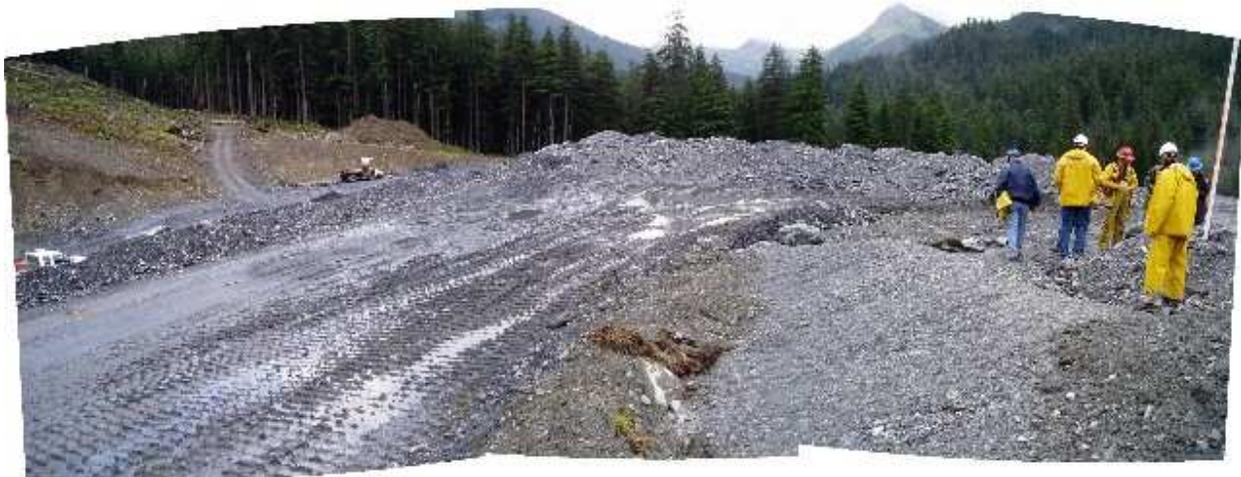
Site 23 was visited. Greens Creek officials pointed out the zones where various classification of waste rock have been placed in accordance with the plan of operations. Additional items noted were water collection appurtenances, finger drains, and the 1-acre engineered cover system that is being monitored to document how it performs relative to the design assumptions.

Differentiation of Class II and Class III waste rock placement zones at Site 23

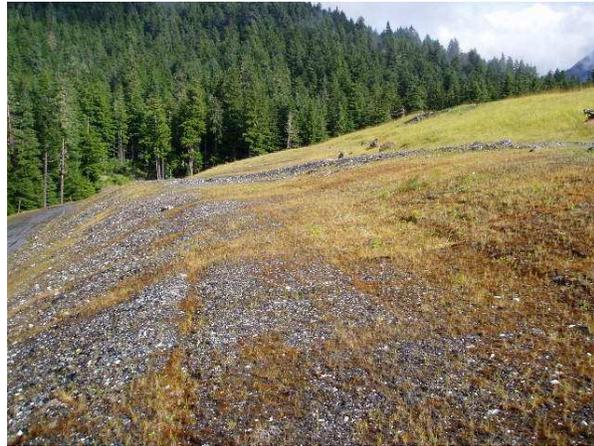
- D. Site E. There were no remarkable changes at Site E since DEC's visit in November 2002. One reclamation alternative being considered for this site is to backhaul the production rock to the tailings disposal site after the stage II tailings expansion is permitted. This would alleviate the need to supply a cover system at Site E. It was reported the cost to do this would be competitive with supplying a reclamation cover system and regarding the existing pile to a 3:1 slope. There are also stability concerns related to native sands under the pile. A geo-technical assessment is currently in progress for Site E to address some of the above issues preparatory to site closure.

Site E, Southeastern Aspect

Site E, Northeastern Aspect

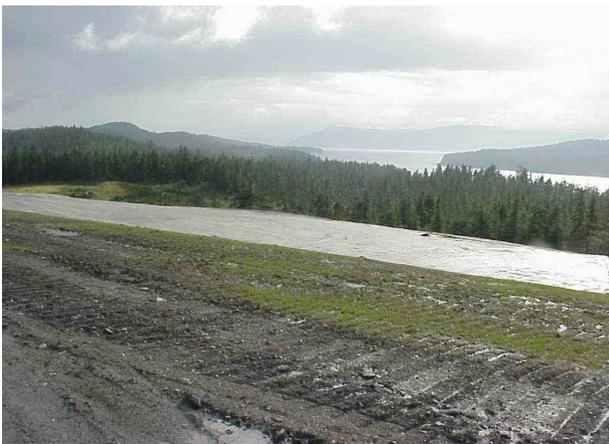
3. Tailings Disposal Site. The tailings site was visited. Portions of the tailings pile are at its presently permitted maximum height and tailings were being placed on the eastern side in the lined quarry area.

Buttress on the west side of the tailings pile

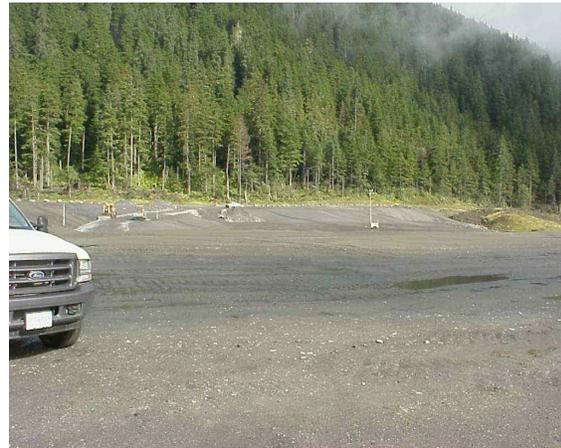
Tailings placement in the lined quarry area
