# MEMORANDUM

State of Alaska

DATE: May 16, 2006

SUBJECT: Kennecott Greens Creek Site  
Visit, May 11, 2006

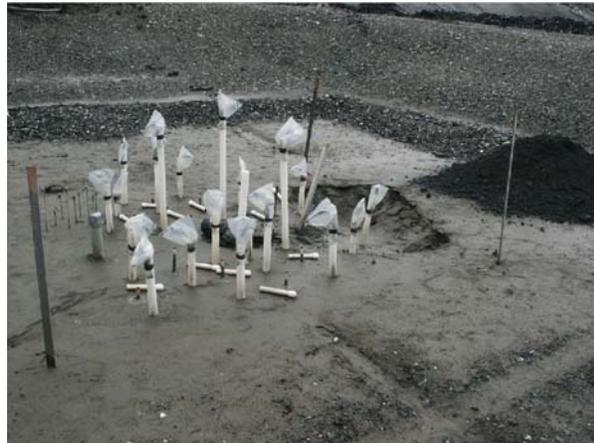
Tailing Site

Sinkhole in southernmost cell

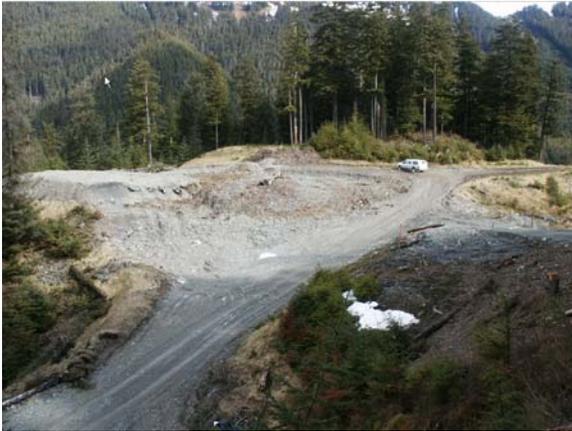
Material from this site had been taken underground. This will continue when feasible during the summer months. A new road had been constructed to a proposed pad that will be used to bore a hole for a ventilation shaft.

Area at Site 1350 where material removed.

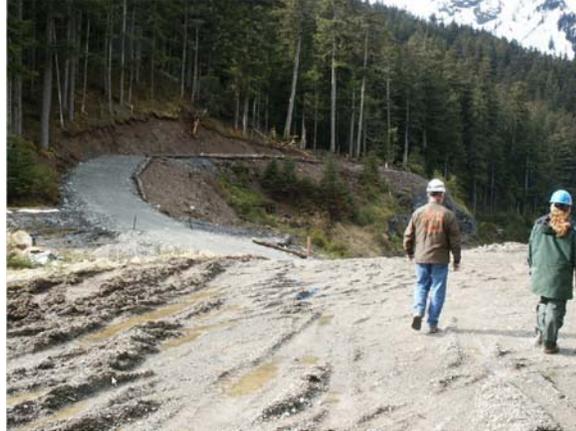
Road to ventilation shaft drill site.

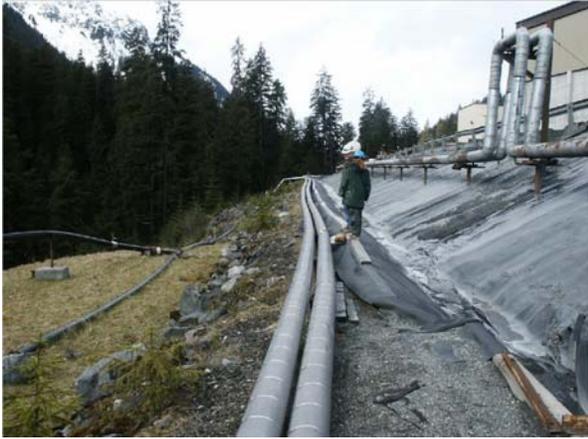
We hiked down the slope from the break to Greens Creek. Sediment was visible in the pipe. The majority of the sediment had been removed from the ground; however there was a small patch of gray solids near the river that Greens Creek will be removing. The sampling technique and protocol for sediments in the river was discussed. Sediment testing is required under the NOV for the spill. Because of the gravel and coarse sediments in the river, it was agreed that the sampling technique specified in the NOV should be modified in order to capture fine sediments. An updated sampling protocol was subsequently sent to KGCMC after the site visit.

The dewatering pipeline that broke.

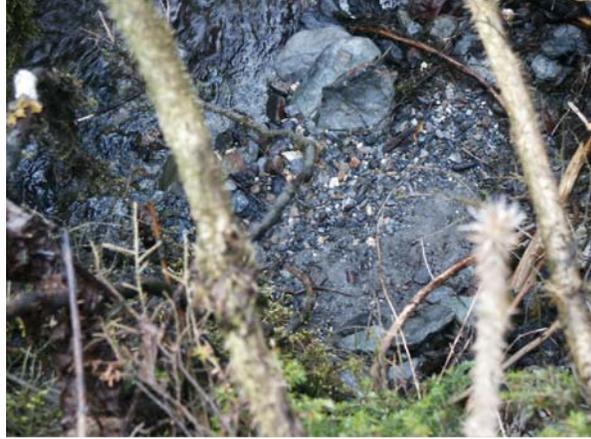
Sediment (which looked like natural sediment) and rocks in the creek.

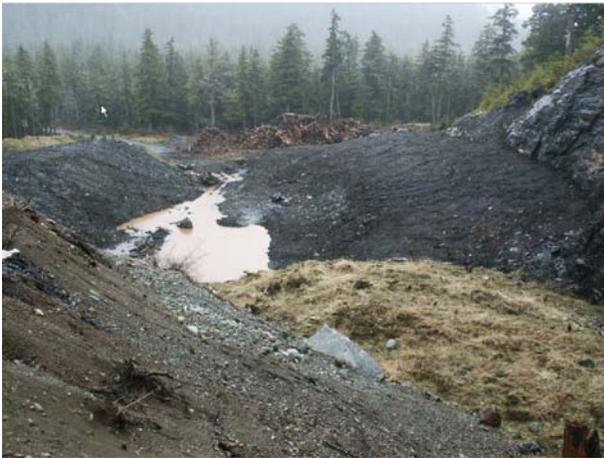
This pit is on the “A” road. Organics such as muskeg have been placed in the pit for storage purposes. It could be seen that a lot of iron and manganese were being released from the organics.

Pit 7 – organics & runoff.

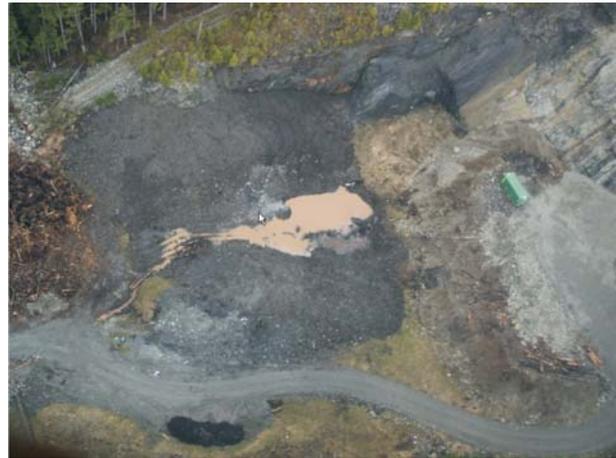
Aerial view of Pit 7.
