# STATE OF ALASKA

## DEPARTMENT OF NATURAL RESOURCES

## FIELD INSPECTION REPORT GREENS CREEK MINE

**Inspection Date:** June 27, 2005  
**Report Date:** July 21, 2005  
**Weather:** Fair. Temperatures around 60°F.  
**Inspection Objectives:** Observation of tailings water storage facilities  
**Operator Contact:** Eric Sundberg, Kennecott Greens Creek Mining Co. (KGCMC)  
**State Personnel:** Ed Emswiler, DEC; Charlie Cobb, DNR,  
**Other Personnel:** Tom Zimmer, KGCMC; Keith Everard, Klohn-Crippen  
**Documentation:** Photos were taken and are available for inspection at DNR in Anchorage and DEC in Juneau.

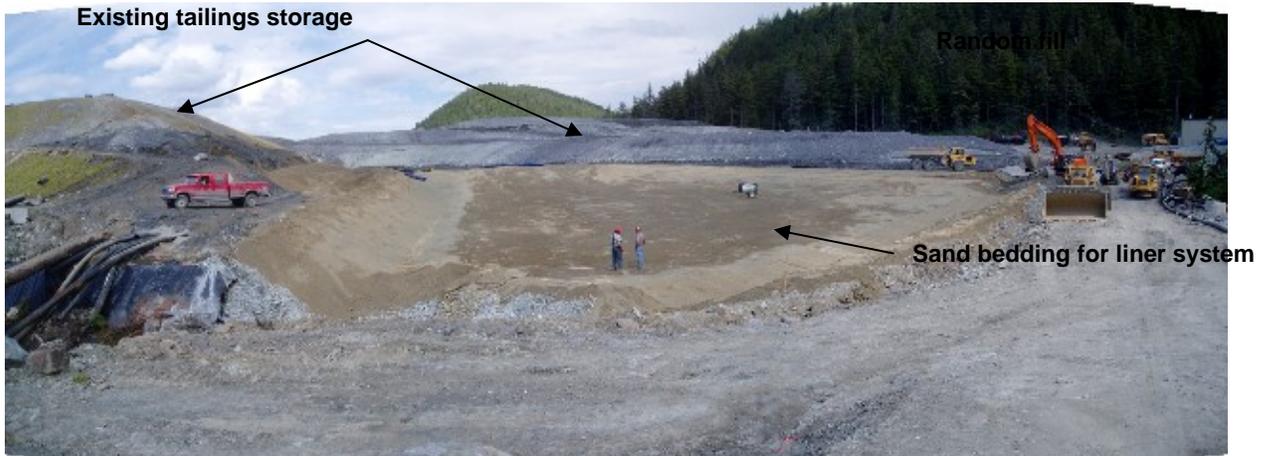
**Figure 1. Tailings Disposal Site – Southeast Expansion Area 2 (looking northeast from Pond 6)**

At the Southeast Expansion Area 2, Tank No. 6 and the truck wash had been removed and the area had been prepared with a sand bedding layer and monitoring equipment (lysimeters and/or piezometers). The work appeared to be contiguous with the specifications in the 2005 work summary. The sand bedding layer was installed and the contractor was beginning to install a geotextile cushion and the 80 mil thick textured (both sides) HDPE geomembrane.

The supplemental geotechnical stability report for the Stage 2 expansion is pending. No additional tailings should be placed above the level of the service layer in the southeast expansion area without ADEC approval. Demonstration of the stability of this critical cross section should be submitted as soon as possible.

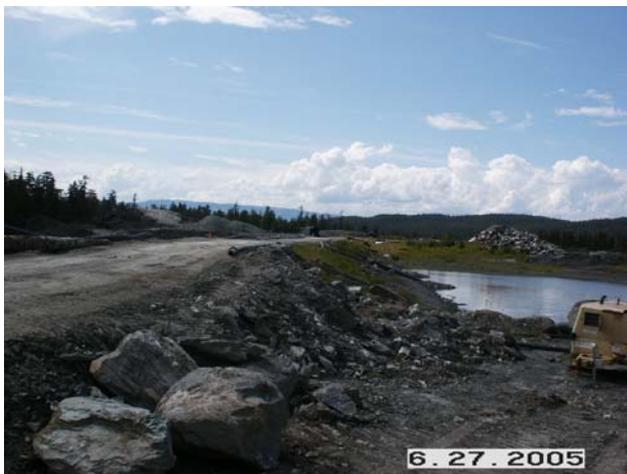
Pond 6 was observed including the Upper Cannery Tailings Dam (National Inventory of Dams number AK00203) which is under jurisdiction of the Alaska Dam Safety Program, as seen in Figures 2 and 3. The water level in the pond was low, and water was observed entering the system from the tailings pile underdrains. The dam and spillway appeared to be in good condition. Pond 6 is scheduled to be removed from service and used for tailings storage as part of the Stage 2 expansion.

**Figure 2. Upper Cannery Tailings Dam.**

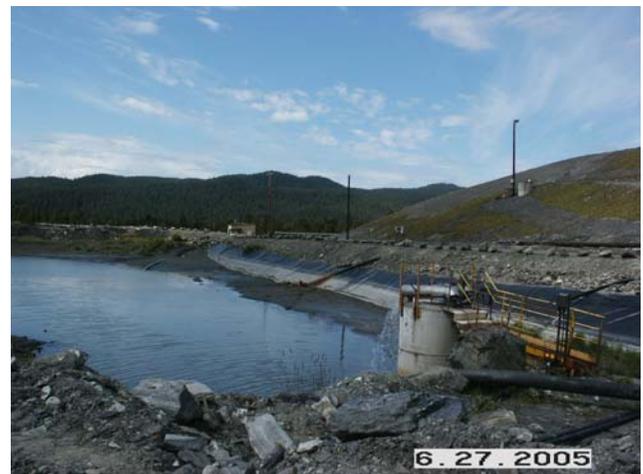
**Figure 3. Pond 6**

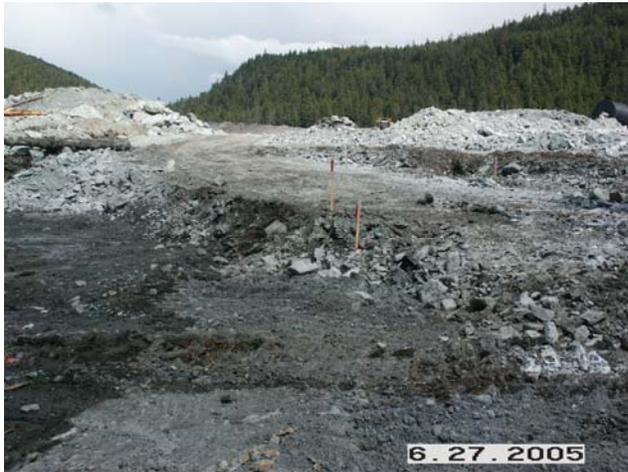
**Figure 4. Pond 7 Dam Excavation and Fill**

We then proceeded to the Pond 7 area that was being excavated and prepared as a stormwater retention pond according to the 2005 work summary. We observed the HDPE components and foundation for a wet well that will be installed in Pond 7, and the portions of exposed foundation and fill placement for the Pond 7 Dam (National Inventory of Dams number AK00307). This dam will be under the jurisdiction of the Alaska Dam Safety Program and a *Certificate of Approval to Construct a Dam* has been issued by ADNR. The area of the spillway was also observed, but a substantial amount of excavation still needed to occur. Some oversized rock was observed in an area of fill. The foundation excavation and construction of the dam and liner system for Pond 7 will be completed over the 2005 construction season. Pond 6 will continue to operate until Pond 7 is commissioned, and will be used for additional operational storage until it is to be used for tailings disposal.

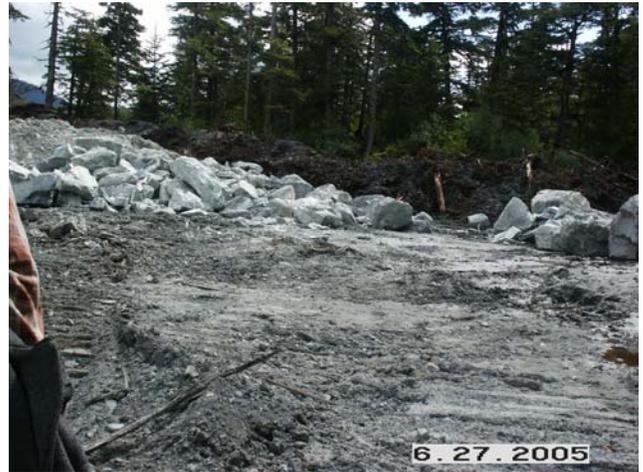
**Figure 5. Oversized rock in fill at Pond 7 Dam**

Oversized rock in fill at Pond 7 Dam should be removed and replaced with fill that meets project specifications.

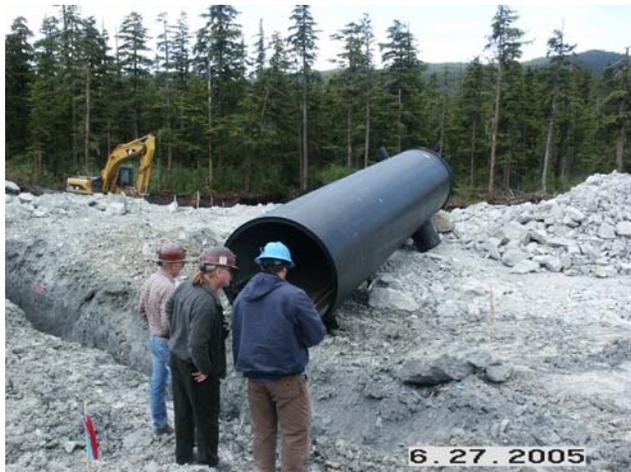
**Figure 6. Pond 7 Wet Well**

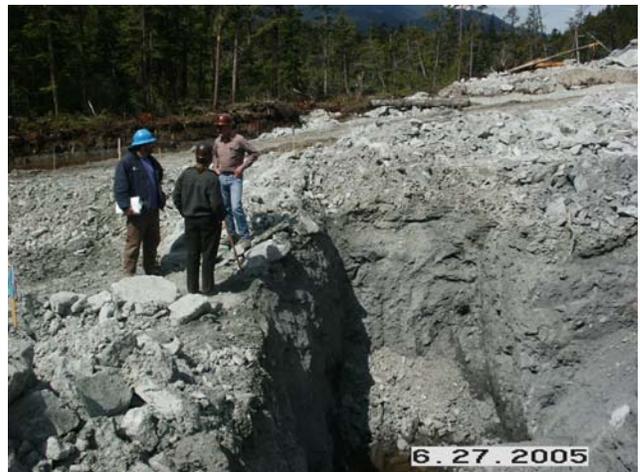
**Figure 7. Pond 7 Wet Well Excavation**

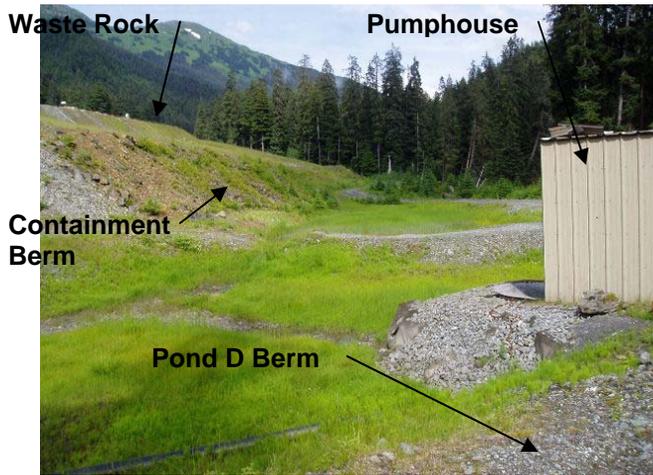
**Figure 8. Site D and Pond D**

At Site D, placement of native glacial till excavated from the mill during site development is overlain by waste rock, as seen in Figure 8. Recent investigative field work and data analysis associated with hydrology, geochemistry and geotechnical stability suggest that there may be long term advantages to relocating the production rock placed at Site D. Field work and data analysis is continuing to identify potential risks and benefits with either leaving the site at the current location or moving the material elsewhere. We observed red staining of the rock in the outer buttress that is most likely due to lichen growth, as seen in Figure 9.

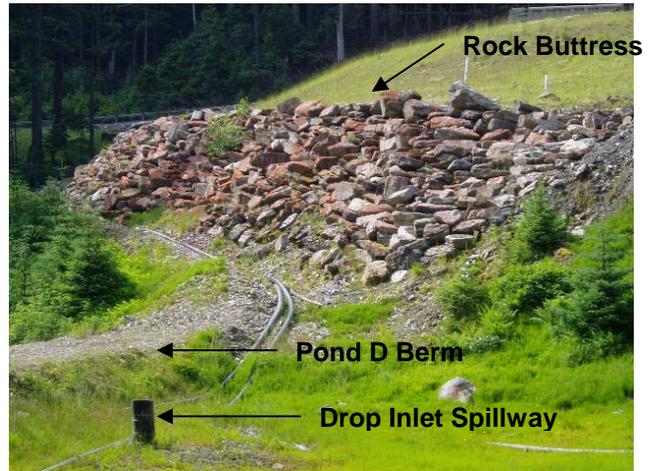
**Figure 9. Site D Buttress and Pond D Berm**

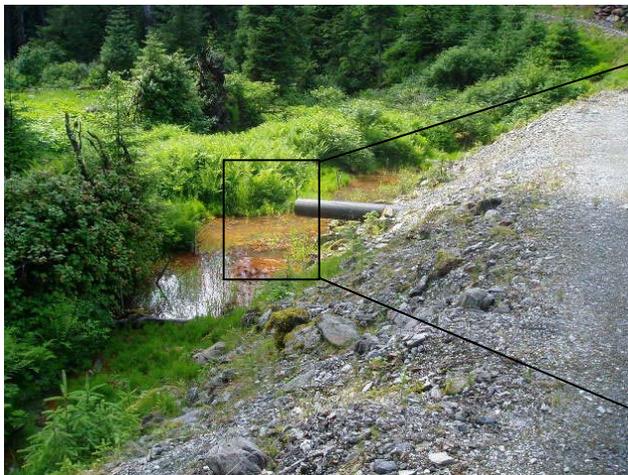
**Figure 10. Pond D Spillway Outlet**

An orange colored precipitate/staining was observed in the water below the Pond D berm at the discharge of the drop inlet spillway, as seen in Figure 10 and 11. The berm at the lower aspect of Site D was constructed to contain the surface and groundwater runoff from Site 23/D and to provide sedimentation control. The berm contains some pyritic quarry rock from the development Pit 405 in 1988. The water was clear. The orange color appeared to result from the sediment and biological growth that settled on the bottom of the pool. Efforts are taken to drain down Pond D to the maximum extent possible. At this visit a minimal amount of water storage was observed in the upper compartment. At the time of this site visit there was no apparent evidence of seeps through the berm, as active pumping maintains the pond empty or very low other than during major storm events.

KGCMC measured field parameters of the pool outside of the Pond D berm (Figure 10) in June 2002. This monitoring produced a pH of 6.9 and conductivity of 620 uS/cm. This represents a low to moderate soluble load and low acidity. A likely explanation for this is that oxidation of pyrite rock in the berm produces soluble iron that precipitates upon reaction with the atmosphere as the water daylights from the toe of the berm. Iron oxidizing bacteria usually promote these reactions. It is also common in disturbed areas to have changes in the water table, or redox-boundary, mobilizing iron and manganese from the original, undisturbed soil. This may contribute to the staining observed at the base of the site. Examples of such natural redox reactions exist at several sites beyond the KGCMC facilities. Water flows intermittently from the Pond D berm into a vegetated boggy area (Figure 10; upper-left) prior to reaching Greens Creek.

The remediation plan for the Pond D berm will result in its being removed within a few years, following completion of other priorities, such as a pumped water return system from Pond C. Plans include reconstructing the berm with inert material; a possible source is material recovered from the continuing development of the upslope of Site 23.

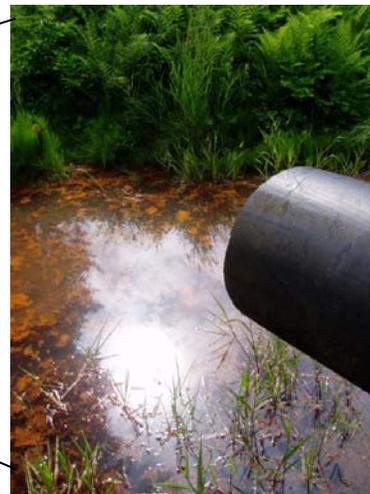
**Figure 11. Pond D Outlet. Note orange color of water.**

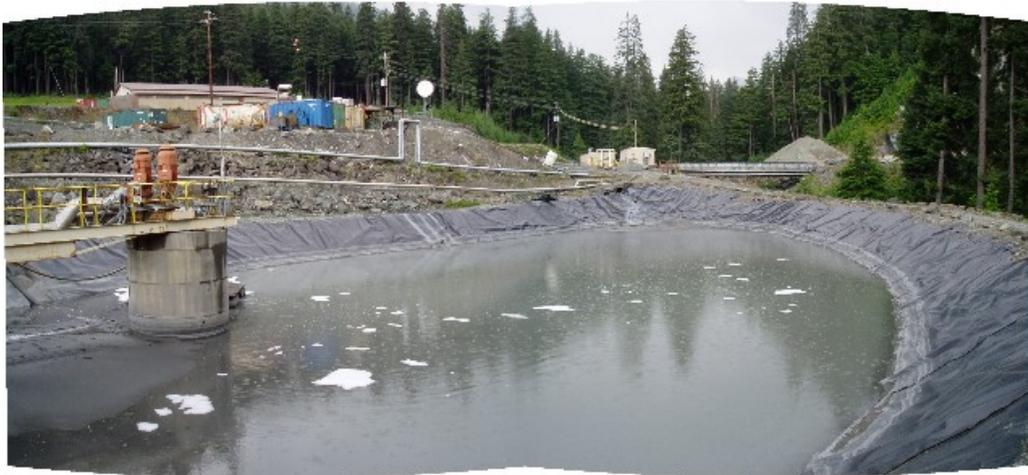
**Figure 12. Pond A. Note proximity to bridge over Greens Creek to portal.**

At about 3:30pm we visited Pond A at the mill area. Pond A is part of the “closed” system that captures waters which contain sediments from the mill area. Runon into Pond A is limited by diversion ditches above the mill. Water captured in Pond A is transmitted to treatment at Pit 5. When sediments build within the pond and other containment structures in this area they are collected and taken back to the mill or taken to the tailings disposal site. Pond A is formed by an embankment adjacent to Greens Creek, as seen in Figure 12.

A review should be conducted of Pond A to determine if the embankment meets the statutory definition of a dam under AS 46.17.900(3). If so, it would be under the jurisdiction of the Alaska Dam Safety Program. A Hazard Potential Classification and Jurisdictional Review form (available from the Dam Safety and Construction Unit) should be completed by an engineer qualified under 11 AAC 93.193.

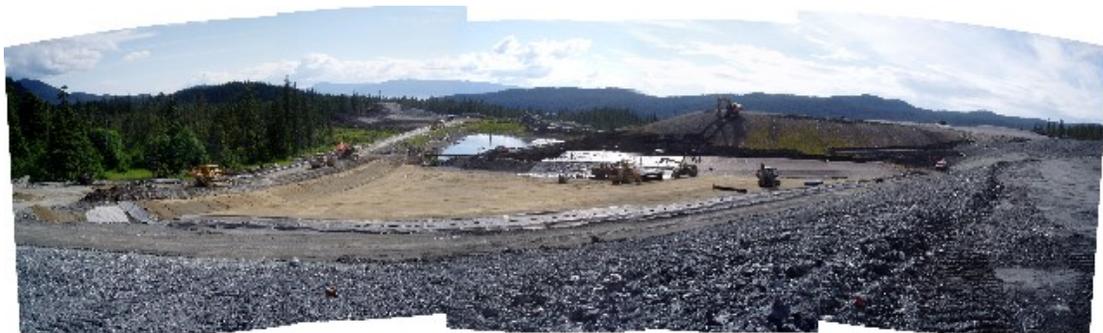
**Figure 13. Liner installation at Southeast Expansion Area #2 of Tailings Storage Facility**

At approximately 4:30pm we traveled back to the cannery area where we turned in our protective gear and caught transportation back to Juneau. On the way we stopped at the tailings site where we observed the geosynthetic liner system being installed at the southeast expansion area 2, as seen in Figure 13.
