INSPECTION REPORT: GREENS CREEK MINE

Tongass National Forest Minerals Group
8510 Mendenhall Loop Rd
Juneau, AK 99801
(907) 789-6276 – office
(907) 586-8808 – fax

Date of Inspection: Wednesday, May 24, 2017
Date of Report: Friday, June 9, 2017
USDA Forest Service Inspector: Edward Gazzetti

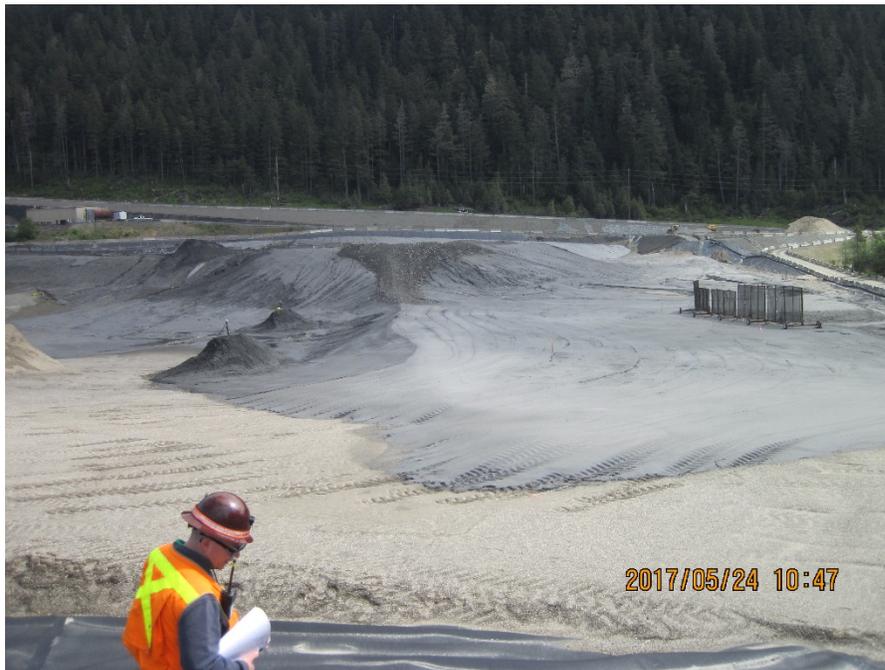
Tailings placement continues along the eastern edge of the Stage 3 Expansion Area (Photo 1). HGCMC crews place class 1 waste rock (low sulfur content) and organic material (i.e. peat) on inactive faces of the tailings facility to mitigate erosion and fugitive dust risk. Organic material for this project is sourced from a peat storage area located within the TDF.

Photo 1. Looking east towards Stage 3 Expansion Area.

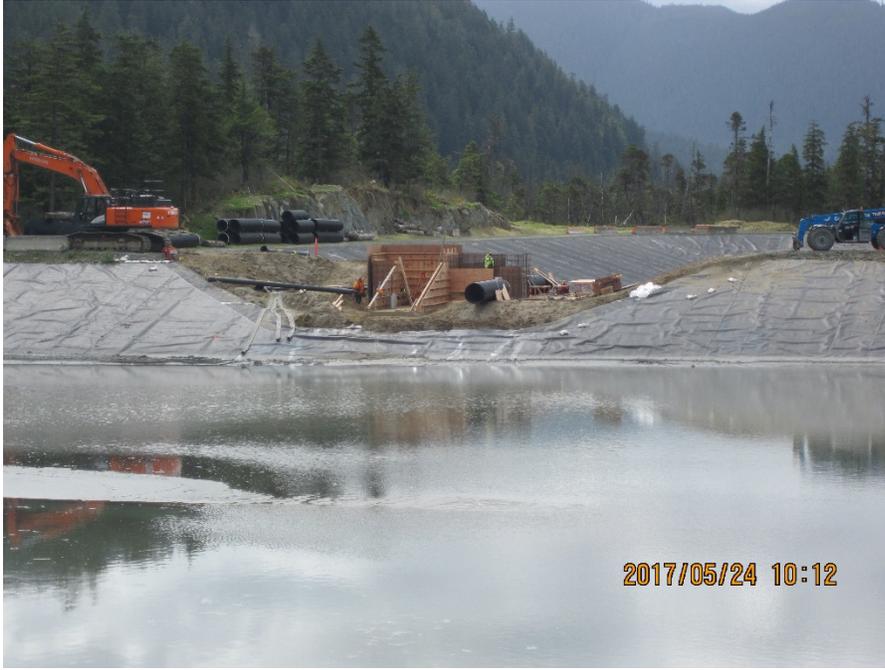
HGCMC appears to be operating the Pond 7 Dam out-of-compliance with Certificate of Approval to Operate a Dam # FY2013-9-AK00307 (COA to Operate). Additionally, construction is occurring on Pond 7 without ADNR's approval to modify a dam. ADNR Dam Safety has issued a temporary COA to Operate, which will be valid until August 12, 2017, in order to allow HGCMC time to come into compliance.

HGCMC temporarily lowered Pond 7's water level and storage capacity to an elevation of 128' above sea level (ASL) during excavation and construction along its southern barrier (Photo 2). The barrier abuts the north end of Pond 10, and was drilled, blasted, and excavated to install water pipelines and a flow control structure. Crews placed a liner between the ponds within a day of the start of construction to limit the risk of Pond 7 overflowing into an unlined area.

Photo 2. Looking south towards the barrier dividing Pond 7 and Pond 10. Storage capacity of Pond 7 was temporarily limited during construction. Four culverts (elevation 137' ASL) will convey water between the ponds once construction is complete.

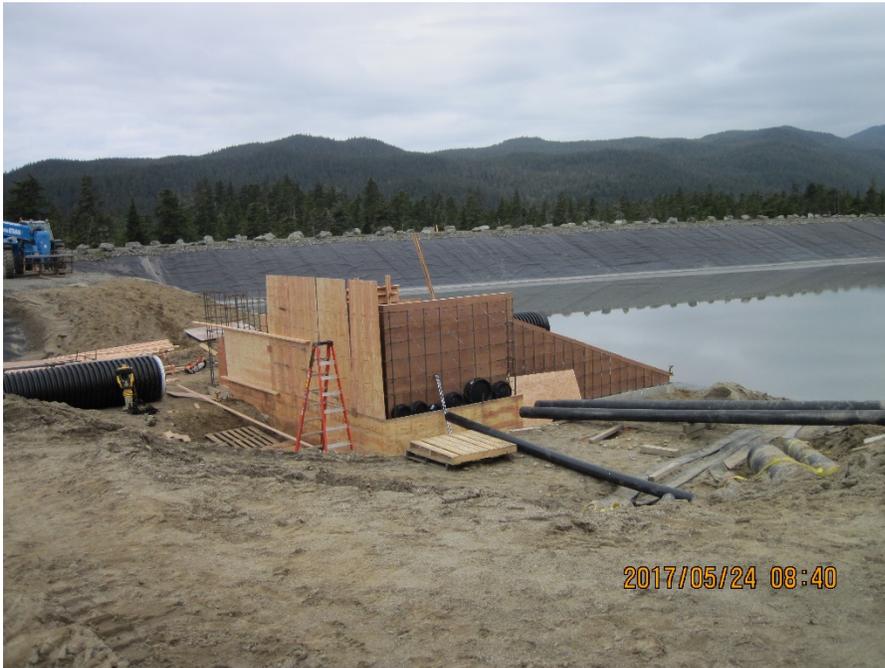
The flow control structure will house a series of pipes and flow meters, and will manage water entering the pond system from the mine property by directing it to either Pond 7 or Pond 10 (Photo 3). Upon completion of construction, a series of four 36" culverts will run adjacent to the flow control structure. These culverts will sit at an elevation of 137' ASL and will allow free flow of water between the two ponds. It is worth noting that while Pond 10 is fully lined, HGCMC does not currently have authorization to operate it.

Photo 3. Once completed, this concrete flow control structure will monitor and distribute water conveyed from the mine property. Water from Pond 23 will eventually flow around the southern edge of the TDF and into this area, where it can be diverted to either Pond 7 or Pond 10. Four 36" culverts, located west (to the left) of this structure will connect the two ponds.

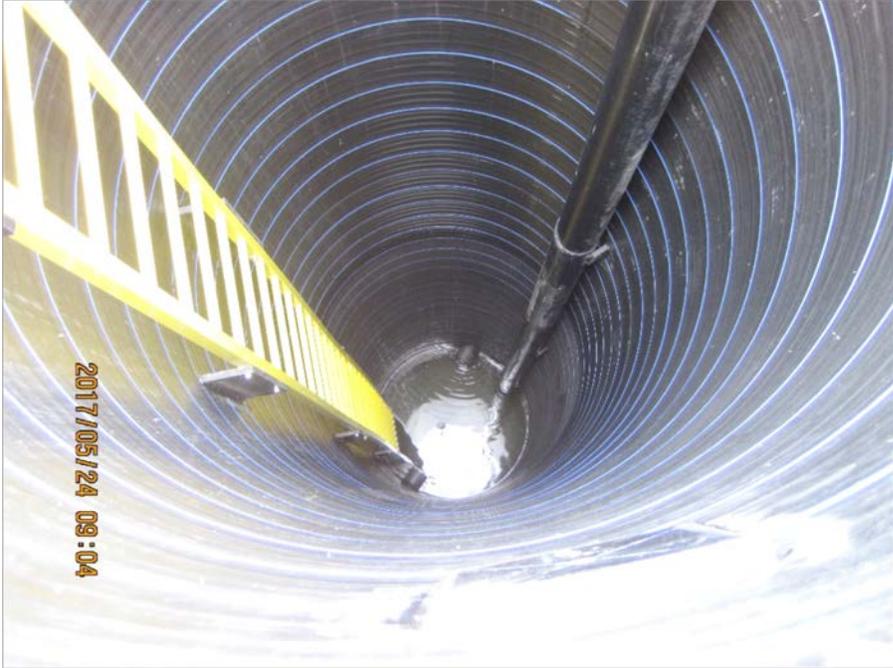
Unlike Pond 7's single-liner design, Pond 10 is lined with primary (upper) and secondary (lower) membranes, both made of 80mm HDPE. A drainage layer between the membranes has the ability to convey potential leakage to a small pipe housed in Wet Well 11 where a transducer monitors water levels and can notify HGCMC personnel if a leak exists (Photo 4). Perforated piping beneath the secondary membrane drains groundwater to Wet Well 11 to relieve pressure caused by upwelling.

Photo 4. Wet Well 11. Transducer within small black pipe can monitor leakage between primary and secondary membranes. Groundwater from beneath secondary membrane drains into the main portion of Wet Well 11.

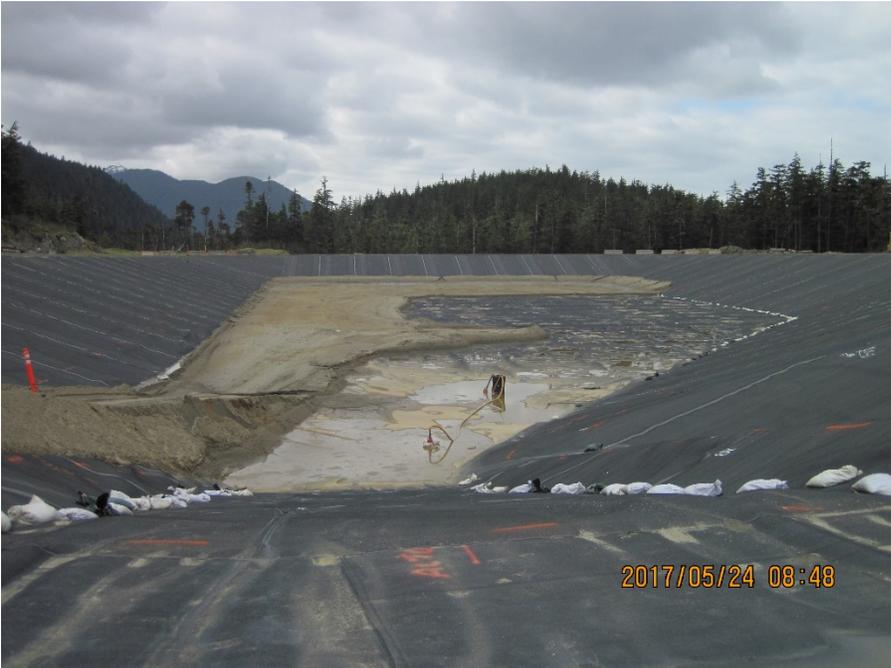
A 24" intake pipe in Pond 10 has the ability to convey water to Wet Well 10 (Photo 5). From there, it can be pumped through pipelines that will tie into the Water Treatment Plant once Pond 10 construction is complete.

Photo 5. Looking south into Pond 10. A service layer of sand allows maintenance within the pond. Black intake pipe in the foreground can convey water to Wet Well 10 (located west of the pond).

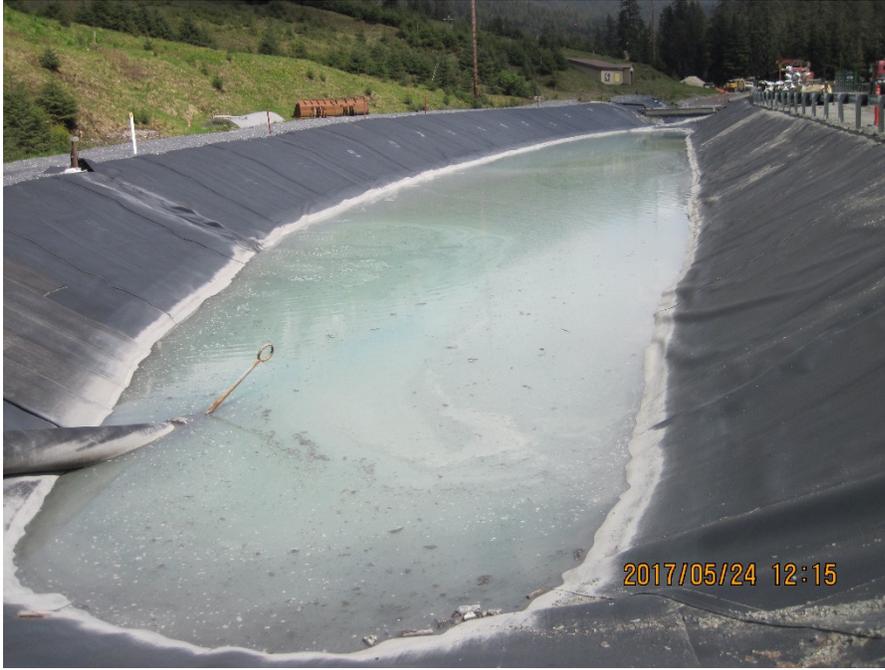
Area is active and tidy (Photo 6). Water from Pond 23 is conveyed either to the Mill for recycling or to Pond 7 for eventual treatment and subsequent discharge into Hawk Inlet.

Photo 6. Pond 23 collects water and can convey it either to the Mill for recycling or to Pond 7 for eventual treatment and subsequent discharge.

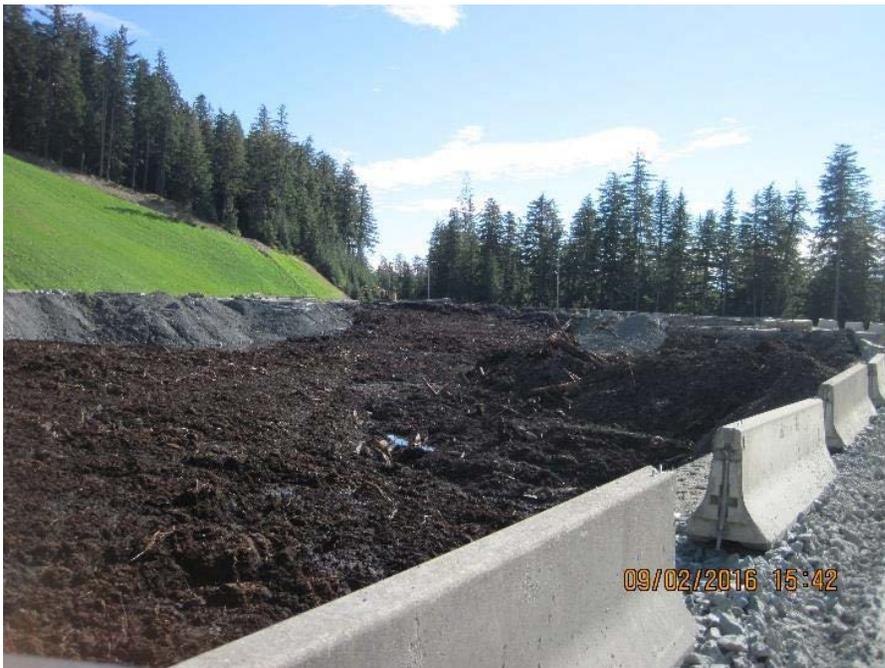
Photo 7. Sand Pit during September 2016 inspection. Note organic material covering entire pit floor and very little ponding at the surface. Photo faces south.

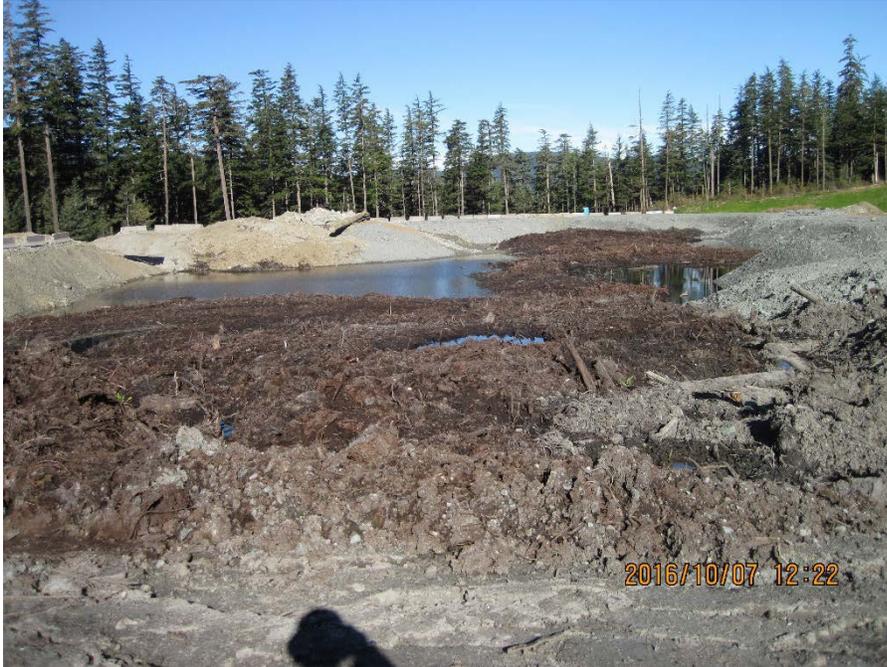
Photo 8. Sand Pit during October 2016 inspection. Note ponding in background. Photo faces north.

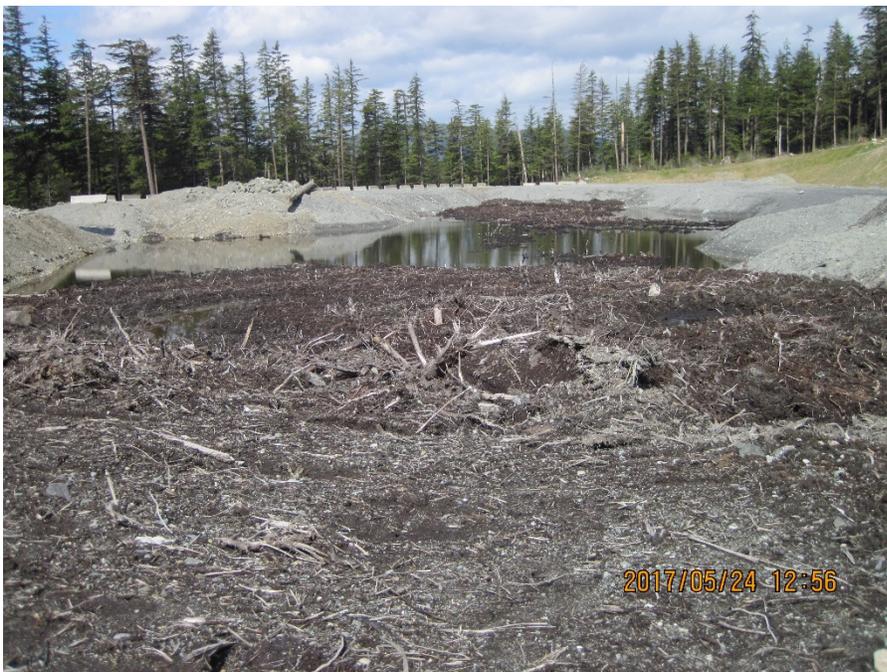
The Sand Pit area was partially filled with organic material (overburden) taken from Pond 10 during its construction in the fall of 2016. HGCMC overestimated the space they needed for overburden storage, resulting in a large volume of unused space within the pit. Since October 2016, water has been accumulating within the unused space (Photos 7-9) (See IR #'s 376 and 377). HGCMC believes the organic material placed in the pit has created a relatively impermeable layer and, as a result, slowed drainage. Since this inspection, HGCMC has used a pump to draw down the water impounded within the pit.

Photo 9. Sand Pit during May 2017 inspection. Water level appears similar to that in October 2016 (Photo 8), although compaction of organic material has occurred since then. Photo faces north. HGCMC has since dropped the water level through pumping.

- Monitor Pond 7 and Pond 10 compliance.
- Monitor water level in Sand Pit.
