STATE OF ALASKA

FIELD INSPECTION REPORT HECLA GREENS CREEK MINING COMPANY

Inspection Date: July 31, 2012, 8:00 AM – 3:45 PM

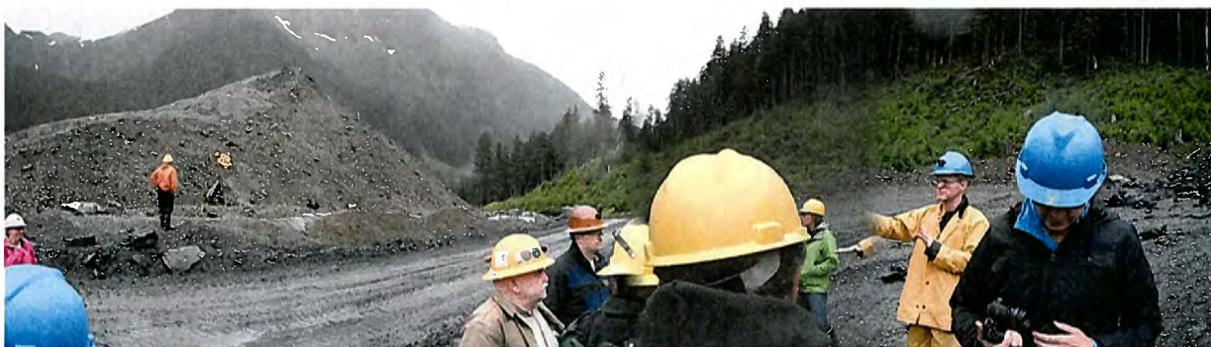
A pile of waste rock from the 1350 area is staged within lined containment at Site 23. This waste contains some Class IV acid producing and metals leaching rock. It has been mixed with lime prior to placement onto the lined pad at Site 23. The staging area is at full capacity. The current plan is to dispose this waste underground when space becomes available. Space at both tailings and underground sites is limited for the disposal of anything other than tailings. Work to extract waste rock from all of the inactive sites is curtailed because of this.

Site 23. Note contained stockpile of Site 1350 waste rock on left

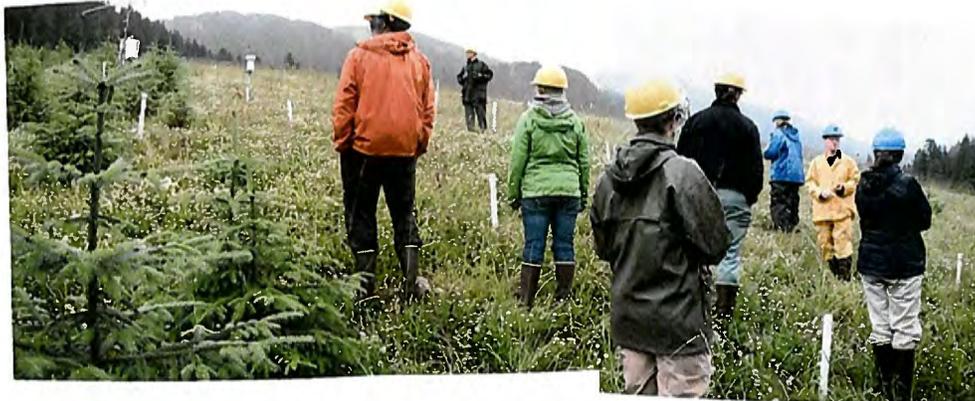
We stopped briefly at the Site 23 test plot at the lower end of Site 23 where the cover system was explained. The barrier layer continues to remain saturated at greater than 85% for the monitoring period. This implies the oxygen diffusion coefficient was minimized thus minimizing ingress of atmospheric oxygen through the barrier layer. However, water continues to flow through the barrier layer at a higher rate than modeled and would have the effect of producing an increased volume of leachate in the final closure configuration for both Site 23 and the Tailings Disposal Facility. The current design modified with a barrier layer with a lower hydraulic conductivity could result in a more effective design. Increasing the growth medium thickness from 2 feet to 1 meter may further protect the underlying capillary break and barrier layer from exposure by windthrow (blow down or uprooting of large, mature trees). This should be included.

The studies of the cover system conducted to date indicate the cover system will function to prevent the effects of freeze/thaw or windthrow. However, HGCMC has not provided details or considered the design of the cover system at the periphery of the landfill. Tree blow-down may be more of a concern at the leading edges of the fill where uprooting of trees may more likely occur and where the cover system is most sensitive to oxygen entry. The toe of the fill is where springs and run-off control devices will be located and where the cover system will also be required to limit the entry of air. Therefore special importance should be placed on how the cover system is designed, constructed and monitored at the toe of the fill. HGCMC is complimented in this inspection report with the work that has been accomplished to study cover system performance. Since there is a lack of experience with these cover systems there continues to be a lack of information with regard to conifer growth and blow-down. Unfortunately, the Oregon and O'Kane work did not bring attention to the lack of information having to do with how to construct the final configuration at the leading edges.

Test Cover System at Site 23. Note volunteer conifer growth and monitoring probes. Also note clover and grass growth on the cap. Deer and bear are excluded by an electric fence that surrounds this test plot

thicker growth layer and barrier layer with a lower hydraulic conductivity. Monitoring for oxygen, NNP and pH beneath the barrier layer would be useful and is recommended.

7. Provide details of the cover system at the periphery of the landfill in the final cover design.
8. HGCMC is considering the development of a modified test plot on the tailings disposal facility that will likely include but not be limited to a thicker growth layer, and a barrier layer with a lower hydraulic conductivity. Monitoring for oxygen, NNP and pH beneath the barrier layer is needed in the design.

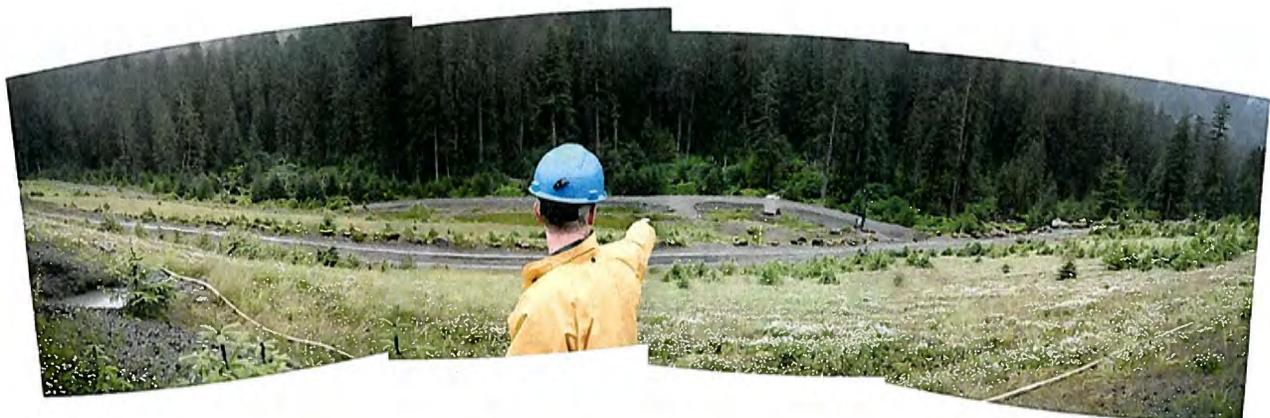
HGCMC has requested, and ADEC would like to see a new compliance monitoring station downstream of Site 54 below the confluence of Gallagher Creek. This station is needed to identify the highest concentration of hazardous constituents migrating from the facility and whether or not contamination from Site 23/D has any effects on the down-gradient surface water environment. The station should be carefully selected and approved by ADEC in order to ensure that it is effective in catching seepage from both Sites 23 and D. The results of a 3-part survey started in the summer of 2011 to identify a new station have been completed and were presented at the annual meeting. ADEC, the USDA Forest Service and HGCMC will meet soon to discuss the new information and to identify the new monitoring station.

Site D. Note the area to the right near Greens Creek will be a potential location of a new surface water monitoring station

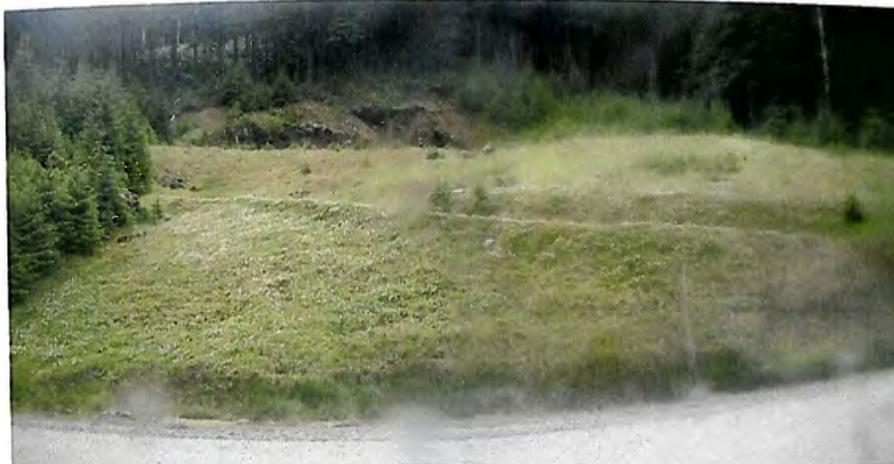
We stopped briefly at Pit 405 which is located at 7.6 mile on the B Road. The rock from this quarry was used for construction of the B Road and other mine infrastructure. Mine records indicate that approximately 13,000 cubic yards of production rock were backfilled into the quarry in 1988. The

quarry received reclamation materials (colluvium and glacial till) in 1994, 1995 and 1998 for use in future reclamation projects. The waste in Pit 405 is pyritic although monitoring of drainage downgradient of the quarry demonstrates that influences from the site are negligible. According to the annual report the production rock in the quarry is suggested to be either removed or covered in-situ. This is yet to be determined. Removal of the rock could be problematic as this would increase exposure of the now covered pyritic quarry wall. Reclamation costs should include the cost to remove waste from this site.

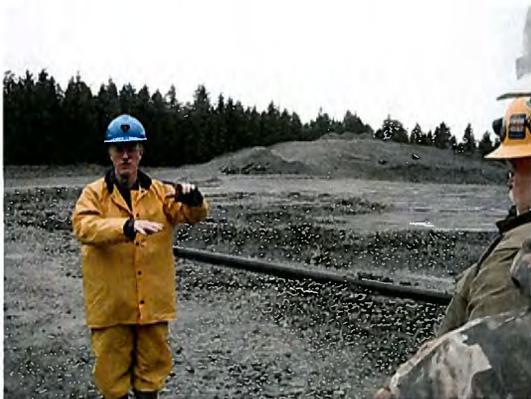
Site E: We stopped briefly at Site E. Approximately 365,000 cy of waste rock was disposed at this site of which about 200,000 cy was acid generating and metals leaching. This will eventually be moved to the tailings facility. Approximately 85,000 cy have been removed so far at around 40,000 cy a year. Until there is an approval for the tailings expansion the amount of material removed from the site will be minimal in order to give preference to tailings from mill operations. The contact water sump was approximately half full and appeared to be functional.

Site E: Approximately 85,000 cy removed

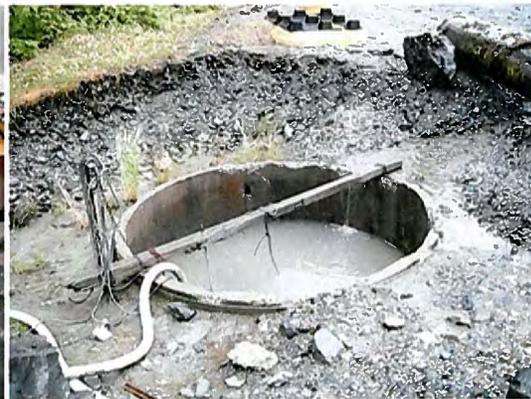
Contact water sump

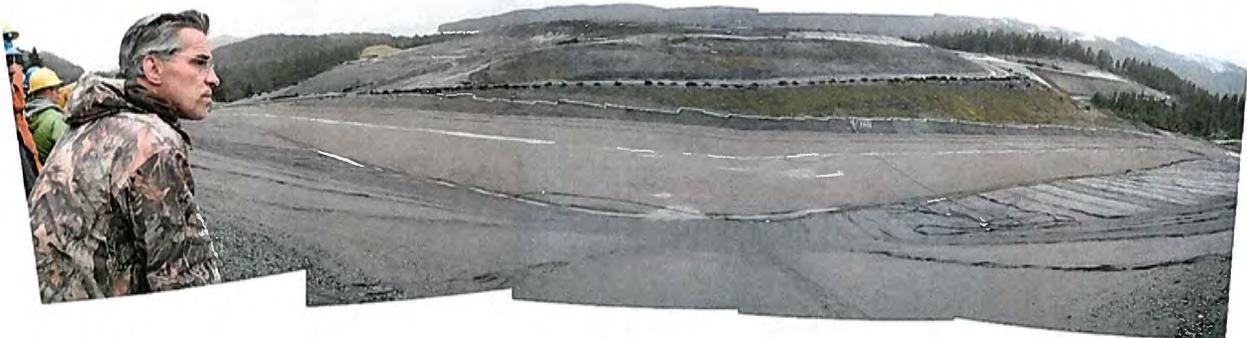
The East Ridge Expansion Area has not yet been used for tailings disposal. HGCMC is waiting for drier weather conditions (i.e., spring) for disposal. Since the shape of the East Ridge area is currently concave, HGCMC would like to place tailings during the driest time of year so that water does not pond. The goal would be to fill it as quickly as possible up to the point that it can more easily shed water, not to its full capacity. A drain in the east expansion area that conducts contact water to Pond 9 was not operational. This will need to be repaired prior to placing tailings in this area.

Tailings Disposal Facility: East Ridge Expansion Area

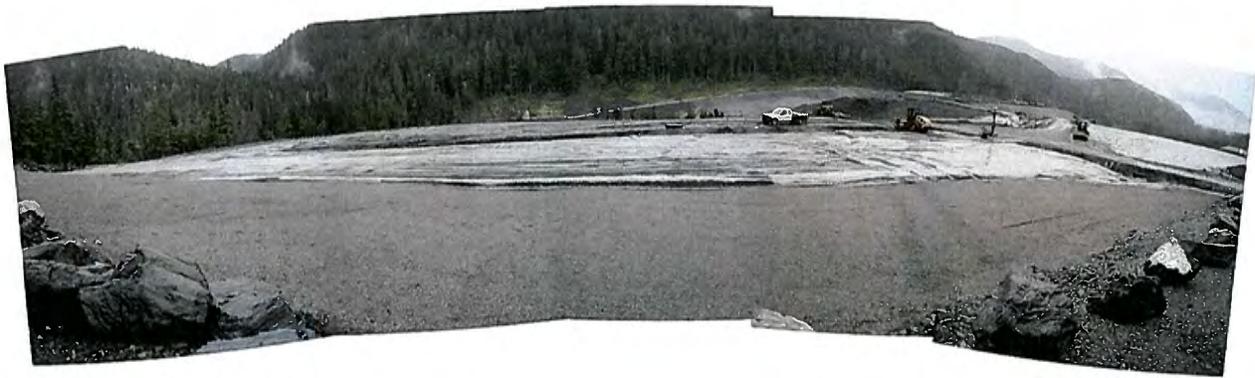
Currently tailings are being placed in the Northwest Pit 5 expansion area. HGCMC placed tailings using the specific criteria established by Klohn Crippen Engineering in 1999 using cellular configurations and compaction standards.

Tailings Disposal Facility: Northwest Expansion area- active placement taking place
