I. Introduction

This 2010 Best Management Practices (BMP) and Storm Water Report is submitted by Hecla Greens Creek Mining Company (HGCMC) pursuant to Sections II.F.1 and II.F.2 of NPDES Permit AK-004320-6, effective 1 July 2005. Authority over the federal permitting, compliance and enforcement NPDES program transferred to the State (ADEC) in November of 2010 for the mining industry. The Report summarizes the scope and dates of the comprehensive site compliance inspections/evaluations, major observations related to implementation of the BMP Plan, corrective actions taken as a result of the inspections/evaluations, identification of potential incidents of noncompliance as they pertain to the BMP Plan, description of the quantity and quality of the storm water discharged, and BMP Plan modifications made during the year. The final section of this report contains the required annual certification under Section II.F.2.

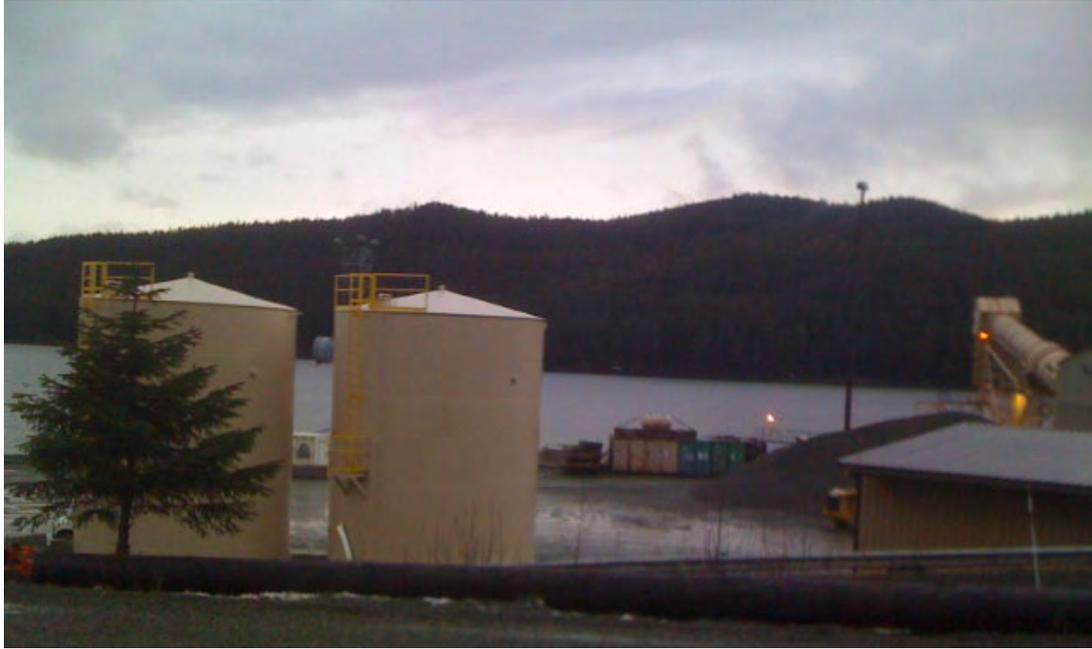
Additional sampling of contributing flows to this outfall in 2009 had found a number of small seeps with elevated metal concentrations from waste rock foundation areas. Investigations into capturing these small seeps and rerouting them to containment led to a storm water containment improvement project at Hawk Inlet. It was determined that in order to capture the seeps and the water reporting to Outfall 003, the storm water collection capacity at Hawk Inlet needed to be expanded. In 2010, two 93,000 gallon water storage tanks were installed adjacent to the existing degritting basin (DB04) at Hawk Inlet. Tanks in this location are meant to disturb the least amount of useable space (vertical tanks minimize footprint). The tanks will also provide storm surge storage capacity. Water will be pumped from these tanks to the water treatment plant.

In 2010, primary construction elements for this project included subgrade excavation, grading, concrete forming and pour, placing the tanks onto the pad, and mechanical connections for filling and draining the tanks. See Photo 1 of the two new tanks at Hawk Inlet. In 2011, minor piping and mechanical work on the tanks will be completed, and a network of small seepage collection sumps with pumps will report to a runoff diversion collection system to collect the seepage and the Outfall 003 waters, and route these flows to the tanks.

PHOTO 1. Hawk Inlet Storm Water Collection Tanks; Fall, 2010

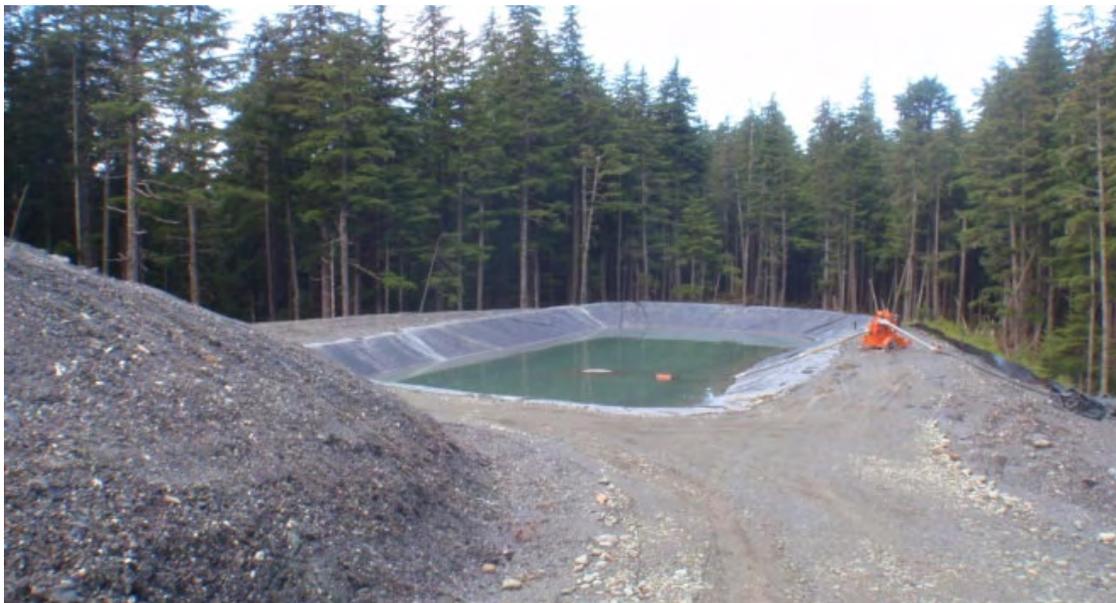
Approximately 40,000 cubic yards of waste rock was removed from Site E in 2010. The waste rock from Site E was hauled to the tailings facility area, and codisposed of with tailings. A 0.9 ac-ft water collection pond was constructed in June 2010 at the north end of the site (see Photo 2). The pond collection area is about 3.6 acres and was designed to collect flow for a 3-inch/24-hr rain event. The pond is lined with 36-mil RPP liner bedded with approximately 6 inches of sand cushion. A 4-inch Godwin diesel pump is located at the pond and operates with manual on/off control when active removal is occurring to route collected water through a 6-inch HDPE pipe to the existing storm pipe system along B-Road, which then flows to the water treatment plant. The plan for Site E in 2011 is continued removal of waste rock for codisposal with tailings.

PHOTO 2. Site E Water Collection Pond, Completed and in use; October 2010

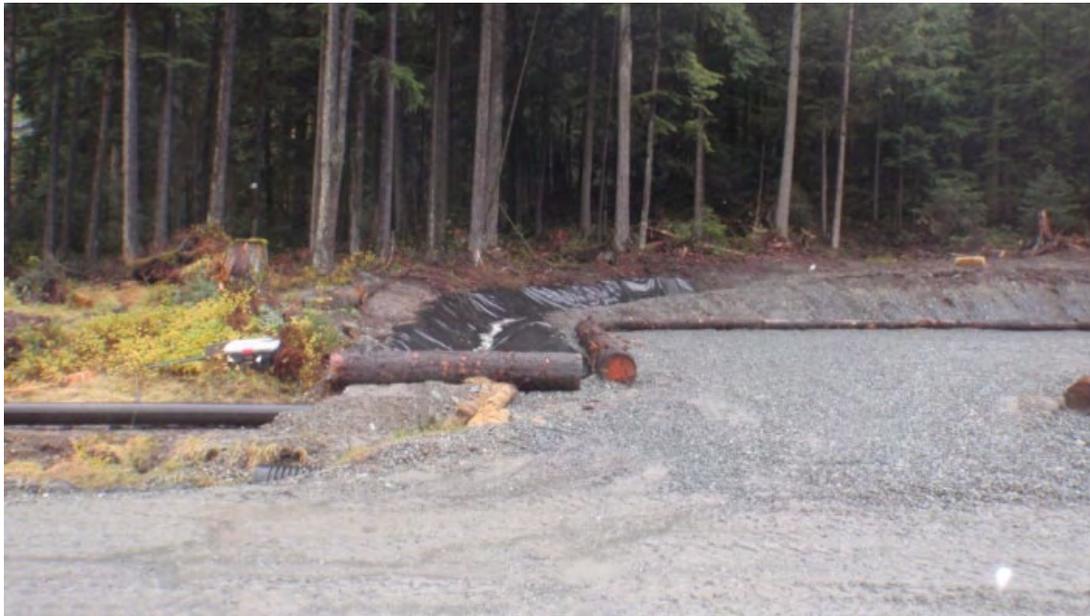
HGCMC constructed a diversion ditch to divert clean, upgradient noncontact water from entering Pond C. This will minimize the volume of water routed to treatment, as well as decrease the chance for storm water discharge from this area during large storm events. A parking pad was constructed, with the installation of a lined diversion drainage channel on the upgradient side of the pad to convey the western portion of the backslope surface diversion directly into Bruin Creek while avoiding any mixing with contact waters from the 920 area (see Photo 3).

PHOTO 3. Pond C Noncontact Water Diversion Ditch and Parking Pad, September 2010

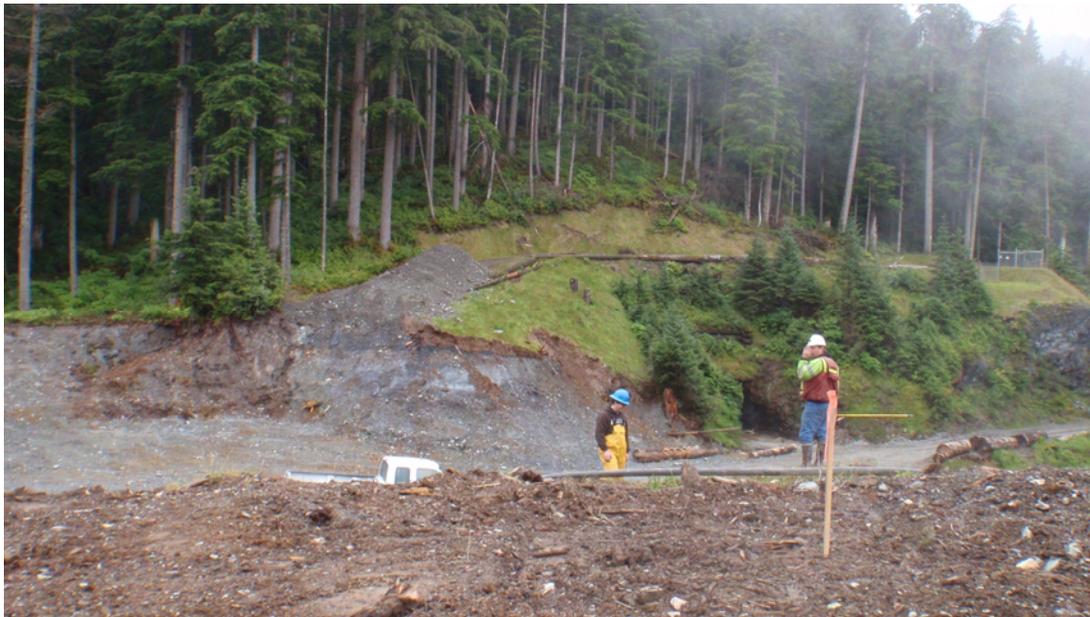
Approximately 9,000 cubic yards of waste rock was removed from the 1350 site in 2010 (See Photo 4). Proposed haulage for 2011 is 25,000 cubic yards. Along with removal activities, there will be continued grading efforts to ensure that contact water from this area is routed to collection at the 1350 portal. Material from this site is transported to the temporary holding pad at Site 23, and taken underground for permanent disposal when void space becomes available.

PHOTO 4. Site 1350 Removal Area Near Portal; August, 2010
