**TAILINGS AND PRODUCTION ROCK SITE  
2013 ANNUAL REPORT**

**Hecla Green Creek Mining Company**

**April 15, 2014**

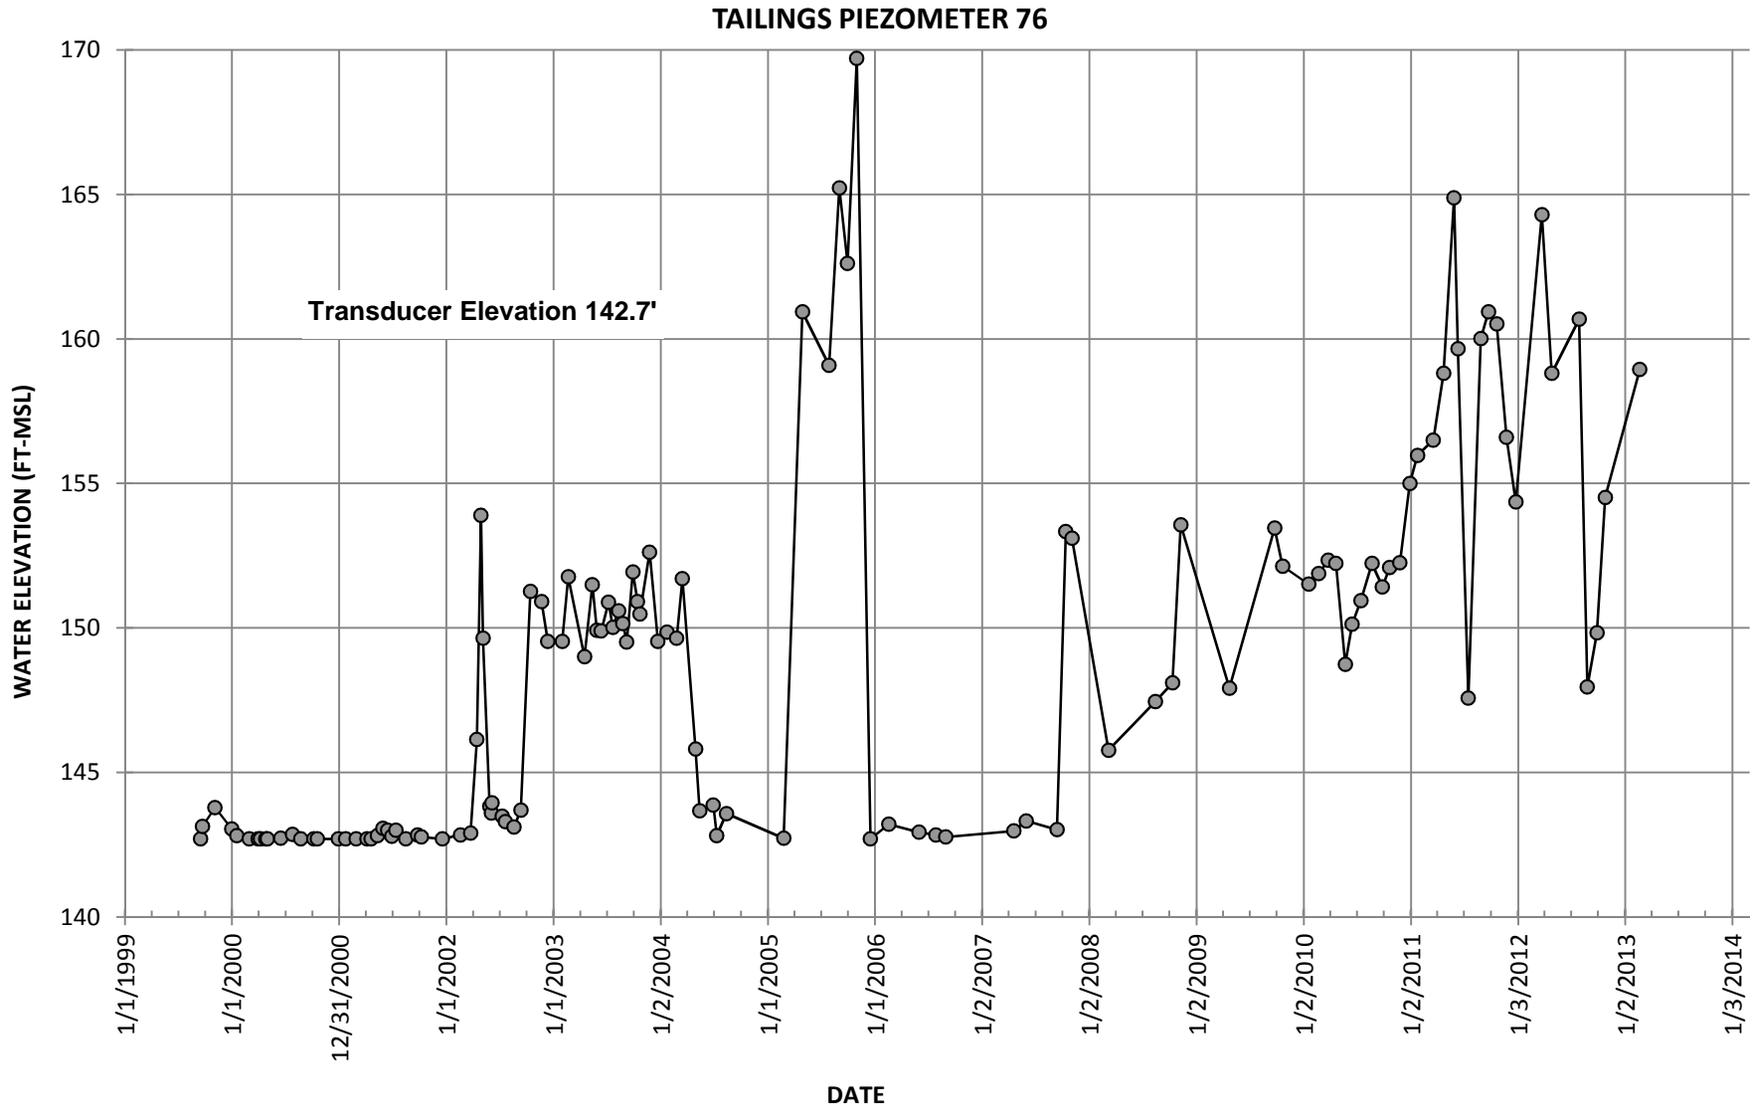
Figure 2.12 Water Level Data for Standpipe Piezometer PZ-T-00-02

The data from standpipe and pneumatic piezometers completed above the blanket drain (Piezometer 76, PZ-T-00-01, PZ-T-00-02, PZ-T-00-03 in Figures 2.10, 2.11, 2.12, 2.13) indicate that saturated conditions can develop above the unsaturated underdrains to a thickness of approximately 12 feet. This is consistent with the low permeability of the tailings and the uncapped condition of the pile. Covering the pile will help minimize the saturated zone in the pile. This was demonstrated by the over 10 foot decrease in the water table that occurred from 1995 to 1997 when the pile was covered (see Figures 2.1 to 2.7). Water levels have rebounded to, and in some cases above, 1994 elevations in most areas. Areas where water levels exceed their 1994 values are areas where the pile is considerably thicker than it was in 1994. The increase in water levels observed in PZ-T-00-01 (and to a lesser extent in instruments nearby) from 2005 to 2007 is likely a result of new tailings placement in the area and staged decommissioning of Wet Well 2.

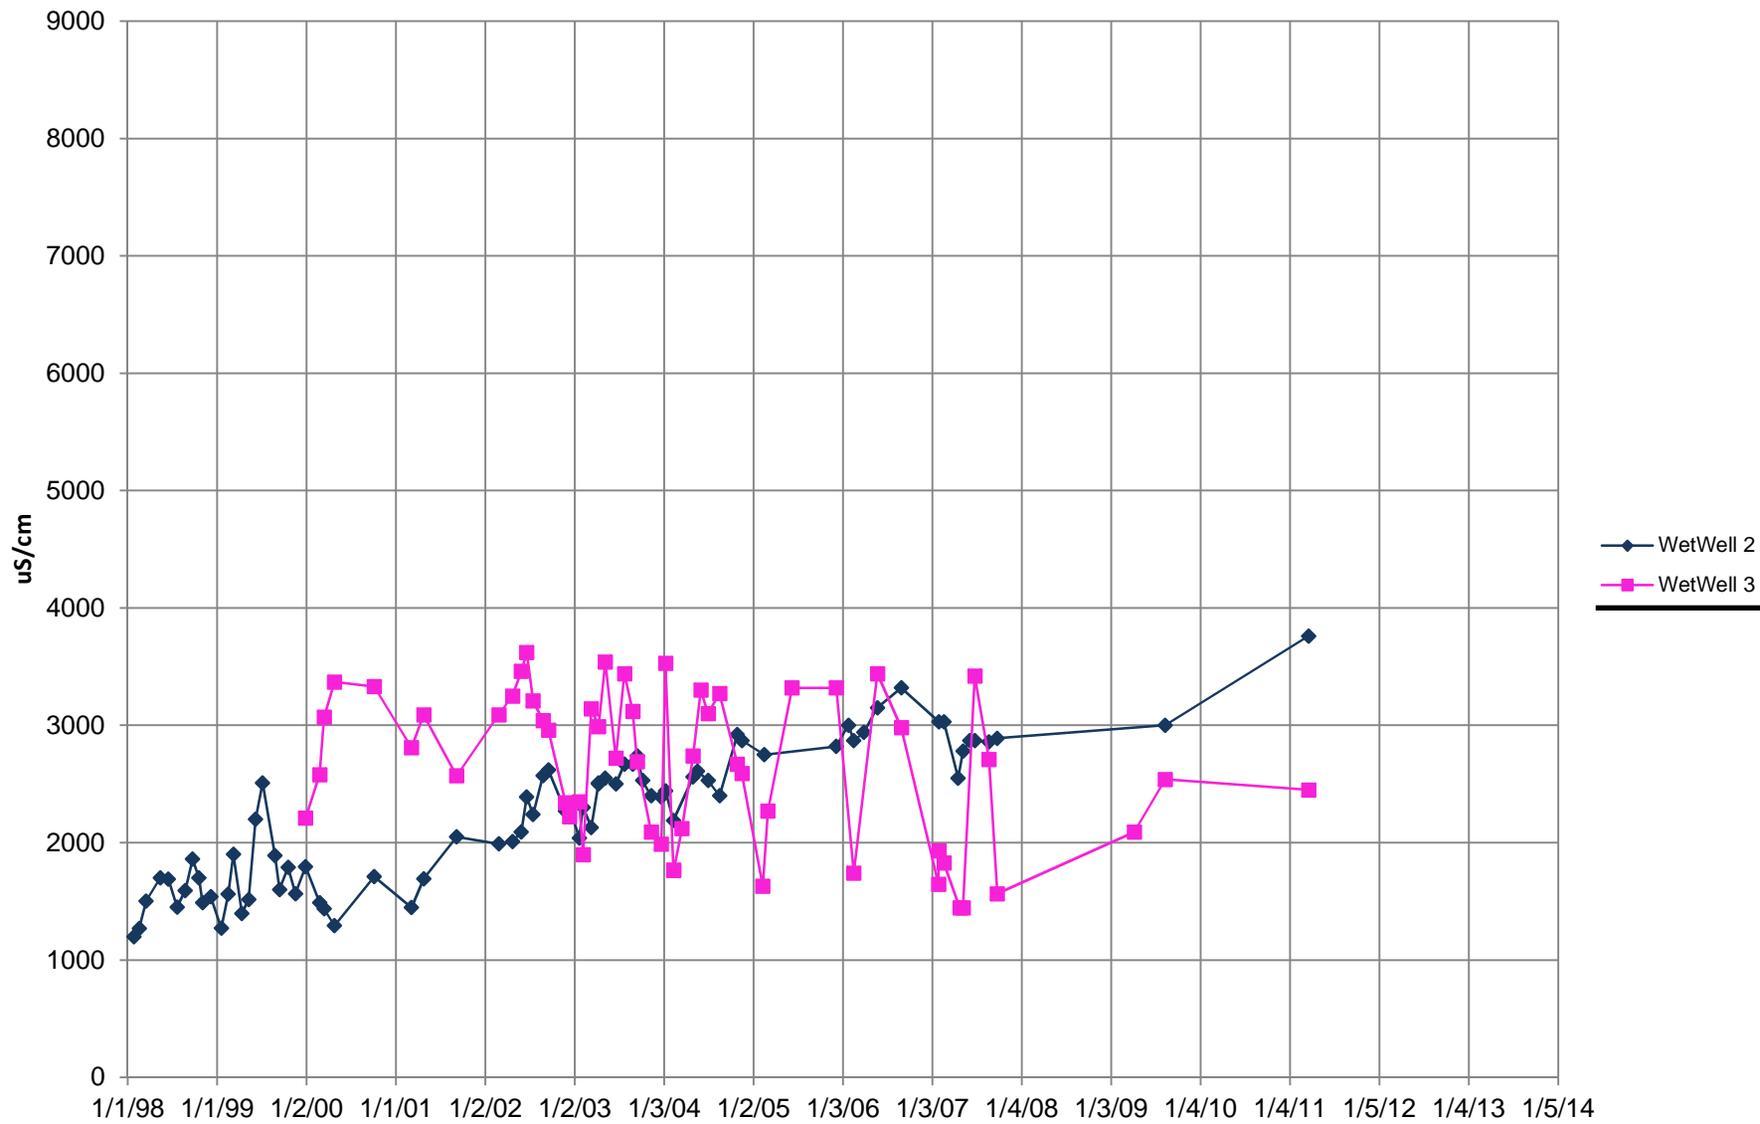
Figure 2.22a GREENS CREEK TAILINGS INTERNAL MONITORING SITES:  
WET WELLS - CONDUCTIVITY DATA

The conductivity results from internal monitoring site waters are presented in Figures 2.22a, b, and c. Conductivity measurements in 2012 ranged between 2,450 and 3,760 in wet wells. Conductivity measurements in 2012 and 2013 ranged between 7,650 (wells completed in tailings) and 2,670 (suction lysimeters) uS/cm. The abrupt conductivity increase observed in PZ-T-00-01 in 2013 is not consistent with other monitoring data (e.g sulfate and hardness) and may be an error. A smaller increase is expected as pore water from formerly exposed surfaces in the pile migrates downward. The higher conductivity of the site contact waters reflects a larger dissolved

load caused by weathering of the tailings. Pyrite oxidation and carbonate dissolution contribute dissolved ions such as sulfate, bicarbonate, calcium and magnesium to the contact waters, increasing their conductivity. Suction lysimeter samples are drawn from the smallest pore spaces of the unsaturated zone. Water held in these pores is often isolated from flow paths and thus usually has higher dissolved constituent concentrations than water from the saturated zone and foundation drains.

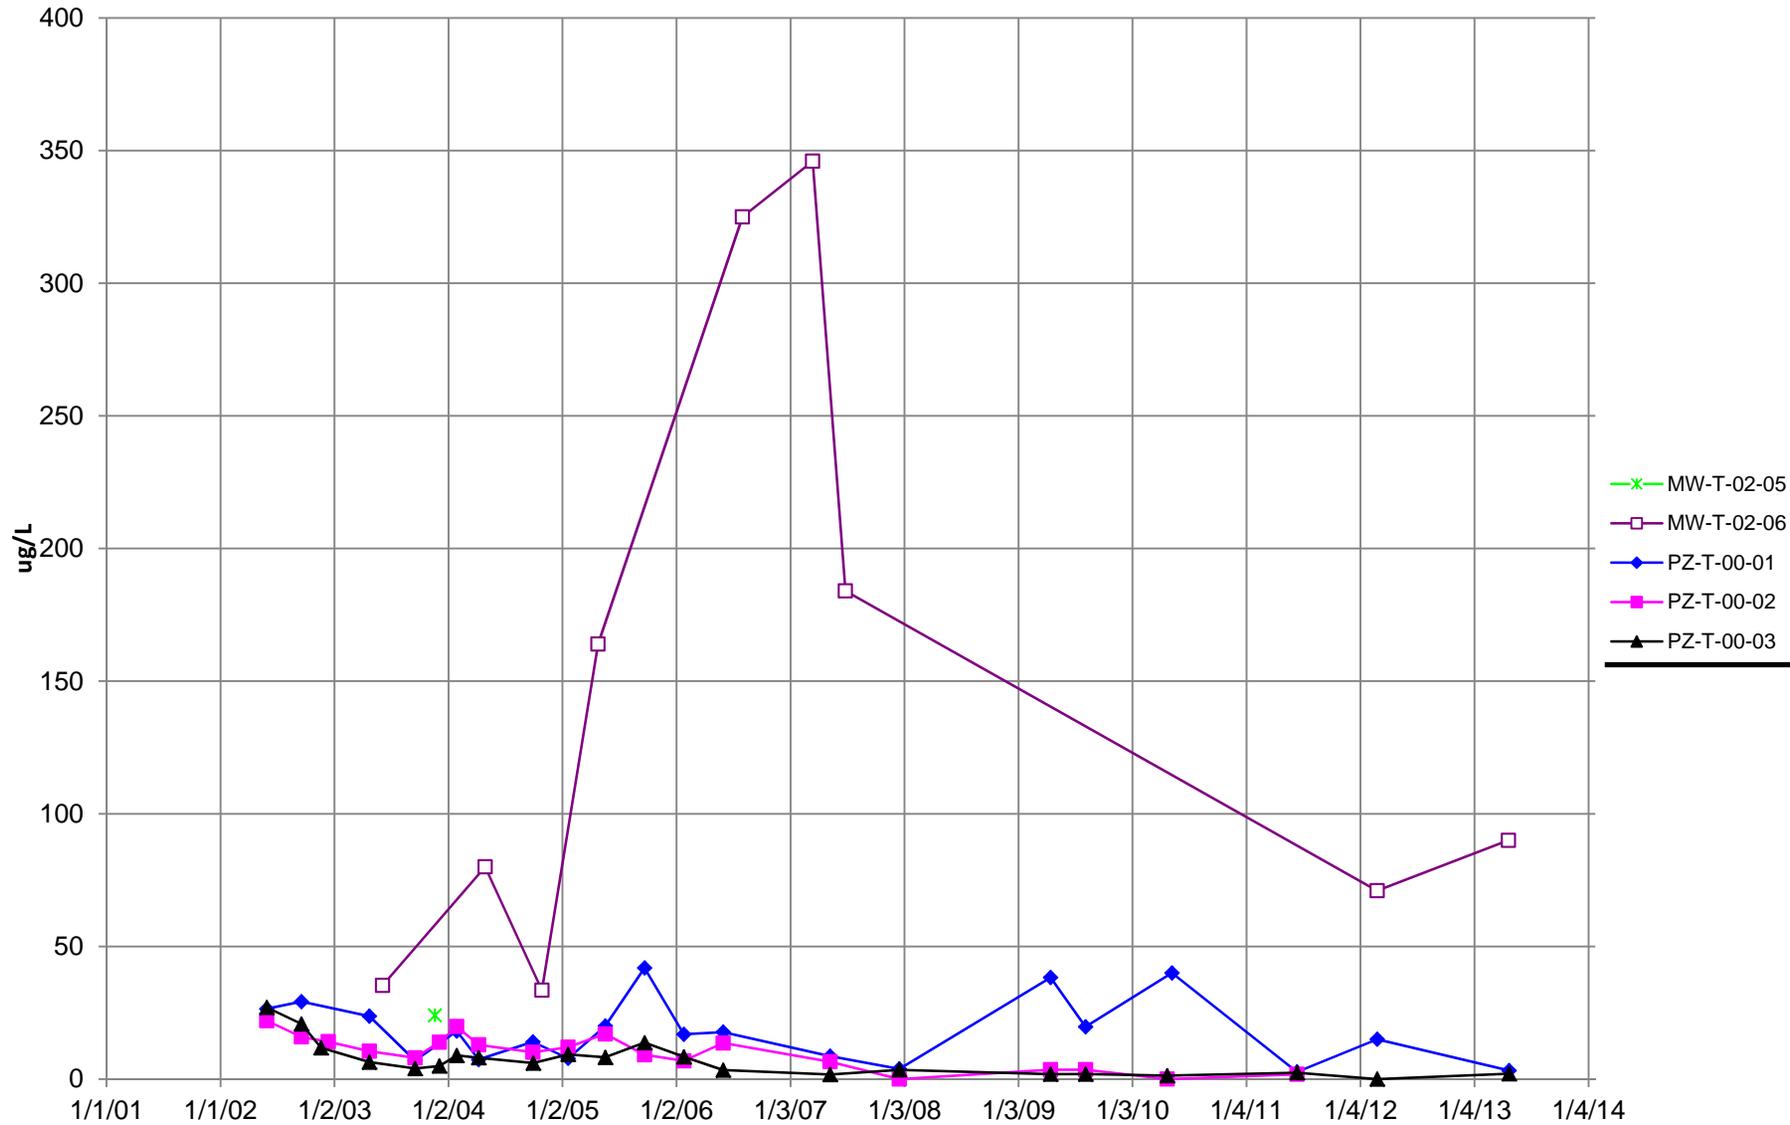
**Figure 2.25b GREENS CREEK TAILINGS INTERNAL MONITORING SITES:  
TAILINGS COMPLETIONS - ARSENIC DATA**  
(Non-detectable analyses plotted as zero)

Arsenic data are presented in Figures 2.25a, b and c. The variability in arsenic concentrations observed in Wet Well 2, MW-T-02-06, and some suction lysimeters is related to evolving redox conditions in the pile. As arsenic-bearing minerals such as tetrahedrite/tennantite (and to a lesser extent pyrite) weather, the arsenic that is released is typically co-precipitated with iron oxyhydroxides. As the pile grows, reducing conditions overtake areas that were once oxidizing. This was particularly true as the water table rose following removal of the temporary PVC cover that was placed on the pile in 1995 (removal began in 1997). Dissolution of oxyhydroxides (and possibly sulfates) is expected as the waters respond to the changing redox conditions. This will contribute arsenic and iron (Figures 2.30a, b and c) to the drainage water. Arsenic concentrations in the pile drainage will therefore decrease when redox conditions in the pile stabilize (e.g. with closure and capping of the pile). Sulfate reduction may also lower arsenic concentrations. This is apparent in the composition of waters from the saturated zone and in some of the SRMP test cells (see 2012 annual report SRMP discussion).

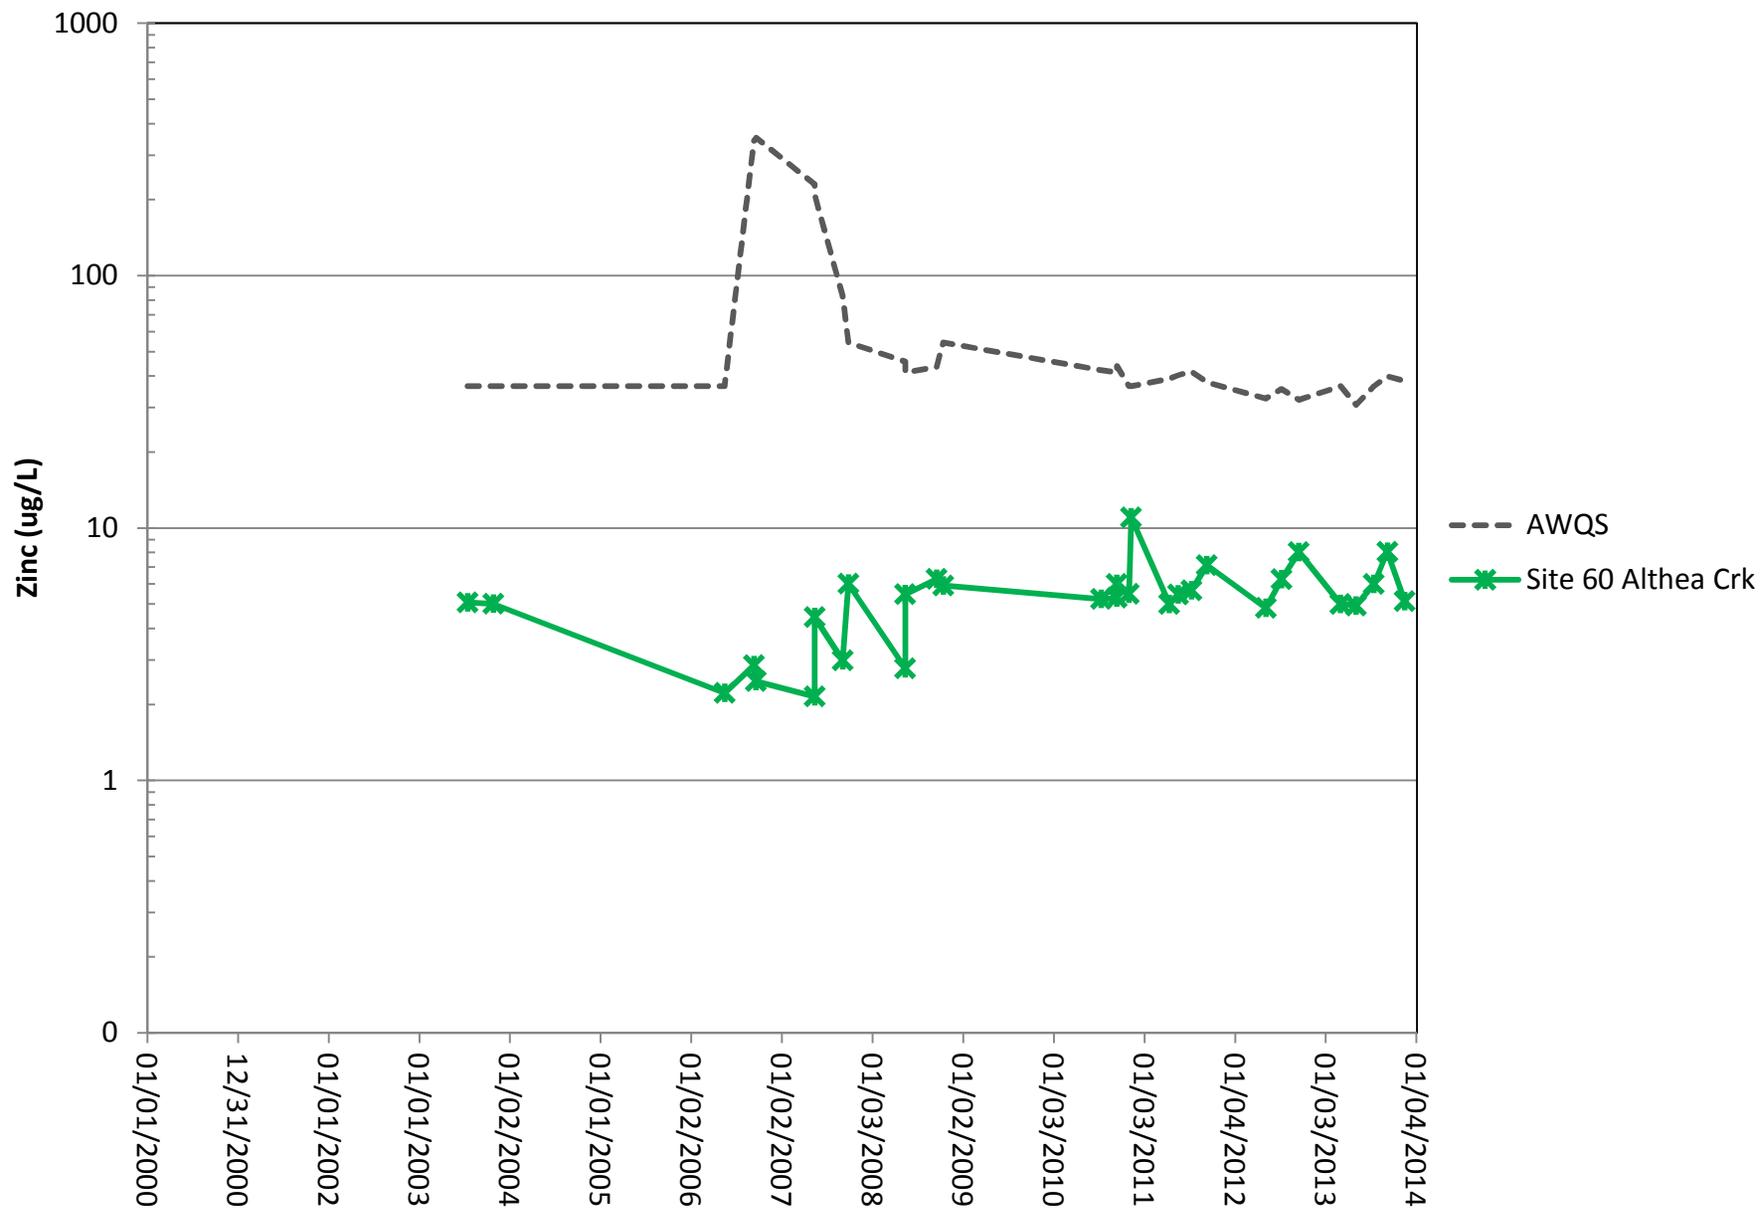
Figure 2.42 Site 60 Zinc Concentration

- Zinc and lead concentrations at Site 60 area shown in Figures 2.42 and 2.43. Zinc concentrations are very low ( $< 10$  ug/L). As the hardness at Site 60 decreases toward background conditions, the AWQS for lead, which is hardness dependent, may approach the lead concentration at Site 60. This was the case in 2012 when a slight increase in lead and a continued decrease in hardness caused an exceedance of the AWQS for lead at Site 60. There were no measured exceedances for lead or zinc in 2013.

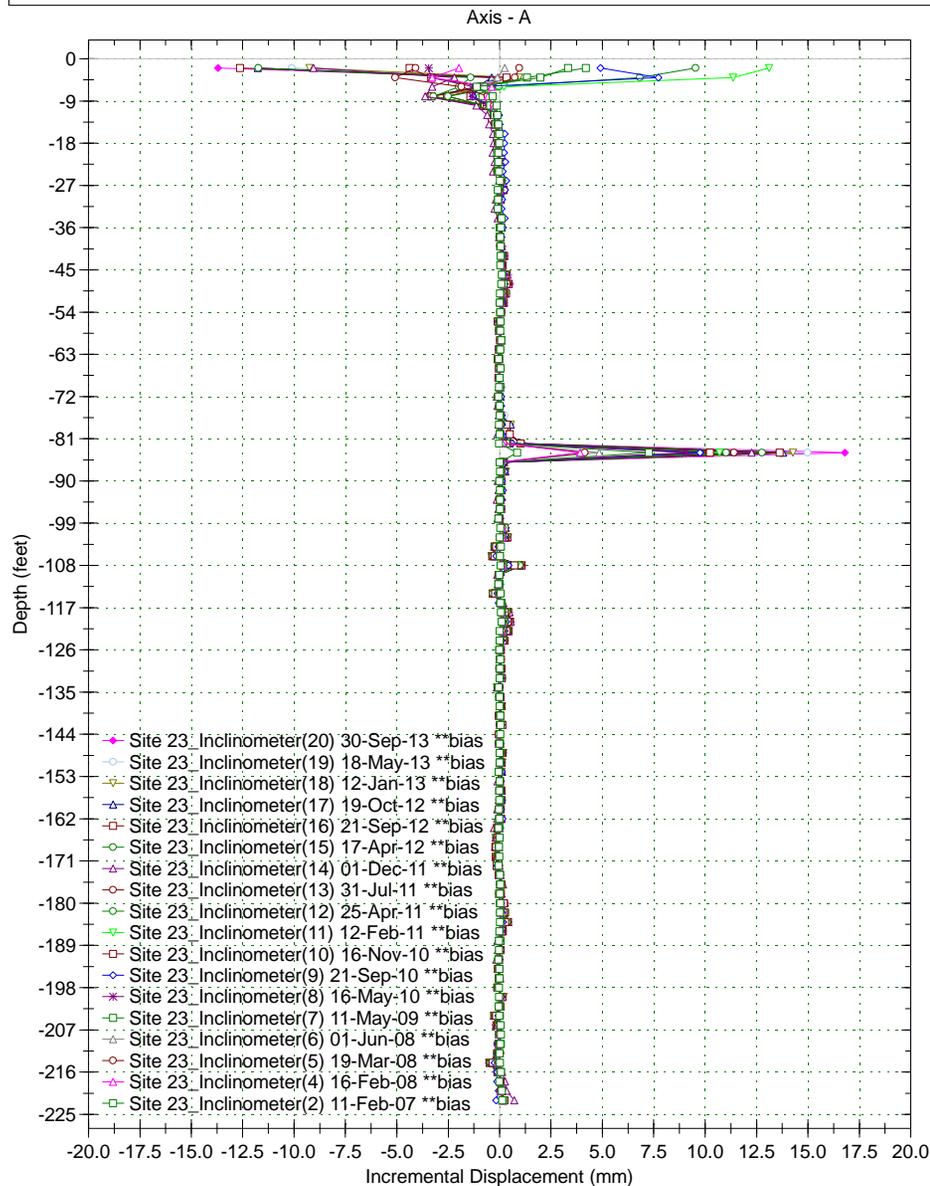
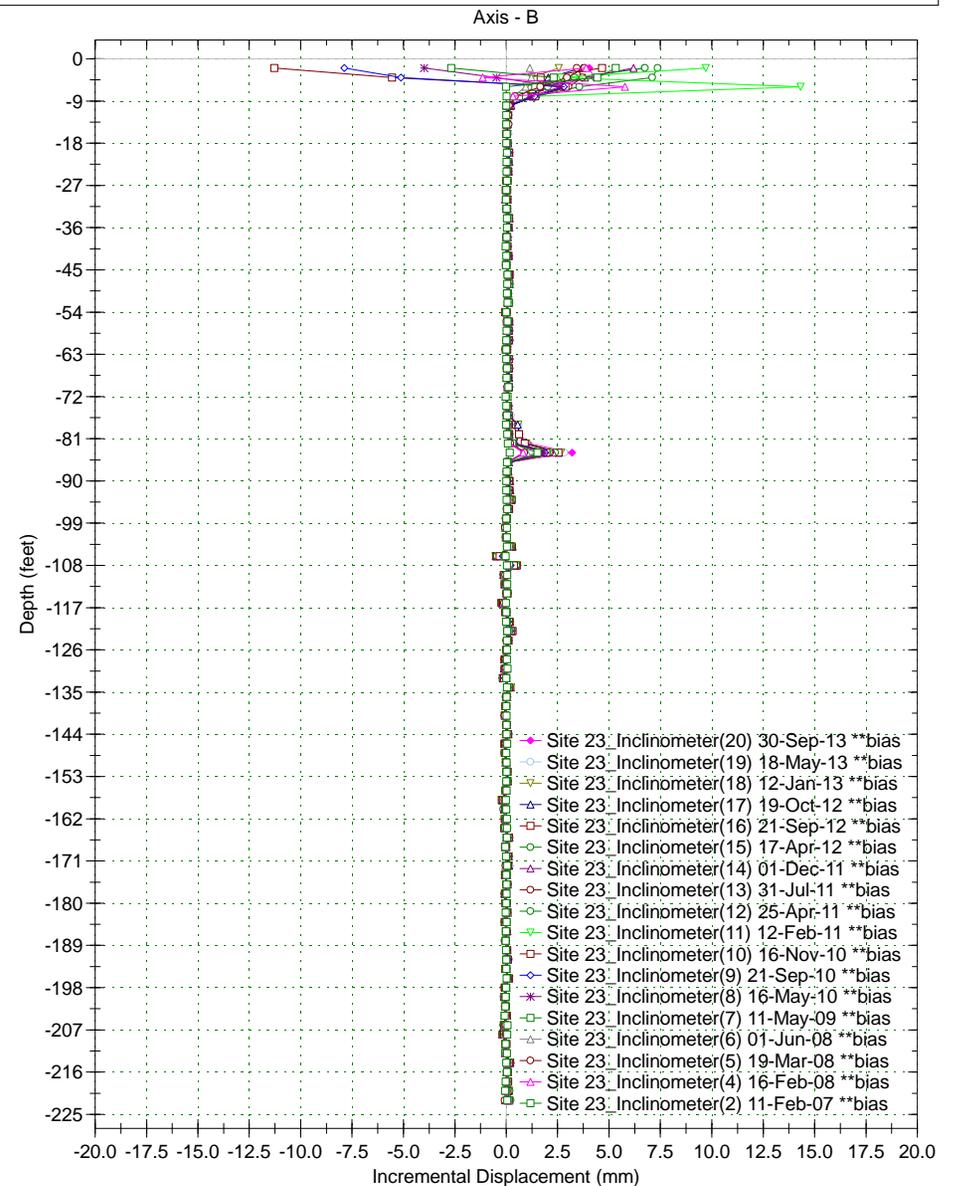
# Figure 3.30 Site 23 Inclinometer Incremental Displacement

Note:  
 Zero reference is top of casing, at -4.7 ft above ground surface.  
 Top section of casing replaced at joint in July 2011 due to damage.  
 Bias-shift correction by pinning data sets at 150-ft depth (A-B axes).

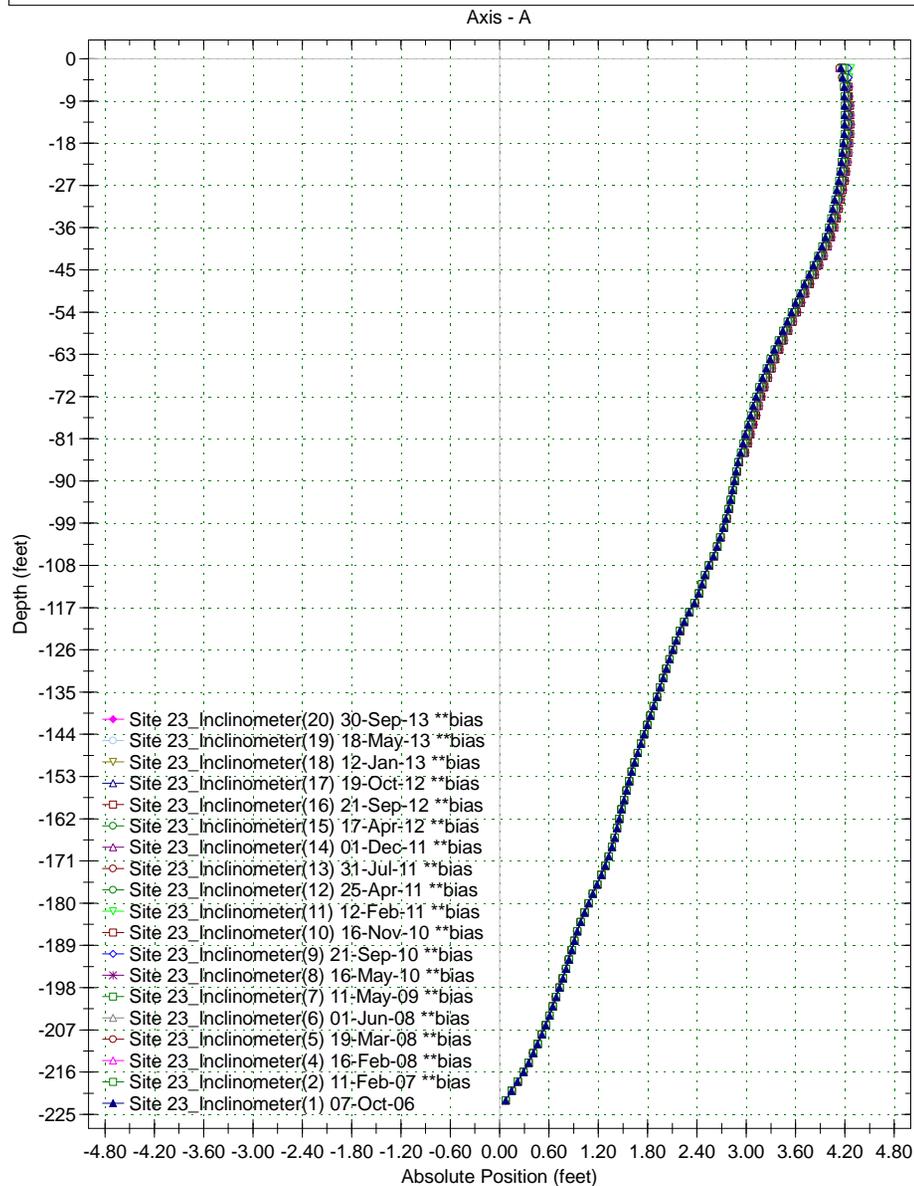
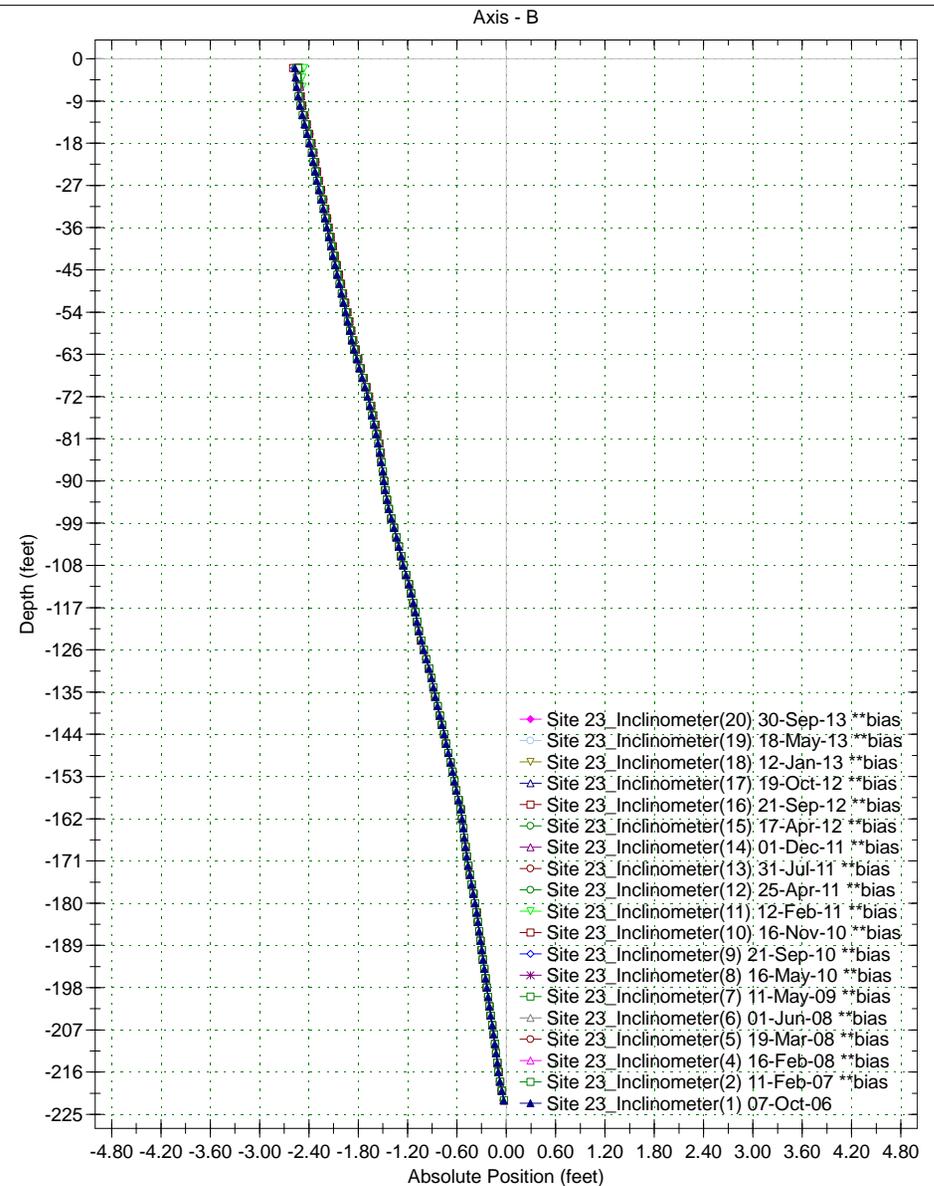
# Figure 3.31 Site 23 Inclinator Absolute Displacement

Note:  
 Zero reference is top of casing, at -4.7 ft above ground surface.  
 Top section of casing replaced at joint in July 2011 due to damage.  
 Bias-shift correction by pinning data sets at 150-ft depth (A-B axes).
