RE: APDES Permit Number AK-004320-6
2014 Annual BMP and Storm Water Monitoring Report

Attached please find the Hecla Greens Creek Mining Company (HGCMC) Annual Best Management Practices and Storm Water Monitoring Report for year 2014 activities.

This 2014 Best Management Practices (BMP) and Storm Water Report is submitted by Hecla Greens Creek Mining Company (HGCMC) pursuant to Sections II.F.1 and II.F.2 of APDES Permit AK-004320-6, effective 1 July 2005. Authority over the federal permitting, compliance and enforcement NPDES program transferred to the Alaska Department of Environmental Conservation (ADEC) in November of 2010 for the mining industry. This report summarizes the scope and dates of the comprehensive site compliance inspections/evaluations, major observations related to implementation of the BMP plan, corrective actions taken as a result of the inspections/evaluations, identification of potential incidents of noncompliance as they pertain to the BMP plan, description of the quantity and quality of the storm water discharged, and BMP plan modifications made during the year. The final section of this report contains the required annual certification under Section II.F.

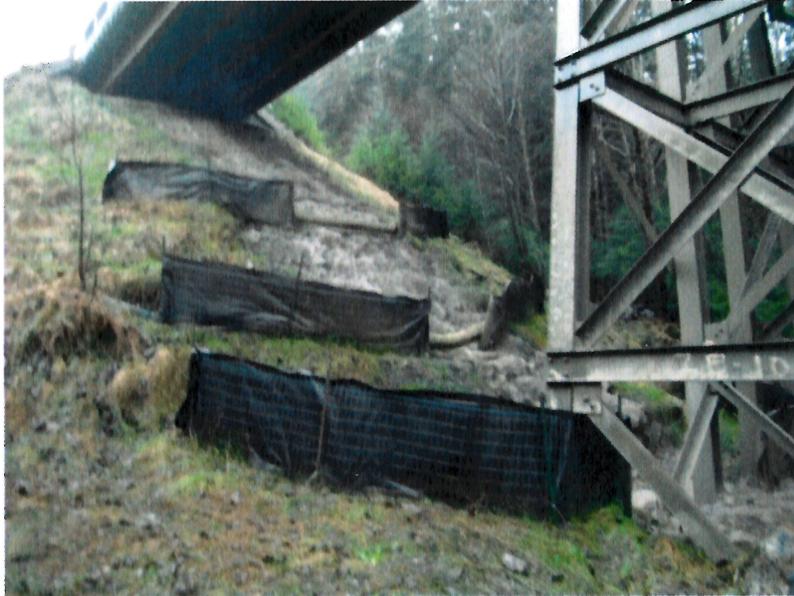
- Major sediment was observed under the Zinc Creek Bridge.
- Silt fences were installed (in a staggered position) but were not effective in controlling the sediment. The staggering of the silt fences was discussed with onsite representatives. It was said that the staggering was an experiment due to bears are constantly destroying the BMPs HGCMC staff put in place.
- Straw wattles were in place near the creek but were filled beyond their effective capacity with sediment.

PHOTO 1. Northern bridge abutment BMPs (24 November 2014). The fencing seen in this photograph was designed to funnel sediment to a sump at the base of the slope and is operating as intended. A portion of the sump can be seen behind the base of the tower.

Within two weeks of receiving the Notice of Violation HGCMC as requested, submitted photographic evidence, that the stormwater Best Management Practices under the Zinc Creek bridge had the necessary maintenance performed. Maintenance of the BMPs began on 18 November 2014 and was completed within a week. In a follow up email from the ADEC it was stated that ‘ADEC considers this matter closed.’

In 2014 accumulated sediment was cleared from underneath the bridge, existing BMPs were maintained, and additional silt fences and straw wattles were installed. These BMPs are routinely damaged by bears, HGCMC is investigating other practices for controlling sediment in the area that are bear 'resistant'.

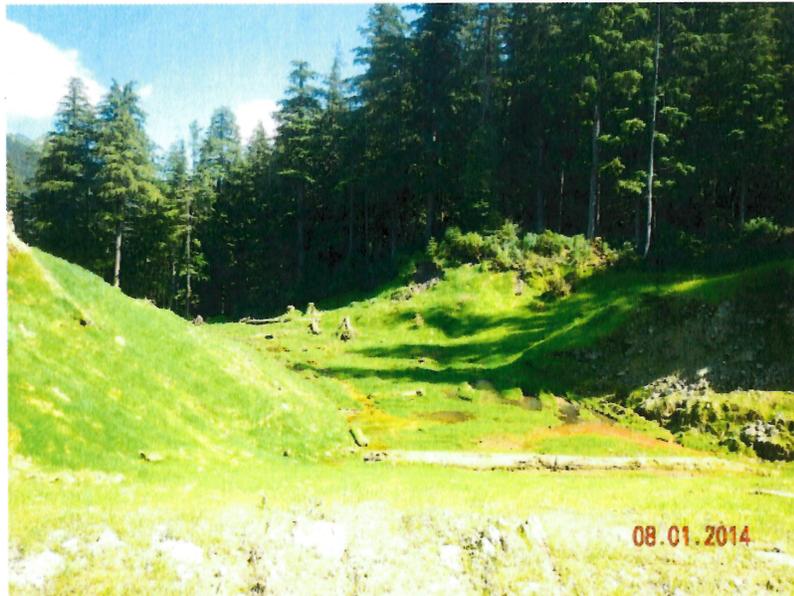
Generally, the results for this year are in the historical range for each of the sites, the notable exception is outfall 009. This outfall is located near the original mine adit at the 1350. HGCMC has been reclaiming the site for several years, by removing the waste rock and disposing of it in the underground mine. The reclamation work in 2014 was directly in the drainage that is monitored at outfall 009. The 9 June 2014 storm water sample was being collected as work was just being started immediately up gradient in an old sediment settling basin. Reclamation activities were stopped, additional sediment controls were added, and surface runoff was captured and pumped to containment.

Water chemistry during the June storm event showed increases in total lead, total suspended solids, and total zinc. By the October samplings TSS was within an expected range, however total lead and total zinc, though lower than in June, remained elevated. HGCMC expects the water chemistry to continue to improve as the site stabilizes from the reclamation disturbance.

PHOTO 2. 1350 area view towards east and former sediment pond location (1 August 2014).

Approximately 11,231 cubic yards of material was removed from the 1350 site in 2014. This material was hauled to the temporary, lined, reclamation storage pad (RSP) at Site 23. Excavation and haul activities, from the 1350, were performed in June 2014 by the HGCMC surface operations group, using a Hitachi 160LC or CAT 330 and two to three 35-ton Volvo off-road haul trucks. HGCMC also operated an excavator at the Site 23 RSP to allow blending of stockpiled materials with lime. The disturbed areas at the 1350 were hydro seeded after removal of material in 2014 (Photo 2). With the completion of these activities, HGCMC had anticipated not needing to remove additional material from the area until final reclamation (material still in the road base to the 1350 portal and ventilation ports). However, in the fall after reviewing water chemistry HGCMC decided that some additional material should be removed from the access road to the ventilation ports. Along with future removal activities, there will be continued grading efforts to ensure that contact water from this area is routed to collection at the 1350 portal.
