INSPECTION REPORT: GREENS CREEK MINE

Tongass National Forest Minerals Group
8510 Mendenhall Loop Rd
Juneau, AK 99801
(907) 789-6273 – office
(907) 586-8808 – fax

Date of Inspection: Tuesday, January 13, 2015
Date of Report: Friday, January 23, 2015
USDA Forest Service Inspector: Curtis Caton

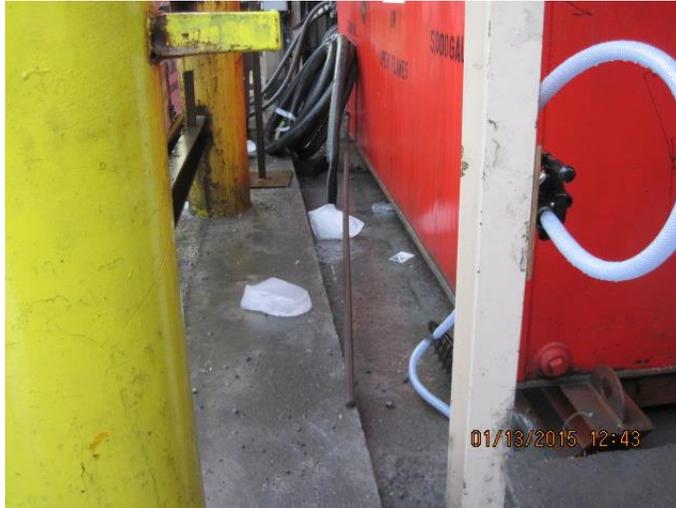
- **Minor housekeeping issues in 920-shop area (Photos 01-02).**

Photo 01. Some loose garbage.

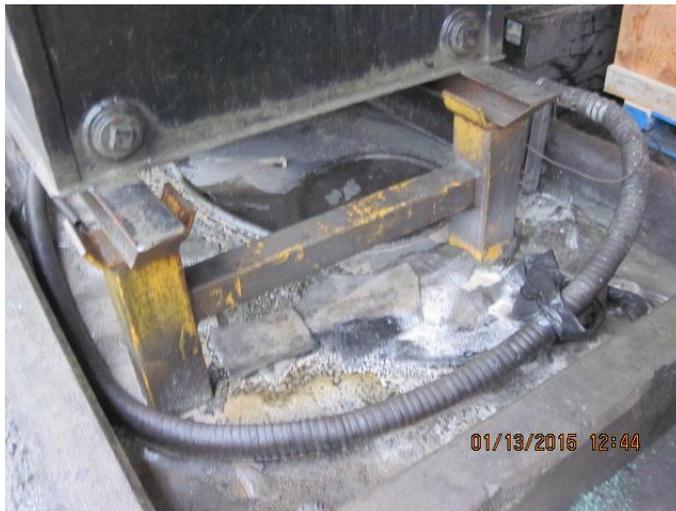
Photo 02. Containment basin should be cleaned of absorbent material and garbage.

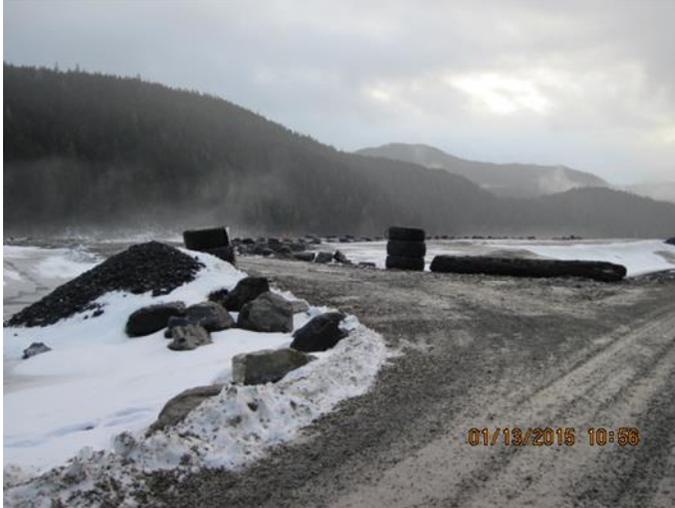
Photo 03. Northern Tracking Point looking South-Southeast.

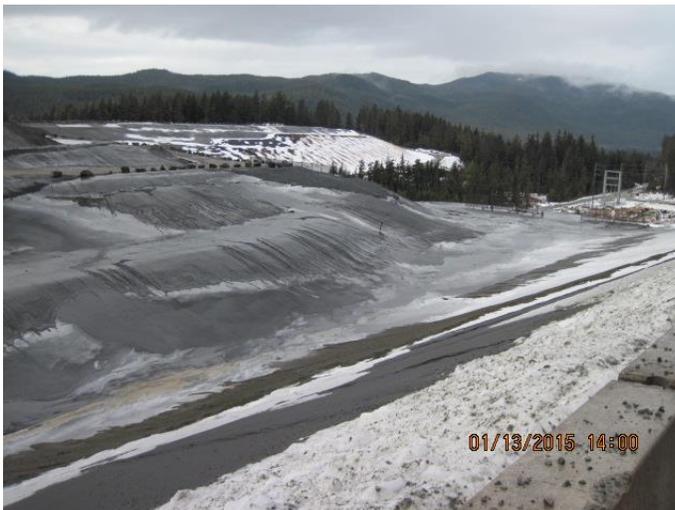
Photo 04. Eastern Tracking Point looking North.

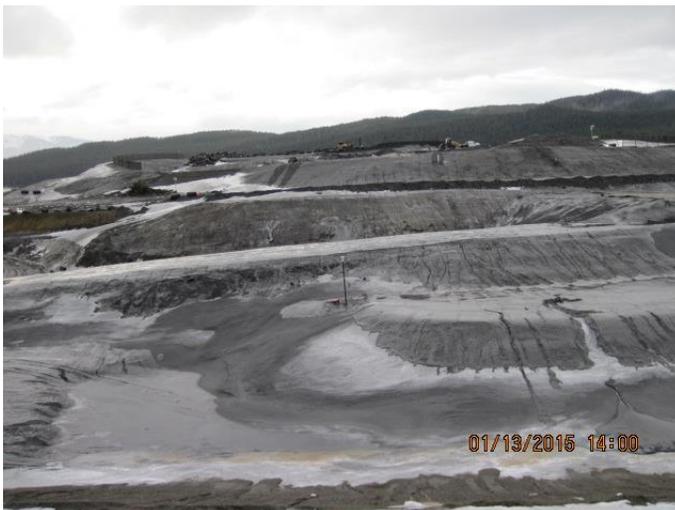
Photo 05. Eastern Tracking Point looking West. Small rills and gullies developing.

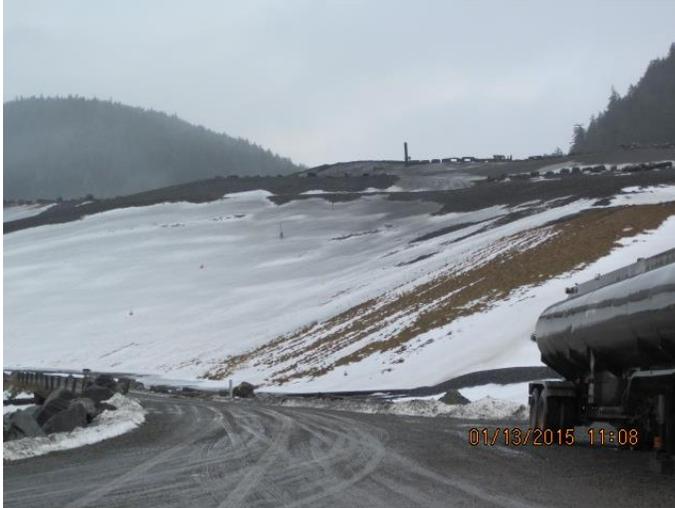
The team drove the perimeter of the TDF along the access roads and visited the three tracking photo points (Photos 03-06). Discoloration of the snow on the southwest slope of the TDF is evidence of fugitive dust. Fugitive dust mitigation at the TDF includes a sampling program, selective disposal of tailings, polymer use, wetting, and construction of multiple wind breaks.

Photo 06. Southern Tracking Point looking North. Fugitive dust discoloration.

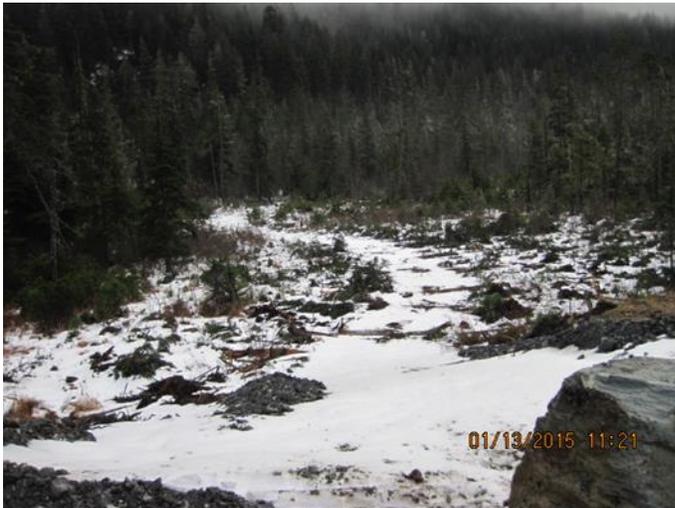
Geo tech work for the TDF expansion has occurred. Drilling and trenching were conducting as follow up to the seismic survey for a suitability test of subsurface conditions (Photo 07).

Photo 07. TDF expansion area. Geotechnical work.

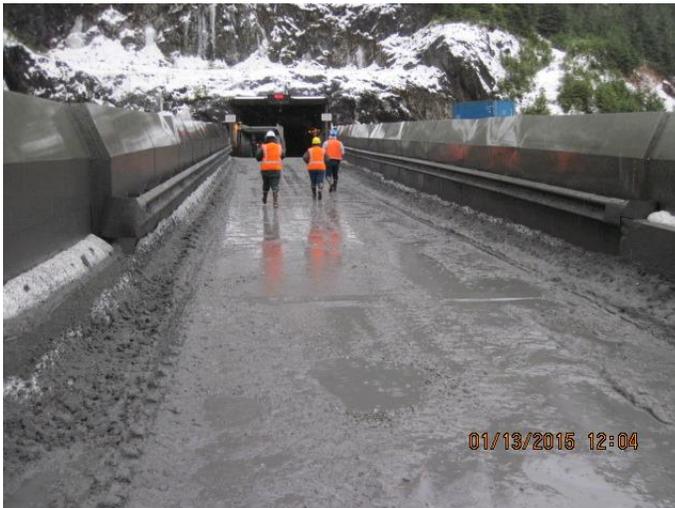
The area surrounding the 920 Bridge and Portal are in good condition (Photo 08-10).

Photo 08. 920 Bridge.

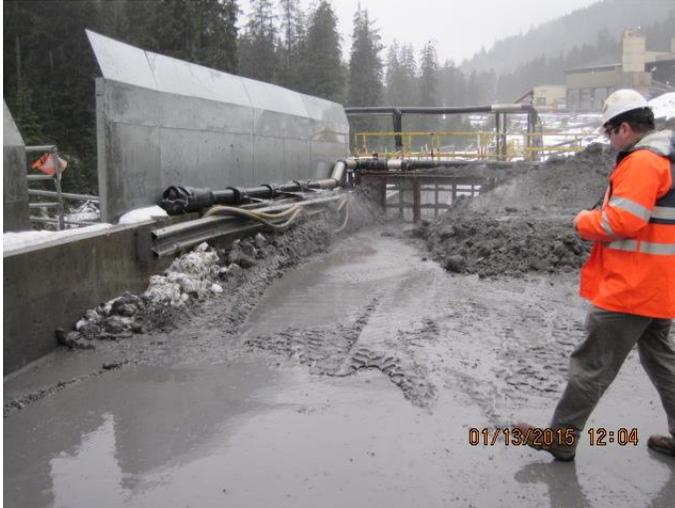
Photo 09. Degrit Basin 01.

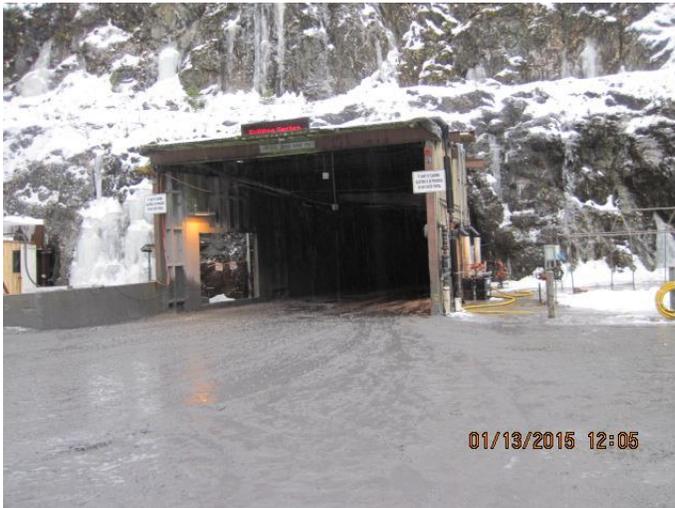
Photo 10. 920 Portal.

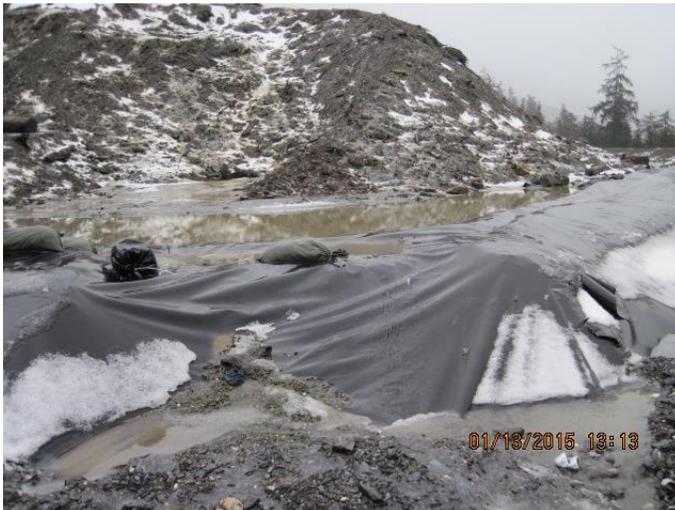
Waste rock from the 1350 area has been moved to site 23 for temporary storage and eventual disposal in the TDF. Waste rock from the 1350 is contained on a lined surface that is bermed to prevent comingling with other material. During this inspection, a frozen drain caused stormwater to overflow from the bermed and lined area. The contact water flowed into a system of lined ditches and was captured at the 23 Pond and piped to Pond 7 for treatment (Photos 11-16). Sediment from 23 Pond is disposed of in the TDF or used underground in backfill. Non-contact water is diverted around Site 23 and drains naturally through the vegetation into the watershed.

Photo 11. 1350 waste rock stored at site 23.

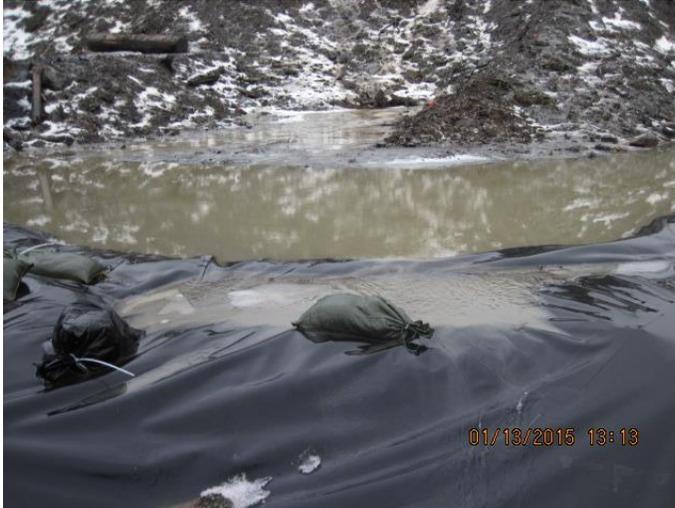
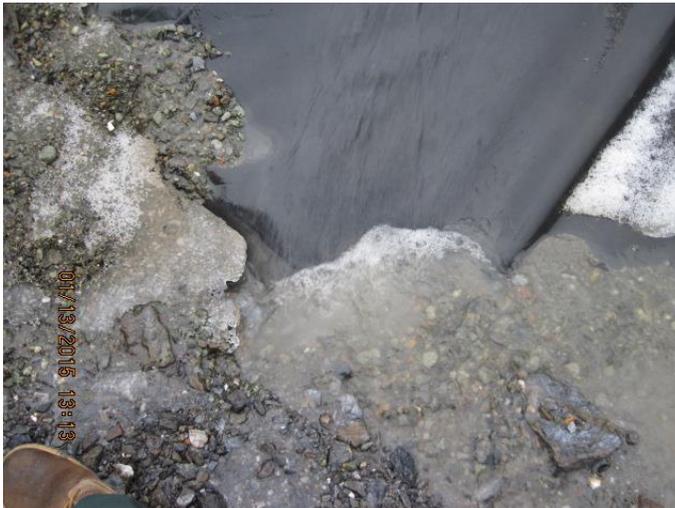
Photo 12. Contact water overflowing containment.

Photo 13. Contact water overflowing containment.

HGCMC responded to the overflow immediately and provided pictures on January 15 that the drain was thawed (Photos 17-18).

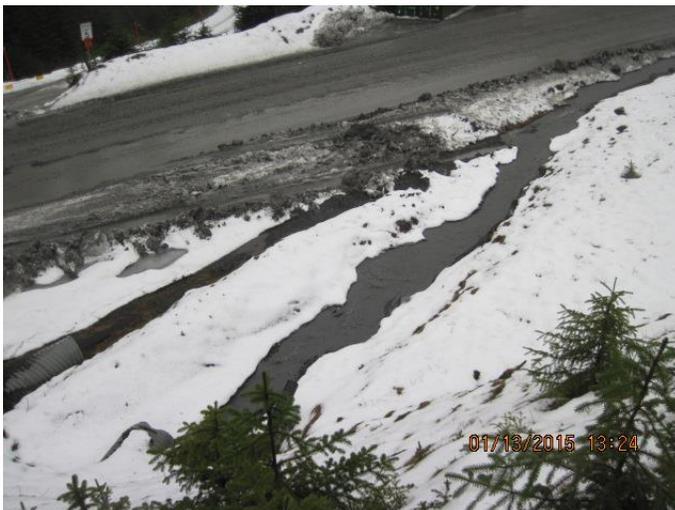
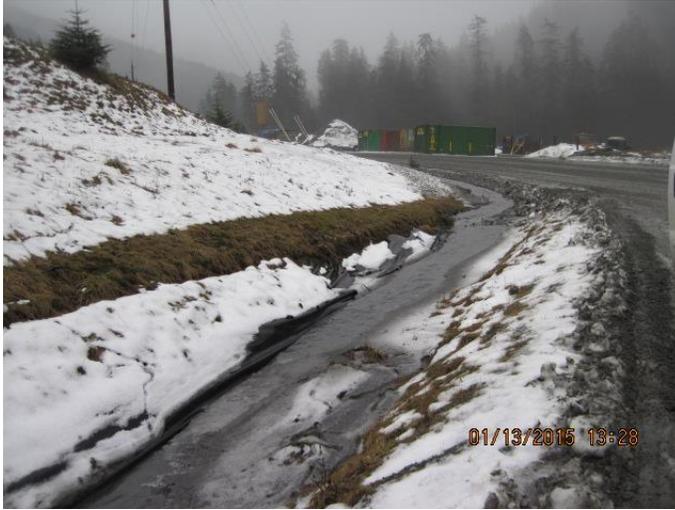
Photo 14. Contact water captured in series of lined ditches.

Photo 15. Contact water captured in series of lined ditches.

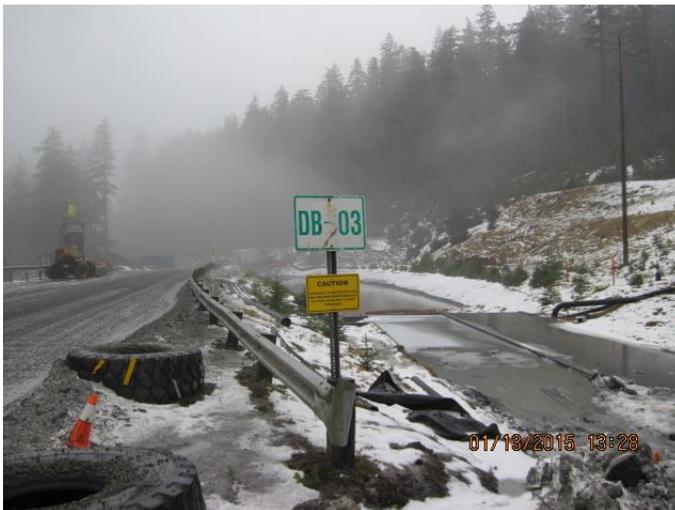
Photo 16. 23 Pond or degrit basin 03.

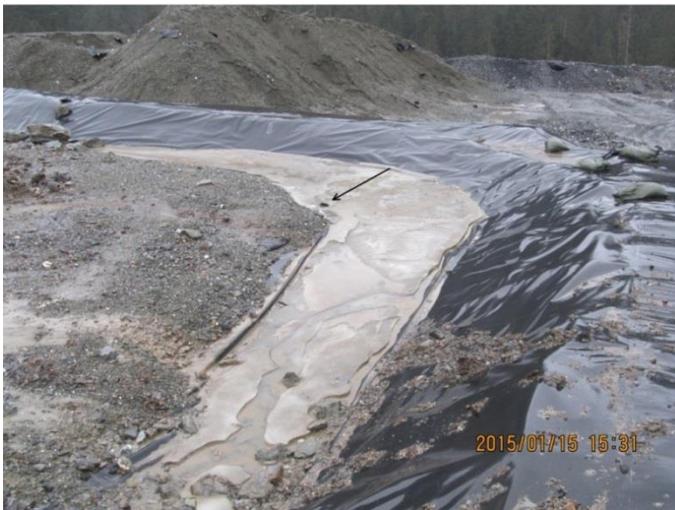
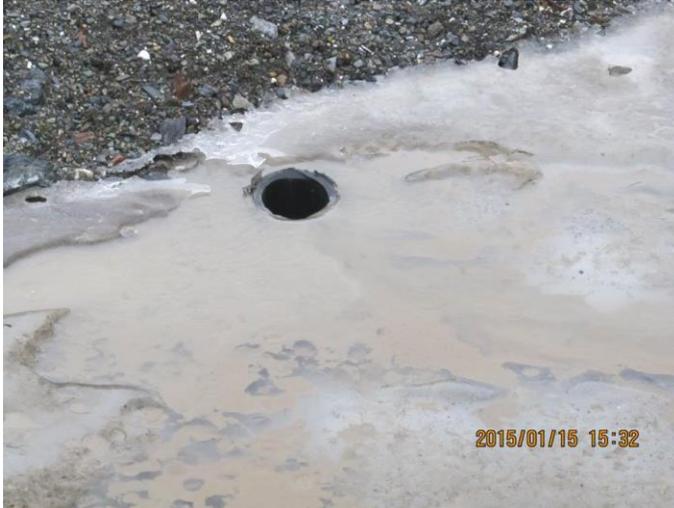
Photo 17. Photo showing repair courtesy of HGCMC.

Photo 18. Photo showing repair courtesy of HGCMC.

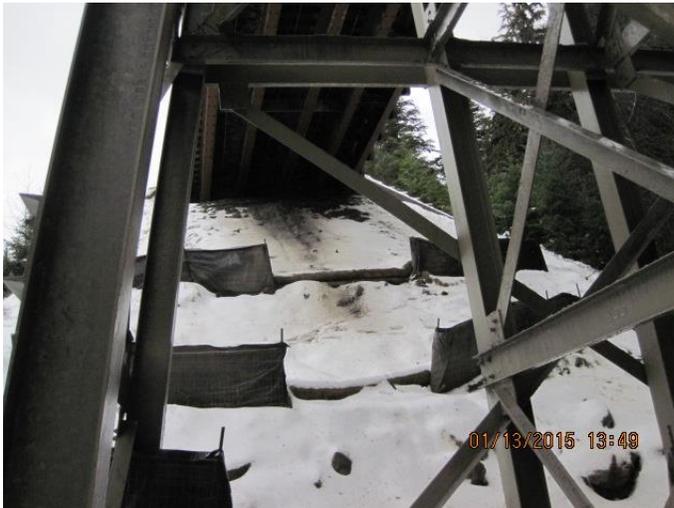
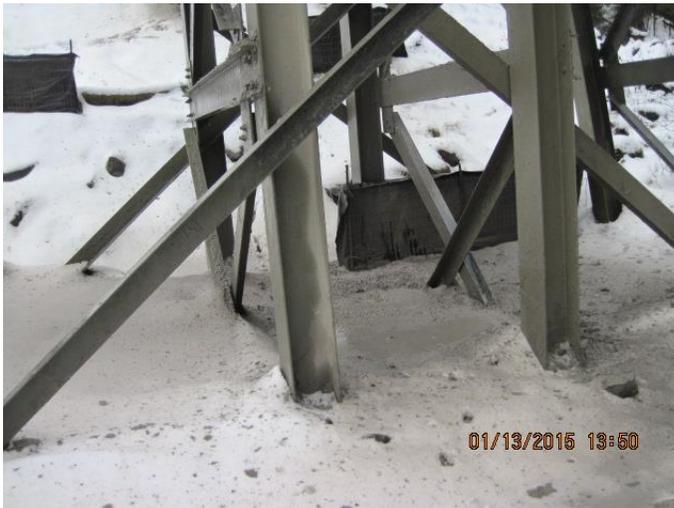
Road sediment is visible beneath Zinc Creek Bridge. The sediment has seeped between the bridge planking and is contained up gradient from Zinc Creek by the emplaced BMP. No erosion was noted during this inspection (Photos 19-21)

Photo 19. Sediment under Zinc Creek Bridge.

Photo 20. Sediment under Zinc Creek Bridge.

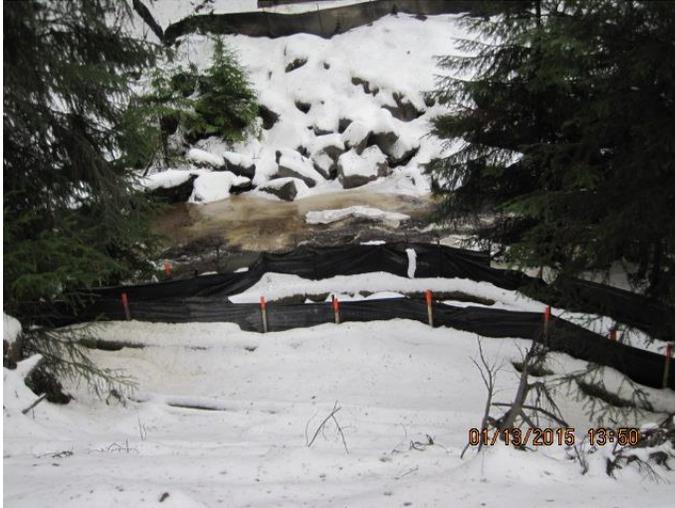
HGCMC has enhanced BMP mitigation at Zinc Creek to comply with the APDES Permit. Although covered with snow during this inspection, the area had additional silt fencing and straw waddles emplaced.

Photo 21. Enhanced BMP at Zinc Creek.

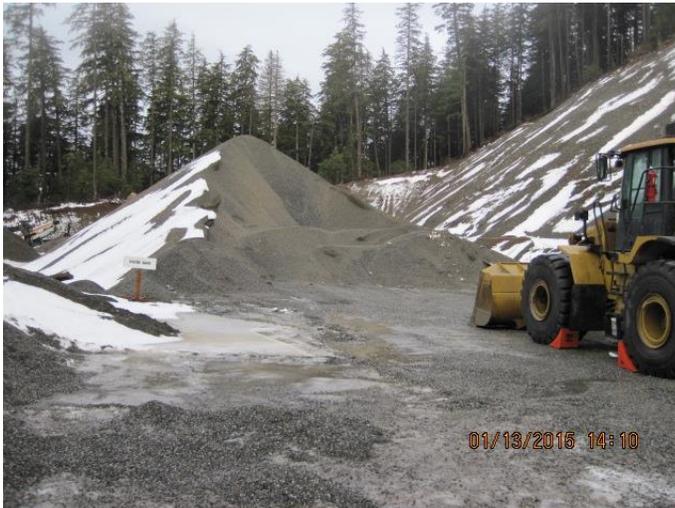
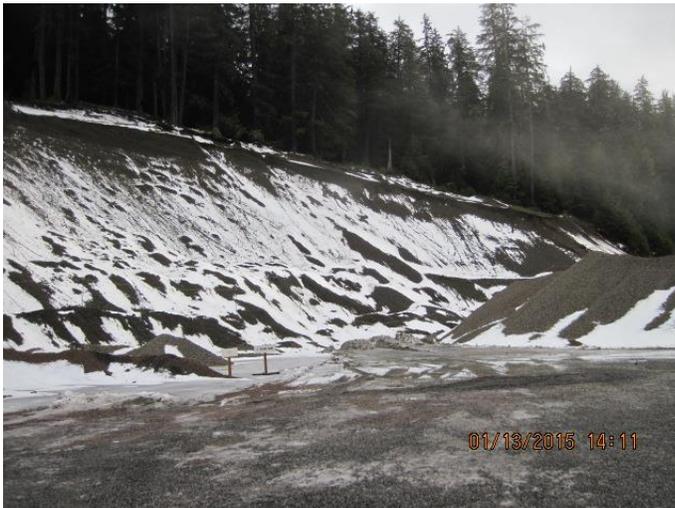
The Sand Pit is located on the A road between Young Bay and Hawk Inlet at mile marker 1.4. The area is an active quarry and stockpile for sand and gravel used at the mine (Photos 22-23).

Photo 22. A Road Sand Pit.

Photo 23. A Road Sand Pit.

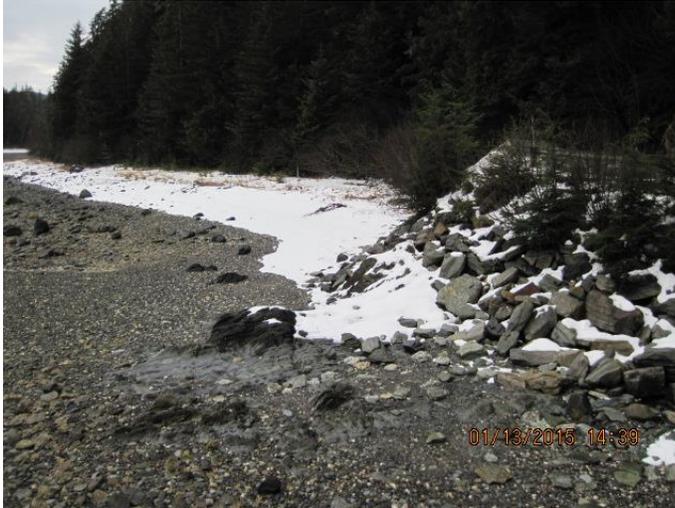
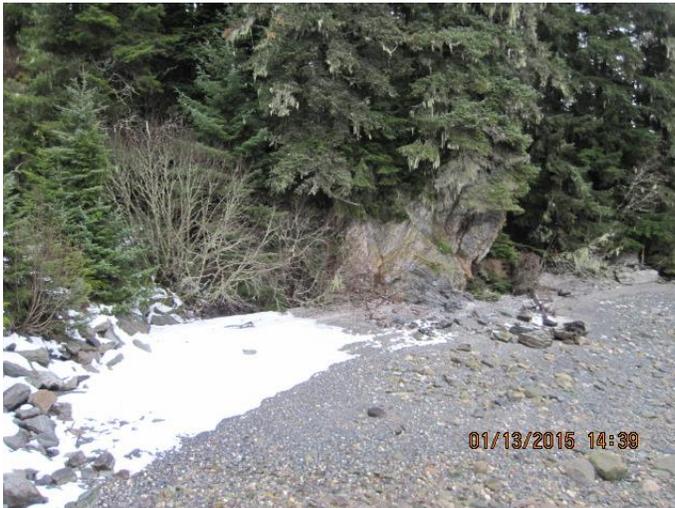
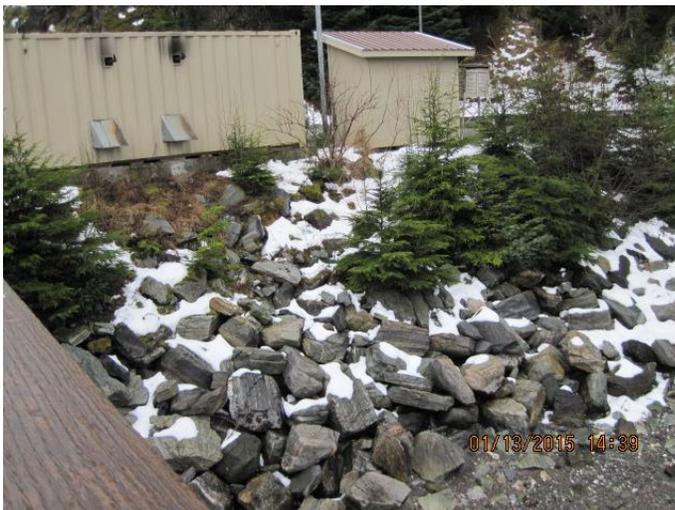
The Young Bay site includes a parking area for crew bus, and a docking facility for the crew ferry that transports personnel to and from the island daily. The Team briefly inspected and photo documented the area of the proposed barge ramp (Photos 24-25).

Photo 24. Young Bay.

Photo 25. Young Bay.

Photo 26. Young Bay.
