**ACTIVE TAILINGS AND PRODUCTION ROCK SITE
2016 ANNUAL REPORT**

Hecla Greens Creek Mining Company

April 15, 2017

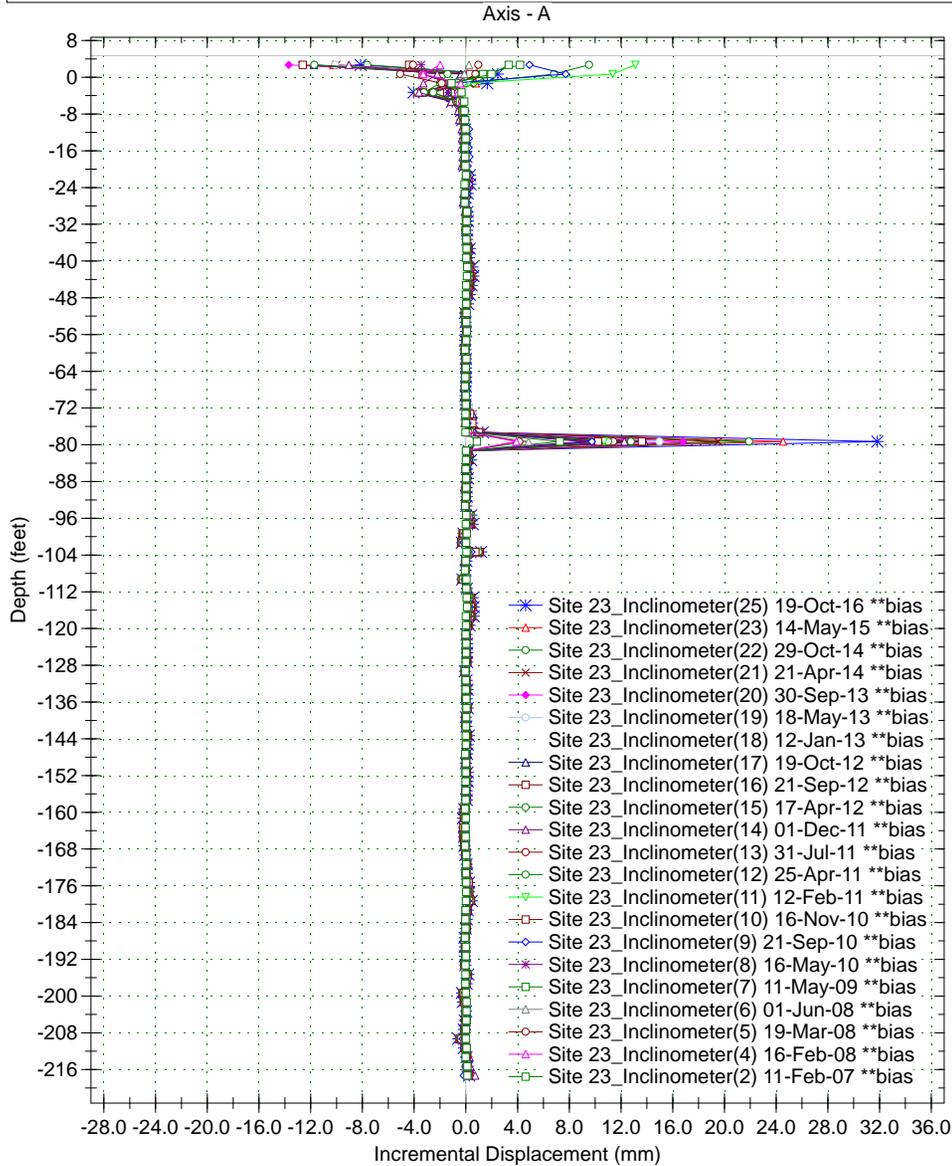
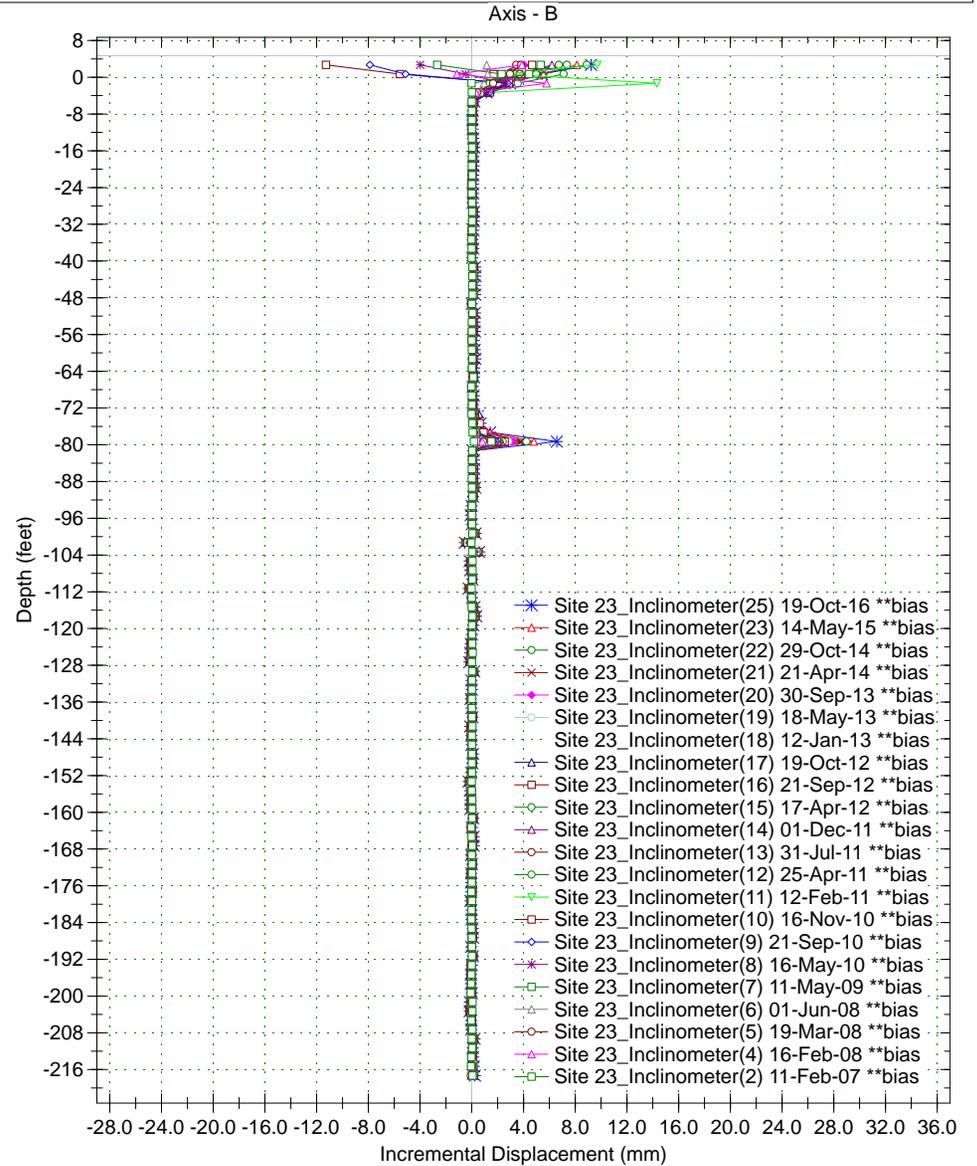
Borehole : Inclinator
 Project : Site 23
 Location : IN-23-05-01
 Northing : 20671.45 ft
 Easting : 17186.42 ft
 Collar : 948.84 ft

Note: Collar elevation is top of casing, at ~4.7 ft above ground surface.
 Top section of casing replaced at joint in July 2011 due to damage. Bias-shift correction by pin of data sets at 150-ft depth (A-B axis).

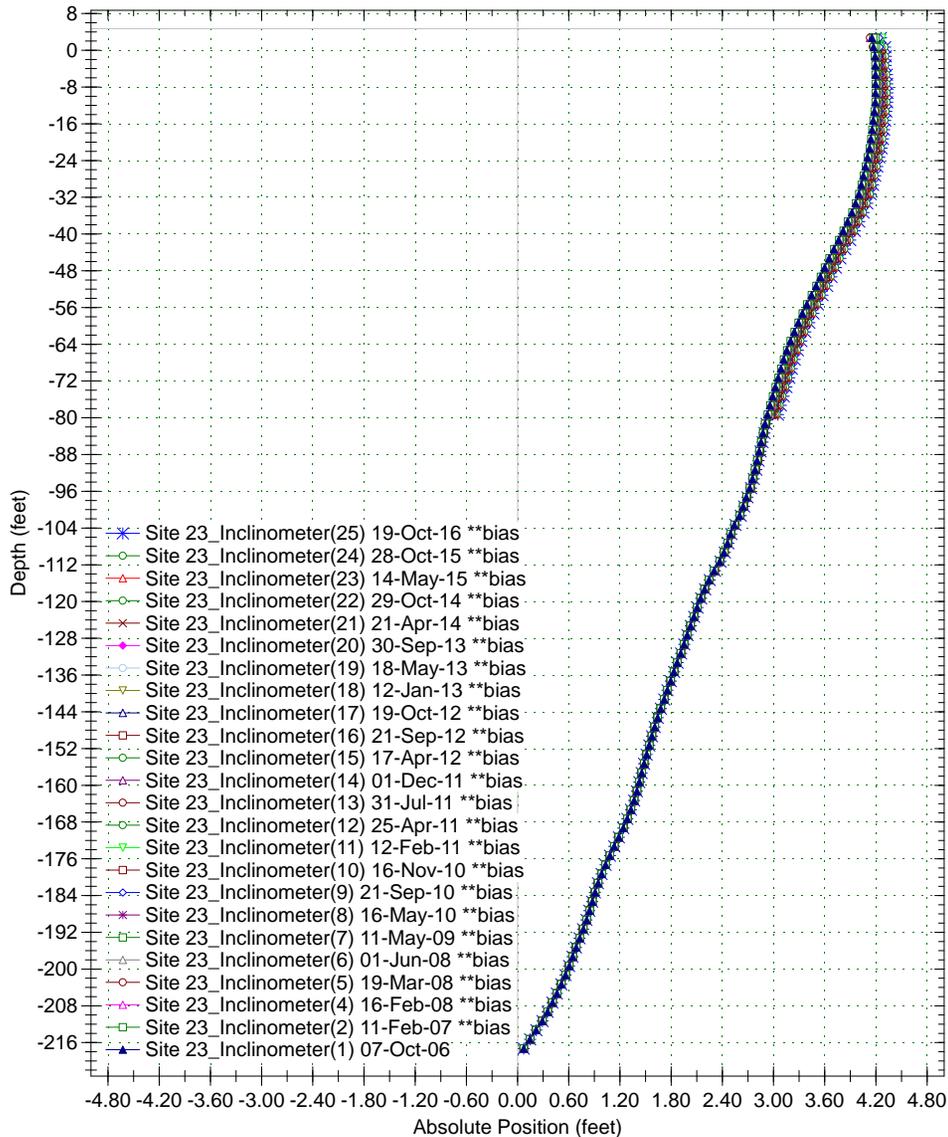
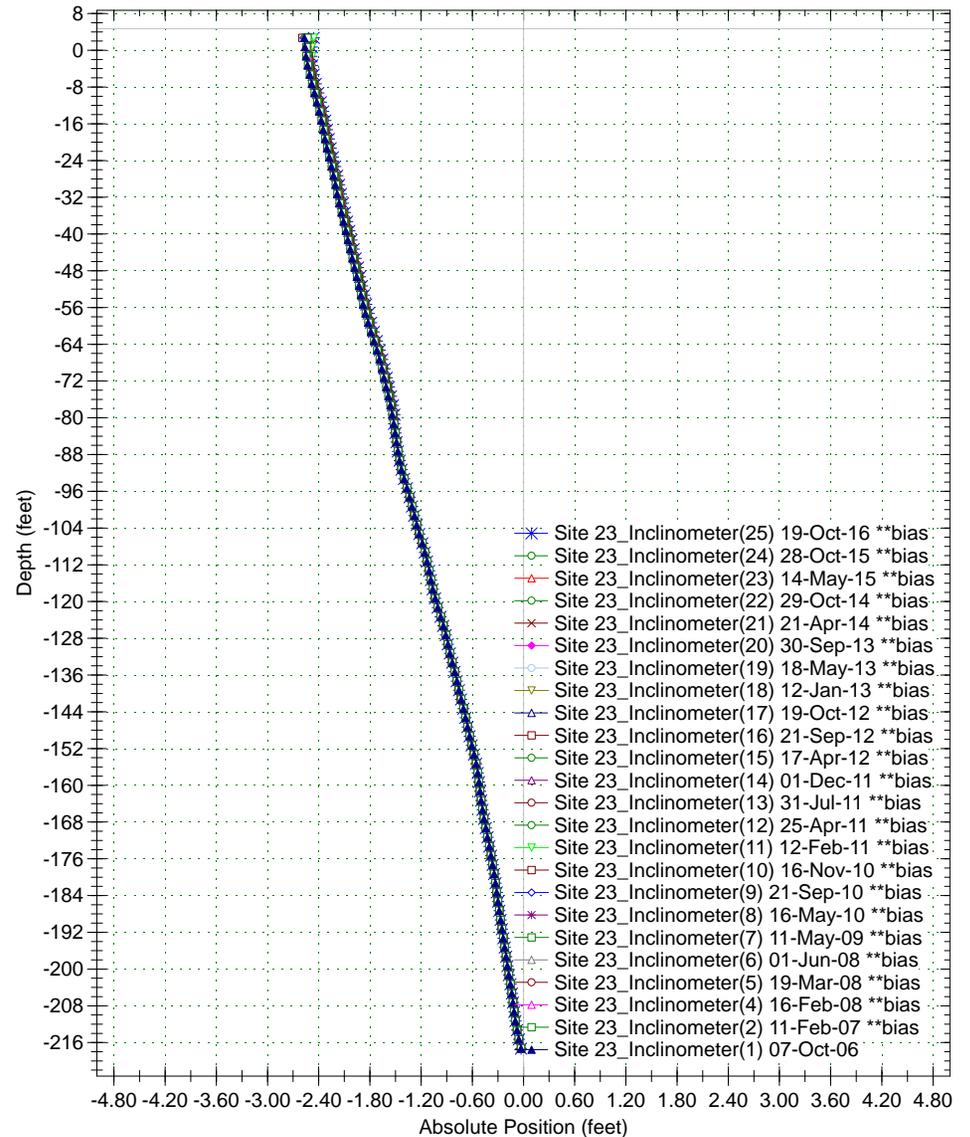
Borehole : Inclinator
 Project : Site 23
 Location : IN-23-05-01
 Northing : 20671.45 ft
 Easting : 17186.42 ft
 Collar : 948.84 ft

Note: Collar elevation is top of casing, at ~4.7 ft above ground surface.
 Top section of casing replaced at joint in July 2011 due to damage. Bias-shift correction pinned at 150-ft depth (A-B axis).
