**TAILINGS AND PRODUCTION ROCK SITE
2008 ANNUAL REPORT**

Hecla Greens Creek Mining Company

April 15, 2009

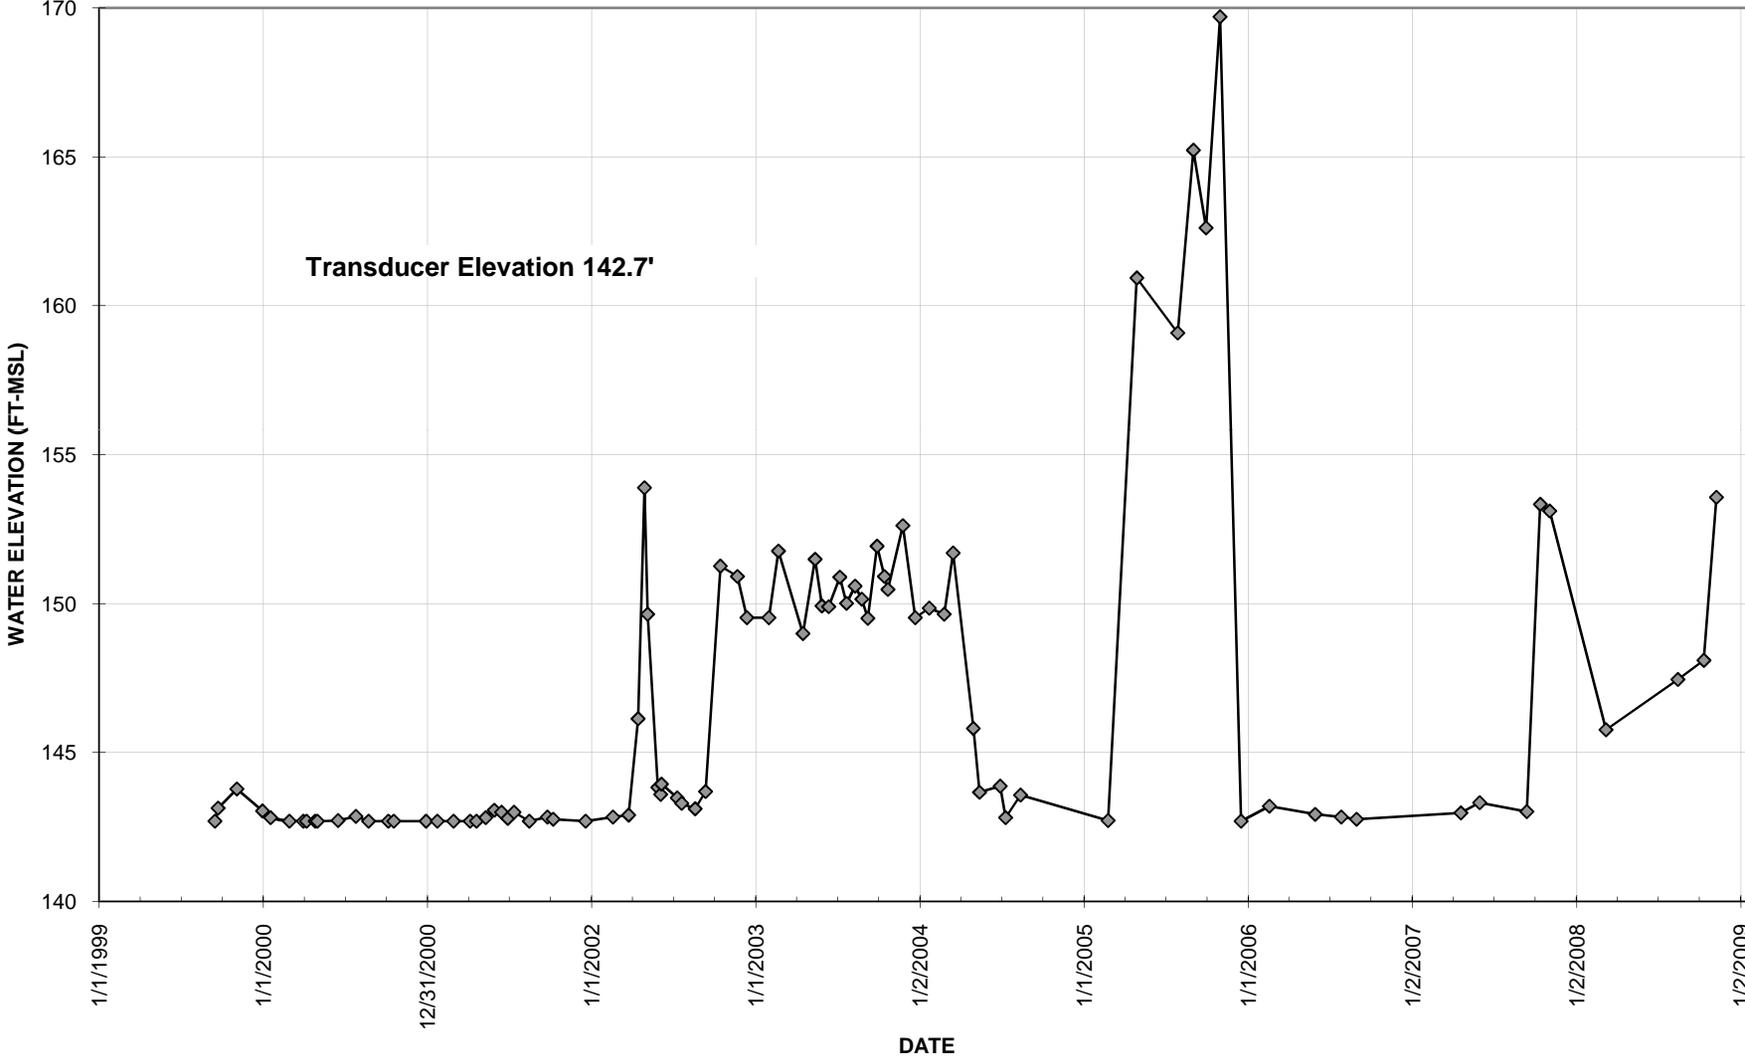
Figure 2.10 Water Level Data for Piezometer 76

The data from standpipe and pneumatic piezometers completed above the blanket drain (Piezometer 76, PZ-T-00-01, PZ-T-00-02, PZ-T-00-03 in Figures 2.10, 2.11, 2.12, 2.13) indicate that saturated conditions can develop above the unsaturated underdrains to a thickness of approximately 12 feet. This is consistent with the low permeability of the tailings and the uncapped condition of the pile. Covering the pile will help minimize the saturated zone in the pile. This was demonstrated by the over 10 foot decrease in the water table that occurred from 1995 to 1997 when the pile was covered (see Figures 2.1 to 2.7). Water levels have rebounded to, and in some cases above, 1994 elevations in most areas. Areas where water levels exceed their 1994 values are areas where the pile is considerably thicker than it was in 1994. The increase in water levels observed in PZ-T-00-01 (and to a lesser extent in instruments nearby) from 2005 to 2008 is likely a result of new tailings placement in the area and staged decommissioning of Wet Well 2.

Periodic spikes in water levels in the wells and piezometers are due to a variety of factors including extreme weather events (e.g. Fall/Winter 2005-2006), changes to water management infrastructure (e.g. decommissioning of Wet Well 2 from 2005-2008), damage to instrumentation (Piezometer 76 in 2004), and measurement errors (e.g. MW-T-00-05A in 2002-2003 and 2007).

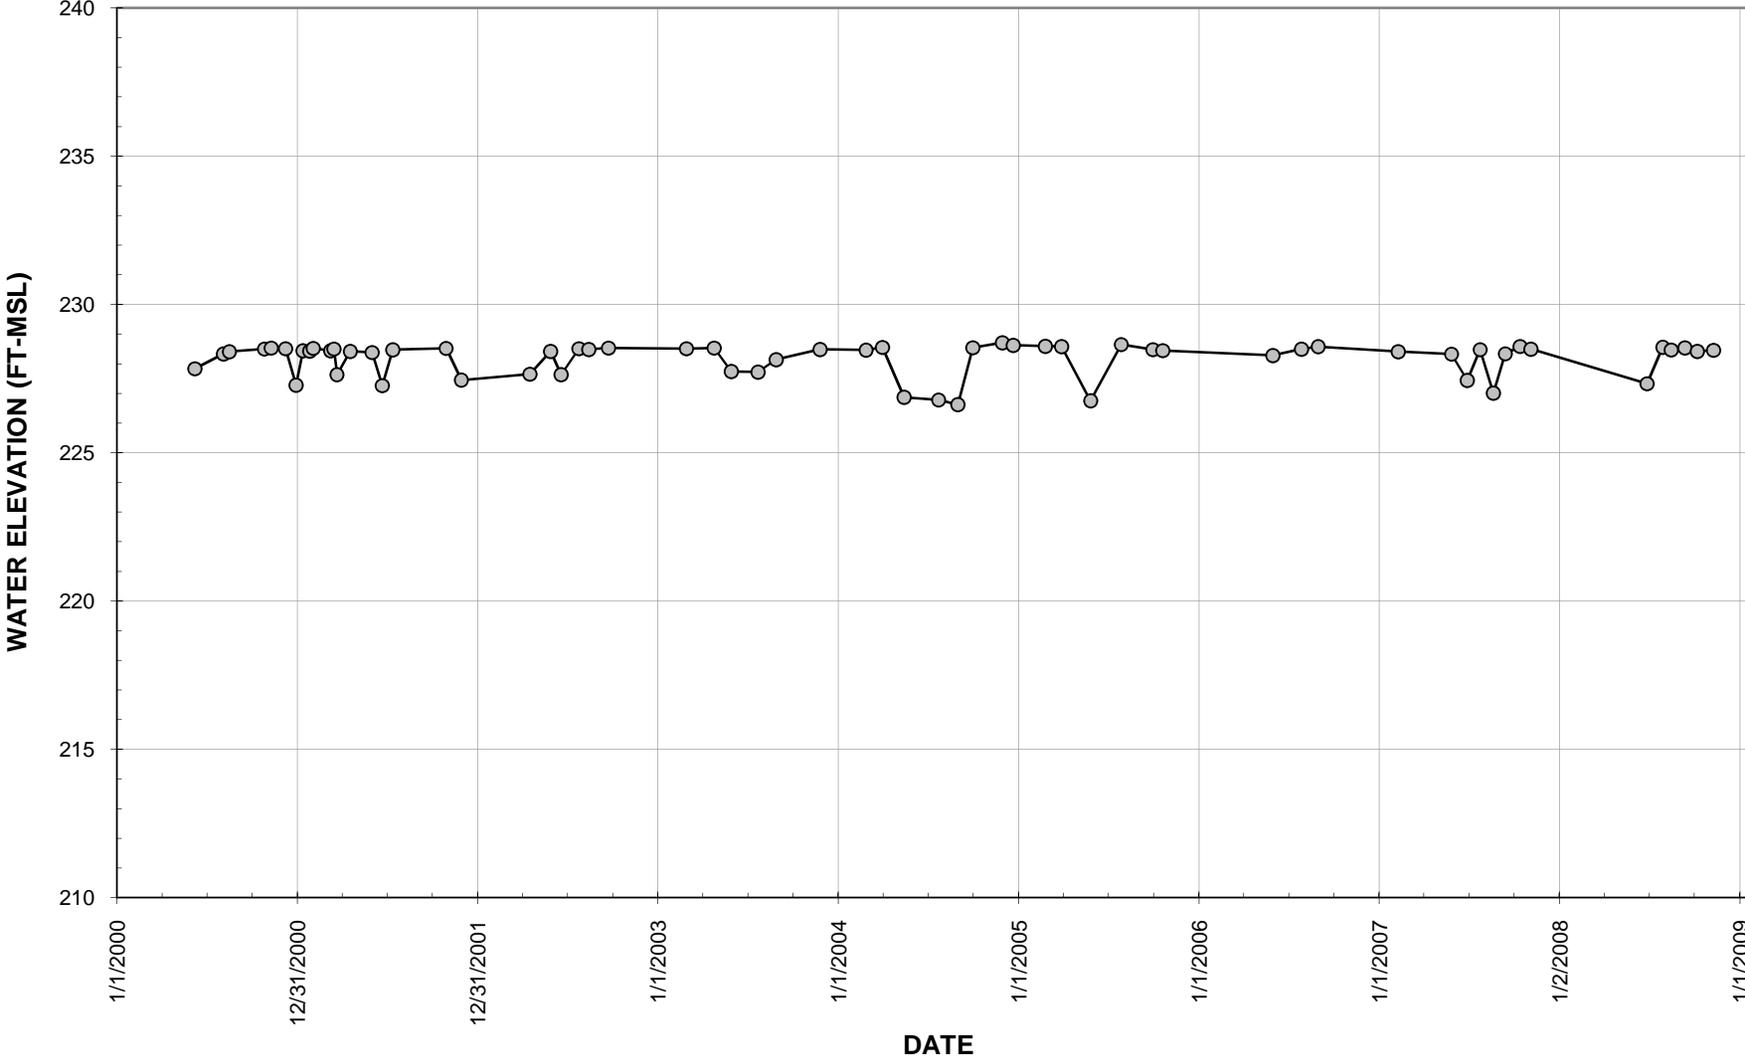
Figure 2.15 Water Level Data for Well MW-T-00-3A

Water levels in four wells completed east and west of the pile are shown for comparison in Figures 2.15 to 2.18. The eastern wells, MW-T-00-03A (Figure 2.15) and MW-T-00-03B (Figure 2.16), are completed in the shallow sands 12 and 17 feet, respectively, below ground surface. The figures for these wells show that the water elevation in shallow completions in native materials can be readily influenced by abnormal weather conditions. Wells MW-T-01-03A and MW-T-01-03B are installed west of the pile. Their water levels are shown in Figures 2.17 and 2.18, respectively. MW-T-01-03A is completed in bedrock to a depth of 20 feet and MW-T-01-03B is completed in clayey silt to a depth of 12 feet. These wells show similar water level fluctuations with weather conditions as the two eastern wells. However, the water level in MW-T-01-03B shows a larger differential than MW-T-01-03A because silts and clays hold more water in tension, so a small increase in water content causes a large change in head. The ground surface elevation is 134 feet in the proximity of these two wells. Both MW-T-01-03A and MW-T-01-03B were damaged by bears in 2006 and attempts to recover them have not been successful.

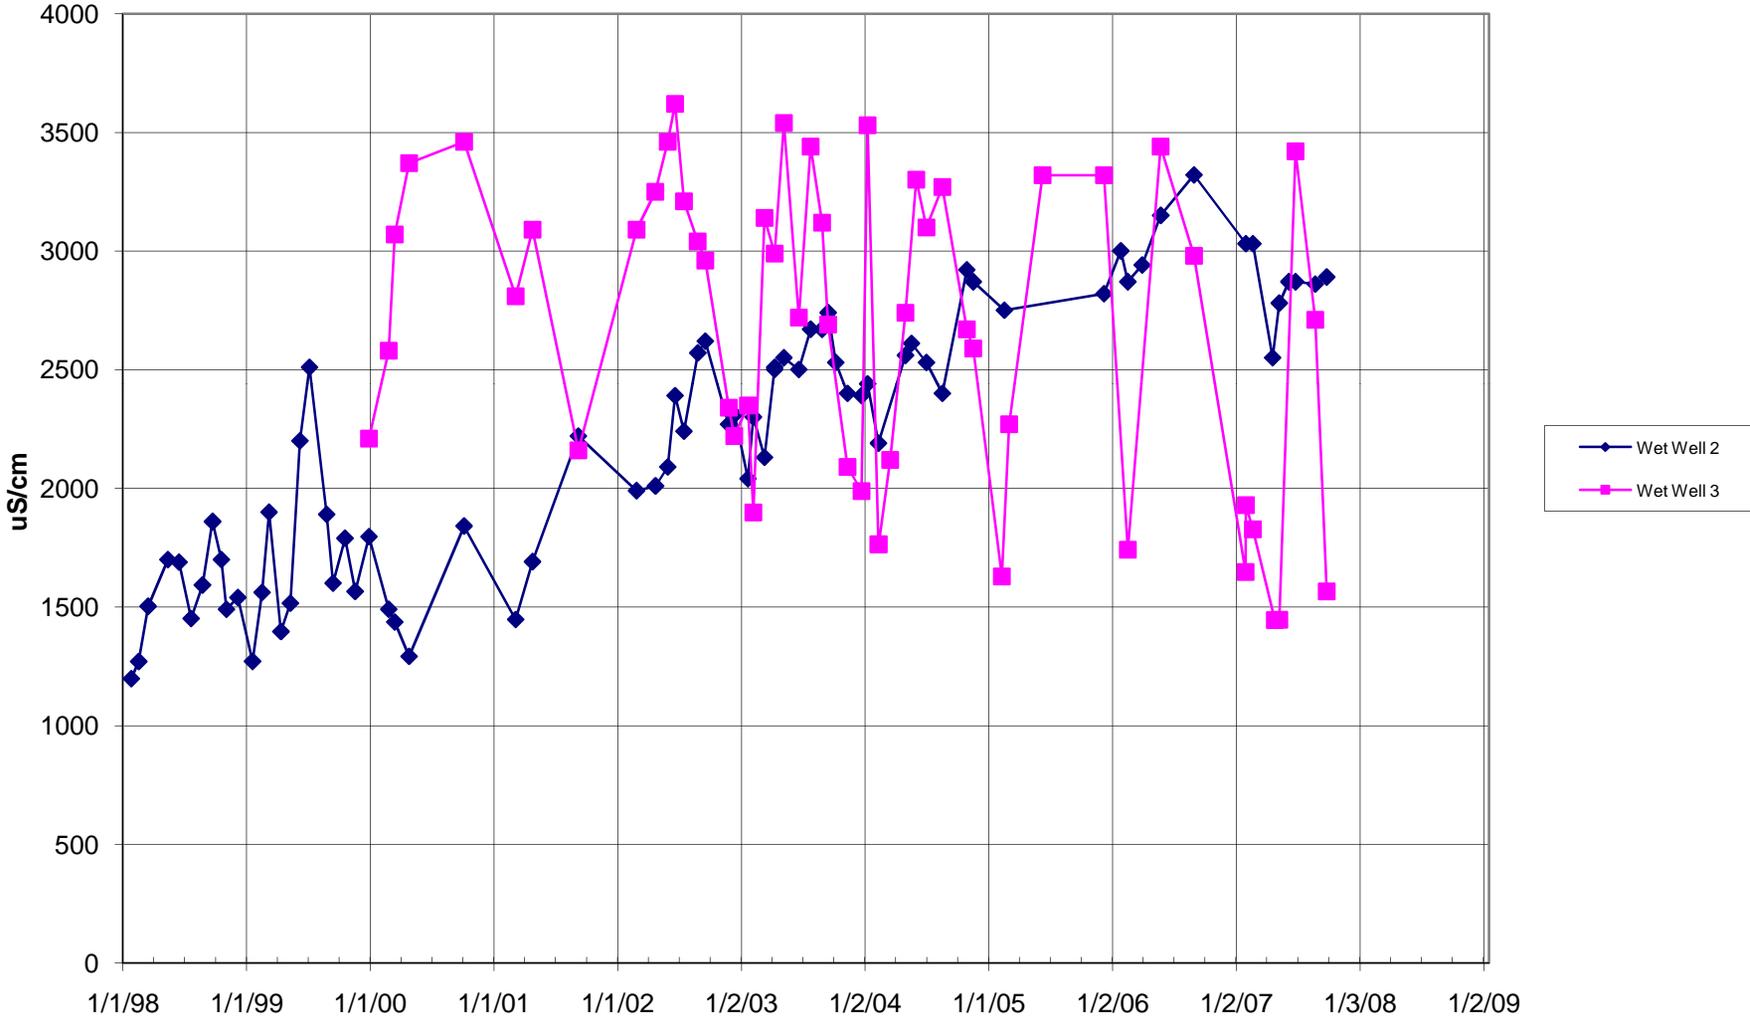
**FIGURE 2.22a GREENS CREEK TAILINGS INTERNAL MONITORING SITES:
WET WELLS - CONDUCTIVITY DATA**

The conductivity results from internal monitoring site waters are presented in Figures 2.22a, b, and c. Conductivity measurement range between 1,446 (wet wells) and 6,610 (suction lysimeters) μ S/cm. The higher conductivity of the site contact waters reflects a larger dissolved load caused by weathering of the tailings. Pyrite oxidation and carbonate dissolution contribute dissolved ions such as sulfate, bicarbonate, calcium and magnesium to the contact waters, increasing their conductivity. Wet Well 3 has a different capture area than Wet Well 2 and shows a different pattern with respect to conductivity. The changes in conductivity observed in Wet Well 3 suggest changes in the relative contributions from runoff, addition of the Northwest Diversion Ditch flow, infiltration and groundwater as the West Buttress was constructed. The increase in conductivity seen in Wet Well 2 over the past several years likely reflects an increasing contribution from contact water in the drain system and an increase in the dissolved load from migration/remobilization of oxidation products in the pile. In 2008 Wet Well 2 was routed to Wet Well A, a new wet well located in the newly modified Pond 6 area, and therefore can no longer be sampled. HGCMC plans to equip Wet Well A with monitoring instruments in 2009. Suction lysimeter samples are drawn from the smallest pore spaces of the unsaturated zone.

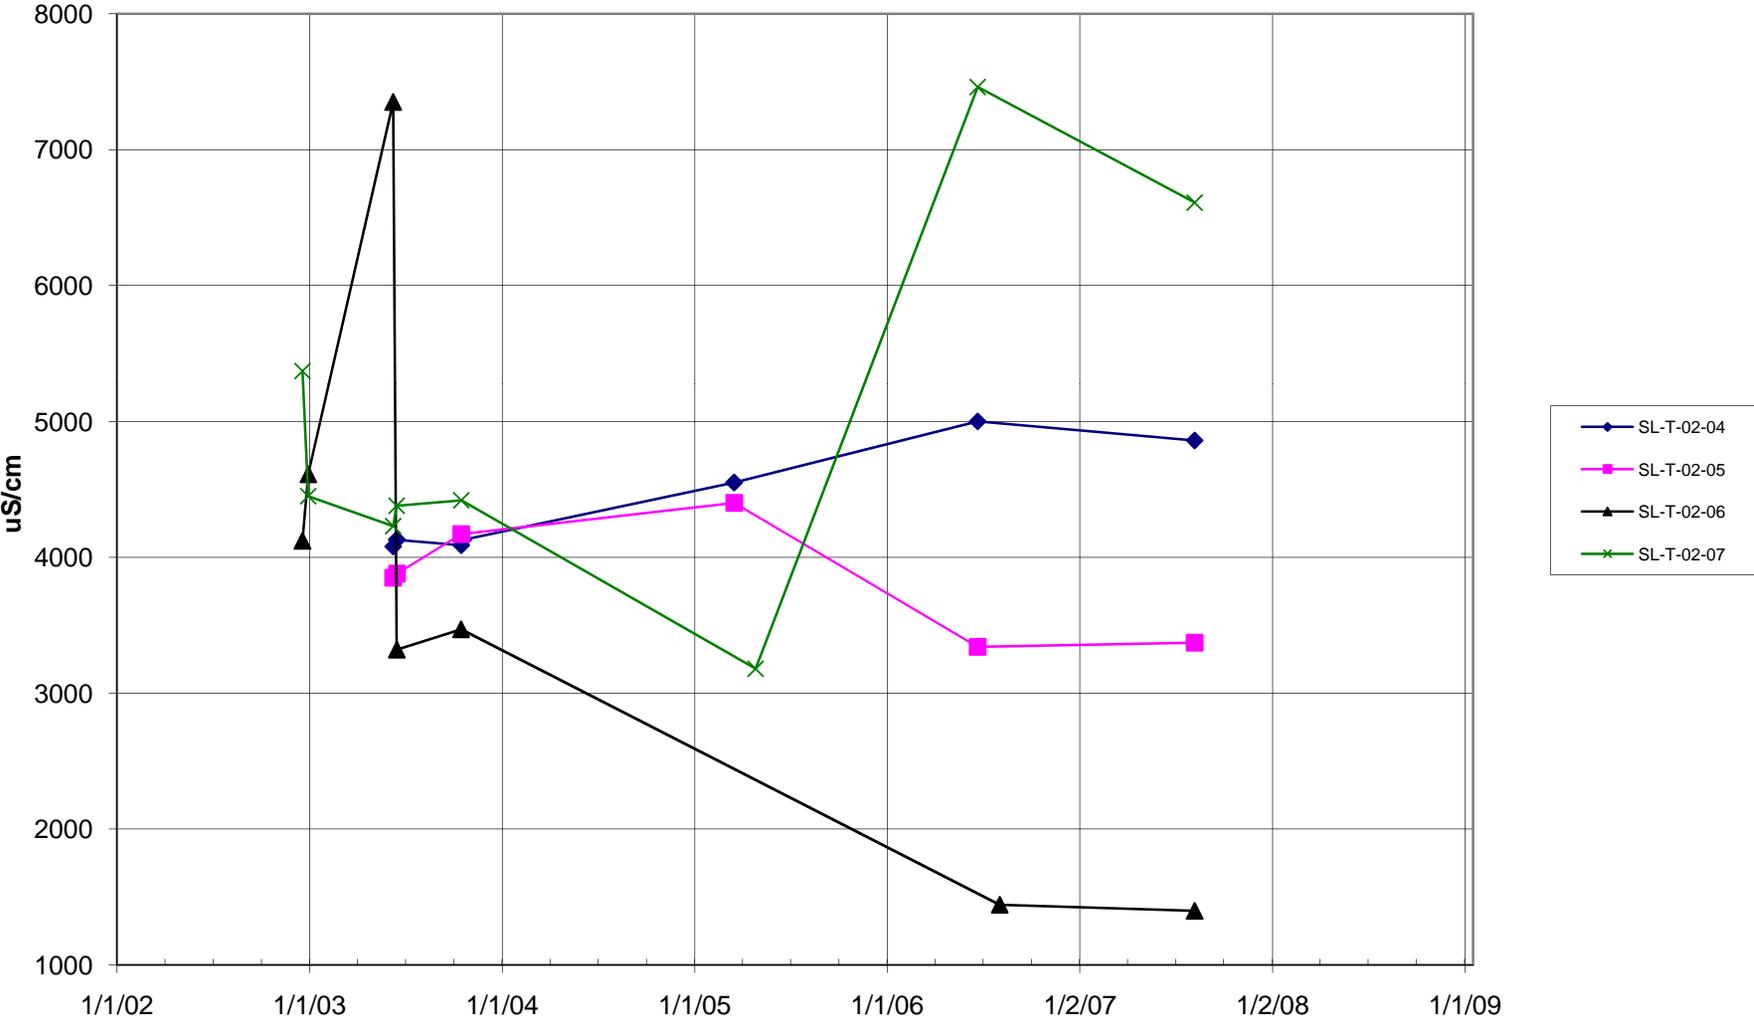
**FIGURE 2.22c GREENS CREEK TAILINGS INTERNAL MONITORING SITES:
SUCTION LYSIMETERS - CONDUCTIVITY**

Water held in these pores is often isolated from flow paths and thus has higher dissolved constituent concentrations than water from the saturated zone and foundation drains.

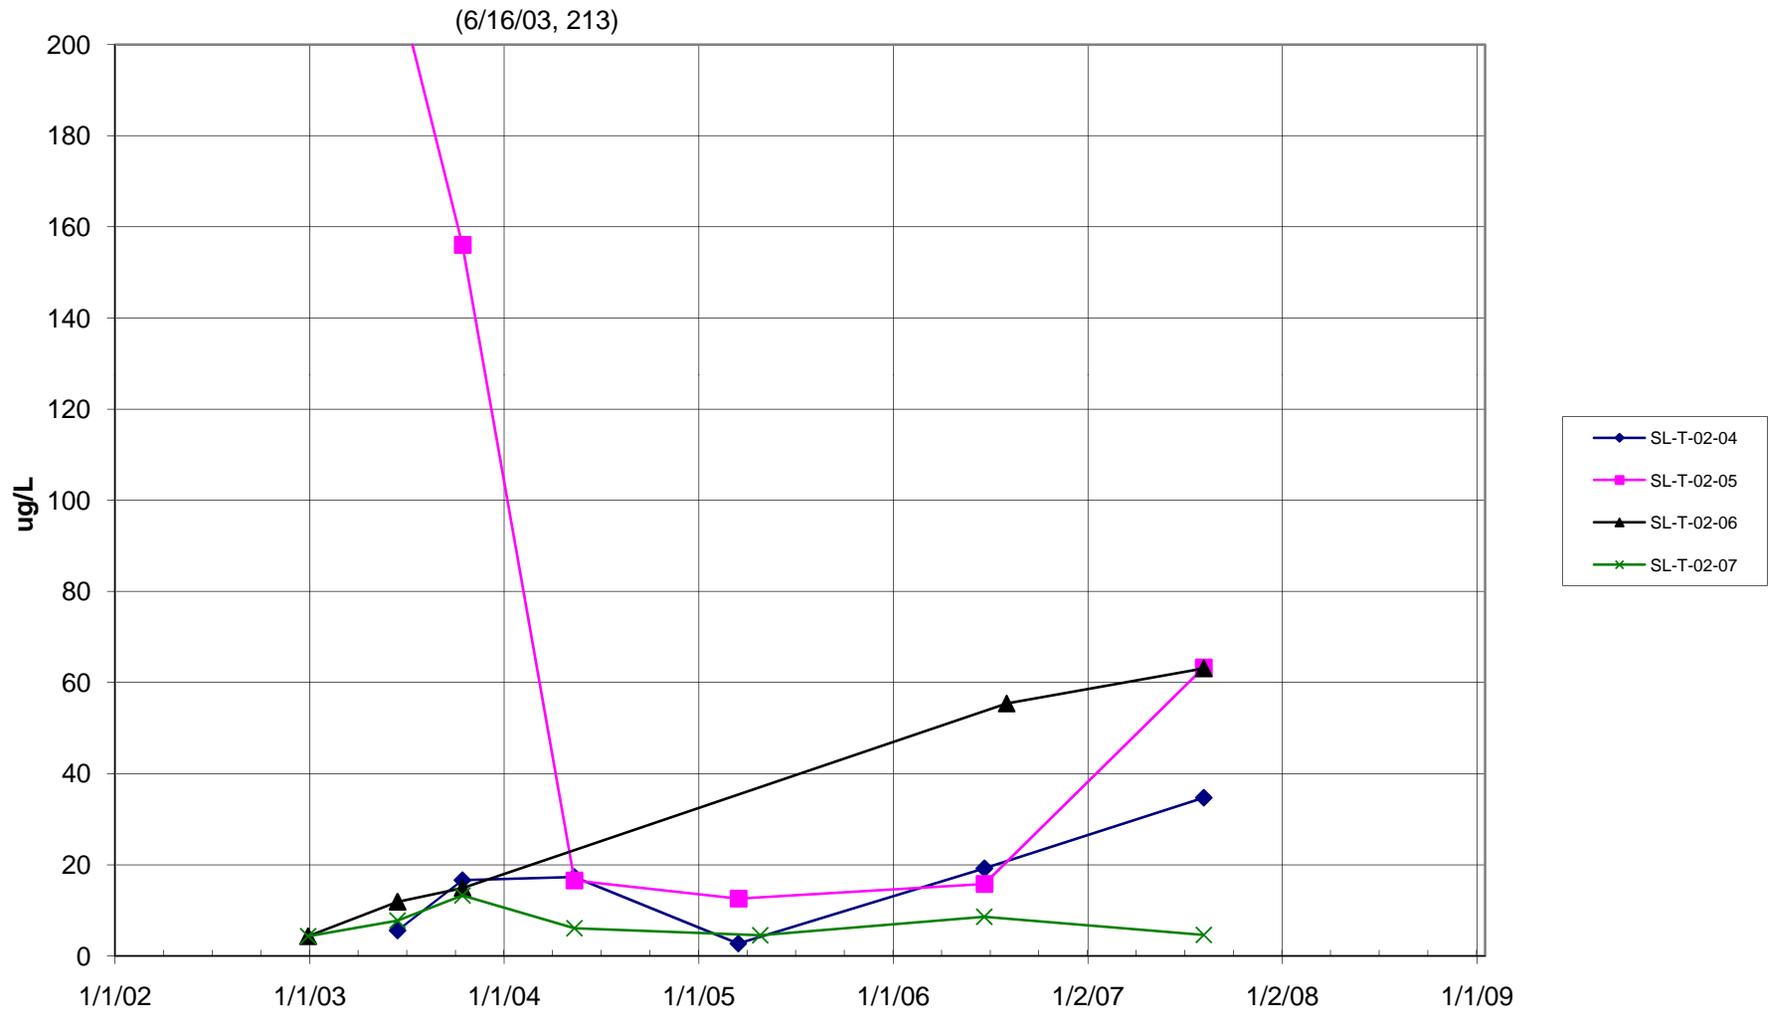
**FIGURE 2.25c GREENS CREEK TAILINGS INTERNAL MONITORING SITES:
SUCTION LYSIMETERS - ARSENIC DATA
(Non-detectable analyses plotted as zero)**

Arsenic data are presented in Figures 2.25a, b and c. The variability in arsenic concentrations observed in Wet Well 2, MW-T-02-06, and some suction lysimeters is related to evolving redox conditions in the pile. As arsenic-bearing minerals such as tetrahedrite/tennantite (and to a lesser extent pyrite) weather, the arsenic that is released is typically co-precipitated with iron oxyhydroxides. As the pile grows, reducing conditions overtake areas that were once oxidizing. This was particularly true as the water table rose following removal of the temporary PVC cover that was placed on the pile in 1995 (removal began in 1997). Dissolution of oxyhydroxides (and possibly sulfates) is expected as the waters respond to the changing redox conditions. This will contribute arsenic and iron (Figures 2.30a, b and c) to the drainage water. Arsenic concentrations in the pile drainage will therefore decrease when redox conditions in the pile stabilize (e.g. with closure and capping of the pile). Sulfate reduction may also lower arsenic concentrations. This is apparent in the composition of waters from the saturated zone and in some of the SRMP test cells, which are discussed in more detail below.
