**TAILINGS AND PRODUCTION ROCK SITE
2009 ANNUAL REPORT**

Hecla Greens Creek Mining Company

April 15, 2010

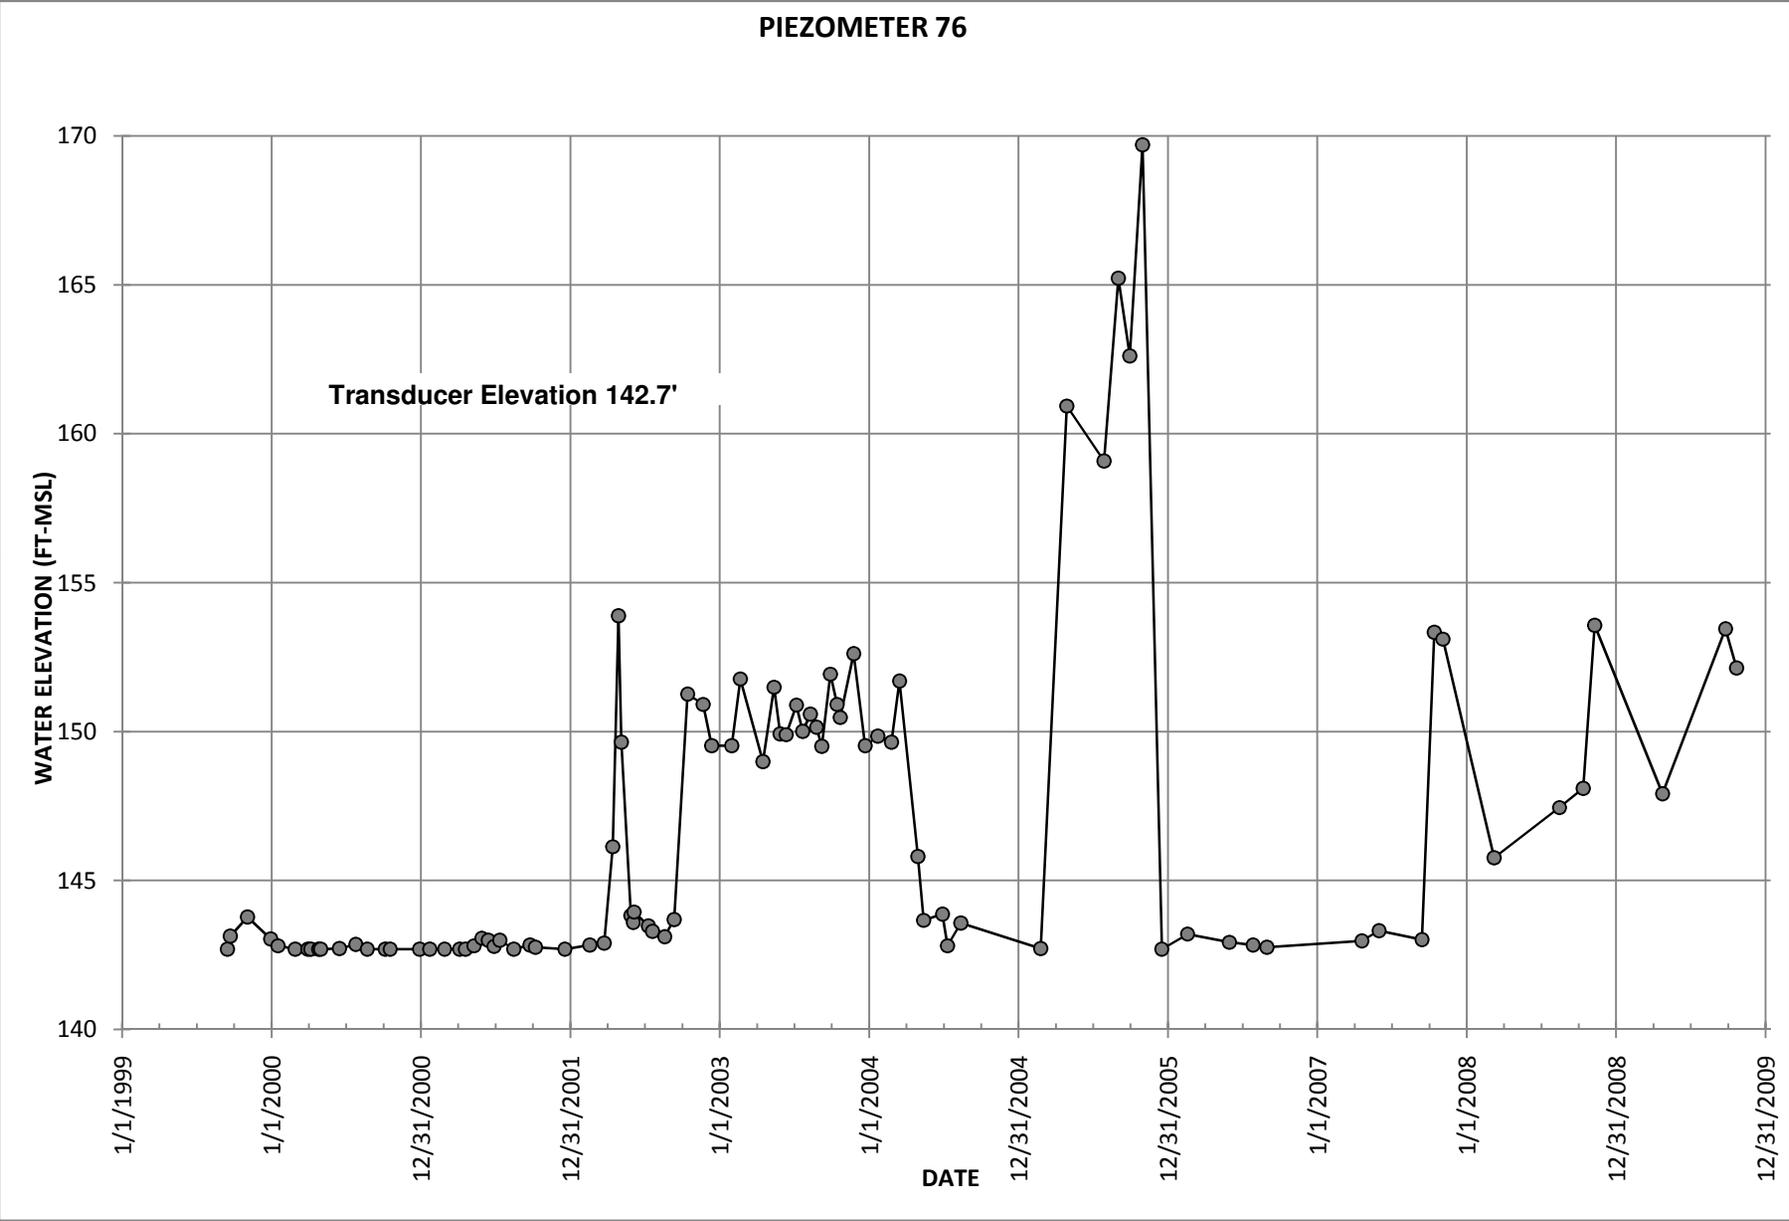
Figure 2.10 Water Level Data for Piezometer 76

The data from standpipe and pneumatic piezometers completed above the blanket drain (Piezometer 76, PZ-T-00-01, PZ-T-00-02, PZ-T-00-03 in Figures 2.10, 2.11, 2.12, 2.13) indicate that saturated conditions can develop above the unsaturated underdrains to a thickness of

approximately 12 feet. This is consistent with the low permeability of the tailings and the uncapped condition of the pile. Covering the pile will help minimize the saturated zone in the pile. This was demonstrated by the over 10 foot decrease in the water table that occurred from 1995 to 1997 when the pile was covered (see Figures 2.1 to 2.7). Water levels have rebounded to, and in some cases above, 1994 elevations in most areas. Areas where water levels exceed their 1994 values are areas where the pile is considerably thicker than it was in 1994. The increase in water levels observed in PZ-T-00-01 (and to a lesser extent in instruments nearby) from 2005 to 2008 is likely a result of new tailings placement in the area and staged decommissioning of Wet Well 2.

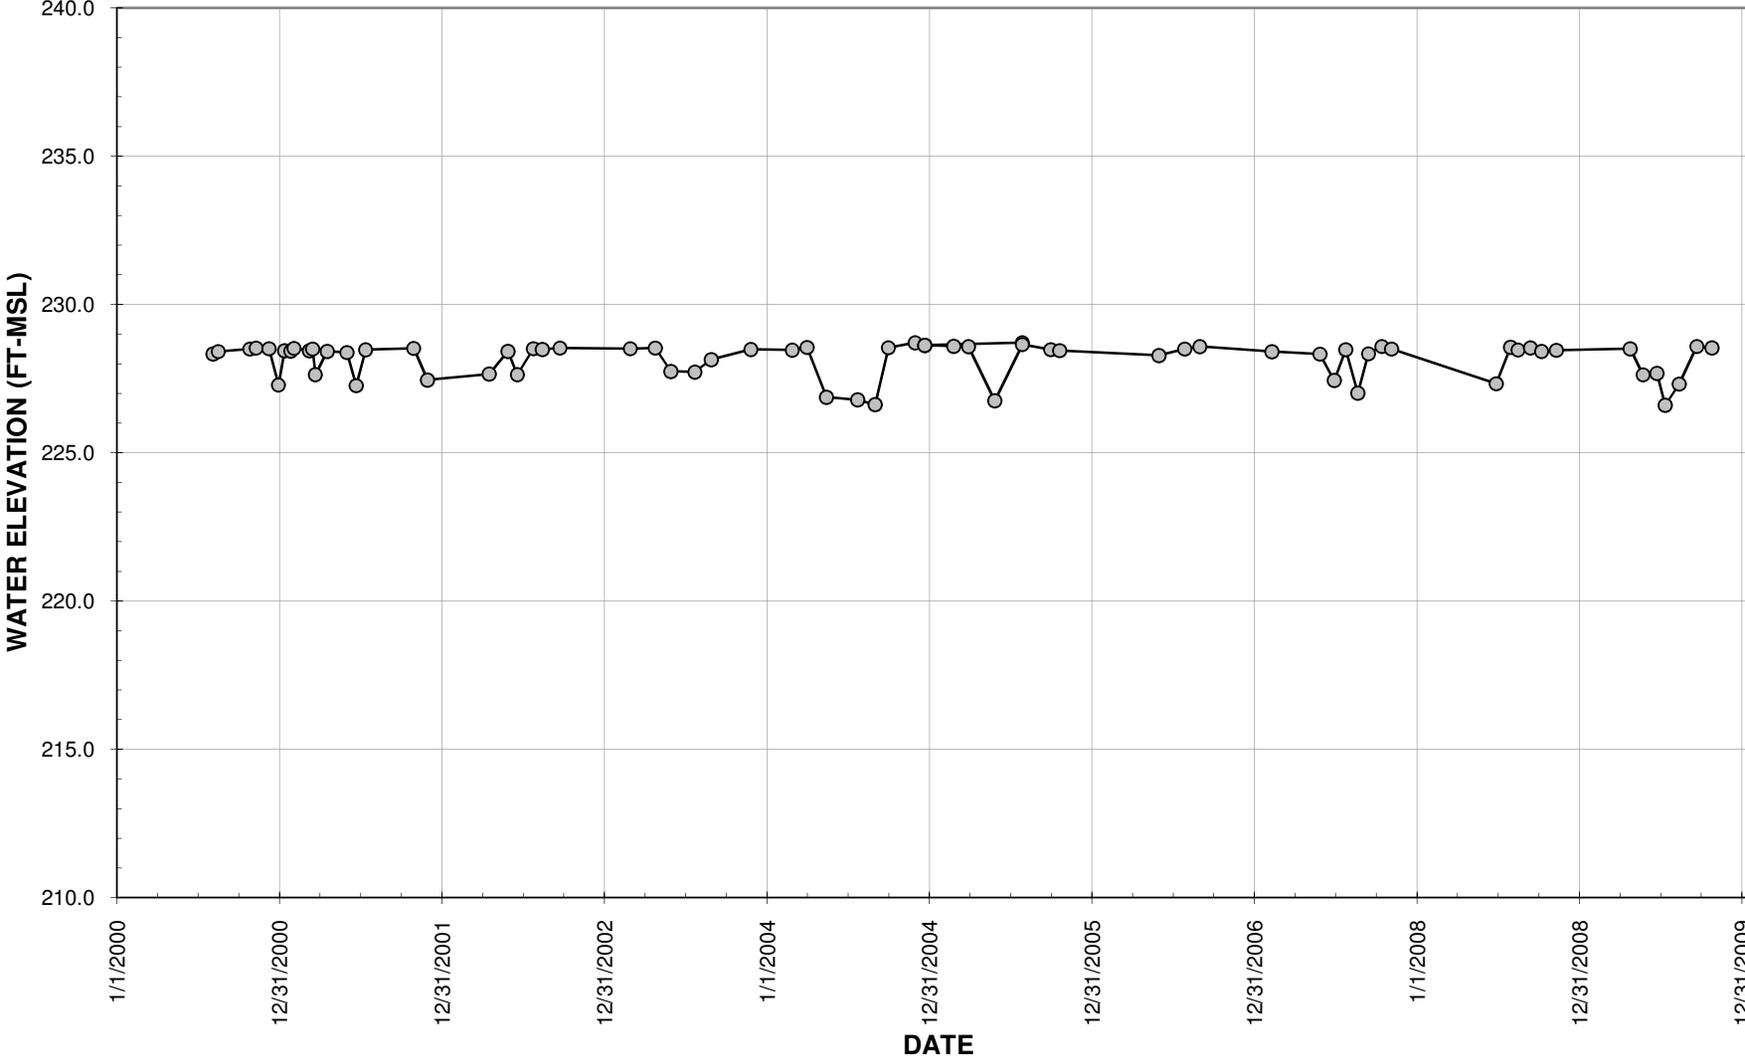
Figure 2.15 Water Level Data for Well MW-T-00-3A

Water levels in four wells completed east and west of the pile are shown for comparison in Figures 2.15 to 2.18. The eastern wells, MW-T-00-03A (Figure 2.15) and MW-T-00-03B (Figure 2.16), are completed in the shallow sands 12 and 17 feet, respectively, below ground surface. The figures for these wells show that the water elevation in shallow completions in native materials can be readily influenced by abnormal weather conditions. Wells MW-T-01-03A and MW-T-01-03B are installed west of the pile. Their water levels are shown in Figures 2.17 and 2.18, respectively. MW-T-01-03A is completed in bedrock to a depth of 20 feet and MW-T-01-03B is completed in clayey silt to a depth of 12 feet. These wells show similar water level fluctuations with weather conditions as the two eastern wells. However, the water level in MW-T-01-03B shows a larger differential than MW-T-01-03A because silts and clays hold more water in tension, so a small increase in water content causes a large change in head. The ground surface elevation is 134 feet in the proximity of these two wells. Both MW-T-01-03A and MW-T-01-03B were damaged by bears in 2006 and attempts to recover them have not been successful. Therefore, no data were obtained from those wells in 2007-2009. HGCMC will consider replacing them during a future drilling program.

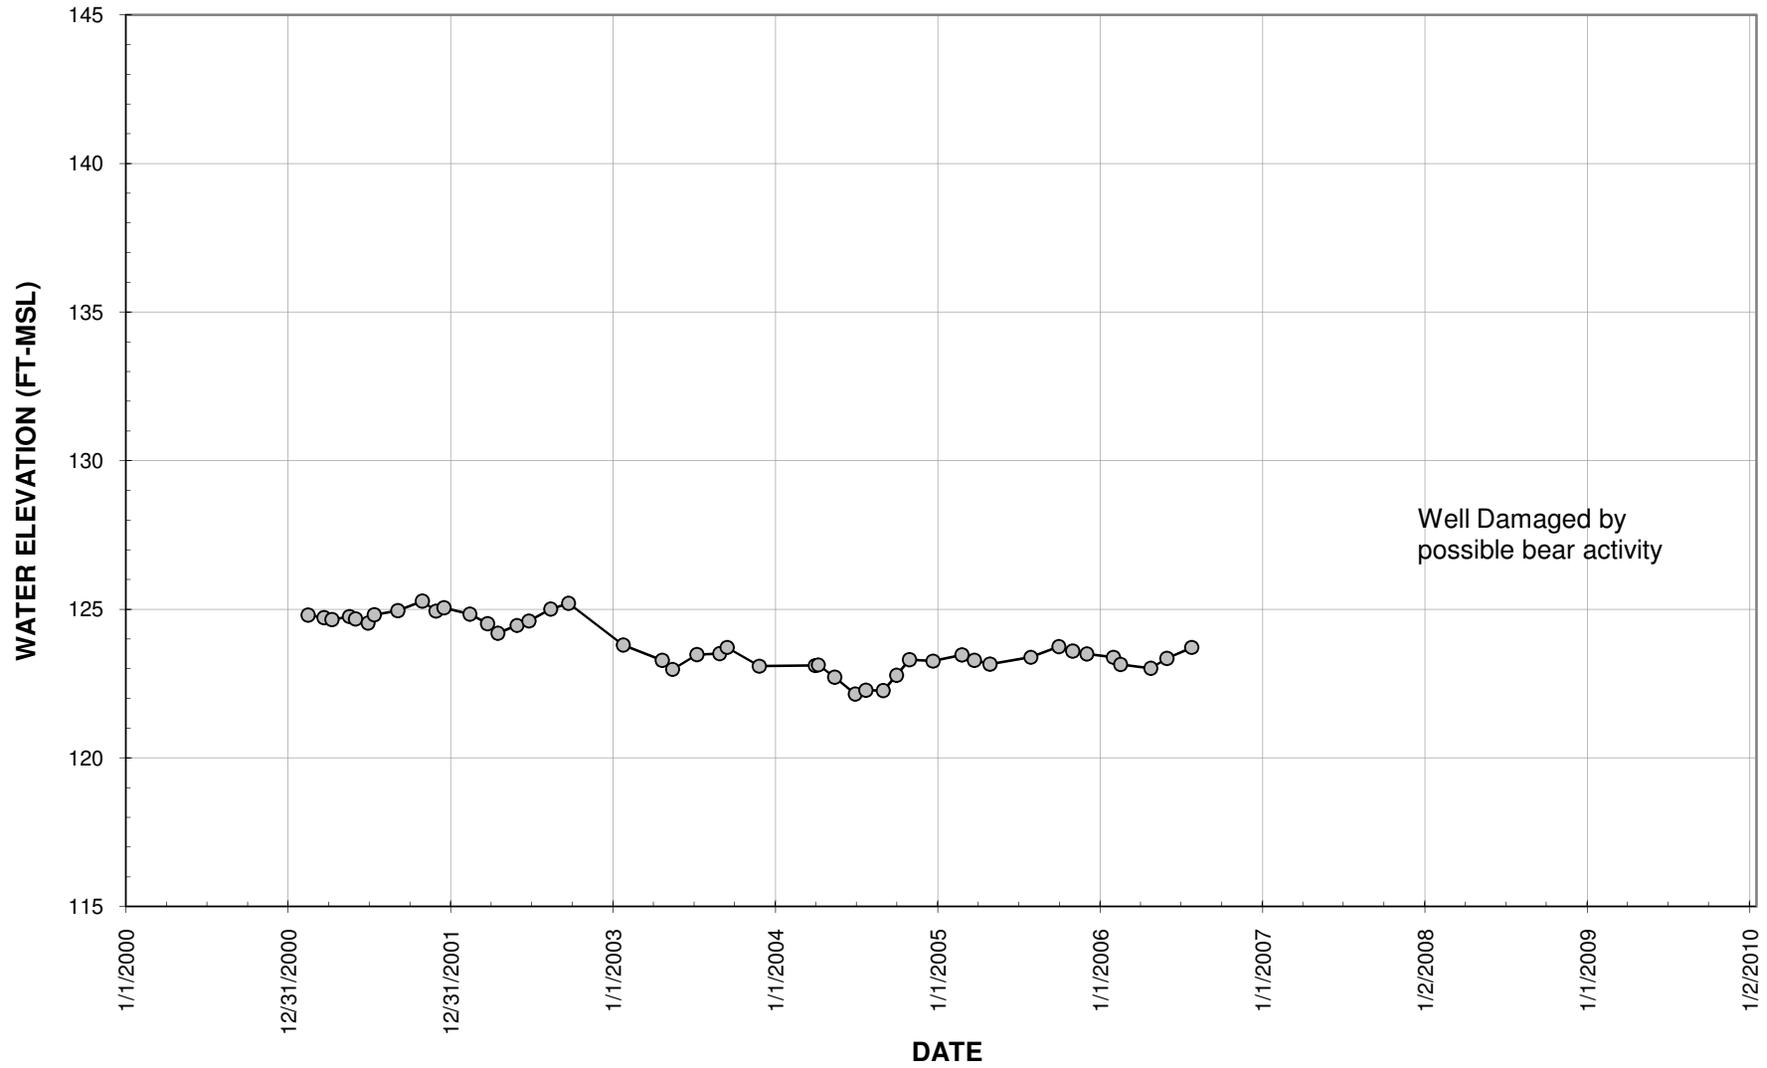
Figure 2.17 Water Level Data for Well MW-T-01-03A

Well Damaged by
possible bear activity

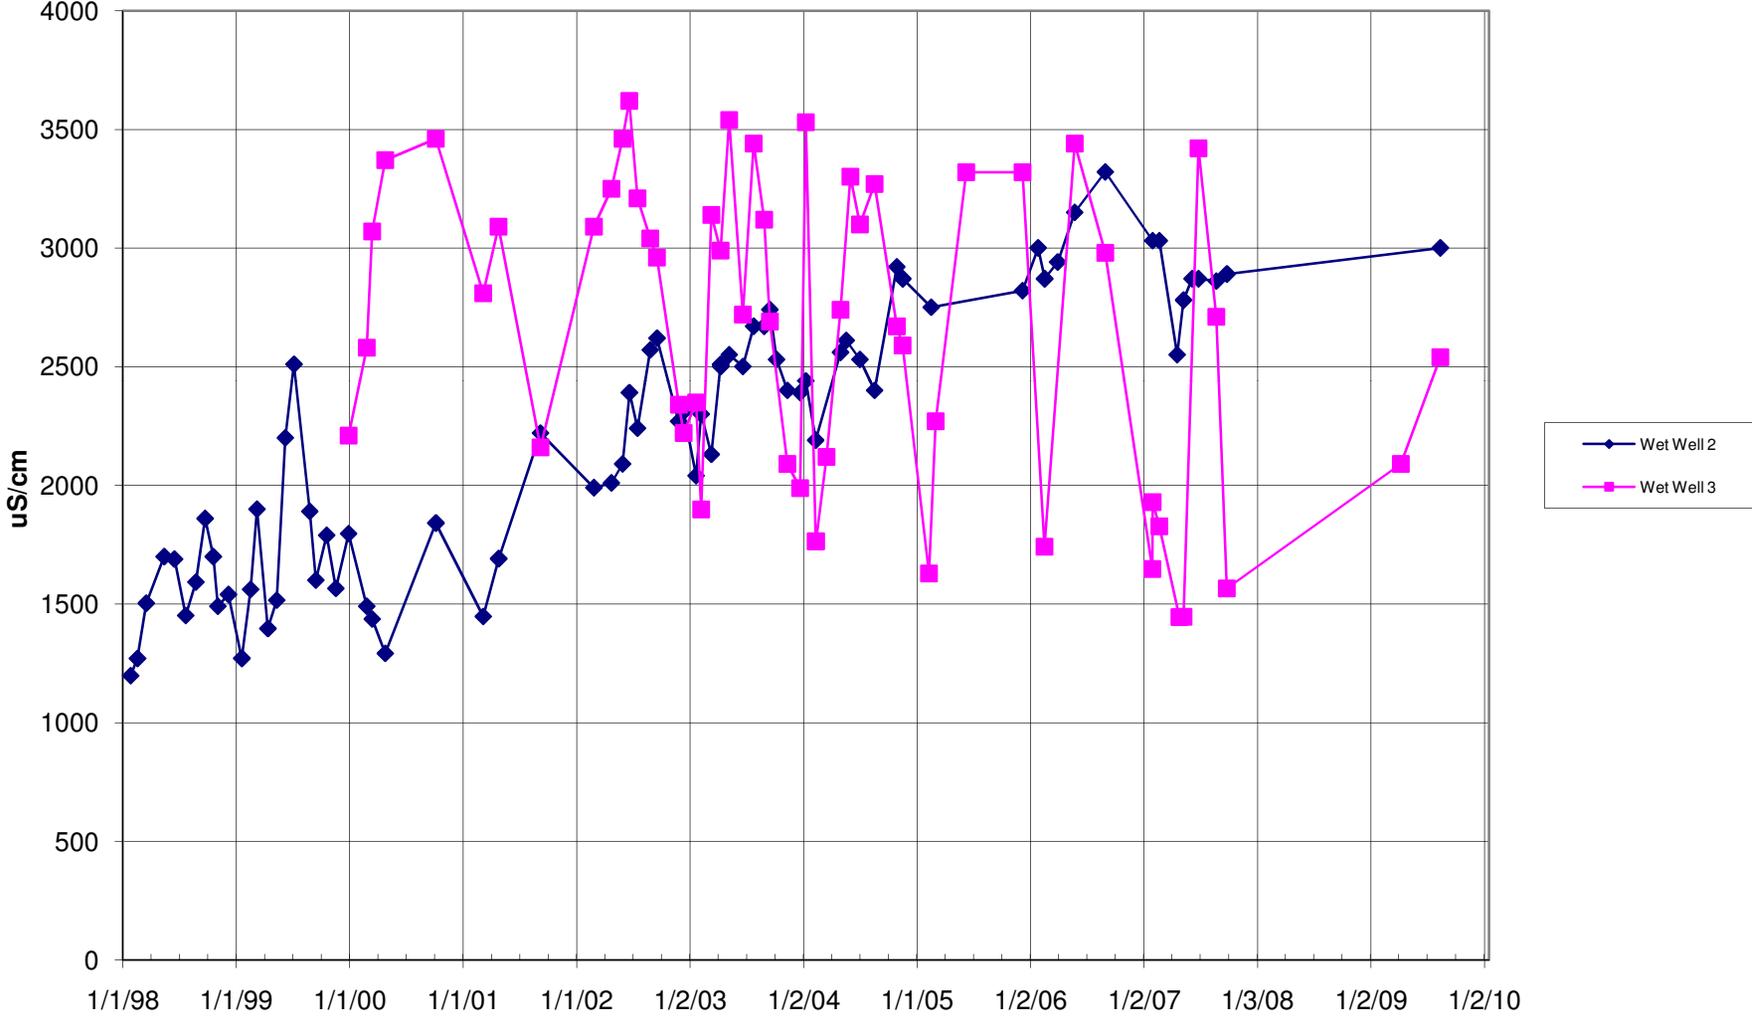
**FIGURE 2.22a GREENS CREEK TAILINGS INTERNAL MONITORING SITES:
WET WELLS - CONDUCTIVITY DATA**

The conductivity results from internal monitoring site waters are presented in Figures 2.22a, b, and c. Conductivity measurements in 2009 ranged between 2,090 (wet wells), 4,070 (wells completed in tailings) and 3,840 (suction lysimeters) μ S/cm. The higher conductivity of the site contact waters reflects a larger dissolved load caused by weathering of the tailings. Pyrite oxidation and carbonate dissolution contribute dissolved ions such as sulfate, bicarbonate, calcium and magnesium to the contact waters, increasing their conductivity. Wet Well 3 has a different capture area than Wet Well 2 and shows a different pattern with respect to conductivity. The changes in conductivity observed in Wet Well 3 suggest changes in the relative contributions from runoff, addition of the Northwest Diversion Ditch flow, infiltration and groundwater as the West Buttress was constructed. The increase in conductivity seen in Wet Well 2 over the past several years likely reflects an increasing contribution from contact water in the drain system and an increase in the dissolved load from migration/remobilization of oxidation products in the pile. In 2008 Wet Well 2 was routed to Wet Well A, a new wet well located in the newly modified Pond 6 area. Suction lysimeter samples are drawn from the smallest pore spaces of the unsaturated zone. Water held in these pores is often isolated from flow paths and thus usually has higher dissolved constituent concentrations than water from the saturated zone and foundation drains.

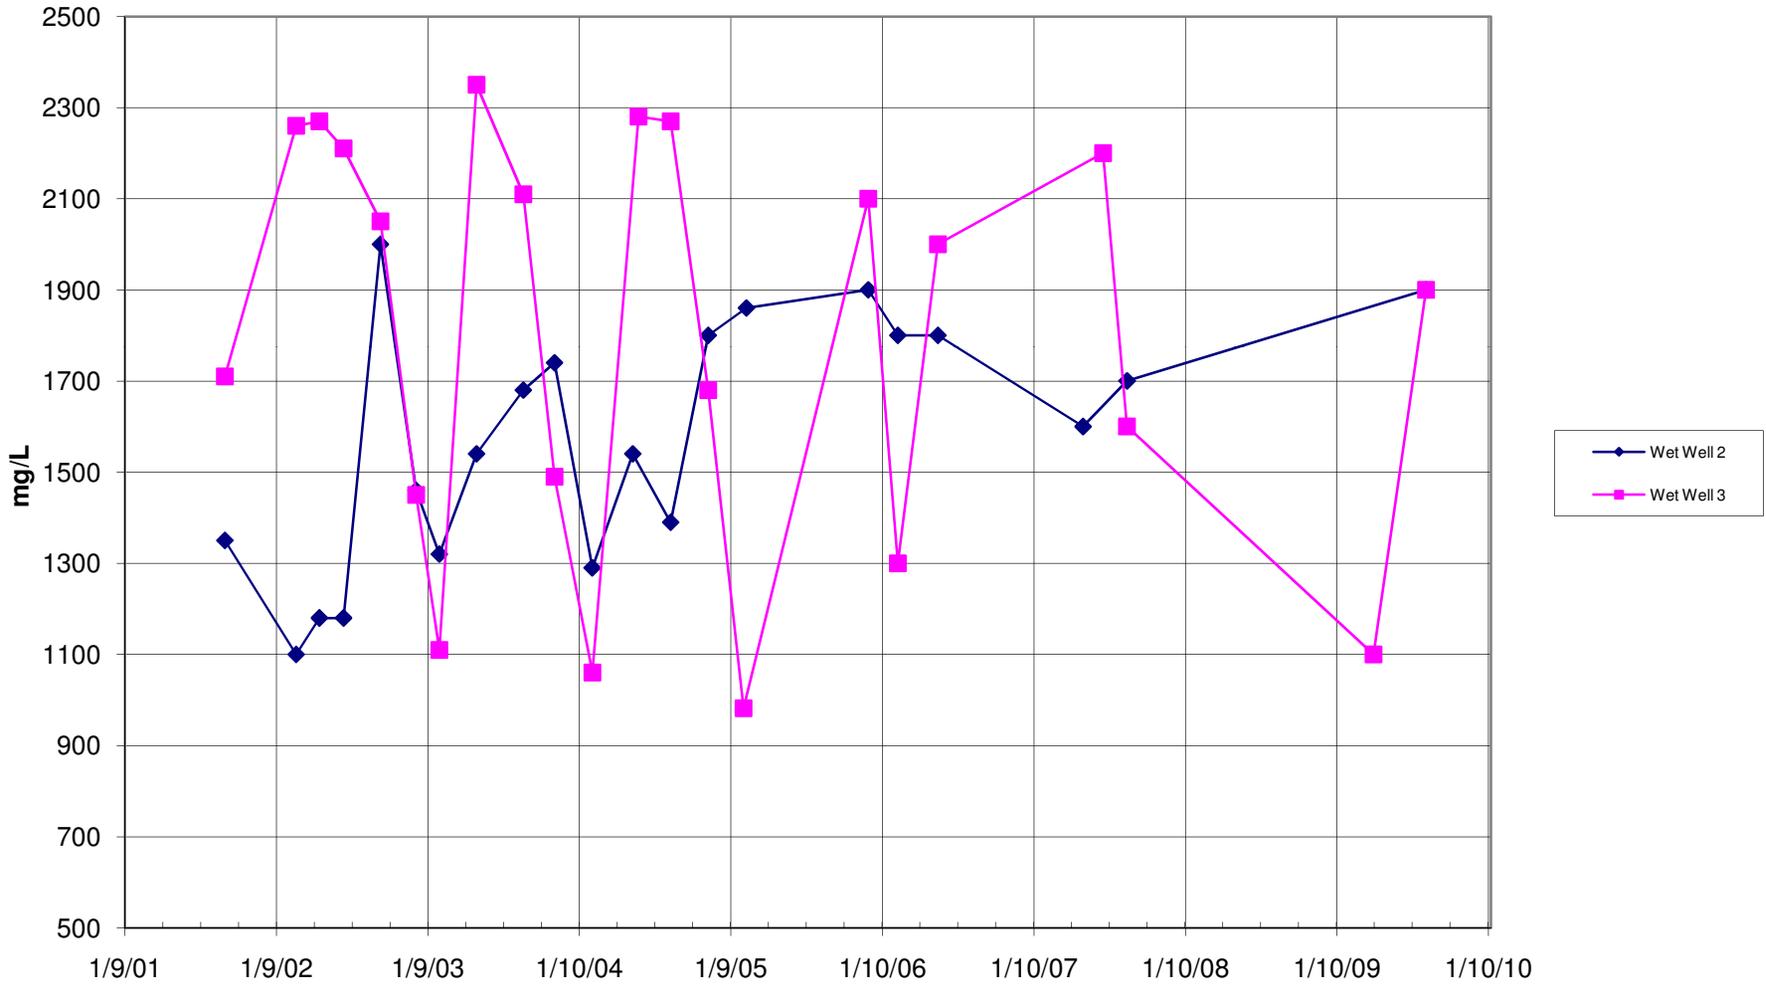
**FIGURE 2.23a GREENS CREEK TAILINGS INTERNAL MONITORING SITES:
WET WELLS - HARDNESS DATA
(Non-detectable analyses plotted as zero)**

Hardness and sulfate concentrations remain consistent with the conductivity results. Calcium and magnesium are the primary contributors to hardness (Figures 2.23a and b) and reflect dissolution of carbonate minerals, such as calcite and dolomite. Carbonate dissolution neutralizes acidity formed by sulfide oxidation, which is also the source of sulfate shown in Figures 2.24a, b, and c. Sulfate concentrations typically range between 500 and 5,120 mg/l in the tailings pile waters. The increase in sulfate and other constituents seen in PZ-T-00-03 likely reflects the replacement of interstitial process water with infiltrating surface water, which carries a higher dissolved load.

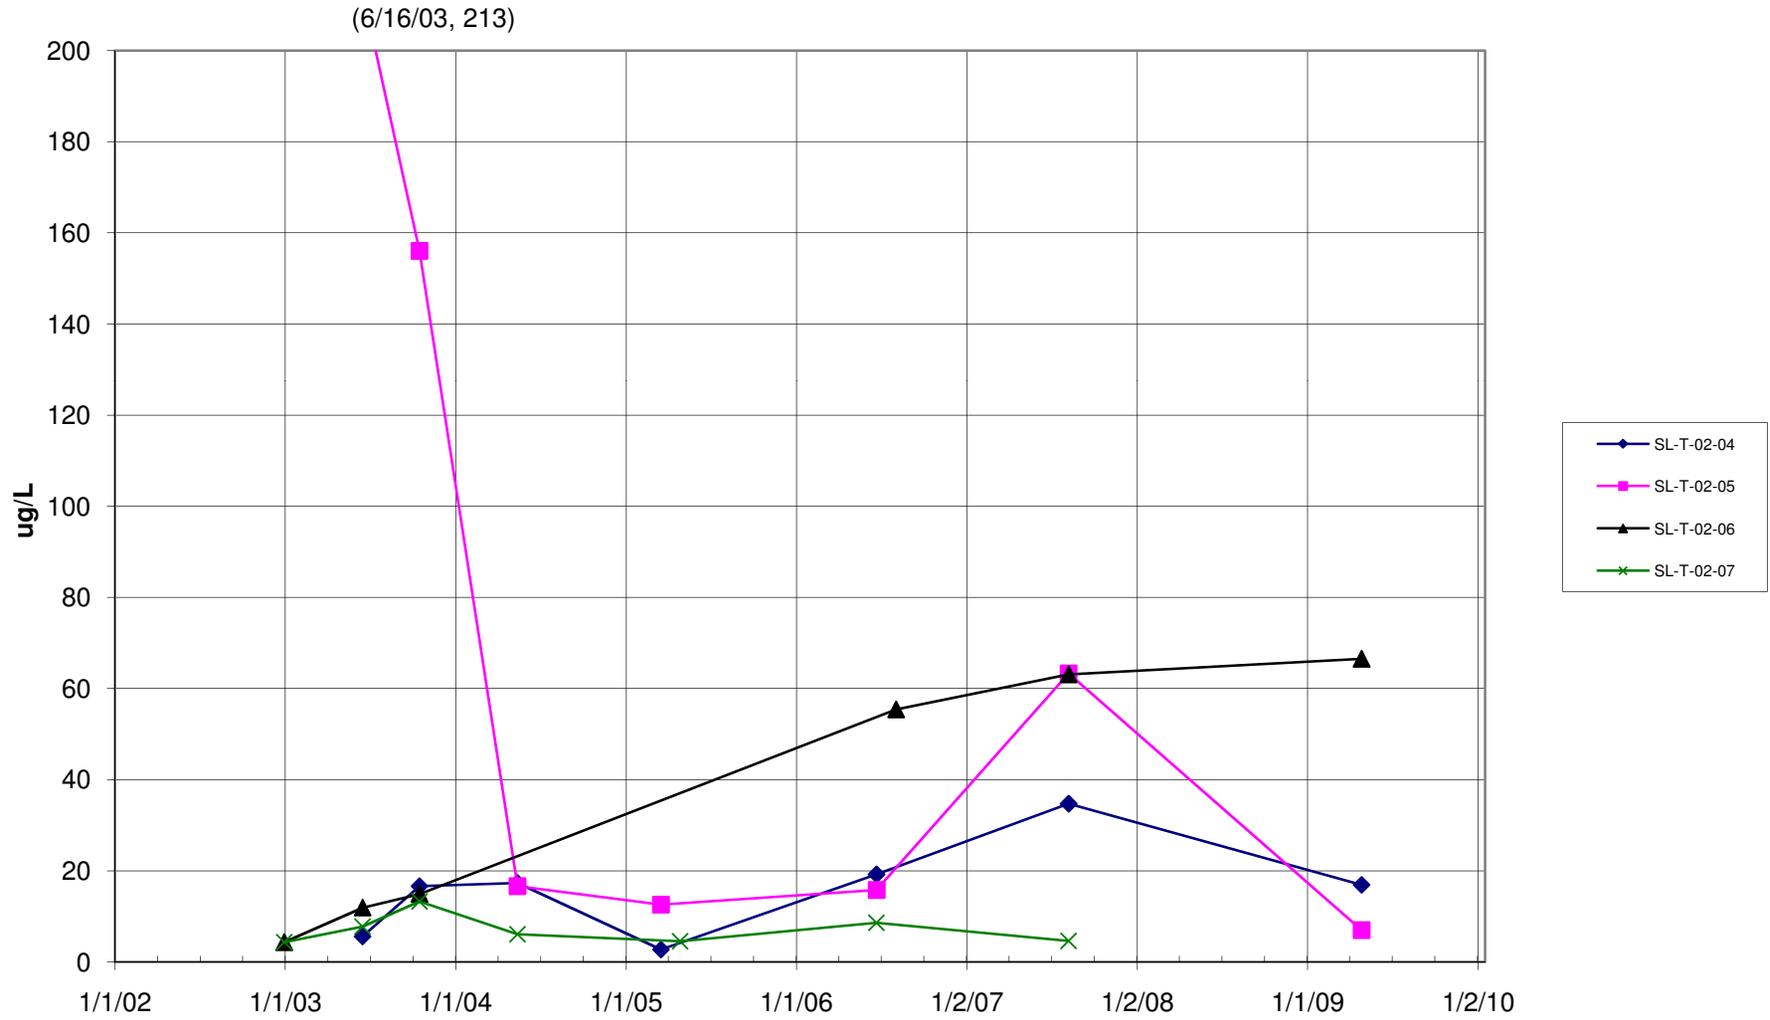
**FIGURE 2.25c GREENS CREEK TAILINGS INTERNAL MONITORING SITES:
SUCTION LYSIMETERS - ARSENIC DATA
(Non-detectable analyses plotted as zero)**

Arsenic data are presented in Figures 2.25a, b and c. The variability in arsenic concentrations observed in Wet Well 2, MW-T-02-06, and some suction lysimeters is related to evolving redox conditions in the pile. As arsenic-bearing minerals such as tetrahedrite/tennantite (and to a lesser

extent pyrite) weather, the arsenic that is released is typically co-precipitated with iron oxyhydroxides. As the pile grows, reducing conditions overtake areas that were once oxidizing. This was particularly true as the water table rose following removal of the temporary PVC cover that was placed on the pile in 1995 (removal began in 1997). Dissolution of oxyhydroxides (and possibly sulfates) is expected as the waters respond to the changing redox conditions. This will contribute arsenic and iron (Figures 2.30a, b and c) to the drainage water. Arsenic concentrations in the pile drainage will therefore decrease when redox conditions in the pile stabilize (e.g. with closure and capping of the pile). Sulfate reduction may also lower arsenic concentrations. This is apparent in the composition of waters from the saturated zone and in some of the SRMP test cells, which are discussed in more detail below.

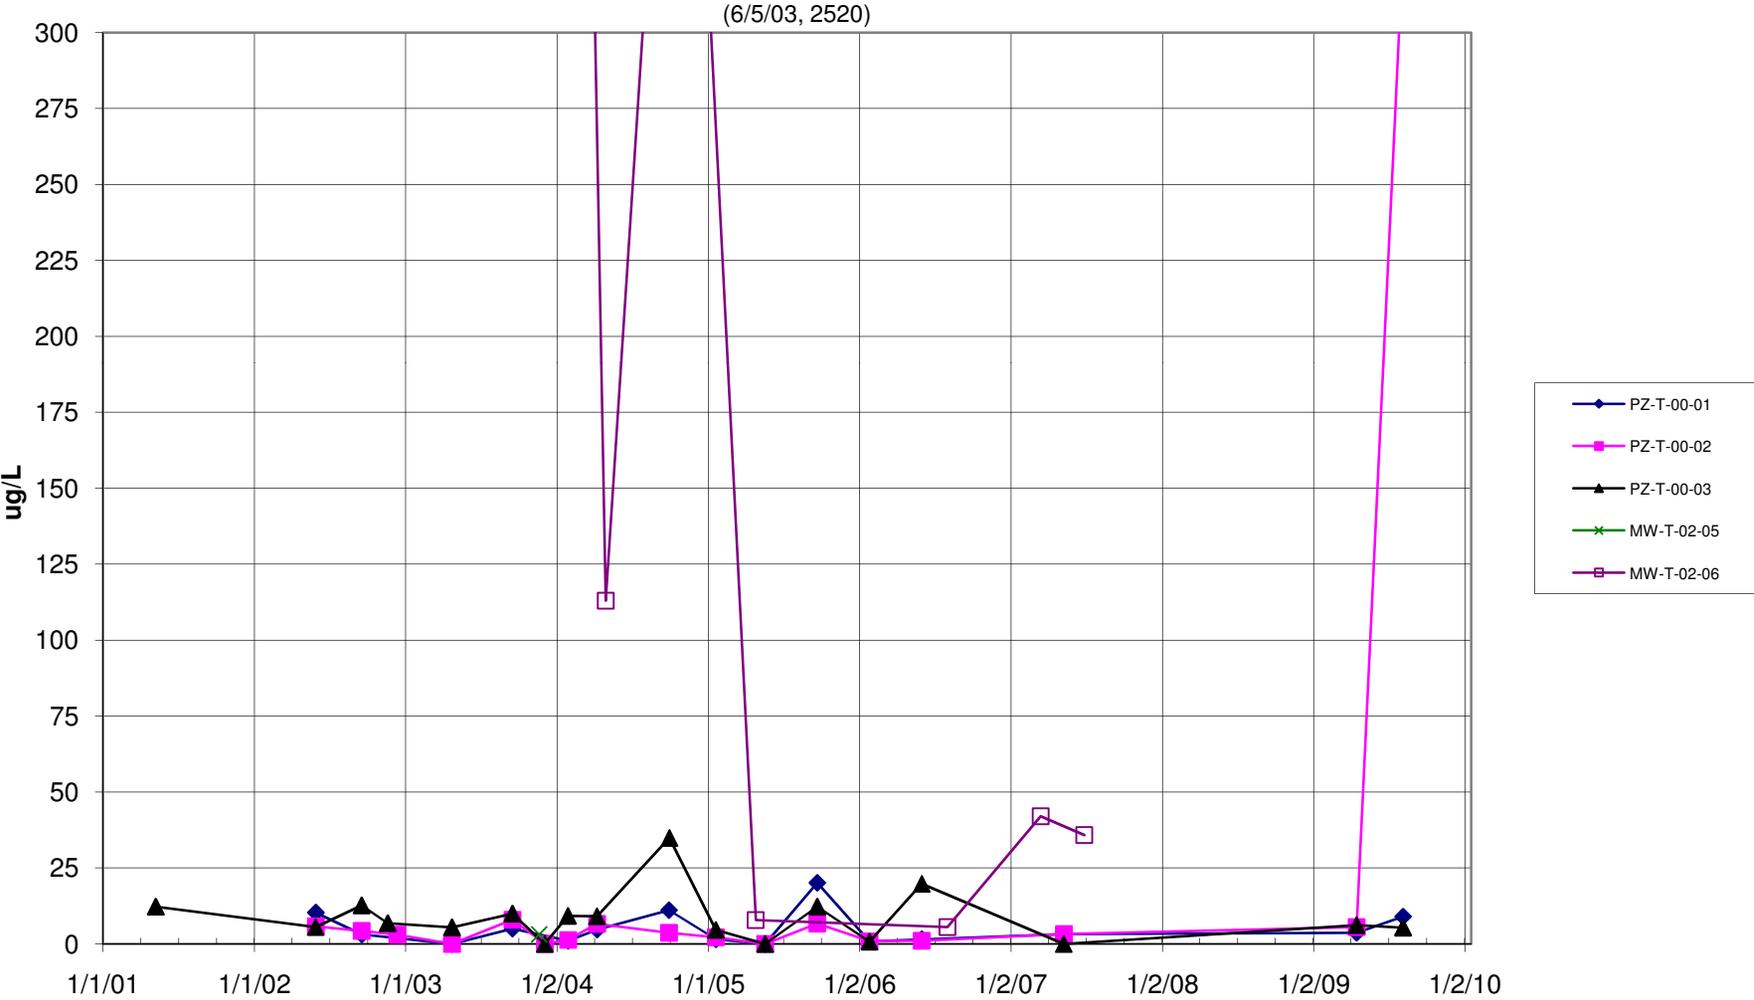
**FIGURE 2.26b GREENS CREEK TAILINGS INTERNAL MONITORING SITES:
TAILINGS COMPLETIONS - ZINC DATA
(Non-detectable analyses plotted as zero)**

Figures 2.26a, b and c show the concentration of zinc from the monitoring sites. Zinc levels from the saturated zone of the pile continue to remain low (Figure 2.26b), a result of sulfate reduction, which promotes zinc sulfide precipitation. An increase in zinc (to 328 ppb) in PZ-T-00-02 in 2009 was observed in one sample from 2009. The cause for the increase is not immediately apparent and HGCMC will continue to monitor this well for additional changes. The zinc concentration in MW-T-02-06 in 2003 and 2004, along with the lower alkalinity, suggest that sulfate reduction may not yet have been occurring in this portion of the West Buttress. However, the April 2005 data showed a significant decrease in the concentration of zinc (from an average of 1,000 µg/l to less than 10 µg/l), and the zinc has continued to remain below 50 µg/l. Placement of argillite on the outer slopes of the West Buttress has also led to higher zinc concentrations in Wet Well 3 from surface runoff flushing of this material when it was initially placed. In 2003, the zinc concentration in this wet well returned to within historical limits, and has remained between 500 – 3,500 µg/l from 2004 – 2009, except for a result of 6030 µg/l in the first sample of 2009. The second sample in 2009 was 1830 µg/l. The two 20 foot suction lysimeters showed zinc concentrations between 730 – 2,410 µg/l (SL-02-05, SL-02-07), and the two 40 foot lysimeters (SL-02-04, SL-02-06) had zinc concentrations less than 150 µg/l (Figure 2.26c).
