INSPECTION REPORT

Alaska Department of Environmental Conservation

Name and Location of Site/ Facility Inspected	Entry Time	Permit Effective Date
General tour of the Comet and Jualin sides of the mine with DNR, EPA and the COE. The main emphasis was on wetlands. Loc: Lat: 58d 49' 58"N Long: 134d 57' 58"W Source: NPDES permit	12:30	September 1, 2005
	Exit Time	Permit Expiration Date
	17:00	August 31, 2010 (Administratively extended)

PHOTO ADDENDUM – KENSINGTON TAILINGS DISPOSAL FACILITY –JANUARY 7, 2010

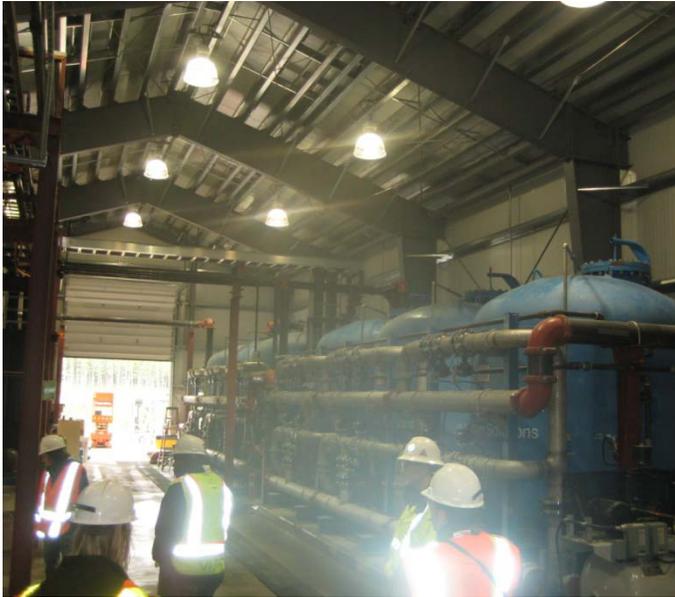
Water Treatment Plant: This was being commissioned. An additional booster pump had been installed at the lake to see if they could boost the flow to accommodate testing the water treatment plant at the design flow of 1500 gpm. At the time of the site visit they had not been able to achieve this flow rate. As noted above, discharge from the plant may not be required for several months. This is precipitation dependent and is being monitored through the site water balance maintained by Coeur.

PHOTO 1. TTF WTP MULTI-MEDIA AND CARBON FILTERS

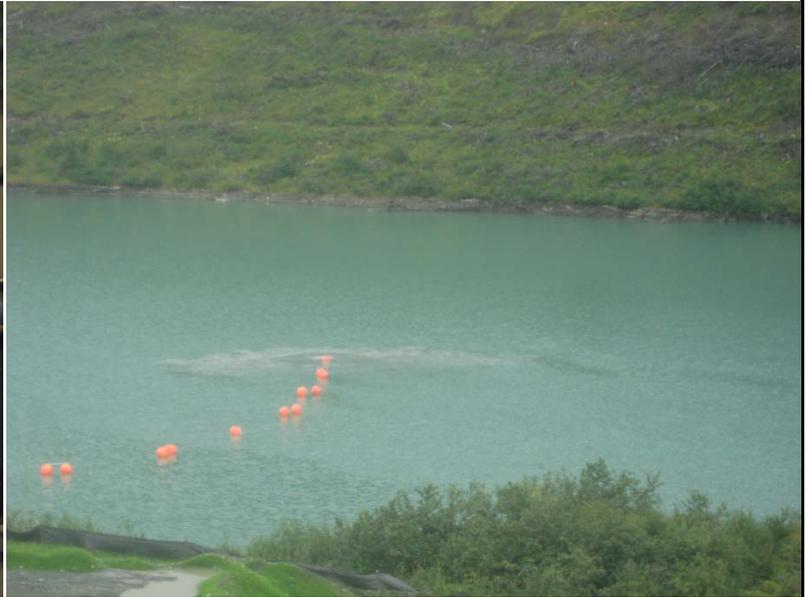
Tailings were being discharged to the TTF. If there is a difference in flow greater than 50 gpm between the mill and the TTF, then the tailings pumps are automatically shut down. There are also leakage detectors that detect leaks into the annular space of the double-walled pipe.

PHOTO 2. TTF – TAILINGS DISCHARGE

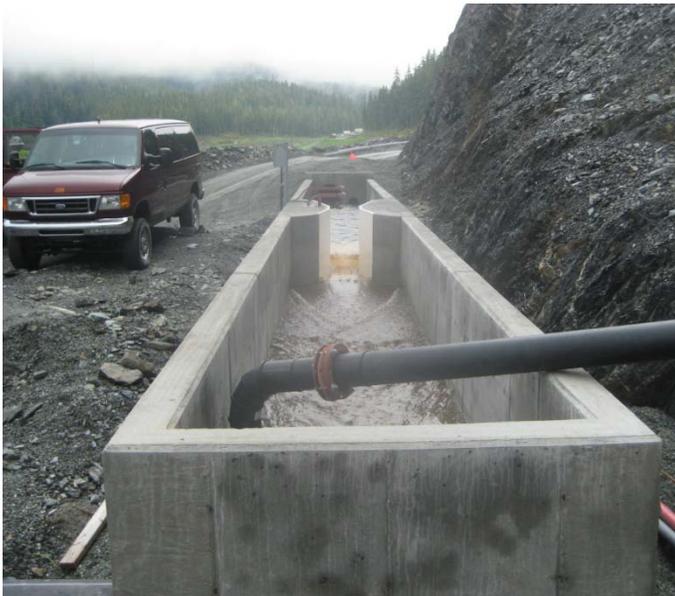
Bypass pipe: This was operating at 1400 gpm.

PHOTO 3. TTF BYPASS PIPE/FLUME @ 1400 GPM

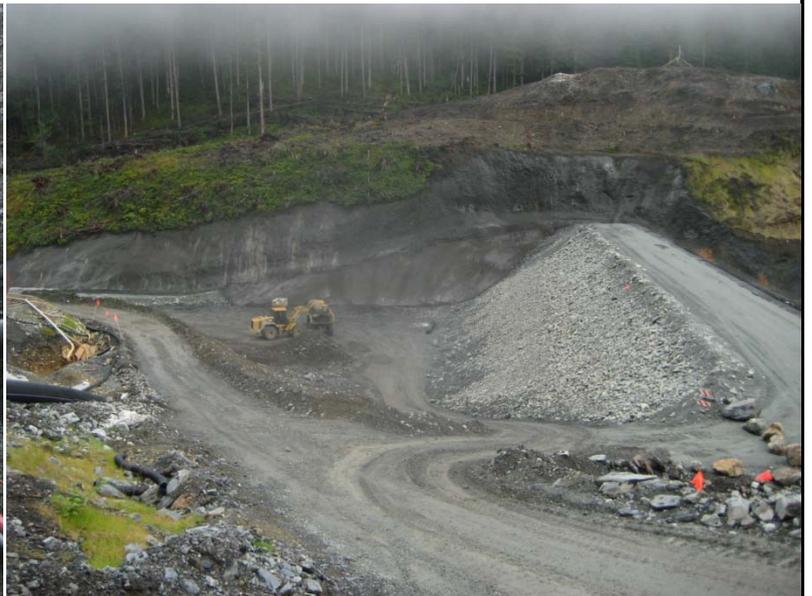
Dam: Phase 1 construction is complete.

PHOTO 4. DAM AND SPILLWAY

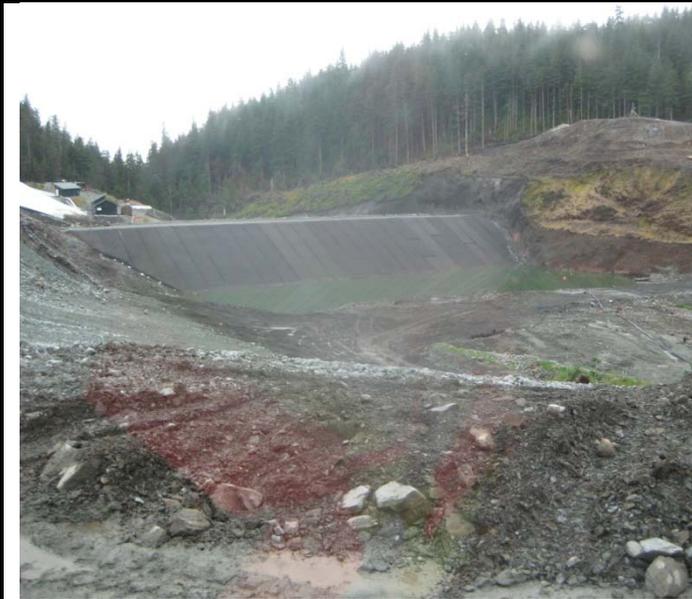
Seepage collection: Baseline average flow of seepage in the seepage collection system is 20 gpm. To complete the construction per the design tailings are being pumped into the space between the cofferdam and main dam to secure the

base of the geomembrane on the main dam face. When the water level rose to 655' the flow into the sump increased to 90-100 gpm. At the time of the visit tailings were not being pumped into this space.

PHOTO 5. DAM WITH WATER/TAILS AGAINST FACE

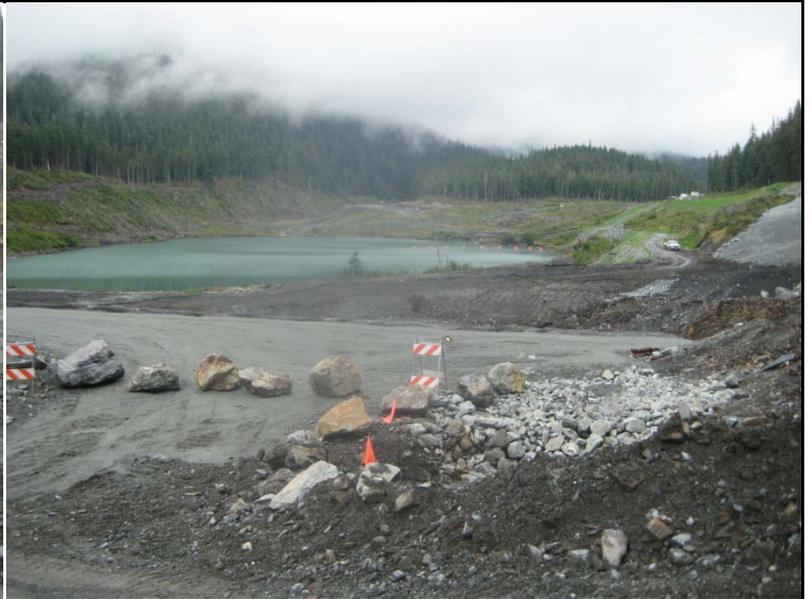
TTF water level: The water level had been drawn down below the original lake water elevation. Because of the available storage volume and the requirement by the City & borough of Juneau to keep 9' of water over the tailings, no water must be discharged from the facility for several months. Tailings are discharged to the surface and appear to settle rapidly. Water is being recycled from the TTF to the mill.

PHOTO 6. TTF WATER LEVEL

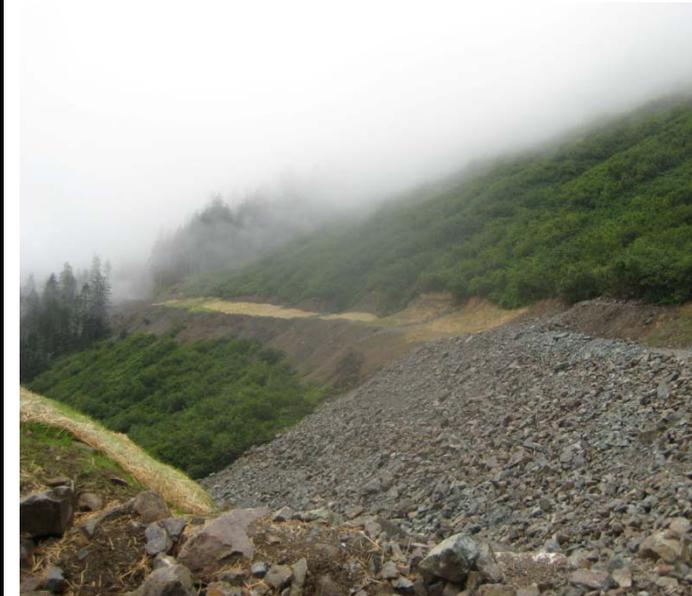
The road from the gulch in Snowslide Gulch to the extent of the avalanche area has been reclaimed to enable snow to pass over the road in the event of an avalanche in this area and to stabilize the slopes in this section of the pipeline corridor.

PHOTO 7. PIPELINE ROAD RECLAIMED IN AVALANCHE AREA

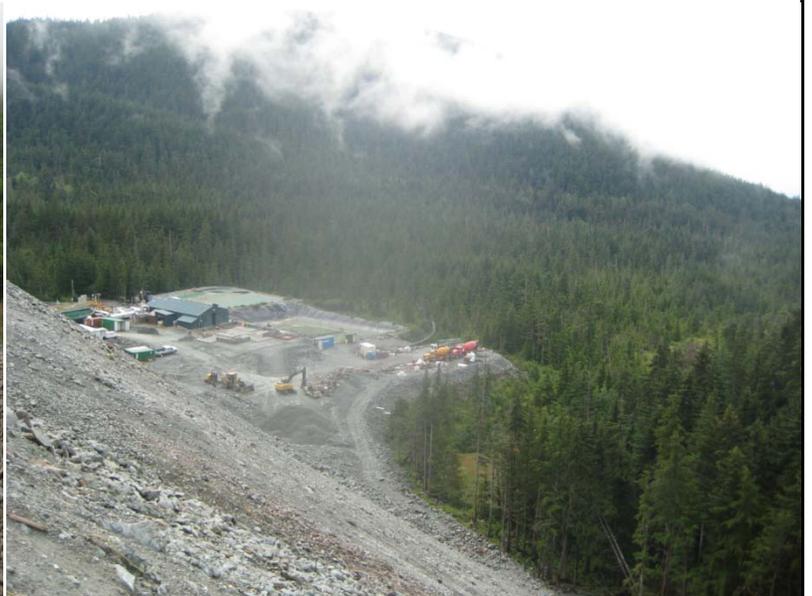
Construction has resumed on the expansion of this plant (from 1500 to 3000 gpm). At the time of the inspection the floor slab had been poured.

PHOTO 8. COMET TREATMENT PLANT

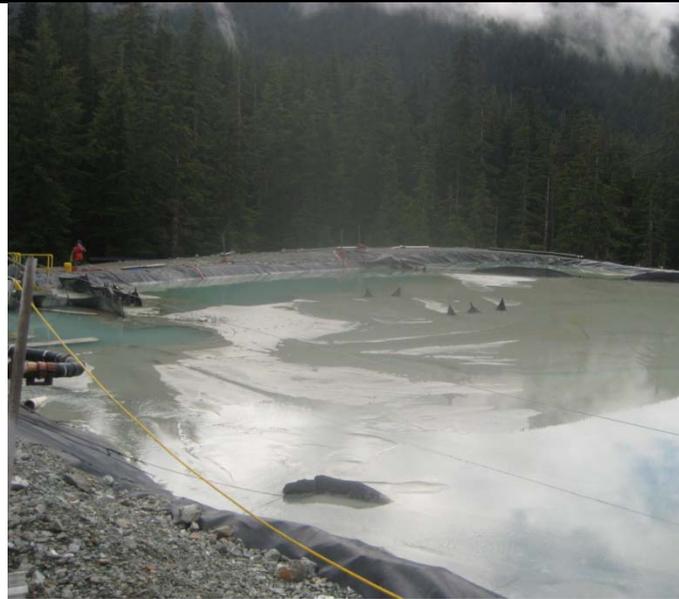
PHOTO 9. SEDIMENT IN POND 1 AT THE COMET PLANT

1. Remove sediments from Pond 1 at the Comet water treatment plant to enable this pond to work as intended in the design for the plant.
2. Maintain the waterbar on the road above the upper camp to prevent storm water from running down the road.
