INSPECTION REPORT Alaska Department of Environmental Conservation Division of Water 410 Willoughby Ave, Juneau, AK 99811	ADEC Inspection Form Last updated (4/08)
		Inspectors: Chris Foley 907-465-5257

Name and Location of Site/ Facility Inspected		Entry Time	Permit Effective Date												
Kensington Lower Slate Lake (LSL) Dam construction and Acid Rock Drainage area adjacent to LSL.	Loc: Lat: 58d 49' 58"N Long: 134d 57' 58"W	09:00	September 1, 2005												
	Source: NPDES permit	Exit Time 12:30	Permit Expiration Date August 31, 2010												
On-Site Representative		Additional Participants:													
Clyde Gillespie (Surface Ops Mgr), Kevin Eppers (Coeur)		Sarah Samuelson, USFS Tom Crafford, ADNR													
Responsible Official(s):

PHOTO ADDENDUM – KENSINGTON LOWER SLATE LAKE – OCTOBER 15, 2009

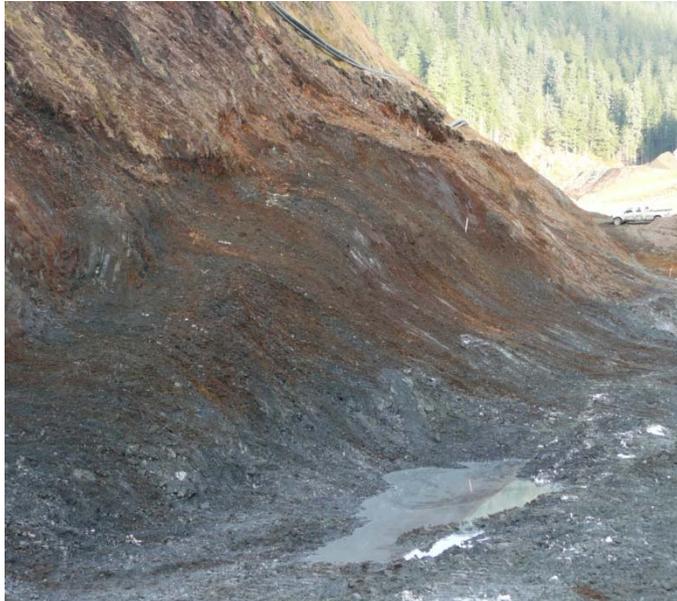
Excavation for Phase 1 dam construction continues (Photos 1 - 4). All graphitic phyllite material being excavated from the area near "Big Hole" during current site preparation activities (Photos 3) is being trucked to the temporary storage pad at Pit 3 / 4 (Photo 9). A geologist is on-site during all excavation activities and determines if the material is suitable for use

PHOTO 1. EXPOSED BEDROCK FOLLOWING OVERBURDEN EXCAVATION

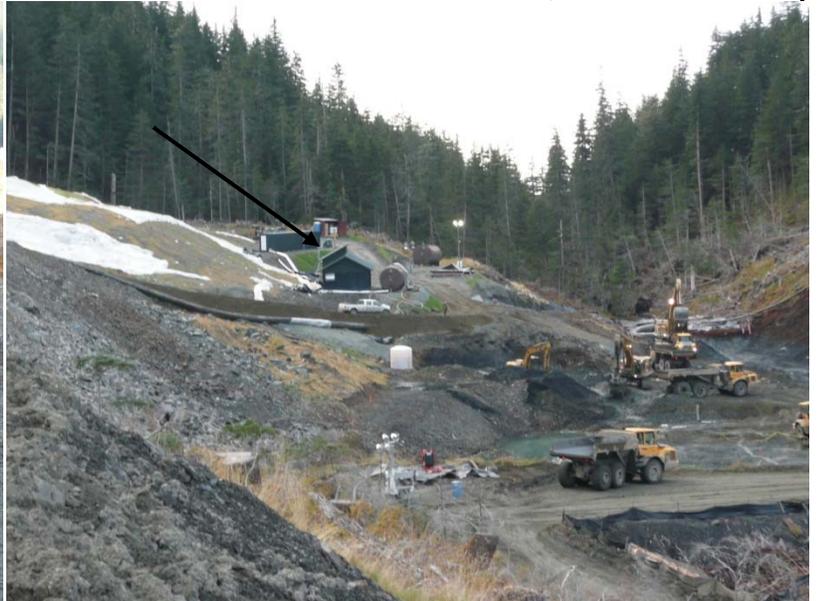
PHOTO 2. ARROW POINTS TO WATER TREATMENT PLANT

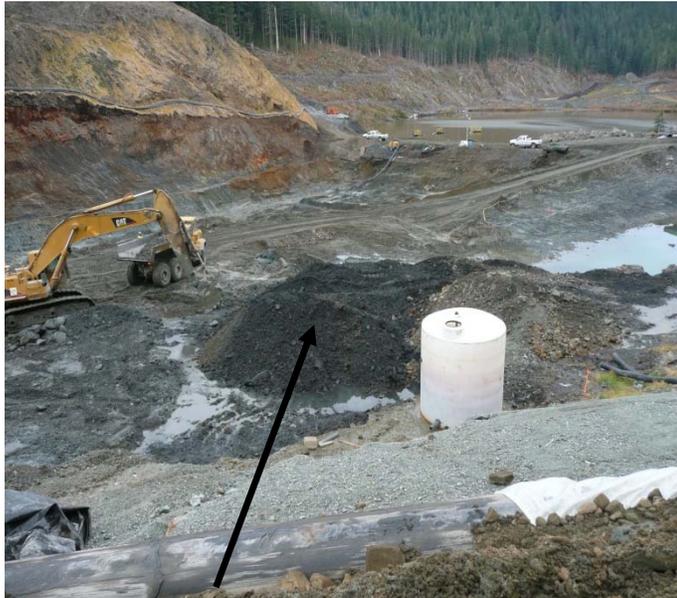
Two tracked excavators were removing overburden and loading dump trucks. Graphitic phyllite material that was excavated was stockpiled near Big Hole for transport to Pit 3 / 4 for storage. None of this material was hauled to the storage area during the inspection.

PHOTO 3. ONGOING CONSTRUCTION ACTIVITIES. ARROW POINTS TOWARDS GRAPHITIC PHYLLITE MATERIAL.

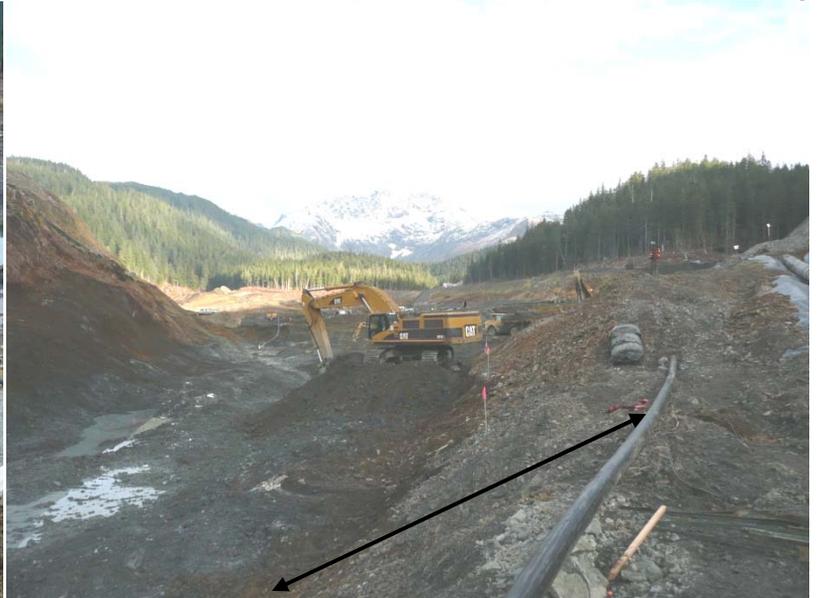
PHOTO 4. BYPASS LINE FROM UPPER SLATE CREEK ADJACENT TO EXCAVATION AREA

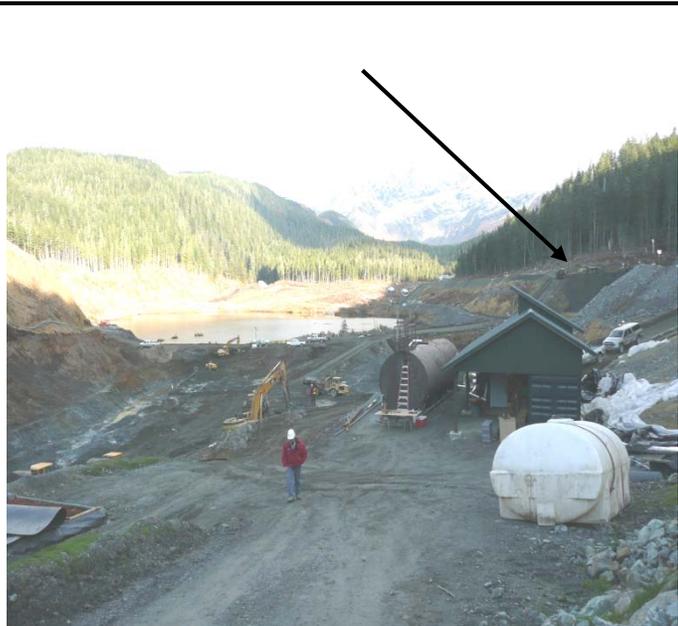
in dam construction. Suitable material is being placed at the junction of the dam site access road (Photo 5). Excavation material (soils) that is classified as unsuitable is transported to the west side of the lake at the head of the lake and stockpiled. The geologist is also responsible for identifying excavation material containing graphitic phyllite material that will be trucked to Pit 3 / 4 for storage.

PHOTO 5. ARROW SHOWS LOCATION OF SUITABLE MATERIAL STORAGE.

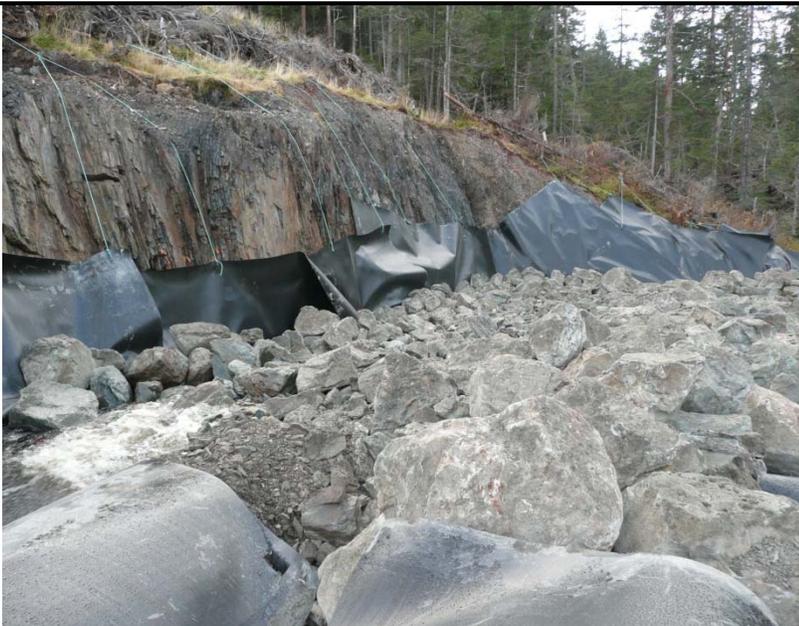
The Phase 1 pipe bypass route on the east side of the dam site has been completed. Rip rap had been placed on a HDPE liner to dissipate flow and reduce possible scour of erodible materials (Photo 6).

PHOTO 6. LOWER END OF UPPER SLATE CREEK BYPASS LINE

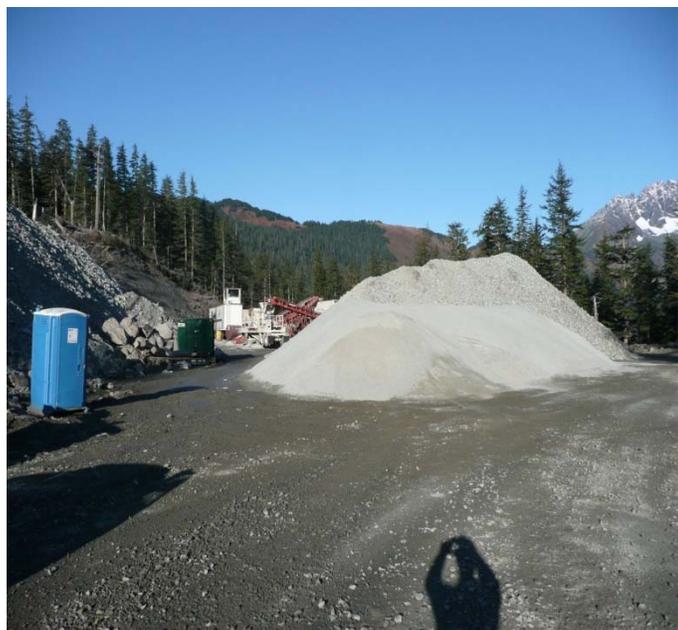
The diorite that will be used for dam construction has been trucked from the Julian development rock storage area near the portal and staged at the LSL lay down area and Pit 7. Coeur's contractor AIC is crushing and sorting rock for dam construction (Photo 7).

PHOTO 7. CRUSHED DIORITE AT PIT 7.

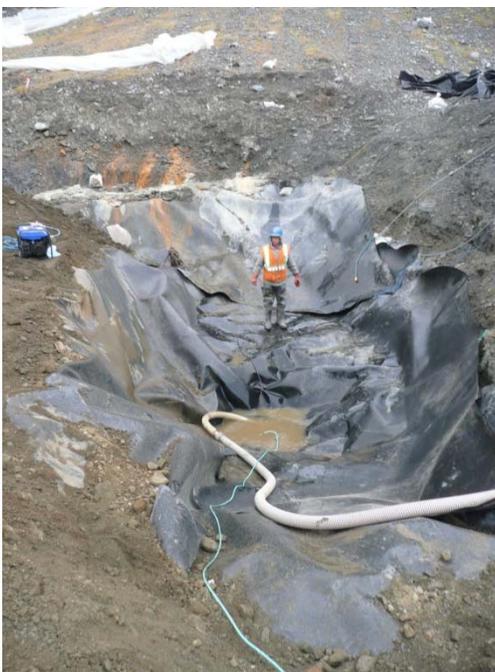
Water from the interim ARD rock storage area is collected in the sump below the WTP (Photo 8). The HDPE liner in the sump has been keyed into bedrock by bentonite. Water from the sump is first pumped into a 20,000 equalization tank which allows the WTP operator to regulate flow into the plant.

PHOTO 8. WTP SUMP.

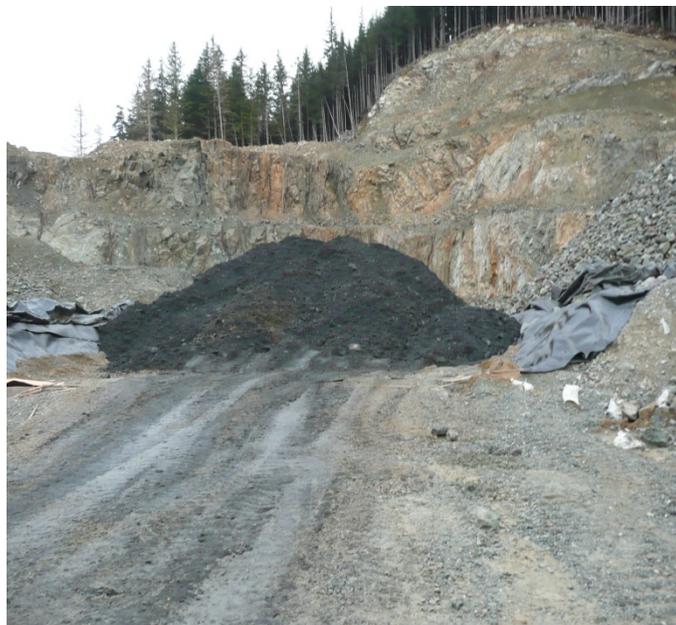
Approximately 500 - 1,000 cy of material had been trucked and placed on the pad. The material is dumped on a 100 ml HDPE liner which drains water into a covered sump. When additional material is not being placed in the cell the material is covered with a 60 ml HDPE cover.

A very small amount of the material is being tracked off the pad by trucks as it appears that the trucks back up onto the edge of the previously placed material to minimize spreading the pile beyond the confines of the liner.

PHOTO 9. GRAPHITIC PHYLLITE STORAGE SITE AT PIT 3 / 4.

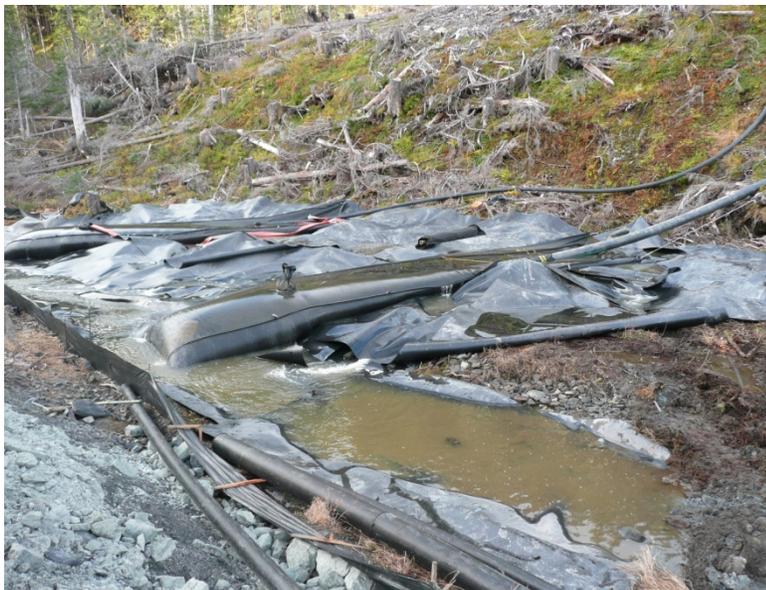
Pumping was occurring at the time of the inspection. Lake water was flowing through two lines that were connected to separate dirt bags prior to discharge into lower East Slate Creek (Photo 10).

PHOTO 10. DIRT BAGS AT LOWER EAST SLATE CREEK

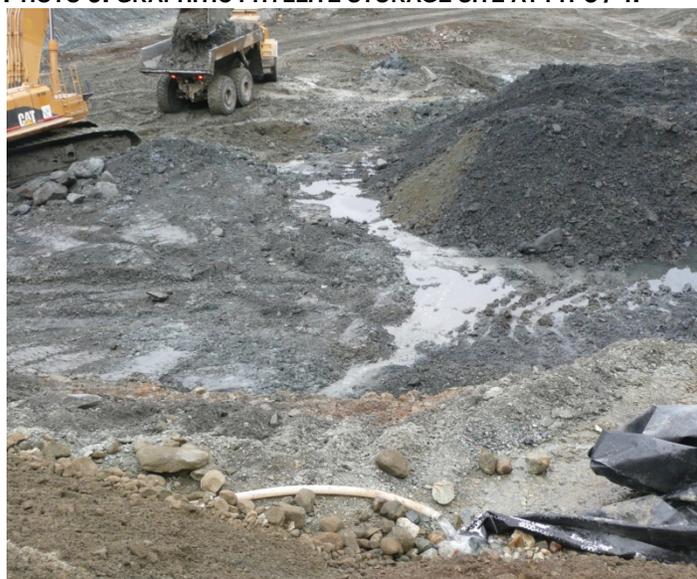
At the time of the inspection some treated effluent was being discharged below the WTP access road towards Big Hole (Photo 11). Water in Big Hole is re-circulated back into the WTP.

The last data received showed treated seep water with elevated aluminum, cadmium (when using receiving water hardness), sulfate, and TDS.

PHOTO 11. TREATED WATER BEING DISCHARGED TOWARDS BIG HOLE

1. Prevention and ensuring no additional treated seep water flows directly to East Fork Slate Creek.
2. Submittal by Coeur of plan for the disposal of treated ARD seep water to the land around and adjacent to the TDF.

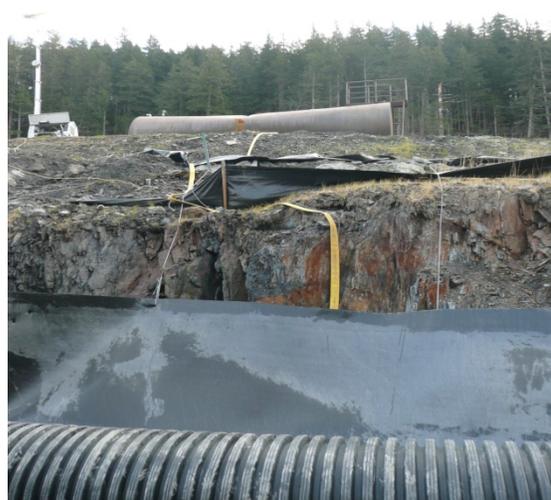
Water was not being discharged from the storage tank over the bank towards the formerly visible Plunge Pool as noted in the October 8, 2009 inspection report at the time of this inspection. A hose remains behind the HDPE liner on the pipe bypass route at the location of the former visible plunge pool (Photo 12). According to Coeur this allows pumping of seep water that accumulates in the original plunge pool. Seep water is pumped to the sump below the interim ARD rock storage area where it is then pumped up into the WTP for treatment. Treated effluent is then pumped into the 20,000 gallon holding tank where it is transferred to the water truck and applied to road surfaces.

PHOTO 12. YELLOW HOSE CAN BE USED TO PUMP SEEP WATER TO THE WTP.
