## INSPECTION REPORT

Alaska Department of Environmental Conservation

Name and Location of Site/ Facility Inspected		Entry Time	Permit Effective Date												
<b>Kensington Lower Slate Lake (LSL)</b> Dam construction and Acid Rock Drainage area adjacent to LSL.		08:00	September 1, 2005												
		Exit Time 13:00	Permit Expiration Date August 31, 2010												
<b>On-Site Representative</b> Clyde Gillespie (Surface Ops Mgr), Kevin Eppers (Environmental Superintendent)		<b>Additional Participants:</b> Sarah Samuelson, USFS Kate Kanouse, ADF&G													
<b>Responsible Official(s):</b> Clyde Gillespie <div style="text-align: right;">x Contacted</div>		<b>Source:</b> NPDES permit  LSL: Nick Lewallen, Construction Project Manager, Coeur, Jen Stetz, Construction Civil Superintendent, AIC													
Clyde: 523-3309 Kevin: 523-3328

**PHOTO ADDENDUM – KENSINGTON LOWER SLATE LAKE – NOVEMBER 9, 2009**

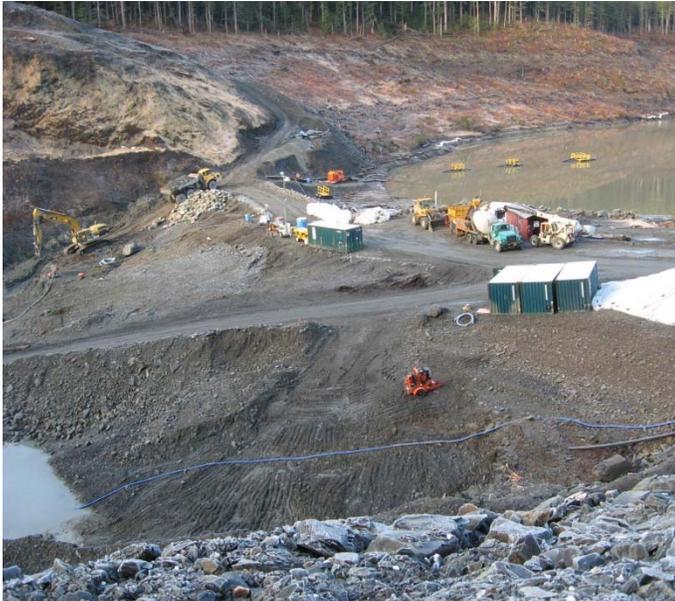
The lake has been pumped down to a level where continuous pumping is not required. The lake had become turbid due to what was thought to be a turnover of the lake; it had cleared somewhat until recent rain, when rainfall ran down rills along the newly exposed shoreline and sediments were washed down into the lake and it again became turbid. Coeur tried placing polyethylene sheeting along the shoreline to protect it, but this was not successful. They are considering matting material. No pumping was under way at the time of the site visit. Coeur employs two people to continually watch the water quality in East Fork Slate Creek. When there is too much turbidity from the lake water, pumping ceases.

**PHOTO 1. LSL / ERODING BANK / COFFERDAM**

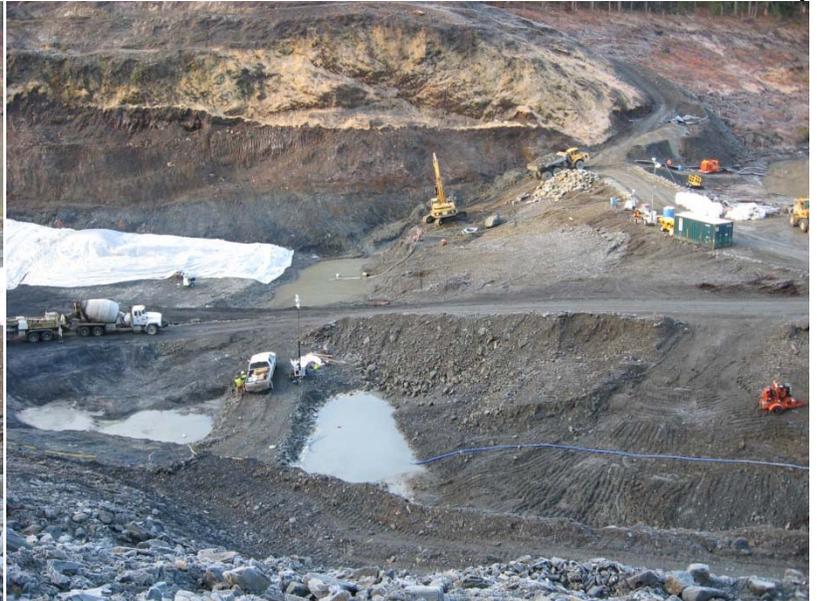
Virtually all material has been removed down to bedrock. More graphitic phyllite material was encountered than was expected, including that in a trench excavated to approximately 30 feet deep to enable drainage from the base of the dam to

**PHOTO 2. DAM EXCAVATION**

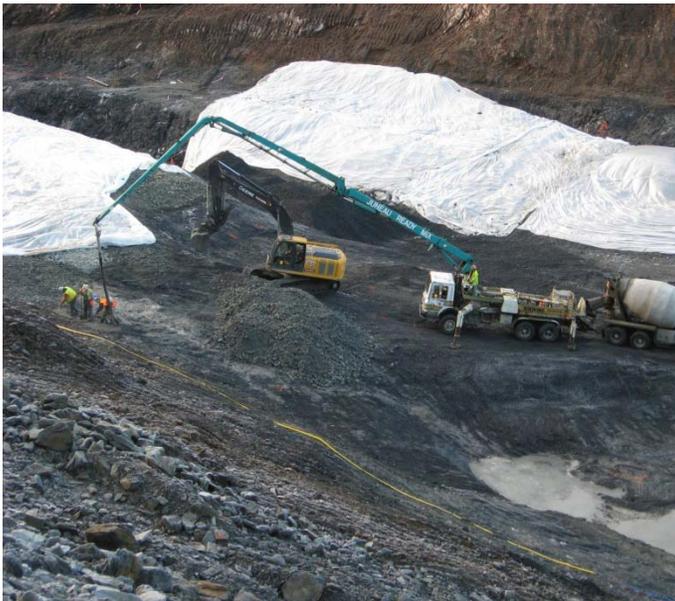
a sump where pumps will be installed to return leakage water to the TDF. "Dental" concrete has been applied to a large area of exposed graphitic phyllite. At the time of the site visit a pumper truck was being used to place concrete over graphitic phyllite on the north side of the foundation. Nick Lewallen, Construction Project Manager for Coeur Alaska said the specs for the concrete was 2200 psi, however they were being conservative and placing 4500 psi concrete. Placing concrete over the remaining areas will be completed in the next 7 - 10 days. Work will continue as long as feasible with two crews working 10-hour shifts; significant freezing or snow would stop work.

**PHOTO 3. PLACING "DENTAL CONCRETE" ON ACID ROCK**

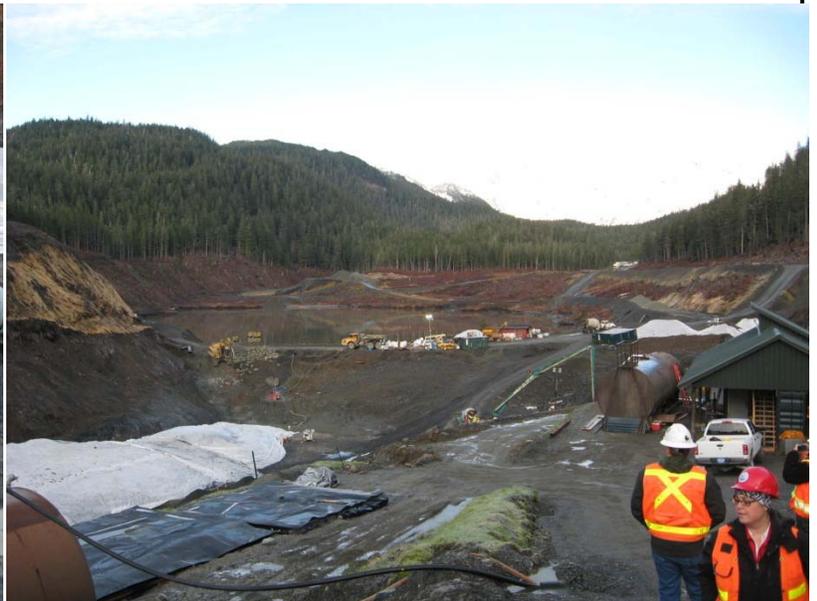
**PHOTO 4. DAM SITE FROM SEEP WTP TANK LOCATION**

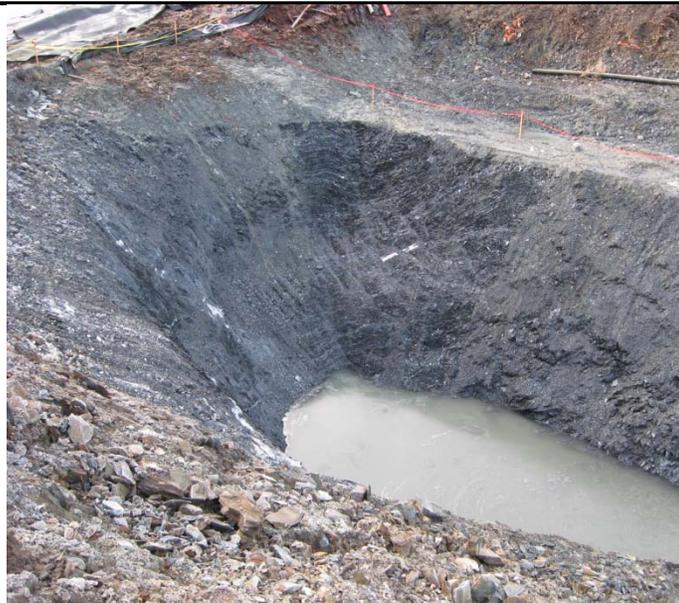
**PHOTO 5. EXCAVATION FOR DAM SEEP WATER SUMP**

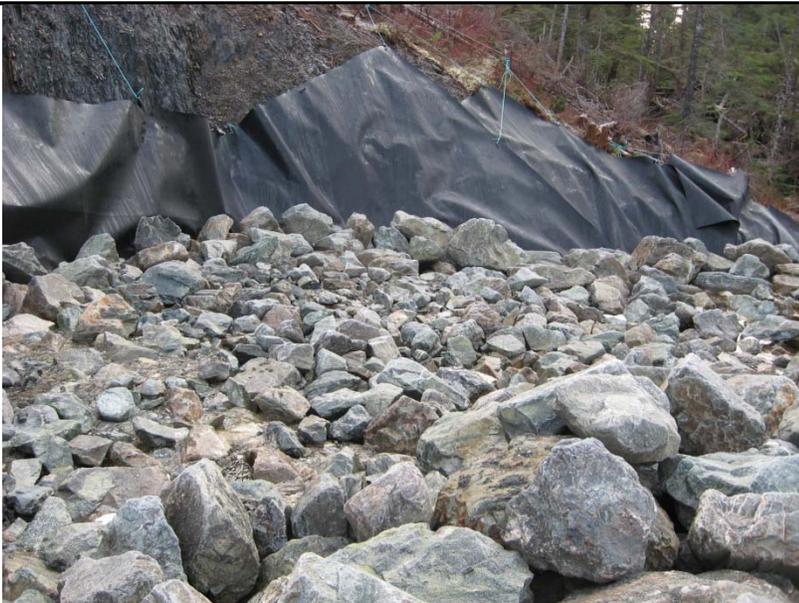
Kate Kanouse was on site to discuss the bypass pipe outlet. The discharge is onto a rock energy dissipater and there is concern that fish may be caught in the rocks at low flow. It was decided that a screen would be placed at the inlet to prevent fish and fry from being carried down the pipe. Coeur intends to construct a plunge pool in the early part of 2010 and the screen will be removed at that time.

**PHOTO 6. USL BYPASS ENERGY DISSIPATION ROCK**

1. ADEC to provide Coeur with approval for the temporary ARD site expansion.
2. Coeur to install land disposal system for treated seep water disposal.
3. Coeur to install a screen at the USL bypass intake.
4. Coeur to protect the ARD pad sump from burial by snow sliding off the pile.

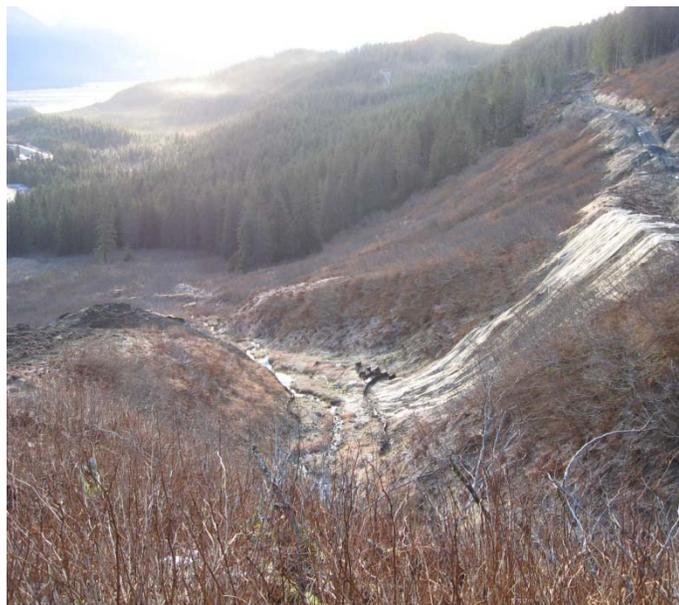
We traversed the road on either side of Snowslide Gulch. Two 3' diameter polyethylene pipes were being welded to convey water in the deep gulch under the tailings road. These two pipes will be laid side-by-side. A minor slide had occurred at the deep gulch and a silt fence installed to capture solids and prevent them from getting to Johnson Creek. There was a more significant slide on the section of road from the lake to Snowslide Gulch, possibly caused by road construction disturbance in conjunction with blasting for the road. The road itself was not affected by the slide and Clyde Gillespie said no material was seen to be washing away below the slide toward Johnson Creek when they walked the area below the slide.

**PHOTO 7. EMBANKMENT FAILURE AT SNOWSLIDE GULCH**

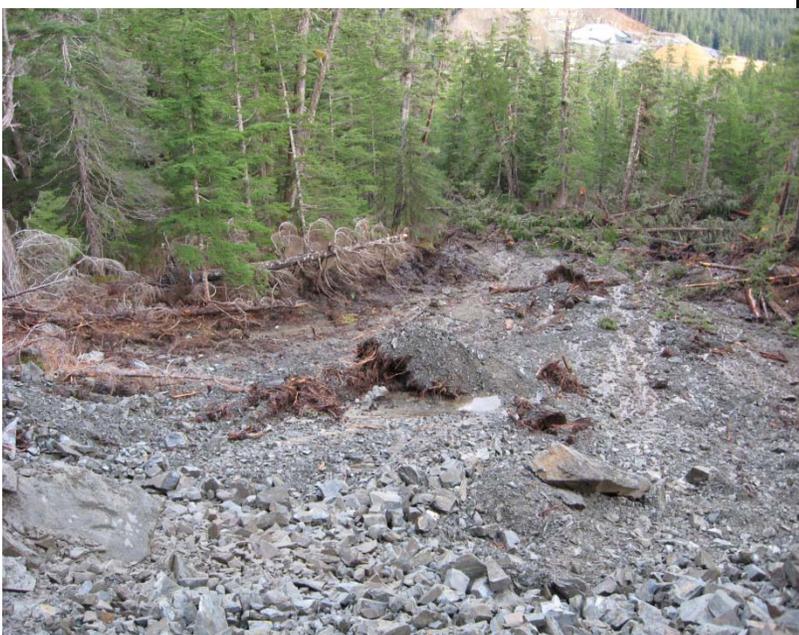
**PHOTO 8. SLIDE BELOW ROAD; LSL SIDE OF ACCESS ROAD**

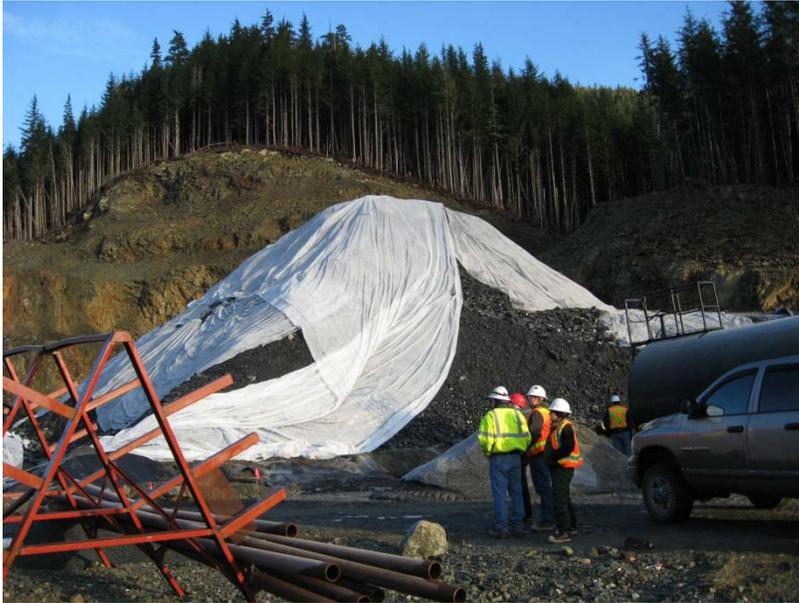
This cell is in Pit 3 (as it is called in the POO, otherwise called Pit 4 by surface operators). Coeur has a submittal in to ADEC for approval for the pad expansion. The pad for temporary storage of graphitic phyllite had been expanded to enable additionally excavated material to be placed on the pad. This expansion area had a polyethylene liner with a geofabric underneath to protect it. Approximately 9000 cy of material have been placed on the pad. Nick Lewallen estimates there may be another 1500 cy to be placed on the pile. A lightweight polyethylene cover covers the majority of the pile. Once all graphitic material on the pad a heavier duty cover will be installed to keep out precipitation. The berm to the pile is adjacent to the sump. It was suggested a barrier such as a braced wall be erected to prevent snow from sliding off the pile and covering the sump.

**PHOTO 9. TEMPORARY PAD FOR ARD STORAGE**

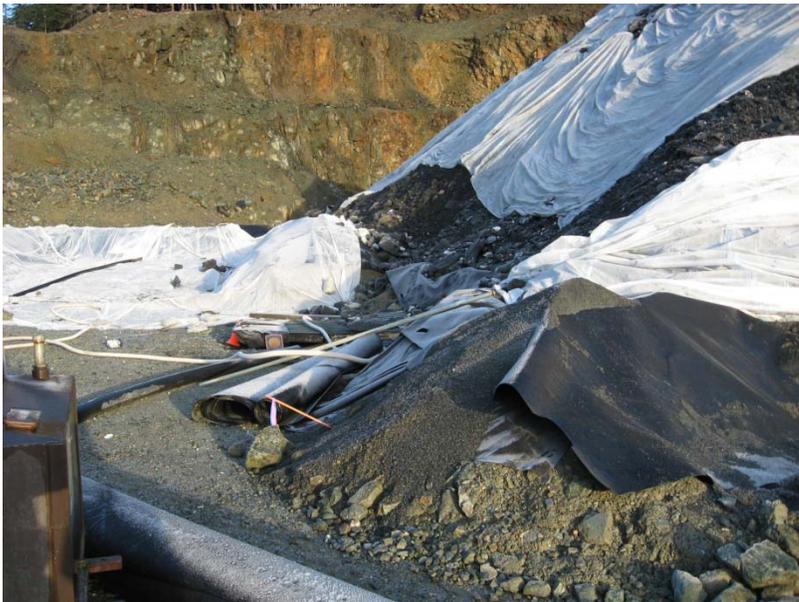
**PHOTO 10. SUMP AT BASE OF ARD PILE**
