FIELD SITE VISIT REPORT COEUR ALASKA/KENSINGTON MINE

Inspection Date: June 26, 2012, 07:00 - 14:00
Report Date: June 28, 2012
Weather: Overcast, a little light rain at times. Temperature 50's
Coeur Personnel: Kevin Eppers, Environmental Manager; Pete Strow,
Environmental Coordinator

Purpose of visit: Annual meeting site visit for agency staff

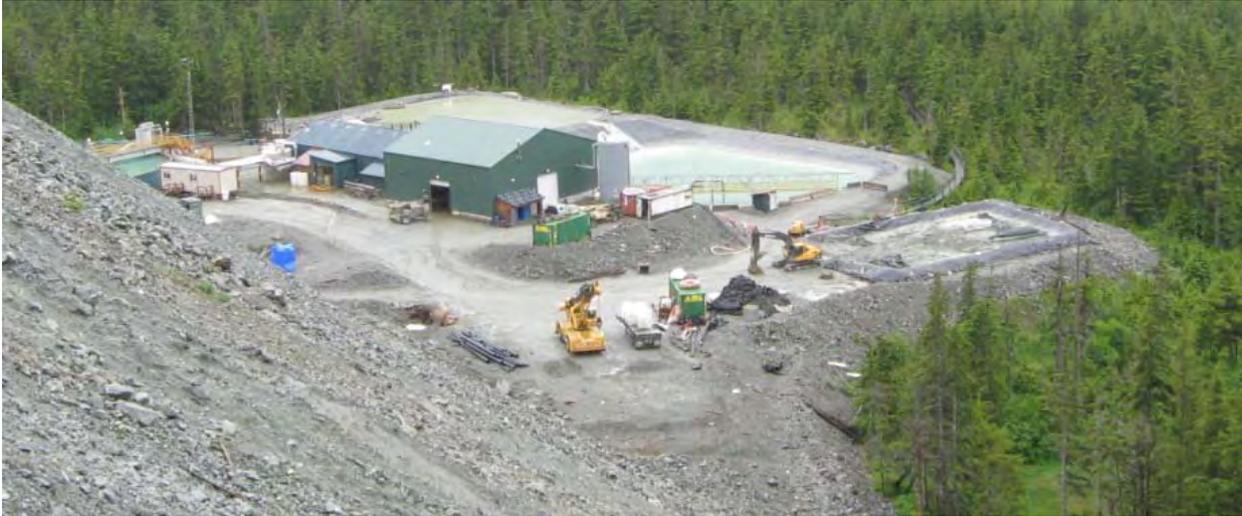
Comet area: Pond 2 was in use. Sediment from the degritting bags was being removed, so the dredge was not operating in Pond 1. Sediment is taken either to the production rock disposal area outside the Comet portal, or underground. (Photo 1). Once the underground sumps are operational, expected within the next two weeks, water from the mine will go to Pond 2. Pond 1 will then be cleaned out, deepened, and lined. Lining is proposed to be done when the contractors are on site to line the temporary Graphitic Phyllite storage cell.

Photo 1: Comet water treatment plant, Pond 2 in operation, sediment removal in progress.

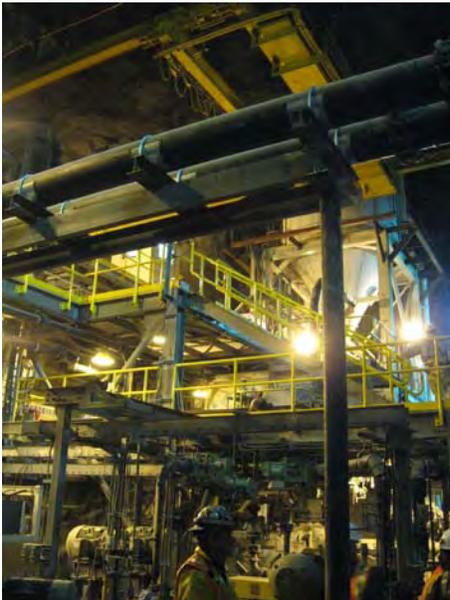
Paste plant: This was toured; it was operational; the underground chambers were impressive in size to accommodate the sludge dewatering infrastructure and the cement addition and mixing and paste pumping. Presently 80% of tails go to this plant for use as structural fill in mined stopes. (Photos 2-6).

Photos 2-6: 2. Paste Plant room.

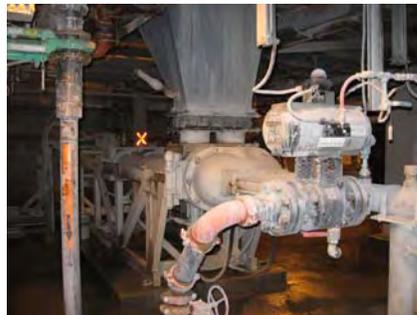
3. Paste pumps.

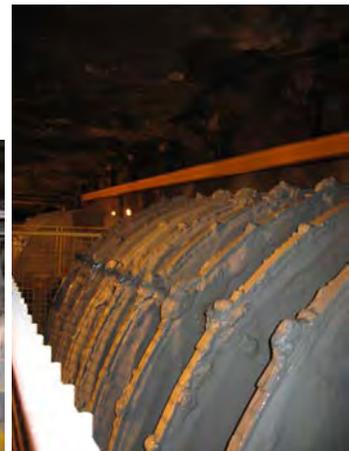
4. Dewatering tailings.

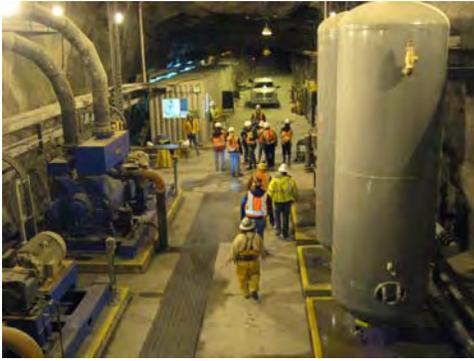
5. Vacuum & pressure pump room.

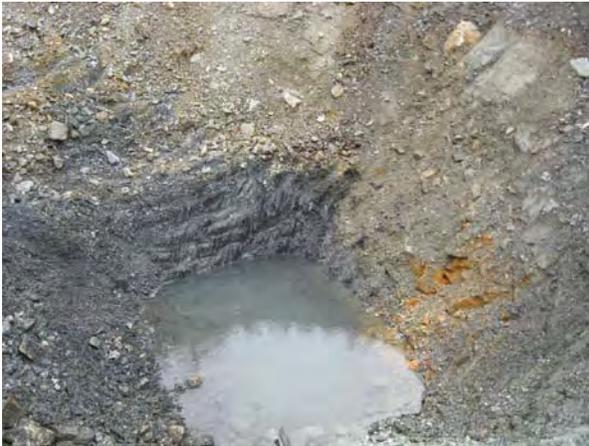
Tailings Treatment Facility (TTF): Excavation had commenced on re-locating the graphitic phyllite drainage sump in preparation for the Phase 2 dam raise. Graphitic phyllite material was exposed on the side wall of the sump. (Photos 7 & 8).

Photo 7: Tailings facility
