INSPECTION REPORT: KENSINGTON GOLD MINE

Tongass National Forest Minerals Group
8510 Mendenhall Loop Rd
Juneau, AK 99801
(907) 789-6275– office
(907) 586-8808 – fax

Date of Inspection: Thursday March 21, 2019
Date of Report: Monday April 15, 2019
USDA Forest Service Inspector: Richard Dudek

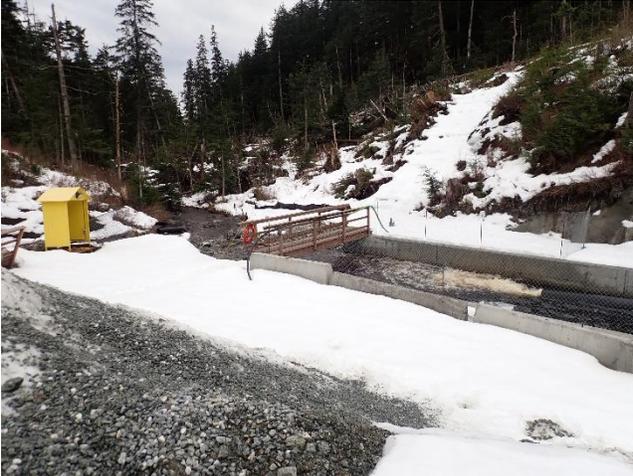
The Upper Slate Lake bypass and the water treatment plant's effluent plunge pool are working as intended (Photos 1-2).

Photo 1. The Upper Slate Lake bypass plunge pool.

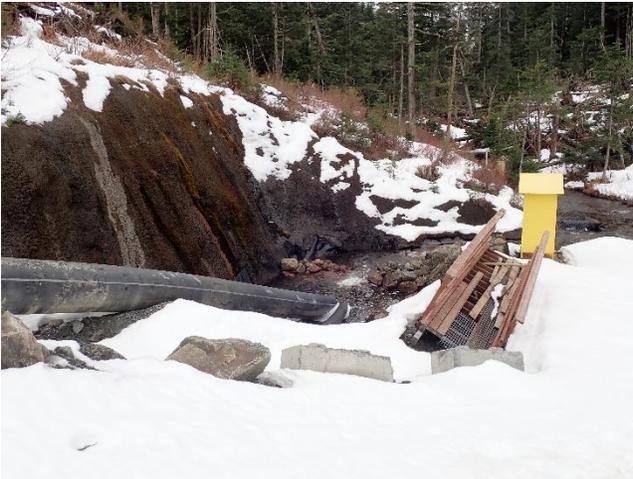
Photo 2. The TTF dam effluent discharge plunge pool.

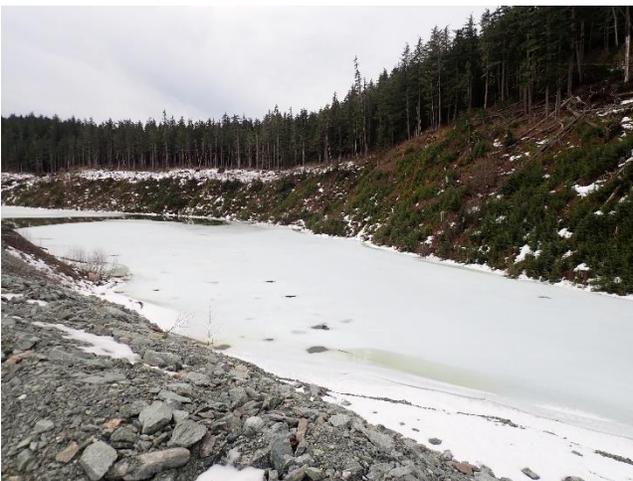
The northern TTF acid rock drainage (ARD) collection ditches were covered in snow and ice (Photo 3).

Photo 3. Northern TTF laydown area.

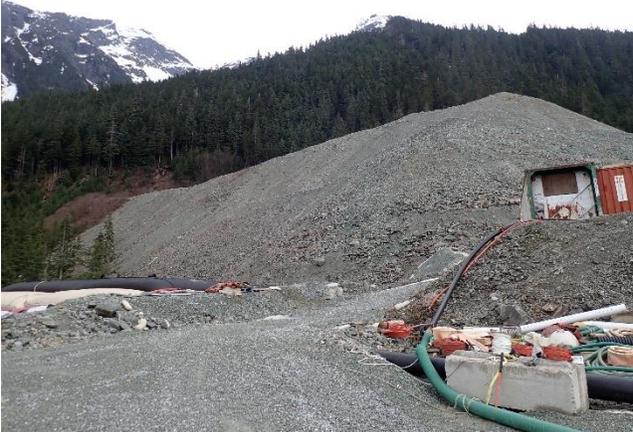
Waste rock from the Raven drift is being deposited at this location (Photo 4).

Photo 4. Comet Development pile.

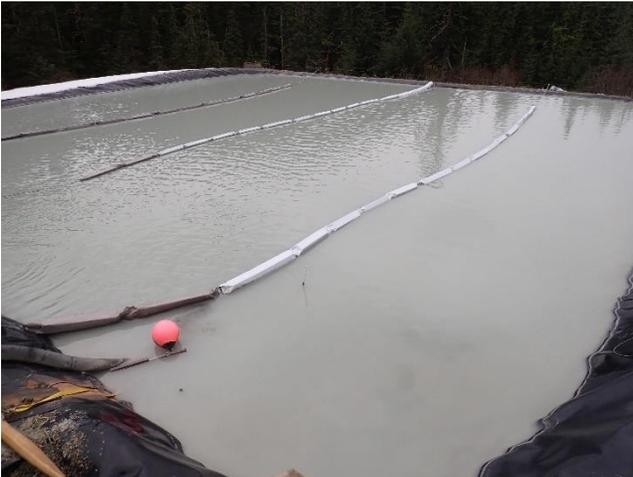
Photo 5. Pond 1

On 3/22/2019, the CWTP was treating 1500 gallons per minute (gpm). Pond-1 (Photo 5) was receiving mine site water. Pond-2 (Photo 6) was receiving backwash from the water treatment plant, and some overflow water from Pond-1. This spring, the CTWP personnel plan to dredge both ponds, which takes approximately three weeks for one pond.

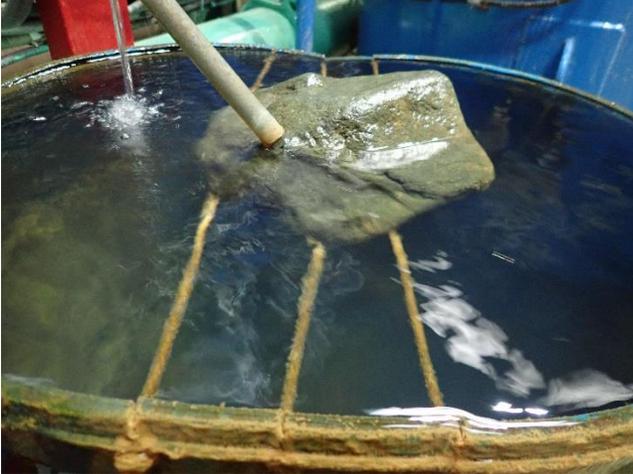
No white material was observed on the test rock used for monitoring precipitation of white material from treated mine site water (Photo 7).

Photo 7. The CWTP test rock.

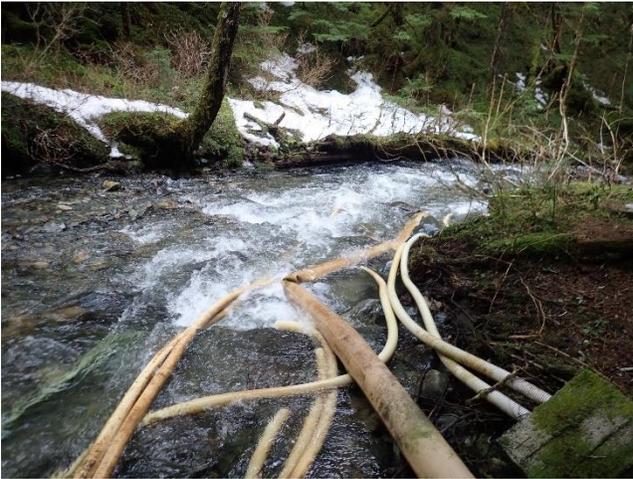
Prior to this inspection, Coeur personnel have observed and reported white material in the creek. However, due to recent high flows, the white material was not observed (Photos 8-9).

Photo 8. Sherman Creek Outfall.

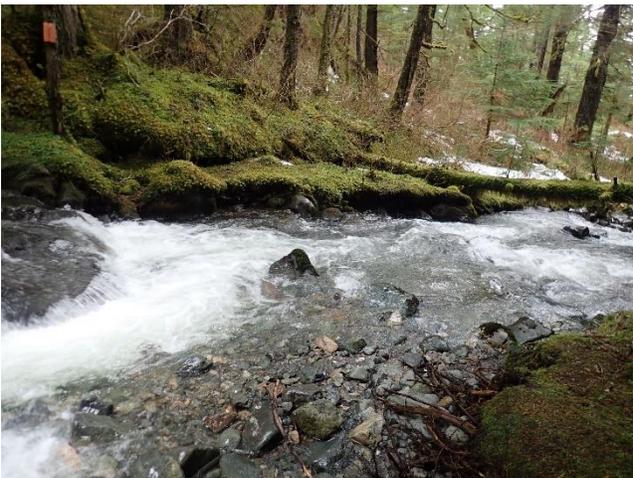
Photo 9. Sherman Creek.

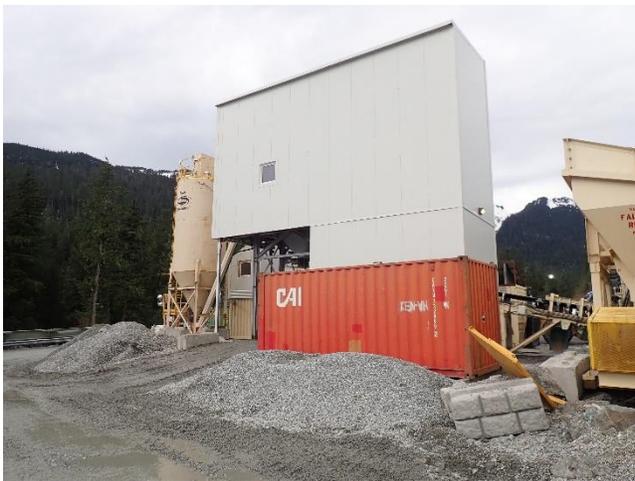
Coeur personnel continue to relocate waste rock from the Kensington development pile to this location. The pug plant is currently online and Coeur Alaska intends to operate the plant until next winter (Photos 10-11).

Photo 10. The pug plant at Pit 4.

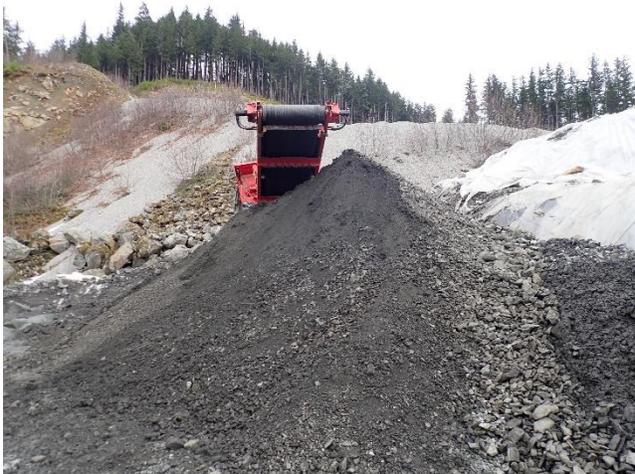
Photo 11. The rock shaker located behind the pug plant.
