INSPECTION REPORT: KENSINGTON GOLD MINE

Date of Inspection: Wednesday August 21, 2019
Date of Report: Thursday September 5, 2019
USDA Forest Service Inspector: Richard Dudek

This inspection included the Access roads, Comet Development Pile, Comet Water Treatment Plant (CTWP), Sherman Creek Outfall 001, Pit 4, the vegetation test plots, and the TTF area.

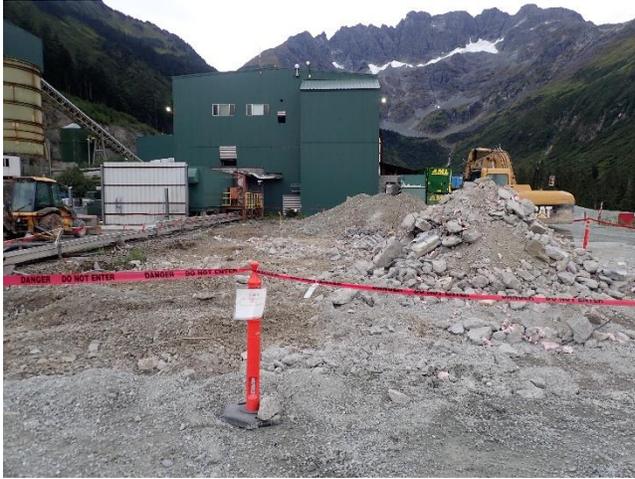
- **The seven generators (Photo 1) have been removed from the mill area and will be shipped off site.**

Photo 1. The former location for the seven decommissioned generators.

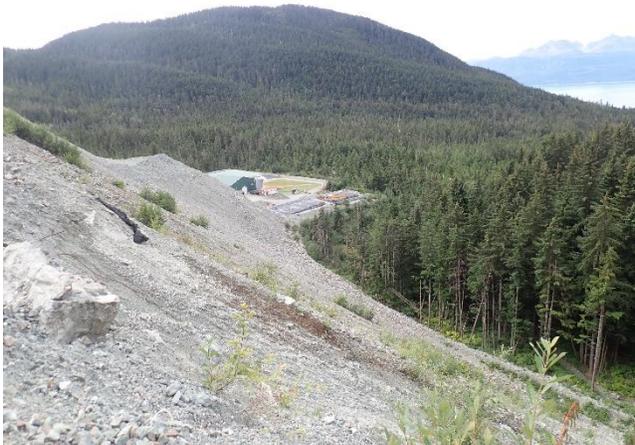
Coeur Alaska continues to deposit waste rock from the Raven drift at this location (Photo 2).

Photo 2. Comet development pile.

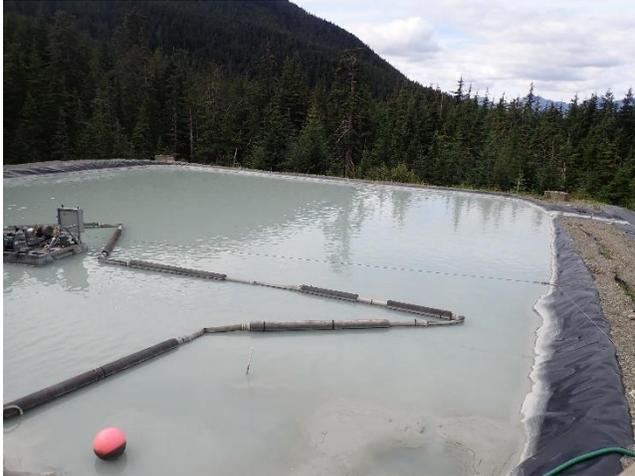
On 8/21/2019, the CWTP was treating 1,200 per minute (gpm). Pond-1 (Photo 3) was receiving mine site water. CWTP operators continue with the dredging of Pond-1. Pond-2 (Photo 4) was receiving backwash from the water treatment plant.

Photo 3. Pond-1 at the Comet Water Treatment Plant.

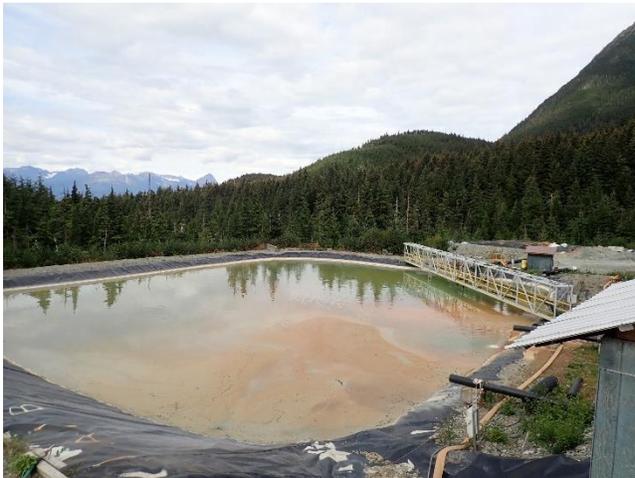
Photo 4. Pond-2 at the Comet Water Treatment Plant.

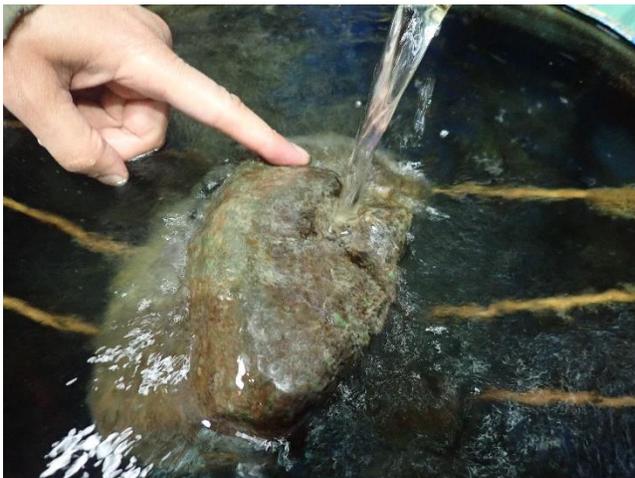
White material was observed on the test rock used for monitoring white material (Photo 5).

Photo 5. The test rock used for monitoring white material in effluent mine site water.

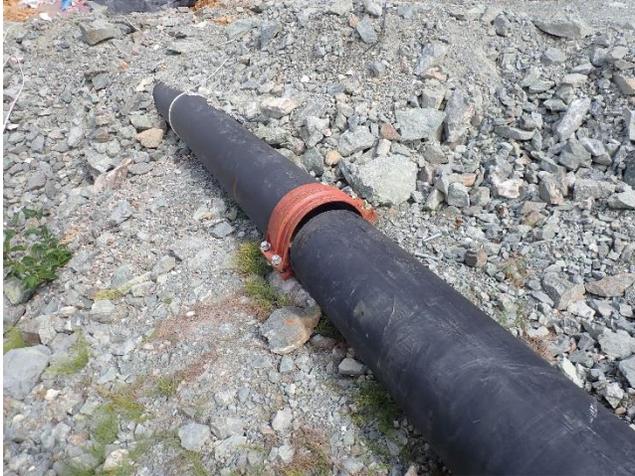
The pipeline (Photo 6) for the de-watering bags sump is disconnected and needs to be fixed.

Photo 6. The section of water pipe near the de-watering bags that needs to be connected.

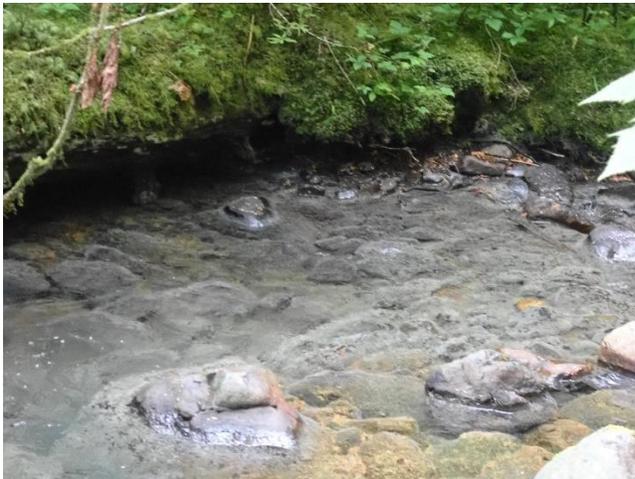
White material was observed in the creek bed (Photos 7). Coeur Alaska continues to use calcium chloride (CaCl_2) as part of the treatment process for removing white material out of solution.

Photo 7. White material covering rocks in Sherman Creek.

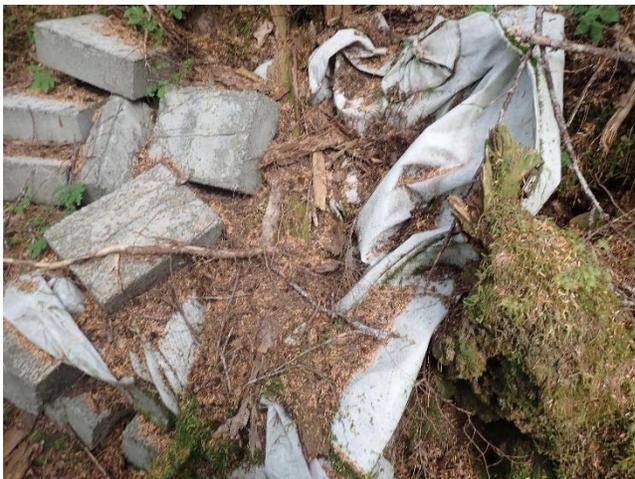
An empty super sack located at Comet SH-113 needs to be removed from this location (Photo 8).

Photo 8. A super sack located at site SH-113.

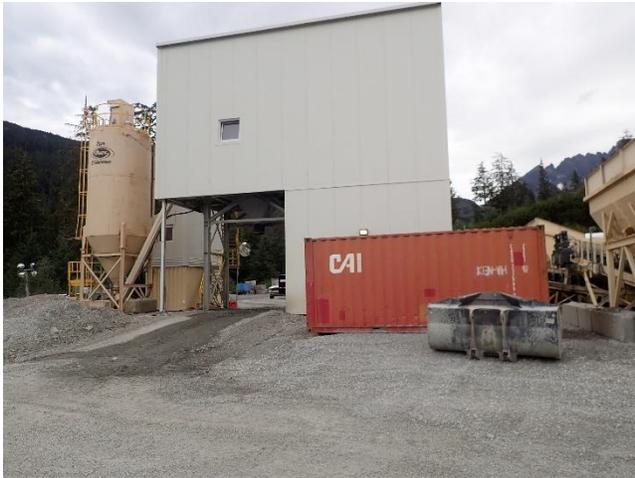
Coeur personnel continue to dispose of the graphitic phyllite (GP) as cemented underground backfill (Photo 9). Approximately 8,238 tons of GP material has been placed underground with 12,306 tons remaining.

Photo 9. The pug plant at Pit-4.

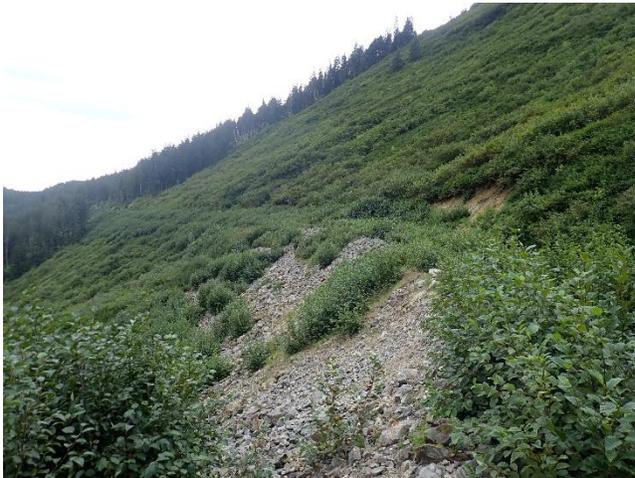
It was observed that alders are now growing in and around the test plots (Photo 10).

Photo 10. The vegetation test plots have become overgrown with alders.

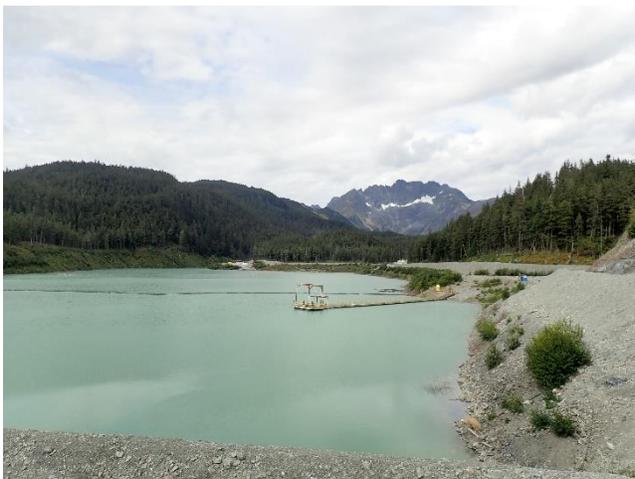
The TTF's recorded water level on 8/21/2019 was 702.85 feet (Photo 11), and algae was observed in the TTF.

Due to the lack of precipitation during the summer months, and to maintain the nine-foot water cover over tailings. The TTF water treatment plant was not treating and discharging effluent water. Water was still being pumped from the TTF reclaim barge to the mill, and then pumped back into the TTF.

Photo 11. The TTF.

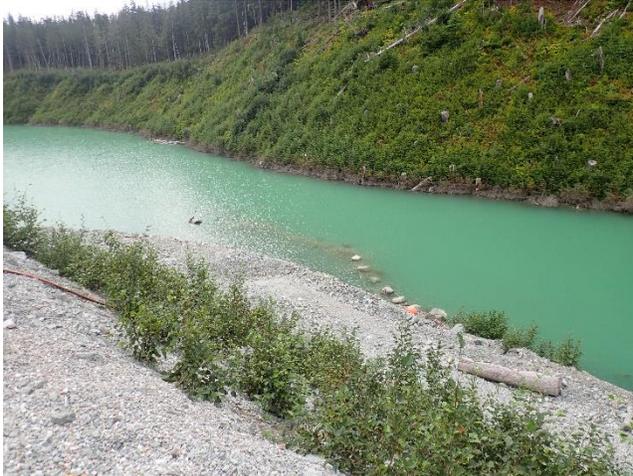
The acid rock drainage (ARD) collection sumps located at northern TTF laydown yard are functioning as intended (Photo 12).

Photo 12. The northern TTF ARD sumps.

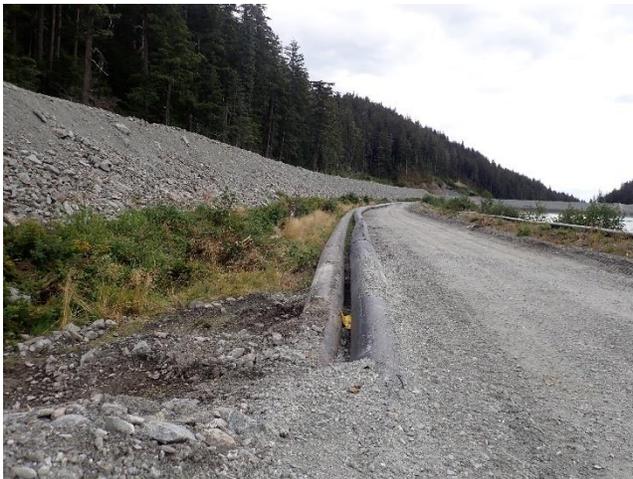
The installation of the second diversion pipeline for the Upper Slate Lake is complete (Photo 13).

Photo 13. The installation for the second diversion pipeline Upper Slate Lakes is completed.
