October 1, 2014

The October 1, 2014 Inspection of the Kensington Gold Mine

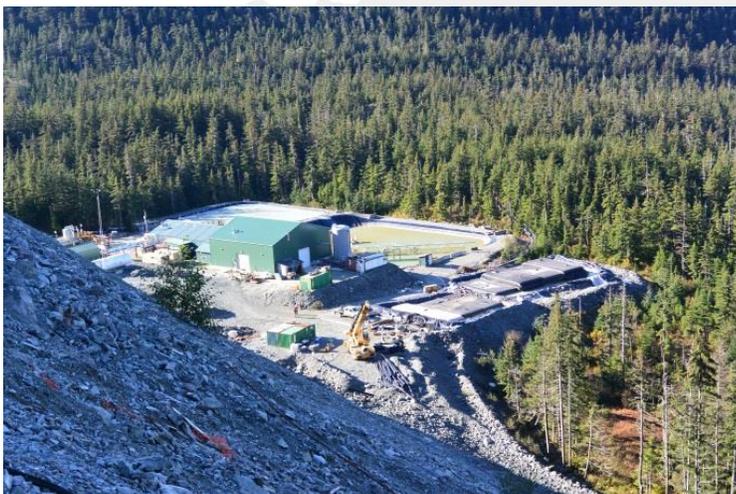
Figure 1 The Comet Water Treatment Plant as seen from atop the Comet Wasterock Pile.

After emerging from the Comet Portal and parking the truck, the team walked across the double berms to the west side of the Comet Wasterock Pile for an overview of the Comet Wastewater Treatment Plant (WTP) (Figure 1). The double berms designed to prohibit dumping of permitted waste off the west side of the pile are working well. There was a moderate flow in Ophir Creek, and the stream bed was clear of debris.

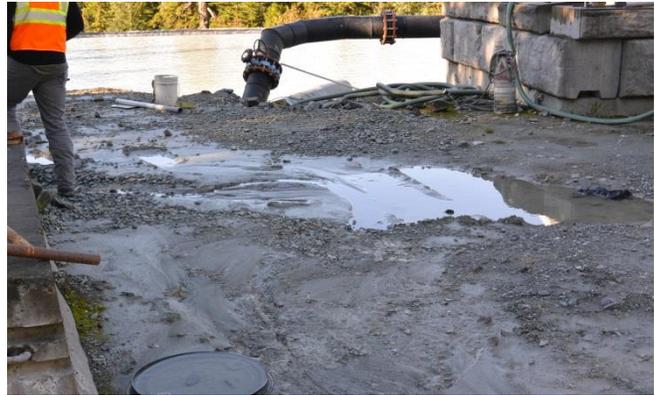
mine was being delivered to Pond One at a rate of about 1300 Gallons Per Minute (GPM) during our visit. A slight preferential flow path could be seen in the gravel laydown area draining into Pond One (Figure 2). Water draining from the access road likely uses the path only during heavy rain events, and the path leads directly into Pond One where the water would be treated. At the time of the inspection there was no cause for concern that the preferential flow path would erode further into the gravel pad.

Figure 2 A preferential flow path draining into Pond One.

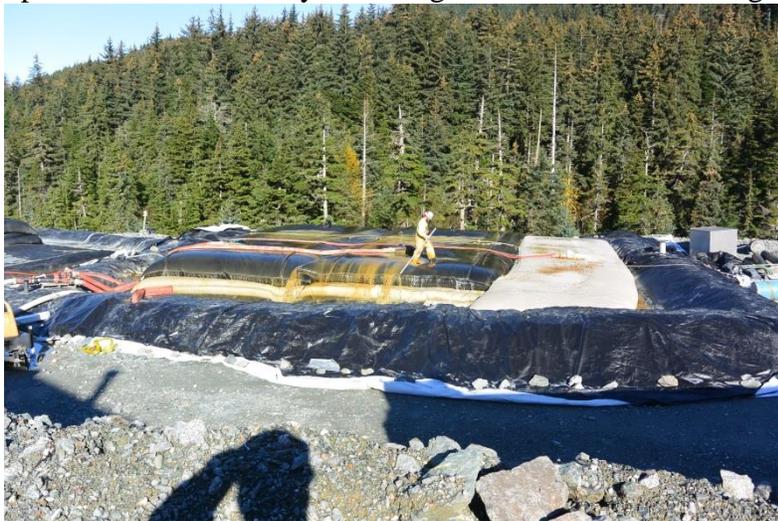
Figure 3 Dewatering bags inside lined containment.

from the bottom of the pond as a slurry, and pumps it into a large porous bag contained inside a lined containment cell (Figure 3). The water is pushed through the pores in the bag, and all but the smallest of particles settle to the bottom of the inside of the bag. The water that exfiltrates from the bag is light brown, and a noticeably different color from the steel gray water contained in the ponds. The water from the sedimentation bags is collected in the lined containment area, and pumped back to the pond. When

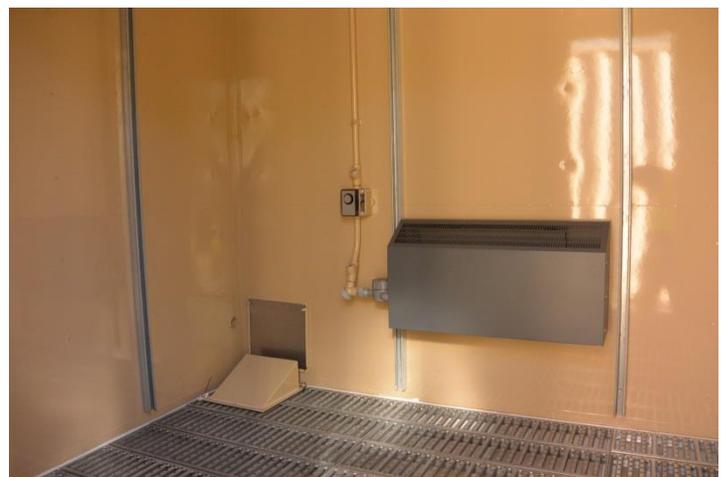
Figure 4 Inside of a new 20 foot container. Note the integrated secondary containment, heater and floor vent.

Two new 20 foot long containers were sitting empty near the treatment plant (Figure 4). These elaborate containers feature integrated secondary containment, onboard heating, and built in ventilation. The approved POO states that all hydrocarbons and hazardous liquids must be stored in secondary containment. Kevin stated that these containers will be used to store reagents for the water treatment plant that are susceptible to freezing.

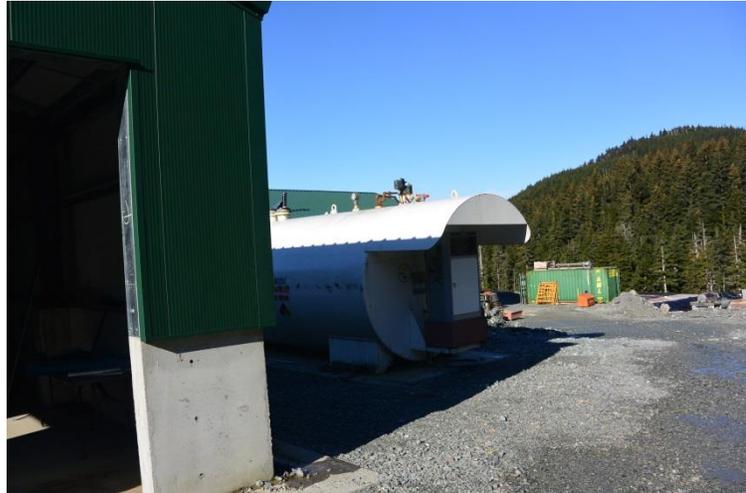
Figure 5 New building and fuel tank.

Since the last inspection performed by ADNR, a 660 square foot concrete and steel building had been built, and a new fuel tank was placed between the WTP and wasterock pile. Both the tank and building have been sited on concrete foundation pads (figure 5). The new tank can hold 10,000 gallons of diesel fuel, and will be used mainly to fuel a 1.2 megawatt backup generator that will be housed in the adjacent new building and diesel heaters in the surrounding buildings.

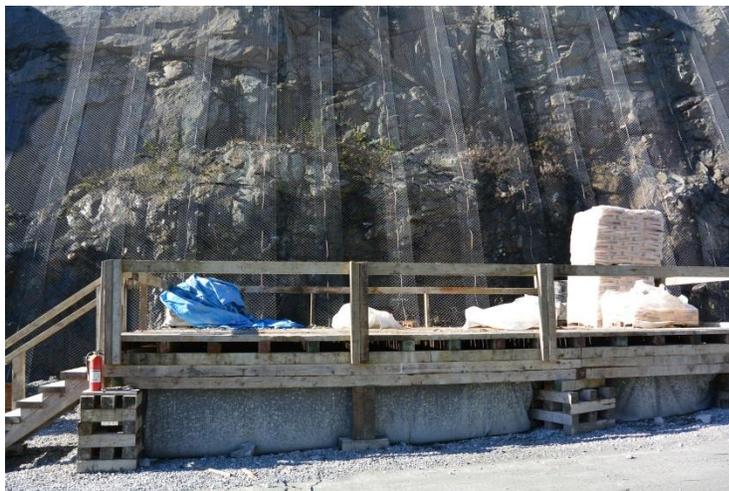
Figure 6 Site of the proposed new portal.

site of the proposed new portal (Figure 6). The portal, if built, would access a previously unknown ore reserve. It would be built on the existing Mill Bench, upon patented claims within the current disturbance footprint. The portal would be about the same size as the existing Jualin Portal (approximately 18' diameter), and would lead to an estimated 8000' decline. The newly discovered ore body is slightly different from the currently mined ore.

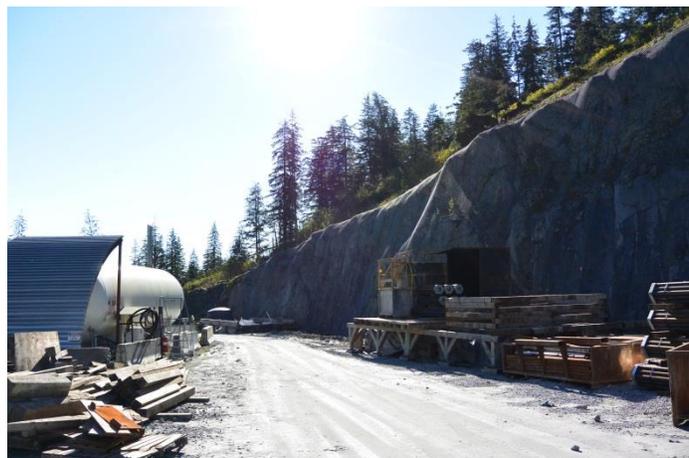
Figure 7 High wall and propane tank.

Limited space is available on the Mill Bench, and a propane tank (Figure 7) used to fuel the portal heaters in winter will need to be relocated to accommodate the haul trucks entering and exiting the portal. The loaded haul trucks will drive around the lower side of the mill, up to the existing portal area, where they will dump ore onto the existing ore pad, or wasterock on the existing Jualin Wasterock Pile.

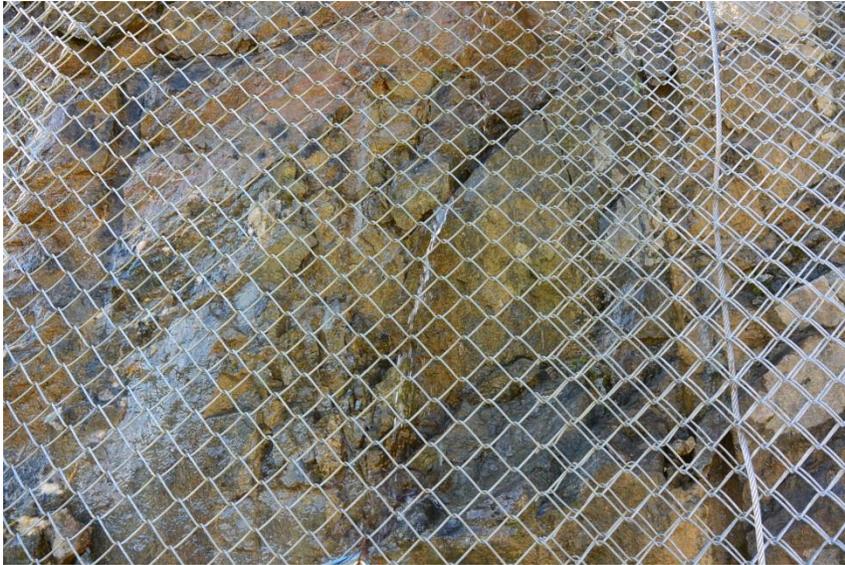
Figure 8 Water seeping from a crack in the high wall.

Water could be seen seeping from the high wall near the location of the proposed portal (Figure 8). Several hundred gallons per minute of water is expected to be encountered infiltrating into the proposed decline. Coeur will attempt to limit the amount of seeping water by pressure grouting flow paths wherever possible. Water from the workings would be collected, pumped to an existing sump near the Jualin Portal, and then pumped to the Comet WTP for treatment.

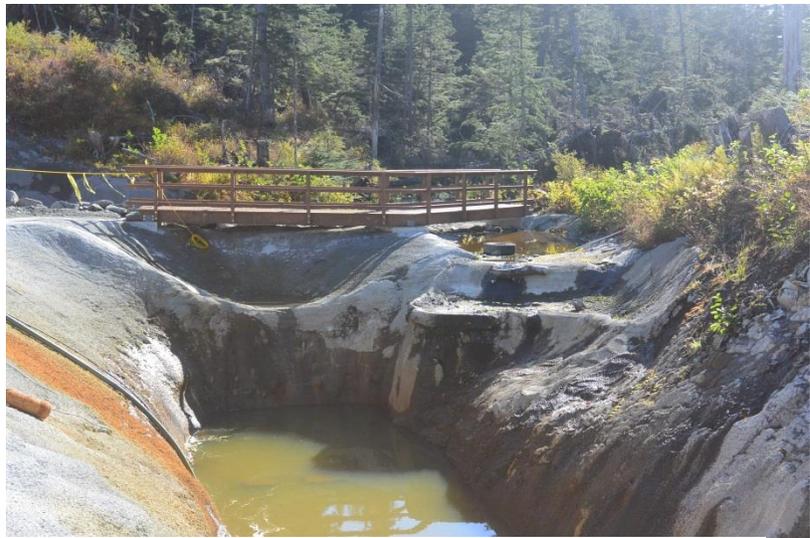
Figure 9 New walkway leading to a water quality monitoring site.

After breaking for lunch, the inspection team drove to the Tailings Treatment Facility (TTF), and moved downstream of the dam. A new walkway had been built since the previous inspection (Figure 9). Kevin stated that the walkway was installed to make it safer to travel to the water sampling point on the East Fork of Slate Creek required by the Quality Assurance Project Plan and Fresh Water Monitoring Plan. The remaining exposed area of the original emergency spillway for Stage One of the TTF Dam has been filled in with diorite (Figure 10). The old

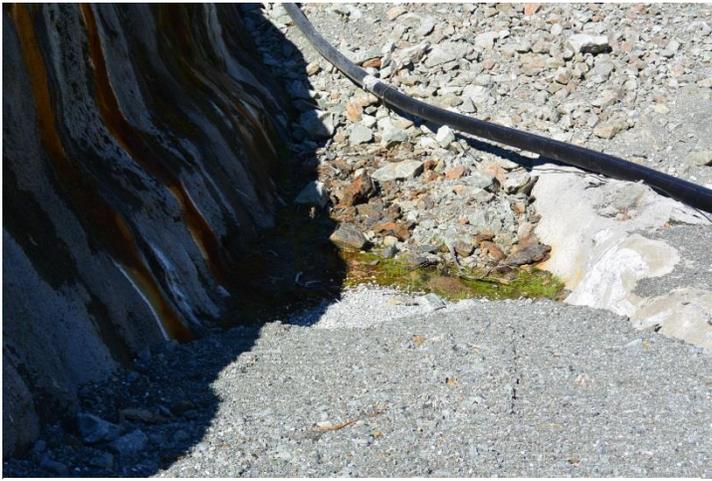
Figure 10 Filled Stage One Emergency Spillway.
upstream of the TTF Dam.

spillway still collects Acid Rock Drainage (ARD) seepage from the shotcrete covered graphitic phyllite formation. Any collected ARD will infiltrate through the porous, crushed diorite containing a high amount of carbonate. The carbonate will help to neutralize acidic drainage before it reaches a sump at the bottom of the now filled spillway where it is collected and pumped to the small ARD Treatment Plant below the dam. The treated water is then discharged into an infiltration gallery just

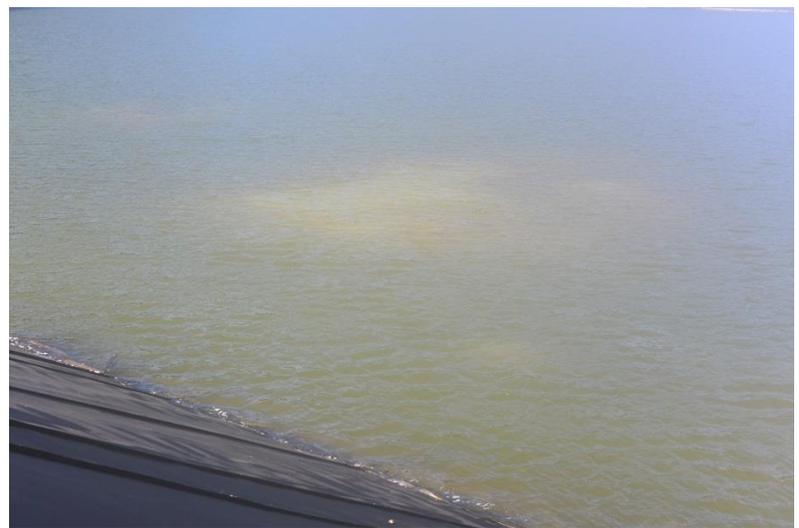
The team moved to the crest of the dam, where we observed several light colored areas that marked the crests of several mounds of tailings that had been deposited on and near the upstream face of the dam (Figure 11). Section 3.5 of the approved POO states that a minimum of 9 feet of water will be maintained above the tailings during operations. It is estimated that a cover of 4-6 feet of water was atop the tailings at the time of this inspection. The depth of the cover is not a safety concern, and the height of the water cover will increase as precipitation increases during the rainy autumn season.

Figure 11 A mound of tailings with a shallow cover of water.

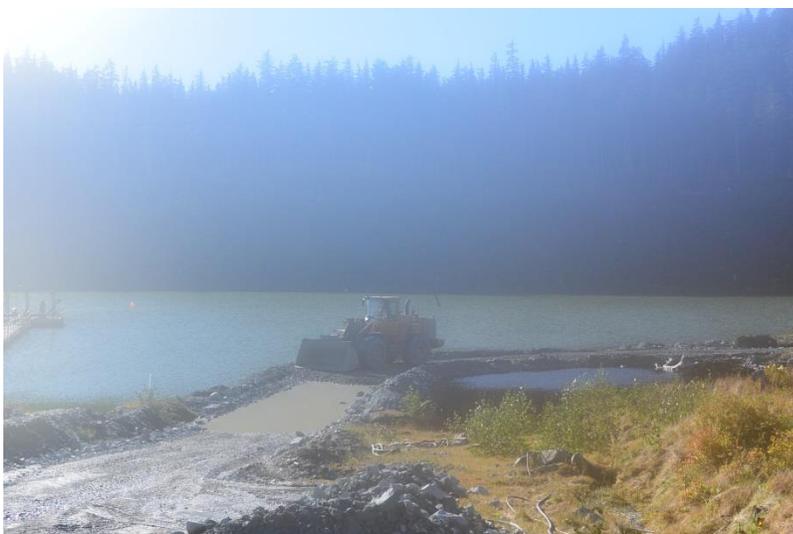
The inspectors traveled north to the road that accesses the site of the barrel tests. The test site was only accessible by foot because a low area of the access road had become inundated by the rising level of water in the TTF. A loader was actively placing fill on the inundated roadbed (Figure 12). Kevin stated that a new road alignment may be needed so that consistent road access to the test area is maintained.

Figure 12 A loader raising the elevation of the road bed. The haze is caused by a fogged up camera lens.
