## February 13<sup>th</sup>, 2014 Inspection of the Kensington Gold Mine

Inspection Team:  
Curtis Caton, USFS  
Cody MacCabe, USFS  
David Wilfong, ADNR

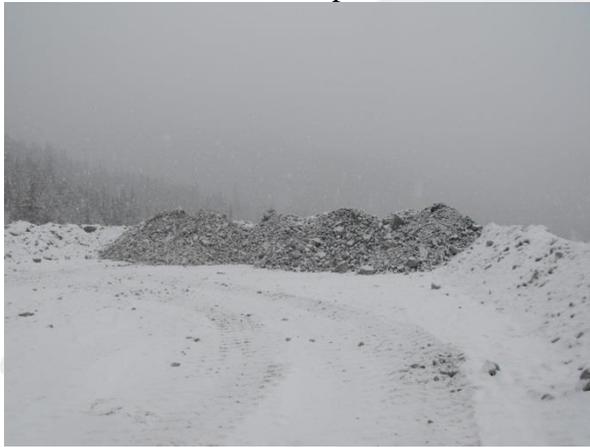
Figure 1 Looking south on the top of the Comet wasterock pile.

to be pushed over the side (Figure 1). Coeur had recently finished a lift at the southern toe in an attempt to lessen the slope of the pile (Figure 2).

After attending the required safety training, the team was shuttled to the mill and donned the extra personal protective equipment (PPE) required for the trip underground. The team then traveled through the almost 3 mile long main tunnel to the Comet Wasterock Pile. Snow was falling heavily on the Comet side, and visibility was poor. A few piles of waste rock were sitting at the southern end of the pile waiting

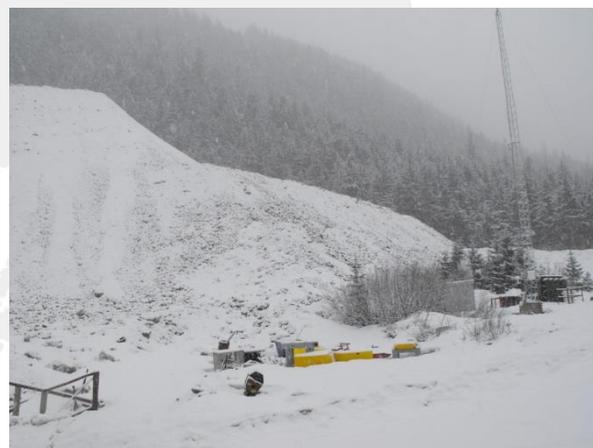
Figure 2 Lift at the south end of the wasterock pile. Looking southeast from the Comet WTP.

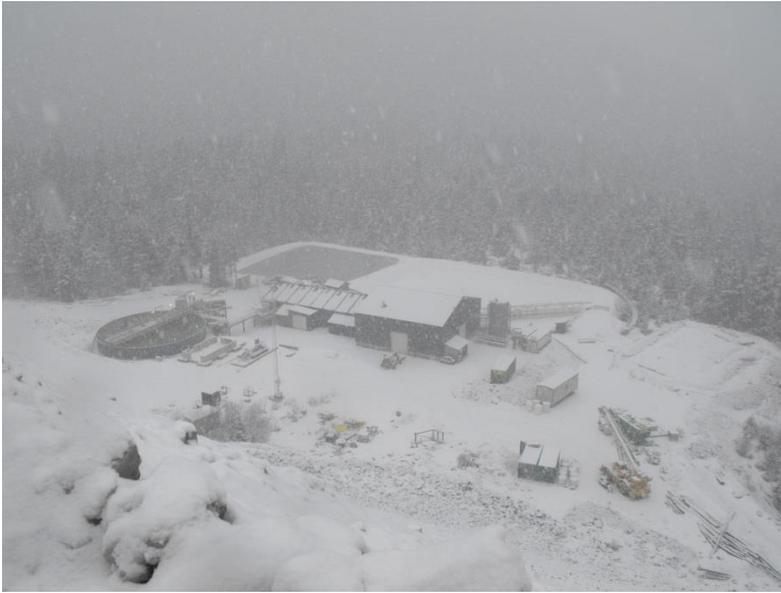
The team then drove to the Comet Wastewater Treatment Plant (Figure 3). Flow from the underground workings was approximately 800 GPM at the time of the inspection, which was relatively low due to freezing conditions. After a tour through the inside of the water treatment plant, the team moved down the trail to the distribution manifold near the outfall for the treatment plant. Past the manifold, trail

**Figure 3 Comet water treatment plant. Looking southwest from the wasterock pile.**

conditions prohibited further travel without ice cleats, so the team returned and walked around the outside of the water treatment plant. No significant issues were observed at the Comet Wasterock Pile or water treatment plant. The Comet Beach area was not visited.

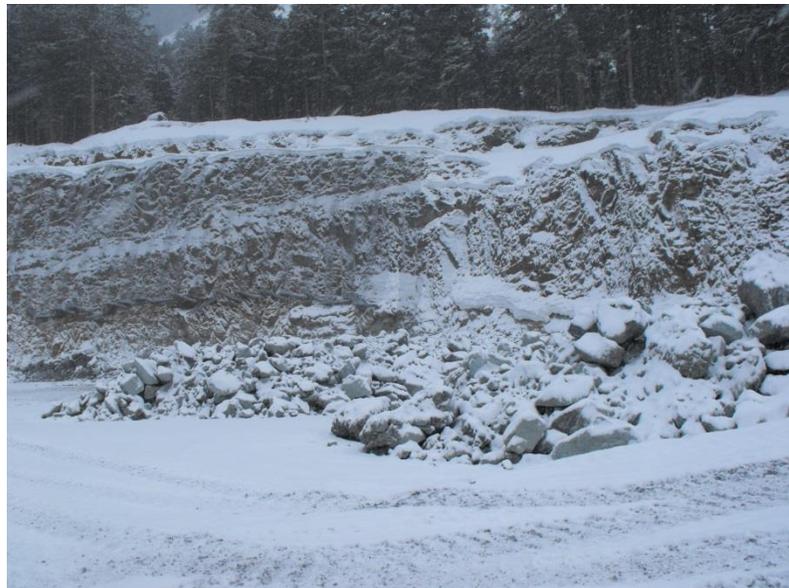
storage site for the construction rock to be used for Phase III of the Tailings Treatment Facility (TTF) Dam. The only other noteworthy item observed, although not a concern, was the significant quantity of oversized ore that had accumulated (Figure 4). Occasionally, an excavator equipped with a rock breaker, fragments the oversized ore into smaller pieces that will fit through the grizzly at the opening of the crusher.

**Figure 4 Oversize ore stored near the Jualin Portal. Looking west.**

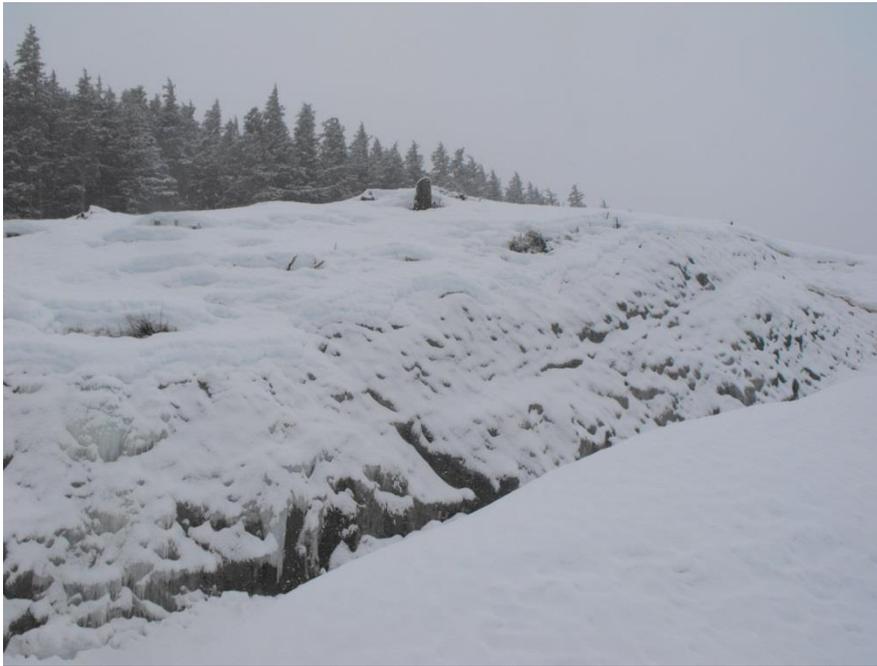
that the spillway and plunge pool had received seepage from the graphitic phyllite formation during the warming trend that had ended just a few days earlier. The shotcrete covering the graphitic phyllite was mostly free of snowpack, but was quickly being covered by the heavy falling snow. Thick icicles covered areas of the exposed bedrock, and no seepage was observed (Figure 5). The small ARD batch treatment plant was not operating at the time of the inspection. The tank used for storing seepage from the graphitic phyllite was covered with plastic, and warm air was being pumped under the cover to keep the tank from freezing. When a predetermined quantity of water fills the tank, it is pumped into the 60 gpm treatment plant where it is treated

Figure 5 Large ice formations have grown (left side of picture) due to ground water seeping and freezing near the shotcrete. Looking northwest.

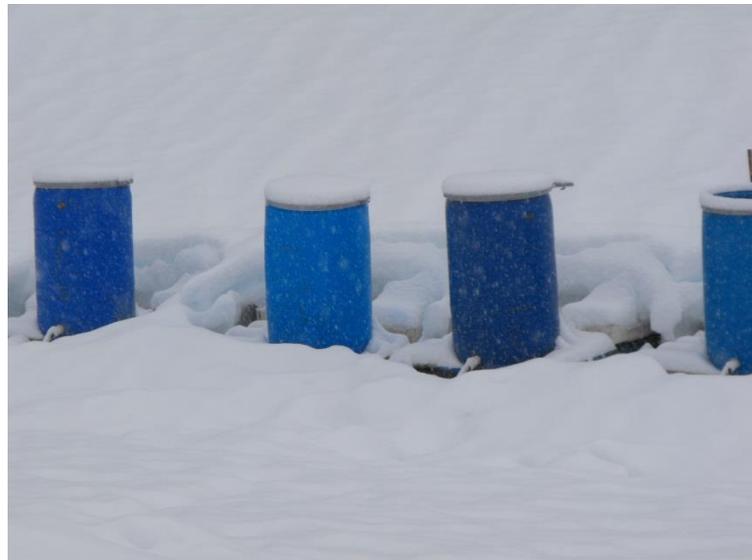
the four barrel tests had lids attached to the barrels (Figure 6) because freeze – thaw cycles were causing the barrels to overflow. Kevin stated that the lids would be removed after the spring break up.

Figure 6 Barrel tests at the north end of the TTF. Looking north.
