Field Inspection Report

-Pebble Copper/Gold Exploration Project-

Inspection Date: February 28-29, 2008

APMA No.: A086118

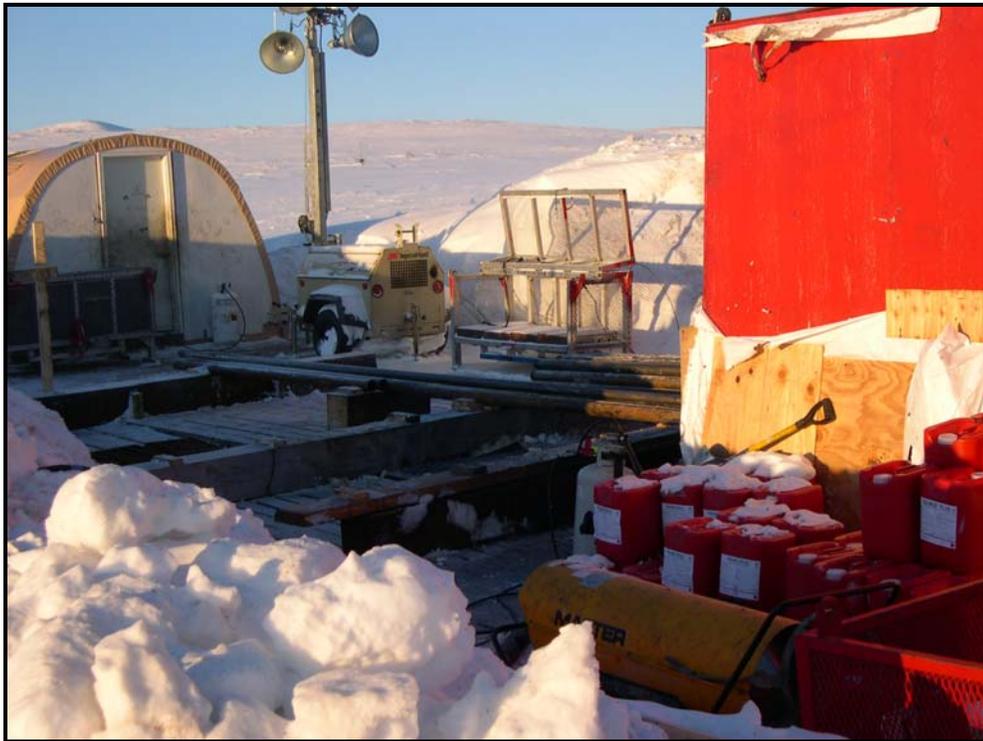
- Distance from water body: **> 100 ft.**
- Location of fuel storage: **On pad (Figure 3).**
- Sorbent Pads Present or Not: **Yes**
- Tundra Mat: **Yes**
- Pipe off Tundra: **Yes**
- Litter: **None**
- Activity: **Set up but not operating during visit because of mechanical problems. Pebble staff informed us it would be operating by day's end.**

- Trash Containment: **Yes**
- Sanitary Facilities: **Yes**
- Any spills or staining, or 'none' for that matter: **None**
- General impression of site: **Clean. No disturbance to tundra.**

Figure 3. Drill rig number 2.

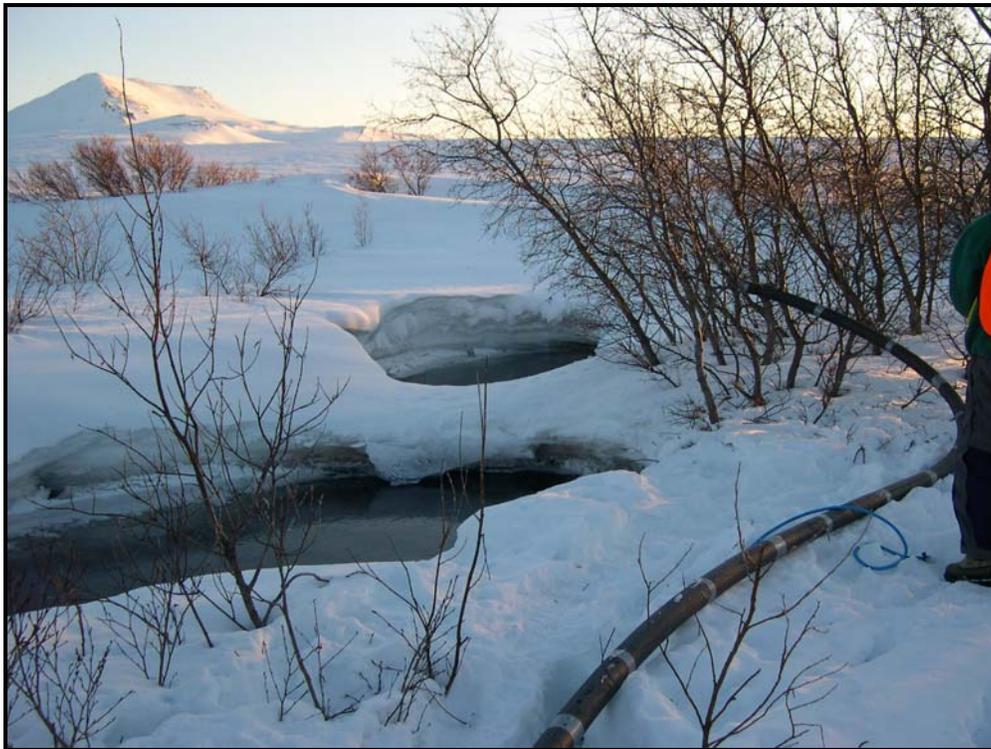
- Stream/Lake/Pond: **Upper Talarik Creek (Figure 4)**
- Location (see Figure 2)
- Adequate water flow and depth for fish passage in streams? **Yes**
- Evidence of significant impacts to riparian vegetation or stream banks? **None**
- Relative water level? **Base Flow**
- General impression of water body, i.e. clear, turbid, tannic colored, etc.? **Clear. No indication of pollution or sedimentation.**
- Intake structure: **Present**
- Structure clear of debris: **NA**
- Mesh size: **N/A**
- Submerged: **NA**
- Pump location to source: **> 100 ft**
- Catch basin for fuel supply: **Yes**
- Sorbent Pads Present or Not: **Yes**
- Hose color: **Black (insulated)**

Figure 4. Water withdrawal point, drill rig number 2, Upper Talarik Creek.

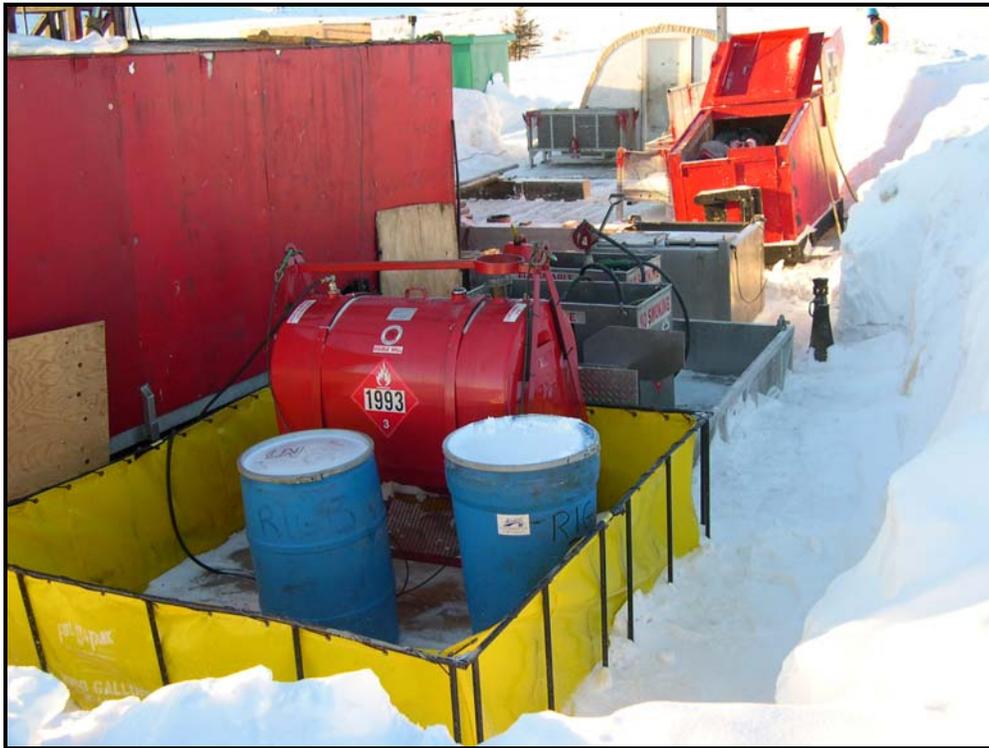
- Distance from water body: **> 100 ft.**
- Location of fuel storage: **On pad (Figure 5).**
- Sorbent Pads Present or Not: **Yes**
- Tundra Mat: **Yes**
- Pipe off Tundra: **Yes**
- Litter: **None**
- Trash Containment: **Yes**
- Sanitary Facilities: **Yes**
- Any spills or staining, or 'none' for that matter:
None
- General impression of site: **Clean. No
disturbance to tundra other than sump pit and
trench. Over flow water (clean) discharged
directly to tundra.**

Figure 5. Fuel storage drill rig number 3

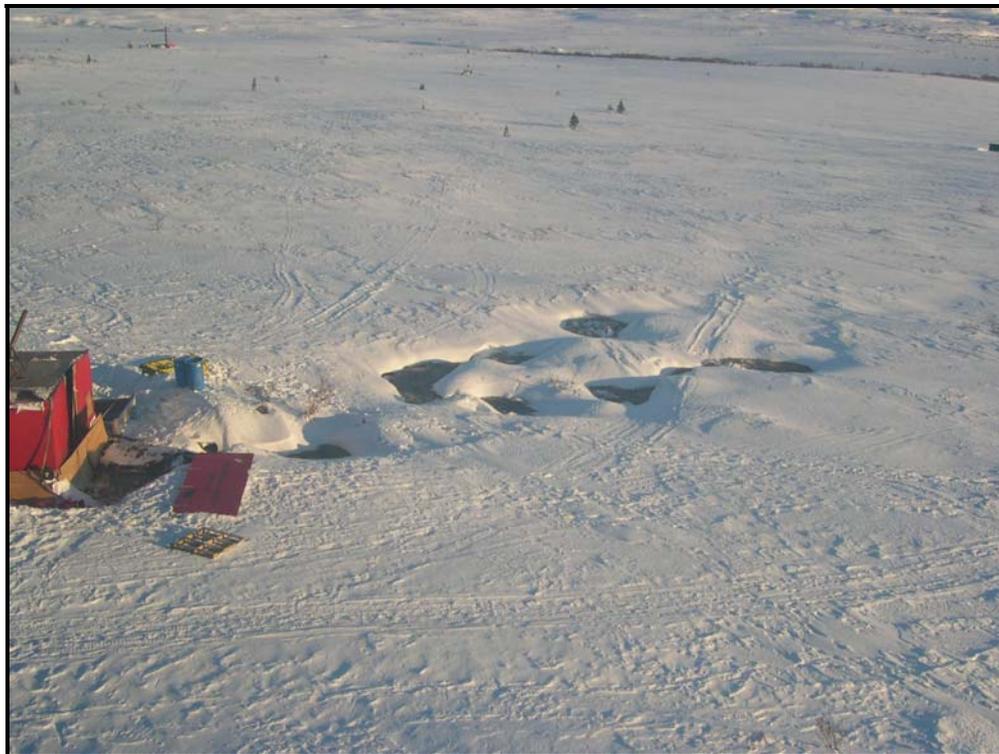
- Drill additives in use (list): **Unknown**
- Drill water discharged: **Onto tundra (Figure 6).**
- Water recirculation: **No**
- Artesian zone encountered: **Unknown**

Figure 6. Drill water discharge, drill rig number 3.

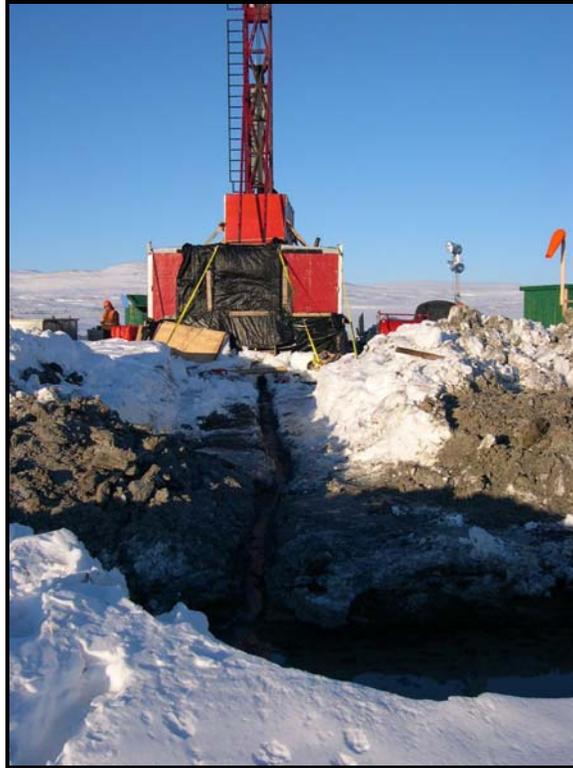
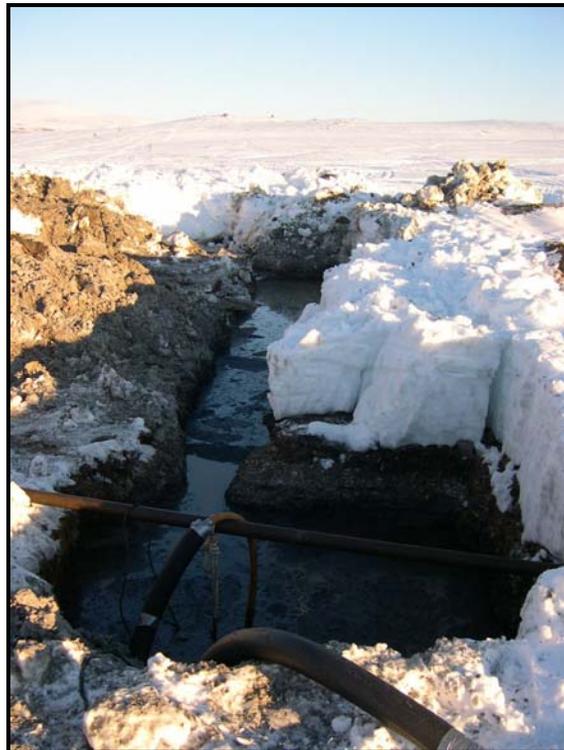
- Sump Pit**
 - Location: **Directly east of rig (Figures 7 & 8).**
 - Discharge trench: **Yes.**
 - Dimension pit: **Not measured.**
 - In use: **Yes**
 - Location and extent of discharged material?
Discharged contained to pit.

Figure 7. Water recycle sump, drill rig number 5.

Figure 8. Water recycle sump, drill rig number 5.
