Field Inspection Report -Pebble Copper/Gold Exploration Project-

Inspection Date: April 17, 2008

APMA No.: A086118

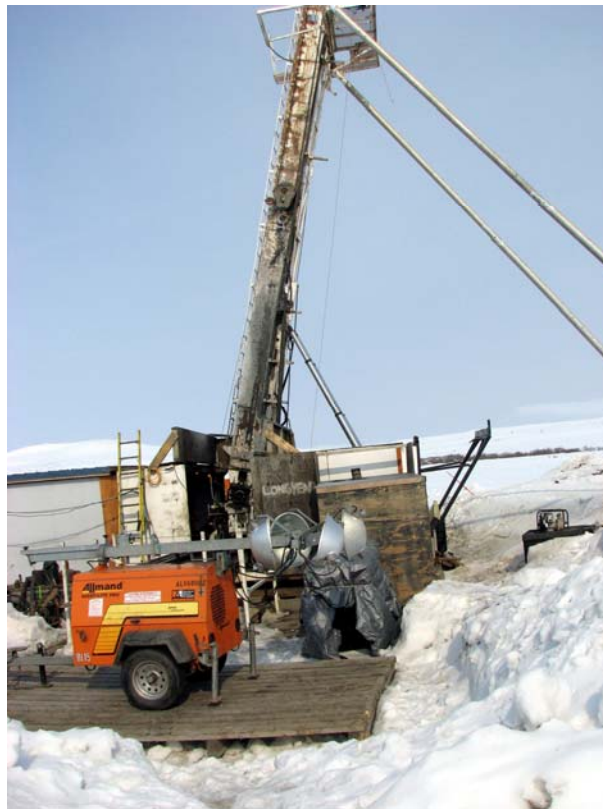
- Tundra Mat: **Yes**
 - Pipe off Tundra: **Yes**
 - Litter: **None**
 - Activity: **Drilling**
 - Trash Containment: **Present**
 - Sanitary Facilities: **Present**

Figure 1. Rig no. 1 on drill site no.8405. Note tundra pad.

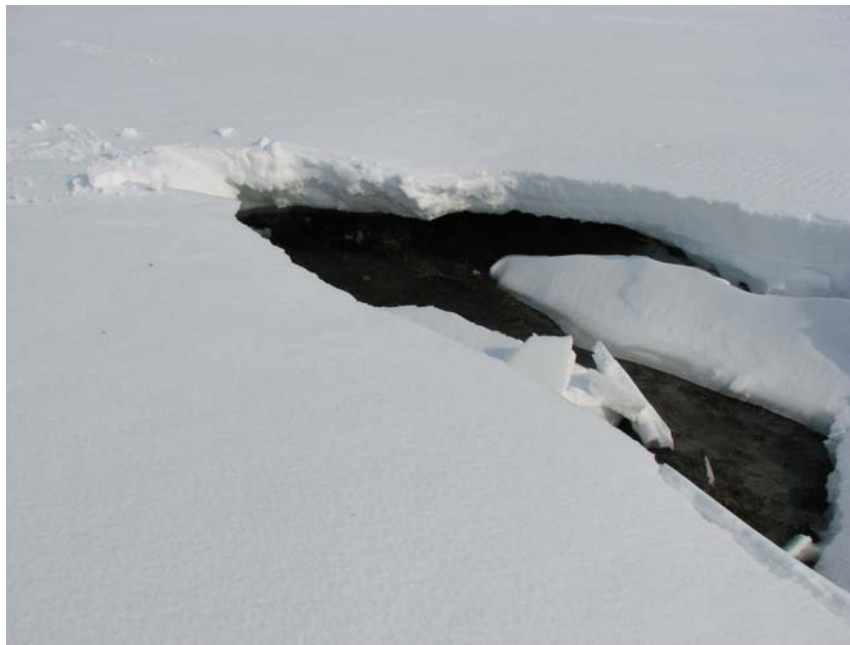
- Water discharged: **Yes/bypass water discharged to tundra. Water was clear.**
 - Drill water recirculation: **Yes. Recirculation system included three tanks used as a settling system for cuttings.**

Figure 4. Rig no. 1 bypass water discharged to tundra.

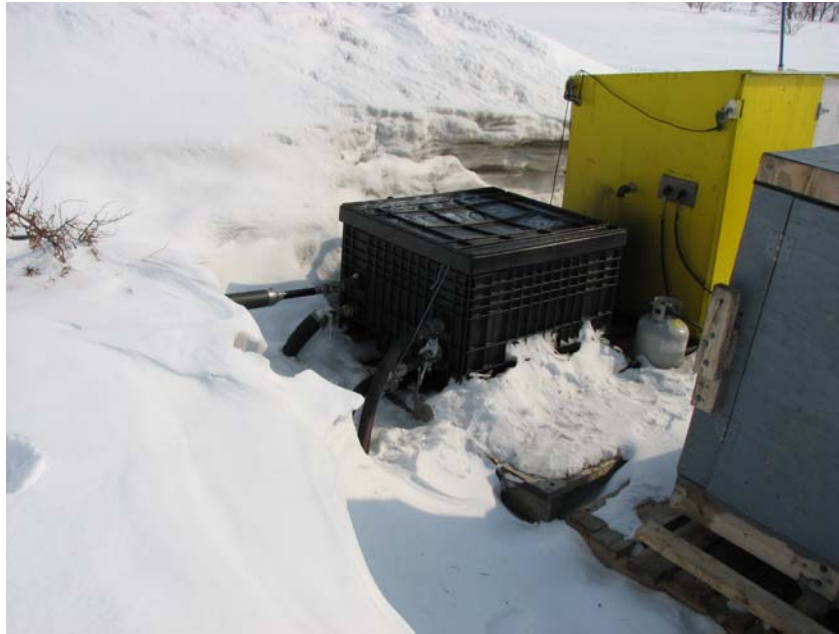
- Structure clear of debris: **Unknown.**
- Mesh size: **Unknown**
- Submerged: **Unknown.**
- Pump location to source: **Pump located on a tundra pad within a secondary catch basin.**

Figure 5. Circulation tank at water source location for rig no. 2

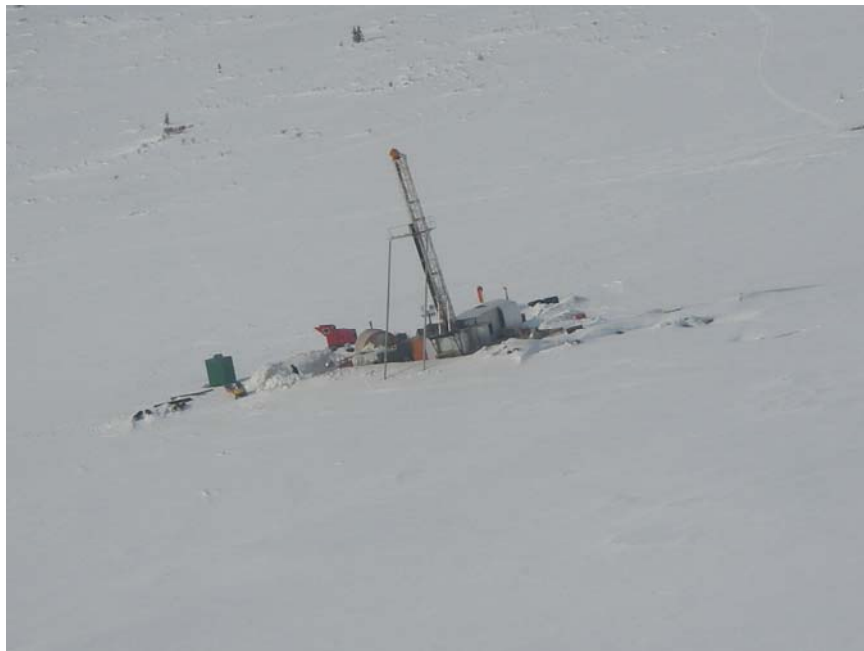
Figure 6. Drill site 8405, rig no. 1.

- Any spills or staining, or 'none' for that matter: **None**
 - General impression of site: **Clean.**
- Drilling Activity**
 - Drill additives in use (list): **NA**

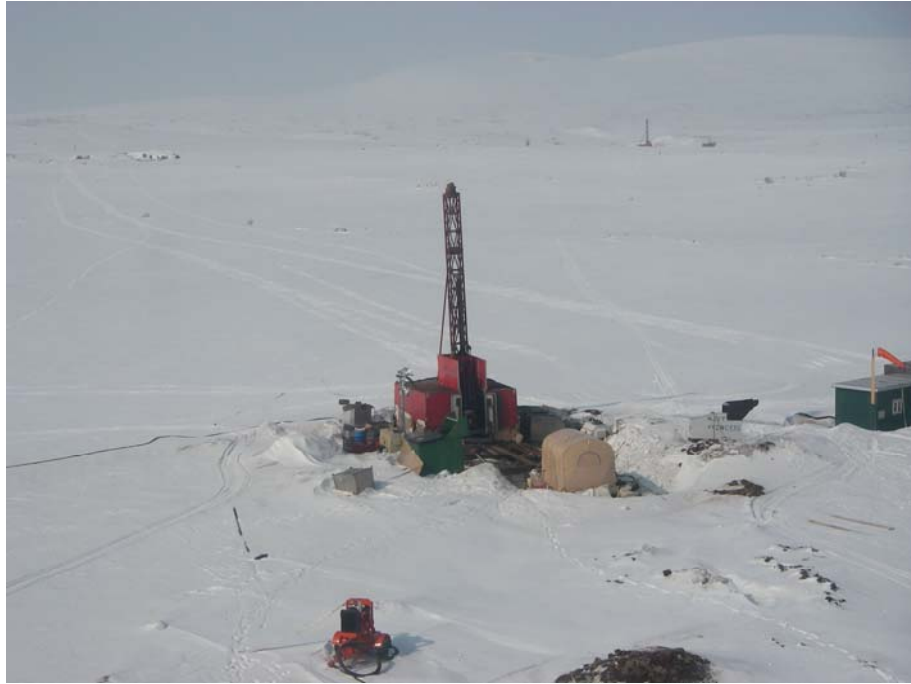
Figure 6. Drill site no. 8402, rig no. 2.

* Did not inspect rig site owing to weather.
