STATE OF ALASKA

Department of Natural Resources
Division of Mining, Land and Water
550 West 7th Avenue, Unit 900B
Anchorage, AK 99501-3577

SUBJECT: Trip Report to Pebble on June
22, 2005

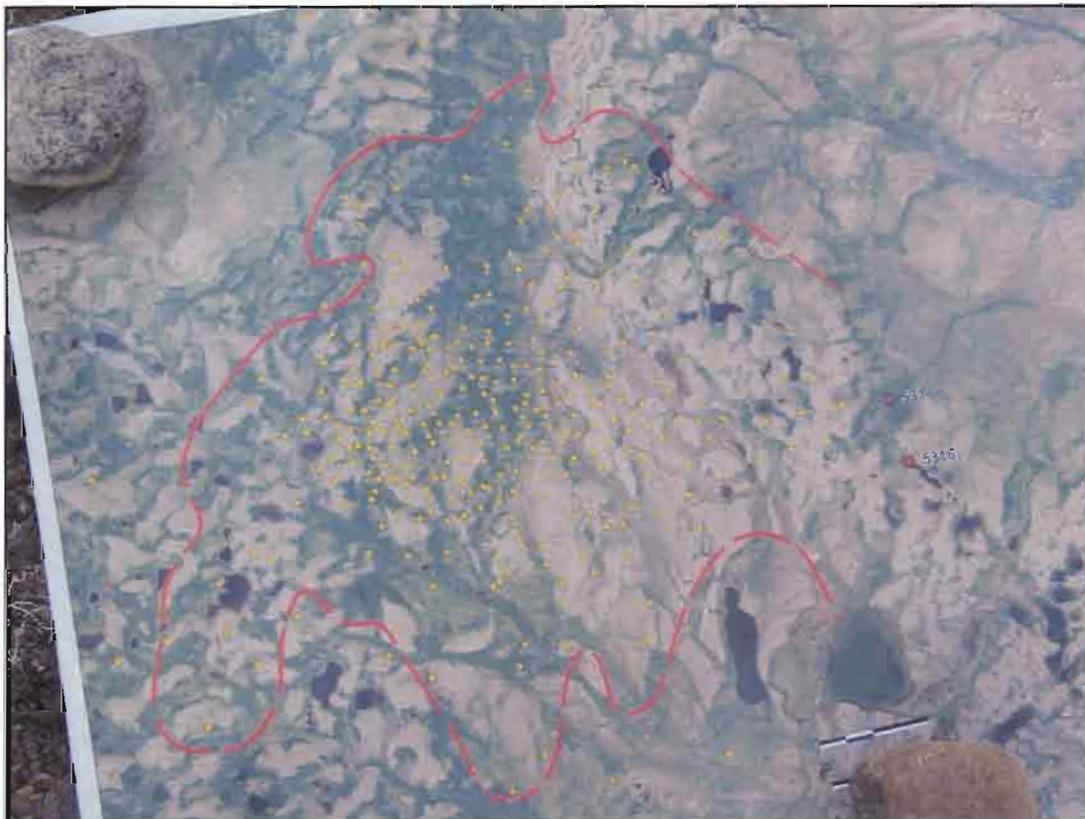
Picture 1

On June 22nd, Mike and Rich flew us out to the drainage divide between Upper Talarik Creek and Upper Kuktuli River so that the group could get a vantage view of the project area. The map below (Picture 1) depicts the completed drill sites to date in Township 3 South, Range 35 West, Sections 21, 22, 27 and 28, Seward Meridian.

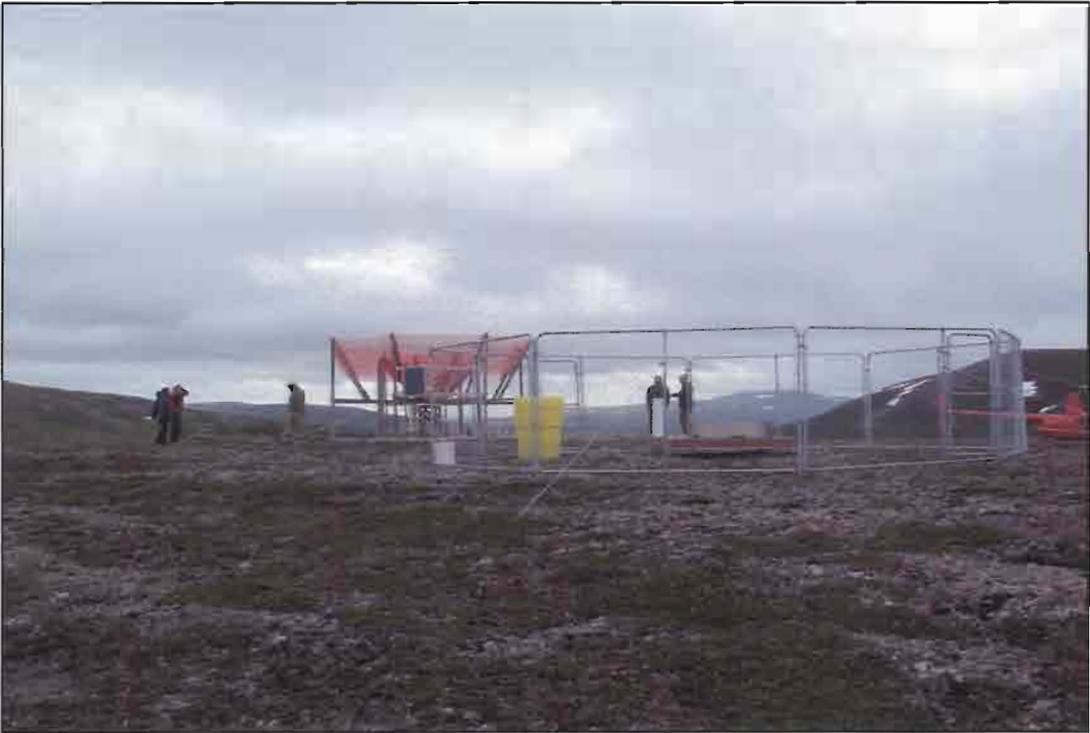
Picture 3

One of the places we stopped at was ND's weather station site (Picture 3) located in the Northeast ¼ of Section 16, Township 4 South, Range 35 West, Seward Meridian.

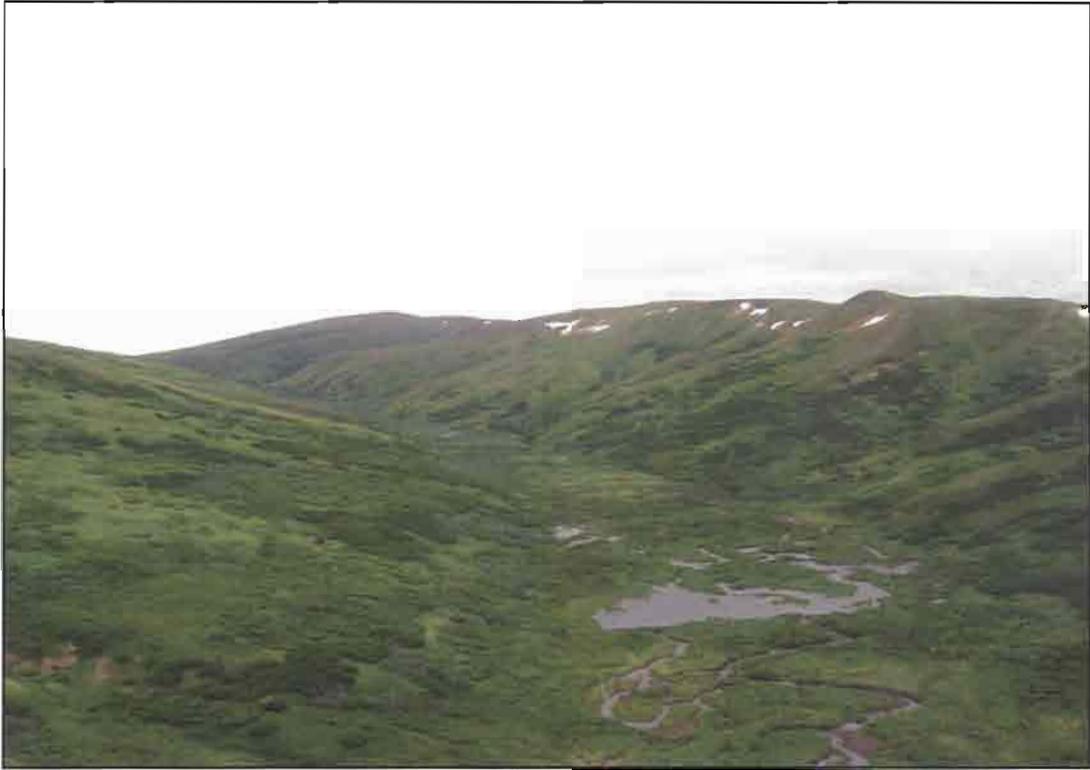
Picture 4 (below) is the drainage immediately west of Frying Pan Lake and the conceptual downstream site of the waste storage basin. This site is located in Sections 31 and 32 of Township 3 South, Range 35 West, and Sections 5 and 6 of Township 4 South, Range 35 West, SM.

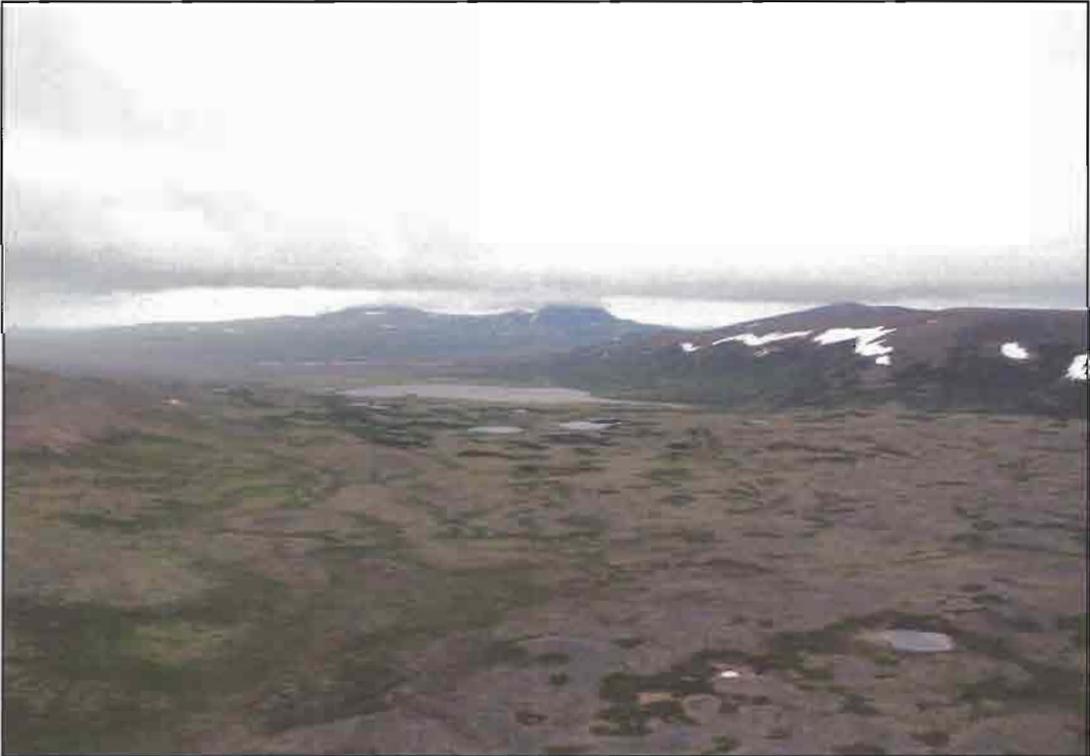
Picture 5 (below) is of the bench south of Frying Pan Lake where the conceptual tailings dam may be located.

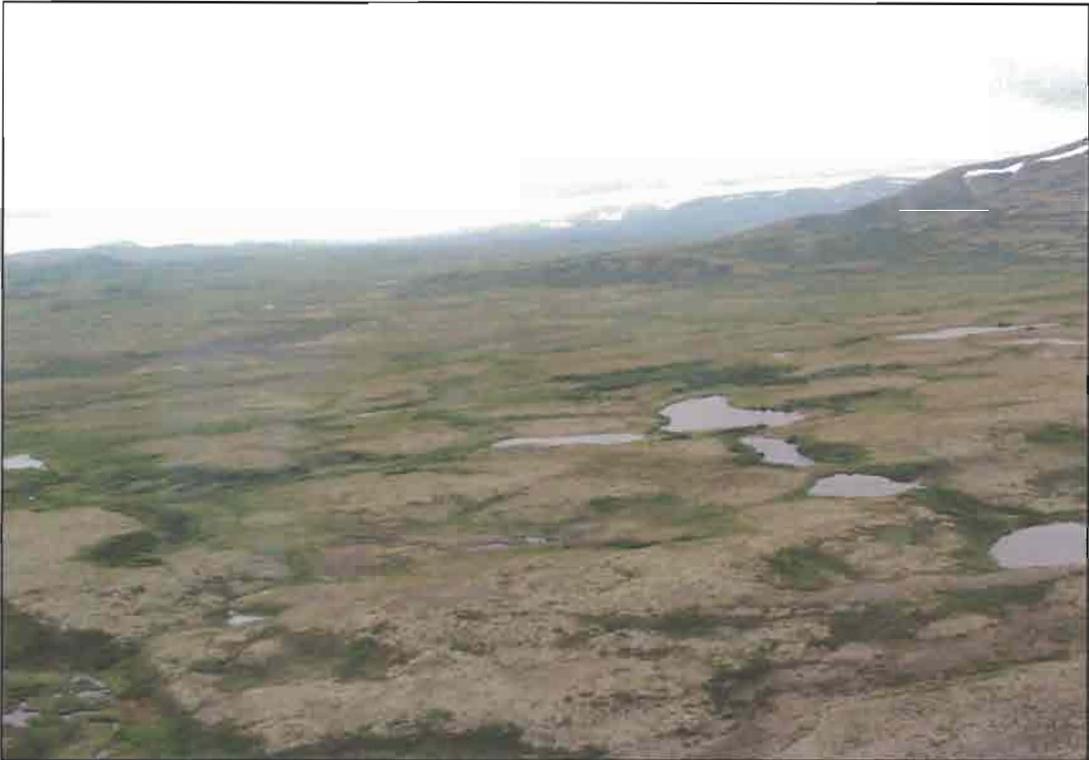
Picture 6 (below) is the location of where the west ore body is situated.

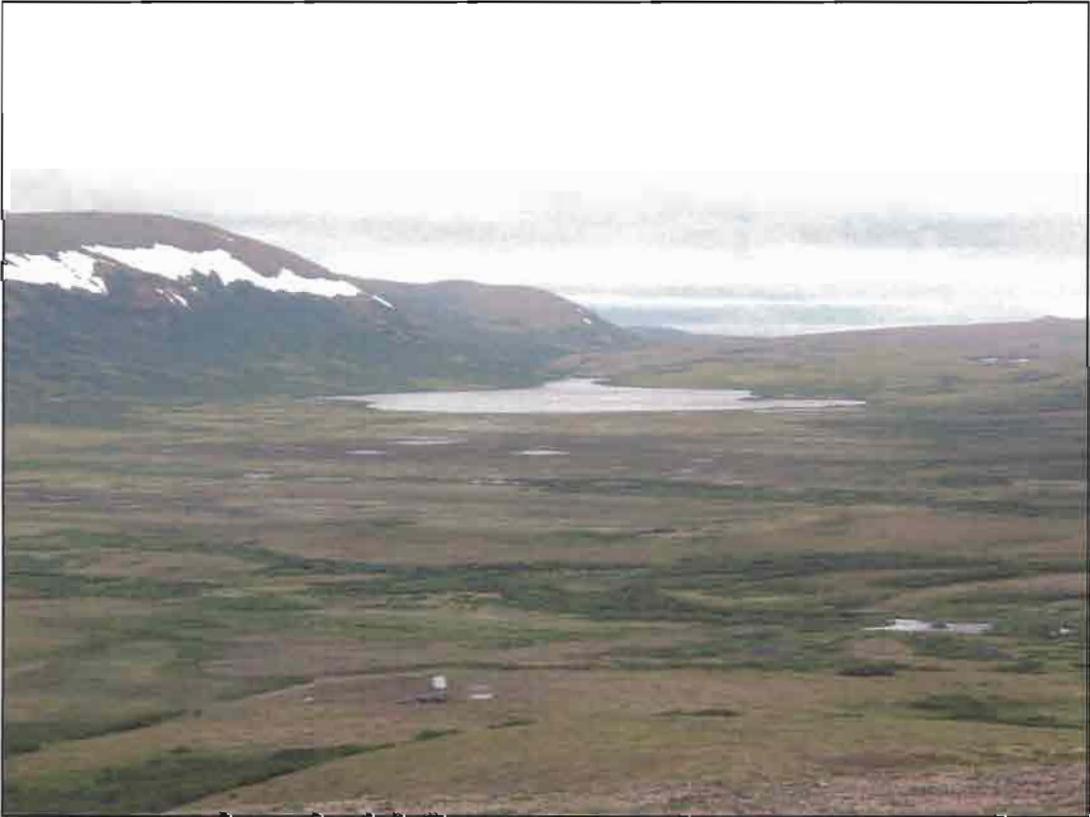
Picture 7 (below) is taken from the conceptual mill site area looking south east at Frying Pan Lake and the potential tailings dam site.

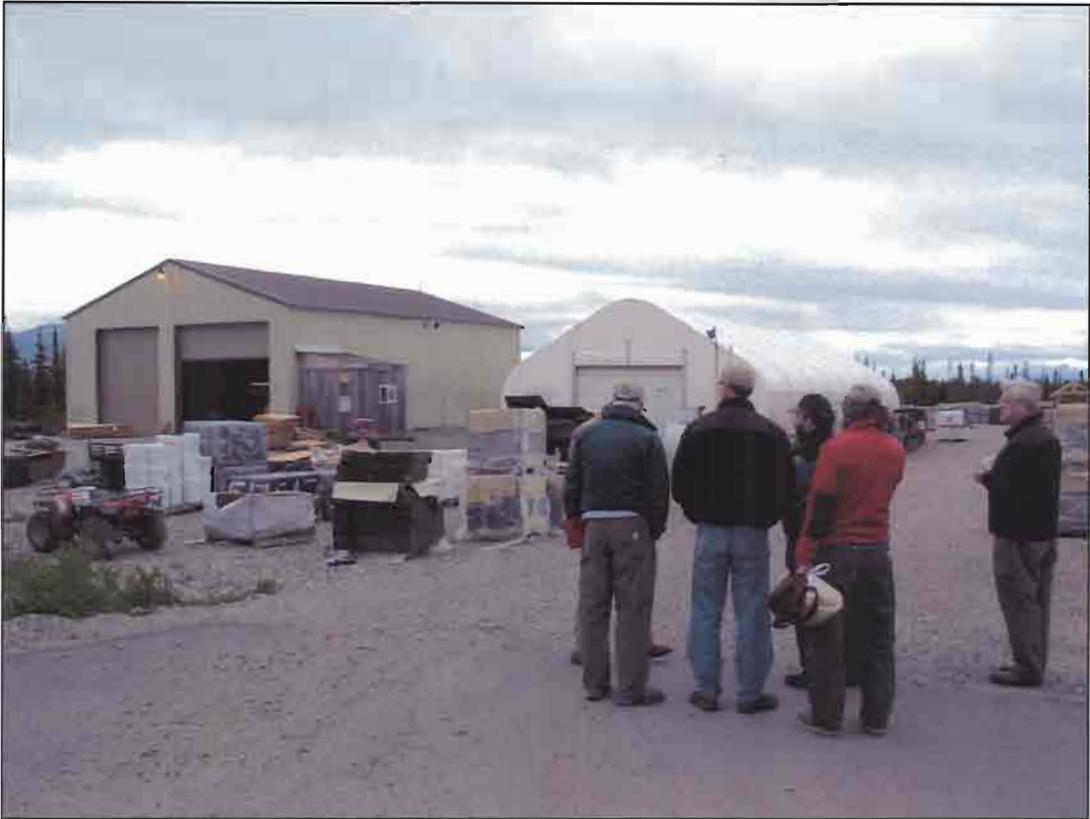
Picture 8

Our final stop before finishing the tour was the core shack (Picture 8 below).
