Field Monitoring Report -- Pebble Copper/Gold Exploration Project --

Personnel:	Inspection Date: 7/8/2010
Kate Malloy, ADF&G	Site Contact: Gernot Wober
Jim Vohden, DNR	APMA #: A20106118
Gay Harpole, DEC	
<input checked="" type="checkbox"/> Inspection Type:	<input checked="" type="checkbox"/> Wildlife Observed:
<input type="checkbox"/> Complete:	<input type="checkbox"/> Bear: None
<input checked="" type="checkbox"/> Partial: x	<input type="checkbox"/> Caribou: None
<input type="checkbox"/> Follow-up:	<input type="checkbox"/> Moose: None
<input type="checkbox"/> Response to Public Complaint:	<input type="checkbox"/> Waterfowl: None
	<input type="checkbox"/> Fish: None
<input checked="" type="checkbox"/> Weather Conditions:	<input type="checkbox"/> Other:
<input type="checkbox"/> Temperature: Approx. 50 F	
<input type="checkbox"/> Wind: Light breeze, Beaufort 2 (4-6 knots)	<input checked="" type="checkbox"/> Water level at Frying Pan Lake:
<input type="checkbox"/> Precipitation: None	<input type="checkbox"/> Observed inflow: Not observed

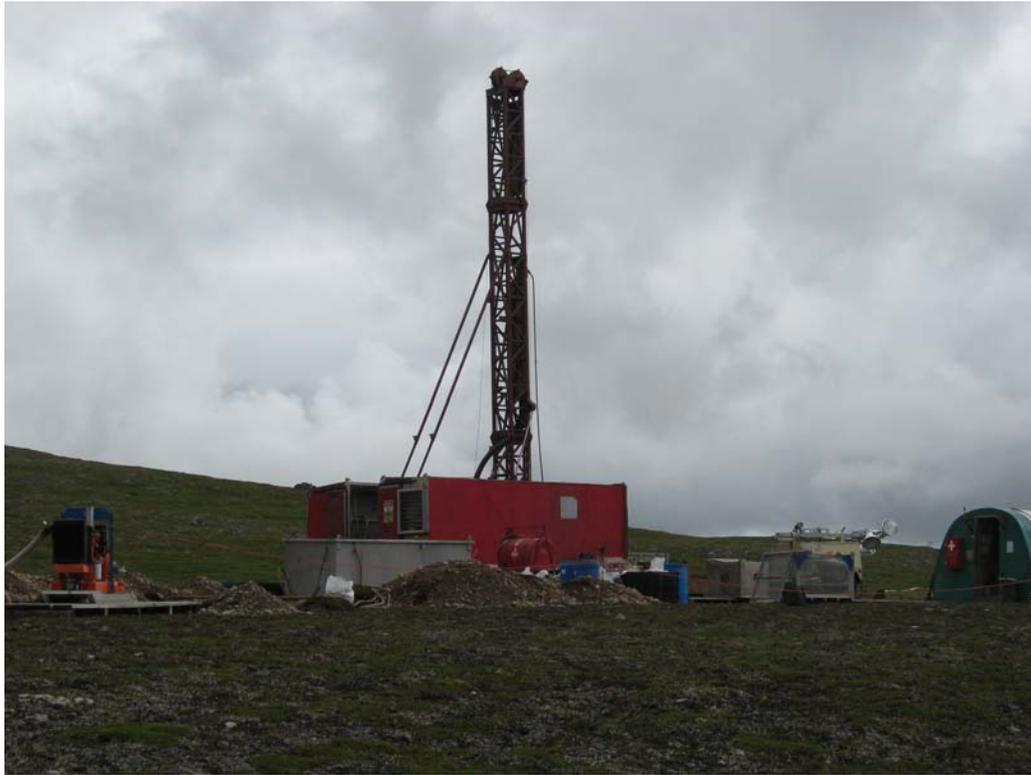
Figure 1. Drill rig 3 on DH 10488.

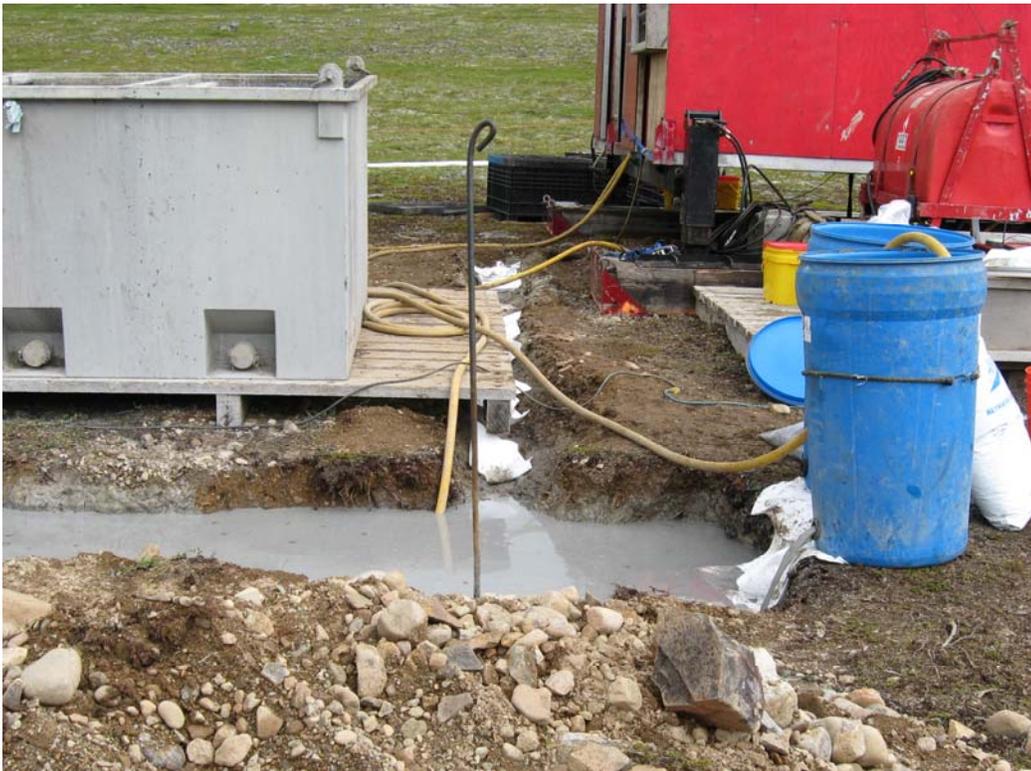
Figure 2. Trench from rig leading to the sump pit. Note white sorbent pads in trench and near blue oil scrubber barrel. Small hydraulic oil spill occurred in the morning on July 8, 2010.

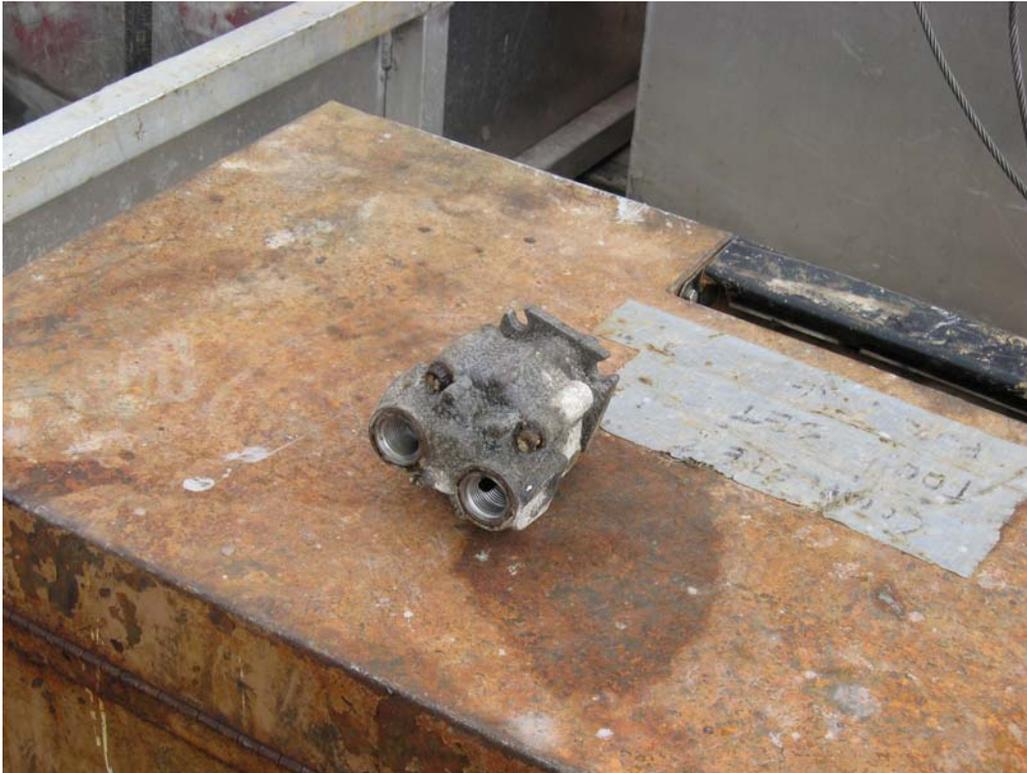
Figure 3. Faulty mud mixer motor was suspected cause of spill.

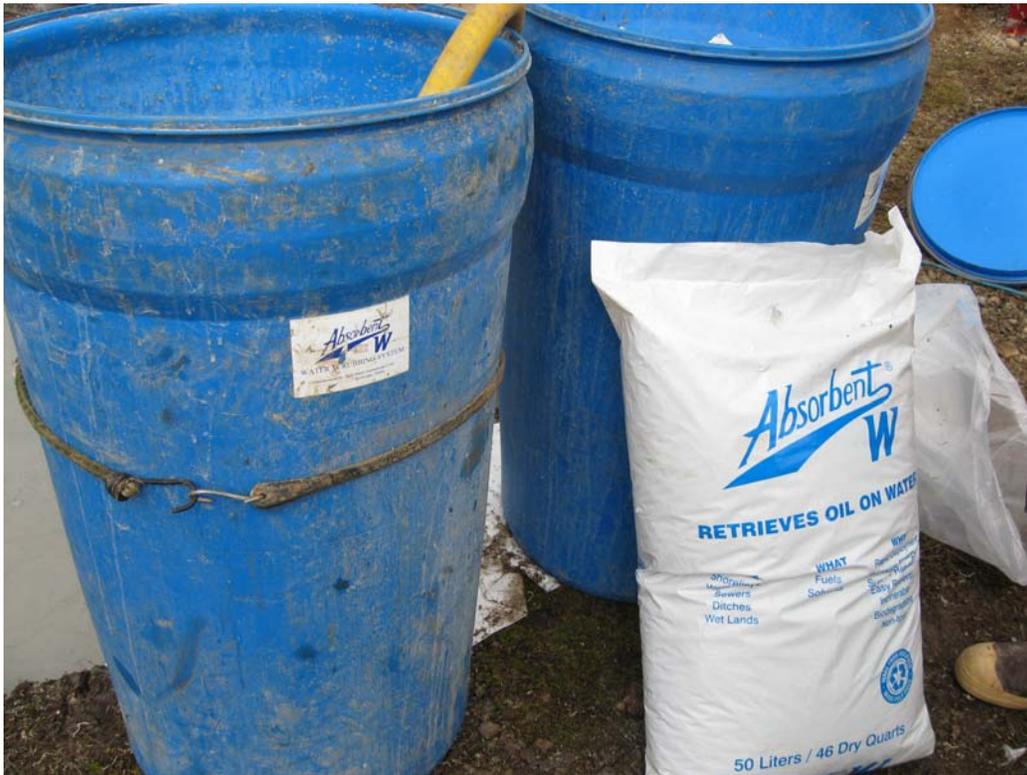
Figure 4. Part of the spill response kit, oil scrubber bin helps remove oil from the water, using the hydrophobic material in the white bag. Water that has been scrubbed goes into the sump pit.

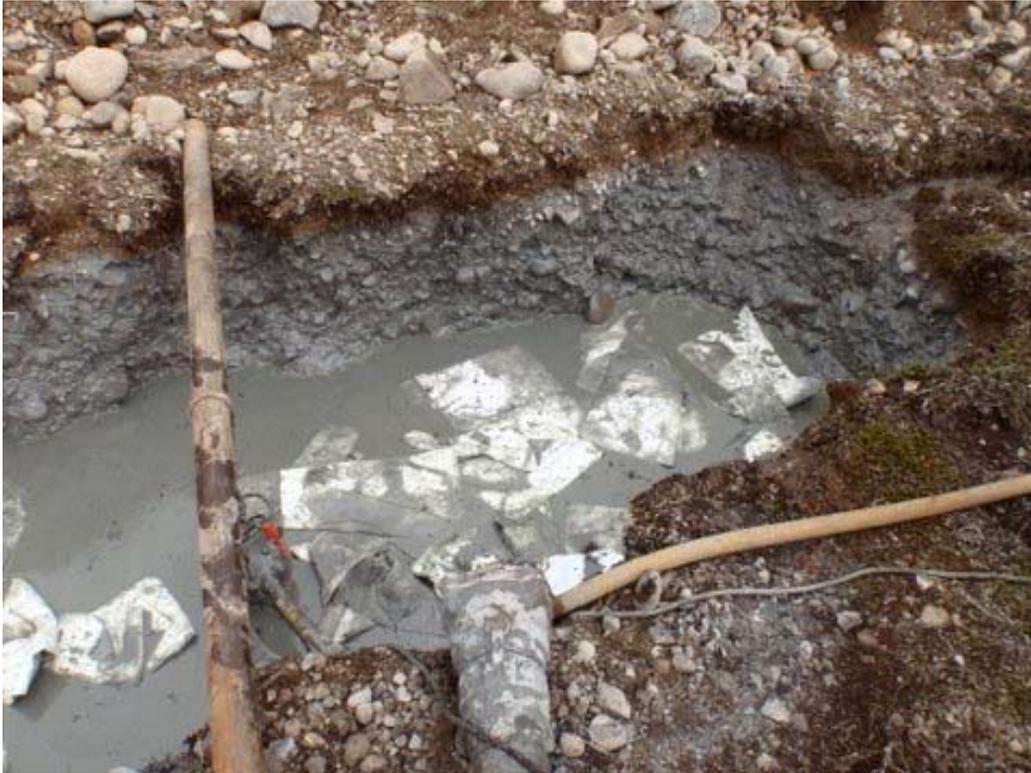
Figure 5. Sorbent pads had been placed in the sump pits to help collect the hydraulic oil.

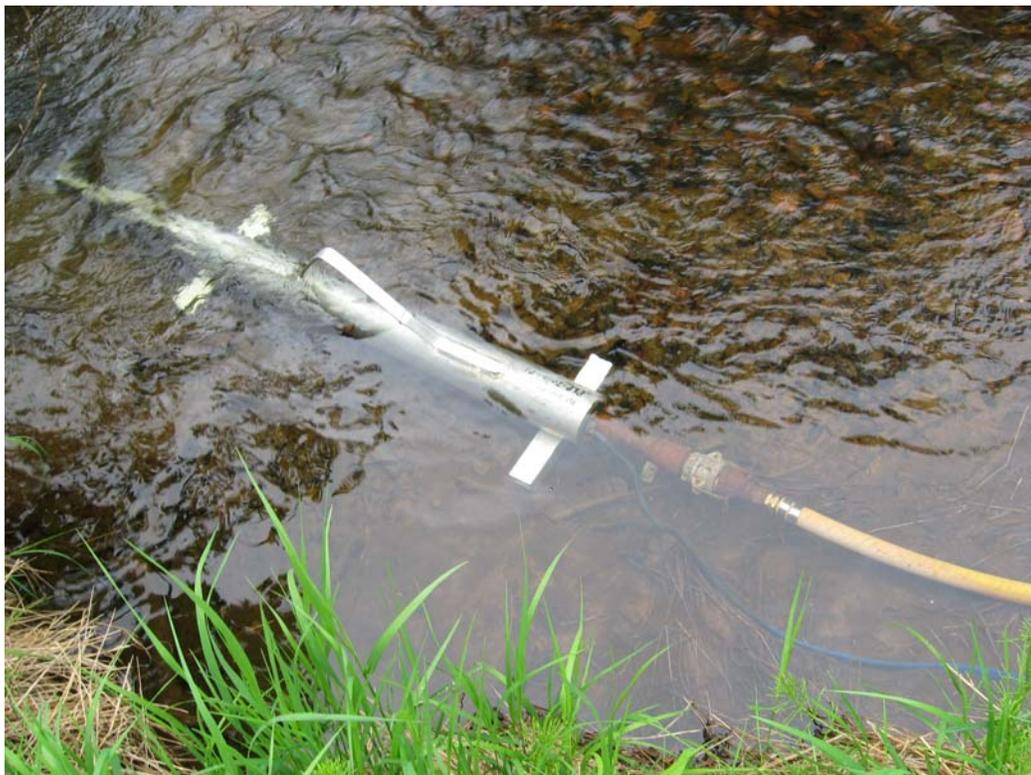
Figure 6. Screened water intake structure.
