## Field Monitoring Report -- Pebble Copper/Gold Exploration Project --

Drill Hole/Site No.: 12547	Date: 7/17/2012
Rig No.: 3	Time: 1:05 pm
Activity: Cementing and casing for water	
<ul style="list-style-type: none"> <li>■ Condition of Drilling Site:</li> </ul>	<ul style="list-style-type: none"> <li>■ Sump Pit (continued):</li> </ul>
<ul style="list-style-type: none"> <li>○ Distance from water body: .2 mi</li> </ul>	<ul style="list-style-type: none"> <li>○ Location and extent of discharged material: About 30' from drill.</li> </ul>
<ul style="list-style-type: none"> <li>○ Location of fuel storage: Just east of mat</li> </ul>	<ul style="list-style-type: none"> <li>○ Topsoil, muck, tundra stockpiled: on liners</li> </ul>
<ul style="list-style-type: none"> <li>○ Sorbent pads present: yes</li> </ul>	<ul style="list-style-type: none"> <li>○ Hose color:</li> </ul>
<ul style="list-style-type: none"> <li>○ Tundra mat: good</li> </ul>	
<ul style="list-style-type: none"> <li>○ Pipe off tundra: yes</li> </ul>	<ul style="list-style-type: none"> <li>■ Drill Water Supply:</li> </ul>

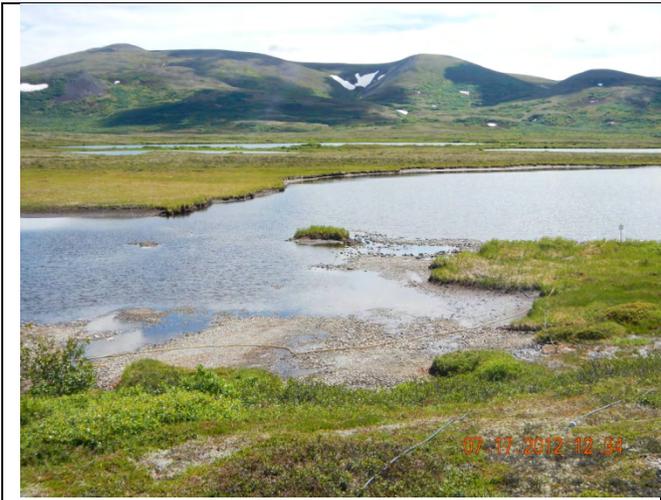
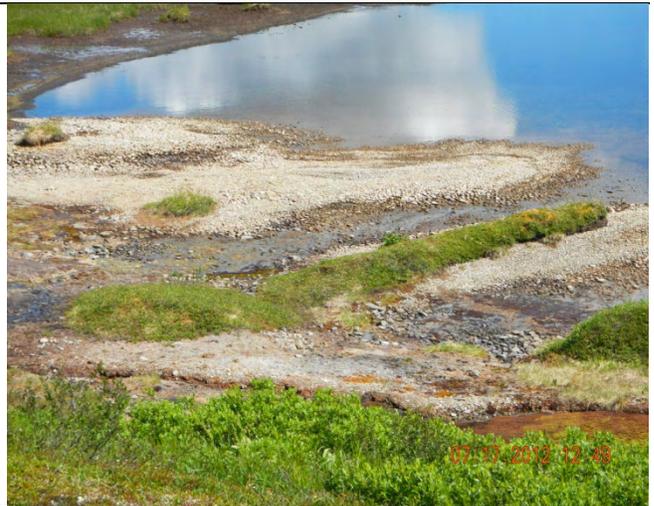
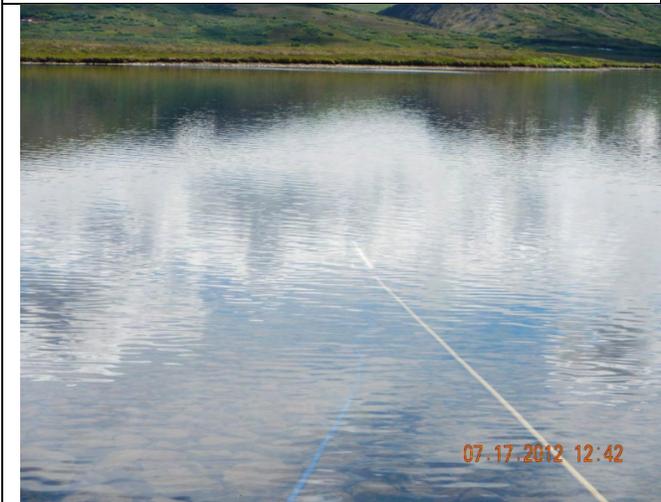
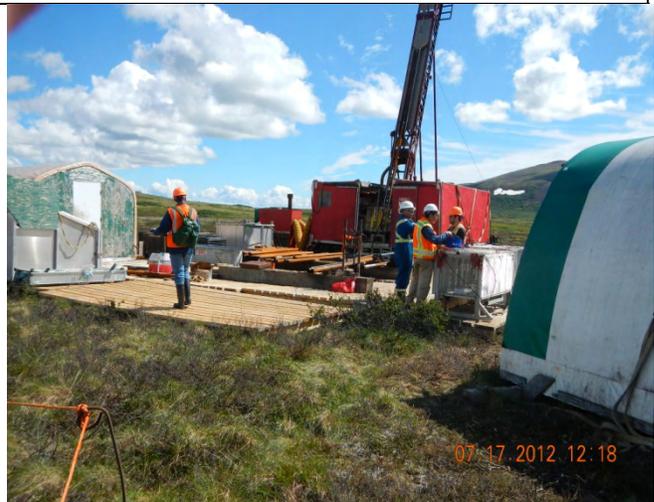
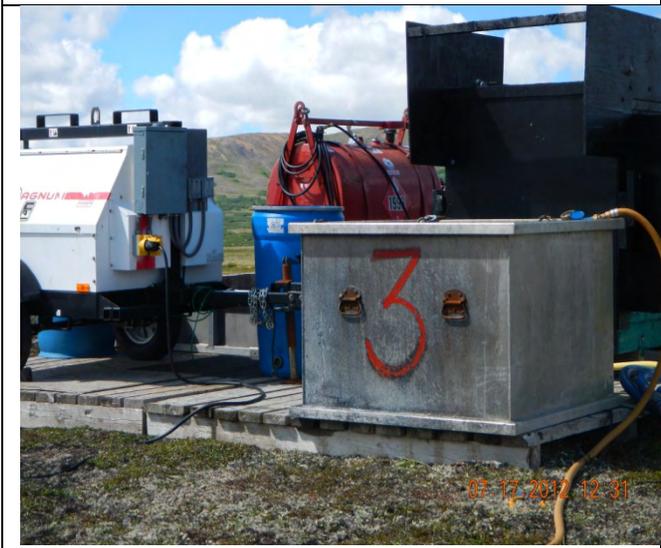
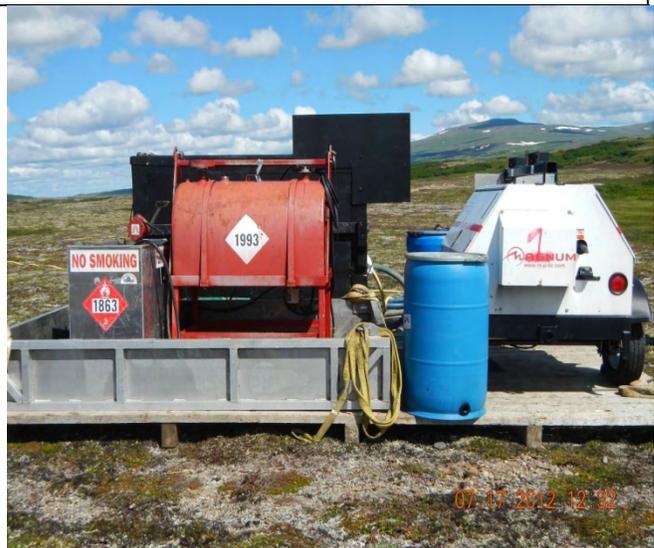
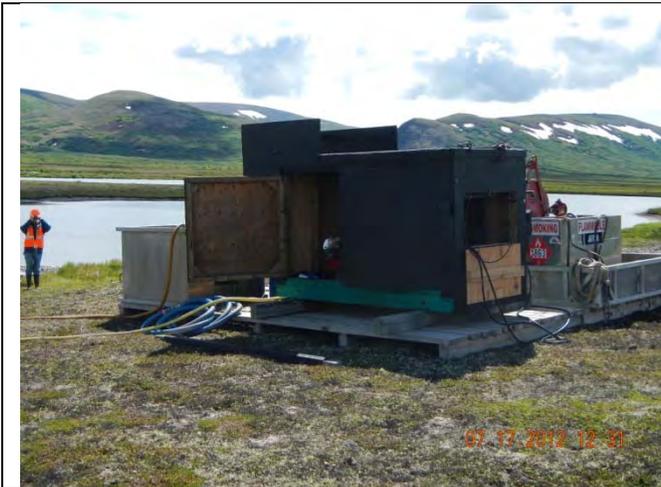
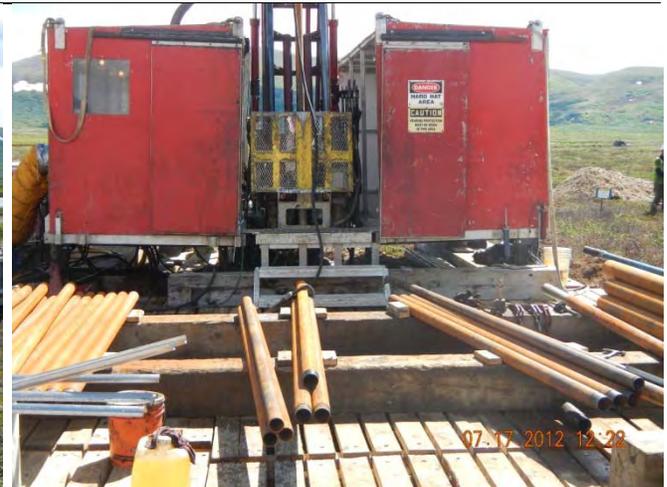
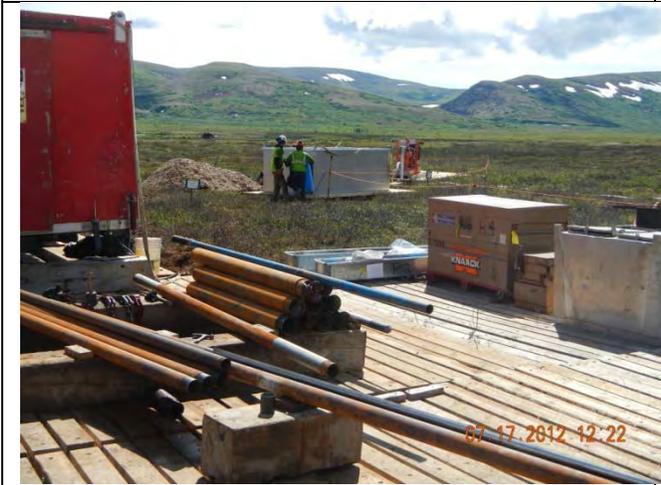
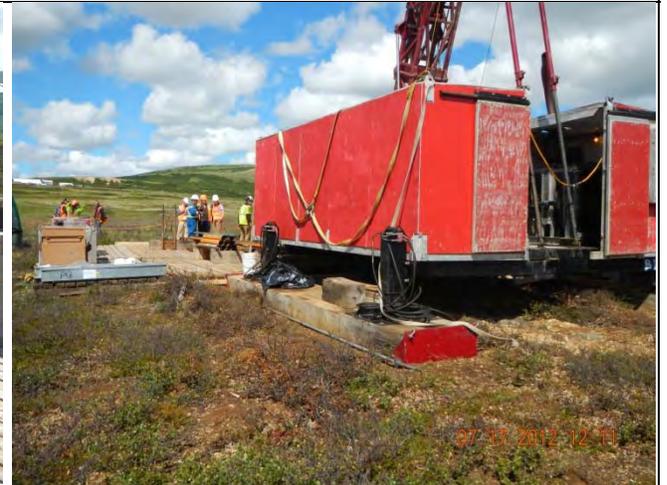
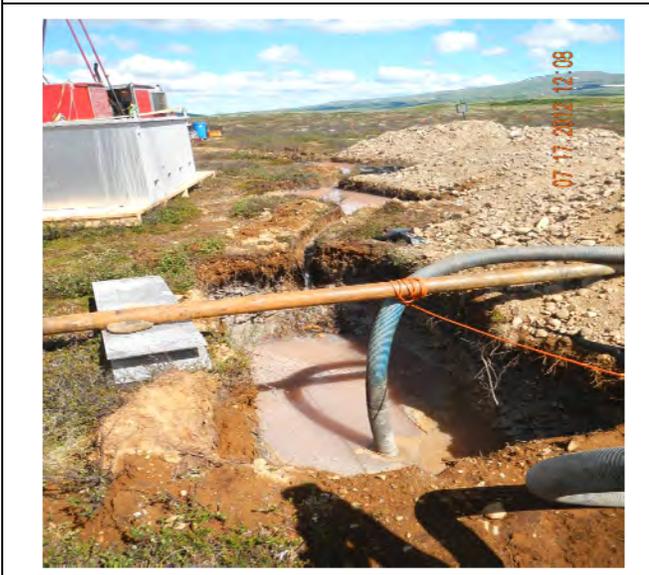
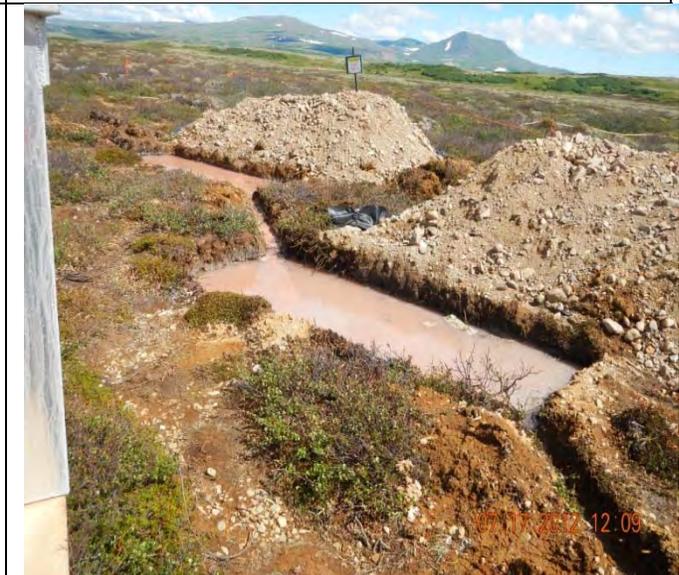
<input type="checkbox"/> Ground Conditions: Dry	
<input checked="" type="checkbox"/> Comments: Ear plug in sump, one handful of Linseed soap lubricant on ground a few feet away from mat. Drill mud not present, water in sump.	
<input checked="" type="checkbox"/> Recommendations: Better housekeeping needed on this site.	
<input checked="" type="checkbox"/> Actions Needed: See above recommendations.
