Field Monitoring Report -- Pebble Copper/Gold Exploration Project --

Personnel: Rick Fredericksen (DNR/DMLW)	Inspection Date: 23 July 2008
Jim Vohden (DNR/DMLW)	Site Contact: Gernot Wober
Travis Gingerich (DNR/DMLW)	APMA #: A086118
■ Inspection Type: ○ Complete: Drill rigs 1, 2, 3, & 4 were visited, several abandoned drill sites, one piezometer installation, and the Westbay installation ○ Partial: ○ Follow-up: ○ Response to Public Complaint:	■ Wildlife Observed: ○ Bear: ○ Caribou: ○ Moose: ○ Waterfowl: ○ Fish: ○ Other: marmot, red fox, robin
■ Weather Conditions: ○ Temperature: 50-60 degrees F ○ Wind: light to moderate ○ Precipitation: some light drizzle ○ Visibility: 2-10 miles ○ Sky Conditions: cloudy, some sun ○ Ground Conditions: clear, damp	■ Water level at Frying Pan Lake: ○ Observed inflow: not observed ○ Observed outflow: not observed
<p>Comments: Overall the drill rigs were clean and orderly. Fuel spill containment measures were in place. Containment basins generally clean and dry. All drilling operations appeared to be in compliance with associated water use and withdrawal permits. Inspected long term geochemical barrel tests in place near medical camp, as well as piezom

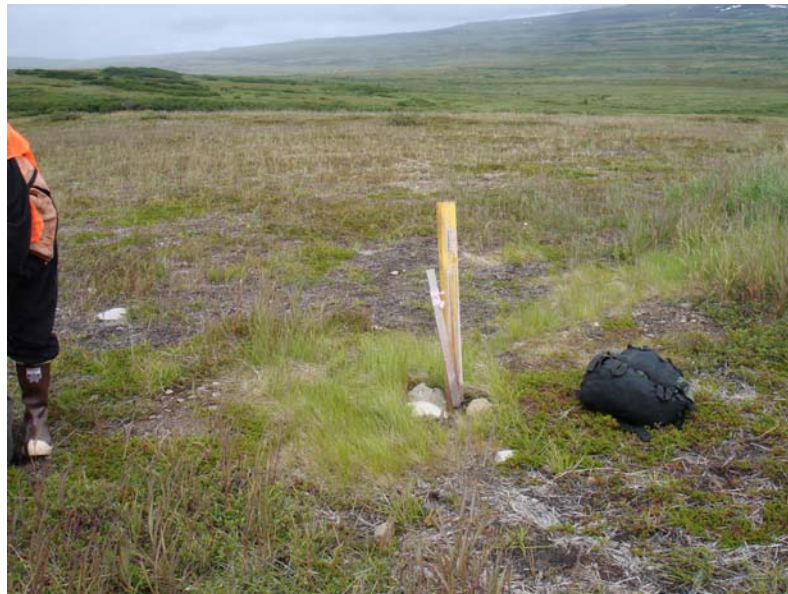
Abandoned Drill Hole/Site No.: 5316

■ Comments/General impression: reclaimed nicely, dry, no pipe visible.

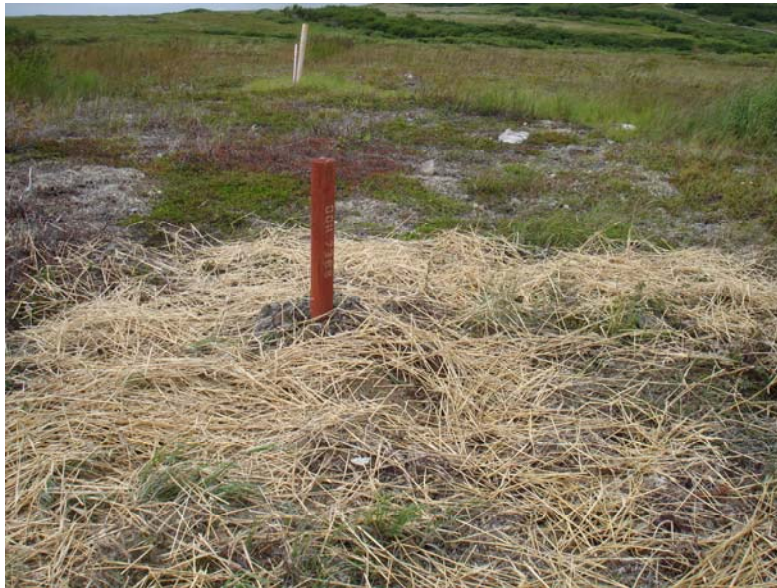
Abandoned Drill Hole/Site No.: 7388

■ Site revegetated: yes, fresh straw on site

■ Comments/General impression: appears to have been reseeded recently; no pipe visible.

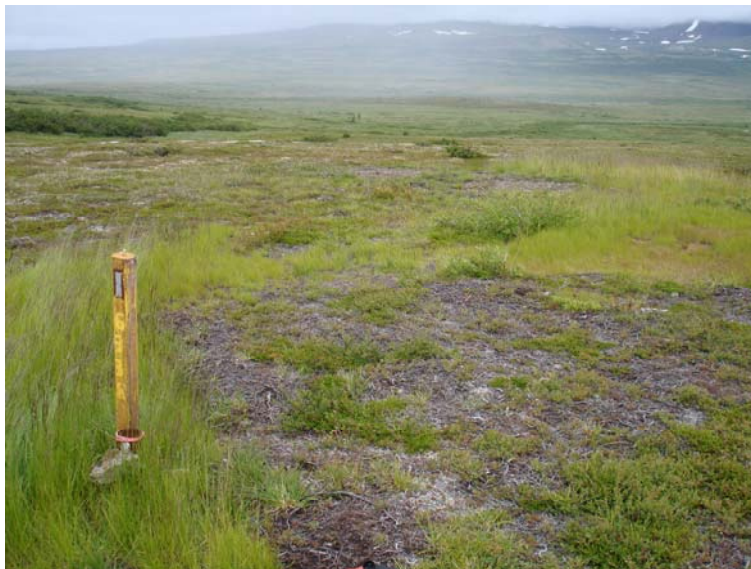
Abandoned Drill Hole/Site No.: 6338

■ Standing pipe: yes, sticks up 8"

■ Site revegetated: yes, good growth around a very clean site, no sign of disturbance

■ Comments/General impression: nicely reclaimed.

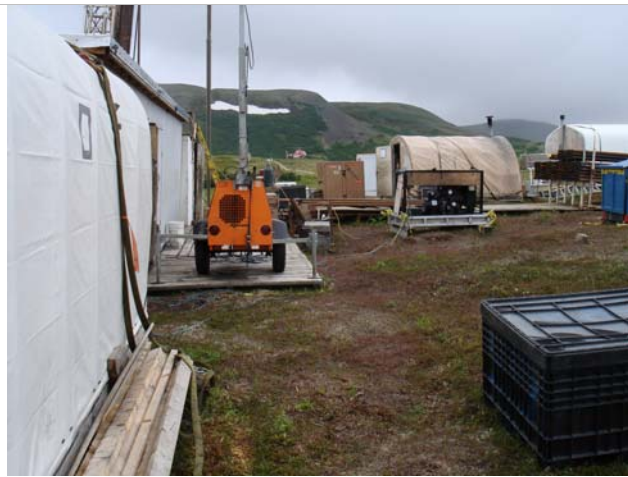
Figure 1. Drill Rig 1.

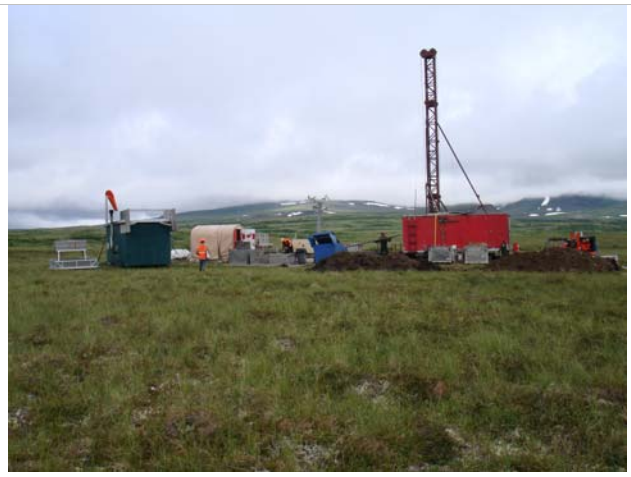
Figure 2. Drill rig 2.

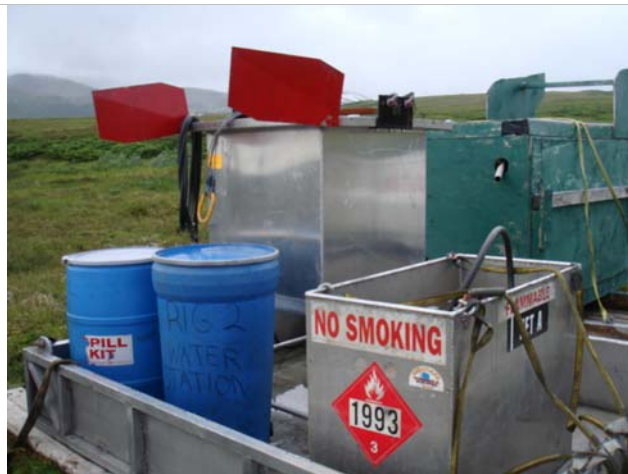
Figure 3. Fuel storage at drill rig 2.

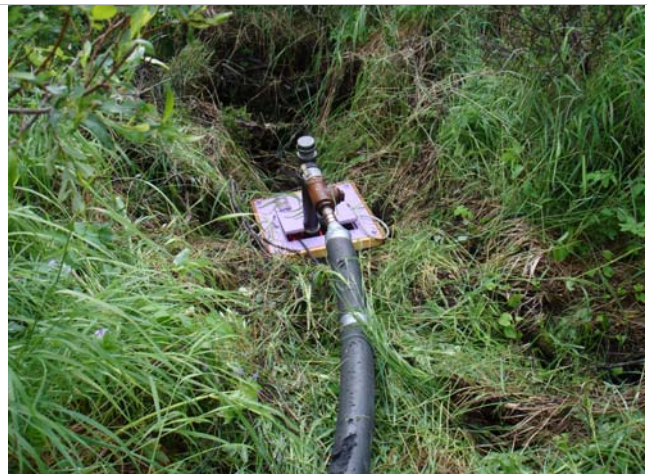
Figure 4. Water intake for drill rig 2.

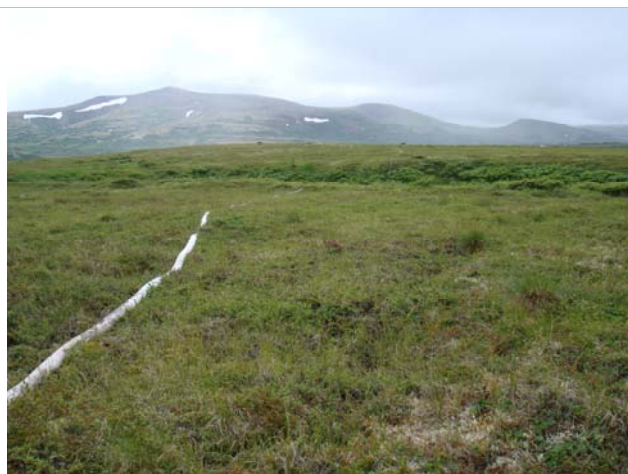
Figure 5. Drill discharge line from drill rig 2.

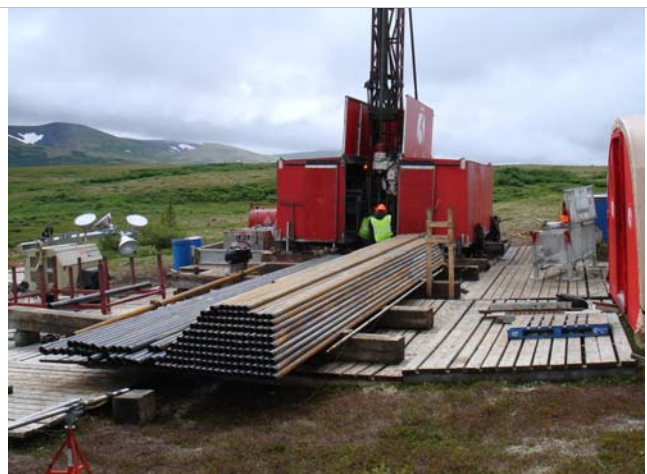
Figure 6. Drill rig 3.

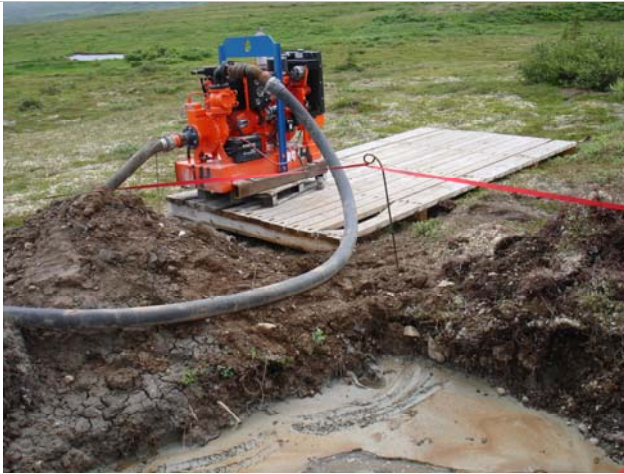
Figure 7. Godwin pump for drilling fluids at drill rig 3.

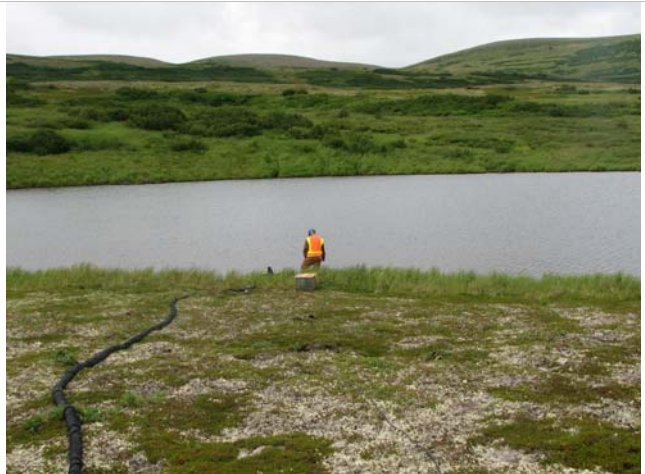
Figure 8. Water supply for drill rig 3.

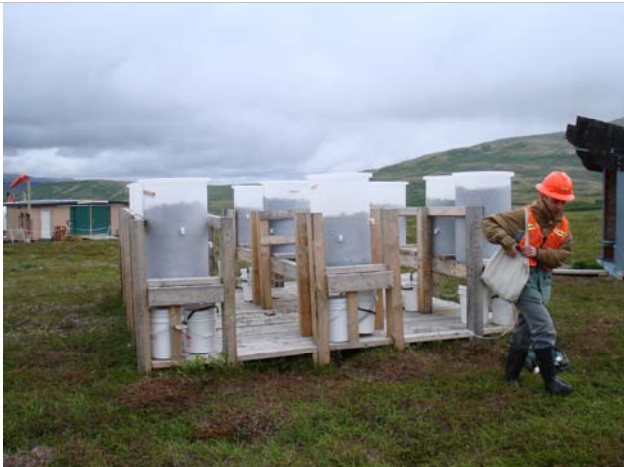
Figure 9. Long-term geochemical barrel tests.

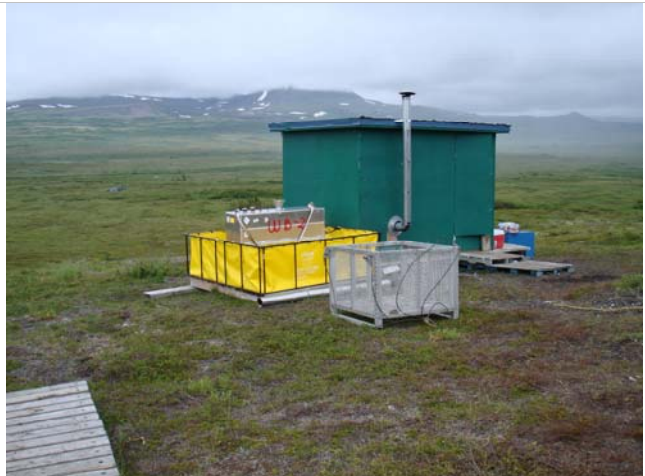
Figure 10. Westbay multi-level sampling well installation.
