Field Monitoring Report -- Pebble Copper/Gold Exploration Project --

Personnel:	Inspection Date: August 19, 2009
Rick Fredericksen, Allan Nakanishi,	Site Contact: Gernot Wober
Travis Gingerich, Ruth Hamilton Heese	APMA #: A096118
	■ Wildlife Observed:
■ Inspection Type:	○ Bear: none observed
○ Complete: Drill rig #2, #3, and #4; abandoned drill sites, the staging area (camp); Big Wiggly fuel depot	○ Caribou: approx. 6 one mile NE of Frying Pan Lake
○ Partial:	○ Moose: none observed
○ Follow-up:	○ Waterfowl: two swans on edge of Big Wiggly Lake.
○ Response to Public Complaint:	○ Fish: none observed
	○ Other: ground squirrels
■ Weather Conditions:	
○ Temperature: 55 degrees F	■ Water level at Frying Pan Lake:
○ Wind: 2-3 knots	○ Observed inflow: ordinary high water
○ Precipitation: none	○ Observed outflow: ordinary high water
○ Visibility: 10-15 miles	
○ Sky Conditions: broken overcast (4800')	■ Water level at Big Wiggly Lake:
○ Ground Conditions: dry to wet	○ Ordinary high water

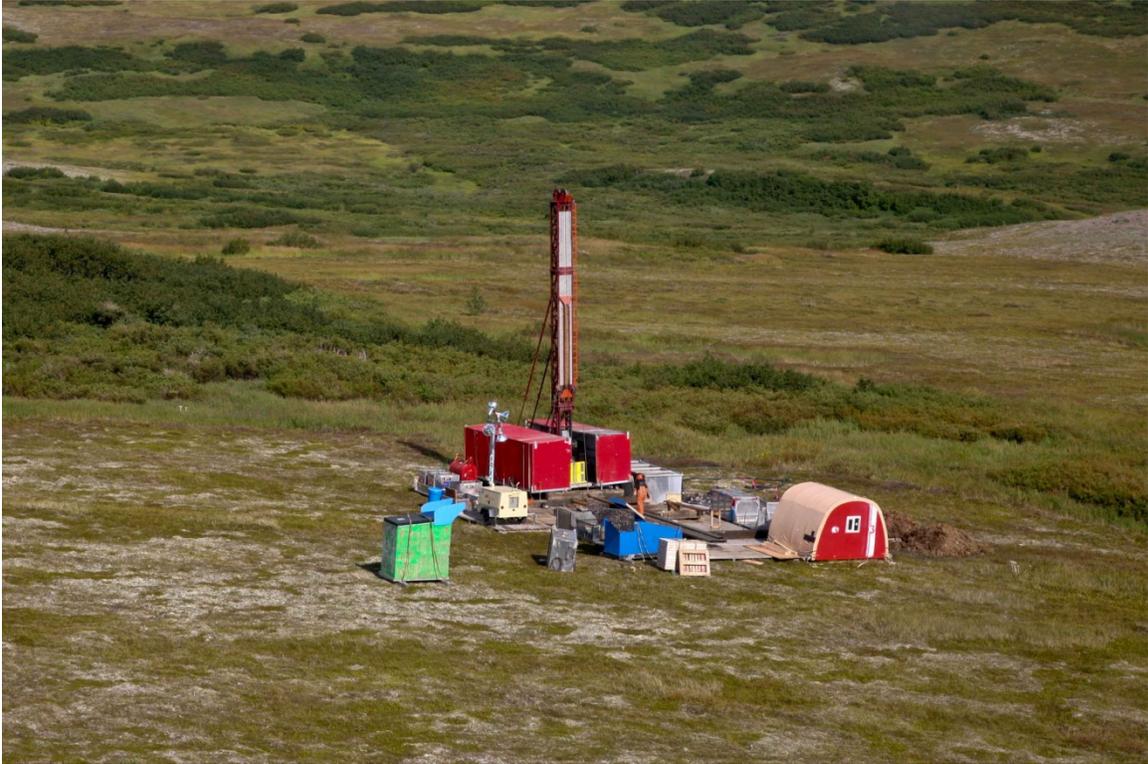
Drill Rig #2- Drill Hole Site #9454.

Drill Hole/Site No.: 9454	Rig No.: 2
Activity: Exploration drilling - coring	Date: 8-19-09
■ Condition of Drilling Site: good <ul style="list-style-type: none"> ○ Distance from waterbody: ~100 feet from small drainage ○ Location of fuel storage: onsite with secondary containment ○ Sorbent pads present: yes ○ Tundra mat: yes ○ Pipe off tundra: yes ○ Litter: none ○ Trash containment: yes ○ Sanitary facilities: yes ○ Any spills or staining: no ○ General impression: good 	■ Sump Pit (continued): <ul style="list-style-type: none"> ○ Location and extent of discharged material: Infiltration at excavated sump. ○ Topsoil, muck, tundra stockpiled: 5 cubic yards ○ Location of secondary sump pit: N/A ○ Hose color: none
■ Drilling Activity: yes <ul style="list-style-type: none"> ○ Drill additives in use: yes ○ Water recirculation: yes ○ Water discharged: yes ○ Artesian zone encountered: no 	■ Drill Water Supply: <ul style="list-style-type: none"> ○ Source: small stream ○ Location: ~700 ft. north ○ Adequate water flow and depth for fish passage in streams: yes ○ Evidence of significant impacts to riparian vegetation or stream banks: no ○ Relative water level: moderate to high ○ General impression of water body, i.e. clear, turbid, tannic: clear ○ Intake structure: yes ○ Structure clear of debris: yes ○ Mesh size: 1mm x 12mm ○ Submerged: yes ○ Pump location to source: < 50 feet

■ Sump Pit: <ul style="list-style-type: none"> ○ Location: adjacent to rig ○ Discharge trench: yes ○ Dimensions of pit: 16' x 5' ○ In use: yes 	<ul style="list-style-type: none"> ○ Catch basin for fuel supply: yes ○ Sorbent pads: yes (2 types) ○ Hose color: yellow

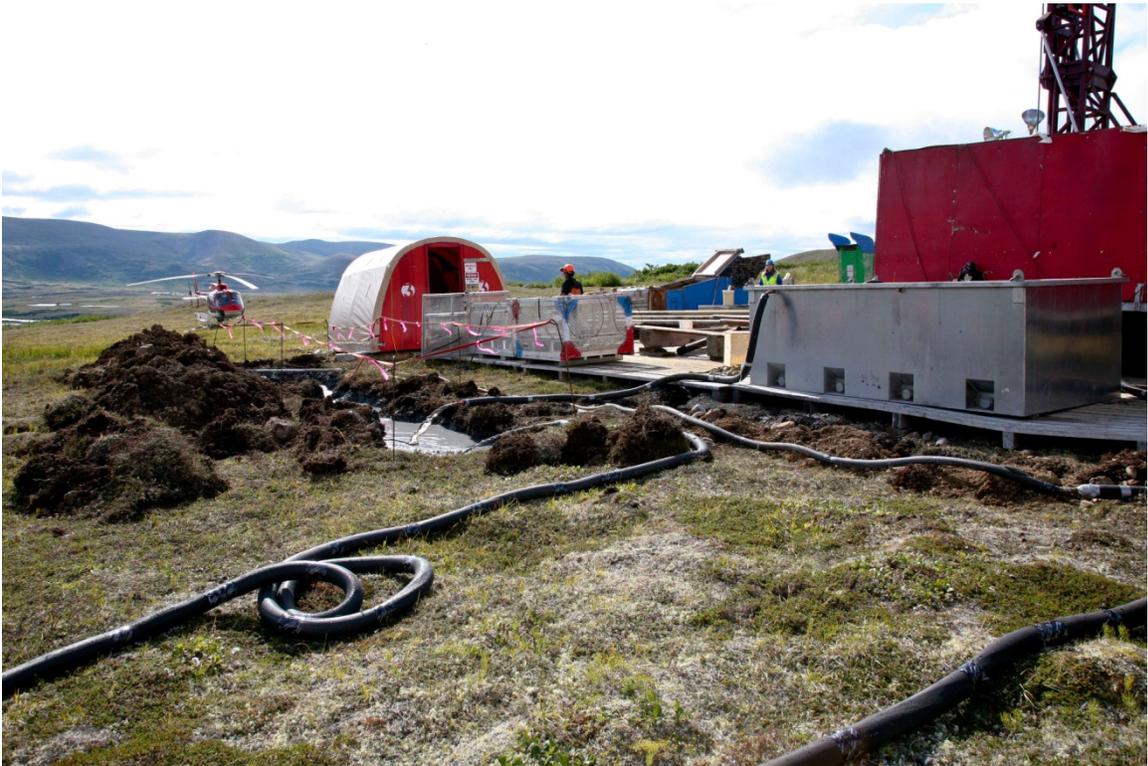
Drill Rig #2- Drill Hole Site #9454. Sump near drill.

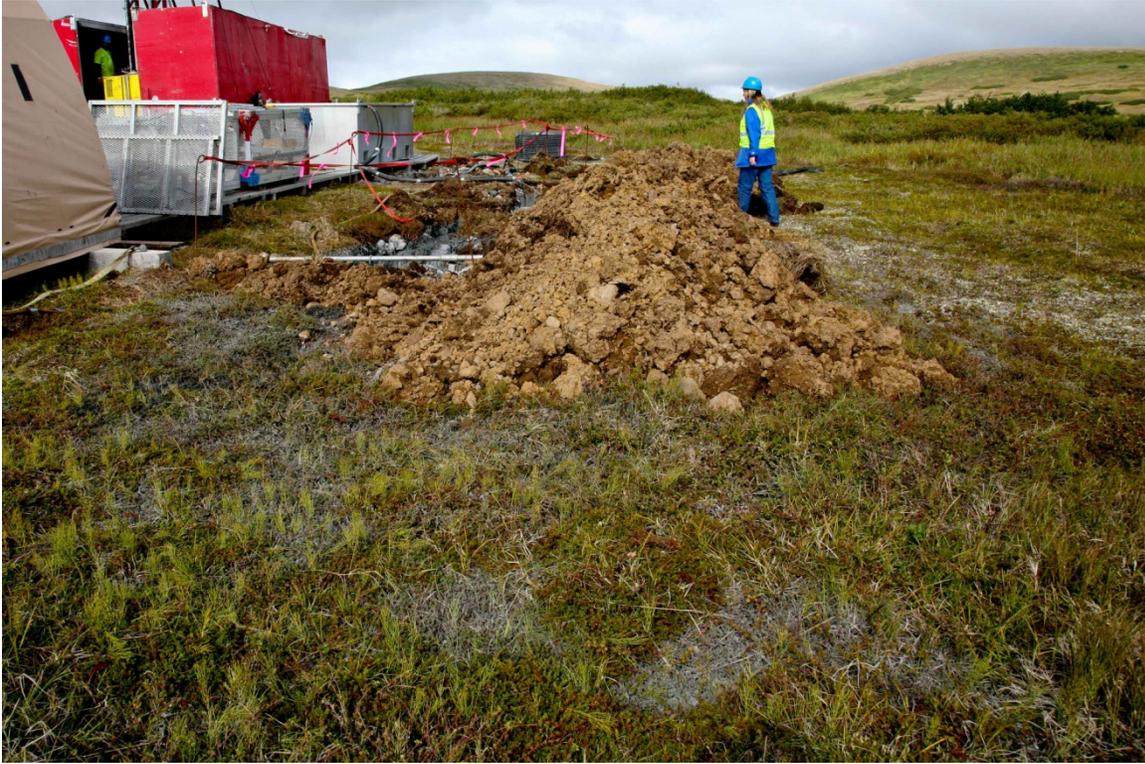
Drill Rig #2- Drill Hole Site #9454. Sump near drill.

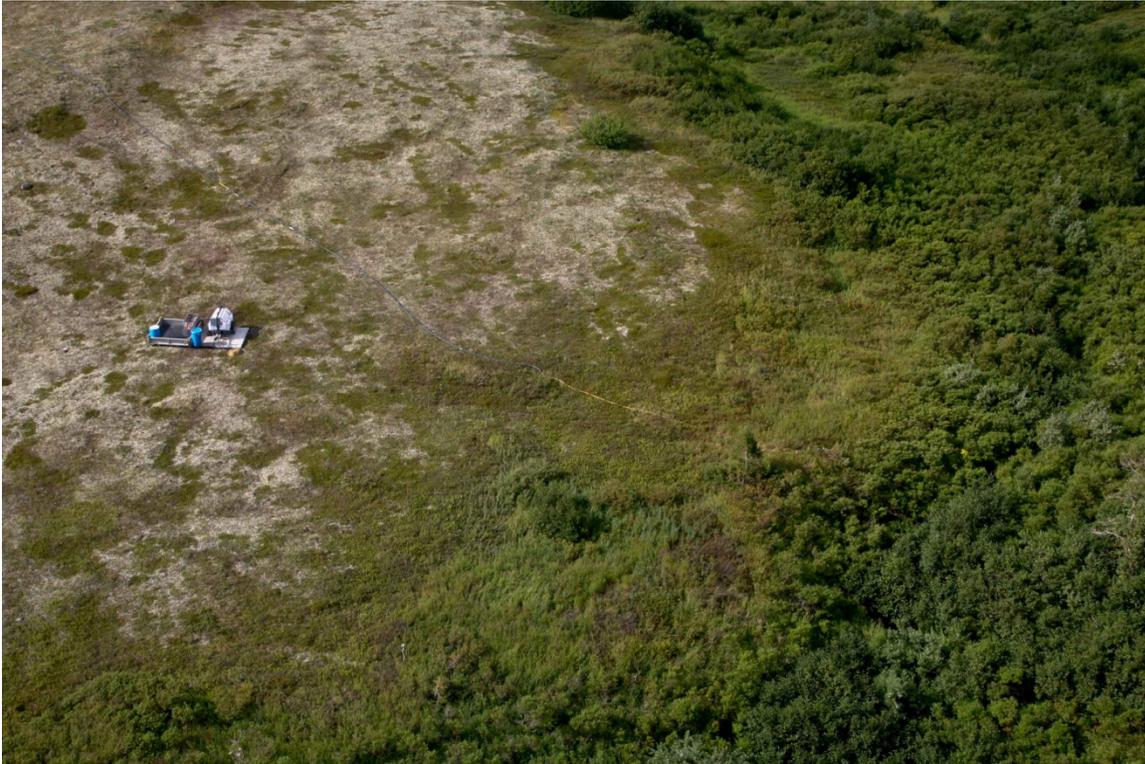
Drill Rig #2- Drill Hole Site #9454. Water source, generator, and pump.

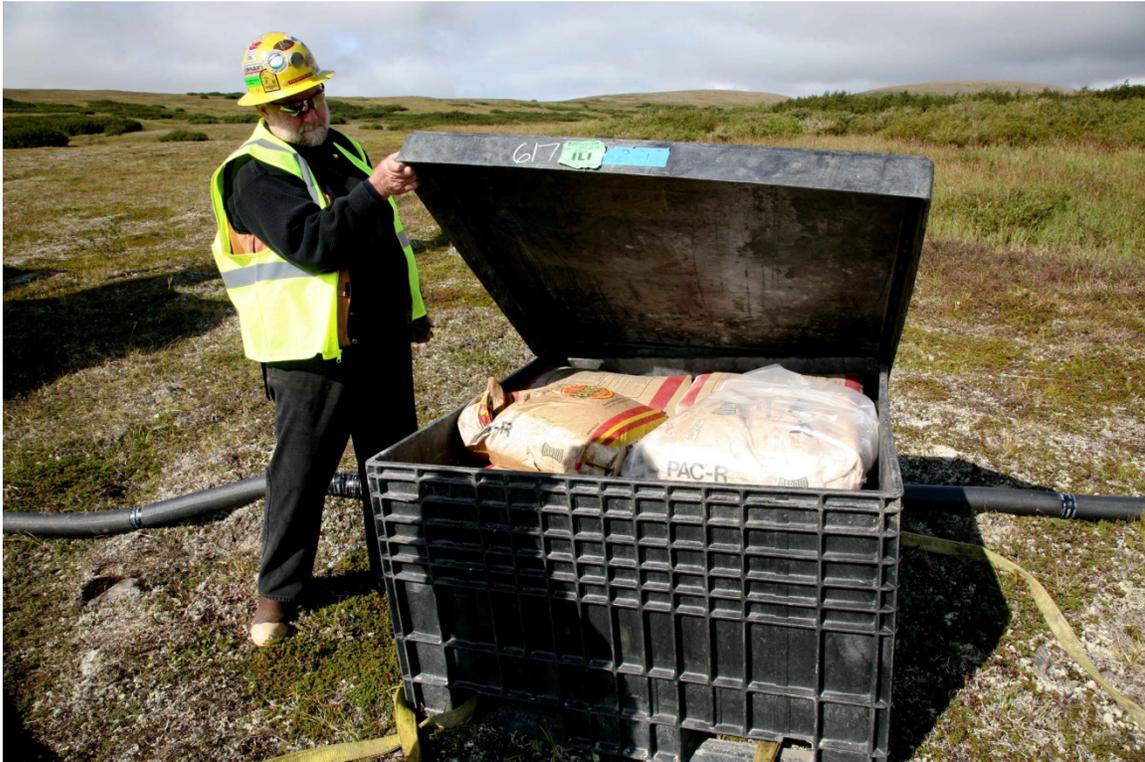
Drill Rig #2- Drill Hole Site #9454. "Quik Gel" drilling mud stored in container.

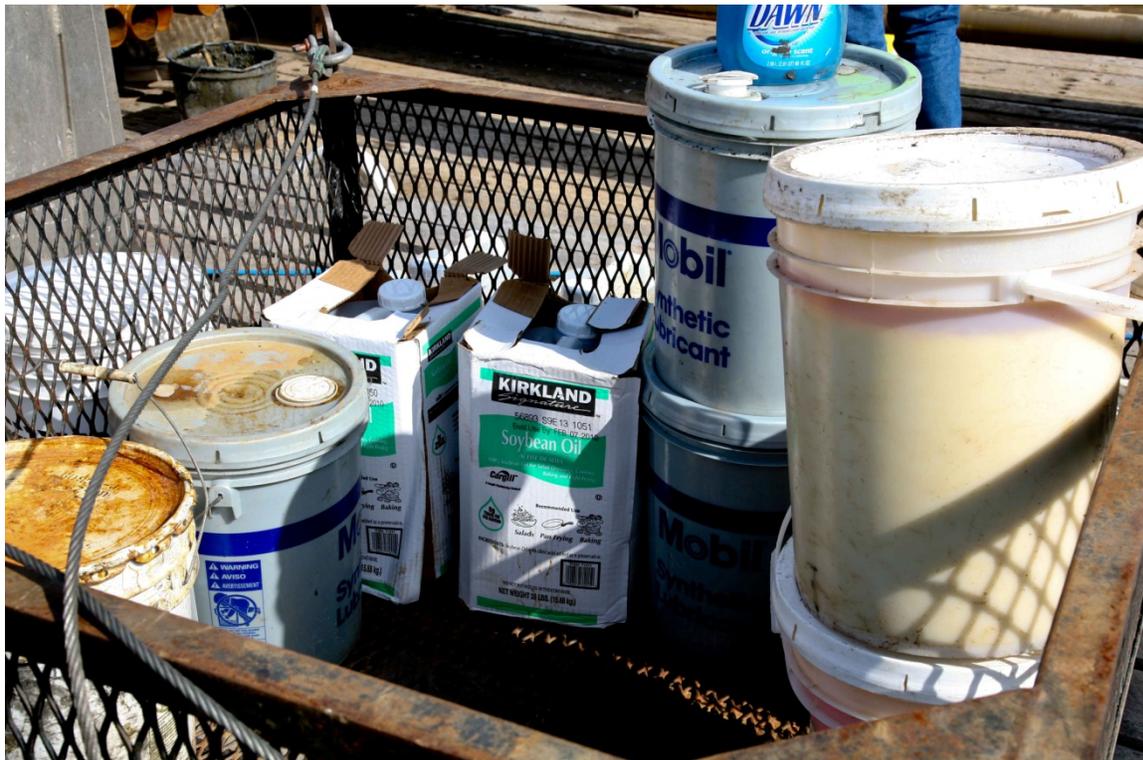
Drill Rig #2- Drill Hole Site #9454. Soybean oil, lubricant, and "Purevis" in containment.

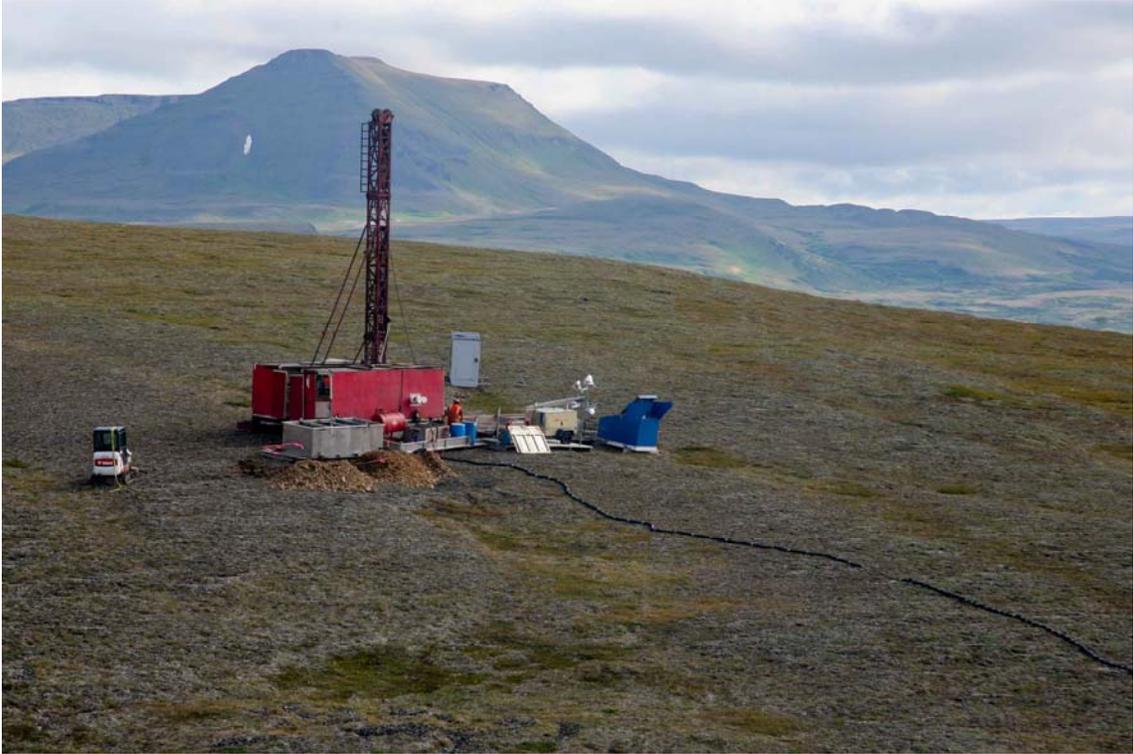
Drill Rig #3 - Drill Hole Site #9452.

Drill Hole/Site No.: 9452	Rig No.: 3
Activity: Exploration drilling - coring	Date: 8-19-09
<ul style="list-style-type: none"> ■ Condition of Drilling Site: good <ul style="list-style-type: none"> ○ Distance from waterbody: >1,000 feet ○ Location of fuel storage: onsite with secondary containment ○ Sorbent pads present: yes ○ Tundra mat: yes ○ Pipe off tundra: yes ○ Litter: none ○ Trash containment: yes ○ Sanitary facilities: yes ○ Any spills or staining: no ○ General impression: good 	<ul style="list-style-type: none"> ■ Sump Pit (continued): <ul style="list-style-type: none"> ○ Location and extent of discharged material: Infiltration at excavated sump. ○ Topsoil, muck, tundra stockpiled: 4 cubic yards ○ Location of secondary sump pit: N/A ○ Hose color: none
	<ul style="list-style-type: none"> ■ Drill Water Supply: <ul style="list-style-type: none"> ○ Source: Small lake/pond ○ Location: ~500 ft. southwest ○ Adequate water flow and depth for fish passage in streams: NA ○ Evidence of significant impacts to riparian vegetation or stream banks: no ○ Relative water level: moderate to high

<ul style="list-style-type: none"> ■ Drilling Activity: rig down awaiting parts <ul style="list-style-type: none"> ○ Drill additives in use: yes ○ Water recirculation: yes ○ Water discharged: yes ○ Artesian zone encountered: no 	<ul style="list-style-type: none"> ○ General impression of water body, i.e. clear, turbid, tannic: clear ○ Intake structure: yes ○ Structure clear of debris: yes ○ Mesh size: 1mm x 12mm ○ Submerged: yes ○ Pump location to source: 50 feet
<ul style="list-style-type: none"> ■ Sump Pit: <ul style="list-style-type: none"> ○ Location: adjacent to rig ○ Discharge trench: yes ○ Dimensions of pit: 17' x 4' ○ In use: yes 	<ul style="list-style-type: none"> ○ Catch basin for fuel supply: yes ○ Sorbent pads: yes (2 types) ○ Hose color: black

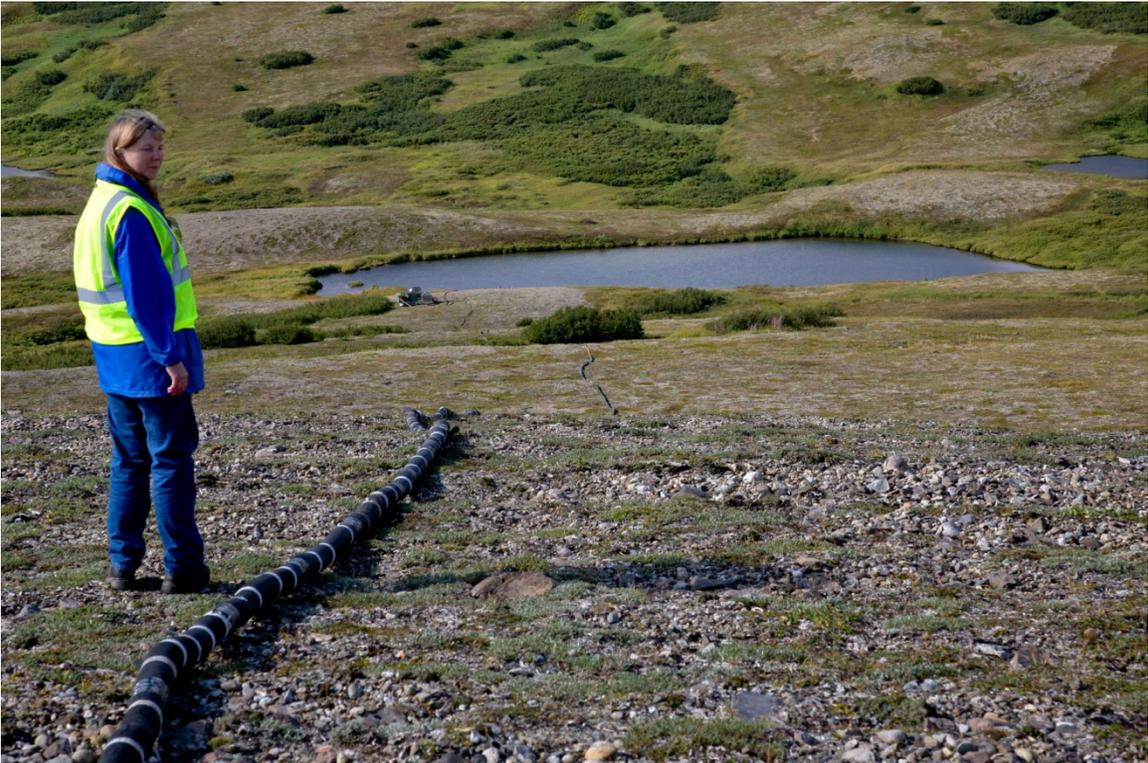
Drill Rig #3 - Drill Hole Site #9452. Insulated pipe leading to water source in background.

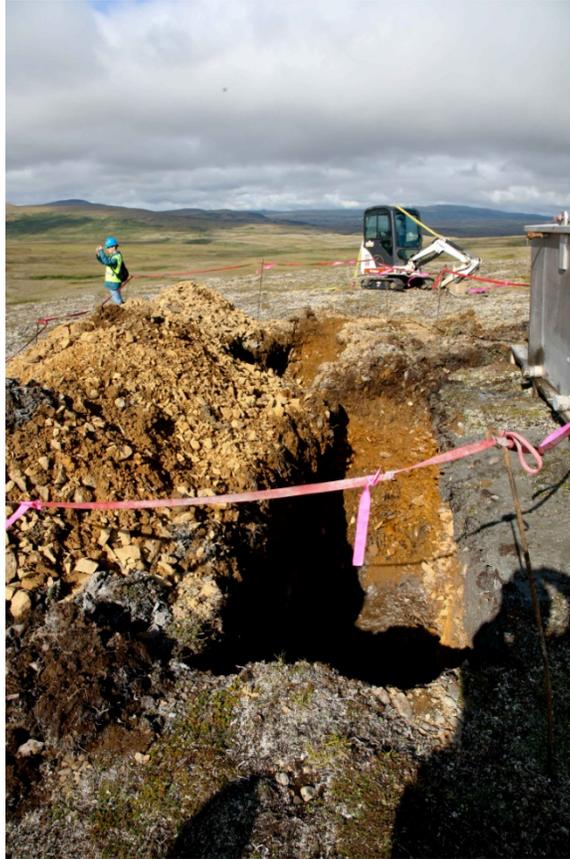
Drill Rig #3 - Drill Hole Site #9452. Sump excavation near drill rig.

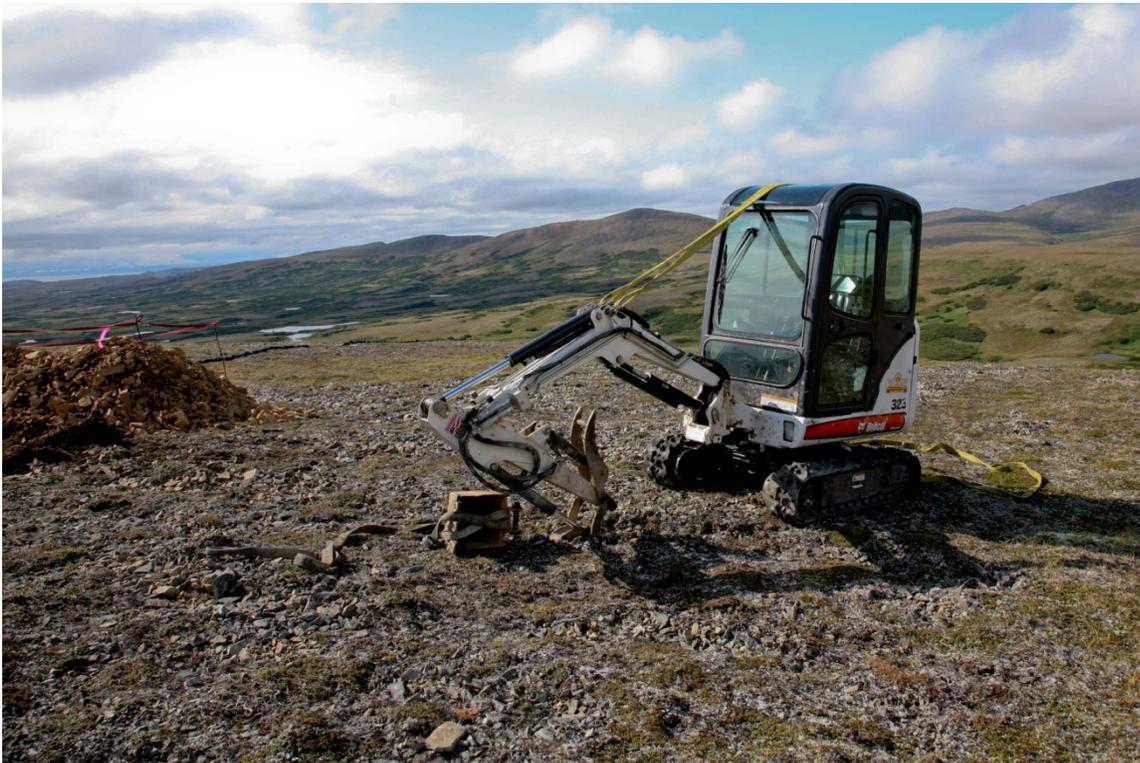
Drill Rig #3 - Drill Hole Site #9452. Excavator.

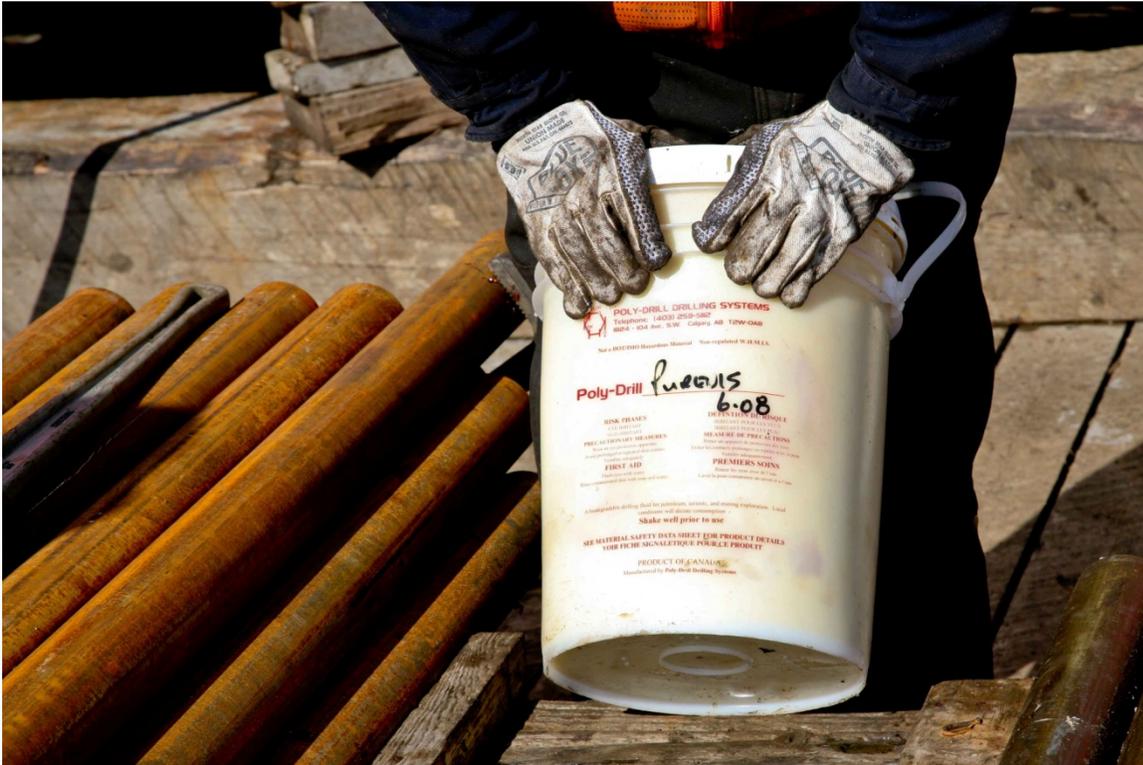
Drill Rig #3 - Drill Hole Site #9452. Poly Drill "Purevis" drilling fluid.

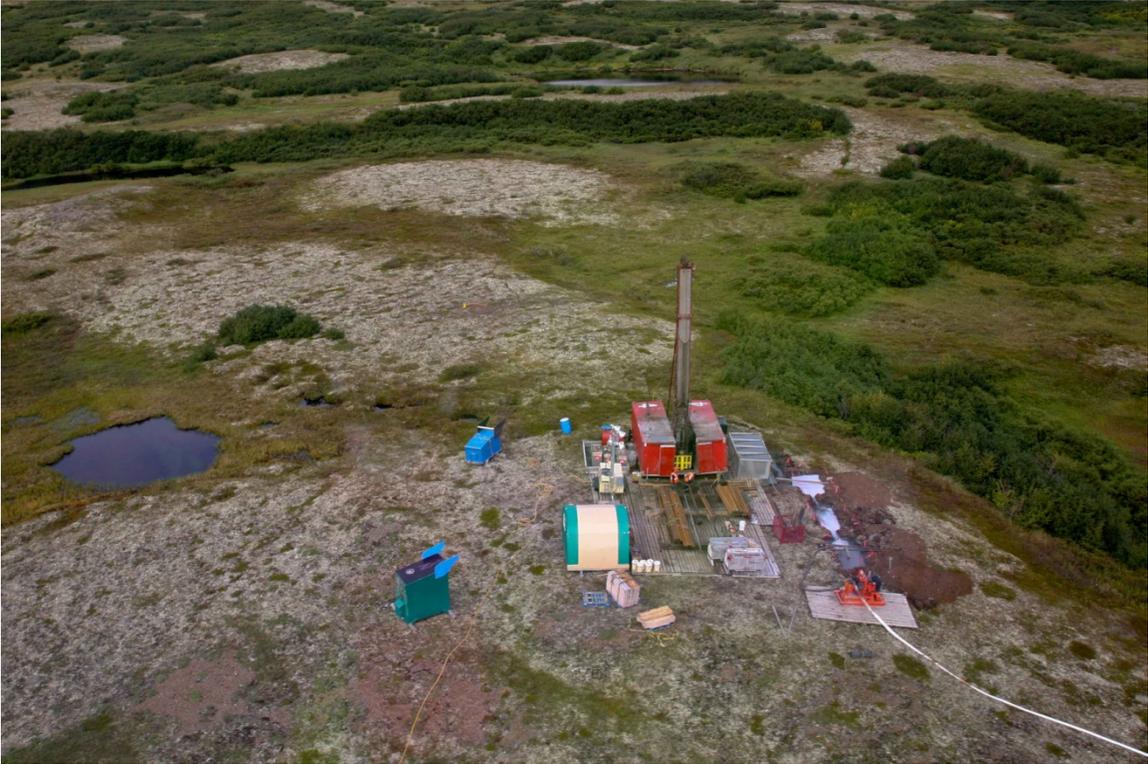
Drill Rig #4- Drill Hole Site #9453.

Drill Hole/Site No.: 9453	Rig No.: 4
Activity: Exploration drilling - coring	Date: 8-19-09
<ul style="list-style-type: none"> ■ Condition of Drilling Site: good <ul style="list-style-type: none"> ○ Distance from waterbody: <100 feet ○ Location of fuel storage: onsite with secondary containment ○ Sorbent pads present: yes ○ Tundra mat: yes ○ Pipe off tundra: yes ○ Litter: none ○ Trash containment: yes ○ Sanitary facilities: yes ○ Any spills or staining: no ○ General impression: good 	<ul style="list-style-type: none"> ■ Sump Pit (continued): <ul style="list-style-type: none"> ○ Location and extent of discharged material: Infiltration at excavated sump. Land application for sump overflow 400' downhill on land. ○ Topsoil, muck, tundra stockpiled: 6 cubic yards ○ Location of secondary sump pit: N/A ○ Hose color: none
<ul style="list-style-type: none"> ■ Drilling Activity: yes <ul style="list-style-type: none"> ○ Drill additives in use: yes ○ Water recirculation: yes ○ Water discharged: yes ○ Artesian zone encountered: no 	<ul style="list-style-type: none"> ■ Drill Water Supply: <ul style="list-style-type: none"> ○ Stream, lake, kettle pond: Small Lake ○ Location: ~300 ft. southeast ○ Adequate water flow and depth for fish passage in streams: NA ○ Evidence of significant impacts to riparian vegetation or stream banks: no ○ Relative water level: moderate to high ○ General impression of water body, i.e. clear, turbid, tannic: clear ○ Intake structure: yes ○ Structure clear of debris: yes ○ Mesh size: 1mm x 12mm ○ Submerged: yes ○ Pump location to source: 25 feet

<ul style="list-style-type: none"> ■ Sump Pit: <ul style="list-style-type: none"> ○ Location: adjacent to rig ○ Discharge trench: yes ○ Dimensions of pit: 20' x 5' ○ In use: yes 	<ul style="list-style-type: none"> ○ Catch basin for fuel supply: yes ○ Sorbent pads: yes (2 types) ○ Hose color: brown

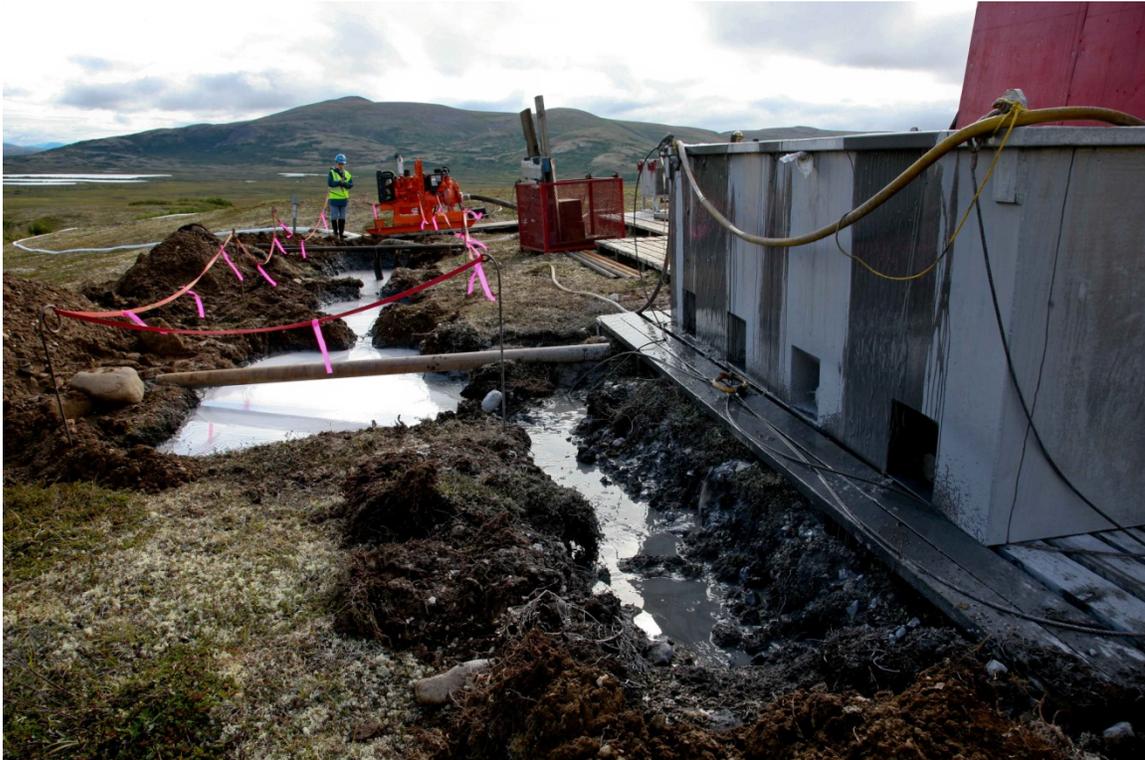
Drill Rig #4- Drill Hole Site #9453. Sump adjacent to drill.

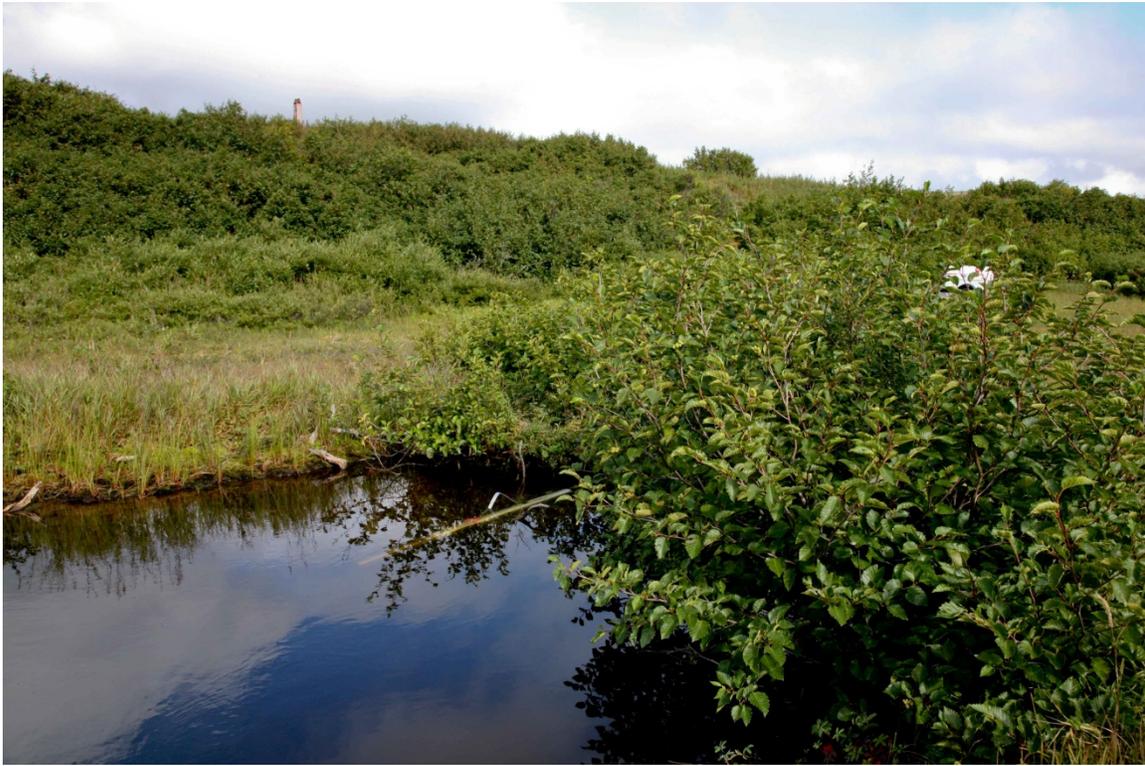
Drill Rig #4- Drill Hole Site #9453. Water Supply Intake

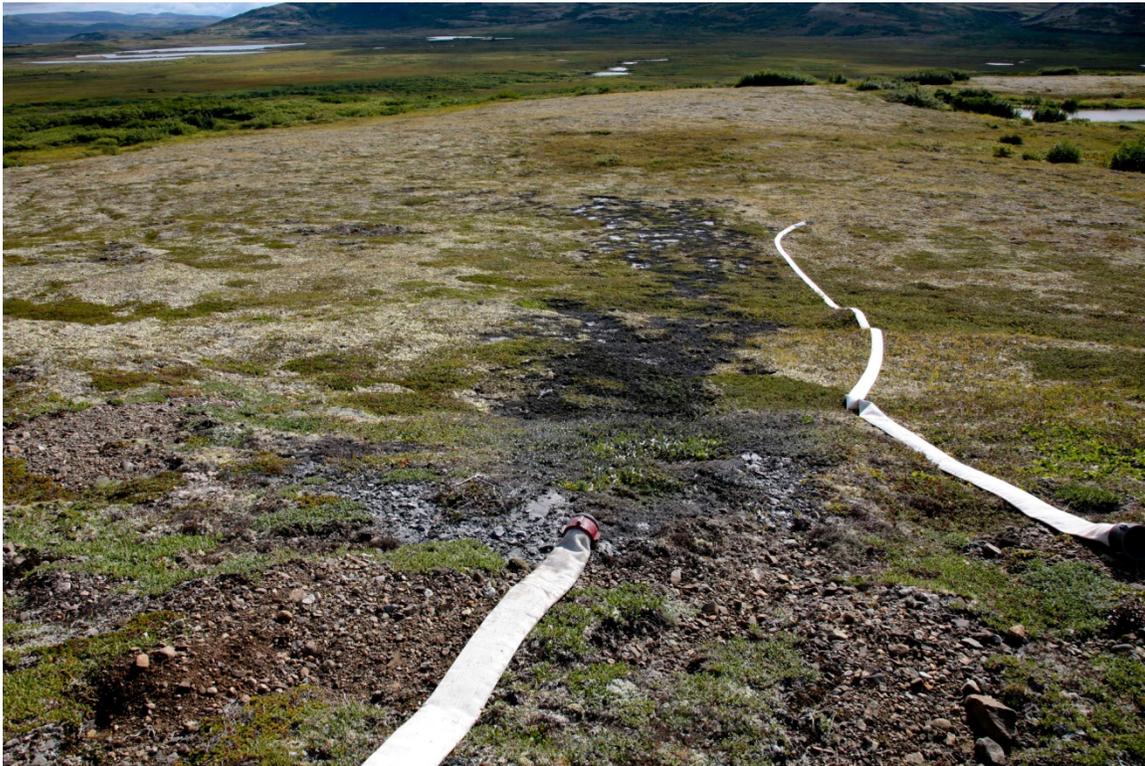
Drill Rig #4- Drill Hole Site #9453. Excess drilling-water discharge area.

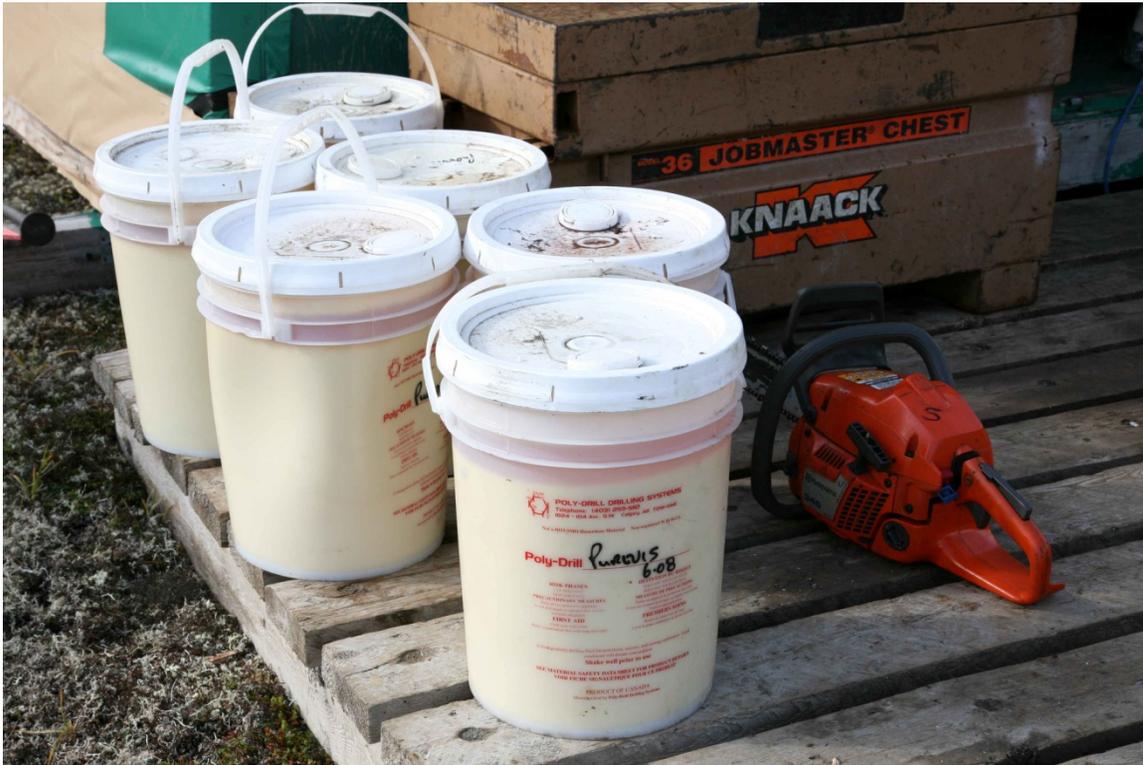
Drill Rig #4- Drill Hole Site #9453. Poly Drill "Purevis" drilling fluid.

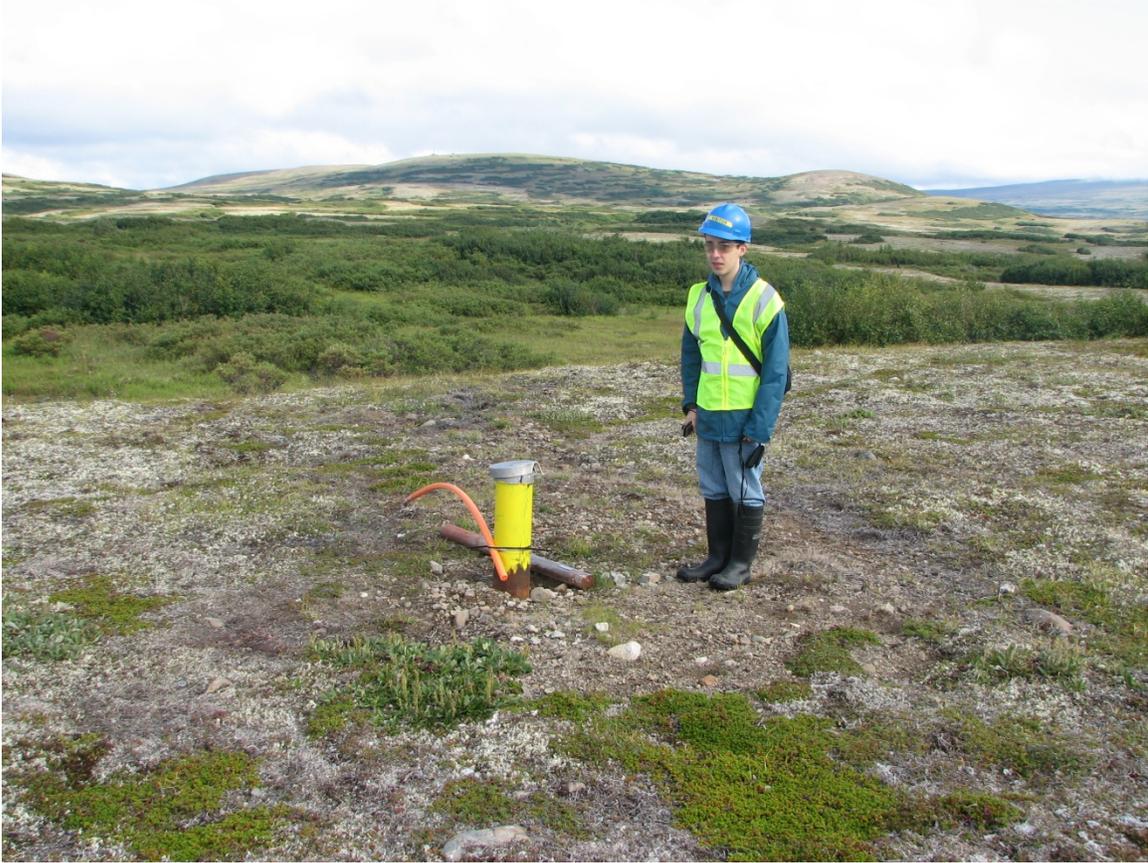
Monitoring Well No.: GH-05-59	Date: 8/19/09
■ Plugged: unable to determine	
■ Cemented: unable to determine	
■ Standing pipe: yes	
■ Sump pit filled in: yes	
■ Water discharge trench filled in: yes	
■ Site revegetated: yes	
■ Artesian water present: no	
■ Any spills or staining: no	
■ Comments/General impression: Overall the site was in very good condition and can be considered completely reclaimed. A small amount of hardened cement was lying near four feet from the collar.

Site #GH-05-59- Monitoring Well- Reclamation Complete

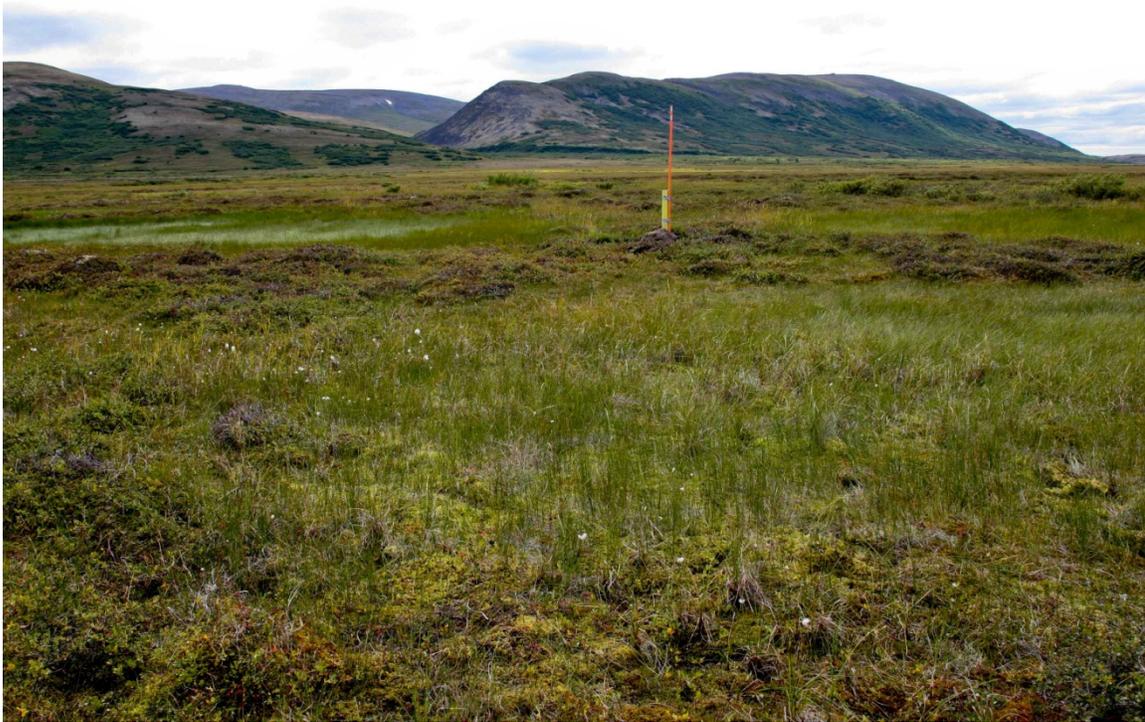
Monitoring Well No.: GH-08-123	Date: 8/19/09
<ul style="list-style-type: none"> ■ Plugged: no; piezometer tube present ■ Cemented: NA ■ Standing pipe: yes ■ Sump pit filled in: yes ■ Water discharge trench filled in: yes ■ Site revegetated: yes ■ Artesian water present: no ■ Any spills or staining: no ■ Comments/General impression: Site clean and no evidence of the drill site remaining.

#GH-08-123- Monitoring Well- Reclamation Complete

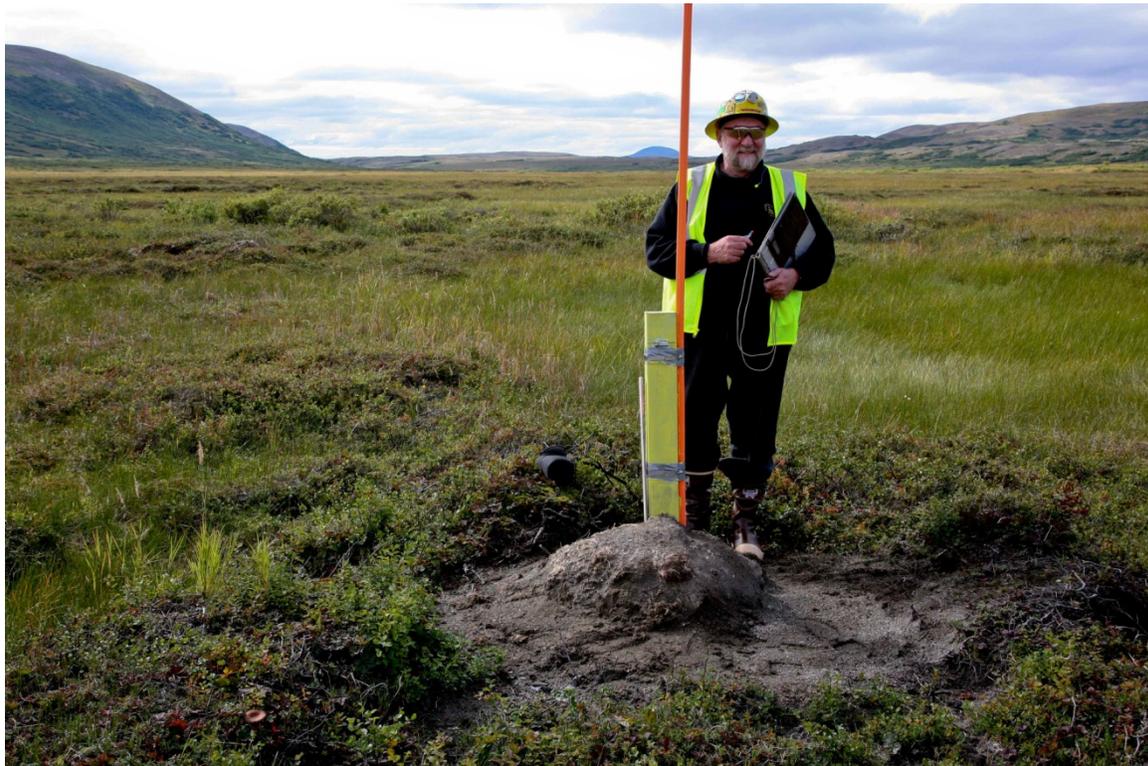
#GH-08-123- Monitoring Well Stickup.

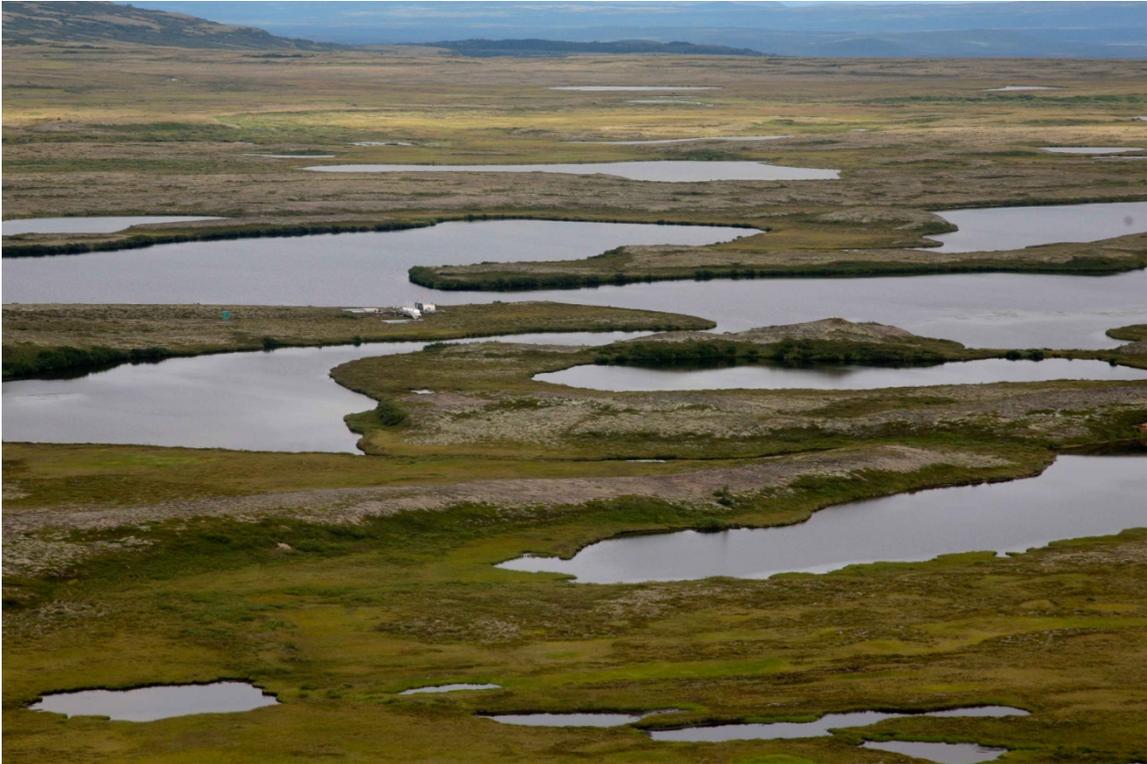
Big Wiggly Lake. Fuel depot in distance.

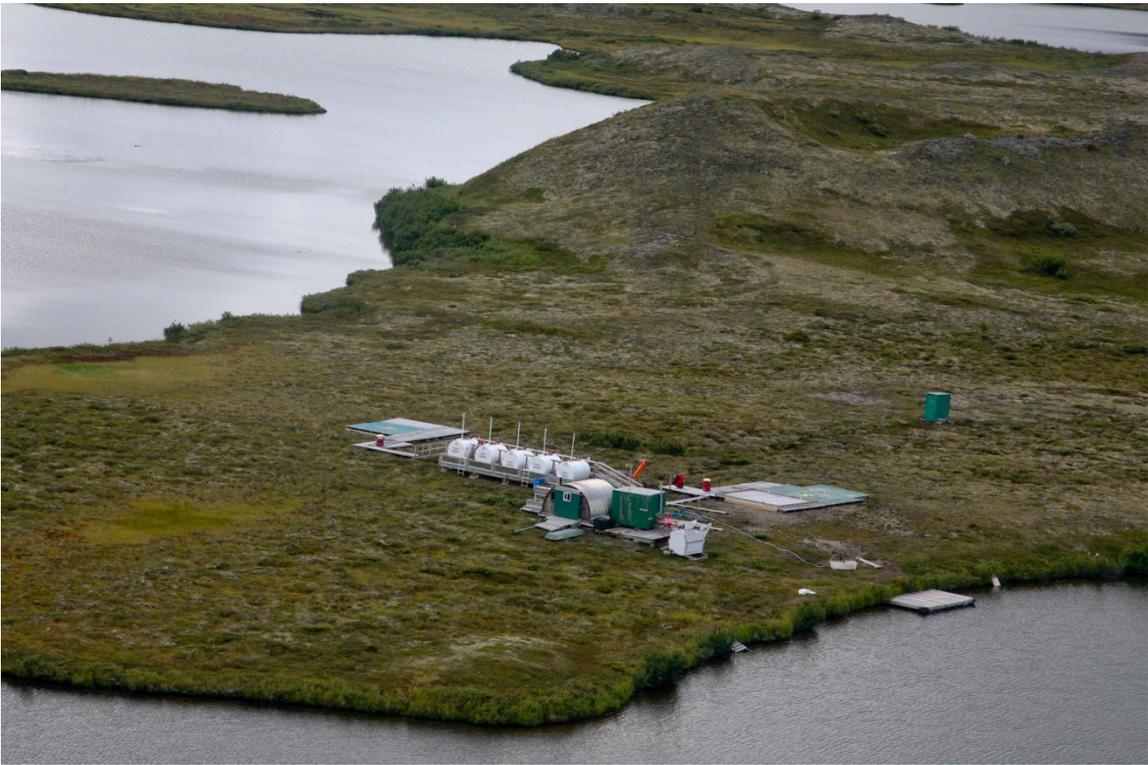
Big Wiggly Lake fuel depot and dock

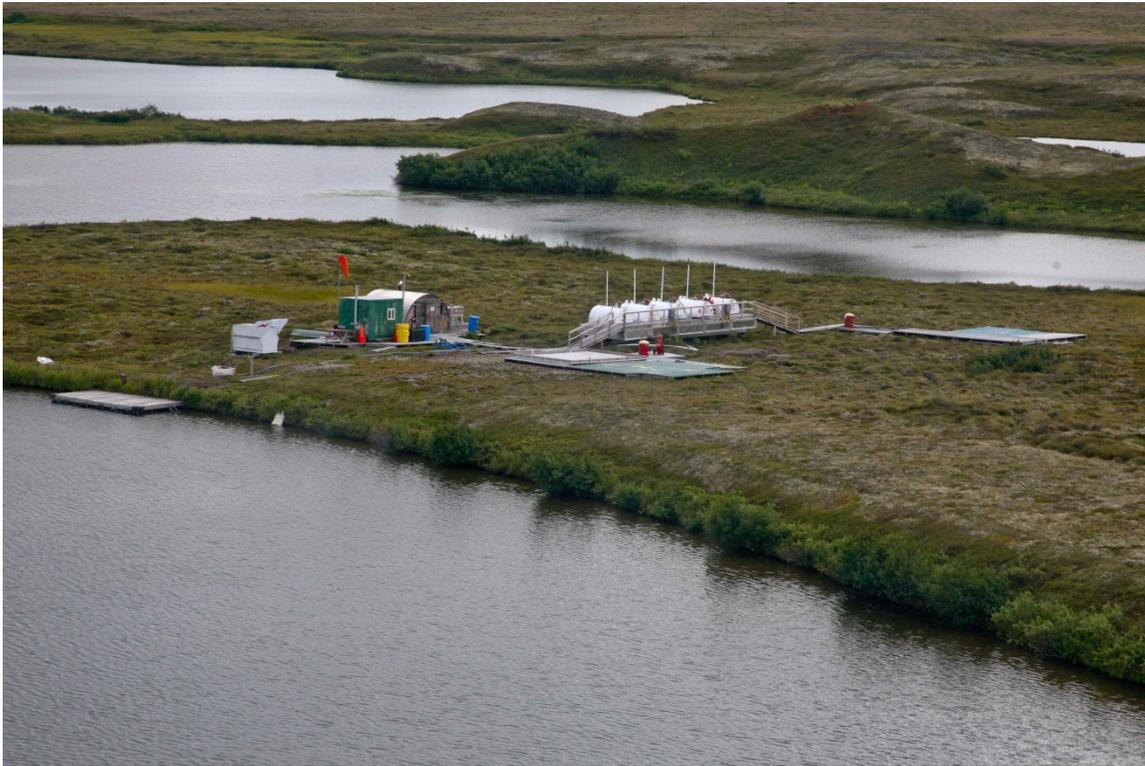
Big Wiggly Lake fuel depot and dock

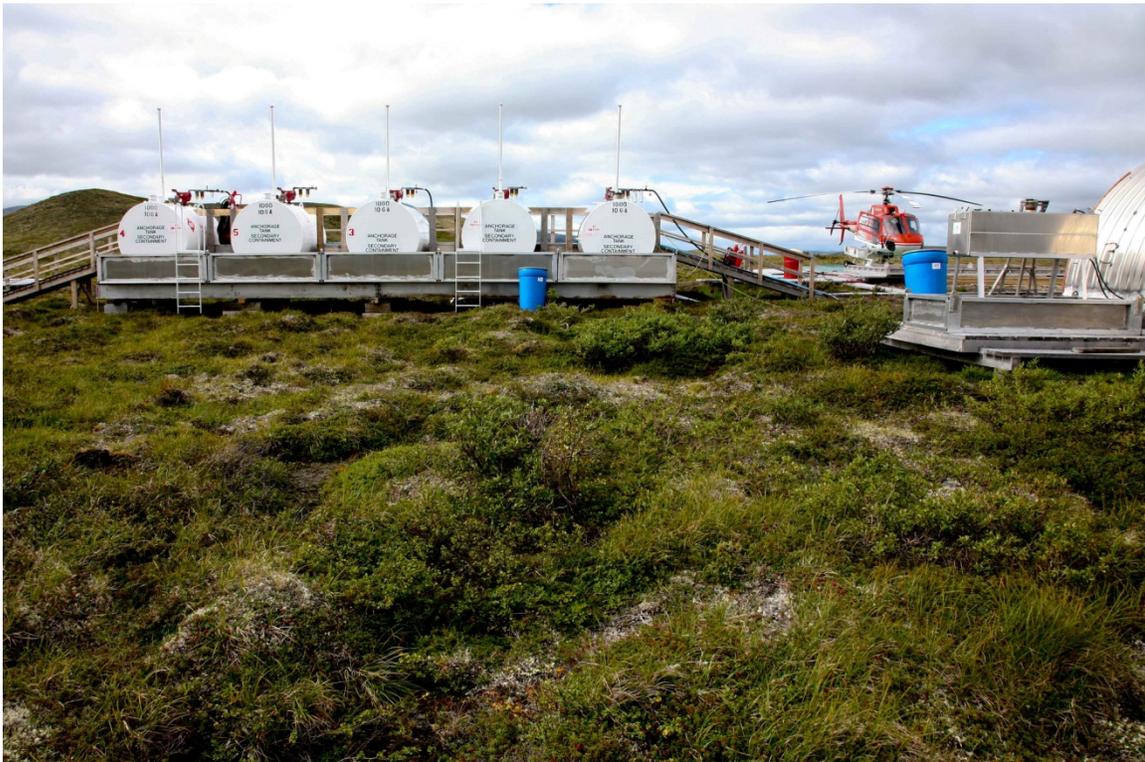
Big Wiggly Lake fuel depot. Fuel tanks and containment.

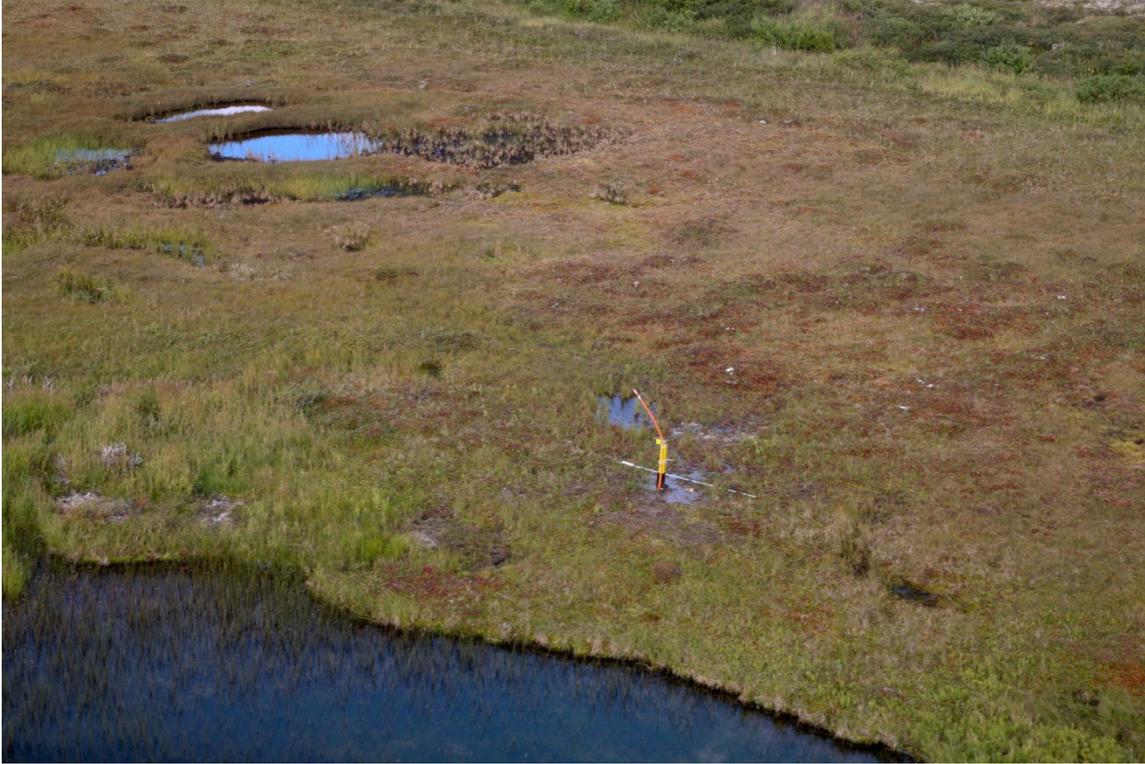
Area drilled in June 2009 -- very little evidence of disturbance except for drill collars.
