Field Monitoring Report -- Pebble Copper/Gold Exploration Project --

Personnel:	Inspection Date: August 19, 2009
Rick Fredericksen, Allan Nakanishi,	Site Contact: Gernot Wober
Travis Gingerich, Ruth Hamilton Heese	APMA #: A096118
	■ Wildlife Observed:
■ Inspection Type:	○ Bear: none observed
○ Complete: Drill rig #2, #3, and #4; abandoned drill sites, the staging area (camp); Big Wiggly fuel depot	○ Caribou: approx. 6 one mile NE of Frying Pan Lake
○ Partial:	○ Moose: none observed
○ Follow-up:	○ Waterfowl: two swans on edge of Big Wiggly Lake.
○ Response to Public Complaint:	○ Fish: none observed
	○ Other: ground squirrels
■ Weather Conditions:	
○ Temperature: 55 degrees F	■ Water level at Frying Pan Lake:
○ Wind: 2-3 knots	○ Observed inflow: ordinary high water
○ Precipitation: none	○ Observed outflow: ordinary high water
○ Visibility: 10-15 miles	
○ Sky Conditions: broken overcast (4800')	■ Water level at Big Wiggly Lake:
○ Ground Conditions: dry to wet	○ Ordinary high water

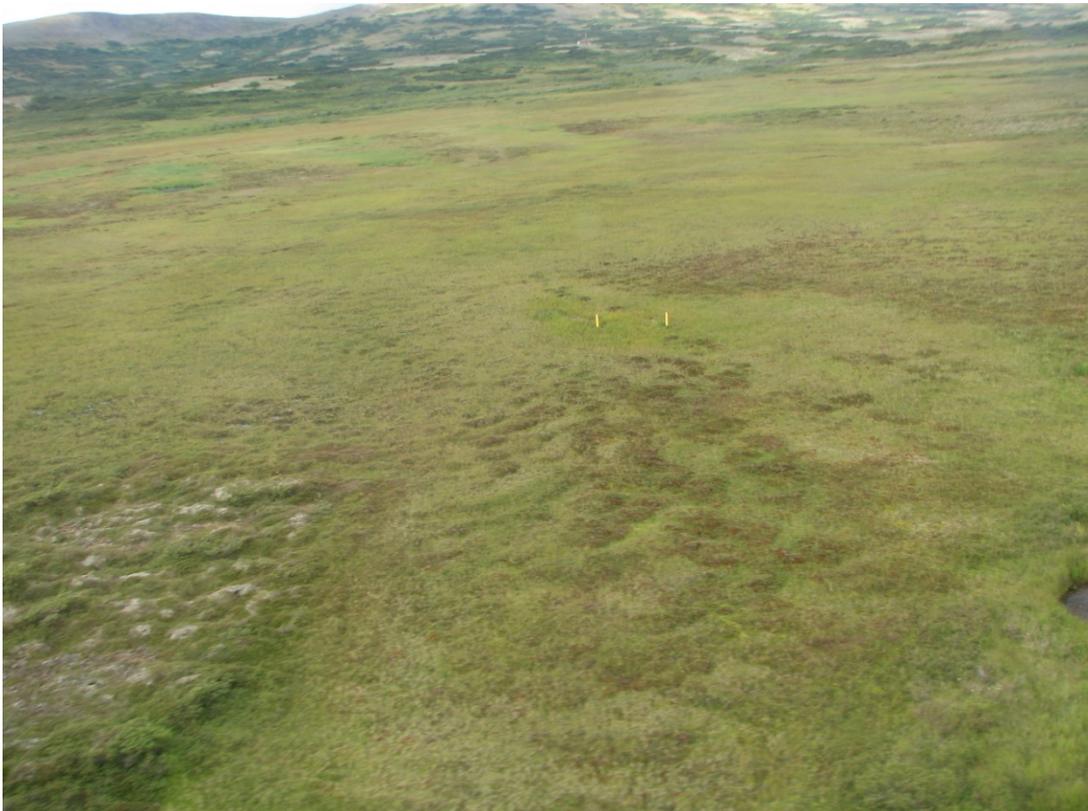
Area drilled in June 2009 -- very little evidence of disturbance except for drill collars.

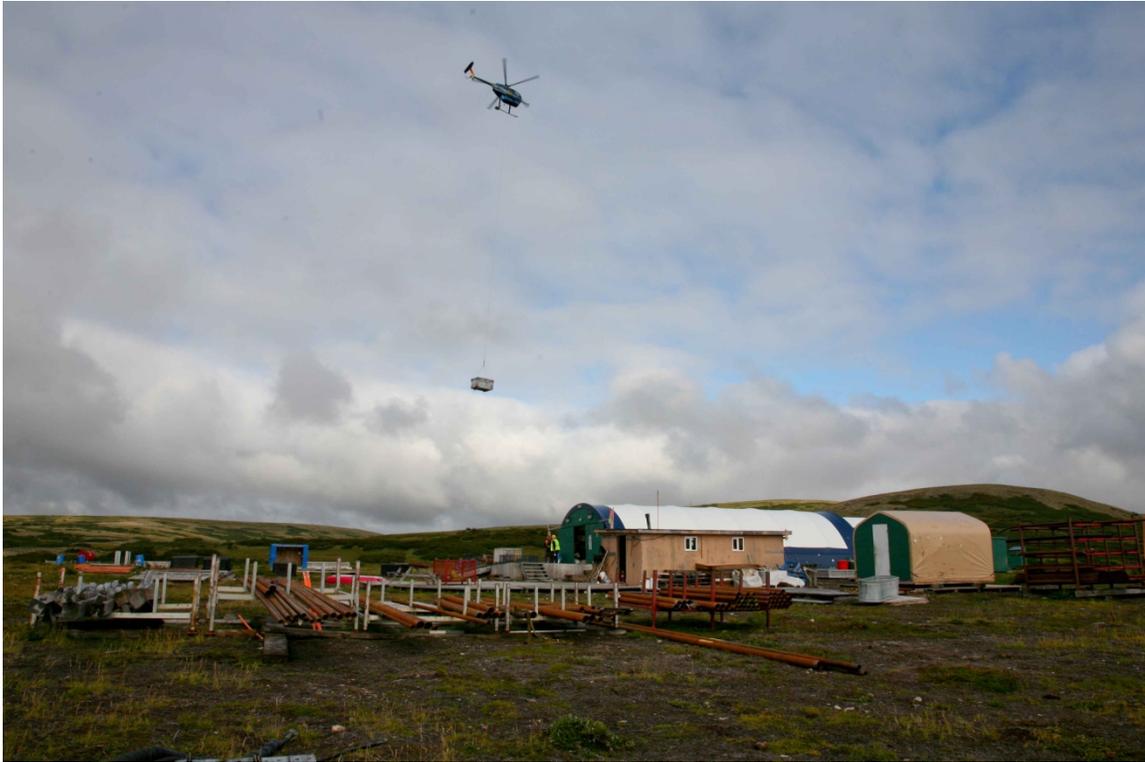
Equipment staging area.

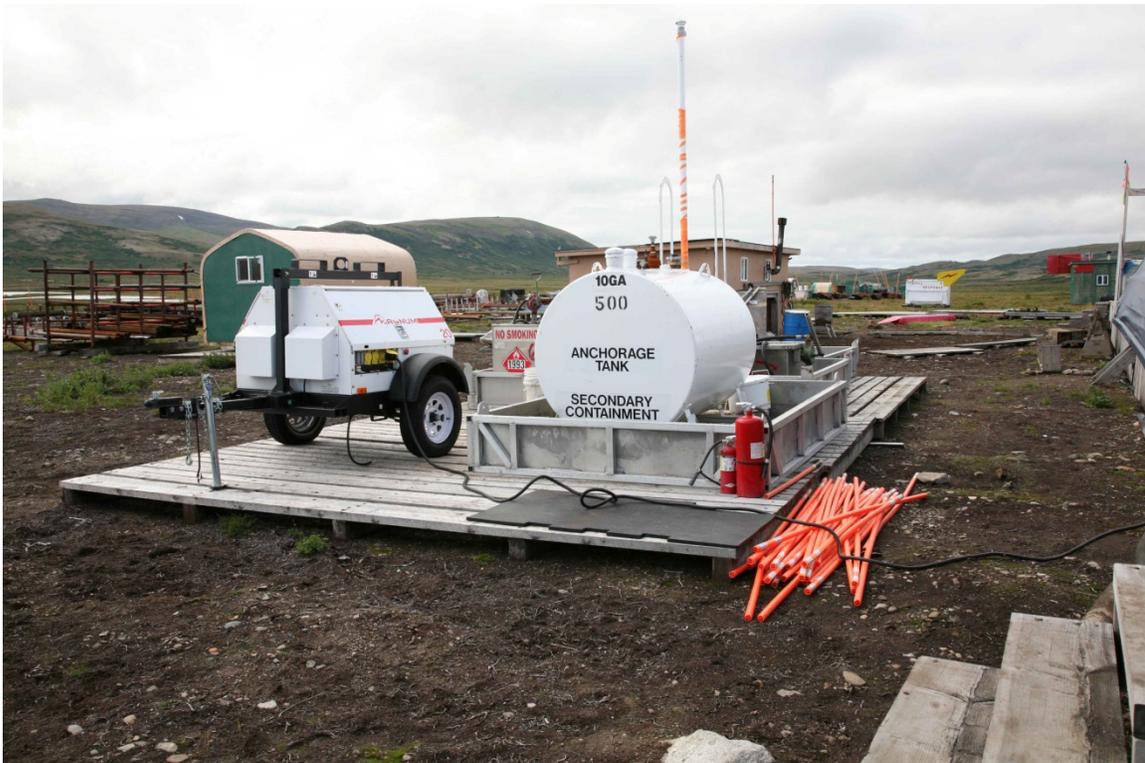
Equipment staging area. Fuel tank with secondary containment and generator.

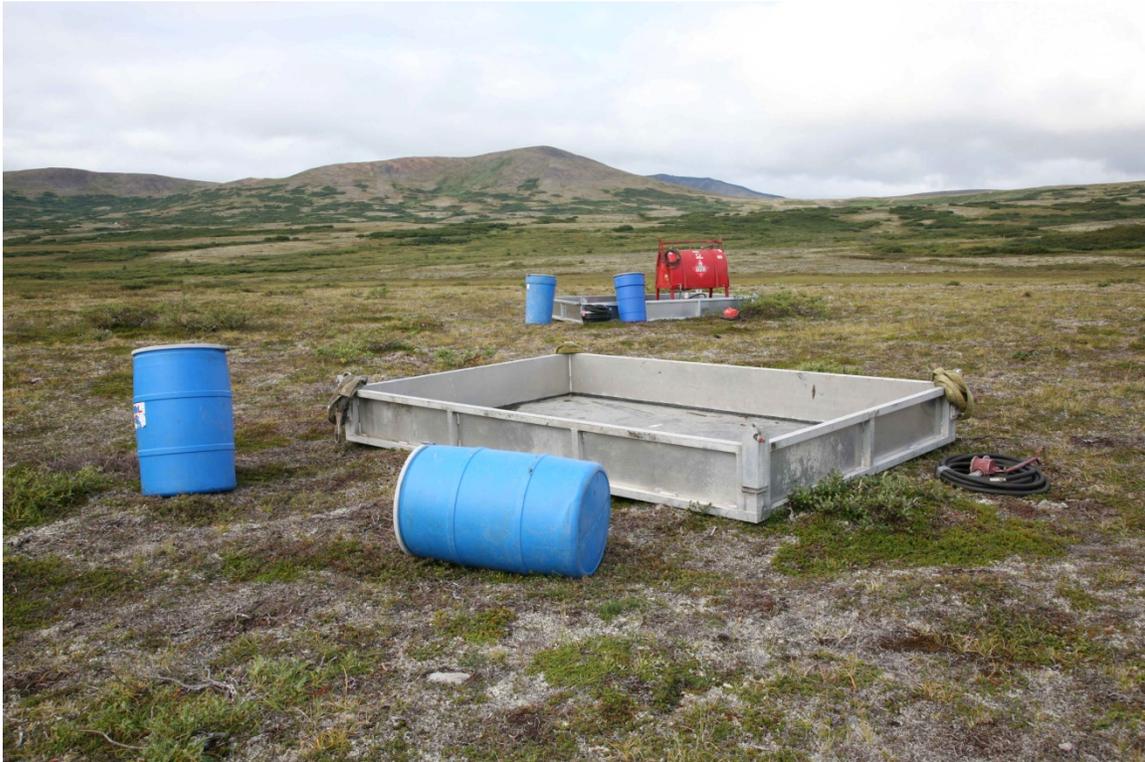
Equipment staging area. Fuel tanks with secondary containment. Note: over-turned blue drum was empty.

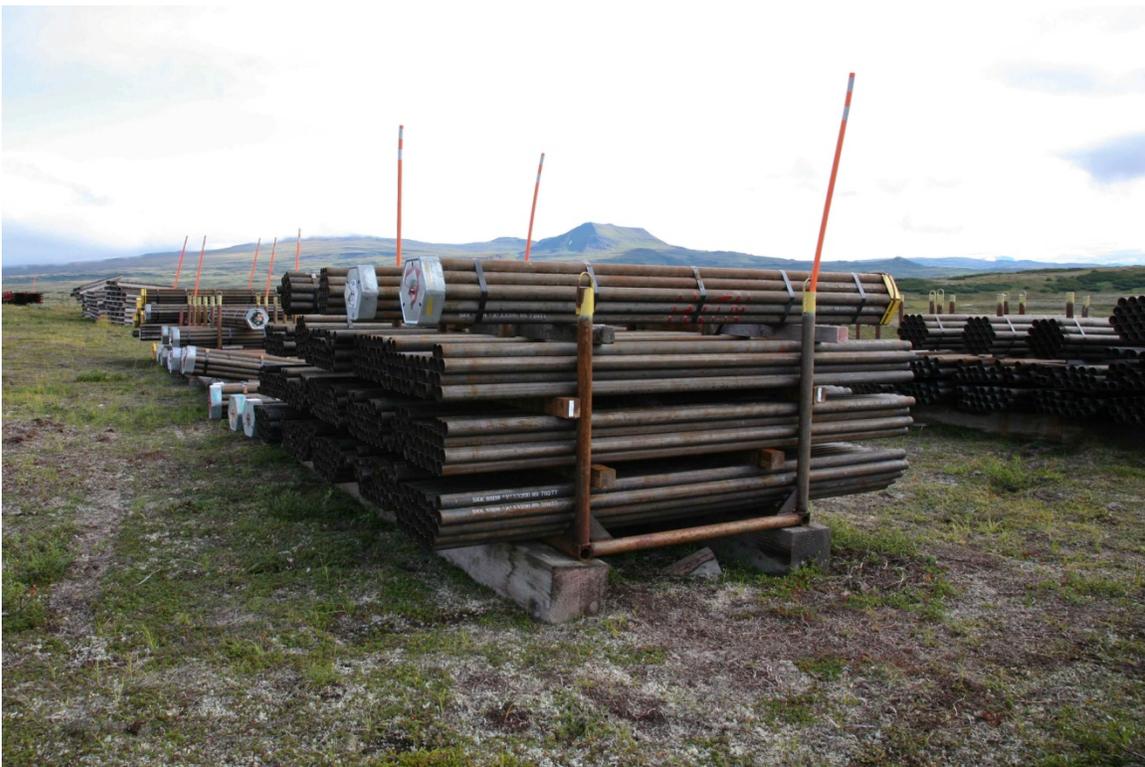
Equipment Staging Area. Drill steel.
